Your Ref: Toyota Alphard  
(chassis number AYH300121025)  
Our Ref : CI/TP23004208/D

**INSPECTION REPORT OF AN UNREGISTERED TOYOTA ALPHARD MOTOR CAR WITH CHASSIS NUMBER AYH300121025**

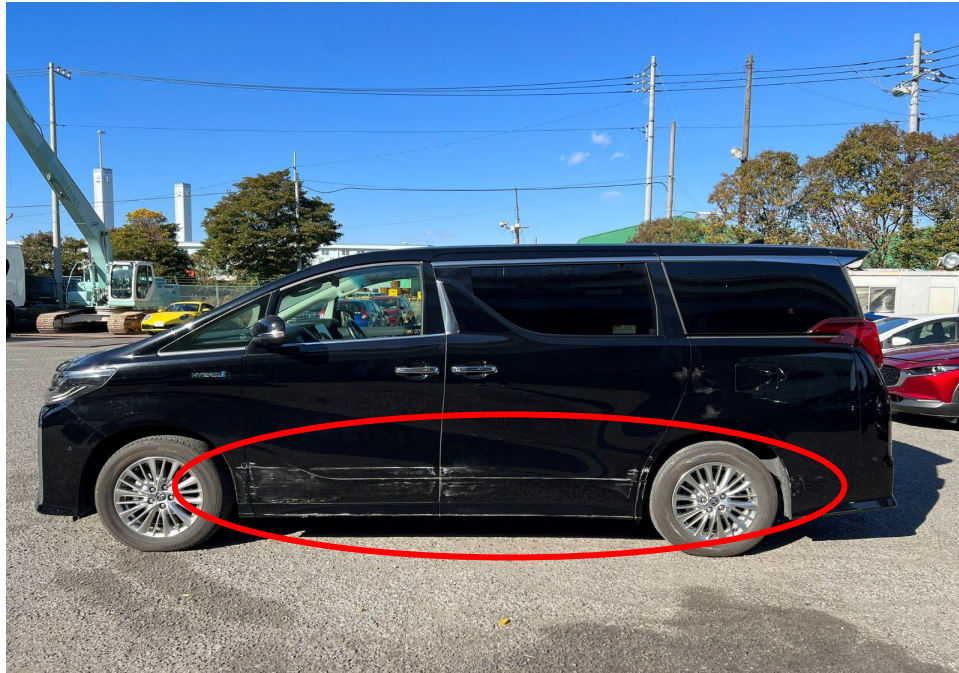
3. The photographs provided to me had showed damage to the left side portion of the Motor Car. The front left fender, front left door, front left door lower moulding, rear left door, rear left door lower moulding, rear left fender and rear bumper were observed to be damaged.
4. No physical damage was observed to other areas of the Motor Car. The airbag(s) of the Motor Car was not deployed as seen from the photographs that were provided to me. See photo 1 – 4 below.

**Photo 1** shows the left side body of the Motor Car (photograph provided to me). The Motor Car was observed to have sustained damage at its left side portion (circled). The front left fender, front left door, front left door lower moulding, rear left door, rear left door lower moulding, rear left fender and rear bumper were observed to be damaged. The airbag(s) of the Motor Car was not deployed.

22. The body parts at the left side portion of the Motor Car were visually examined and it was noted that the repair/restoration works carried out to the damaged area of the Motor Car (refer to photograph 1 above) were reasonably adequate and in order.

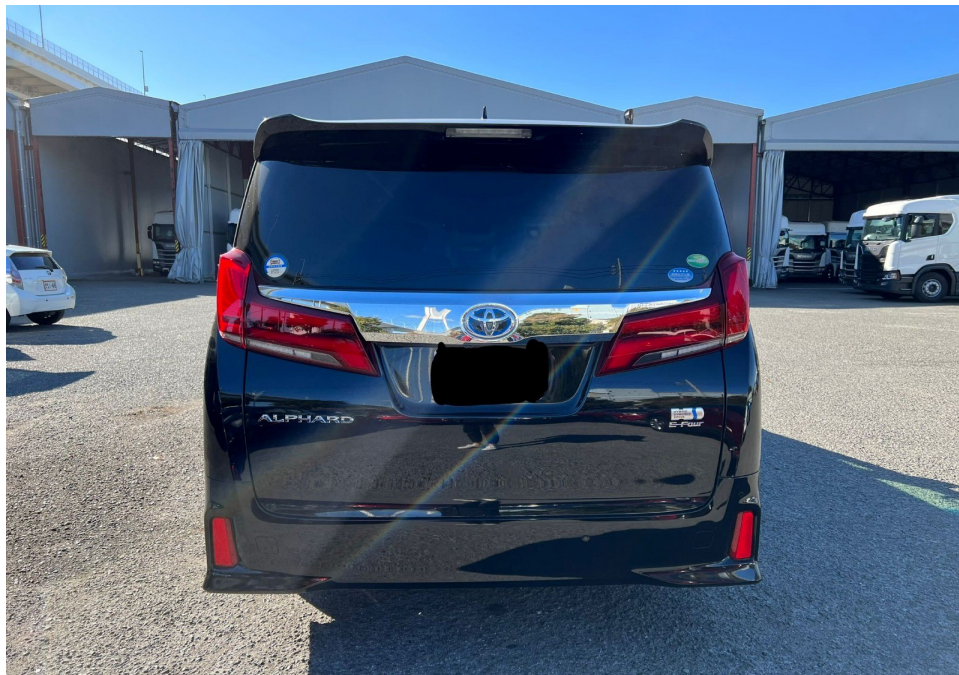
**Photo 2** shows the rear body of the Motor Car (photograph provided to me). Apart for the left side portion, the photographs provided to me did not show physical damage to other areas of the Motor Car.

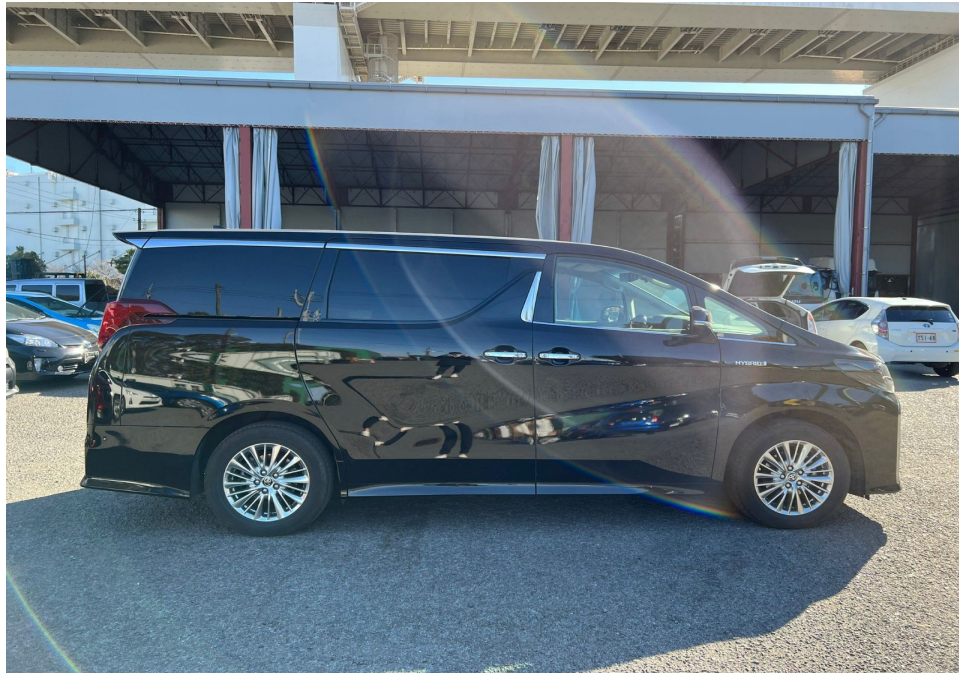
**Photo 3** shows the right side body of the Motor Car (photograph provided to me). Apart for the left side portion, the photographs provided to me did not show physical damage to other areas of the Motor Car. The airbag(s) of the Motor Car was not deployed.

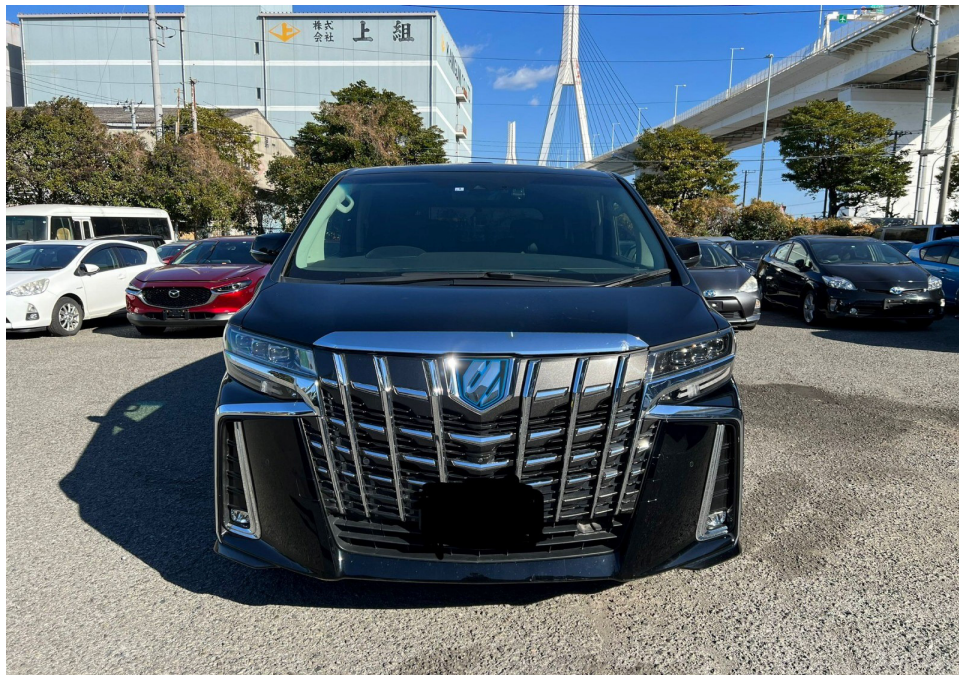
**Photo 4** shows the frontal body of the Motor Car (photograph provided to me). Apart for the left side portion, the photographs provided to me did not show physical damage to other areas of the Motor Car. The airbag(s) of the Motor Car was not deployed.

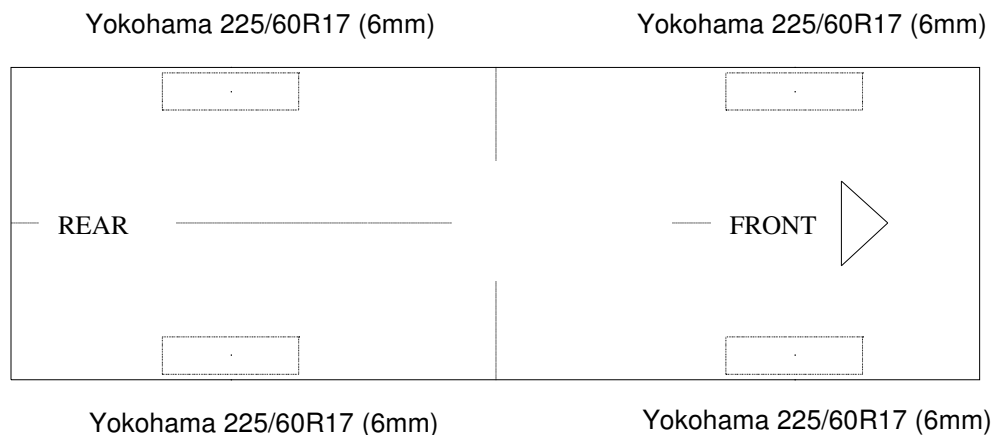
8. It was fitted with 17inch sport wheel rims that were wrapped with tyres that were observed to be of serviceable condition. The tyres were also sufficiently inflated for vehicular operation. The tyre brand, tyre size and approximate remaining tread depth of the 4 tyres of the Motor Car were recorded as follows: -

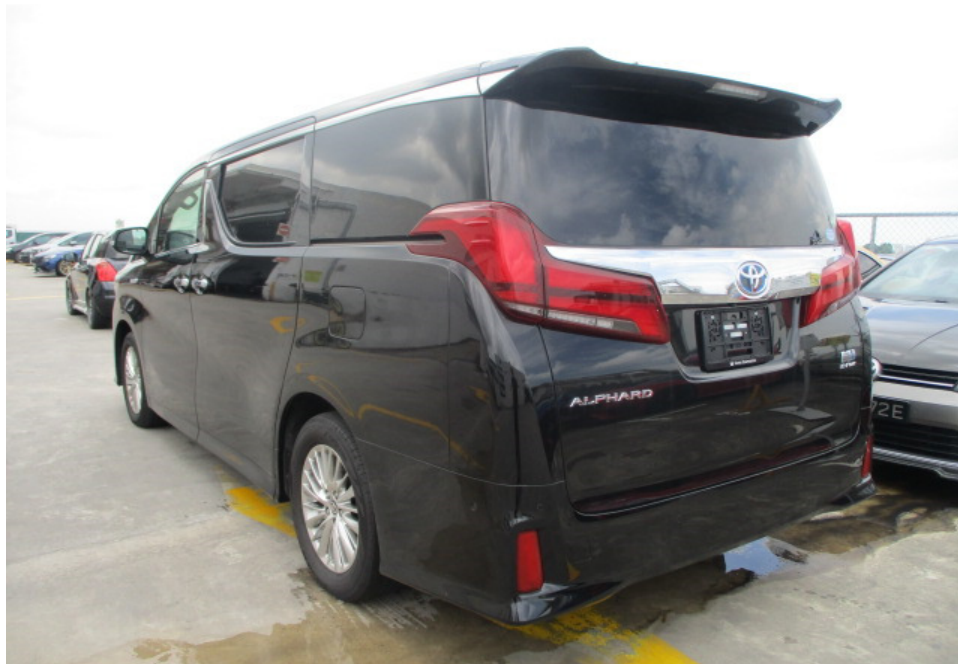
**Photo 5** shows a general view of the rear left body of the Motor Car at the time of my inspection. The Motor Car was observed to be in a relatively good general condition with no loose exterior fittings observed. The body parts at the left side portion of the Motor Car were visually examined and it was observed that the repair/restoration works carried out to the damaged area of the Motor Car (refer to photograph 1 above) were reasonably adequate and in order.

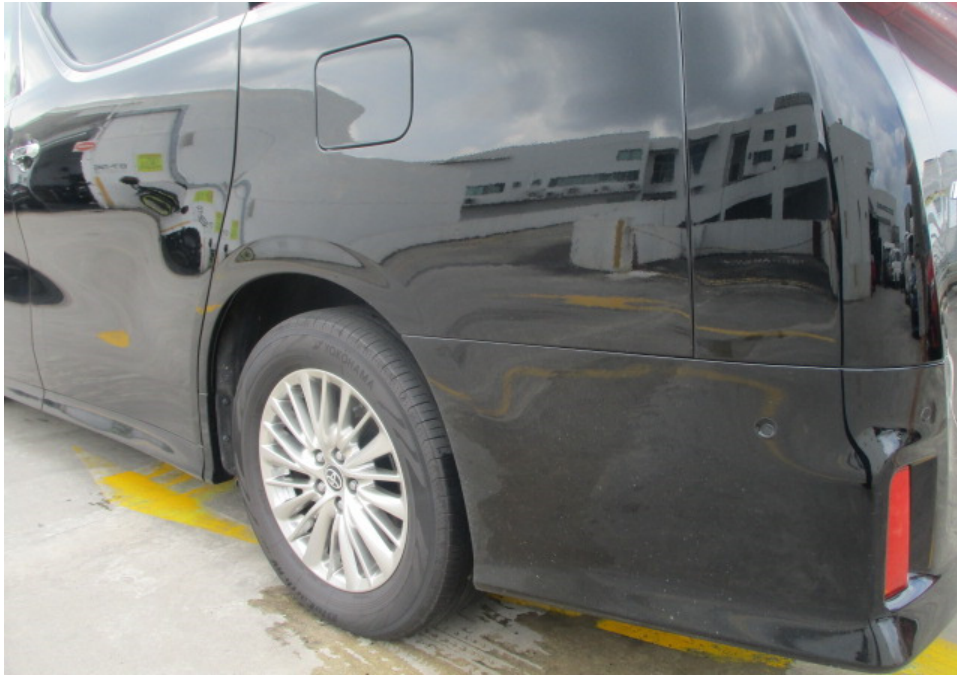
**Photo 6** shows a closer view of the Motor Car's rear bumper, rear left wheel rim and rear left fender. The body parts at the left side portion of the Motor Car were visually examined and it was observed that the repair/restoration works carried out to the damaged area of the Motor Car (refer to photograph 1 above) were reasonably adequate and in order.

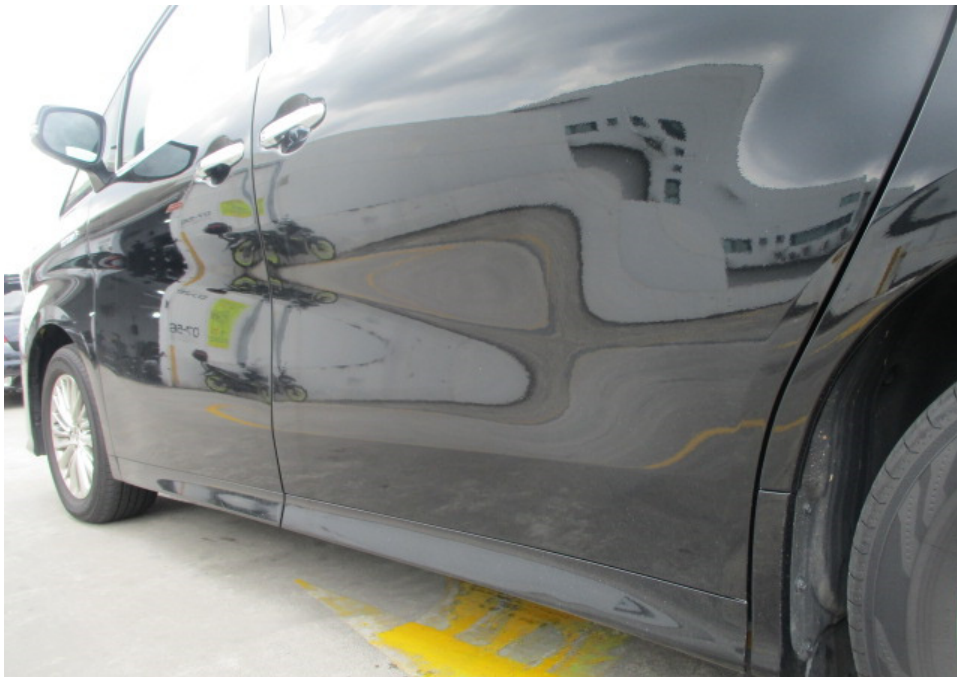
**Photo 7** shows a closer view of the Motor Car's rear left fender, rear left door and rear left door lower moulding. The body parts at the left side portion of the Motor Car were visually examined and it was observed that the repair/restoration works carried out to the damaged area of the Motor Car (refer to photograph 1 above) were reasonably adequate and in order.

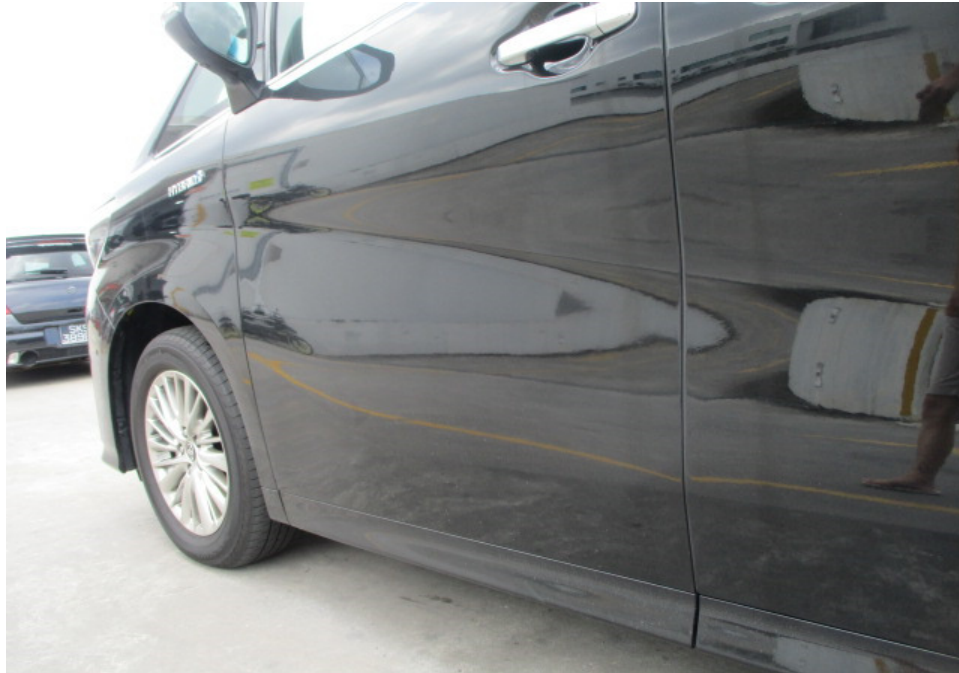
**Photo 8** shows a closer view of the Motor Car's front left door, front left door lower moulding and front left fender. The body parts at the left side portion of the Motor Car were visually examined and it was observed that the repair/restoration works carried out to the damaged area of the Motor Car (refer to photograph 1 above) were reasonably adequate and in order.

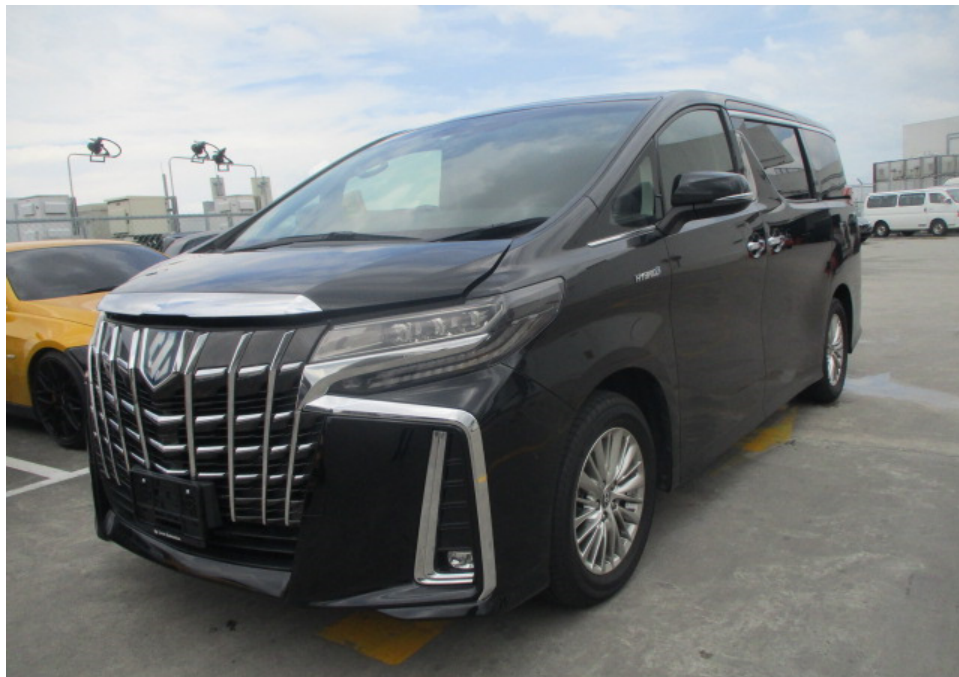
**Photo 9** shows a general view of the front left body of the Motor Car at the time of my inspection. The Motor Car was observed to be in a relatively good general condition with no loose exterior fittings observed. The body parts at the left side portion of the Motor Car were visually examined and it was observed that the repair/restoration works carried out to the damaged area of the Motor Car (refer to photograph 1 above) were reasonably adequate and in order.

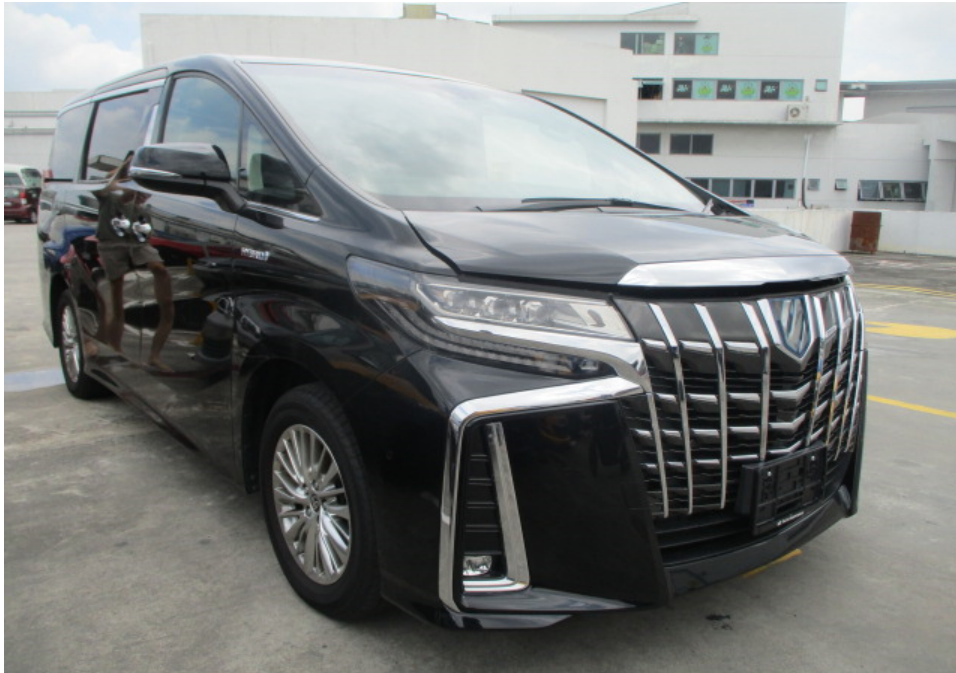
**Photo 10** shows a general view of the front right body of the Motor Car at the time of my inspection. The Motor Car was observed to be in a relatively good general condition with no loose exterior fittings observed. The mileage of the Motor Car recorded at the time of my inspection was 701km.

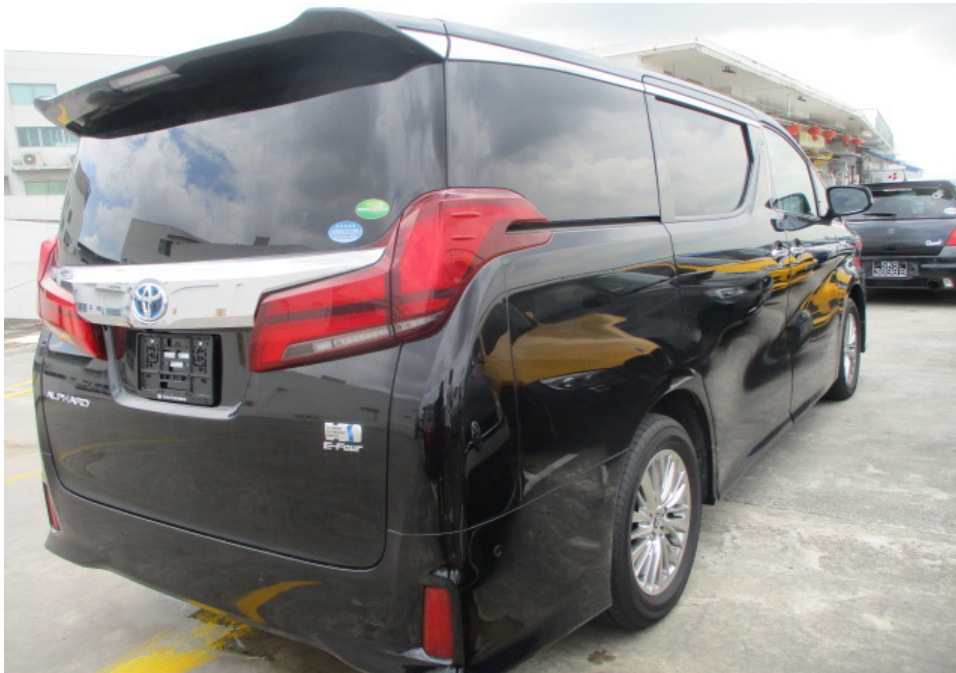
**Photo 11** shows a general view of the rear right body of the Motor Car at the time of my inspection. The Motor Car was observed to be in a relatively good general condition with no loose exterior fittings observed. The mileage of the Motor Car recorded at the time of my inspection was 701km.

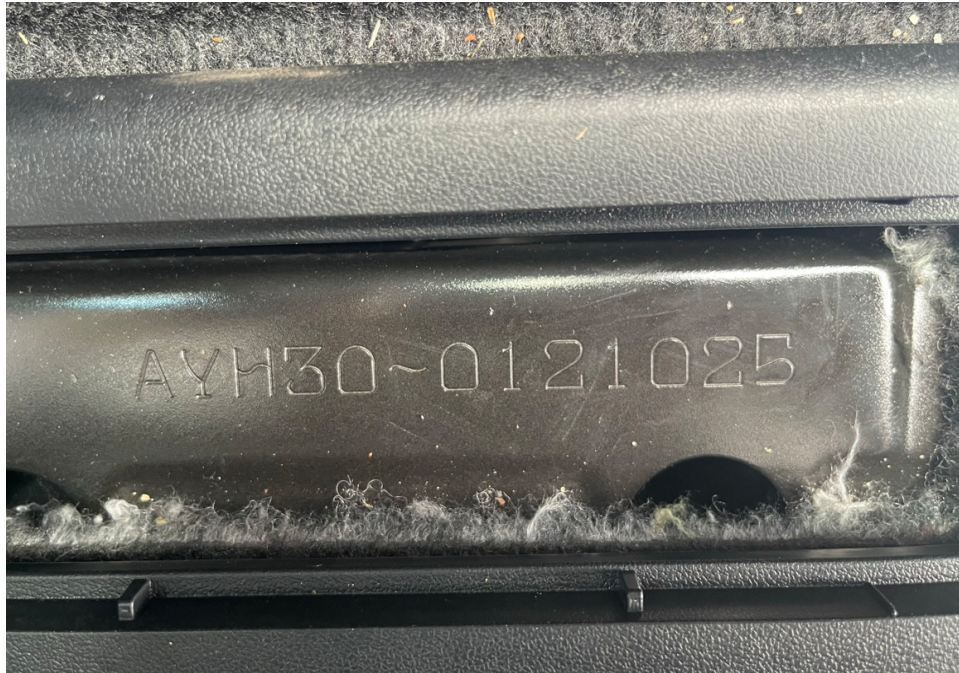
**Photo 12** shows the chassis number of the Motor Car. The chassis number recorded was AYH300121025.

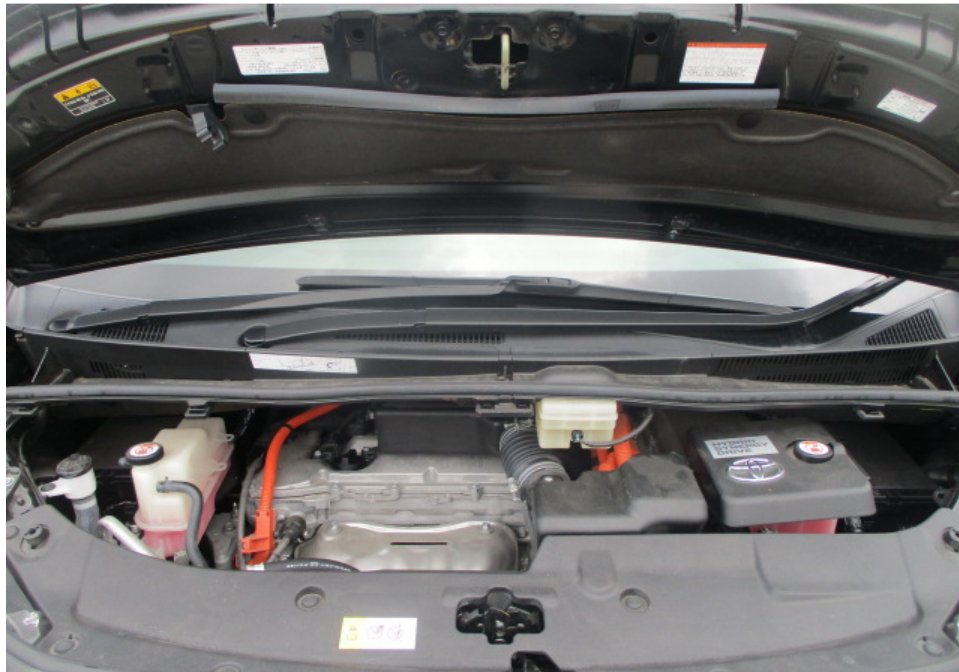
**Photo 13** shows a general view of the engine compartment of the Motor Car at the time of my inspection. The various parts and components inside the engine compartment were all observed to be intact and properly fitted. There was no sign(s) or indication(s) of fluid leak and/or fluid stain found inside the engine compartment.

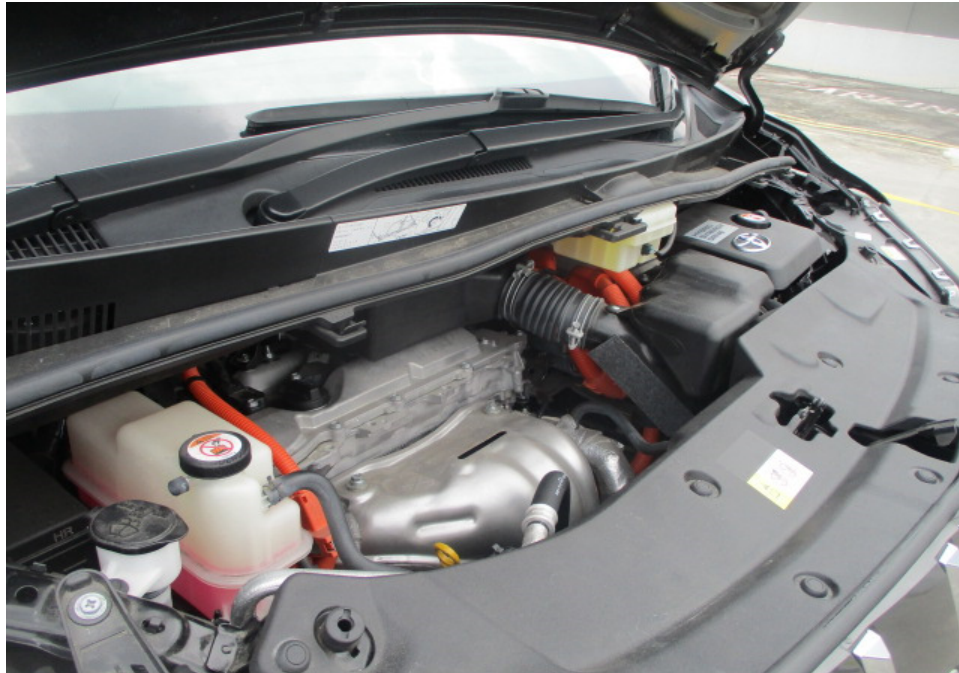
**Photo 14** shows another view of the engine compartment of the Motor Car at the time of my inspection. The various parts and components inside the engine compartment were all observed to be intact and properly fitted. There was no sign(s) or indication(s) of fluid leak and/or fluid stain found inside the engine compartment.

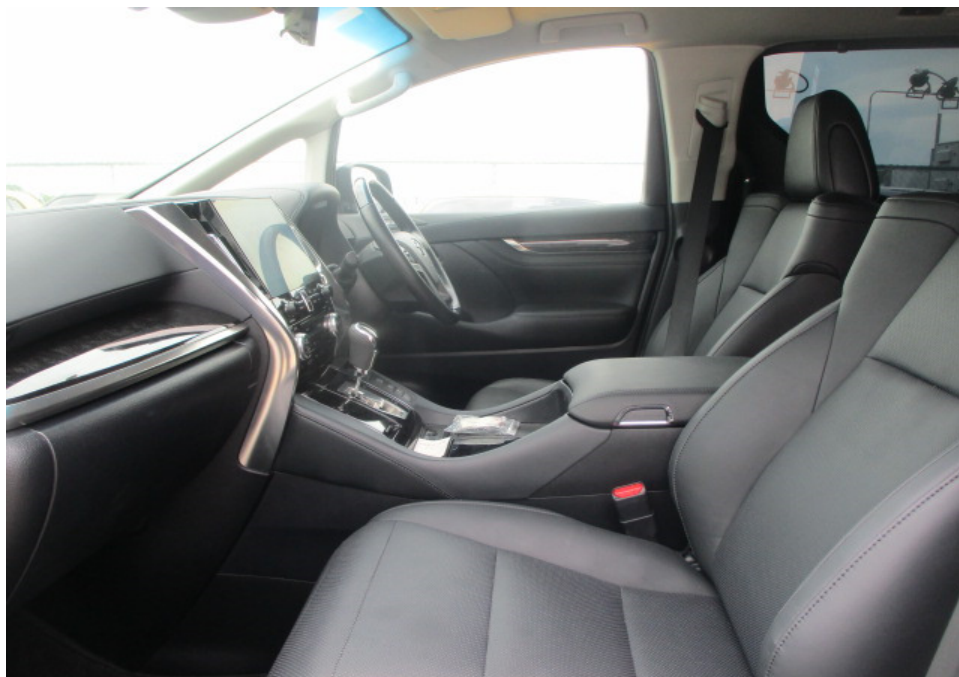
**Photo 15** shows the interior compartment of the Motor Car at the time of my inspection. The various parts and components, trims, carpet and upholstery inside the interior compartment were all observed to be intact and properly fitted.

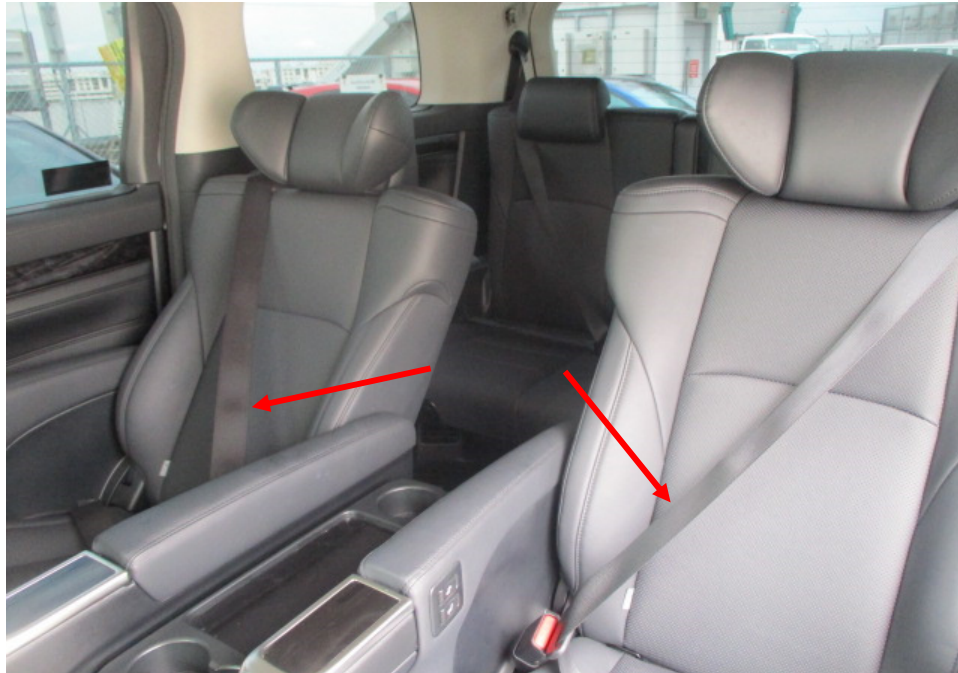
**Photo 16** shows the rear seats at the 1<sup>st</sup> row of the Motor Car. All the seats of the Motor Car were secured via seat rails to the floorboard. They were also fitted with a retractable seat belt reel and a pre-tensioner. The seat belts (arrowed) were tested and were able to be fastened into the respective pre-tensions that were fitted on the side of each individual seat.

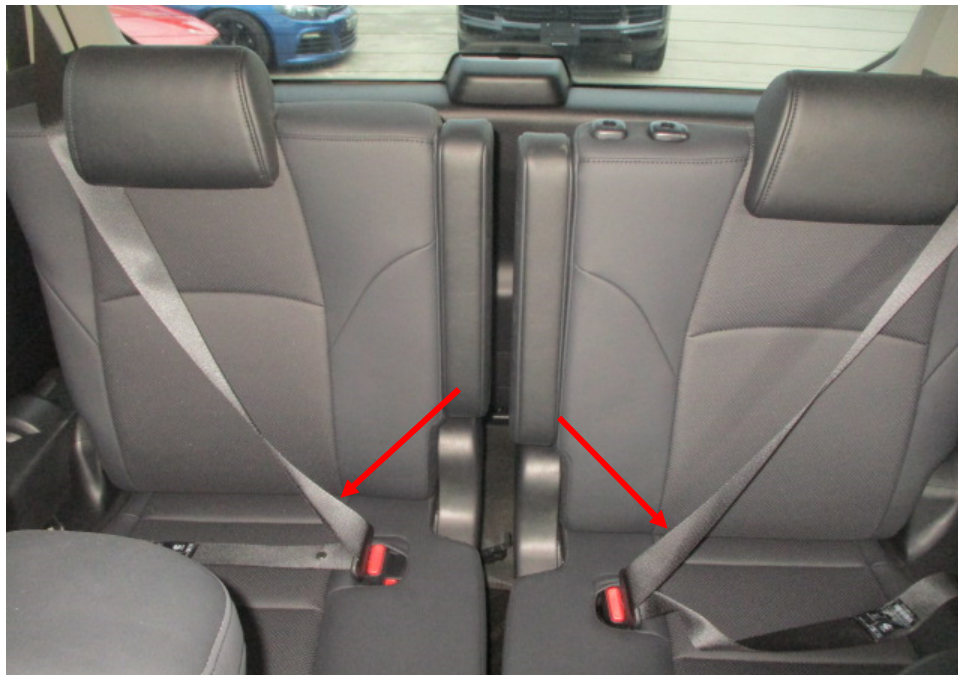
**Photo 17** shows the rear seats at the 2<sup>nd</sup> row of the Motor Car. All the seats of the Motor Car were secured via seat rails to the floorboard. They were also fitted with a retractable seat belt reel and a pre-tensioner. The seat belts (arrowed) were tested and were able to be fastened into the respective pre-tensions that were fitted on the side of each individual seat.

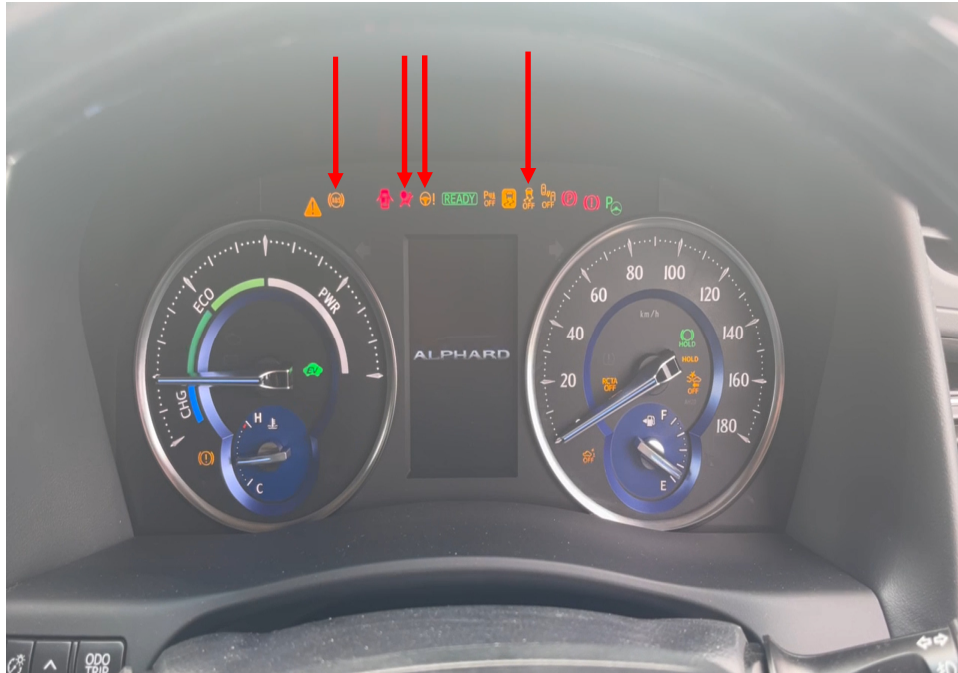
**Photo 18** shows the warning lights for the various electronic safety features appearing on the instrument panel of the Motor Car during its self-test when the engine is cranked, in particular the lights for the ABS, SRS, EPS, VSC (arrowed) and the various collision prevention systems.

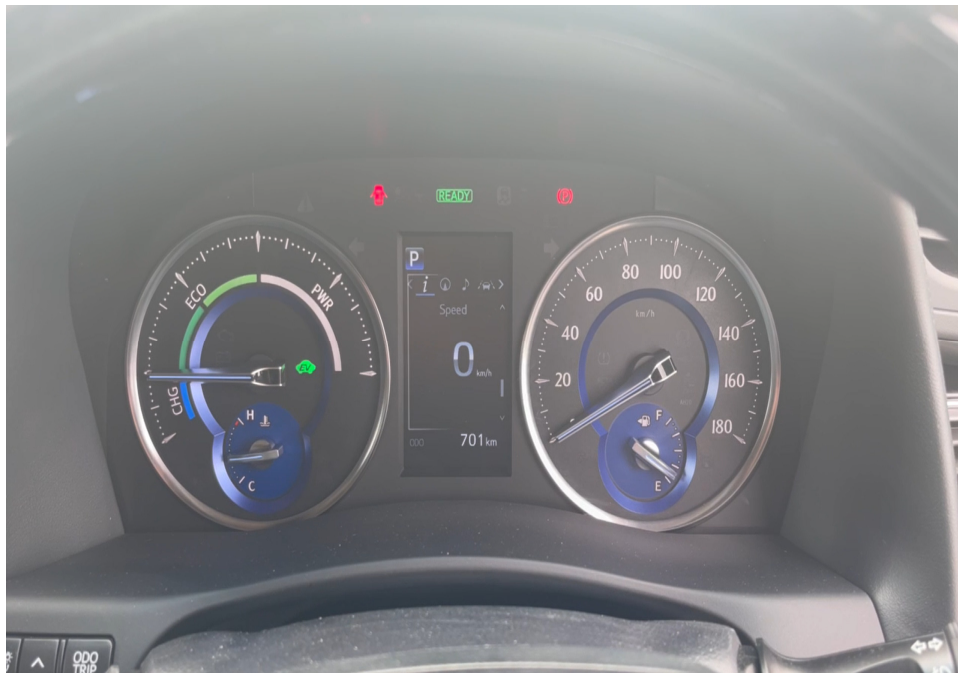
**Photo 19** shows the respective warning lights no longer illuminated, indicating that there is no fault detected to the ABS, SRS, EPS, VSC and the various collision prevention systems of the Motor Car during the self-test. These electronic systems were hence in working condition at the time of my inspection.

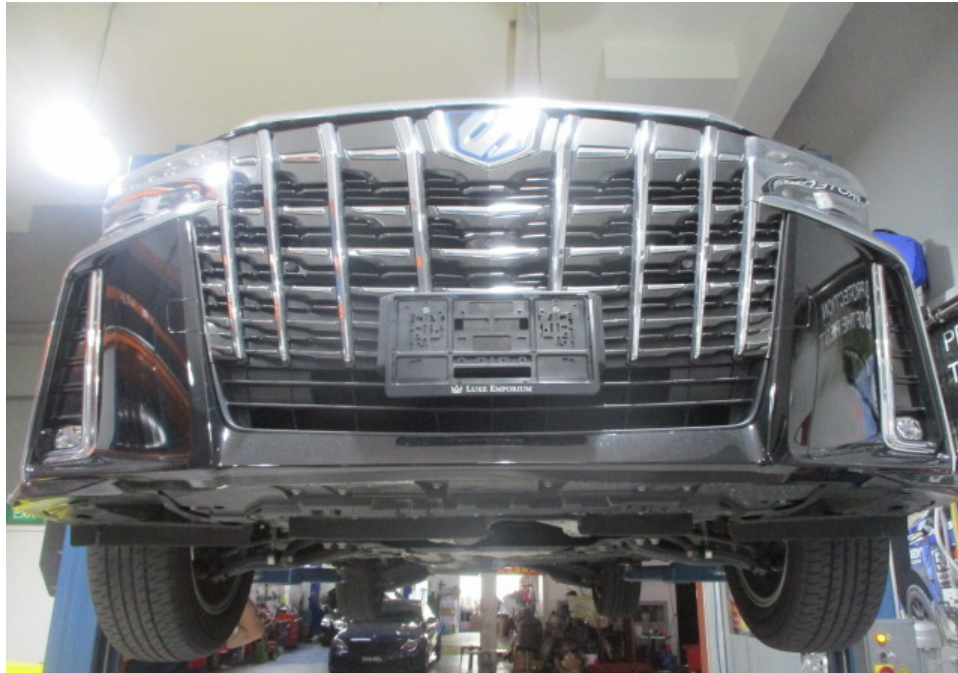
**Photo 20** shows the Motor Car hoisted up for checks on its undercarriage. There was no sign(s) or indication(s) of fluid leakage and/or fluid stain(s) on the underside of the Motor Car. The undercarriage components of the Motor Car were also all observed to be intact and secured in an appropriate manner.

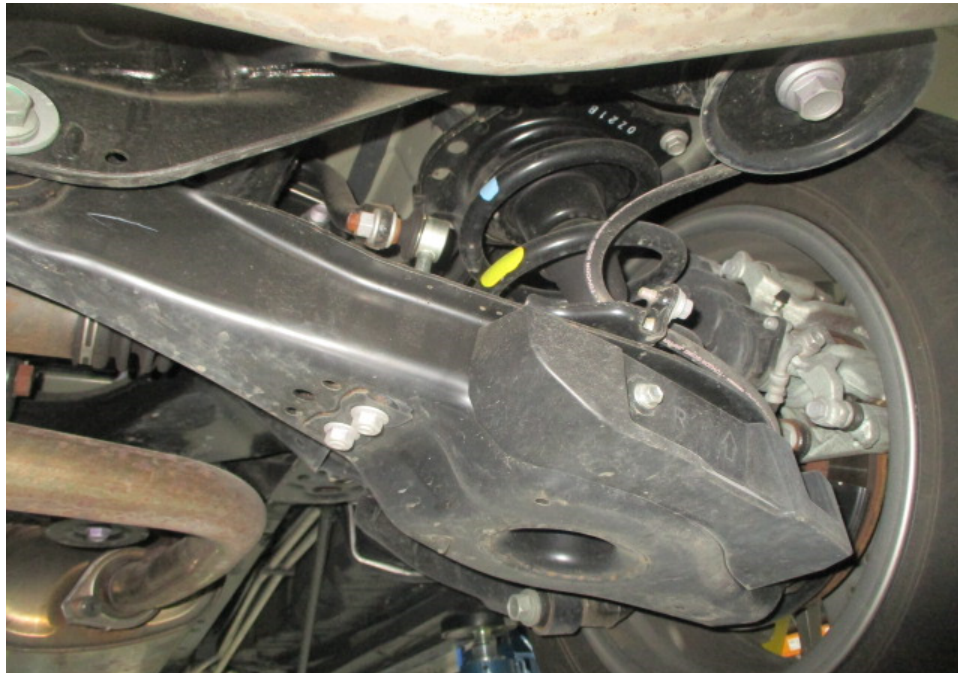
**Photo 21** shows a general view of the control arms and linkages at the rear right wheel of the Motor Car. I did not observe any fluid leak and/or fluid stain on the underside of the Motor Car. All of the Motor Car's undercarriage components were observed to be intact and secured in an appropriate manner.

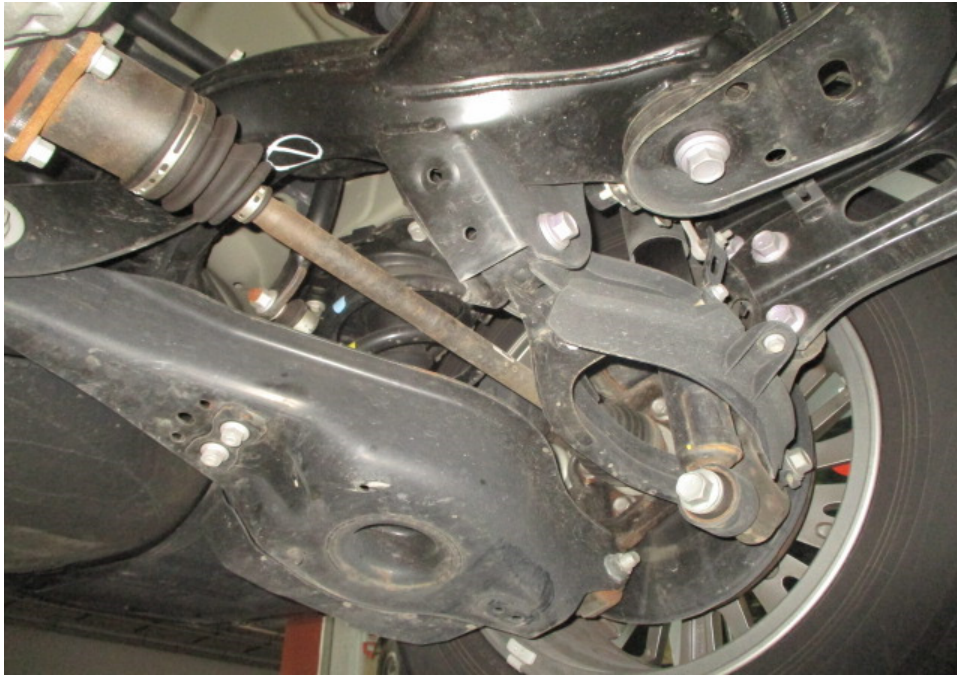
**Photo 22** shows a general view of the control arms and linkages at the rear left wheel of the Motor Car. I did not observe any fluid leak and/or fluid stain on the underside of the Motor Car. All of the Motor Car's undercarriage components were observed to be intact and secured in an appropriate manner.

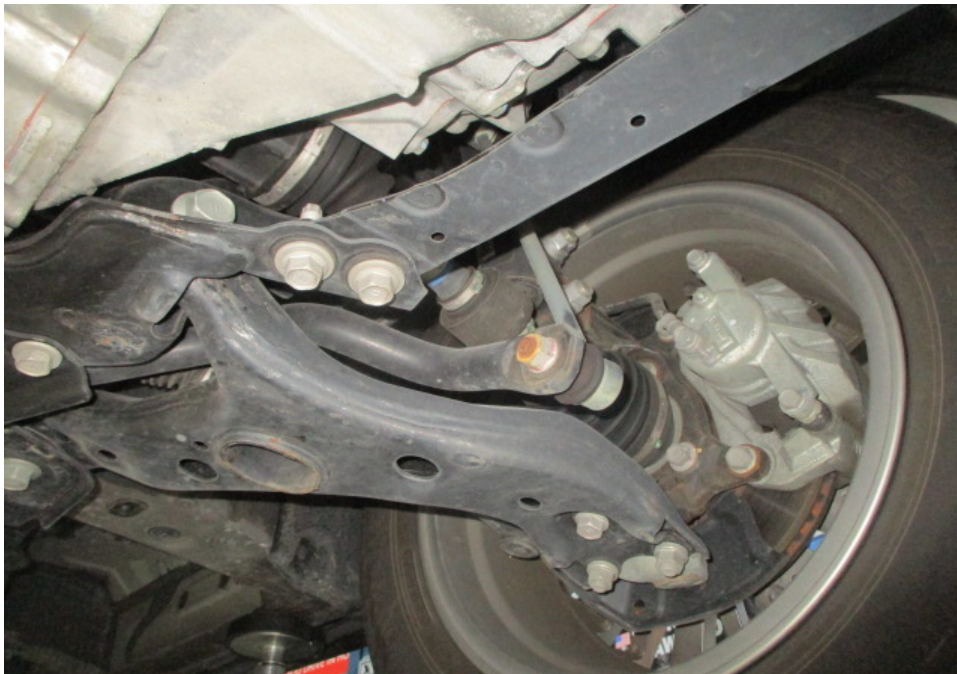
**Photo 23** shows the various undercarriage components at the front left wheel of the Motor Car. The mechanical components, control arms and linkages were all found to be intact and secured in an appropriate manner.

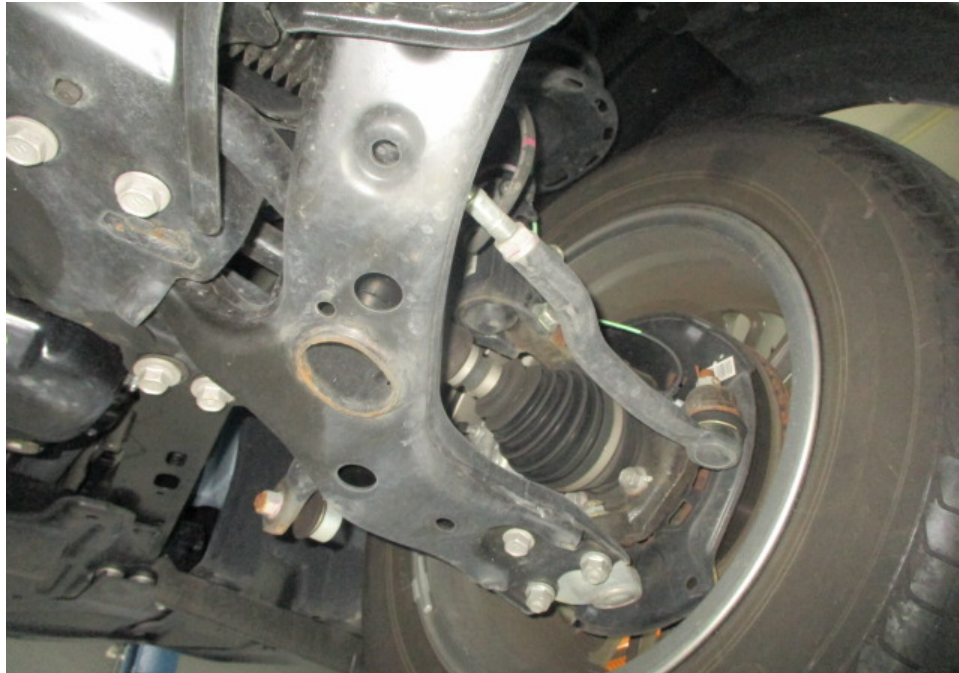
**Photo 24** shows the various undercarriage components at the front right wheel of the Motor Car. The mechanical components, control arms and linkages were all found to be intact and secured in an appropriate manner. I also did not observe any fluid leak and/or fluid stain on the underside of the Motor Car.

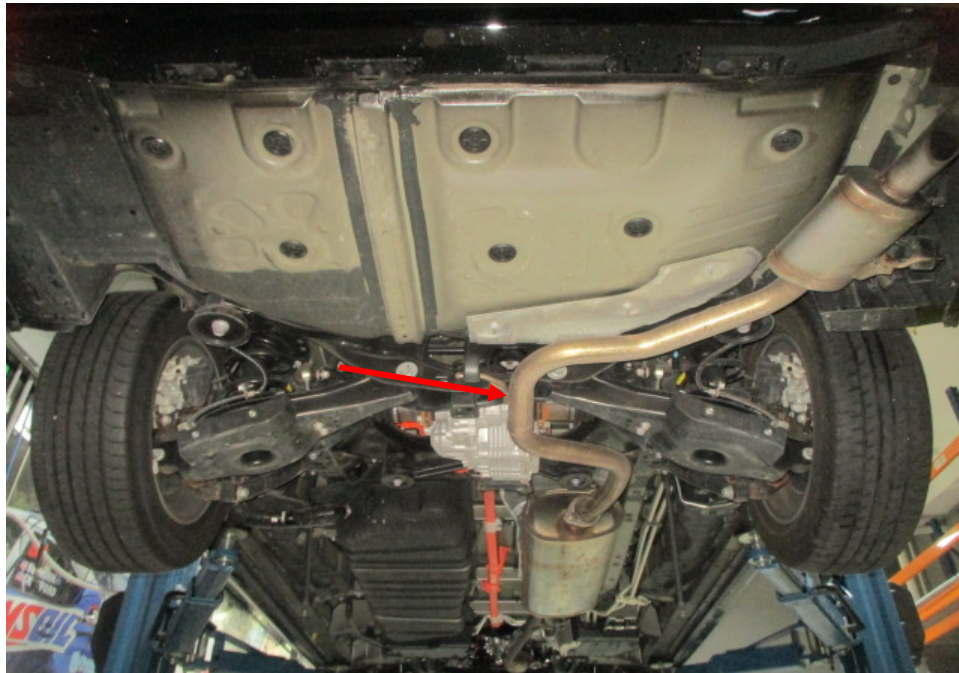
**Photo 25** shows a general view of the rear section of the Motor Car's exhaust system. My examination of the Motor Car's exhaust system revealed no sign(s) or indication(s) of any cut or weld marks along its exhaust pipe (arrowed), on its catalytic converter, on its centre resonator box and on its rear muffler.

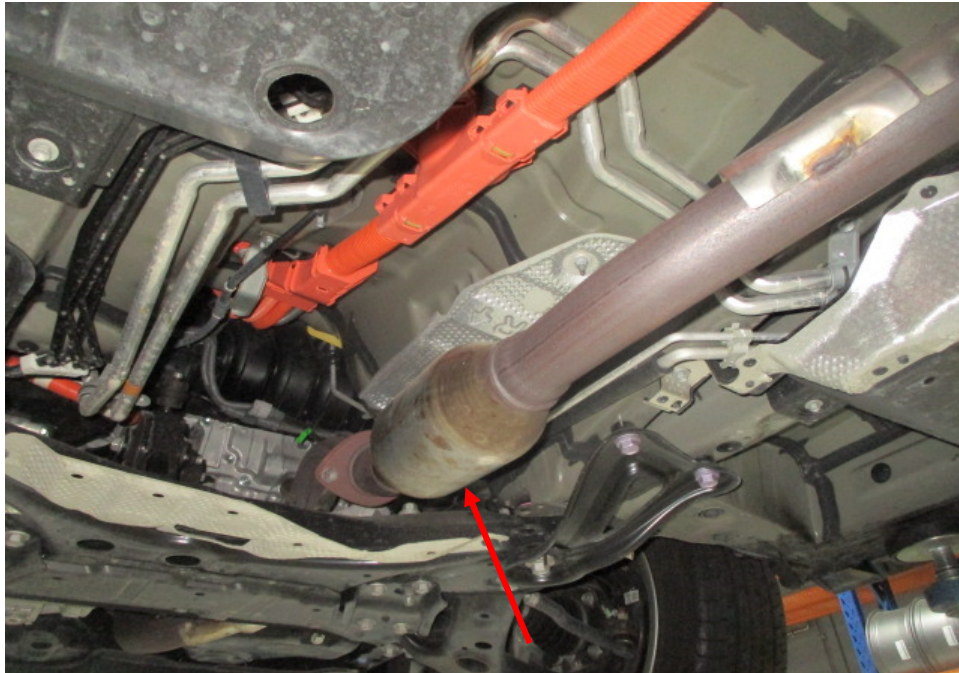
**Photo 26** shows a general view of the front section of the Motor Car's exhaust system. My examination of the Motor Car's exhaust system revealed no sign(s) or indication(s) of any cut or weld marks along its exhaust pipe, on its catalytic converter (arrowed), on its centre resonator box and on its rear muffler.

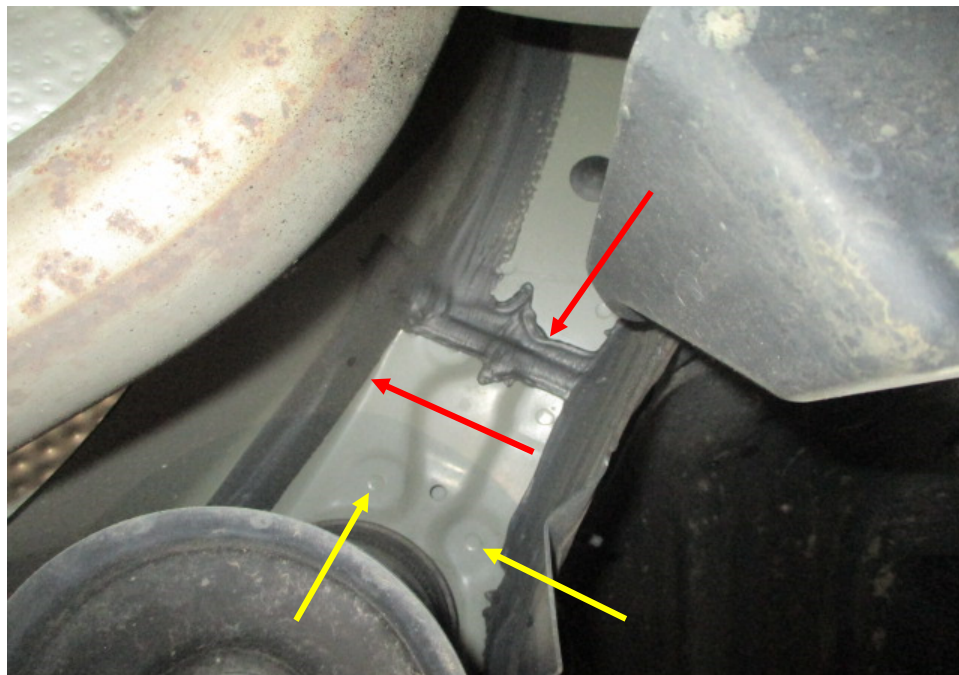
**Photo 27** shows the chassis/structural body at the underside rear right of the Motor Car. I did not find any weld marks other than original spot weld marks (yellow arrow) on the chassis/structural body of the Motor Car. The original factory sealant (red arrow) at the joints along the chassis/structural body was untouched, indicating no work was done on the chassis/structural body of the Motor Car and that the chassis/structural body was originally fitted.

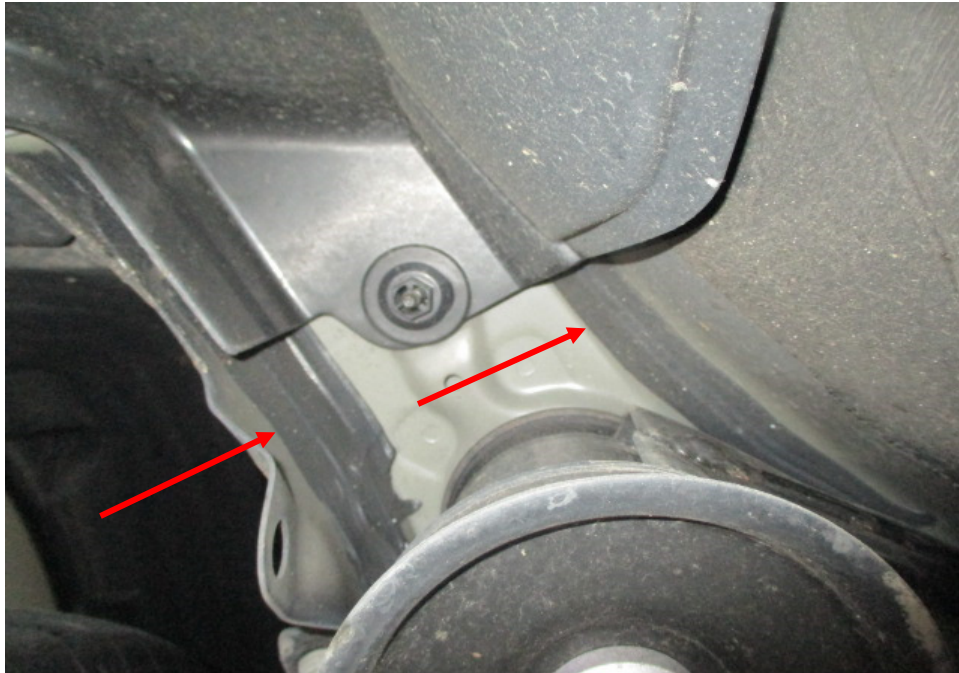
**Photo 28** shows the chassis/structural body at the underside rear left of the Motor Car. The original factory sealant (arrowed) at the joints along the chassis/structural body was observed to be untouched. In general, I had found no work was carried out on the chassis/structural body of the Motor Car. The chassis/structural body of the Motor Car was originally fitted.

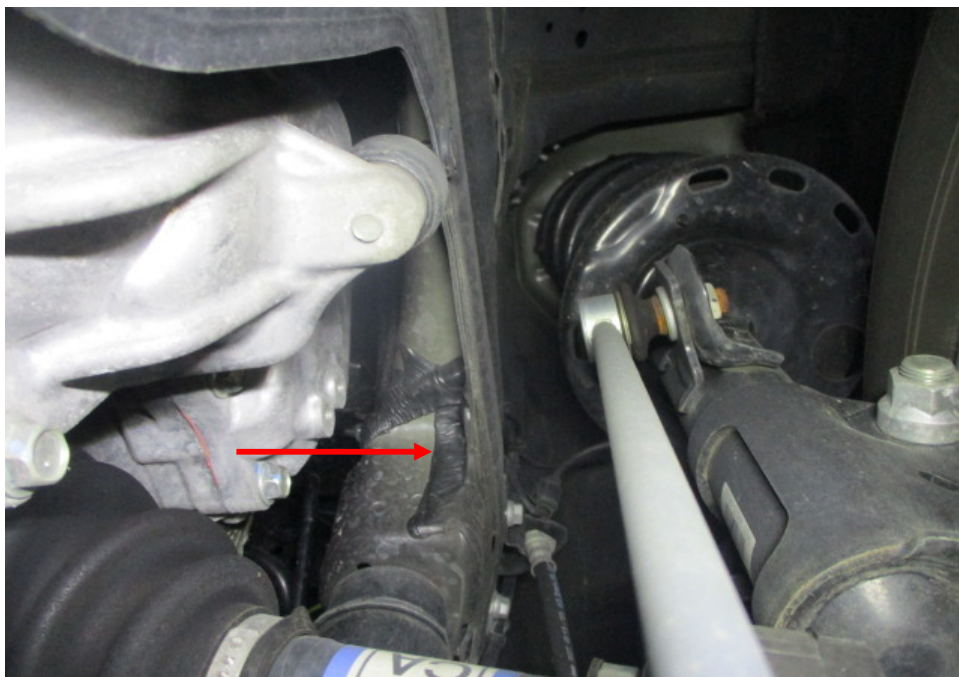
**Photo 29** shows the chassis/structural body at the underside front left of the Motor Car. The original factory sealant (arrowed) at the joints along the chassis/structural body was observed to be untouched. In general, I had found no work was carried out on the chassis/structural body of the Motor Car. The chassis/structural body of the Motor Car was originally fitted.

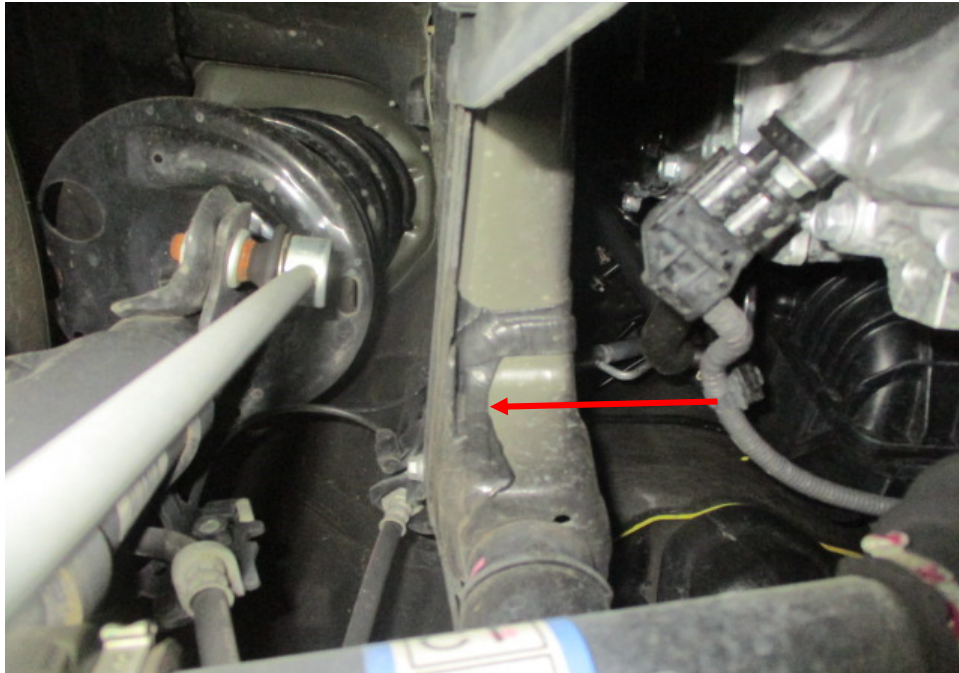
**Photo 30** shows the chassis/structural body at the underside front right of the Motor Car. I did not find any weld marks other than original spot weld marks on the chassis/structural body of the Motor Car. The original factory sealant (arrowed) at the joints along the chassis/structural body was untouched, indicating no work was done on the chassis/structural body of the Motor Car and that the chassis/structural body was originally fitted.
