Your Ref: Toyota Alphard  
(chassis number AYH300121025)  
Our Ref : CI/TP23004208/D

**INSPECTION REPORT OF AN UNREGISTERED TOYOTA ALPHARD MOTOR CAR WITH CHASSIS NUMBER AYH300121025**

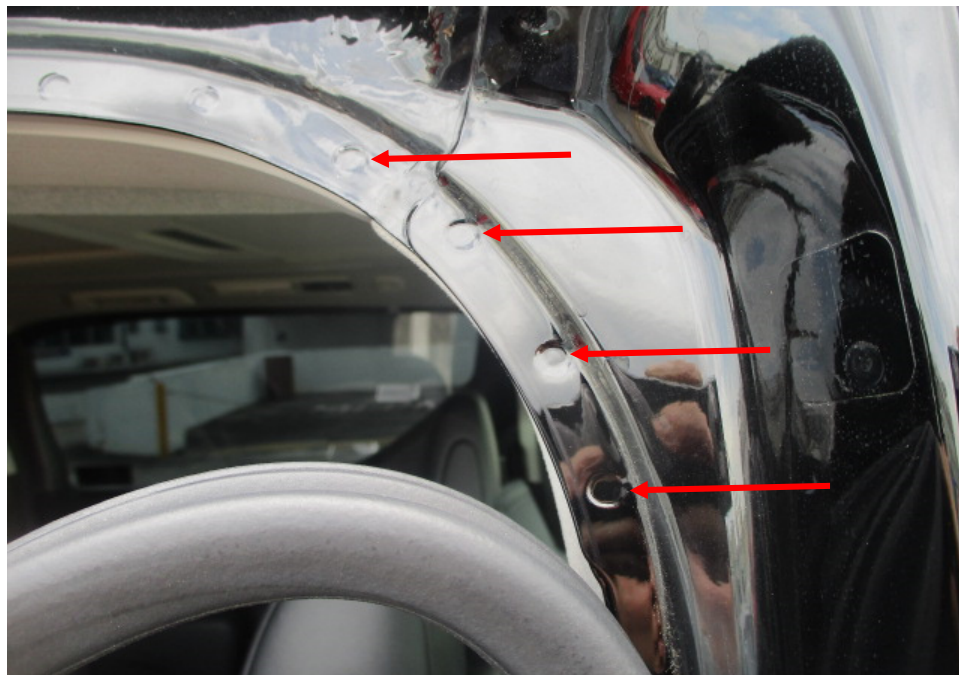
**Photo 31** shows the right side "B" pillar of the Motor Car. I did not find any weld marks other than original spot weld marks (arrowed) on the right side "B" pillar of the Motor Car, which indicates that there was no re-welding works carried out. In general, I had found all the non-detachable body panels of the Motor Car to be originally fitted at the time of my inspection.

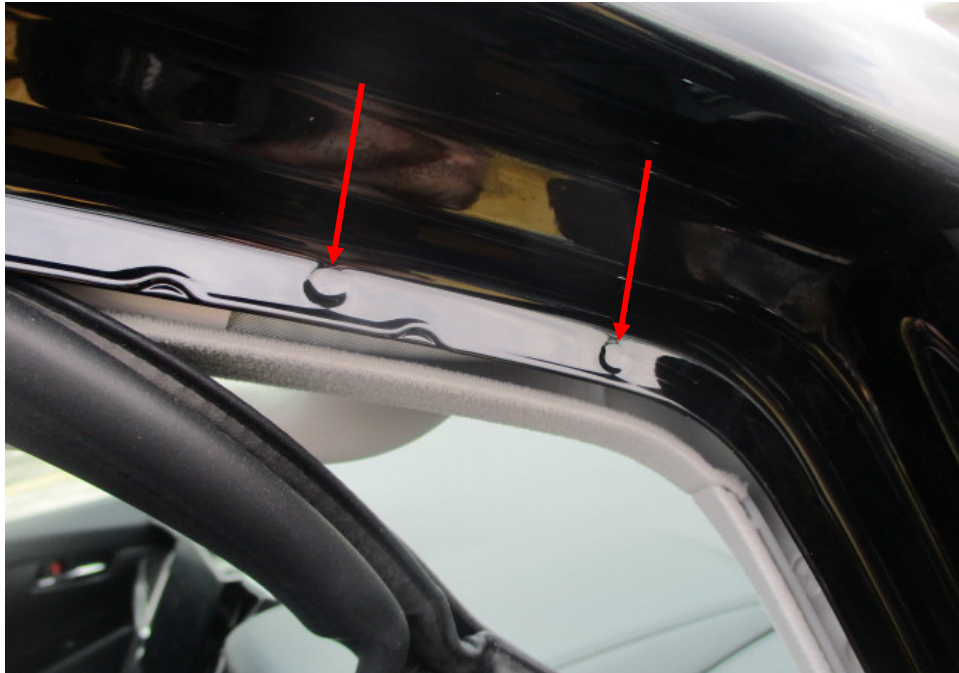
**Photo 32** shows the right side "A" pillar of the Motor Car. I did not find any weld marks other than original spot weld marks (arrowed) on the right side "A" pillar of the Motor Car, which indicates that there was no re-welding works carried out. In general, I had found all the non-detachable body panels of the Motor Car to be originally fitted at the time of my inspection.

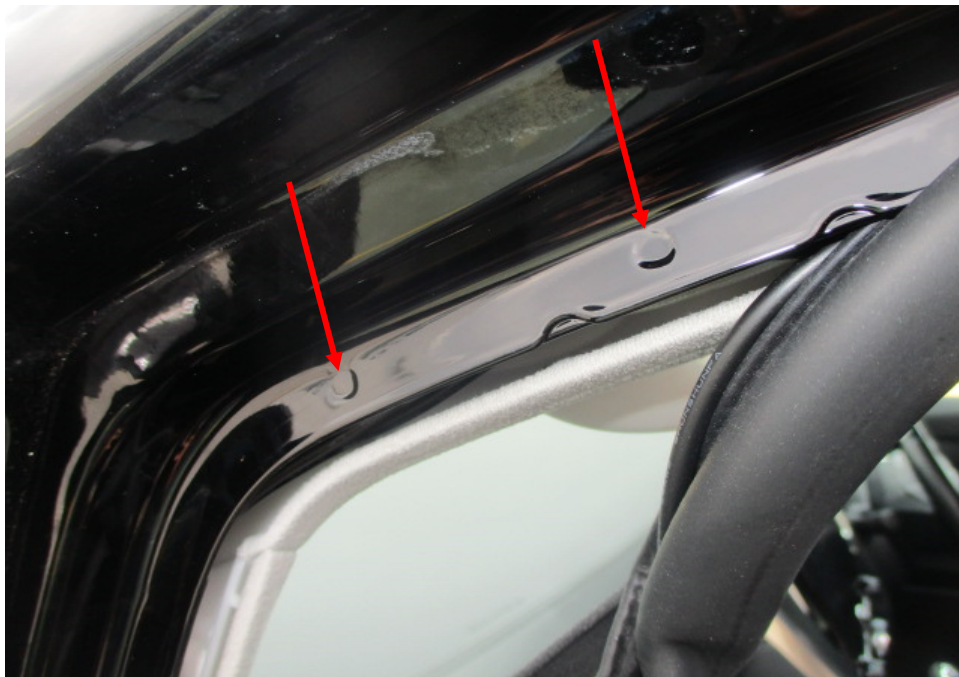
**Photo 33** shows the left side "A" pillar of the Motor Car. I did not find any weld marks other than original spot weld marks (arrowed) on the left side "A" pillar of the Motor Car, which indicates that there was no re-welding works carried out. In general, I had found all the non-detachable body panels of the Motor Car to be originally fitted at the time of my inspection.

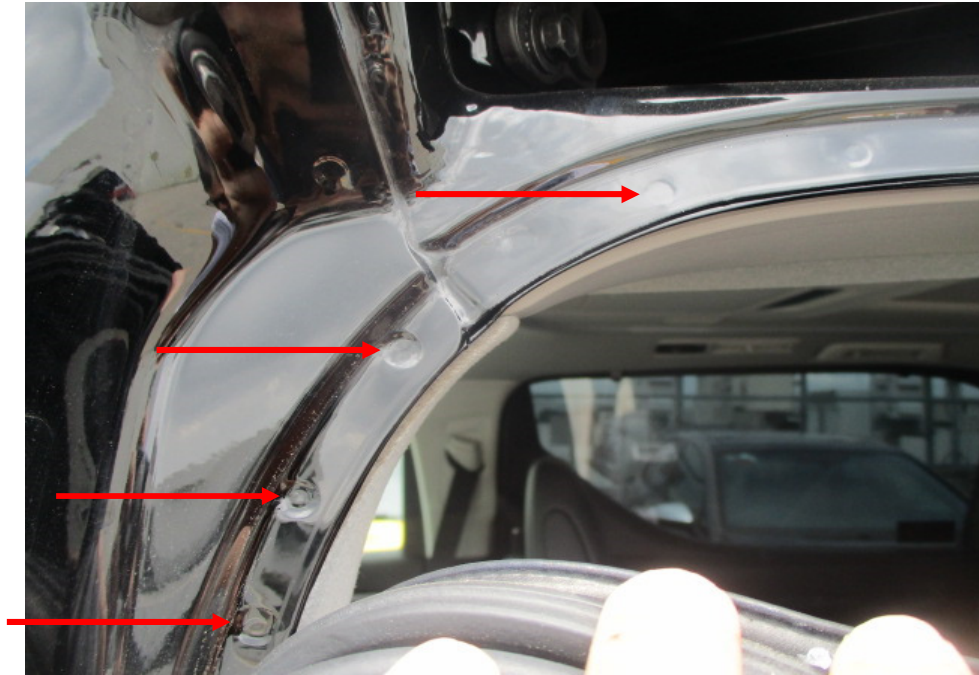
**Photo 34** shows the left side "B" pillar of the Motor Car. I did not find any weld marks other than original spot weld marks (arrowed) on the left side "B" pillar of the Motor Car, which indicates that there was no re-welding works carried out. In general, I had found all the non-detachable body panels of the Motor Car to be originally fitted at the time of my inspection.
