# ALLIED AUTO APPRAISAL

**Our Ref: Allied/TP/22-12010**

**Veh No**      **GBJ 9867 E**

| Make & Model | : | <b>Ford Rangeer 2.0 Double Cab A</b> | Date of Registration | : | <b>31-Oct-19</b> |

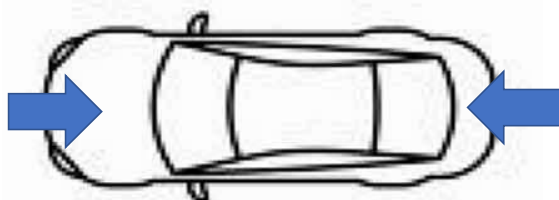
The inspected vehicle sustained damage at the **FRONT & REAR** portion.

During visual inspection, our surveyor noted that the front bumper, front headlamps, front reinforcement, rear bumper, tailgate, rear fenders and among other parts were affected.

The repairer agree to repair the vehicle on a **Lump Sum Basis** with our recommendation of **SGD 50,100.00 (SGD Fifty Thousand and One Hundred only)** and we are in the opinion the repairer would need about a **21.0** working day period to repair the vehicle.
