Your Ref: GBK 5701X
Our Ref : CI/III23004316/P

**TECHNICAL INVESTIGATION REPORT OF WARRANTY CLAIM INVOLVING
THE INSURED VEHICLE GBK 5701X ON 30th March 2023**

Vehicle Registration No.	: GBK 5701X
Make / Model	: FORD RANGER RAPTOR ECOBLE 4X4 DOUBLE CAB AUTO
Chassis No	: 6FPPXXMJ2PKS25968
Year of Registration	: SEP 2020
Mileage	: 44,329KM

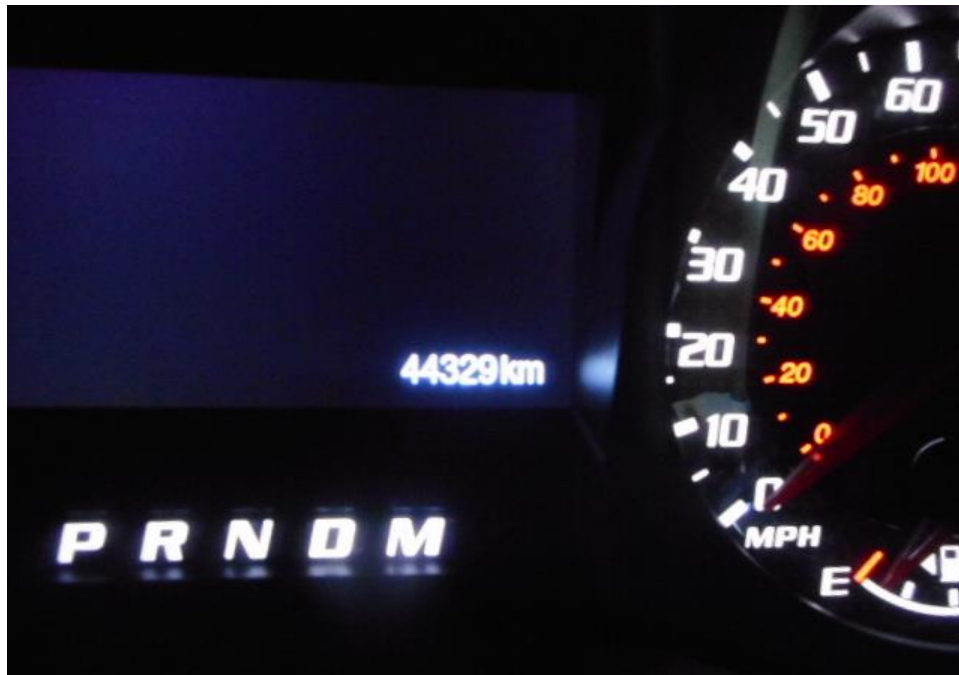
Photo 1 shows the mileage of the Insured Vehicle recorded at the time inspection at 44,329KM

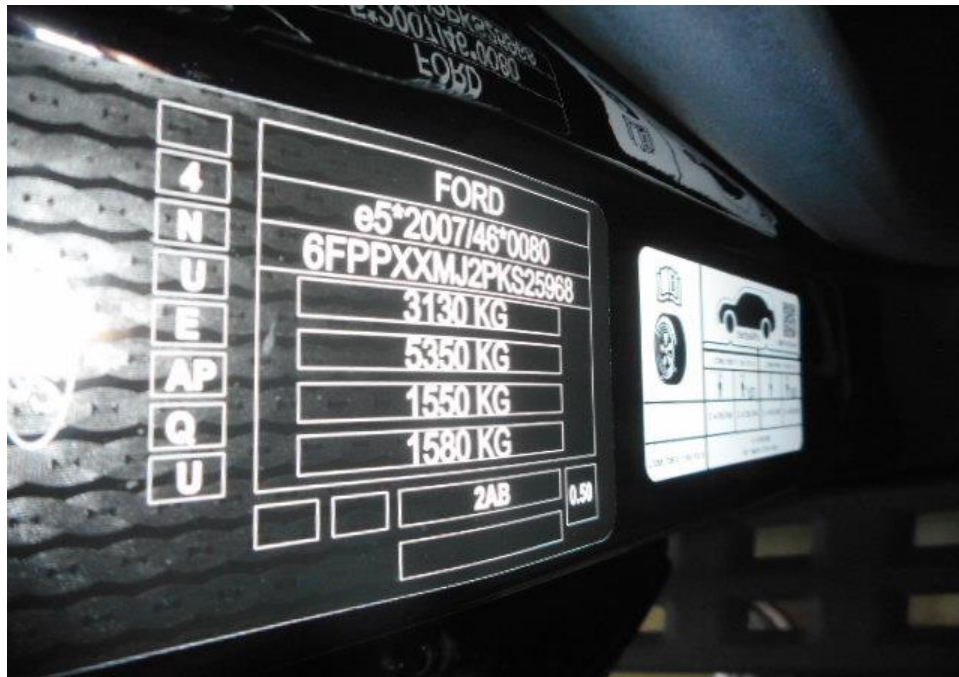
Photo 2 shows the chassis number of the Insured Vehicle at the time of our inspection.

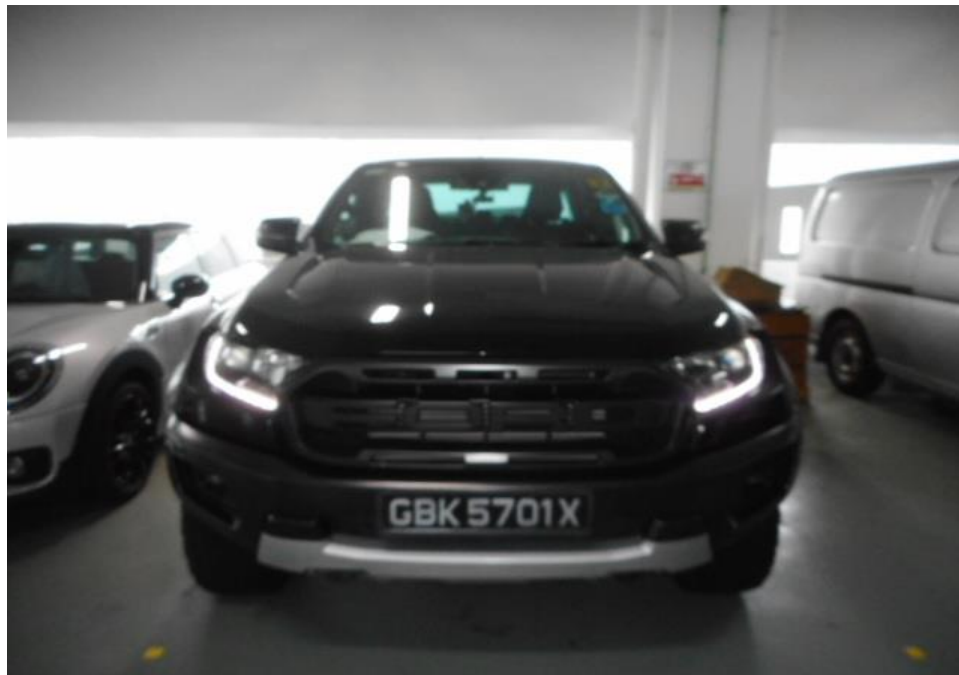
Photo 3 shows the general view of the front portion of the Insured Vehicle at the time of our inspection. The Insured Vehicle is observed to be unaffected by any signs of accident.

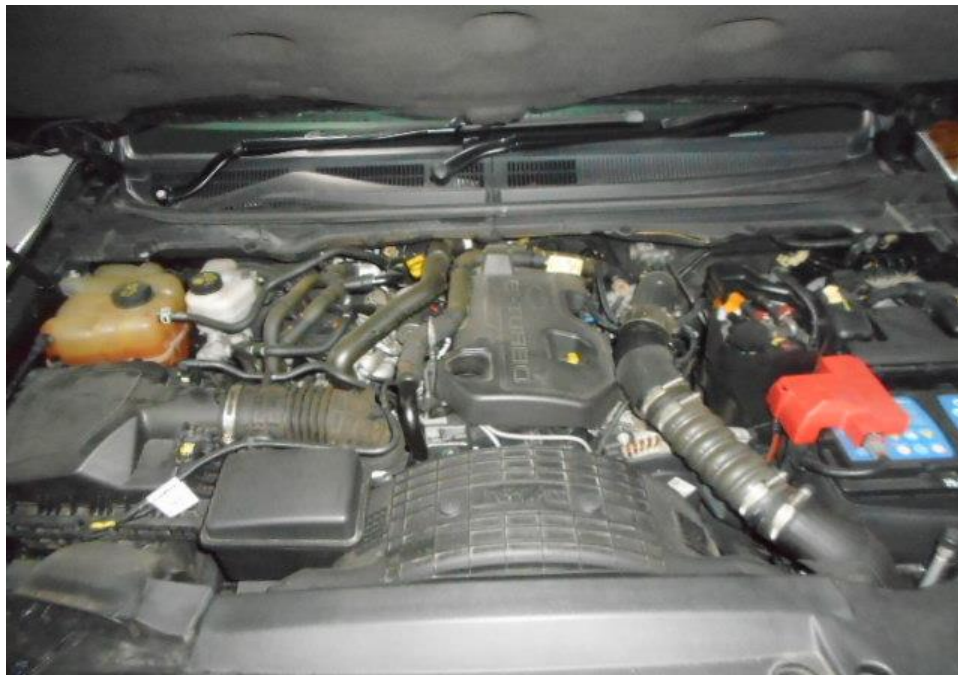
Photo 4 shows the general view of the engine portion of the Insured Vehicle at the time of our inspection. The engine compartment is observed to be unaffected by any signs of accident.

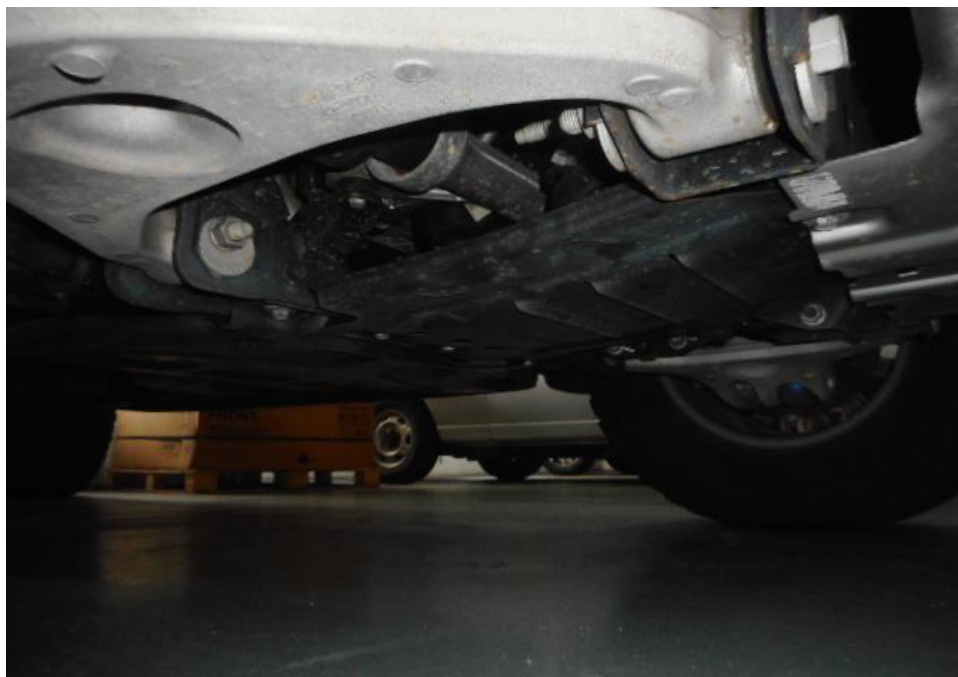
Photo 5 shows the general view of the gearbox underside portion of the Insured Vehicle at the time of our inspection. The gearbox underside compartment is observed to be unaffected and by any signs of accident.

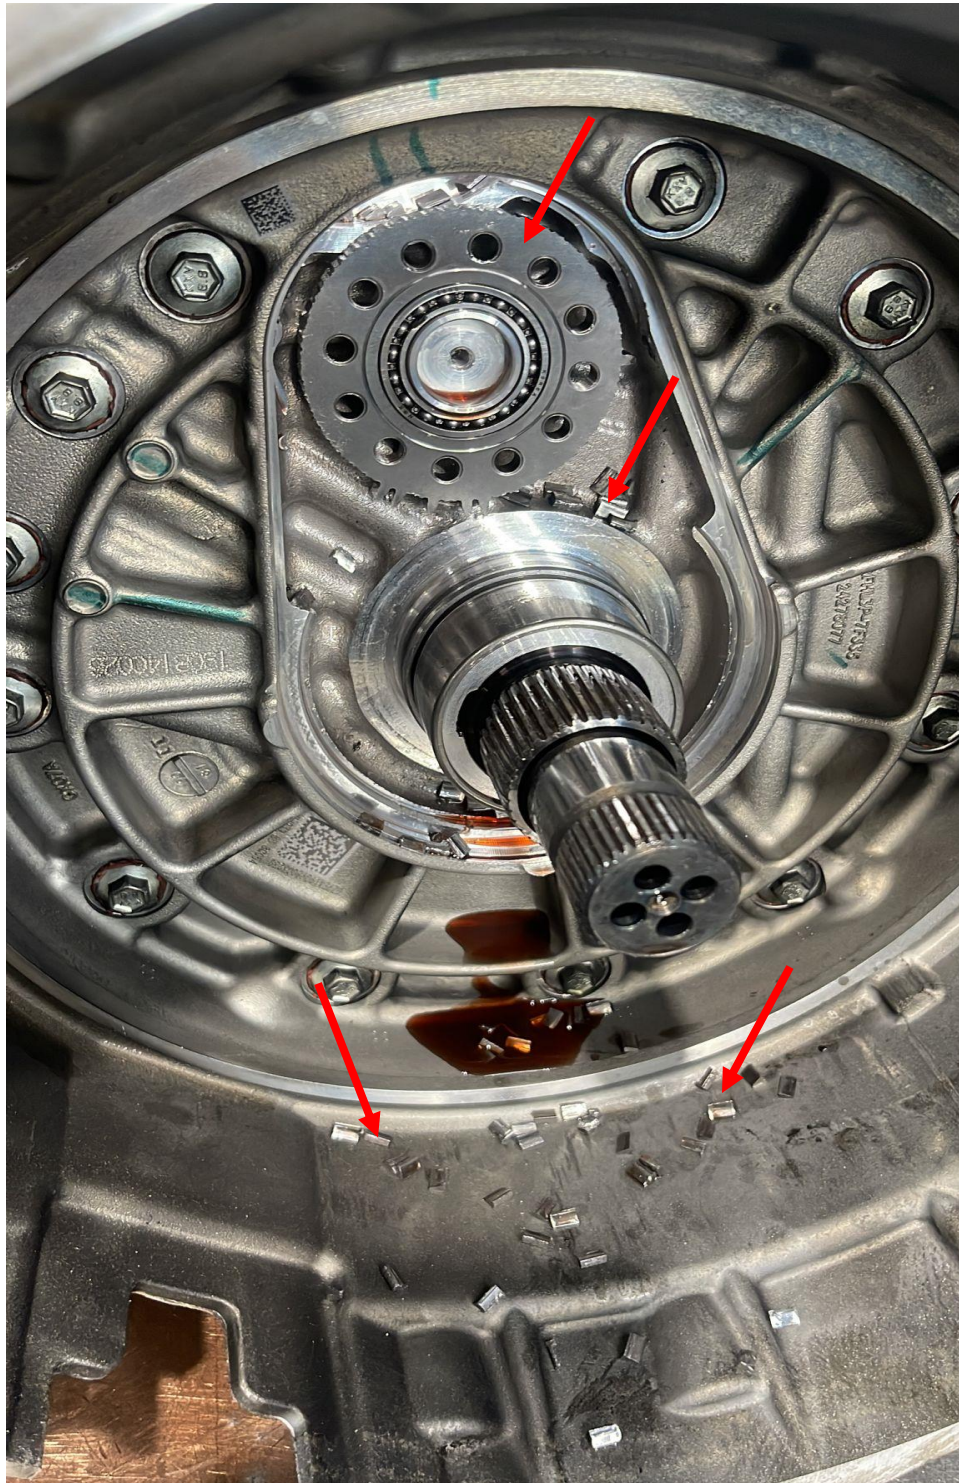
6. Prior to our inspection, the workshop had informed us that they had already conducted checks and upon dismantling the gearbox unit they have found damages to the transmission gears in the gearbox of the Insured Vehicle and agreed that the complained problem is from these components in the gearbox unit See photos 1 – 6 below.

Photo 6 shows the close up view of inside the gearbox unit of the Insured Vehicle at the time of our inspection. The transmission gears (arrowed) component in the gearbox unit is observed to be damaged and broken into pieces, this is the cause for the complained problems of not responses from the gearbox when changing of gears on the Insured Vehicle.

7. We did not find any evidence which had suggested that the cause of abnormalities to the Insured Vehicle was due to poor maintenance and/or recurring problem.
8. The recommendation to replace the repair and overhaul the gearbox unit at \$5,572.80 as stated in the quotation is justifiable as all the relevant checks has been conducted to the Insured Vehicle.
