Your Ref: SDN 93K
Our Ref : CI/III23004317/P

**TECHNICAL INVESTIGATION REPORT OF WARRARTY CLAIM INVOLVING
THE INSURED VEHICLE SDN 93K ON 22nd March 2023**

Vehicle Registration No.	: SDN 93K
Make / Model	: TOYOTA APLHARD 7-SEATER 2.5 SC CVT
Chassis No	: AGH300214834
Mileage	: 113,556KM

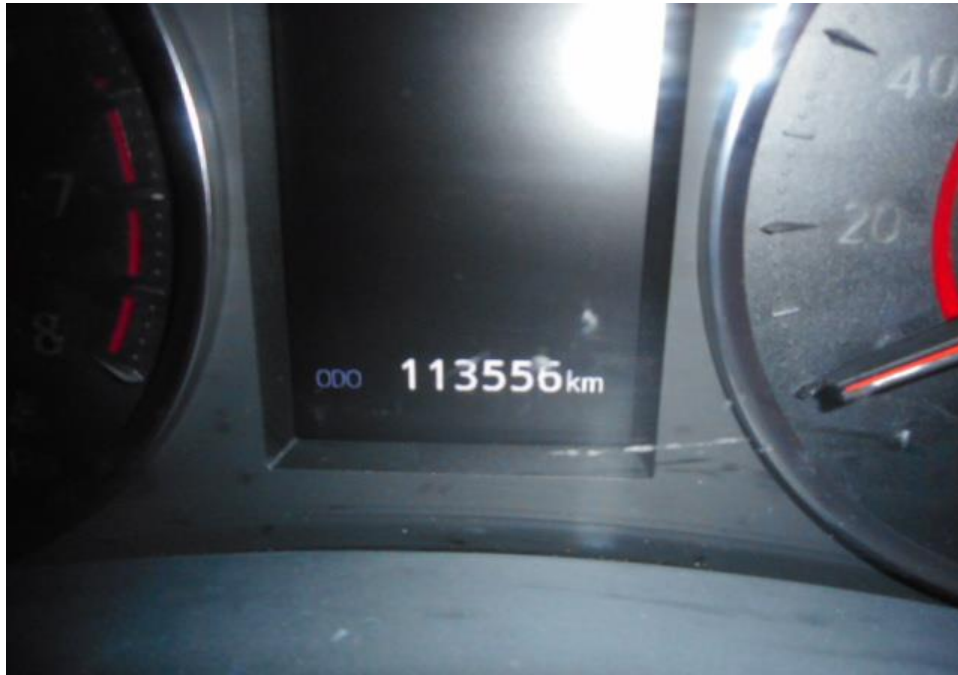
Photo 1 shows the mileage of the Insured Vehicle recorded at the time inspection at 113,556KM

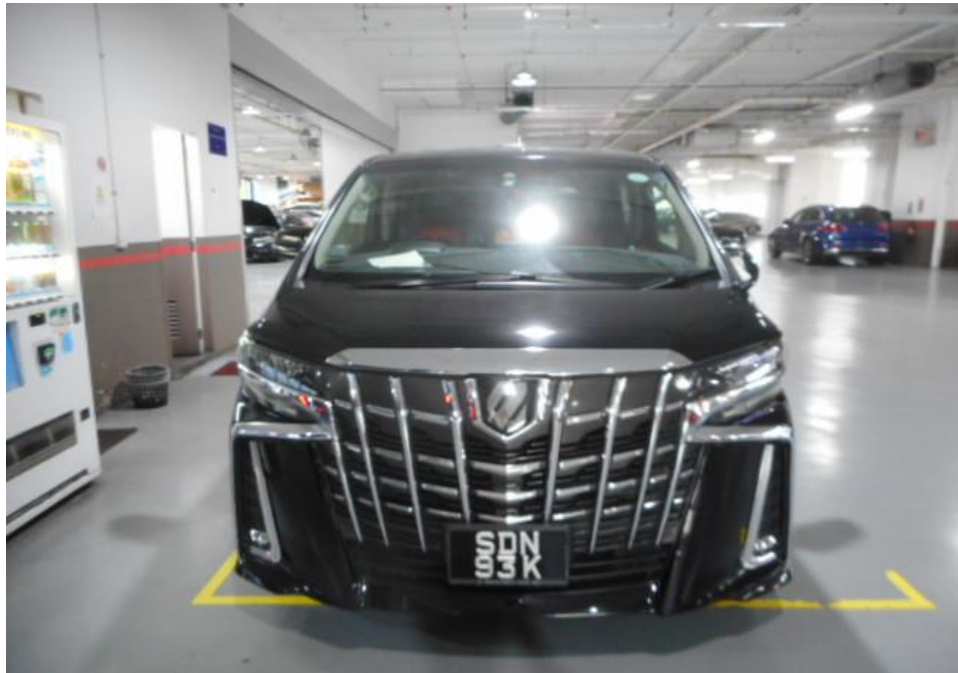
Photo 2 shows the general view of the front portion of the Insured Vehicle at the time of our inspection. The Insured Vehicle is observed to be unaffected by any signs of accident.

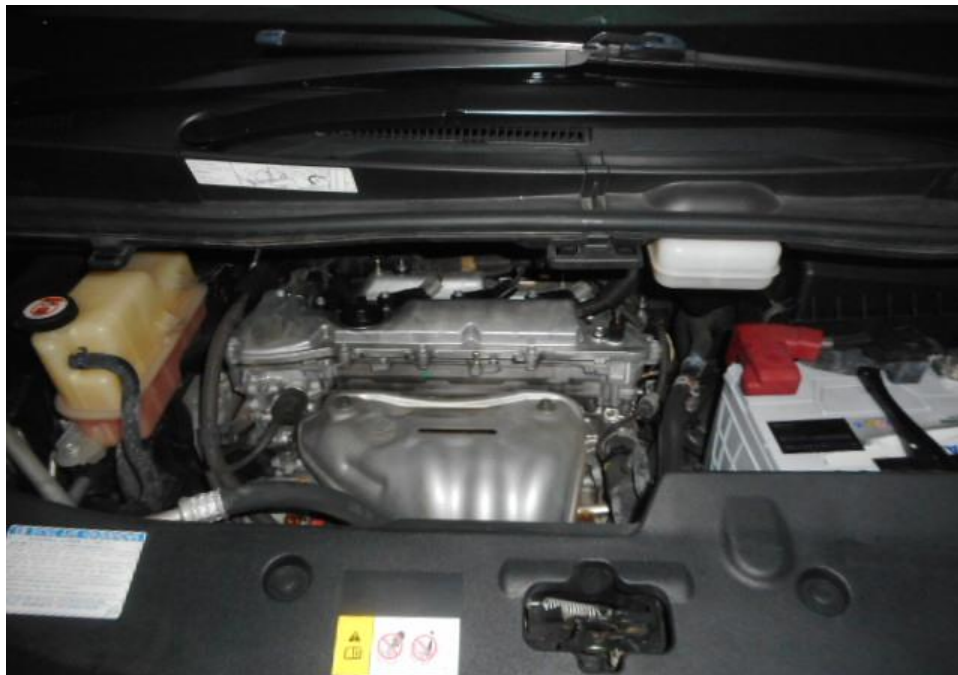
Photo 3 shows the general view of the engine portion of the Insured Vehicle at the time of our inspection. The engine compartment is observed to be unaffected by any signs of accident.

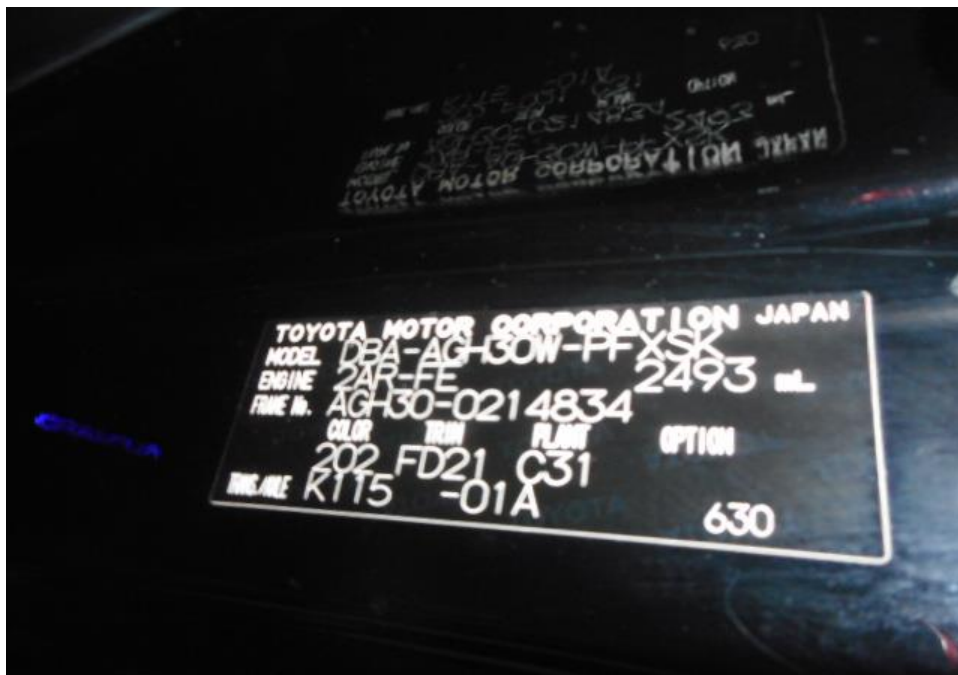
Photo 4 shows the chassis number of the Insured Vehicle at the time of our inspection.

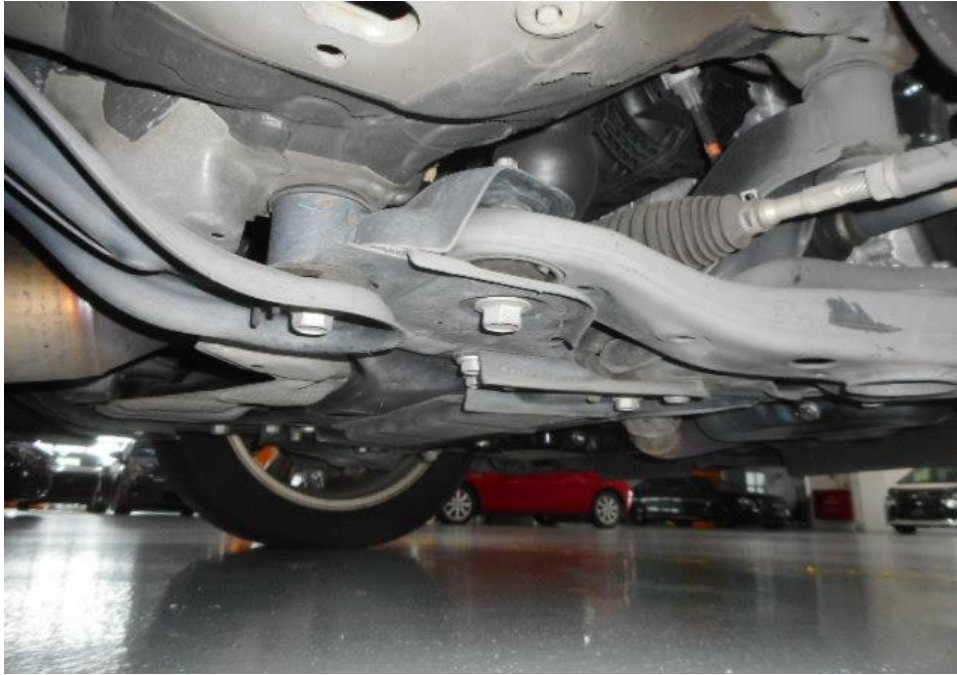
Photo 5 shows the general view of the engine and transmission underside portion of the Insured Vehicle at the time of our inspection. The engine and transmission underside compartment is observed to be unaffected and by any signs of accident.

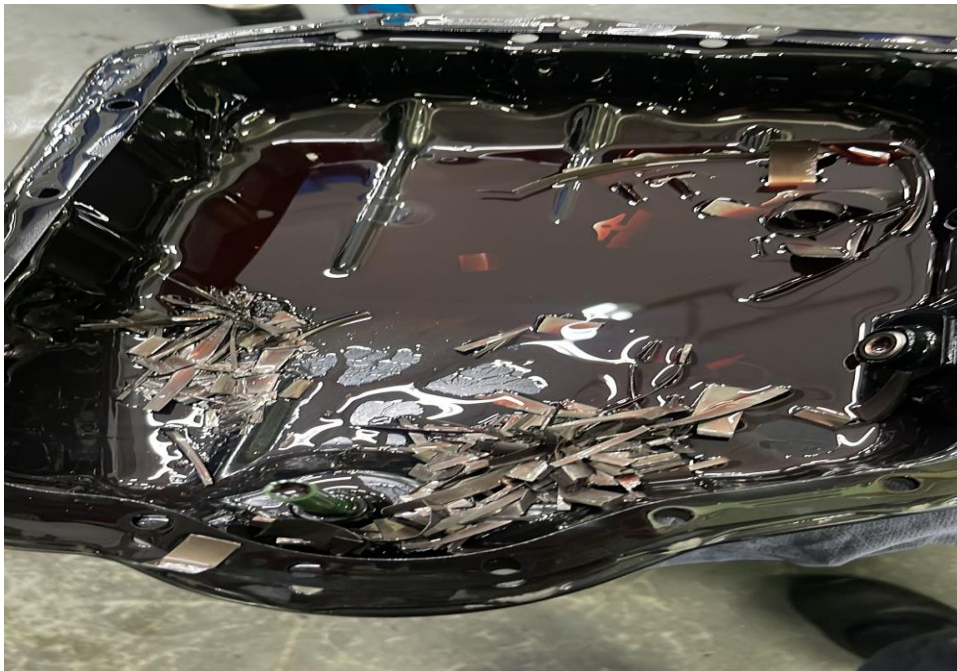
Photo 6 shows the close up view of the CVT transmission unit underside portion of the Insured Vehicle at the time of our inspection. We observed broken CVT transmission drive belt and transmission components that had fallen down to the oil sump.

6. We did not find any evidence which had suggested that the cause of abnormalities to the Insured Vehicle was due to poor maintenance and/or recurring problem.
7. The recommendation to replace the gears, shafts, clutches and CVT chain in the CVT automatic transmission at \$2,800 is justifiable as all the relevant checks has been conducted.

5. The complaint on the Insured Vehicle was noted be to a faulty gearbox as the CVT automatic transmission belt broke while driving and the vehicle had lost its driving ability at the material time. The recommendation by the workshop to was to replace the gears, shafts, clutches and CVT chain in the CVT automatic transmission unit. The vehicle was observed to be unaffected by any signs of accident. See photos 1 – 7 below.

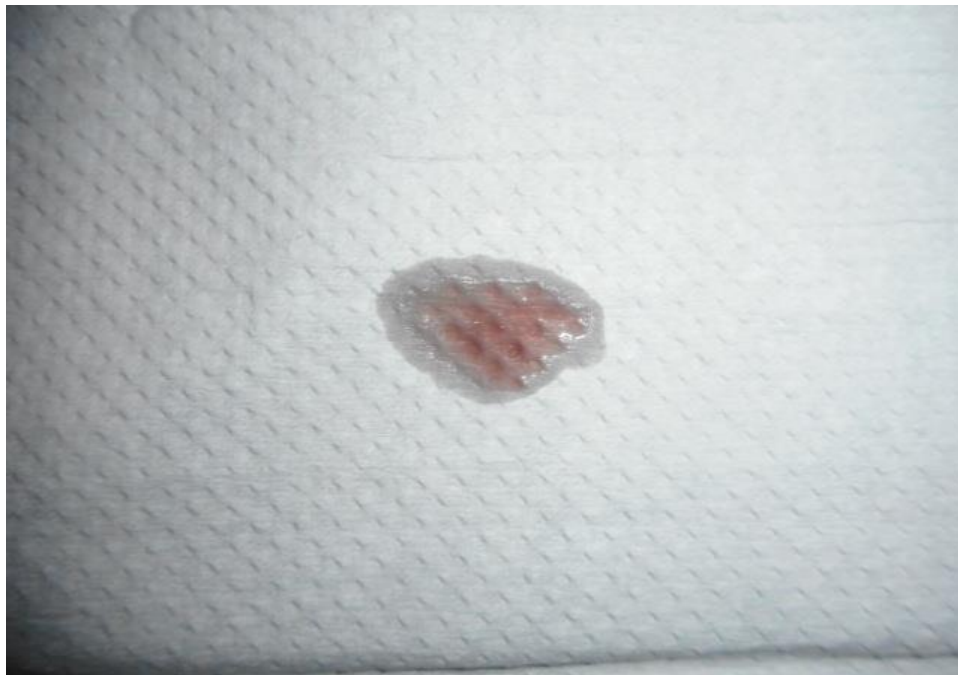
Photo 7 shows the close up view of the CVT transmission fluid of the Insured Vehicle at the time of our inspection. We observed that CVT transmission fluid was observed to be without any visible contamination.
