Your Ref: SDA 5111C
Our Ref : CI/III23004318/P

**TECHNICAL INVESTIGATION REPORT OF WARRANTY CLAIM INVOLVING
THE INSURED VEHICLE SDA 5111C ON 24th March 2023**

Vehicle Registration No.	: SDA 5111C
Make / Model	: MERCEDES BENZ S500 M-HYBRID
Chassis No	: W1K2231632A017450
Year of Registration	: JUNE 2021
Mileage	: 35,156KM

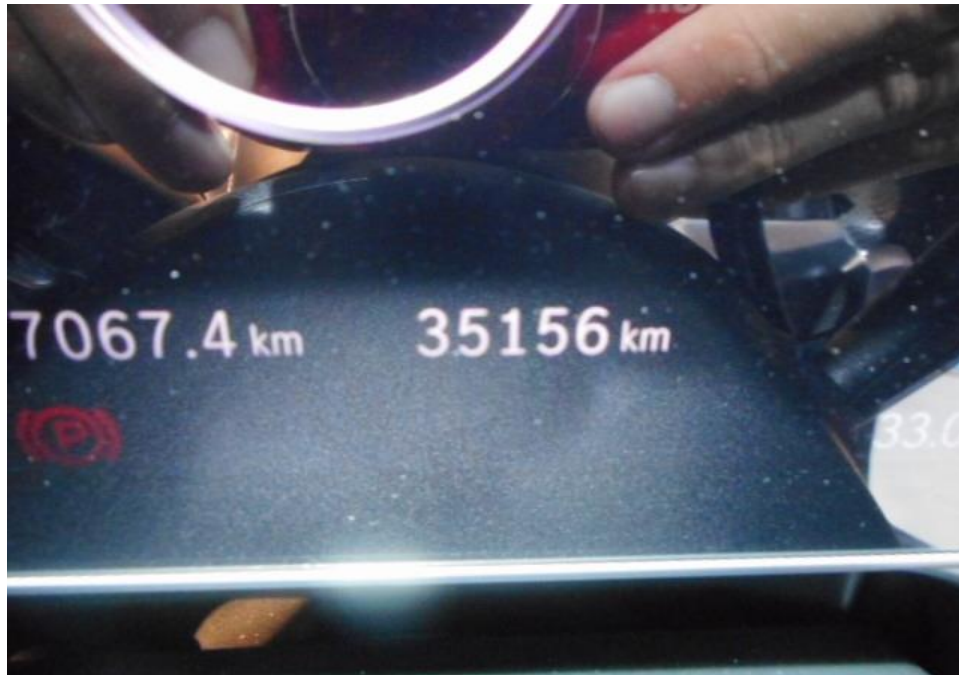
Photo 1 shows the mileage of the Insured Vehicle recorded at the time inspection at 35,156KM

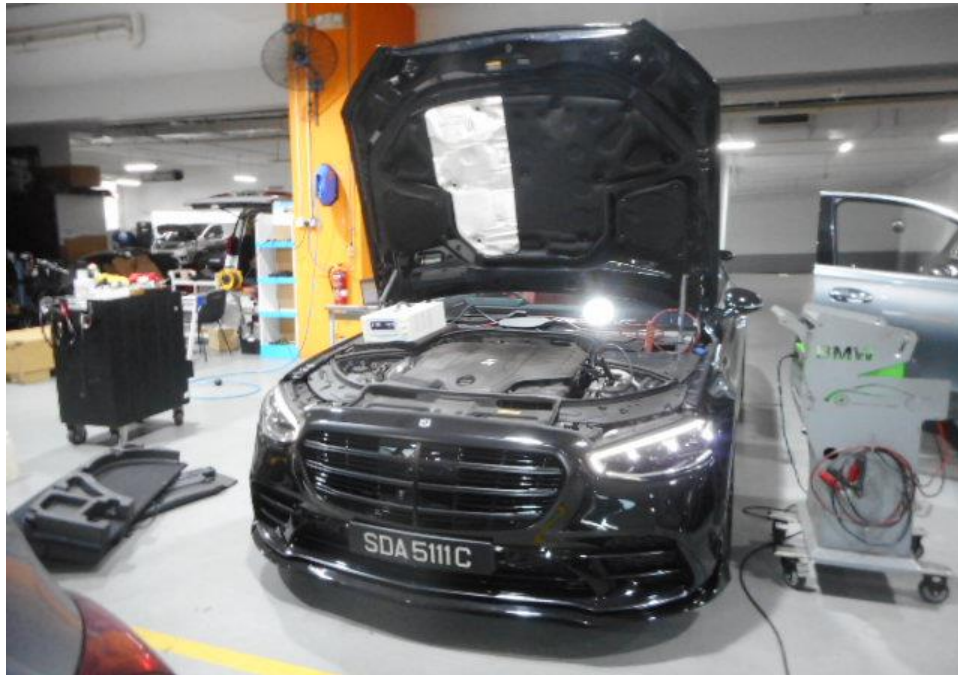
Photo 2 shows the general view of the front portion of the Insured Vehicle at the time of our inspection. The Insured Vehicle is observed to be unaffected by any signs of accident.

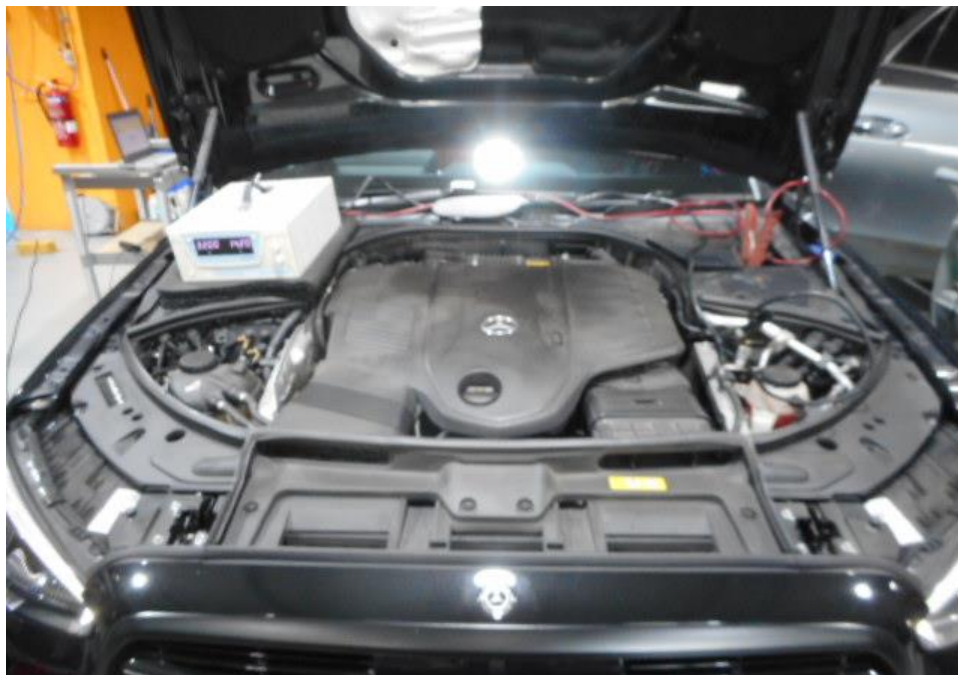
Photo 3 shows the general view of the engine portion of the Insured Vehicle at the time of our inspection. The engine compartment is observed to be unaffected by any signs of accident.

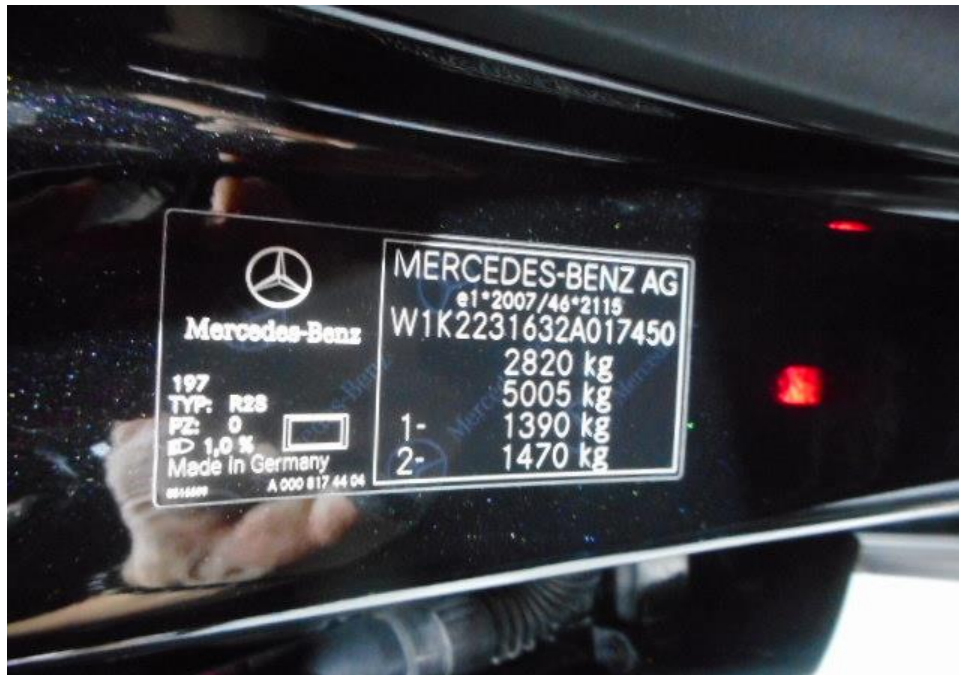
Photo 4 shows the chassis number of the Insured Vehicle at the time of our inspection.

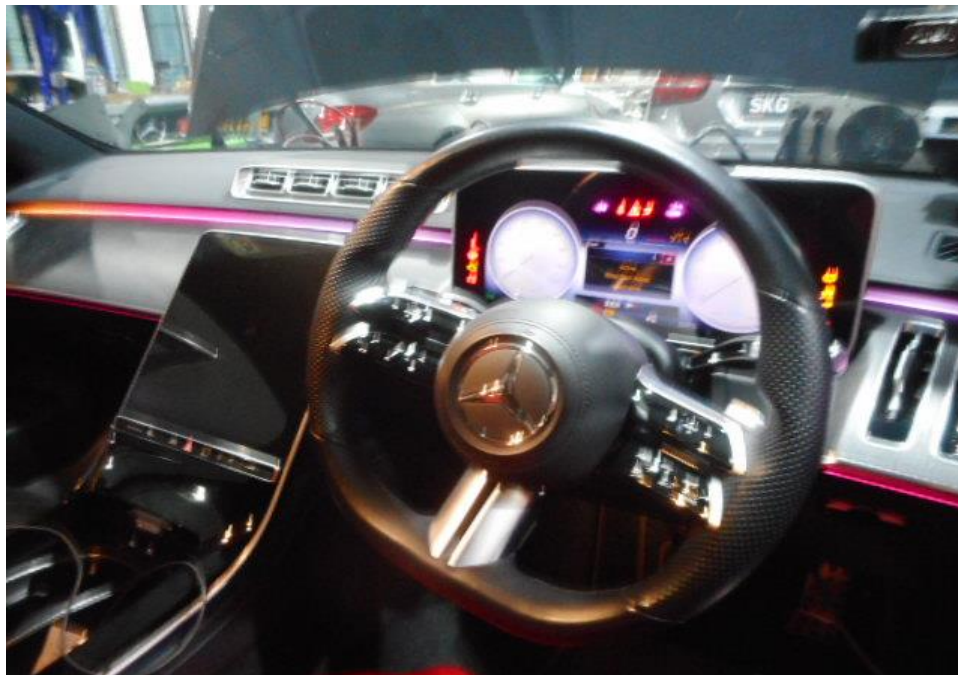
Photo 5 shows the general view of the interior portion of the Insured Vehicle at the time of our inspection. The interior portion is observed to be unaffected and by any signs of accident.

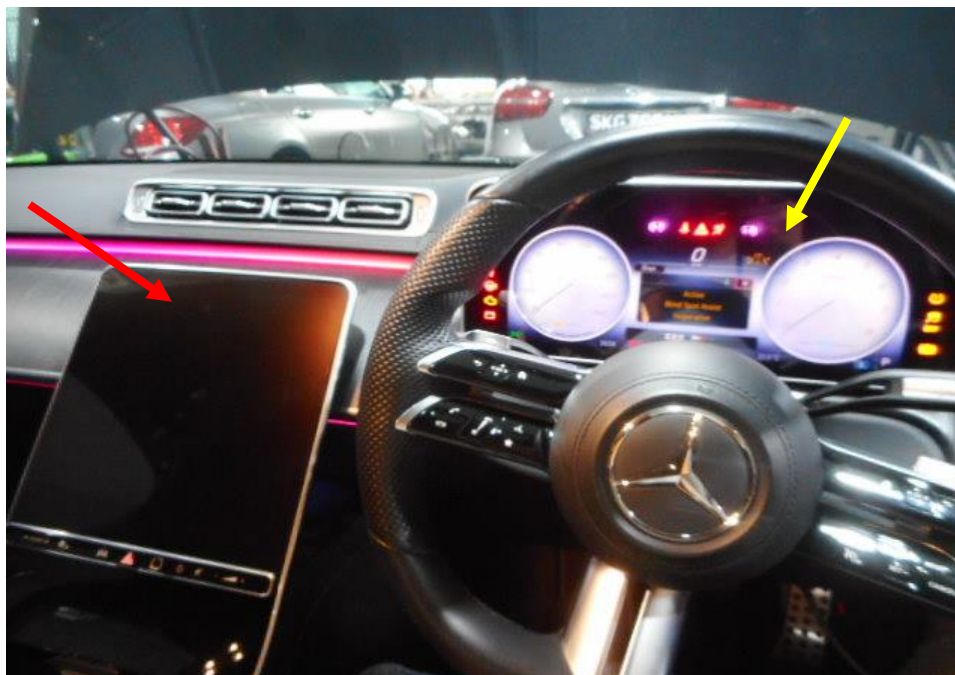
5. The complaint on the Insured Vehicle was noted be that the digital infotainment display would not turn on when the Insured Vehicle is started up. There is a recommendation by the workshop to replace the Infotainment control module. The vehicle was observed to be unaffected by any signs of accident.

Photo 6 shows the close up view of the vehicle instrument portion of the Insured Vehicle at the time of our inspection. The infotainment instrument display (red arrowed) did not turn on even when the vehicle's engine is turned on as compared to the driver's display panel (yellow arrow).

7. We did not find any evidence which had suggested that the cause of abnormalities to the Insured Vehicle was due to poor maintenance and/or recurring problem.
8. The recommendation to replace the Infotainment control module at \$4,730.40 is justifiable as all the relevant checks has been conducted.
