Your Ref: SMY 5232D
Our Ref : CI/III23004319/P

**TECHNICAL INVESTIGATION REPORT OF WARRANTY CLAIM INVOLVING
THE INSURED VEHICLE SMY 5232D ON 6th March 2023**

Vehicle Registration No.	: SMY 5232D
Make / Model	: MERCEDES BENZ CLA200 AMG LINE (A)
Chassis No	: W1K1183872N157588
Year of Registration	: MARCH 2021
Mileage	: 47,024KM

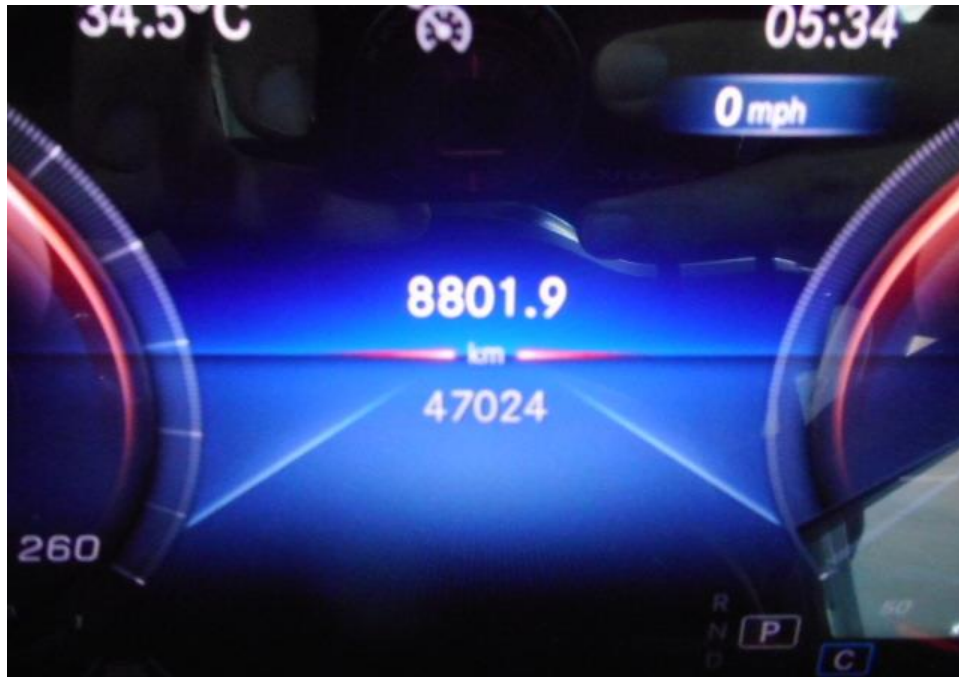
Photo 1 shows the mileage of the Insured Vehicle recorded at the time inspection at 47,024KM

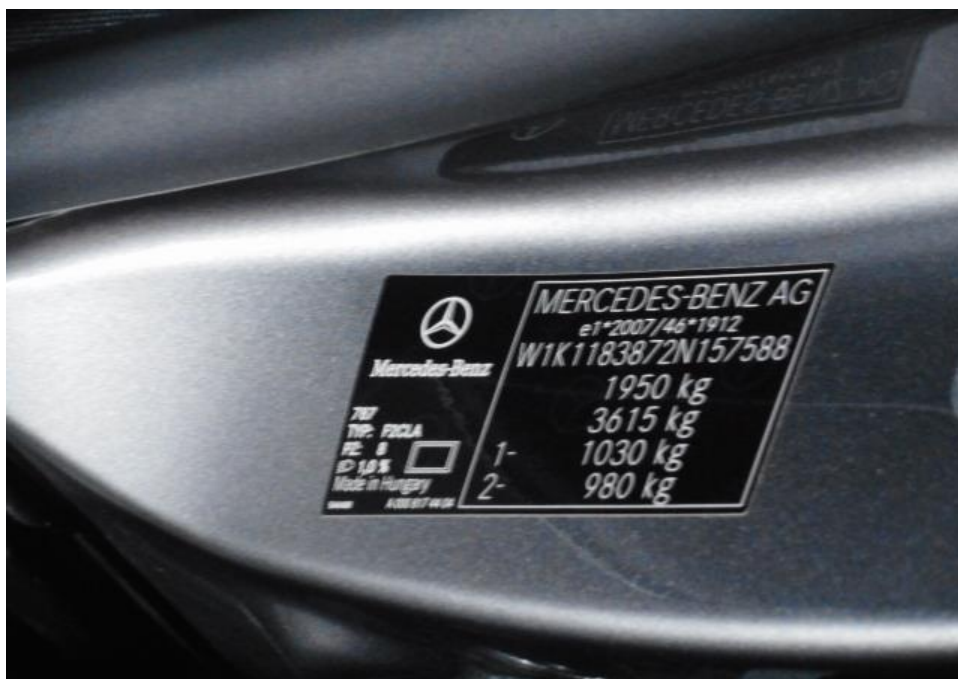
Photo 2 shows the chassis number of the Insured Vehicle at the time of our inspection.

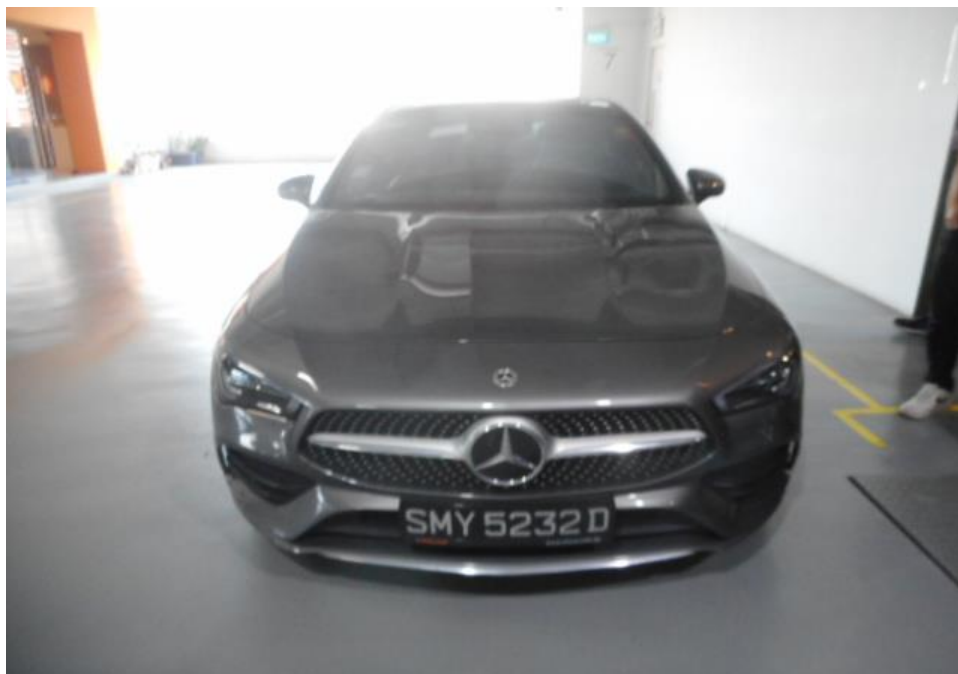
Photo 3 shows the general view of the front portion of the Insured Vehicle at the time of our inspection. The Insured Vehicle is observed to be unaffected by any signs of accident.

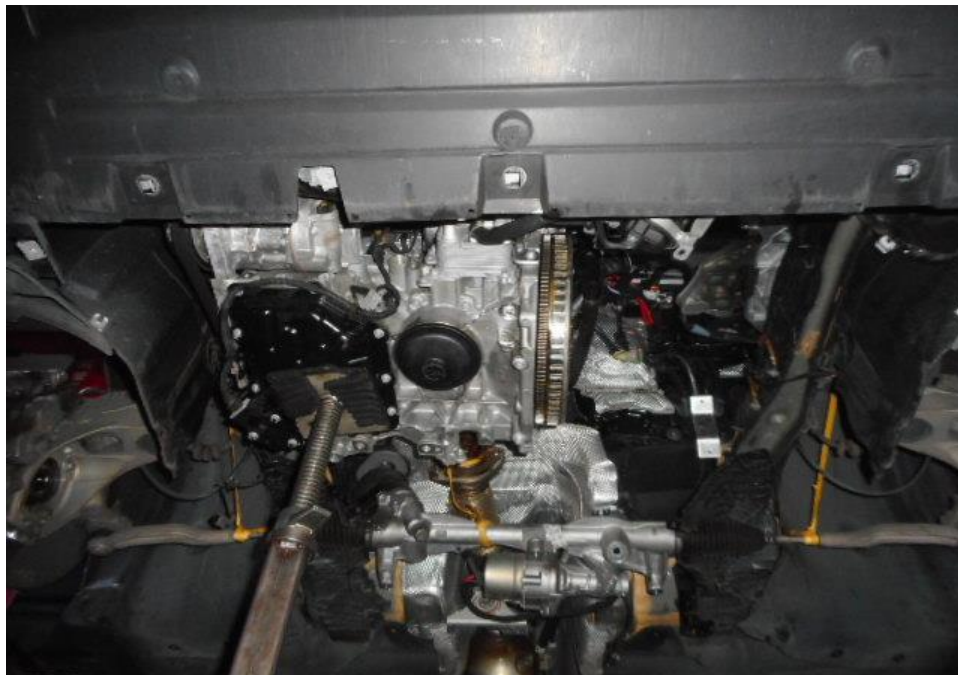
Photo 4 shows the general view of the undercarriage portion of the Insured Vehicle at the time of our inspection. The undercarriage compartment is observed to be unaffected by any signs of accident.

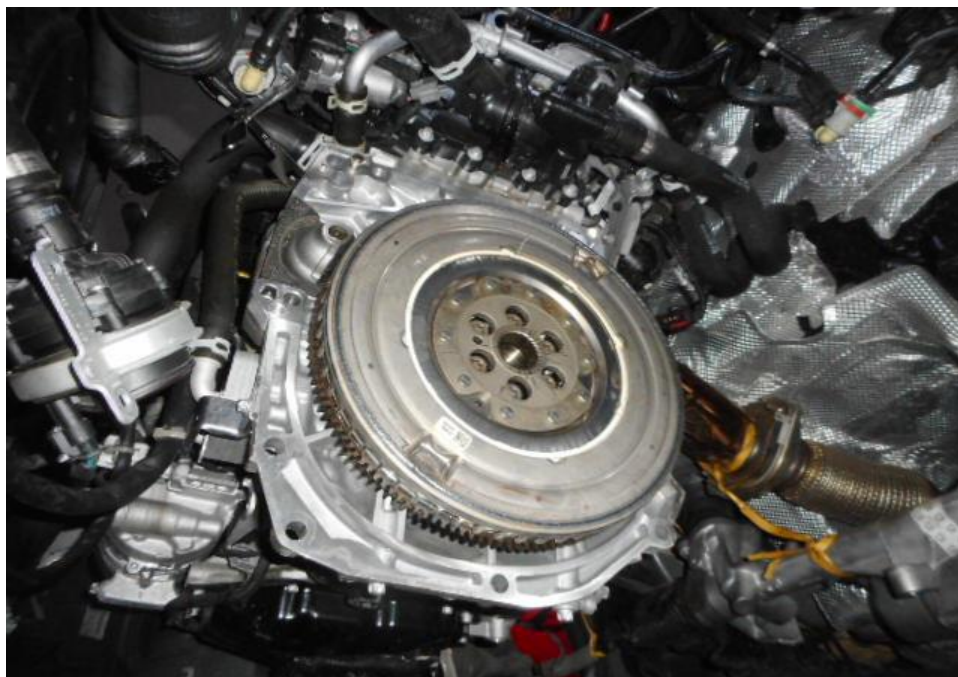
Photo 5 shows the general view of the gearbox underside portion of the Insured Vehicle at the time of our inspection. The gearbox underside compartment is observed to be unaffected and by any signs of accident.

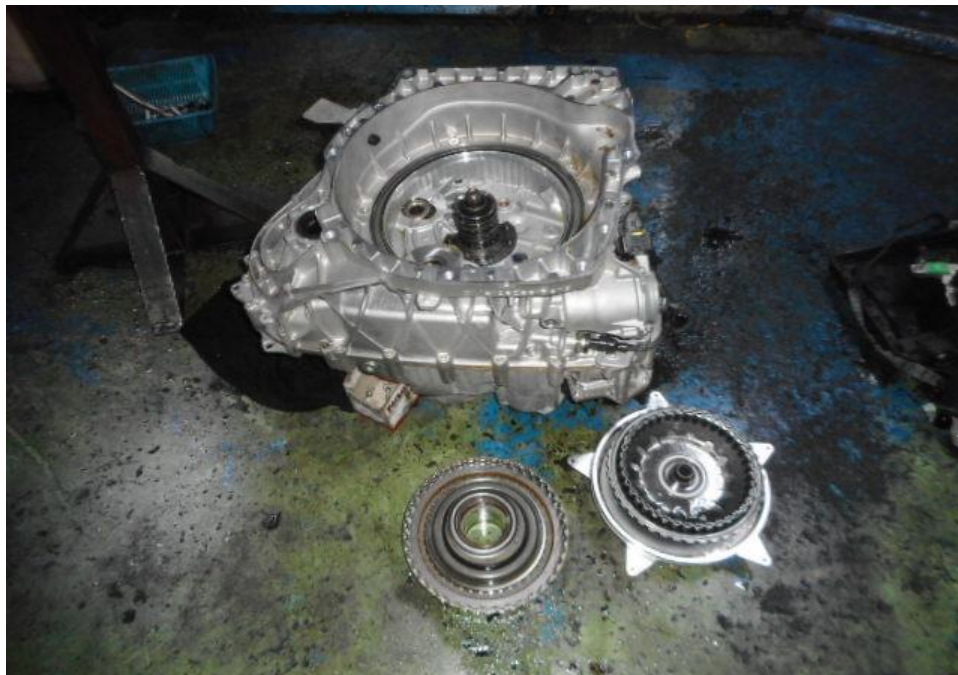
Photo 6 shows the general view of inside the gearbox unit of the Insured Vehicle at the time of our inspection. The components in the gearbox unit is observed to be unaffected and by any signs of accident.

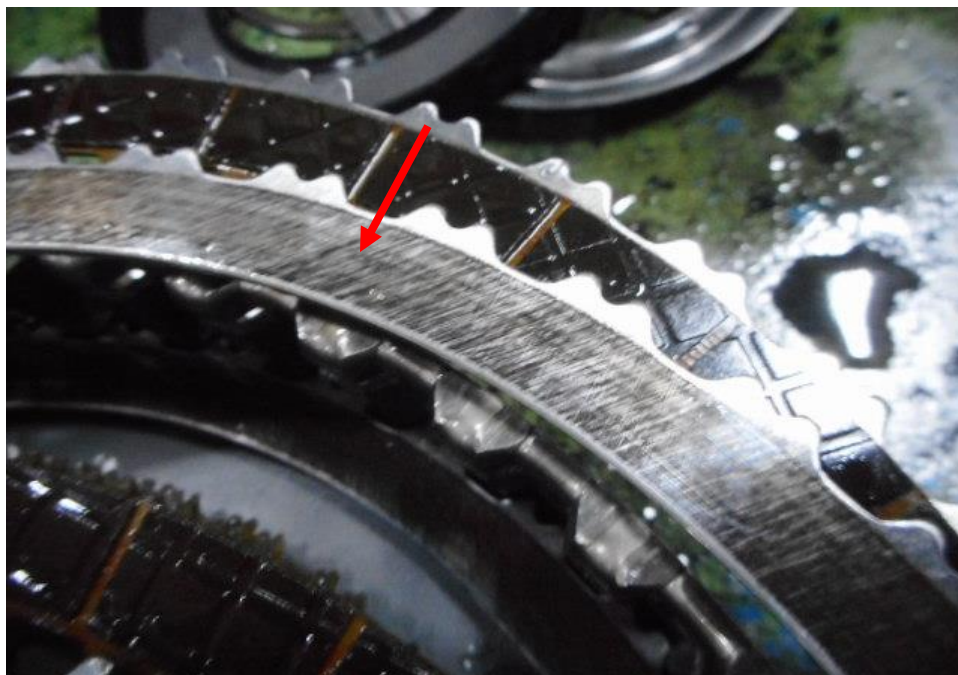
Photo 7 shows the close up view of inside the gearbox unit of the Insured Vehicle at the time of our inspection. The clutch pack (arrowed) component in the gearbox unit is observed to be damaged with scratches on the surface on the clutch packs linings, this is the cause for the complained problems of difficulty in changing gears and the sound coming for the gearbox of the Insured Vehicle.

7. We did not find any evidence which had suggested that the cause of abnormalities to the Insured Vehicle was due to poor maintenance and/or recurring problem.
8. The recommendation to replace the clutches and overhaul the gearbox unit at \$8,078.40 as stated in the quotation is justifiable as all the relevant checks has been conducted to the Insured Vehicle.

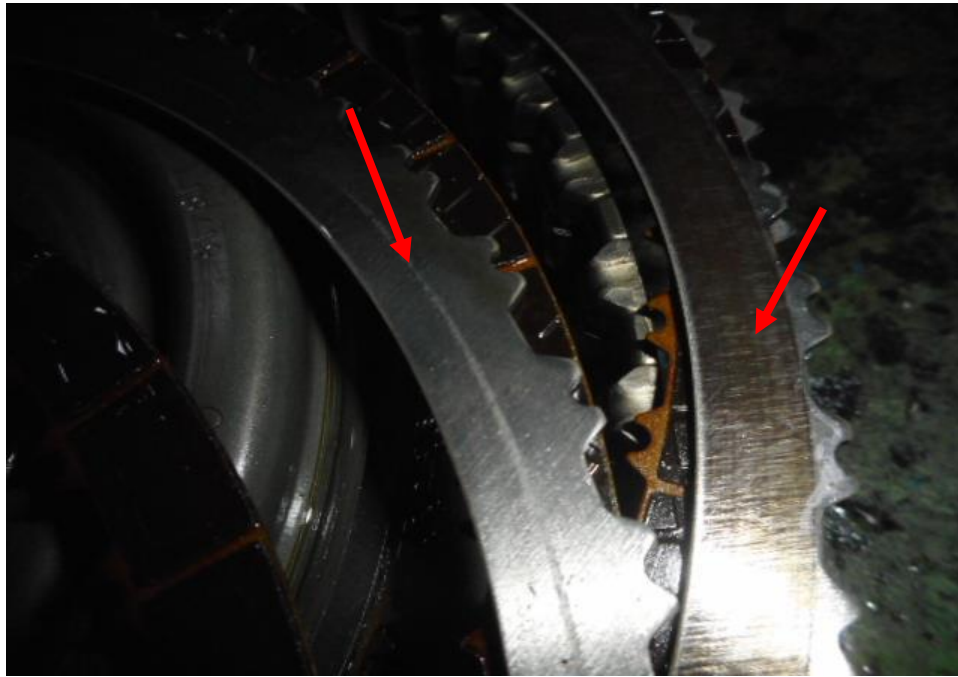
Photo 8 shows the close up view of inside the gearbox unit of the Insured Vehicle at the time of our inspection. The clutch pack (arrowed) component in the gearbox unit is observed to be damaged with scratches on the surface on the clutch packs linings, this is the cause for the complained problems of difficulty in changing gears and the sound coming for the gearbox of the Insured Vehicle.
