**TECHNICAL INVESTIGATION REPORT OF WARRANTY CLAIM INVOLVING
THE INSURED VEHICLE SMY 6787M ON 17th February 2023**

Vehicle Registration No.	: SMY 6787M
Make / Model	: A3 SEDAN 1.4 TFSI AMBIENTE MY 15
Chassis No	: WAUZZZ8V9F1026551
Year of Registration	: NOV 2014
Mileage	: 136,322KM

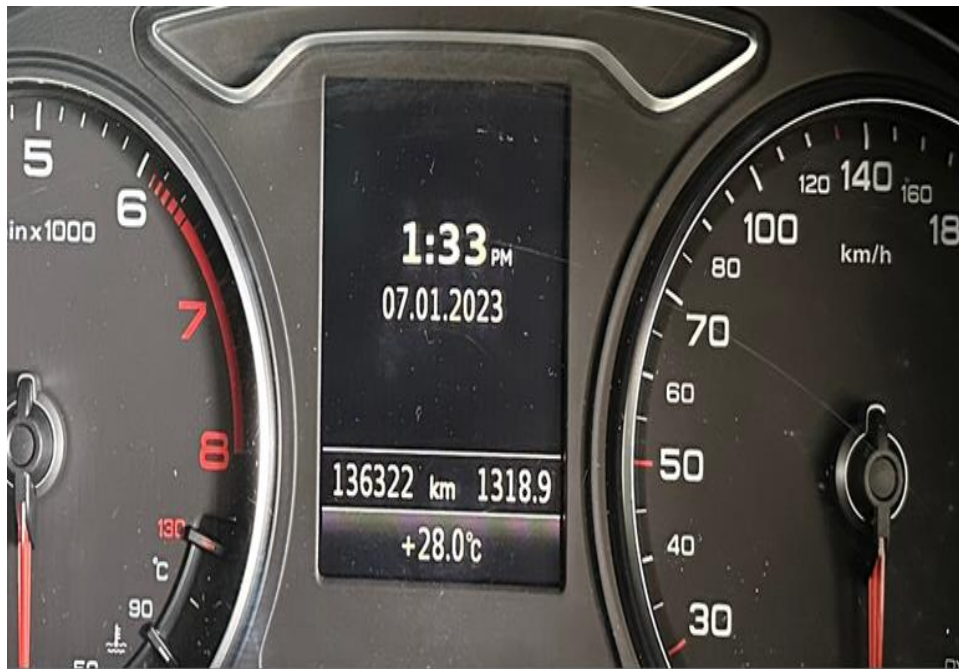
Photo 1 shows the mileage of the Insured Vehicle recorded at the time inspection at 136,322KM

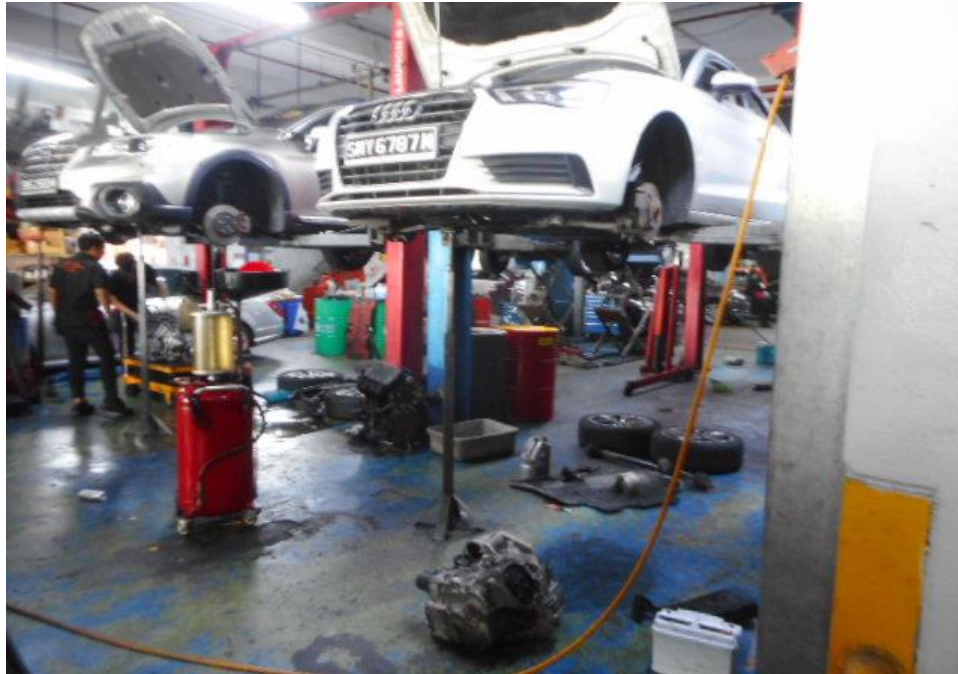
Photo 2 shows the general view of the front portion of the Insured Vehicle at the time of our inspection. The Insured Vehicle is observed to be unaffected by any signs of accident.

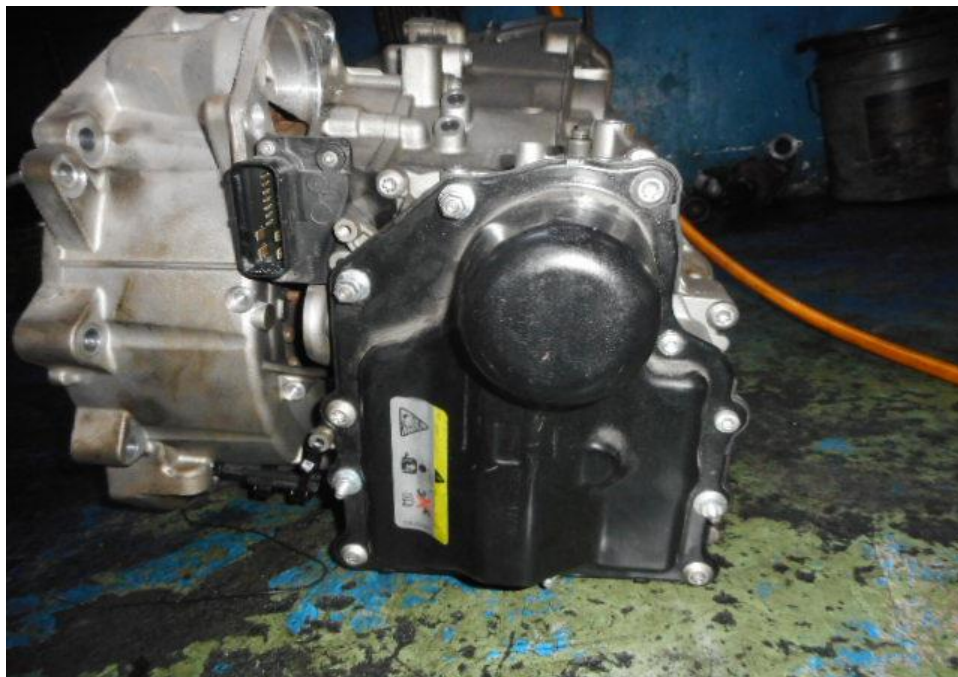
Photo 3 shows the general view of the gearbox and mechatronic unit portion of the Insured Vehicle at the time of our inspection. These undercarriage components is observed to be unaffected by any signs of accident.

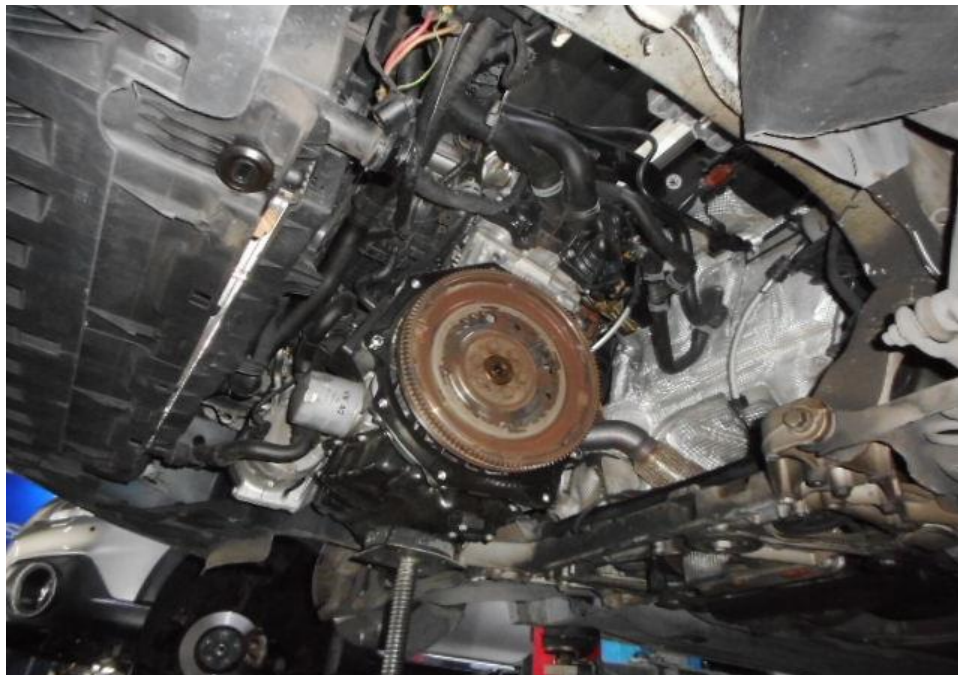
Photo 4 shows the general view of the gearbox underside portion of the Insured Vehicle at the time of our inspection. The gearbox underside compartment is observed to be unaffected and by any signs of accident.

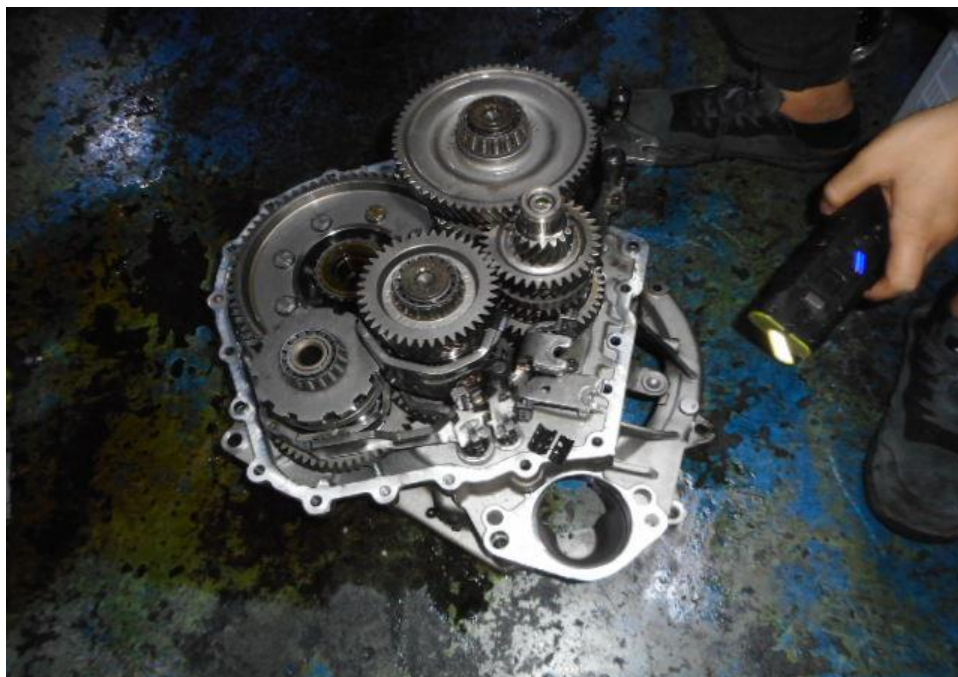
Photo 5 shows the general view of gearbox unit of the Insured Vehicle at the time of our inspection. The gearbox component in the gearbox unit is observed to be damaged and fallen out of place. These damaged components is likely the cause of the failure to the gearbox system.

7. We did not find any evidence which had suggested that the cause of abnormalities to the Insured Vehicle was due to poor maintenance and/or recurring problem.
8. The recommendation to replace the clutch of the gearbox unit at \$5,346 as stated in the quotation is justifiable as all the relevant checks has been conducted to the Insured Vehicle.

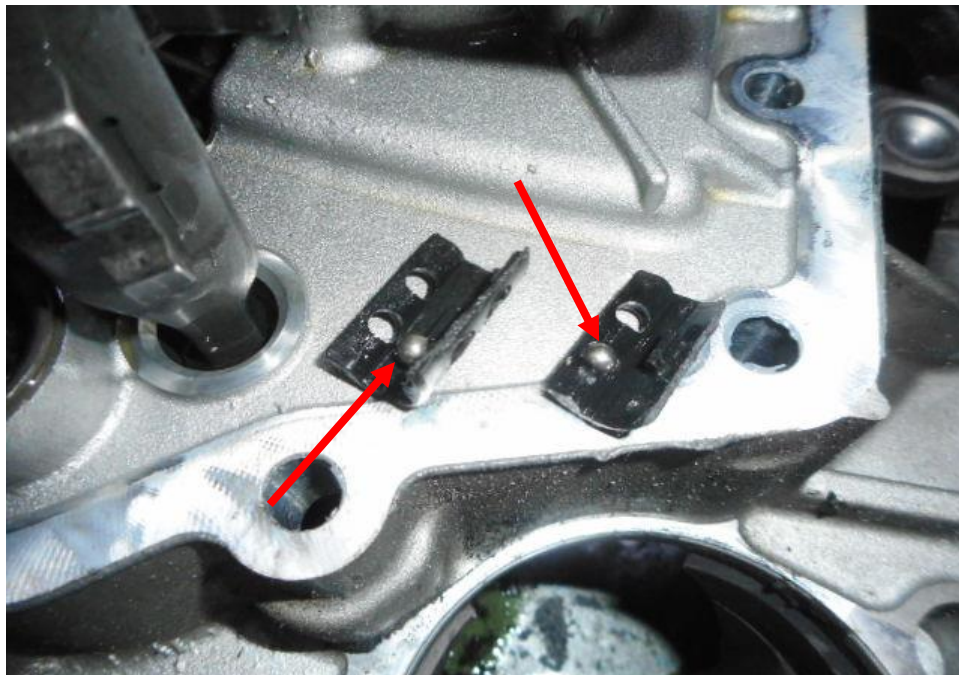
Photo 6 shows the close up view of gearbox unit of the Insured Vehicle at the time of our inspection. The gearbox ball bearing component (arrowed) in the gearbox unit is observed to be damaged and fallen out of place. These damaged components is likely the cause of the failure to the gearbox system.

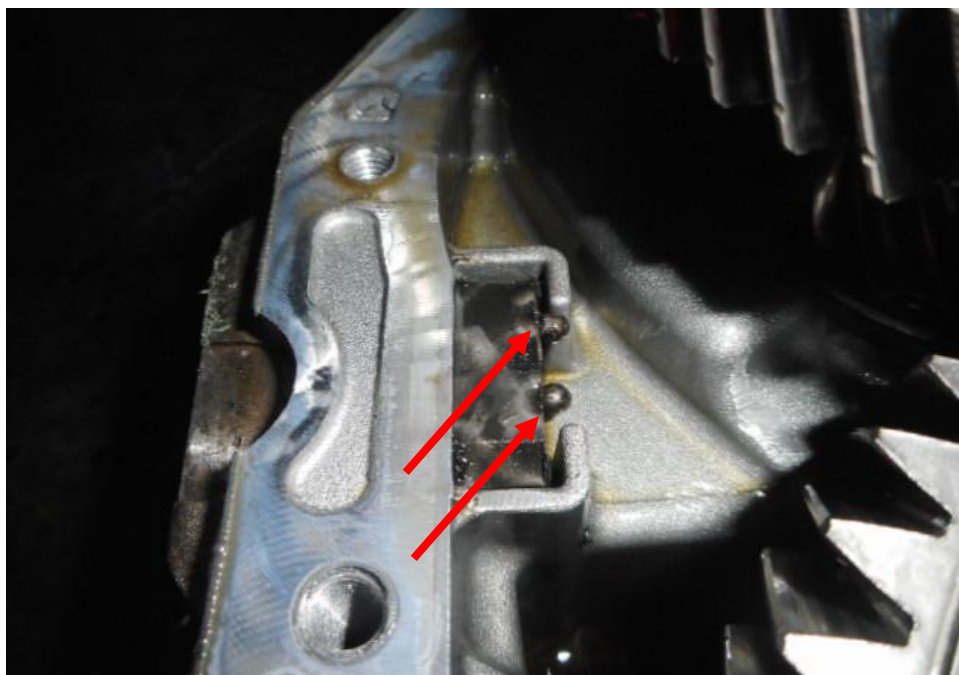
Photo 7 shows the close up view of gearbox unit of the Insured Vehicle at the time of our inspection. The gearbox ball bearing component (arrowed) in the gearbox unit is observed to be damaged and fallen out of place. These damaged components is likely the cause of the failure to the gearbox system.
