INVESTIGATION REPORT:

Our Ref : CS4/EGI23004325/N
Policy No : DMPG23001918
Insured : SND 8430C
Date of Accident : 25 April 2023
Location : Depot Lane Heavy Vehicle Carpark lots 80-85

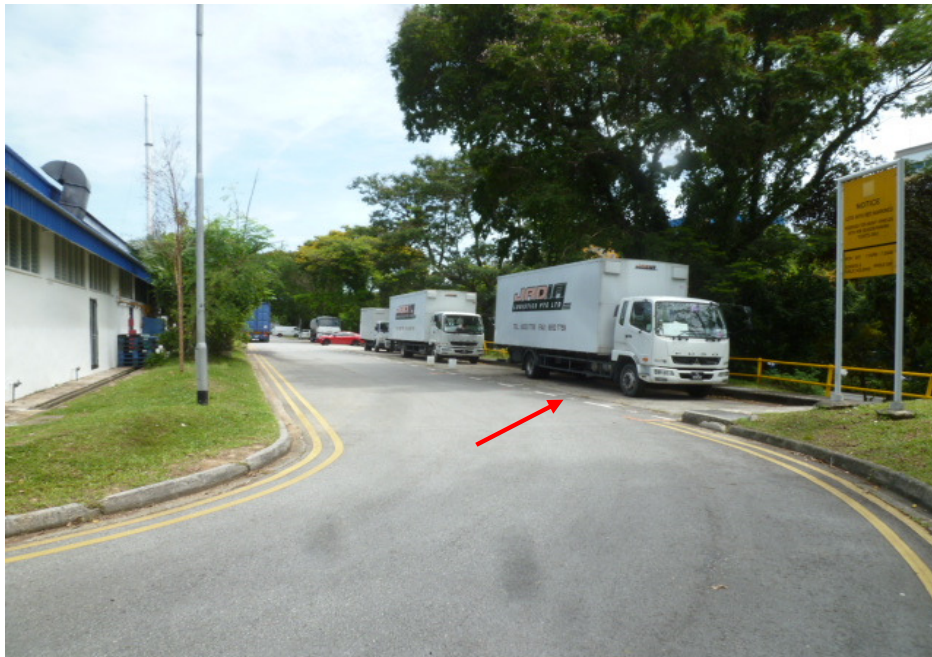
Photo 1 shows the general vicinity of the open public heavy vehicle carpark located at Depot Lane where the Insured Vehicle was parked (arrowed).

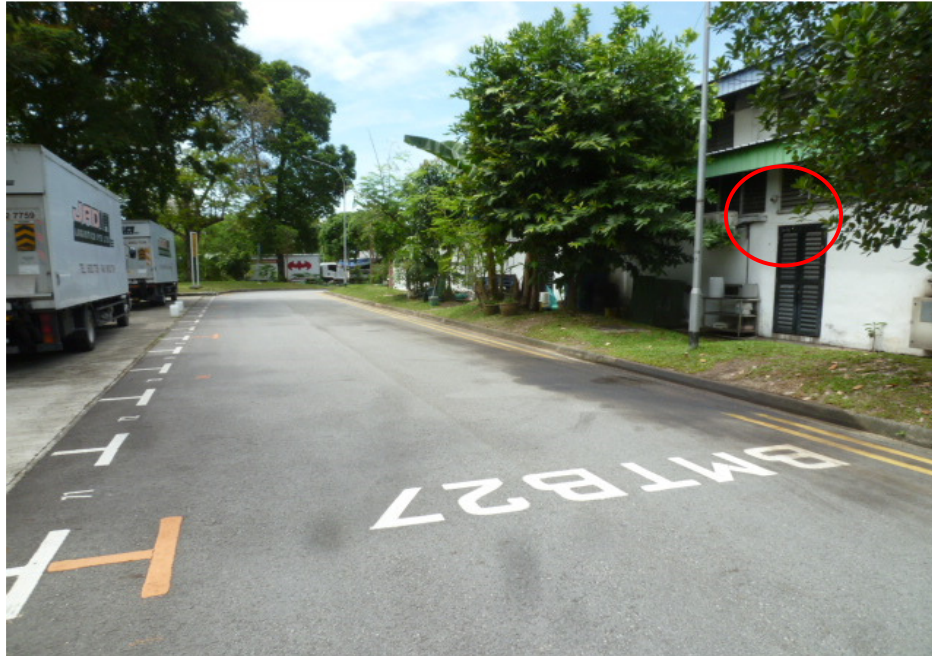
10. Upon closer examination of the surrounding area, we noticed a CCTV camera nearest to the accident location that belongs to unit #01-72 of Block 4007. We inspected the premises of the said unit. The CCTV camera was positioned on the wall at the back of the unit. However the angle of the camera is such that it is facing away from lots 80 – 85. See photos 1 – 3 below.

Photo 2 shows the position of the CCTV camera nearest to the accident location that belongs to unit #01-72 of Block 4007 (circled).

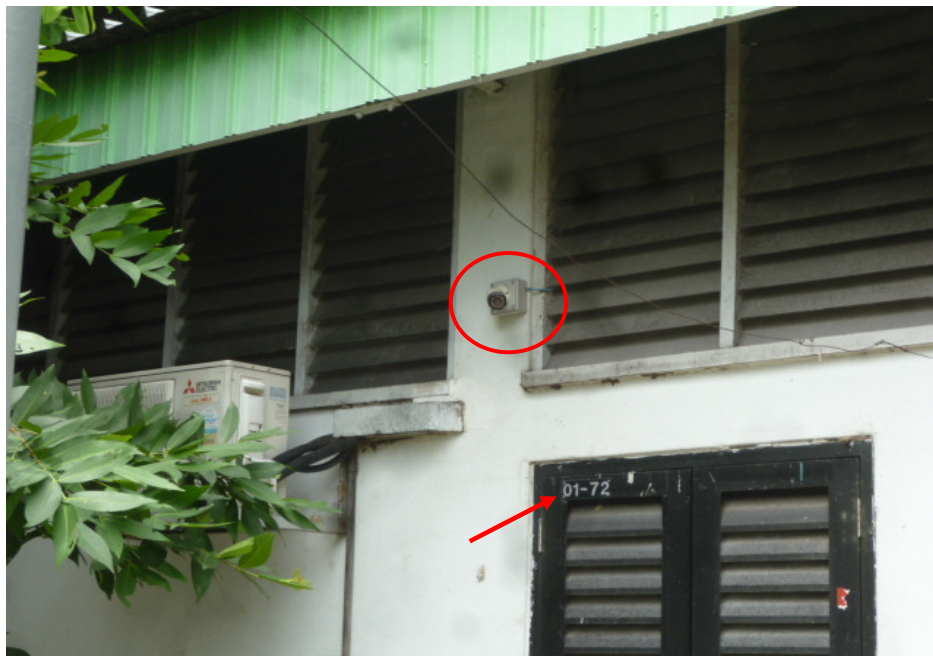
Photo 3 shows a closer view of the CCTV camera (circled) nearest to the accident location that belongs to unit #01-72 of Block 4007 (arrowed). The CCTV camera was positioned on the wall at the back of the unit. However the angle of the camera is such that it is facing away from lots 80 – 85.

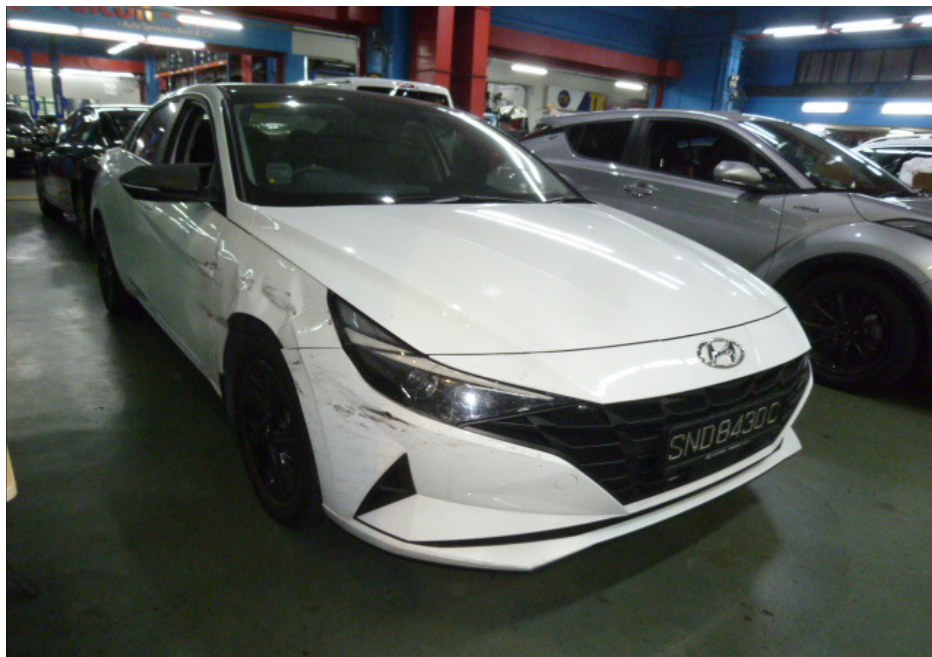
11. Based on the accident report provided to us by Mr Kee, the Insured Vehicle had sustained significant damages to its right body.
12. Our physical inspection of the Insured Vehicle at Falcon revealed that the Insured Vehicle had sustained significant damages to its right body, particularly to its right front headlamp, front bumper, right front fender, driver door, right rear door, rear bumper and right wheel rims. Upon closer examination of the front bumper, the graze marks and scuff marks observed on the front bumper of the Insured Vehicle did not corroborate with Mr Kee's statement of a hit-and-run accident. The damages found on the front bumper seemed to correspond with the front bumper coming into contact with bushes or shrubs. See photos 4 – 11 below.

Photo 4 shows the general frontal right portion of the Insured Vehicle during the physical inspection at Falcon. The Insured Vehicle had sustained significant damages to its right body, particularly to its right front headlamp, front bumper, right front fender, driver door, right rear door, rear bumper and right wheel rims as a result of the incident.

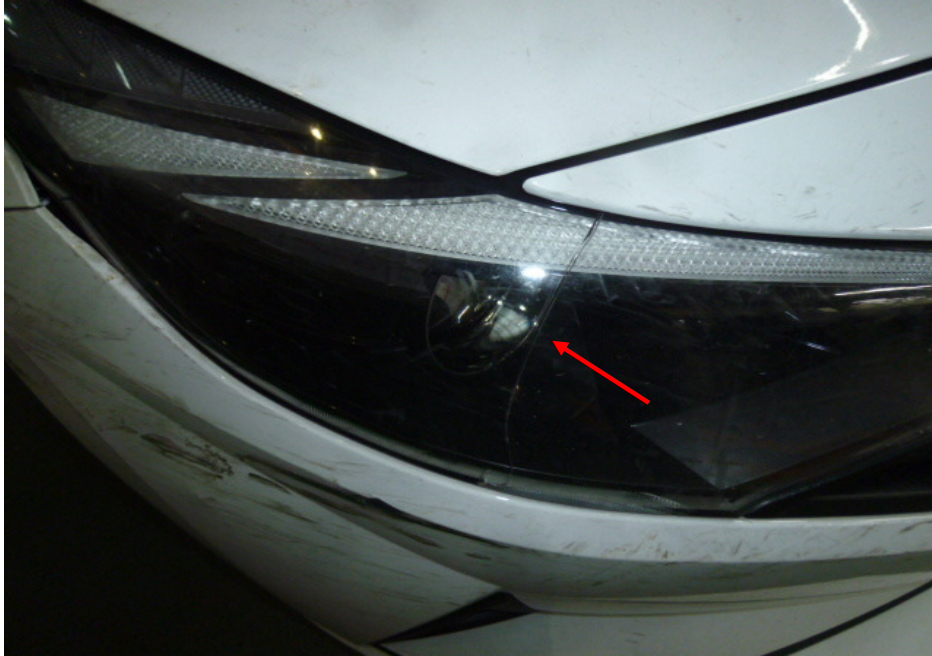
Photo 5 shows the cracked right front headlamp of the Insured Vehicle as a result of the accident (arrowed).

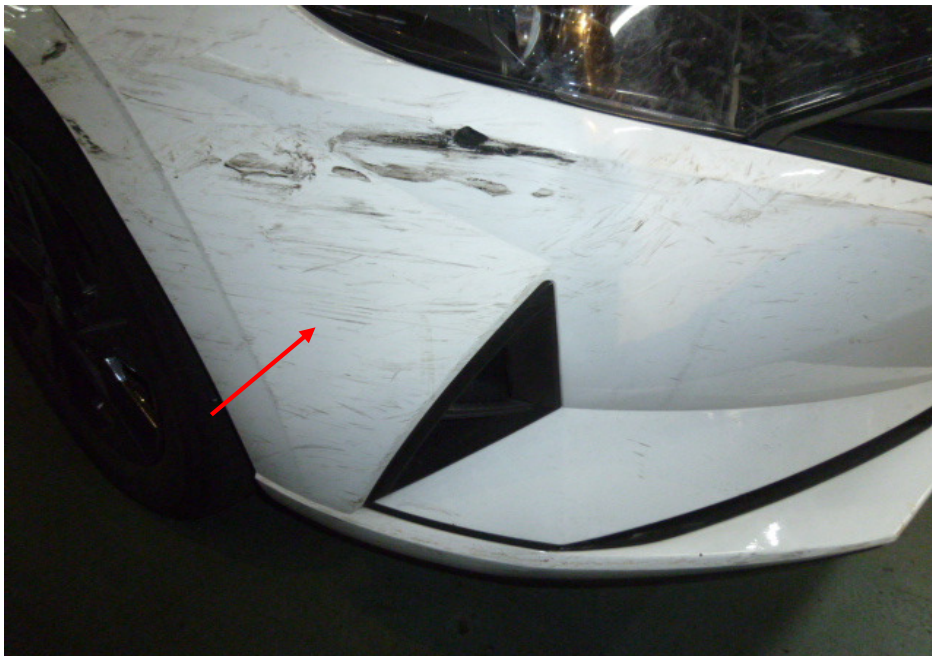
Photo 6 shows upon closer inspection, the graze marks and scuff marks sustained to the front bumper of the Insured Vehicle (arrowed) did not corroborate with Mr Kee's statement of a hit-and-run accident.

15. Basing on the available evidence gathered during the course of our investigations, we are of the view that the damages to the front bumper of the Insured Vehicle SND 8430C did not corroborate with Mr Kee's statement of a hit-and-run accident. The damages found on the front bumper seemed to correspond with the front bumper coming into contact with bushes or shrubs.
16. The physical inspection carried out on the Insured Vehicle SND 8430C had also revealed that its 4 tyres were in serviceable condition with remaining thread depth of approximately 5mm each.

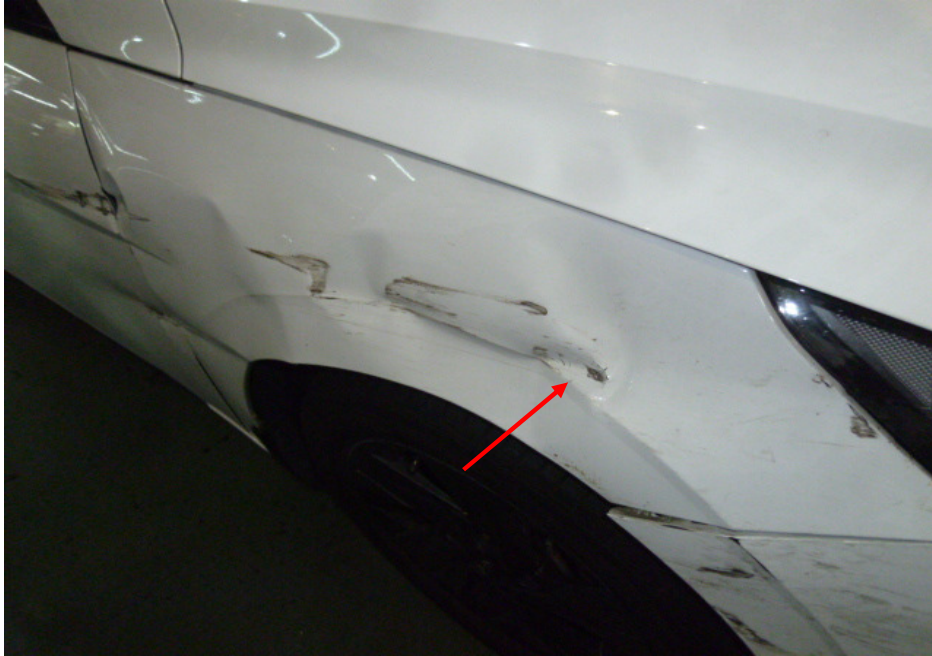
Photo 7 shows the dented right front fender of the Insured Vehicle as a result of the accident (arrowed).

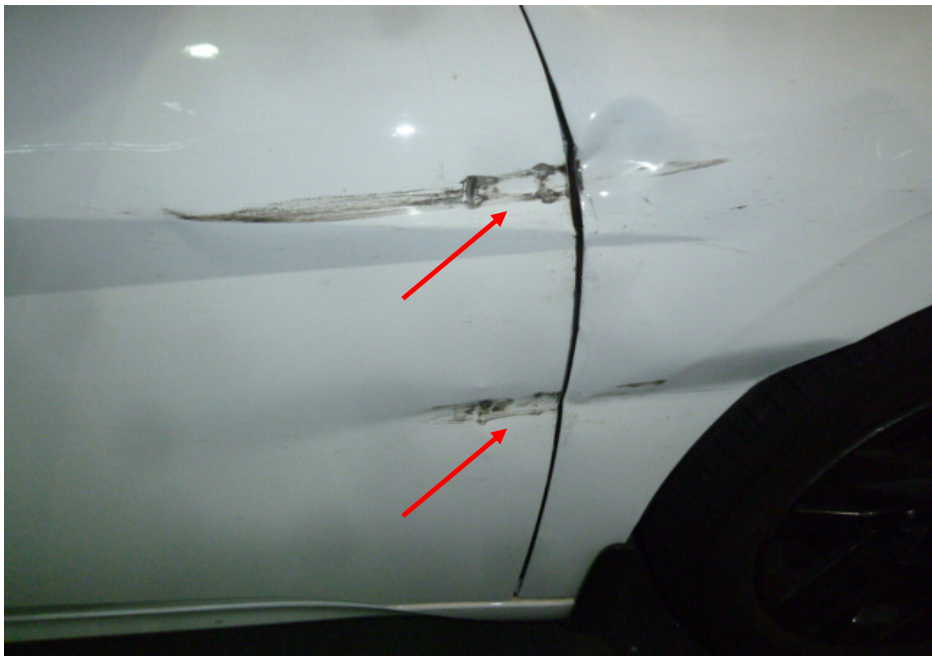
Photo 8 shows the dented driver door of the Insured Vehicle as a result of the accident (arrowed).

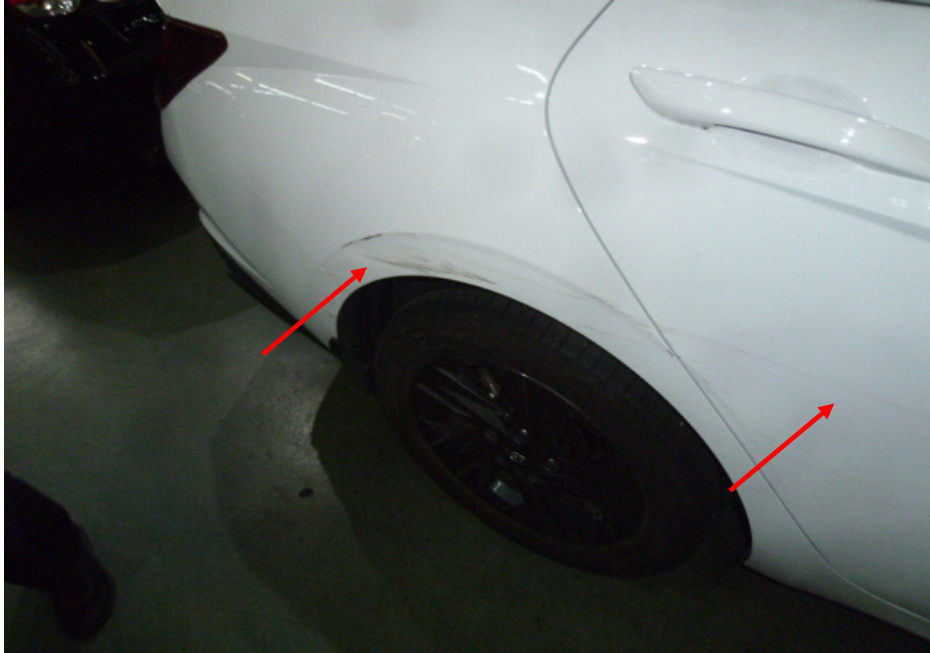
Photo 9 shows the grazed right rear door and rear bumper of the Insured Vehicle as a result of the accident (arrowed).

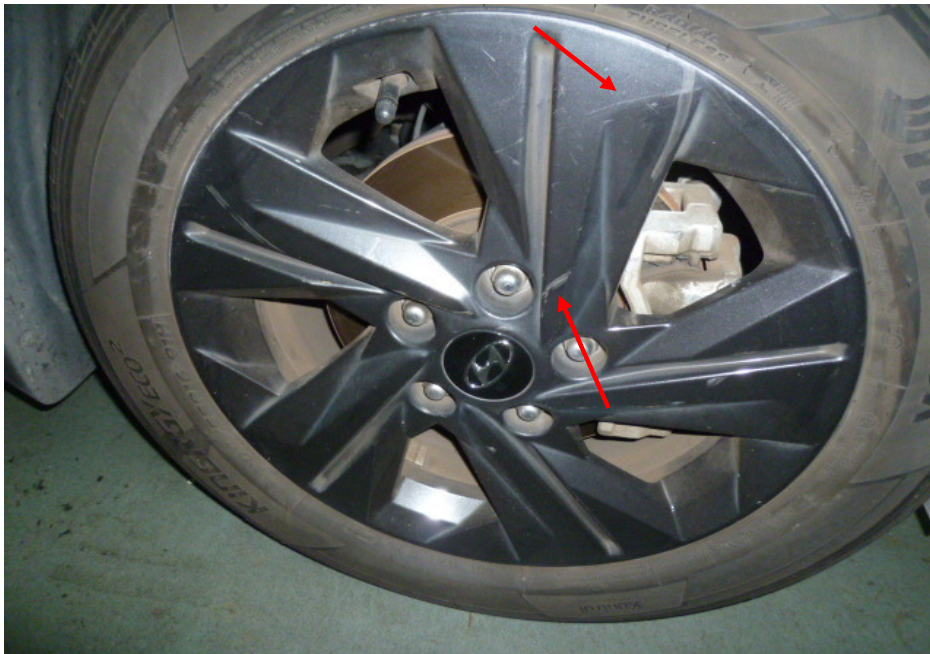
Photo 10 shows a closer view of the relatively minor marks of grazing nature observed around the right front wheel rim (arrowed) of the Insured Vehicle during the physical inspection at Falcon.

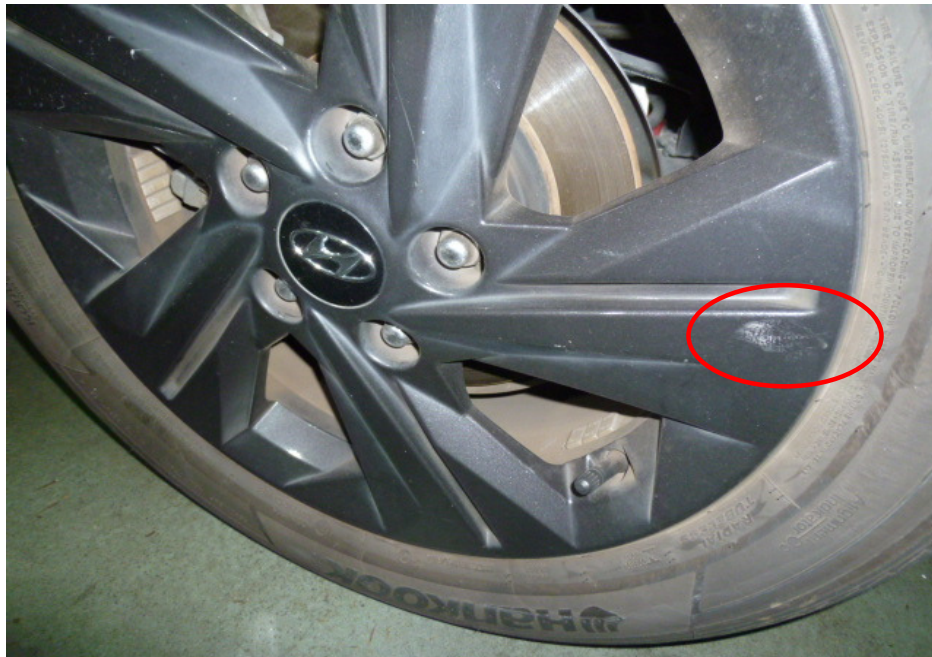
Photo 11 shows a closer view of the relatively minor marks of grazing nature observed around the right rear wheel rim (circled) of the Insured Vehicle during the physical inspection at Falcon.
