Your Ref: Porsche Cayenne
(chassis number WP1ZZZ9YZMDA43175)
Our Ref : CI/TP23004392/D

29 April 2023

**INSPECTION REPORT OF AN UNREGISTERED PORSCHE CAYENNE
MOTOR CAR WITH CHASSIS NUMBER WP1ZZZ9YZMDA43175**

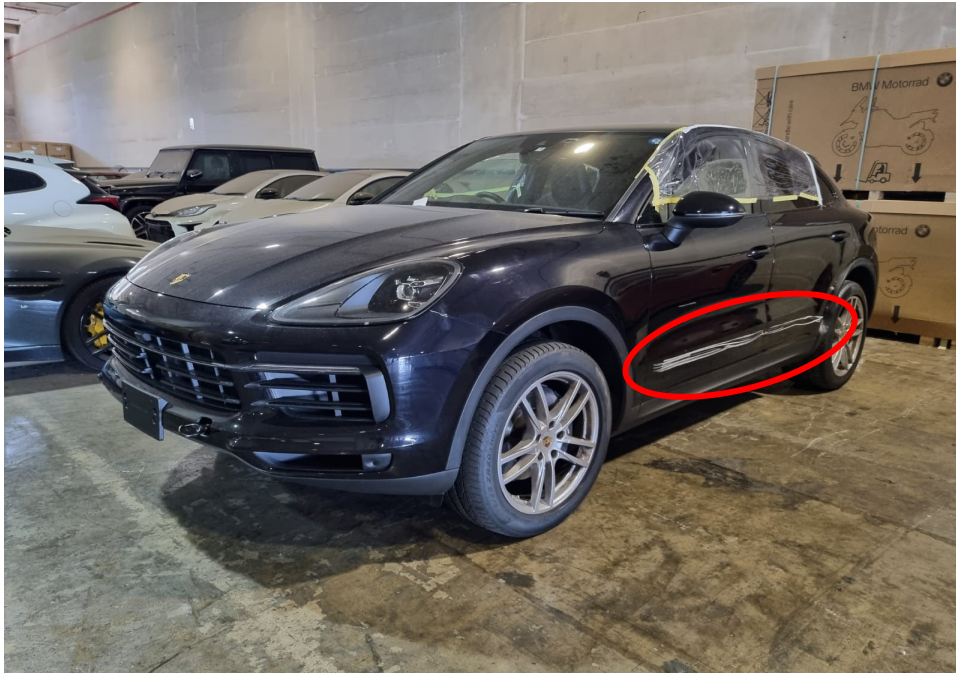
3. The photographs provided to me had showed damage to the Motor Car's left side centre portion. Its front left door and rear left door were damaged.
4. Apart for the left side centre portion, there was no physical damage observed to other areas of the Motor Car. The airbag(s) of the Motor Car was not deployed as seen from the photographs that were provided to me See photo 1 – 4 below.

Photo 1 shows the front left body of the Motor Car (photograph provided to me). The Motor Car was observed to have sustained damage at its left side centre portion (circled). Its front left door and rear left door were damaged. The Motor Car's airbag (s) was not deployed as seen from the photographs that were provided to me.

22. The body parts at the left side centre portion of the Motor Car were visually examined and it was noted that the repair/restoration works carried out to the damaged area of the Motor Car (refer to photograph 1 & 2 above) were reasonably adequate and in order.

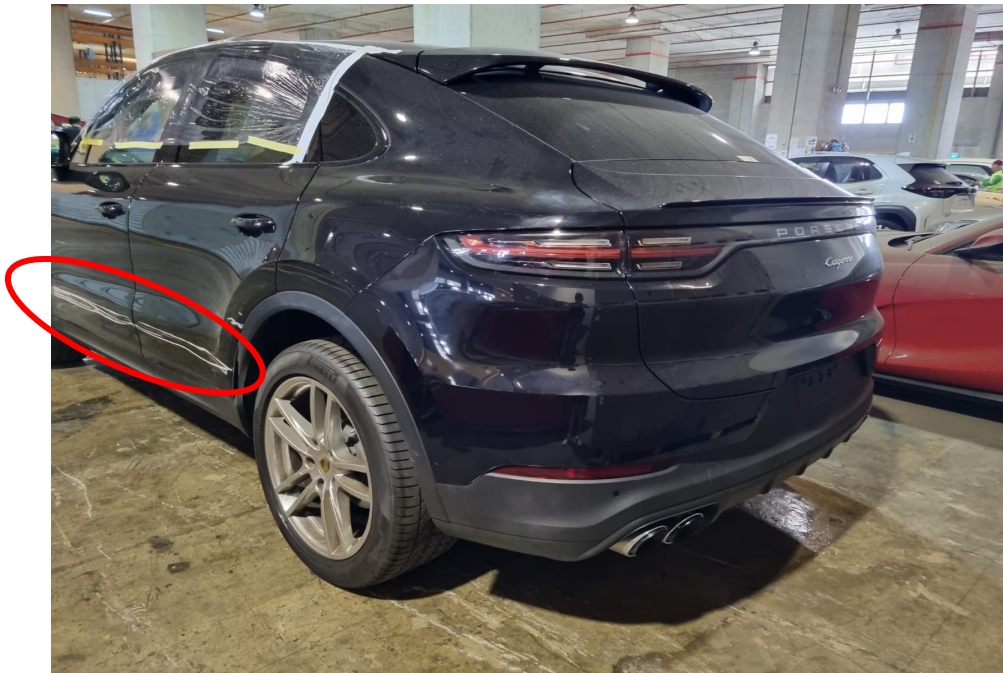
Photo 2 shows the rear left body of the Motor Car (photograph provided to me). The Motor Car was observed to have sustained damage at its left side centre portion (circled). Its front left door and rear left door were damaged.

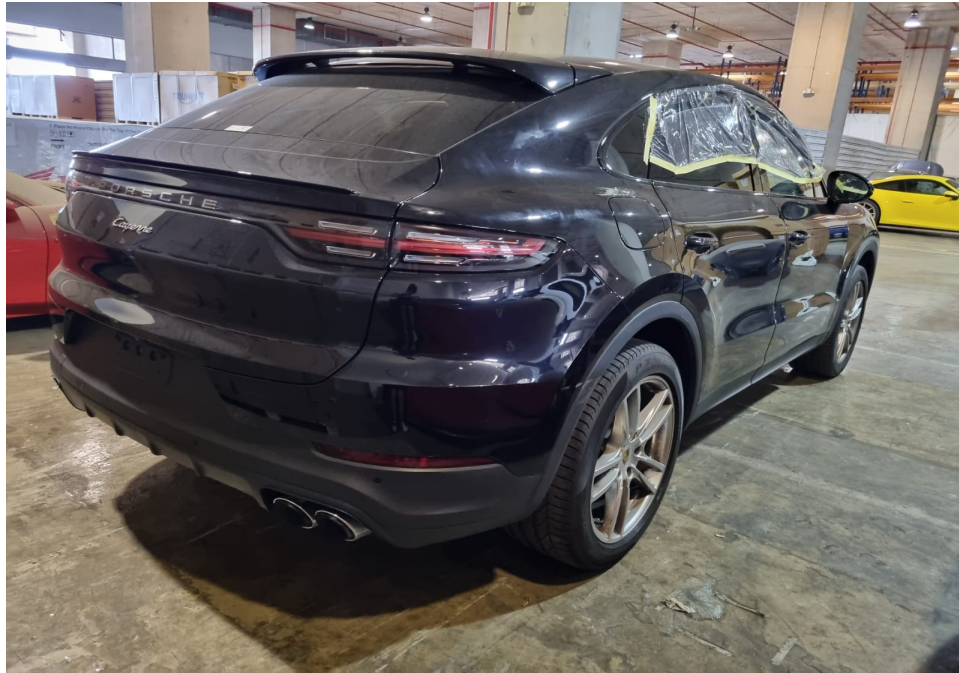
Photo 3 shows the rear right body of the Motor Car (photograph provided to me). Apart for the left side centre portion, there was no physical damage observed to other areas of the Motor Car.

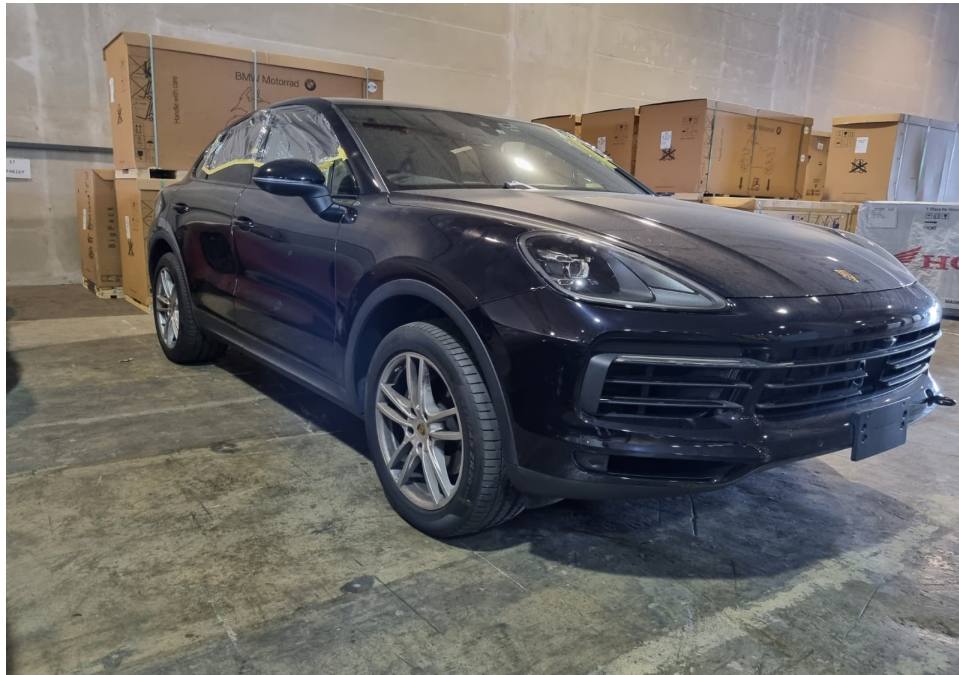
Photo 4 shows the front right body of the Motor Car (photograph provided to me). Apart for the left side centre portion, there was no physical damage observed to other areas of the Motor Car. The Motor Car's airbag (s) was not deployed as seen from the photographs that were provided to me.

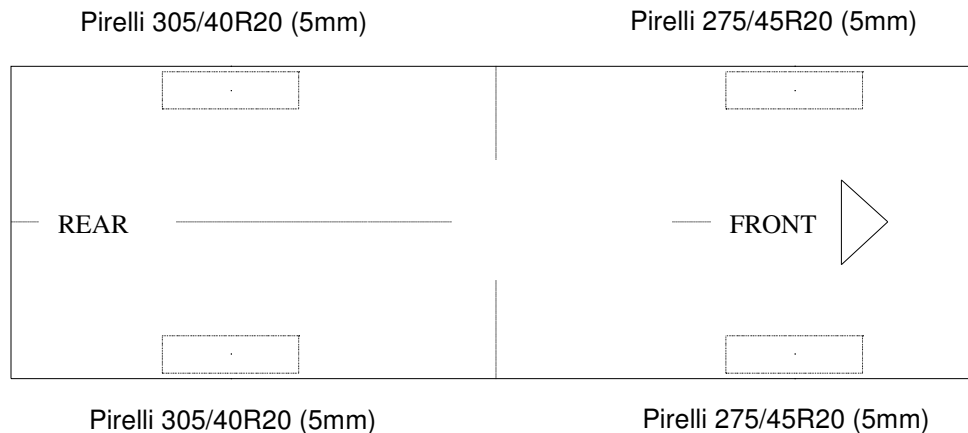
8. It was fitted with 20inch sport wheel rims that were wrapped with tyres that were observed to be of serviceable condition. The tyres were also sufficiently inflated for vehicular operation. The tyre brand, tyre size and approximate remaining tread depth of the 4 tyres of the Motor Car were recorded as follows: -

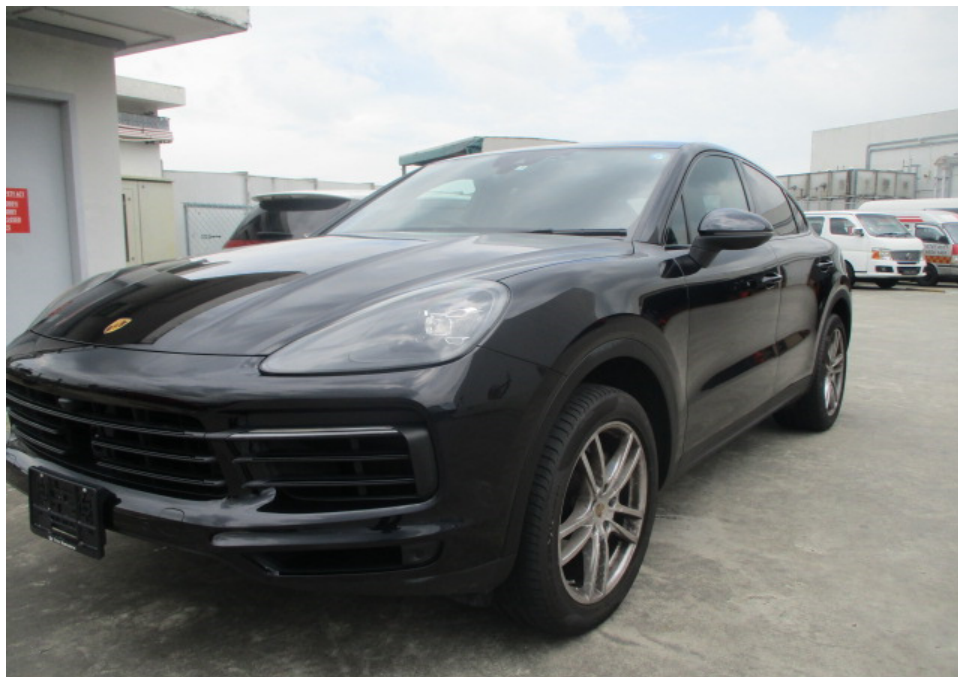
Photo 5 shows a general view of the front left body of the Motor Car at the time of my inspection. The Motor Car was observed to be in a relatively good general condition with no loose exterior fittings observed. The body parts at the left side centre portion of the Motor Car were visually examined and it was observed that the repair/restoration works carried out to the damaged area of the Motor Car (refer to photograph 1 & 2 above) were reasonably adequate and in order.

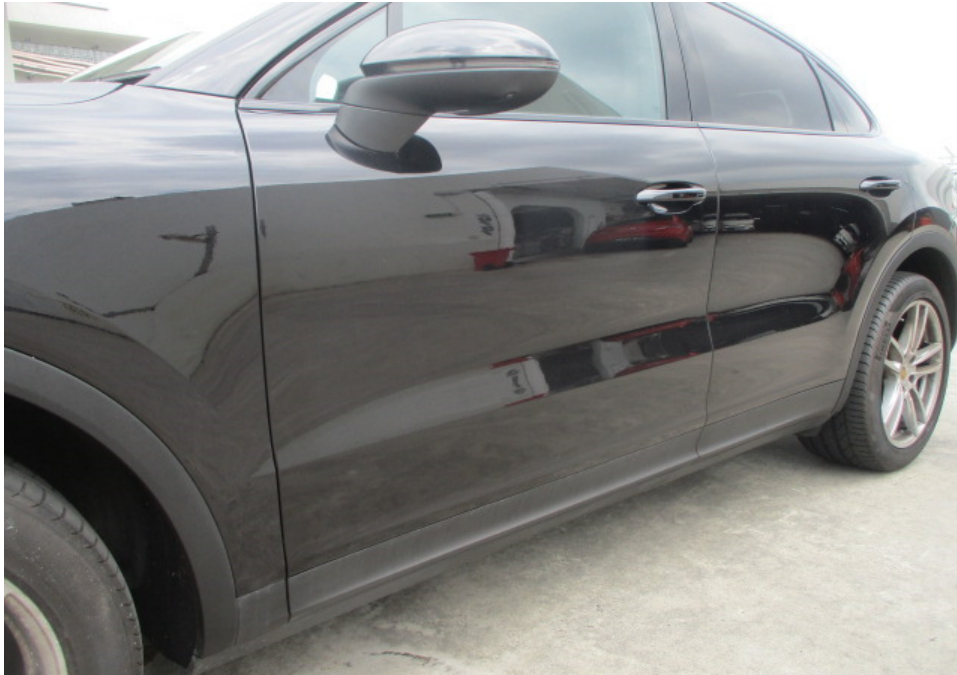
Photo 6 shows a closer view of the Motor Car's front left fender, front left door, front left door lower moulding and rear left door. The body parts at the left side centre portion of the Motor Car were visually examined and it was observed that the repair/restoration works carried out to the damaged area of the Motor Car (refer to photograph 1 & 2 above) were reasonably adequate and in order.

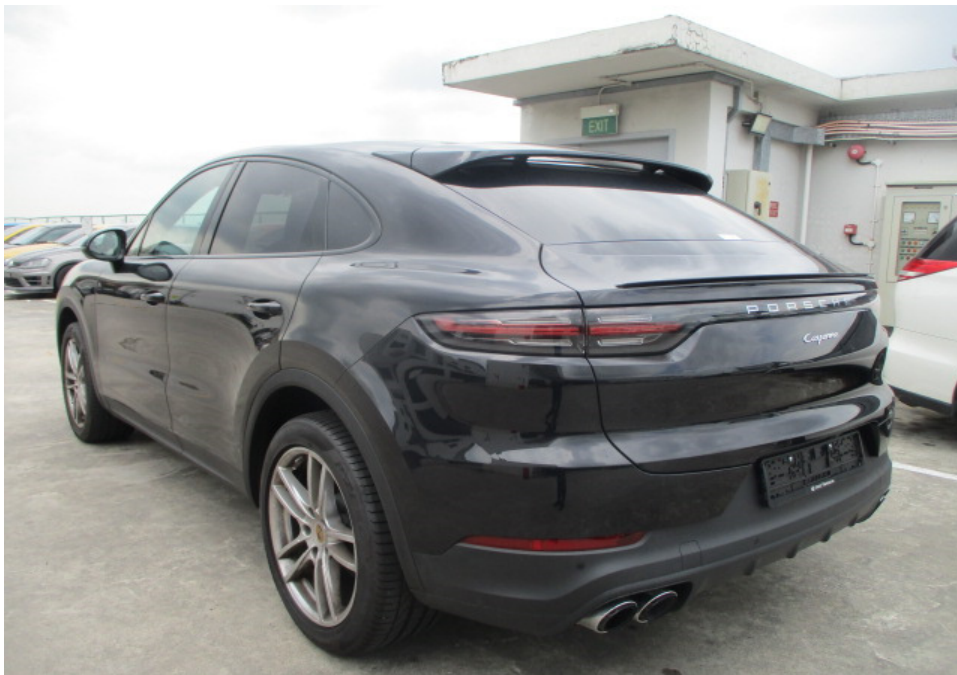
Photo 7 shows a general view of the rear left body of the Motor Car at the time of my inspection. The Motor Car was observed to be in a relatively good general condition with no loose exterior fittings observed. The body parts at the left side centre portion of the Motor Car were visually examined and it was observed that the repair/restoration works carried out to the damaged area of the Motor Car (refer to photograph 1 & 2 above) were reasonably adequate and in order.

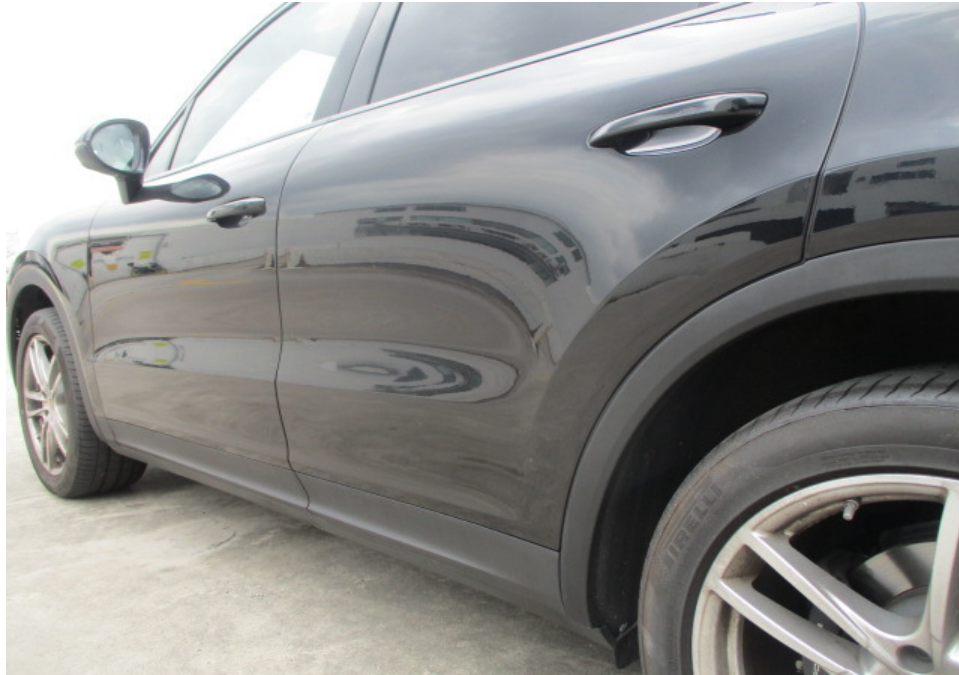
Photo 8 shows a closer view of the Motor Car's rear left fender, rear left fender wheel arc garnish and rear left door. The body parts at the left side centre portion of the Motor Car were visually examined and it was observed that the repair/restoration works carried out to the damaged area of the Motor Car (refer to photograph 1 & 2 above) were reasonably adequate and in order.

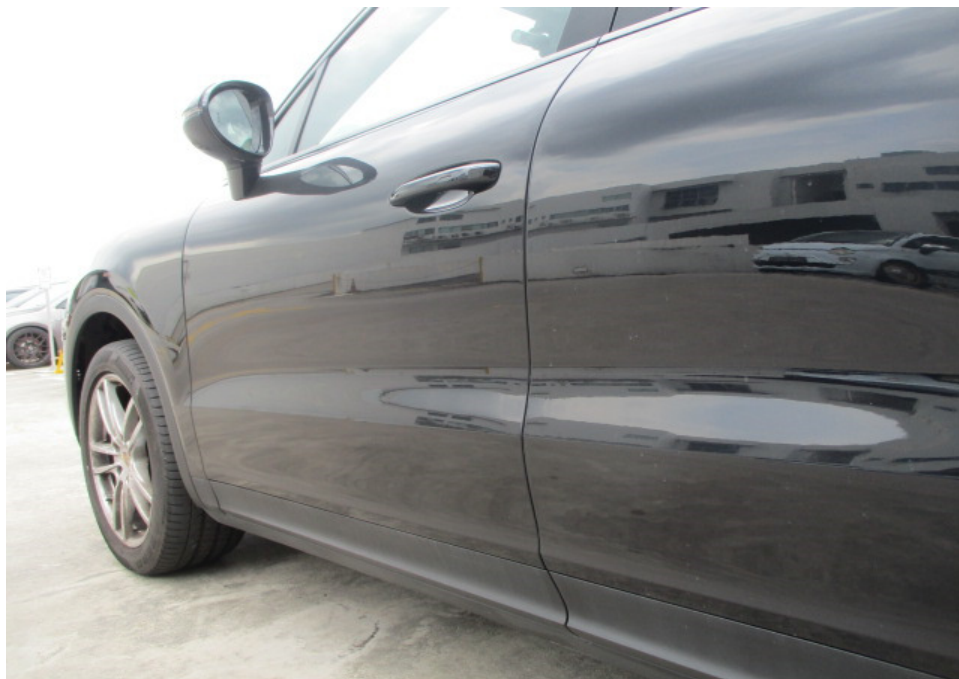
Photo 9 shows a closer view of the Motor Car's rear left door, rear left door lower moulding, front left door and front left door lower moulding. The body parts at the left side centre portion of the Motor Car were visually examined and it was observed that the repair/restoration works carried out to the damaged area of the Motor Car (refer to photograph 1 & 2 above) were reasonably adequate and in order.

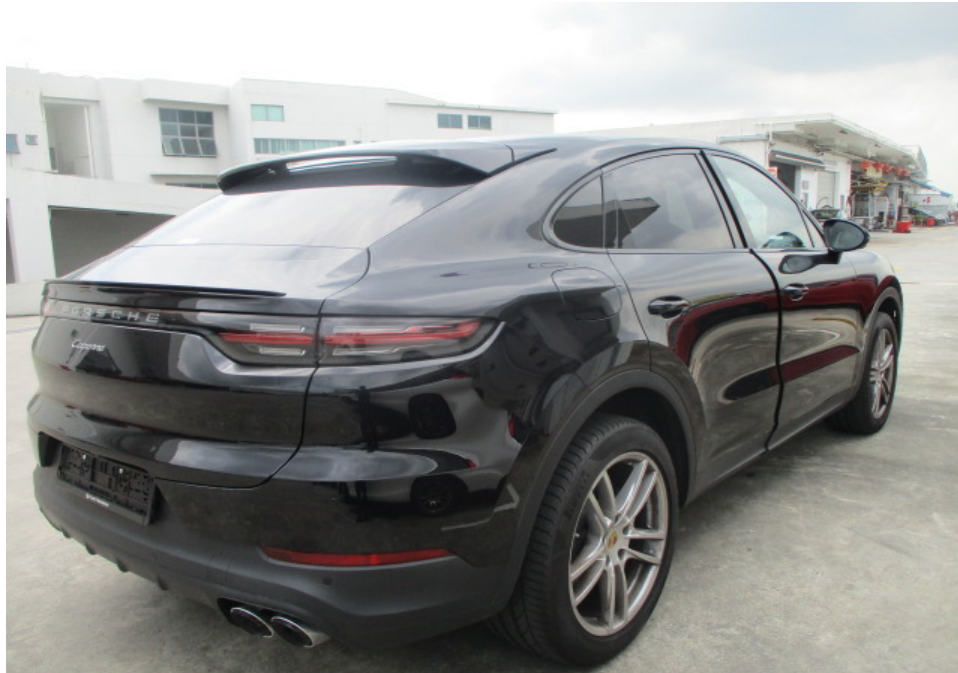
Photo 10 shows a general view of the rear right body of the Motor Car at the time of my inspection. The Motor Car was observed to be in a relatively good general condition with no loose exterior fittings observed. The mileage of the Motor Car recorded at the time of my inspection was 10,658km.

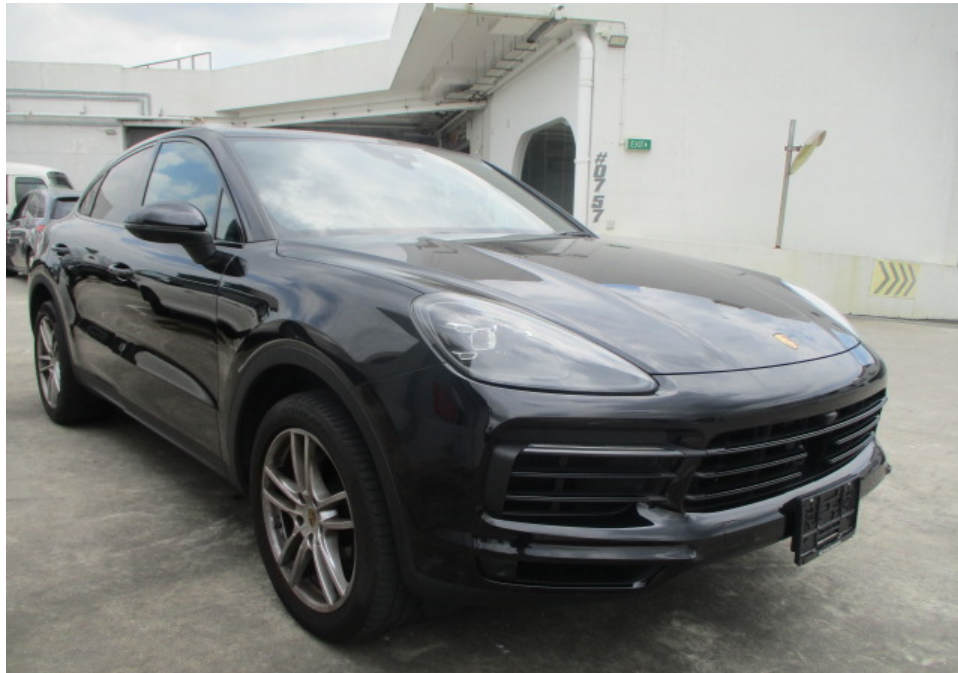
Photo 11 shows a general view of the front right body of the Motor Car at the time of my inspection. The Motor Car was observed to be in a relatively good general condition with no loose exterior fittings observed. The mileage of the Motor Car recorded at the time of my inspection was 10,658km.

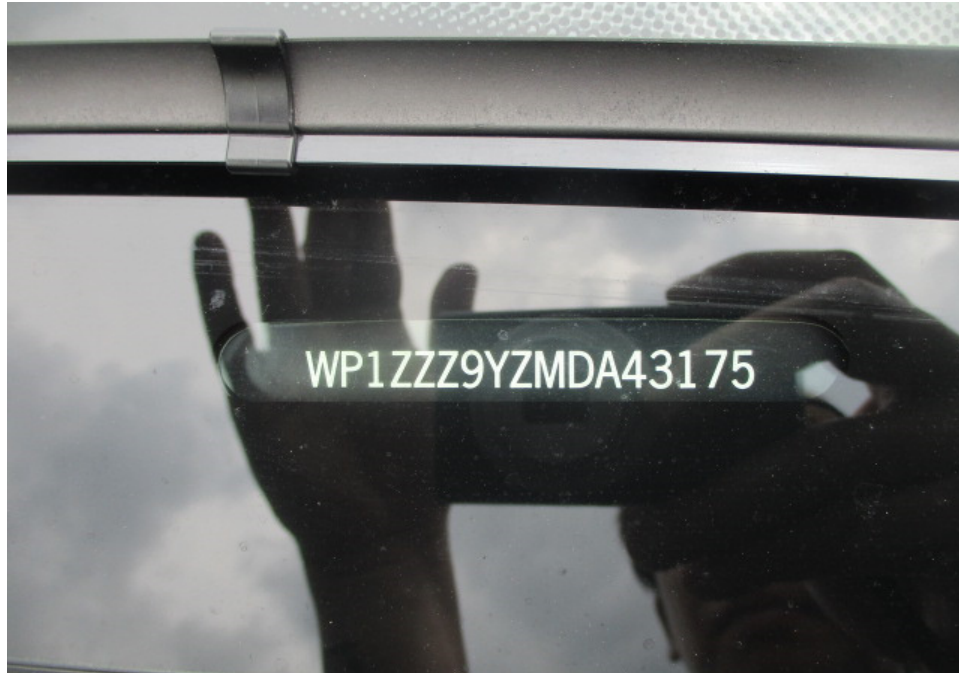
Photo 12 shows the chassis number of the Motor Car. The chassis number recorded was WP1ZZZ9YZMDA43175.

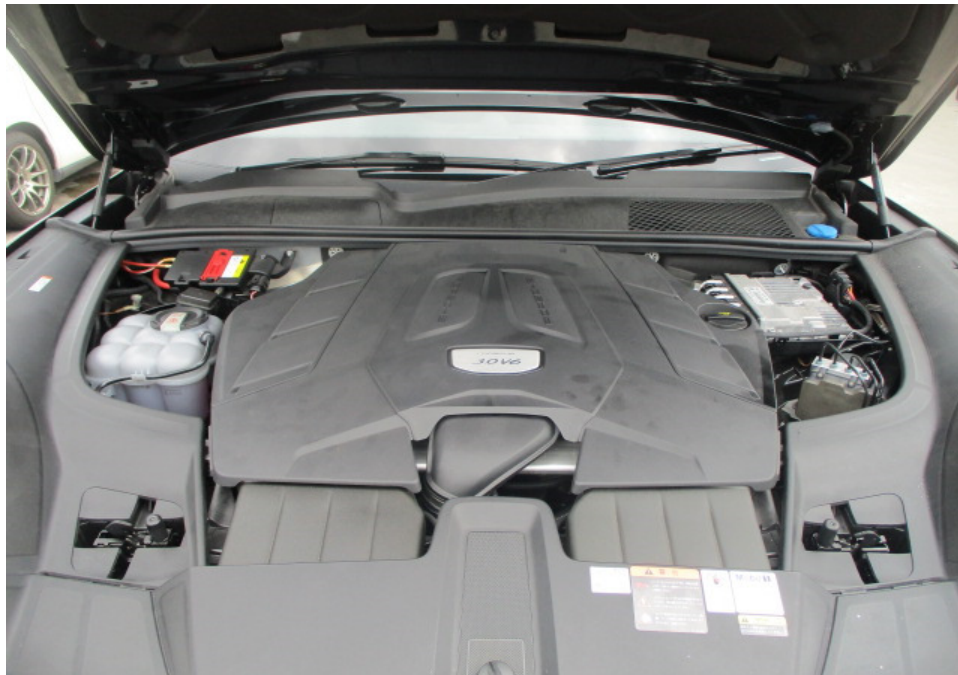
Photo 13 shows a general view of the engine compartment of the Motor Car at the time of my inspection. The various parts and components inside the engine compartment were all observed to be intact and properly fitted. There was also no sign(s) or indication(s) of fluid leak and/or fluid stain found inside the engine compartment.

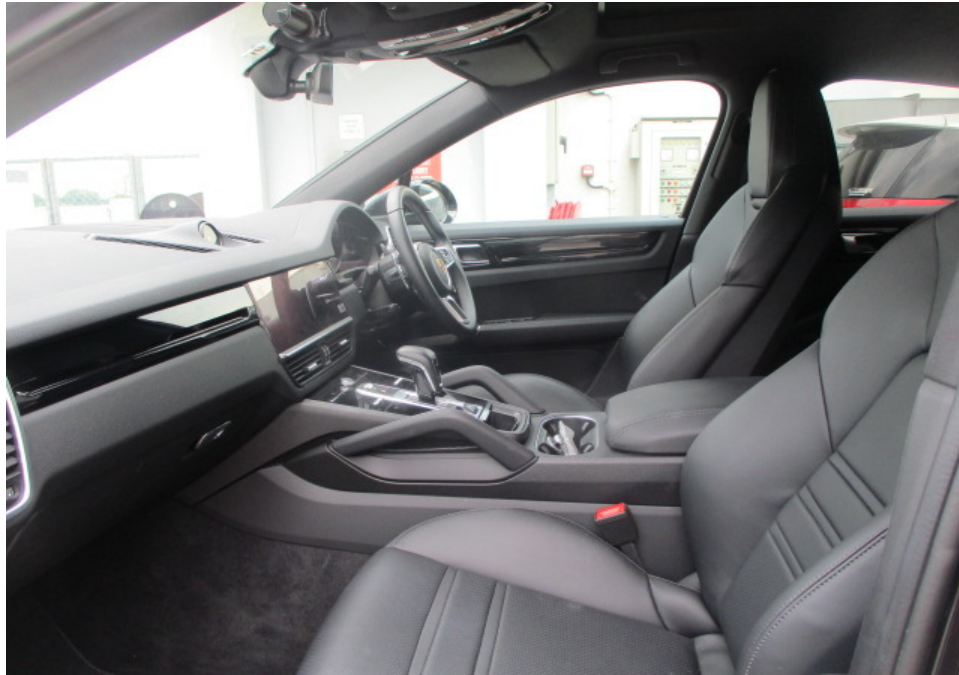
Photo 14 shows the interior compartment of the Motor Car. The front dashboard, steering wheel, seats, upholstery and trims etc were all observed to be intact and properly fitted.

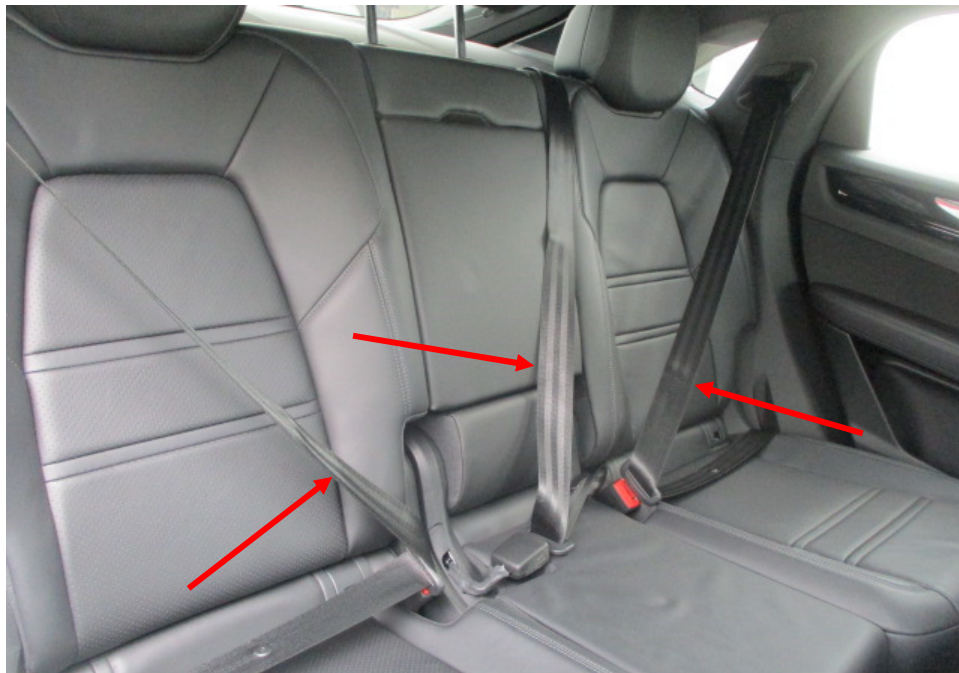
Photo 15 shows the rear seats of the Motor Car. All the seats of the Motor Car were secured via seat rails to the floorboard. They were also fitted with a retractable seat belt reel and a pre-tensioner. The seat belts (arrowed) were tested and were able to be fastened into the respective pre-tensions that were fitted on the side of each individual seat.

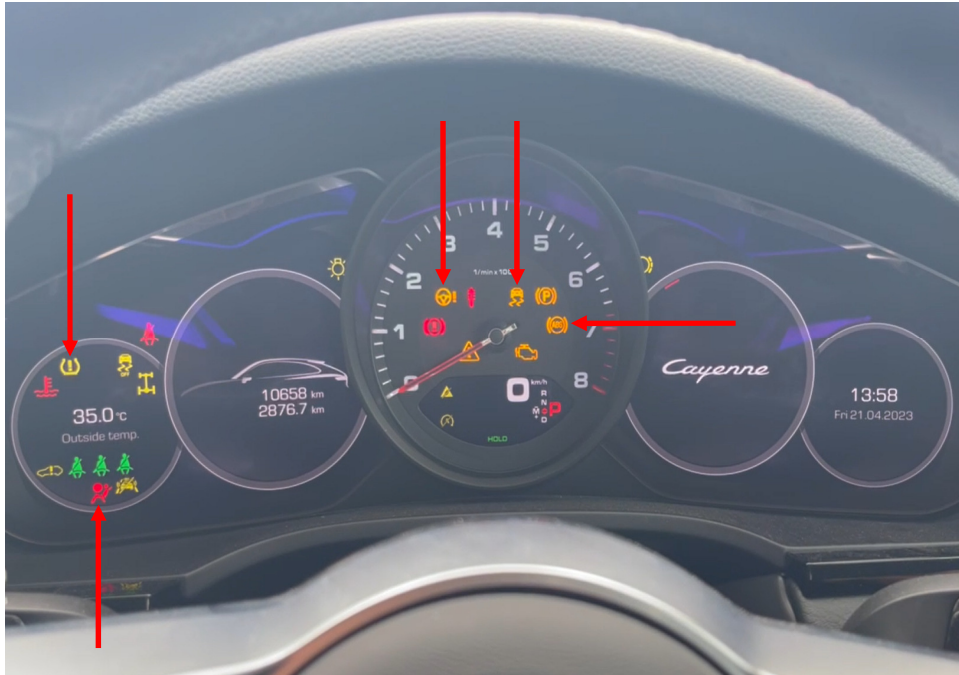
Photo 16 shows the warning lights for the various electronic safety features appearing on the instrument panel of the Motor Car during its self-test when the engine is cranked, in particular the ABS, SRS, TPM, EPS and TCS lights (arrowed).

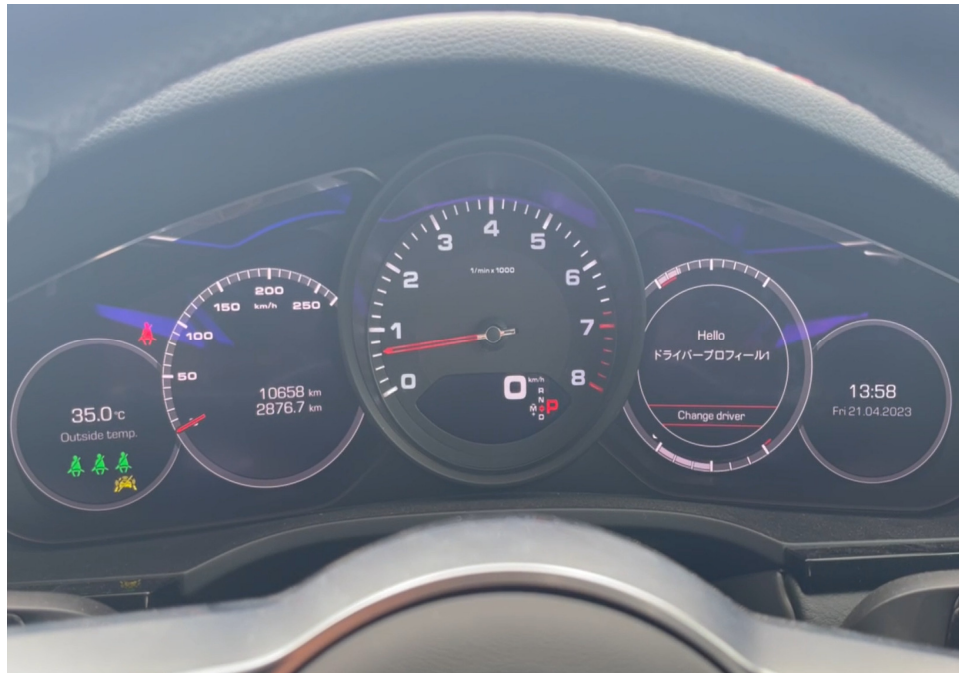
Photo 17 shows the respective warning lights no longer illuminated, indicating that there is no fault detected to the ABS, SRS, TPM, EPS and TCS systems of the Motor Car during the self-test. These electronic systems were hence in working condition at the time of my inspection.

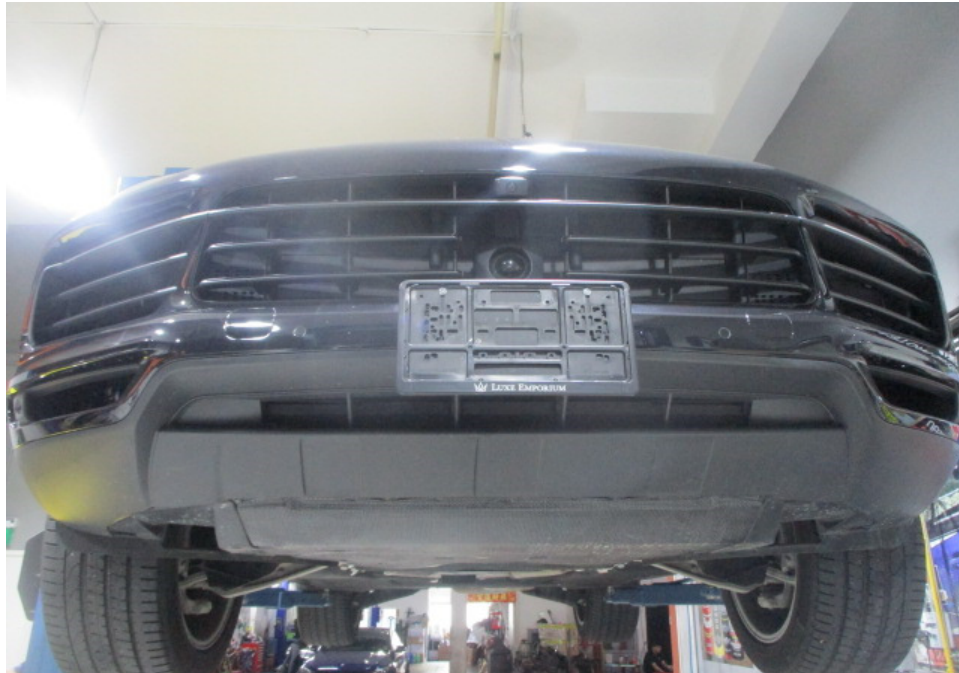
Photo 18 shows the Motor Car hoisted up for checks on its undercarriage. There was no sign(s) or indication(s) of fluid leakage and/or fluid stain(s) on the underside of the Motor Car. The undercarriage components of the Motor Car were also all observed to be intact and secured in an appropriate manner.

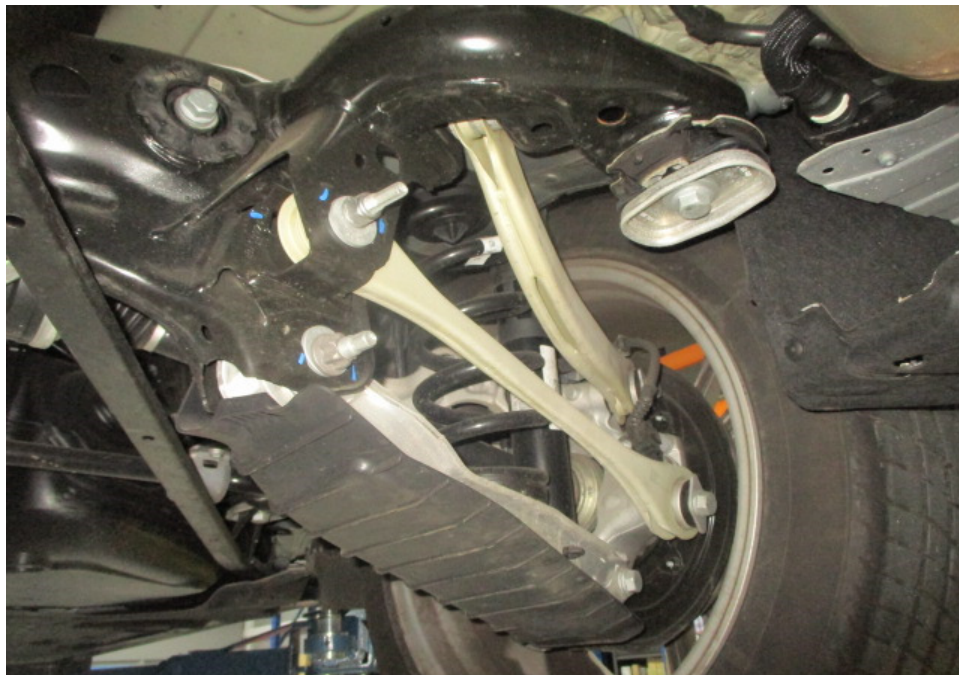
Photo 19 shows a general view of the control arms and linkages at the rear right wheel of the Motor Car. I did not observe any fluid leak and/or fluid stain on the underside of the Motor Car. All of the Motor Car's undercarriage components were observed to be intact and secured in an appropriate manner.

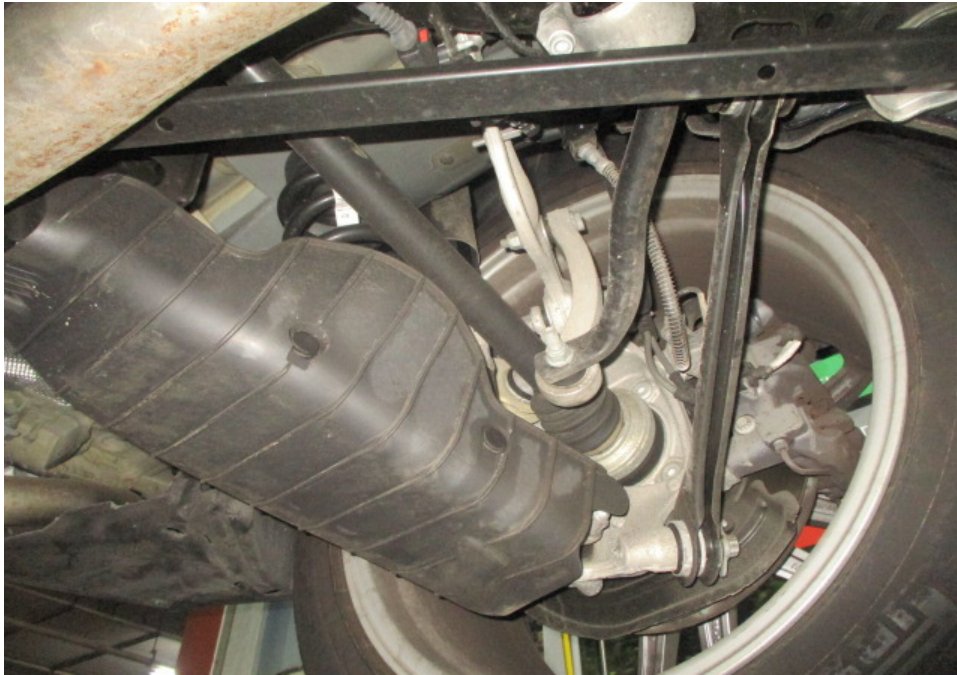
Photo 20 shows a general view of the control arms and linkages at the rear left wheel of the Motor Car. I did not observe any fluid leak and/or fluid stain on the underside of the Motor Car. All of the Motor Car's undercarriage components were observed to be intact and secured in an appropriate manner.

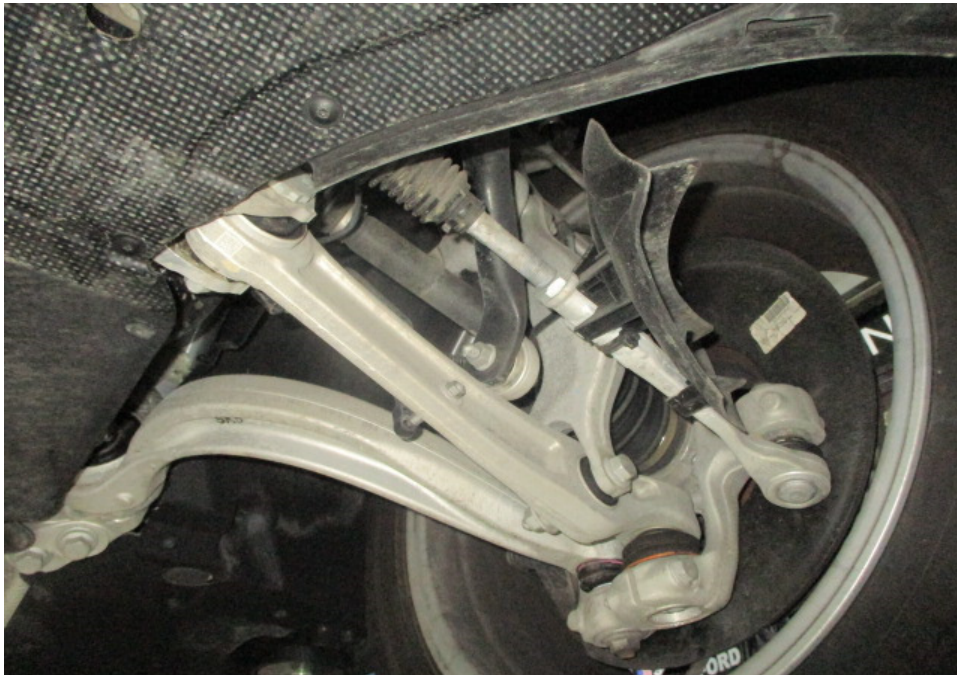
Photo 21 shows a general view of the control arms and linkages at the front left wheel of the Motor Car. I did not observe any fluid leak and/or fluid stain on the underside of the Motor Car. All of the Motor Car's undercarriage components were observed to be intact and secured in an appropriate manner.

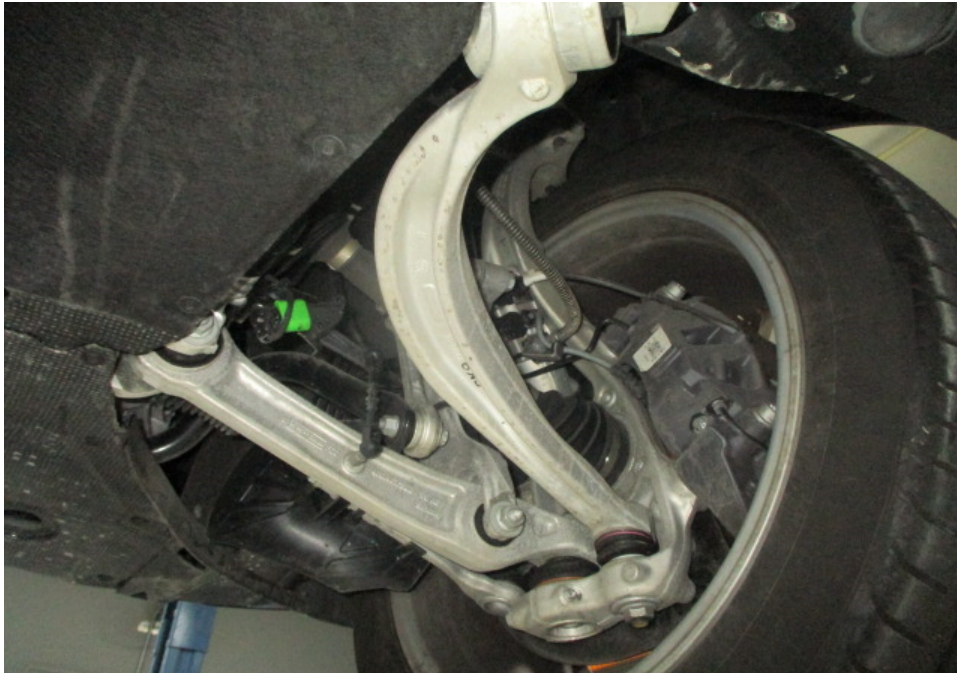
Photo 22 shows the various undercarriage components at the front right wheel of the Motor Car. The mechanical components, control arms and linkages were all found to be intact and secured in an appropriate manner. I also did not observe any fluid leak and/or fluid stain on the underside of the Motor Car.

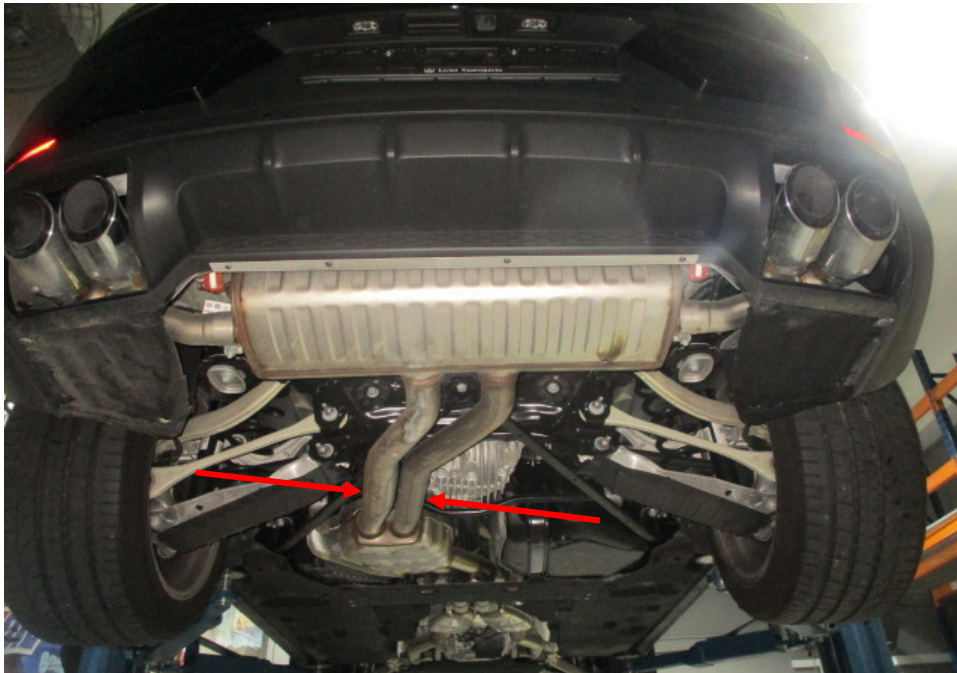
Photo 23 shows the rear section of the Motor Car's exhaust system. My examination of the Motor Car's exhaust system revealed no sign(s) or indication(s) of any cut or weld marks along its exhaust pipes (arrowed), on its rear muffler, on its centre resonator boxes and on its catalytic converters.

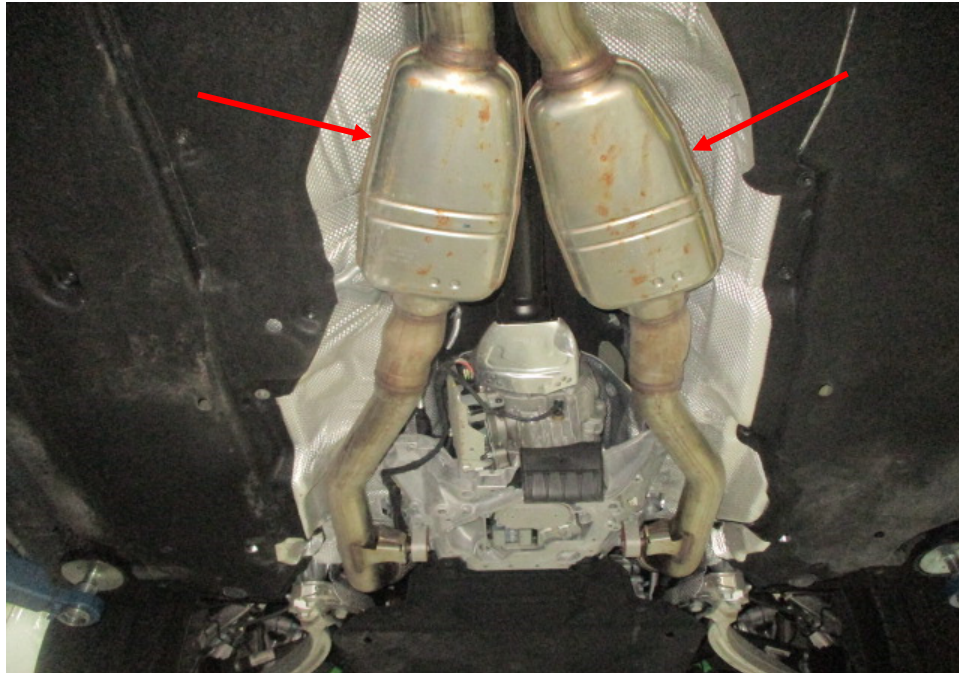
Photo 24 shows the front section of the Motor Car's exhaust system. My examination of the Motor Car's exhaust system revealed no sign(s) or indication(s) of any cut or weld marks along its exhaust pipes, on its rear muffler, on its centre resonator boxes (arrowed) and on its catalytic converters.

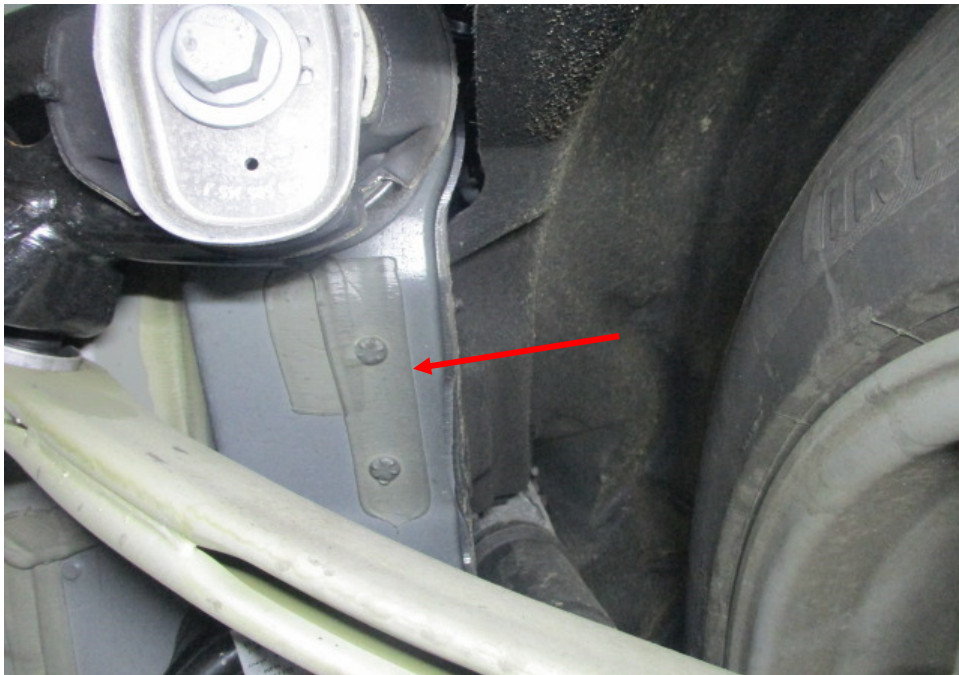
Photo 25 shows the chassis/structural body at the underside rear right of the Motor Car. I did not find any weld marks other than original spot weld marks on the chassis/structural body of the Motor Car. The original factory sealant (arrowed) at the joints along the chassis/structural body was untouched, indicating no work was done on the chassis/structural body of the Motor Car and that the chassis/structural body was originally fitted.

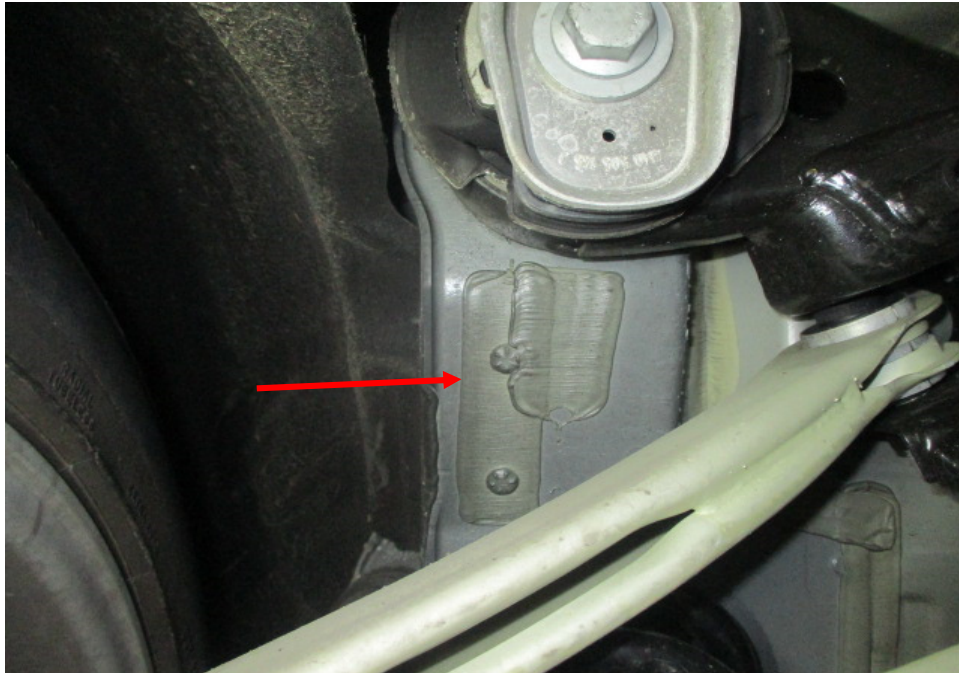
Photo 26 shows the chassis/structural body at the underside rear left of the Motor Car. The original factory sealant (arrowed) at the joints along the chassis/structural body was observed to be untouched. In general, I had found no work was carried out on the chassis/structural body of the Motor Car. The chassis/structural body of the Motor Car was originally fitted.

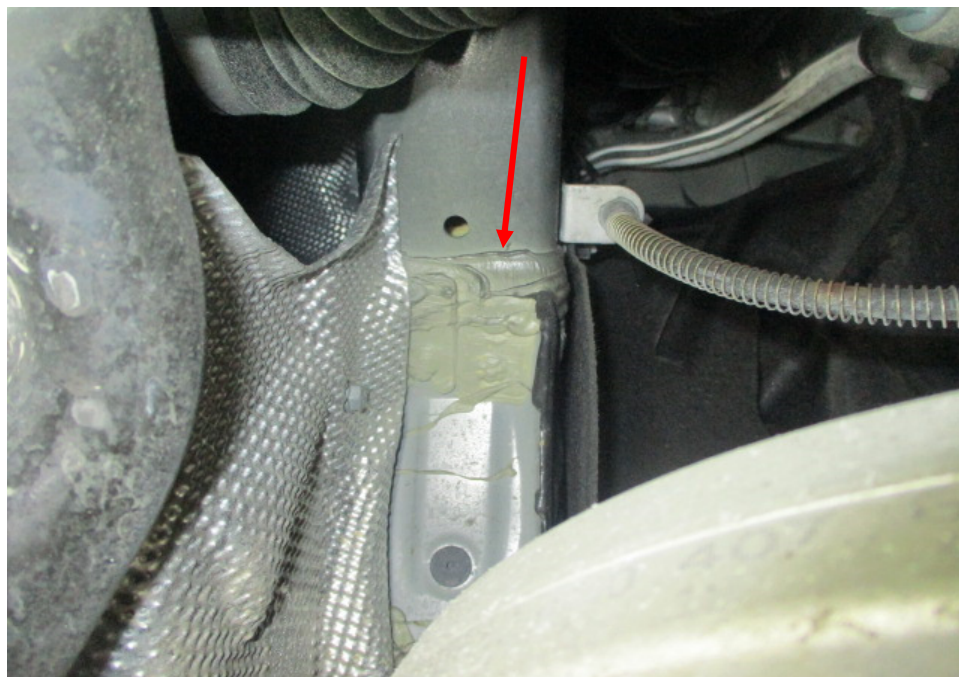
Photo 27 shows the chassis/structural body at the underside front left of the Motor Car. I did not find any weld marks other than original spot weld marks on the chassis/structural body of the Motor Car. The original factory sealant (arrowed) at the joints along the chassis/structural body was untouched, indicating no work was done on the chassis/structural body of the Motor Car and that the chassis/structural body was originally fitted.

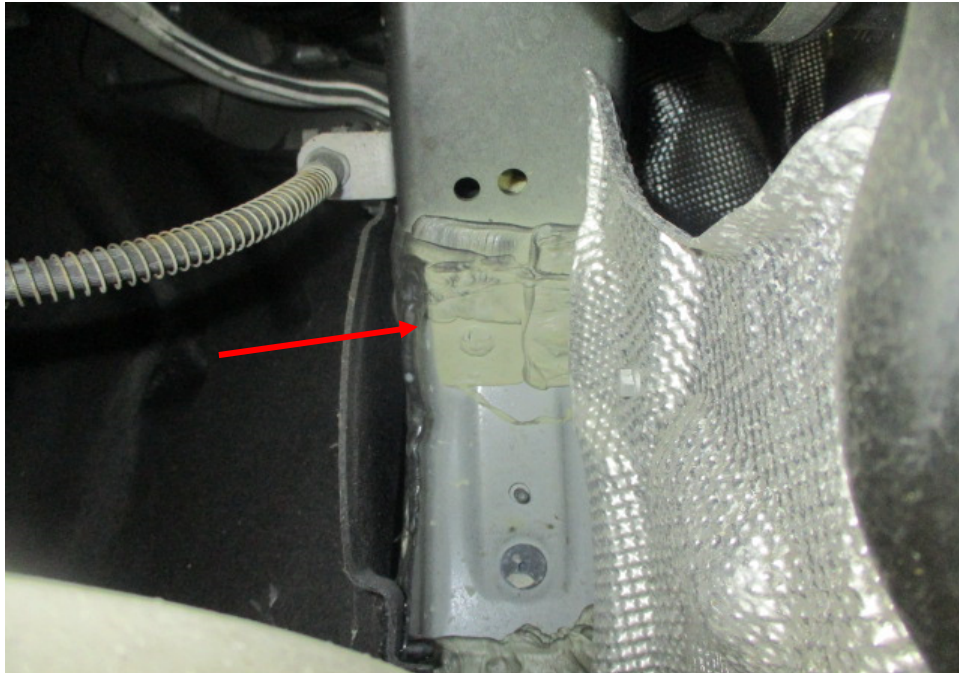
Photo 28 shows the chassis/structural body at the underside front right of the Motor Car. The original factory sealant (arrowed) at the joints along the chassis/structural body was observed to be untouched. In general, I had found no work was carried out on the chassis/structural body of the Motor Car. The chassis/structural body of the Motor Car was originally fitted.
