Your Ref: Ferrari 488 Pista
(chassis number ZFF90HMC000258332)
Our Ref : CI/TP23004393/D

01 May 2023

**INSPECTION REPORT OF AN UNREGISTERED FERRARI 488 PISTA
MOTOR CAR WITH CHASSIS NUMBER ZFF90HMC000258332**

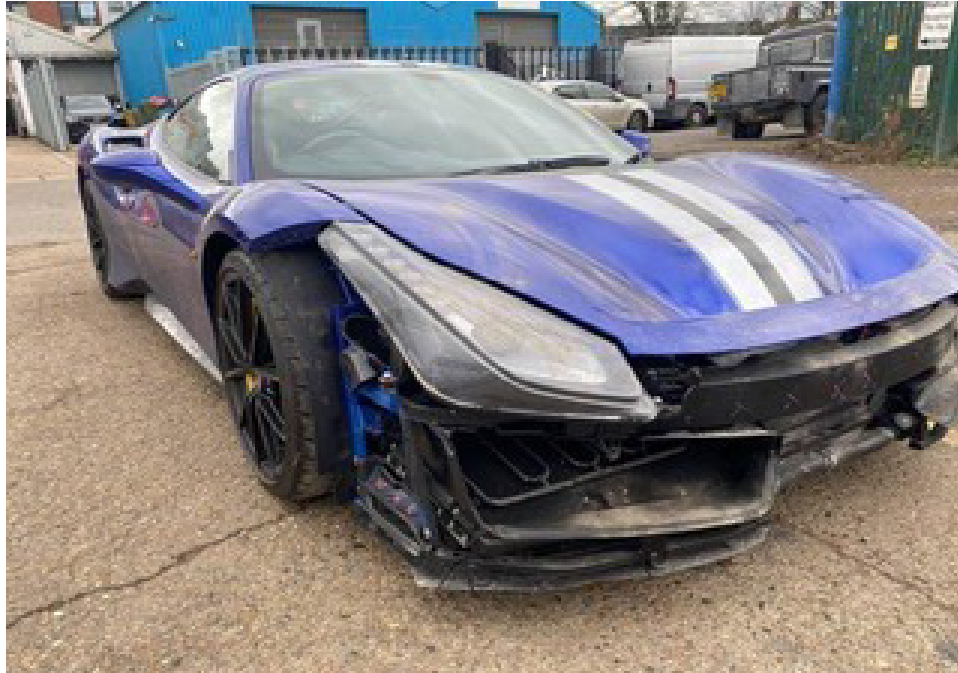
3. The photographs provided to me had showed the Motor Car's front left fender dented. The Motor Car's front left headlamp, front left fender inner shield, front left fender emblem, front left fender signal lamp, front bumper and all its related parts and attachments like the front bumper left lower lip, front bumper right lower lip, front bumper left side bracket, front bumper right side bracket, front bumper left lower grille, front bumper right lower grille, front bumper centre lower carbon garnish and front bumper sensors amongst others, were missing/dislodged/damaged.

Photo 1 shows the front right body of the Motor Car (photograph provided to me). The photographs provided to me had showed the front bumper and all its related parts and attachments like the front bumper right lower lip, front bumper right side bracket, front bumper right lower grille, front bumper centre lower carbon garnish and front bumper sensors amongst others, missing/dislodged/damaged.

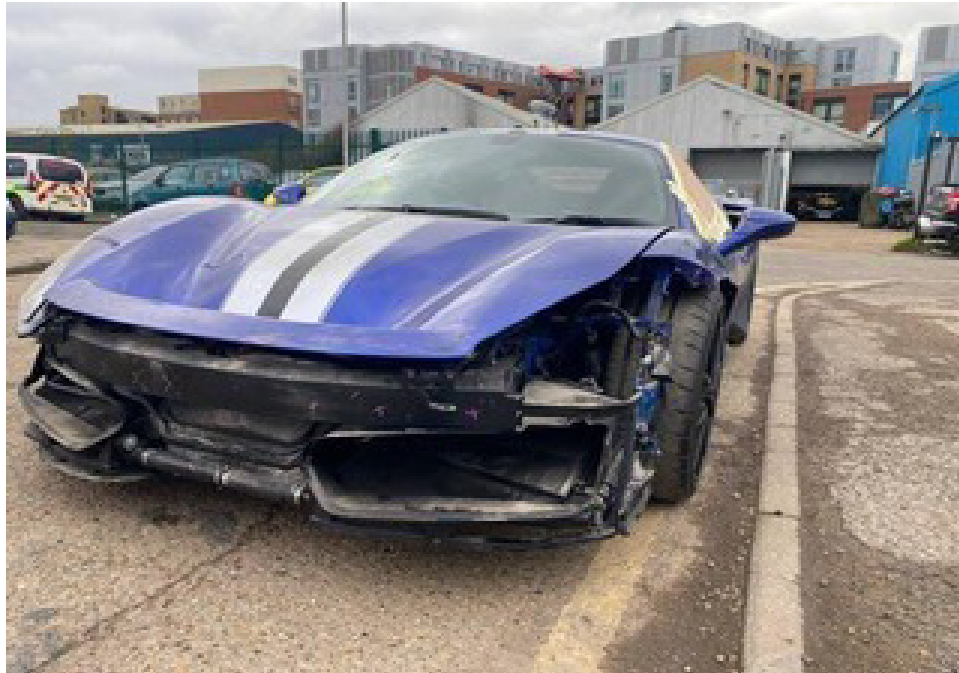
Photo 2 shows the front left body of the Motor Car (photograph provided to me). The photographs provided to me had showed the front left headlamp, front bumper and all its related parts and attachments like the front bumper left lower lip, front bumper left side bracket, front bumper left lower grille, front bumper centre lower carbon garnish and front bumper sensors amongst others, missing/dislodged/damaged.

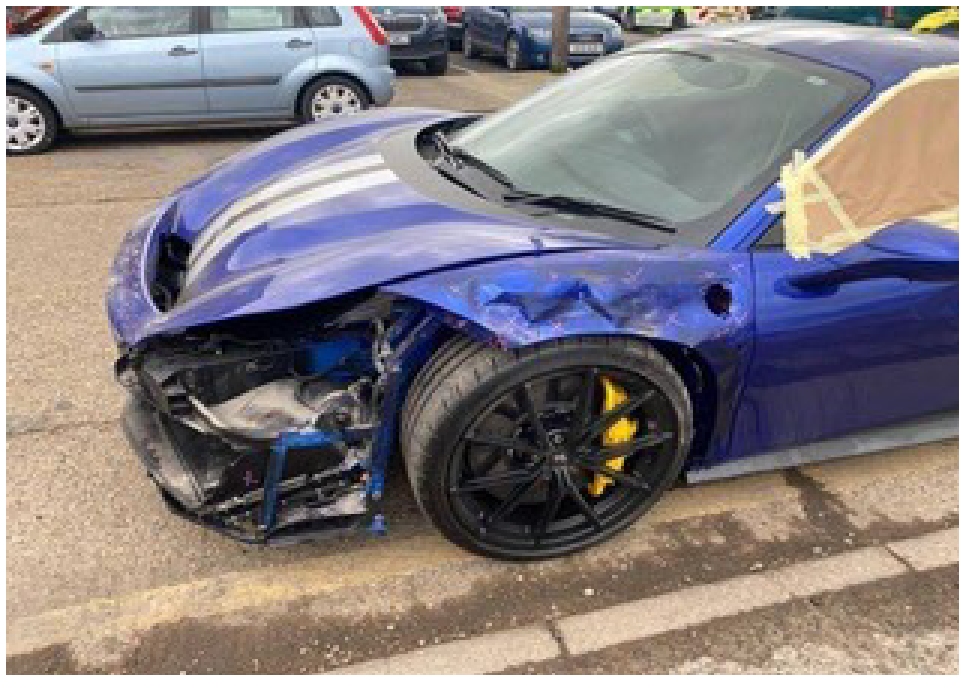
Photo 3 shows the left side front body of the Motor Car (photograph provided to me). The Motor Car's front left fender was observed to be dented. The front left fender emblem, front left fender inner shield and front left signal lamp amongst others were missing/dislodged/damaged.

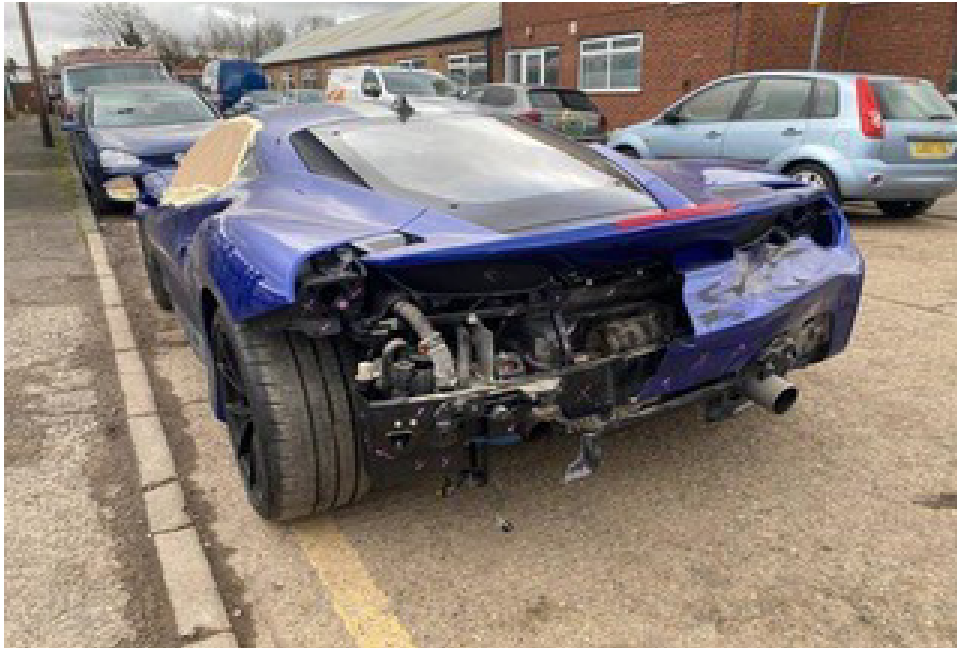
4. I had also observed that the Motor Car's rear bumper was torn. Its rear left taillamp, rear right taillamp, rear centre top garnish, rear left exhaust tip, rear bumper and all its related parts and attachments like the rear bumper lower cover, rear bumper left reflector, rear bumper right reflector, rear bumper left side garnish, rear bumper right side garnish and rear bumper sensors amongst others, were missing/dislodged/damaged.

Photo 4 shows the rear left body of the Motor Car (photograph provided to me). The photographs provided to me had showed the Motor Car's rear bumper was torn. In addition, its rear left taillamp, rear centre top garnish, rear left exhaust tip, rear bumper and all its related parts and attachments like the rear bumper lower cover, rear bumper left reflector, rear bumper left side garnish and rear bumper sensors amongst others were missing/dislodged/damaged.

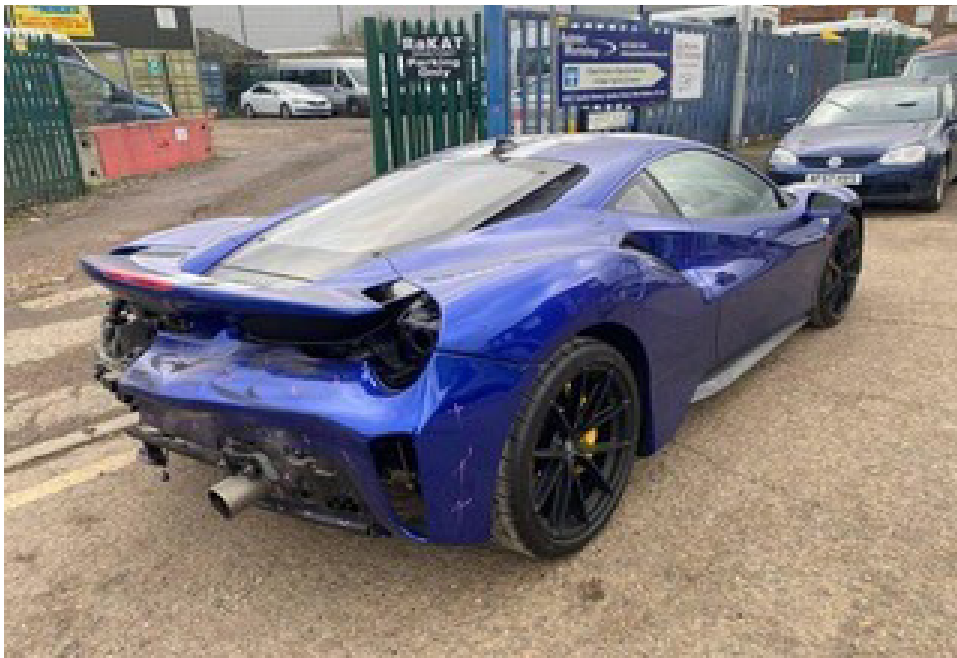
Photo 5 shows the rear right body of the Motor Car (photograph provided to me). The photographs provided to me had showed the Motor Car's rear bumper was torn. In addition, its rear right taillamp, rear centre top garnish, rear bumper and all its related parts and attachments like the rear bumper lower cover, rear bumper right reflector, rear bumper right side garnish and rear bumper sensors amongst others were missing/dislodged/damaged.

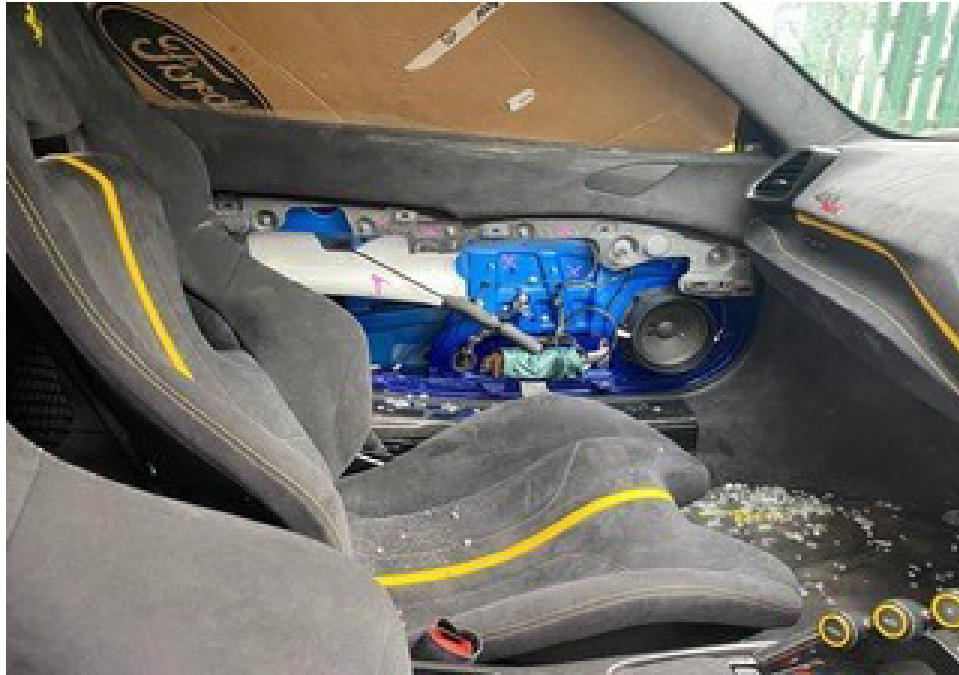
5. In addition, the photographs provided had also showed the Motor Car's front left door window shattered and front left door inner trimboard missing/dislodged/damaged. The airbag(s) of the Motor Car was not deployed. See photo 1 – 6 below.

Photo 6 shows the interior compartment of the Motor Car (photograph provided to me). The Motor Car's front left door window was observed to be shattered. Its front left door inner trimboard was also missing/dislodged/damaged. The Motor Car's airbag(s) was not deployed.

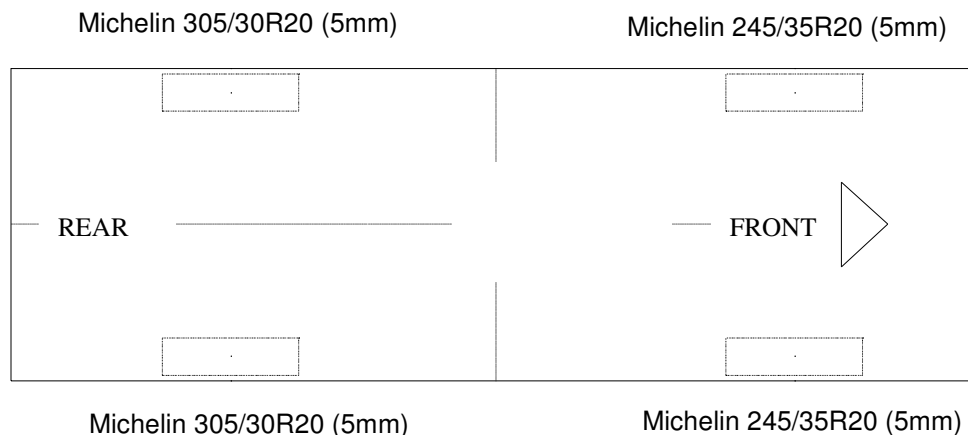
9. It was fitted with 20inch sport wheel rims that were wrapped with tyres that were observed to be of serviceable condition. The tyres were also sufficiently inflated for vehicular operation. The tyre brand, tyre size and approximate remaining tread depth of the 4 tyres of the Motor Car were recorded as follows: -

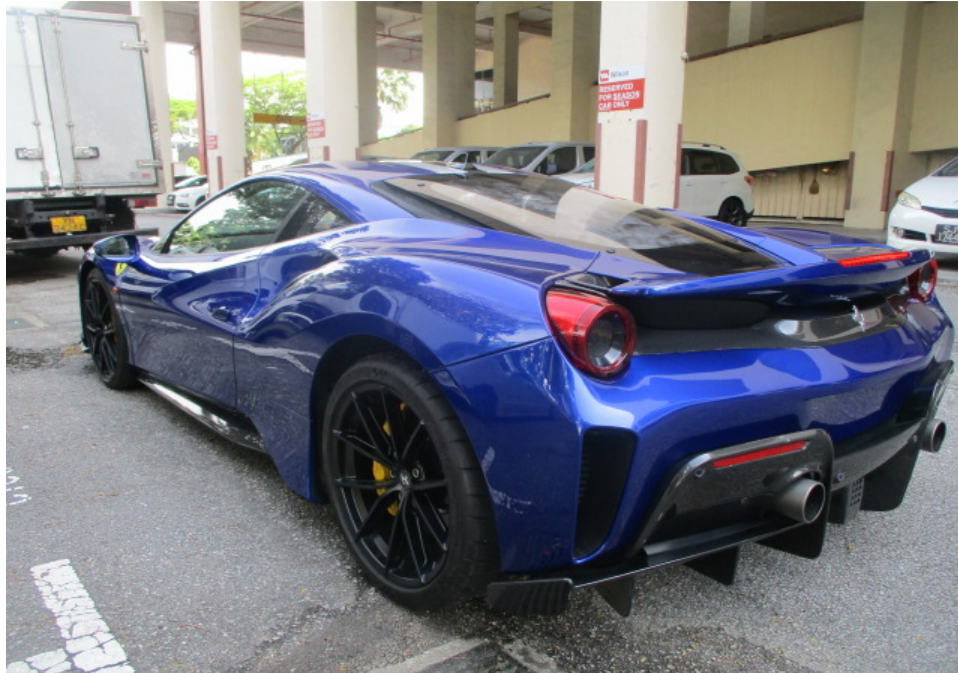
Photo 7 shows a general view of the rear left body of the Motor Car at the time of my inspection. The Motor Car was observed to be in a relatively good general condition with no loose exterior fittings observed. The body parts at the rear portion of the Motor Car were visually examined and it was observed that the repair/restoration works carried out to the damaged area of the Motor Car (refer to photograph 4 & 5 above) were reasonably adequate and in order.

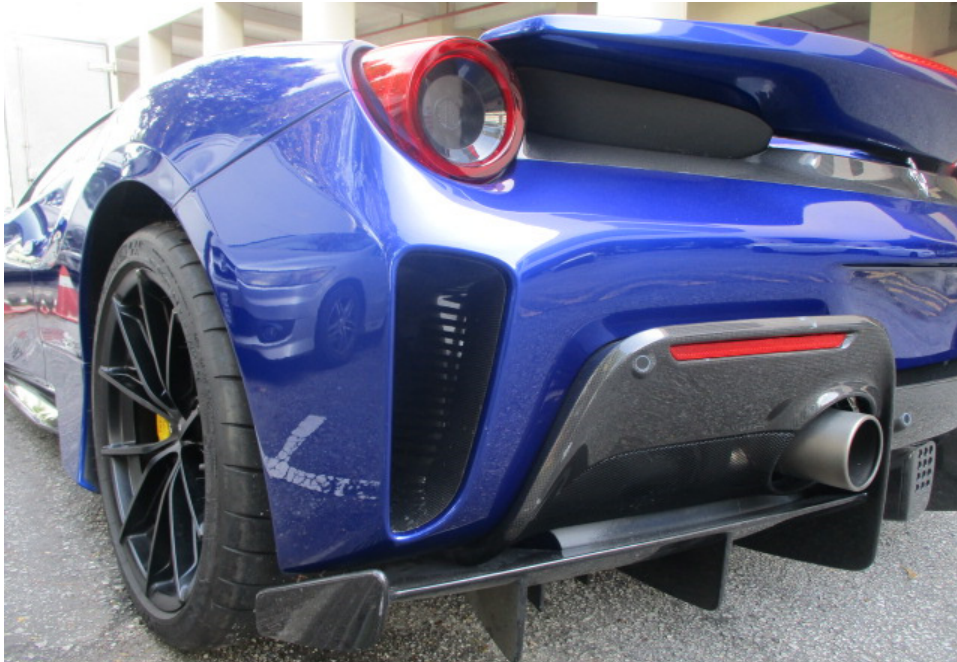
Photo 8 shows a closer view of the Motor Car's rear left taillamp, rear left exhaust tip, rear bumper, rear bumper lower cover, rear bumper left reflector, rear bumper left side garnish and rear bumper sensors. The body parts at the rear portion of the Motor Car were visually examined and it was observed that the repair/restoration works carried out to the damaged area of the Motor Car (refer to photograph 4 & 5 above) were reasonably adequate and in order.

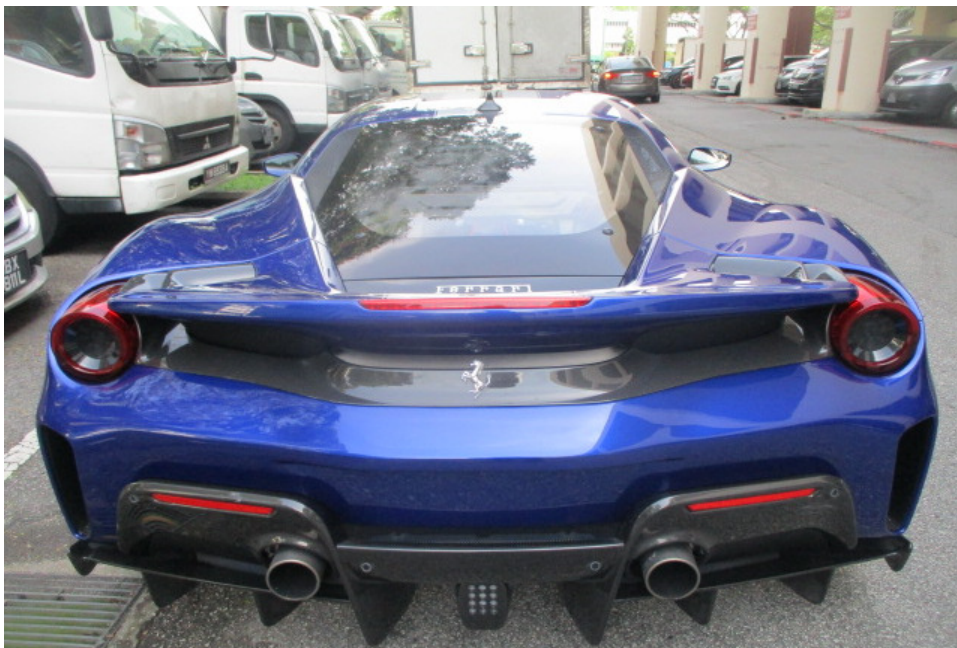
Photo 9 shows a closer view of the Motor Car's rear left taillamp, rear right taillamp, rear centre top garnish, rear bumper, rear bumper lower cover, rear bumper left reflector and rear bumper right reflector. The body parts at the rear portion of the Motor Car were visually examined and it was observed that the repair/restoration works carried out to the damaged area of the Motor Car (refer to photograph 4 & 5 above) were reasonably adequate and in order.

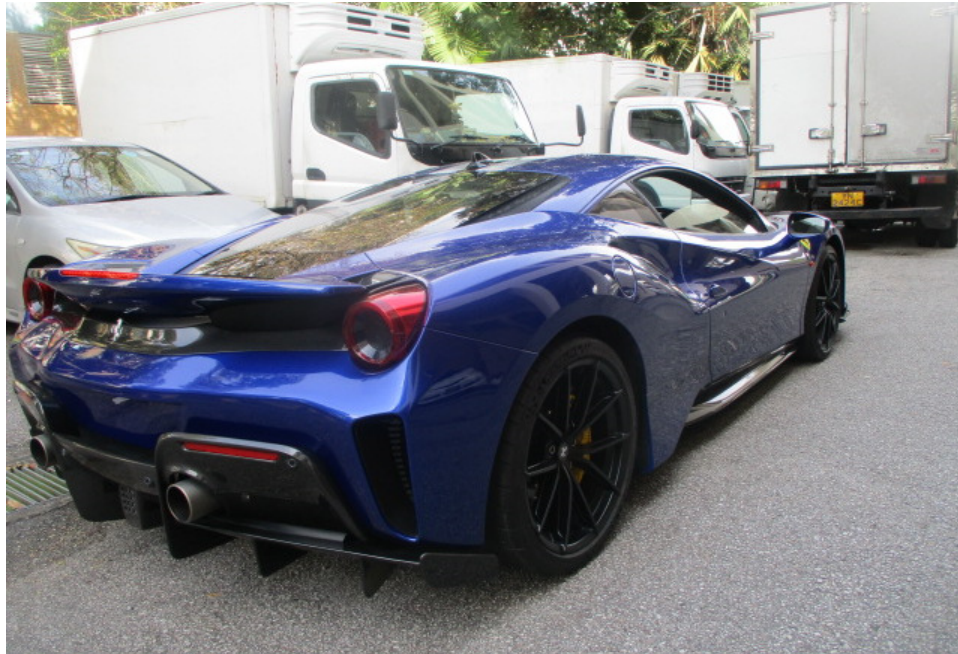
Photo 10 shows a general view of the rear right body of the Motor Car at the time of my inspection. The Motor Car was observed to be in a relatively good general condition with no loose exterior fittings observed. The body parts at the rear portion of the Motor Car were visually examined and it was observed that the repair/restoration works carried out to the damaged area of the Motor Car (refer to photograph 4 & 5 above) were reasonably adequate and in order.

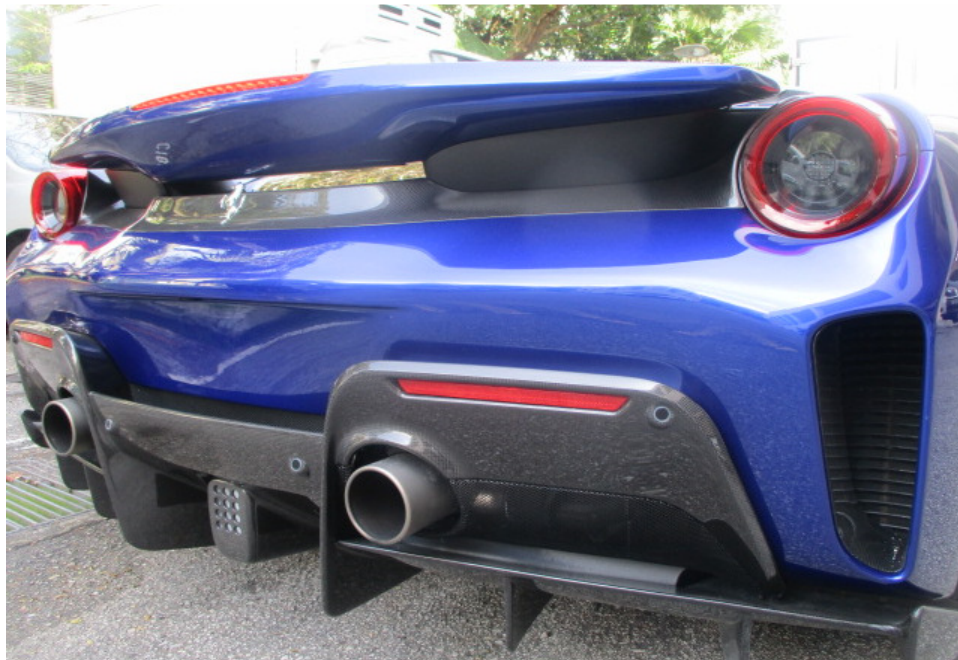
Photo 11 shows a closer view of the Motor Car's rear right taillamp, rear right exhaust tip, rear bumper, rear bumper lower cover, rear bumper right reflector, rear bumper right side garnish and rear bumper sensors. The body parts at the rear portion of the Motor Car were visually examined and it was observed that the repair/restoration works carried out to the damaged area of the Motor Car (refer to photograph 4 & 5 above) were reasonably adequate and in order.

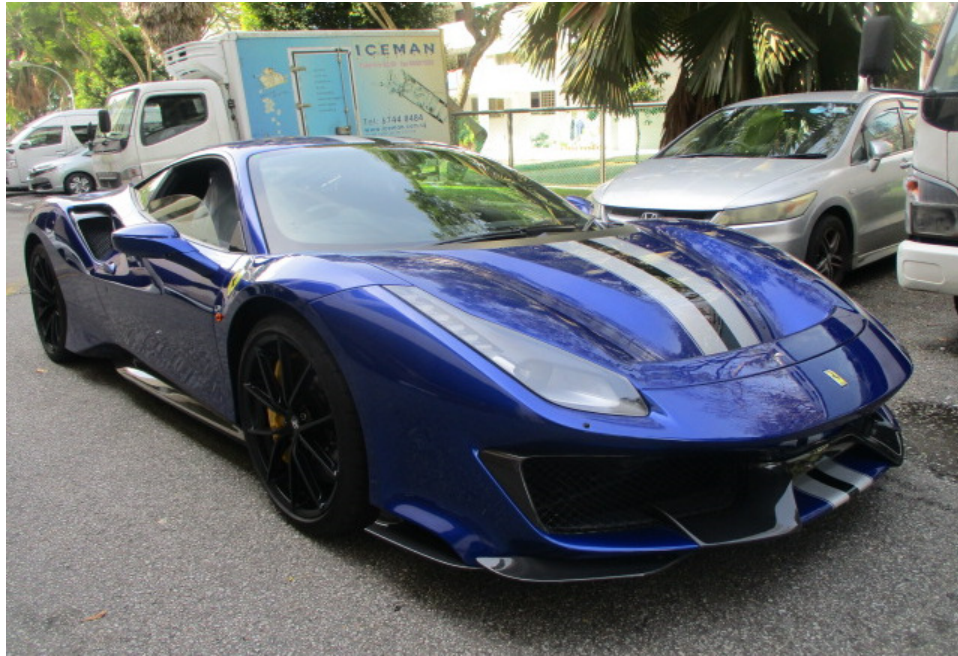
Photo 12 shows a general view of the front right body of the Motor Car at the time of my inspection. The Motor Car was observed to be in a relatively good general condition with no loose exterior fittings observed. The body parts at the frontal portion of the Motor Car were visually examined and it was observed that the repair/restoration works carried out to the damaged area of the Motor Car (refer to photograph 1 - 3 above) were reasonably adequate and in order.

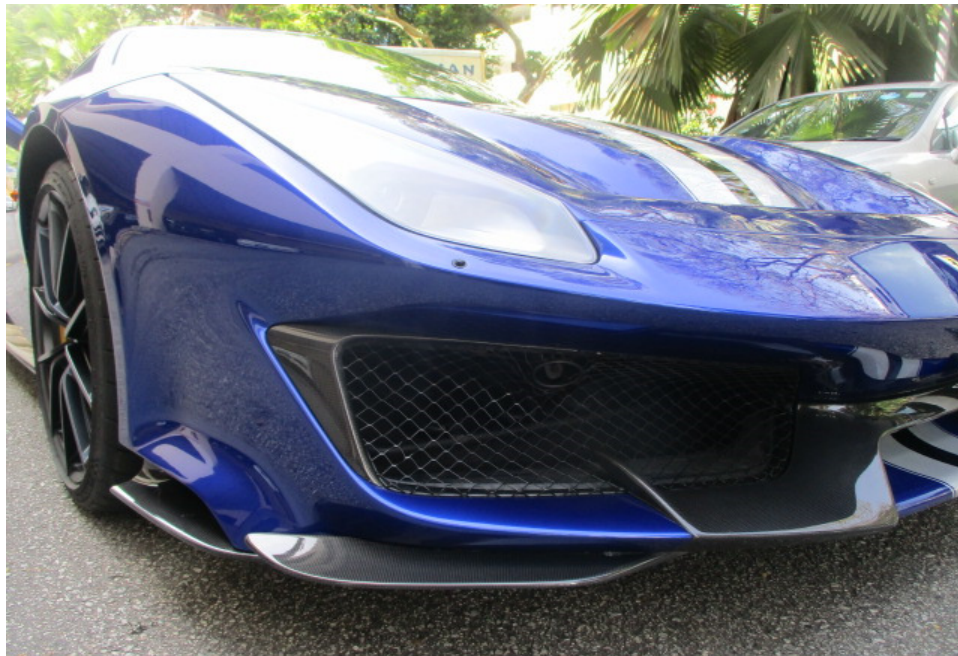
Photo 13 shows a closer view of the Motor Car's front bumper, front bumper right lower lip, front bumper right lower grille and front right headlamp at the time of my inspection. The body parts at the frontal portion of the Motor Car were visually examined and it was observed that the repair/restoration works carried out to the damaged area of the Motor Car (refer to photograph 1 - 3 above) were reasonably adequate and in order.

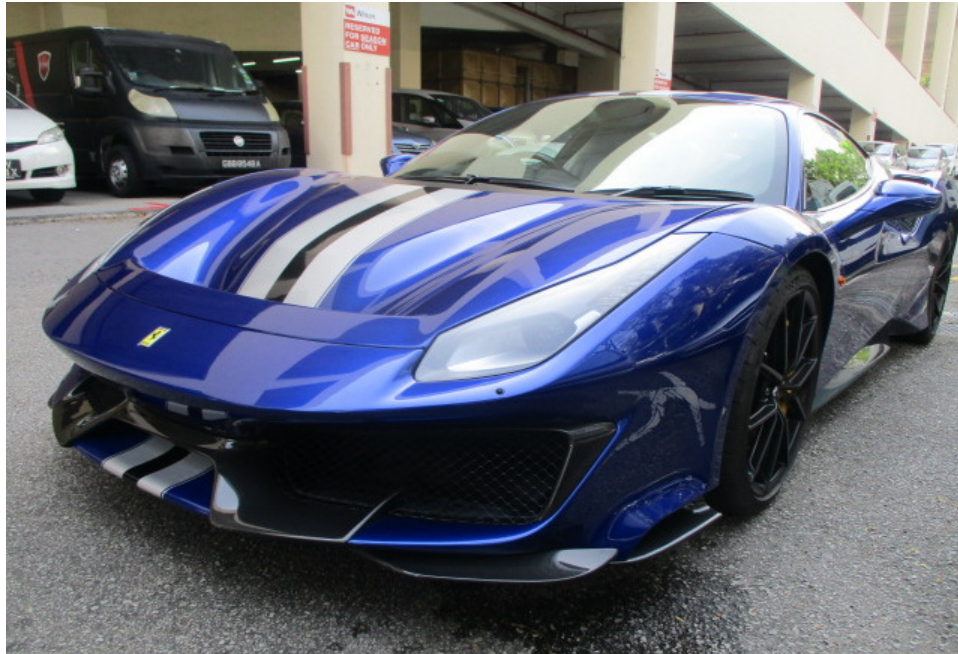
Photo 14 shows a general view of the front left body of the Motor Car at the time of my inspection. The Motor Car was observed to be in a relatively good general condition with no loose exterior fittings observed. The body parts at the frontal portion of the Motor Car were visually examined and it was observed that the repair/restoration works carried out to the damaged area of the Motor Car (refer to photograph 1 - 3 above) were reasonably adequate and in order.

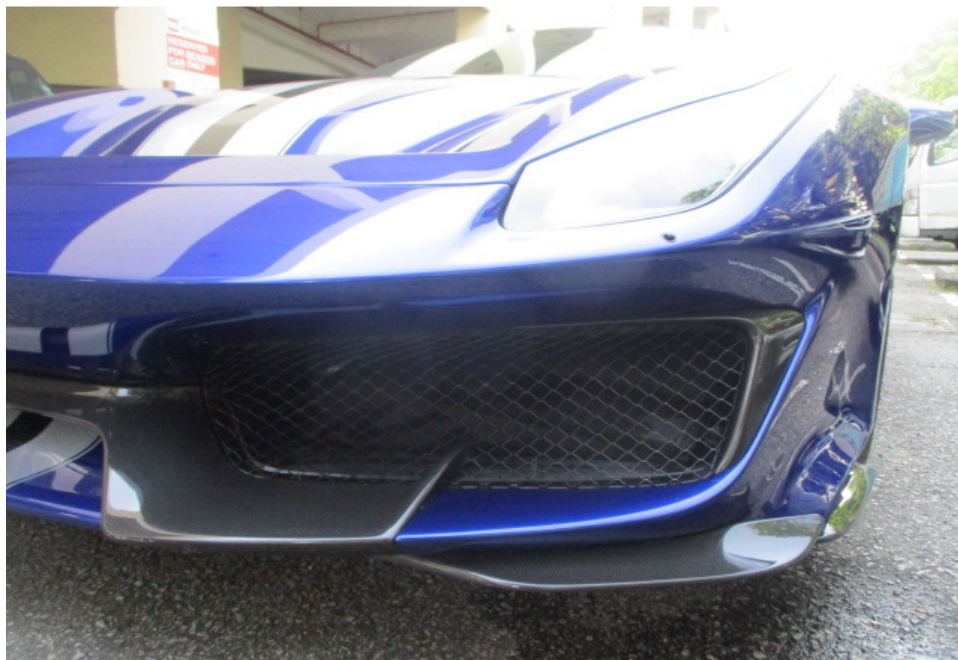
Photo 15 shows a closer view of the Motor Car's front bumper, front bumper left lower lip, front bumper left lower grille and front left headlamp at the time of my inspection. The body parts at the frontal portion of the Motor Car were visually examined and it was observed that the repair/restoration works carried out to the damaged area of the Motor Car (refer to photograph 1 - 3 above) were reasonably adequate and in order.

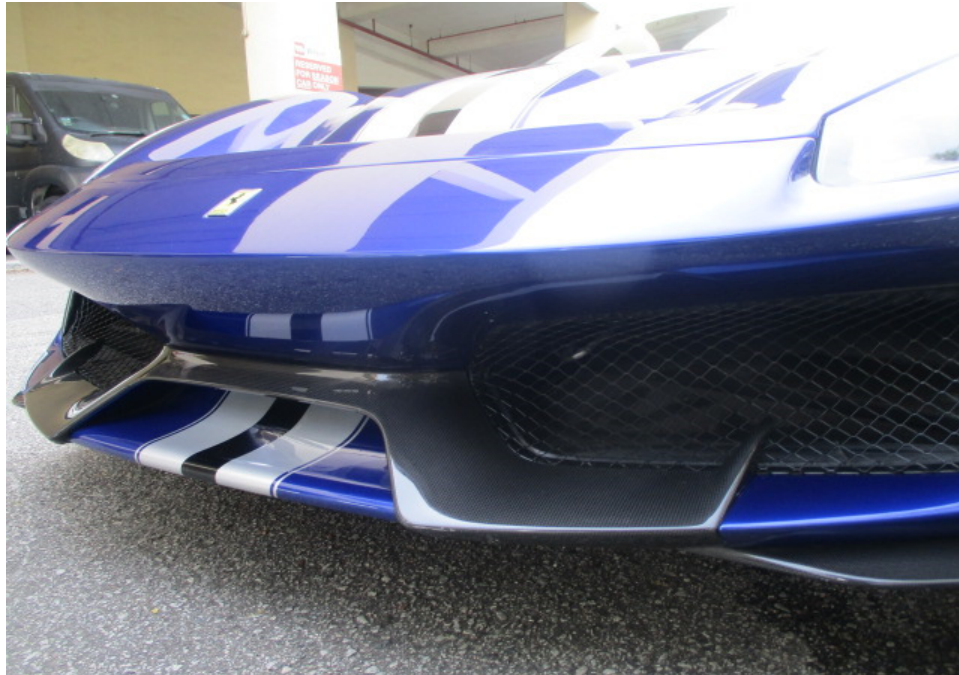
Photo 16 shows a closer view of the Motor Car's front bumper, front bumper centre lower carbon garnish and front bonnet at the time of my inspection. The body parts at the frontal portion of the Motor Car were visually examined and it was observed that the repair/restoration works carried out to the damaged area of the Motor Car (refer to photograph 1 - 3 above) were reasonably adequate and in order.

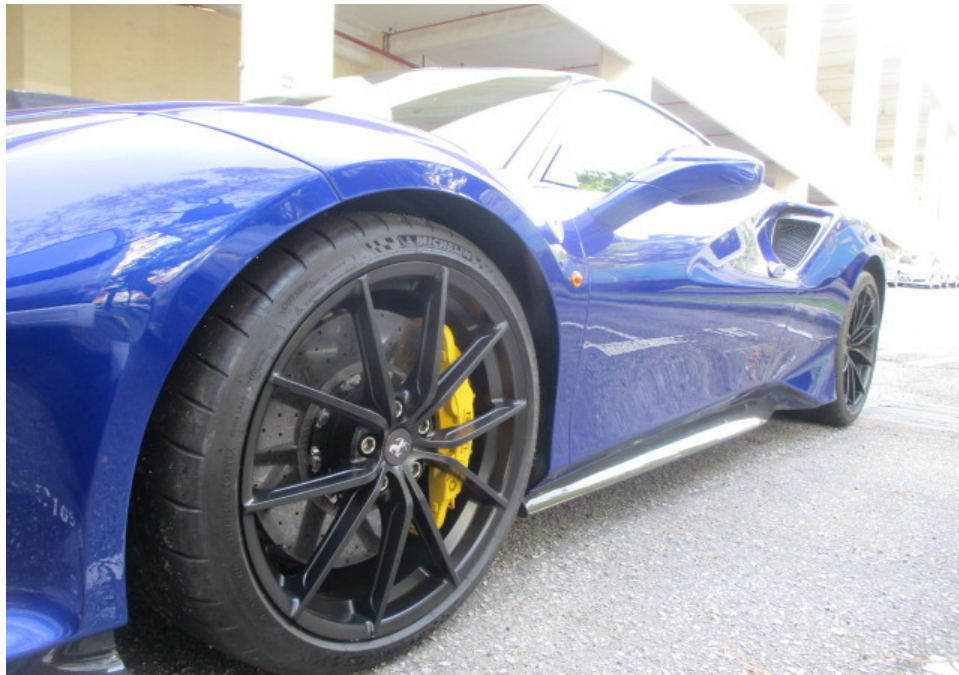
Photo 17 shows a closer view of the Motor Car's front left fender and front left wheel rim at the time of my inspection. The body parts at the frontal portion of the Motor Car were visually examined and it was observed that the repair/restoration works carried out to the damaged area of the Motor Car (refer to photograph 3 above) were reasonably adequate and in order.

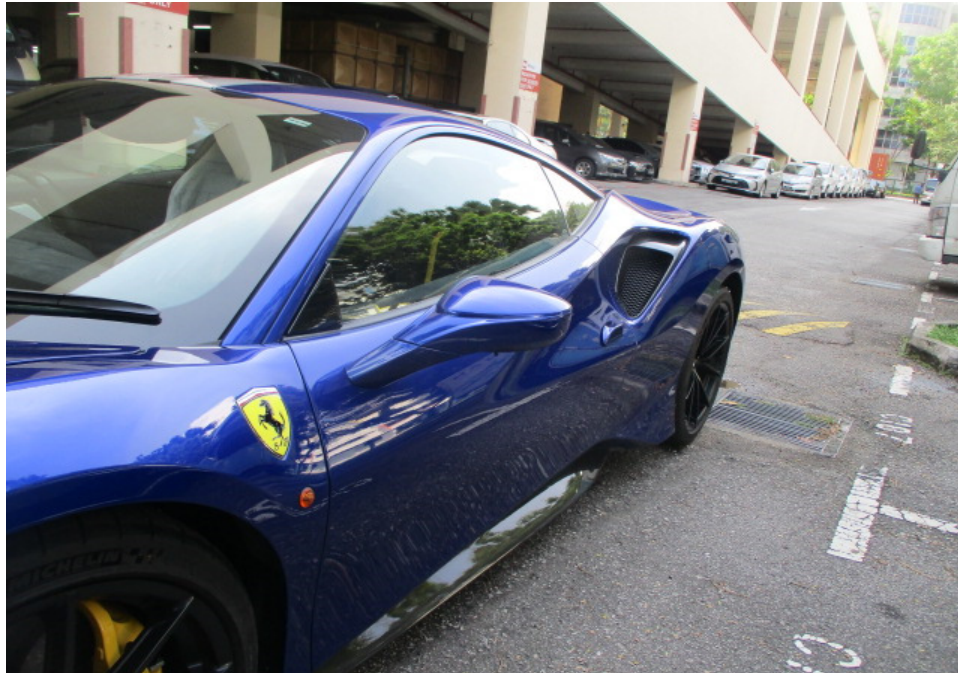
Photo 18 shows a closer view of the Motor Car's front left fender, front left fender emblem, front left signal lamp, front left door and front left door window at the time of my inspection. The body parts at the frontal portion of the Motor Car were visually examined and it was observed that the repair/restoration works carried out to the damaged area of the Motor Car (refer to photograph 3 above) were reasonably adequate and in order.

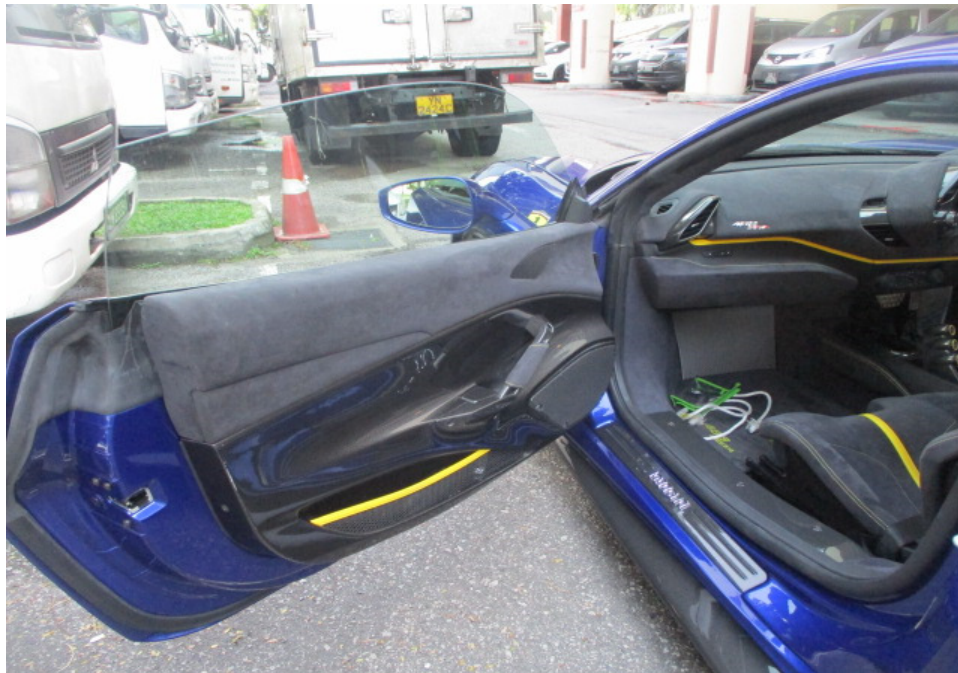
Photo 19 shows a closer view of the Motor Car's front left door inner trimboard and front left door window at the time of my inspection. The body parts at the frontal portion of the Motor Car were visually examined and it was observed that the repair/restoration works carried out to the damaged area of the Motor Car (refer to photograph 6 above) were reasonably adequate and in order.

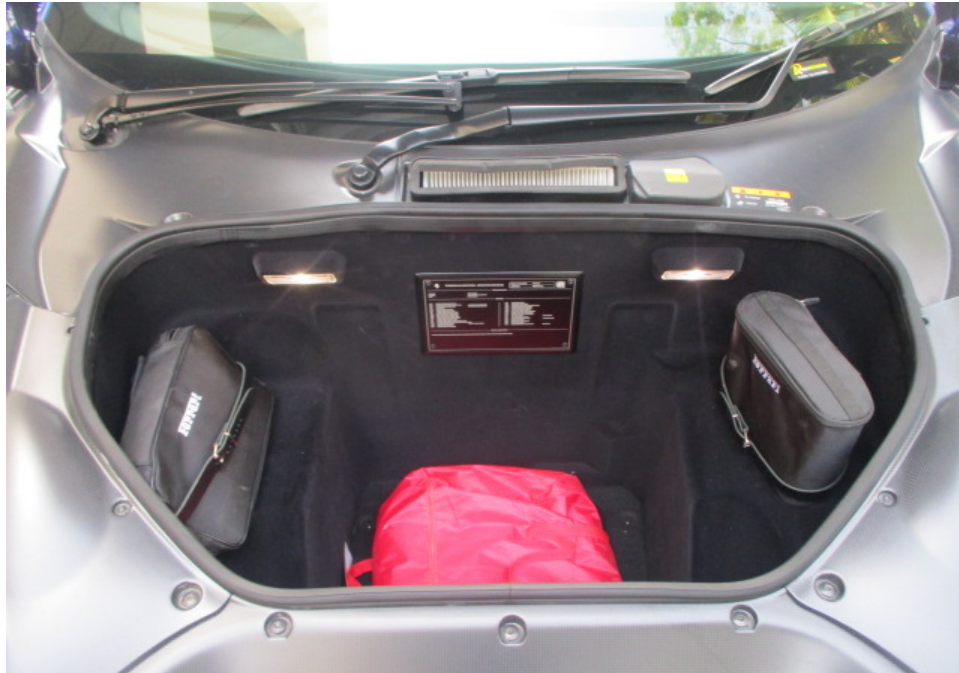
Photo 20 shows a general view of the Motor Car's front bonnet compartment at the time of my inspection. All inner trims, garnishes and upholstery etc were observed to be intact and properly fitted.

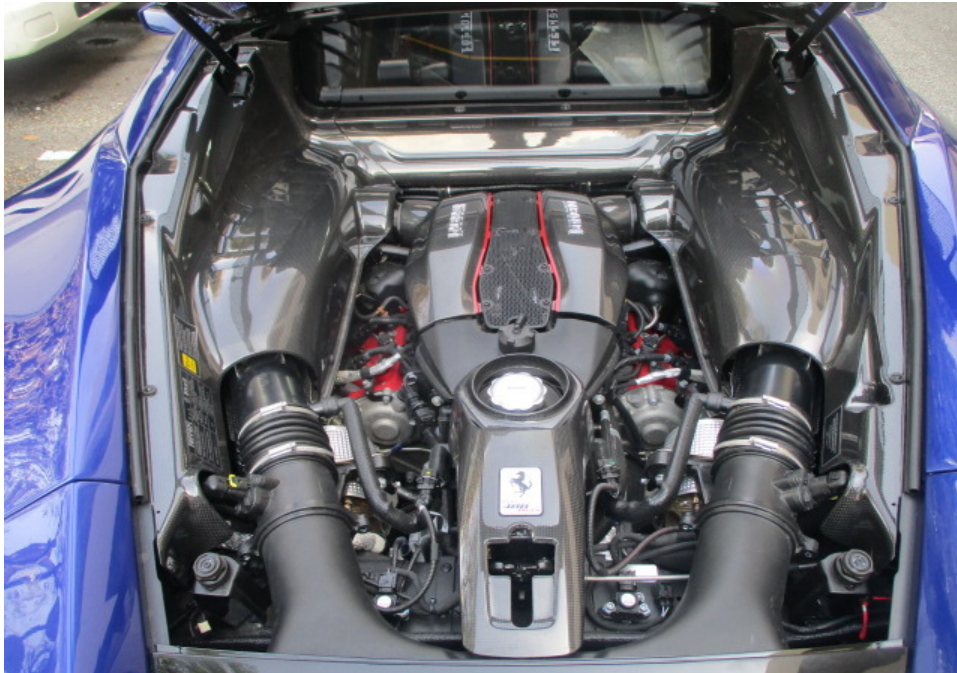
Photo 22 shows a general view of the Motor Car's engine compartment at the time of my inspection. I had found the various parts and components inside the engine compartment to be intact and properly fitted. There was also no sign(s) or indication(s) of fluid leak and/or fluid stain found inside the engine compartment. Refer to photograph 33 & 34 below for additional photographs showing the engine compartment from the underside of the Motor Car.

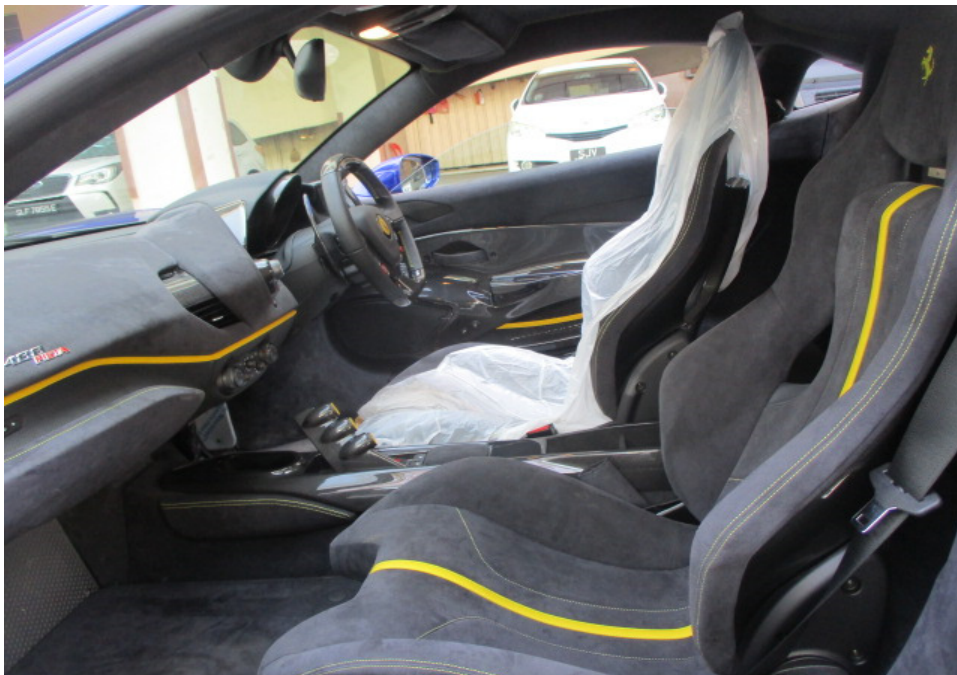
Photo 23 shows the interior compartment of the Motor Car at the time of my inspection. The various parts and components, trims, carpet, and upholstery inside the interior compartment were all observed to be intact and properly fitted.

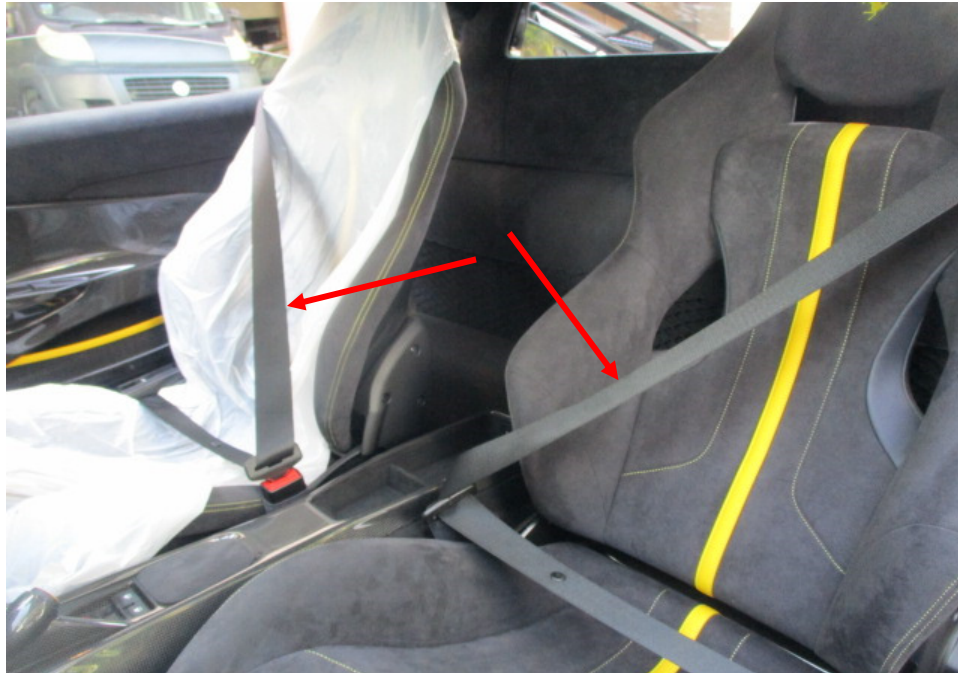
Photo 24 shows the seats of the Motor Car. All the seats of the Motor Car were secured via seat rails to the floorboard. They were also fitted with a retractable seat belt reel and a pre-tensioner. The seat belts (arrowed) were tested and were able to be fastened into the respective pre-tensions that were fitted on the side of each individual seat.

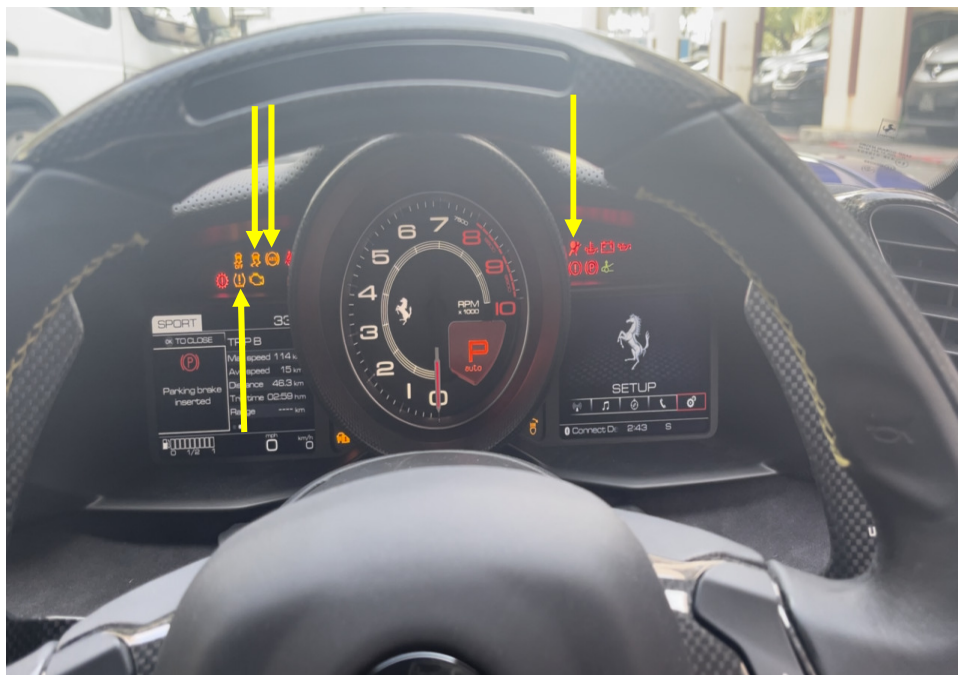
Photo 25 shows the warning lights for the various electronic safety features appearing on the instrument panel of the Motor Car during its self-test when the engine is cranked, in particular the ABS, SRS, TPM and TCS lights (arrowed).

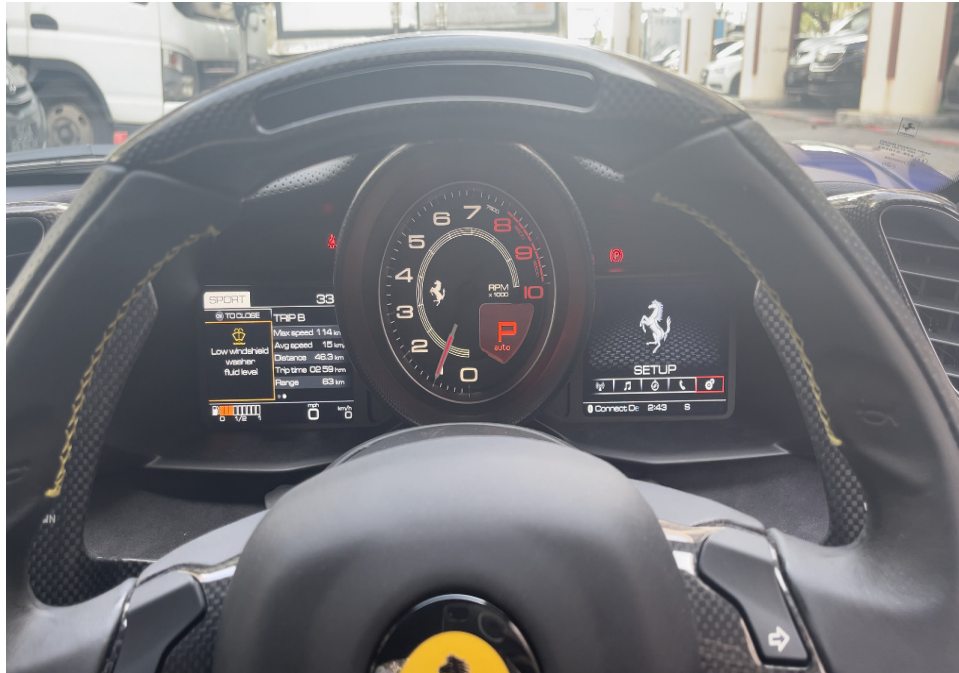
Photo 26 shows the respective warning lights no longer illuminated, indicating that there is no fault detected to the ABS, SRS TPM and TCS systems of the Motor Car during the self-test. These electronic systems were hence in working condition at the time of my inspection.

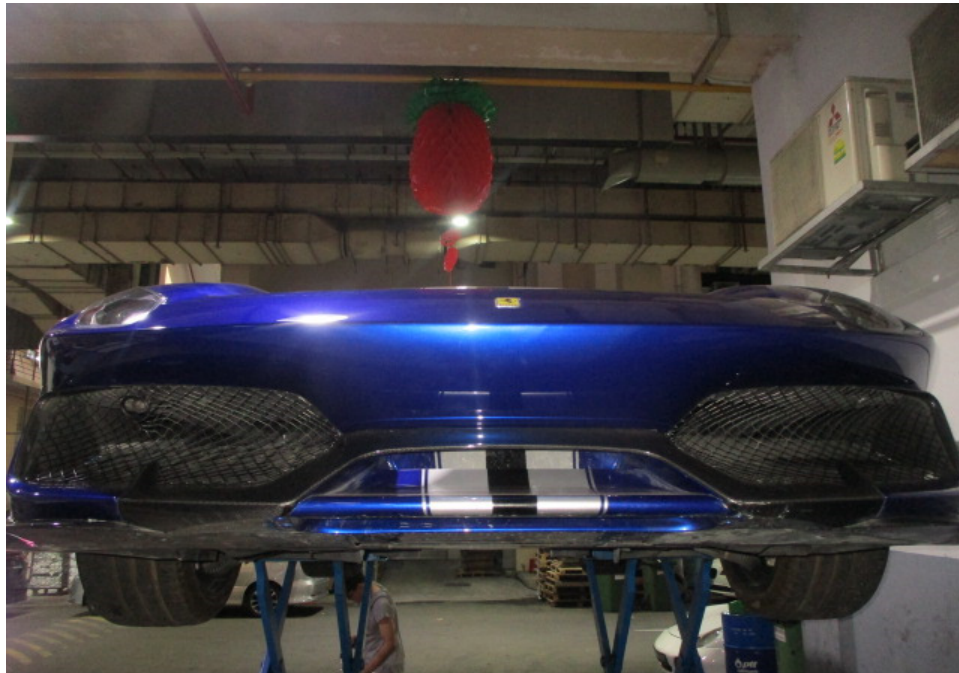
Photo 27 shows the Motor Car hoisted up for checks on its undercarriage. There was no sign(s) or indication(s) of fluid leakage and/or fluid stain(s) on the underside of the Motor Car. The undercarriage components of the Motor Car were also all observed to be intact and secured in an appropriate manner.

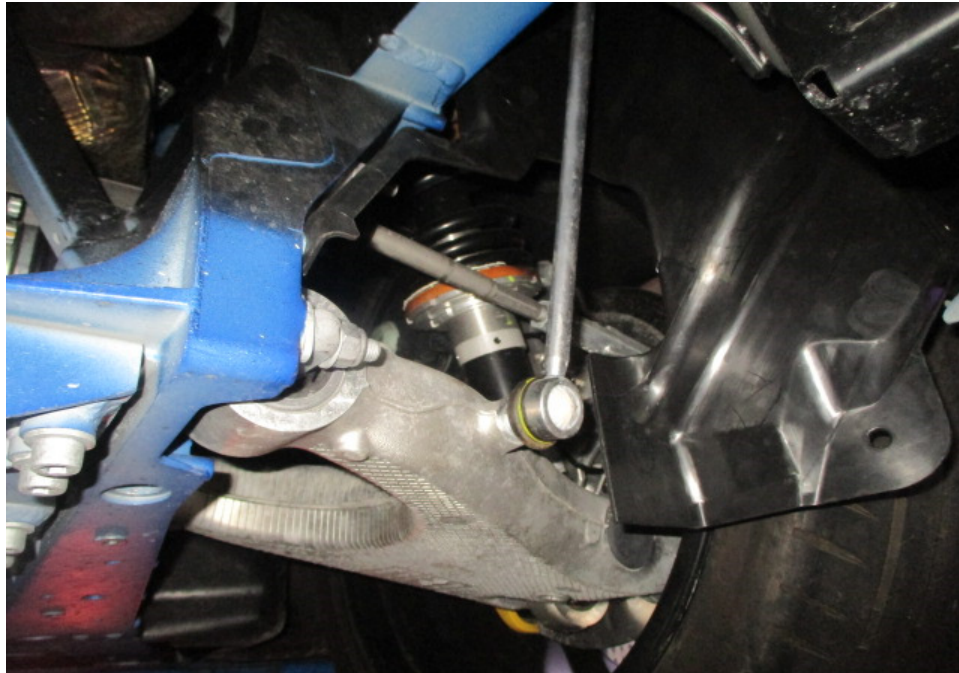
Photo 28 shows a general view of the control arms and linkages at the rear right wheel of the Motor Car. I did not observe any fluid leak and/or fluid stain on the underside of the Motor Car. All of the Motor Car's undercarriage components were observed to be intact and secured in an appropriate manner.

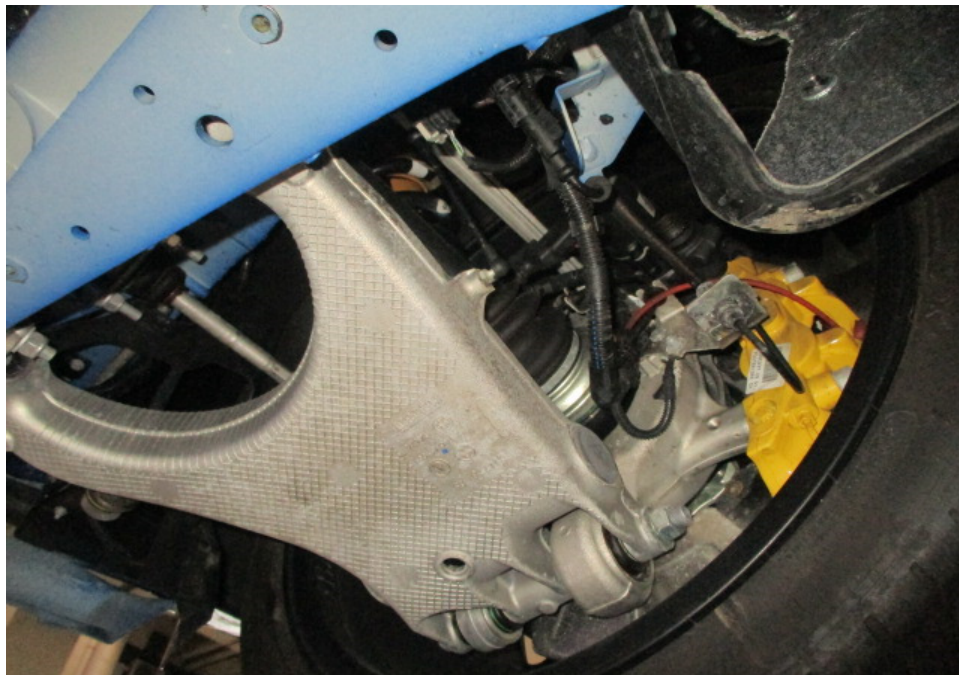
Photo 29 shows a general view of the control arms and linkages at the rear left wheel of the Motor Car. I did not observe any fluid leak and/or fluid stain on the underside of the Motor Car. All of the Motor Car's undercarriage components were observed to be intact and secured in an appropriate manner.

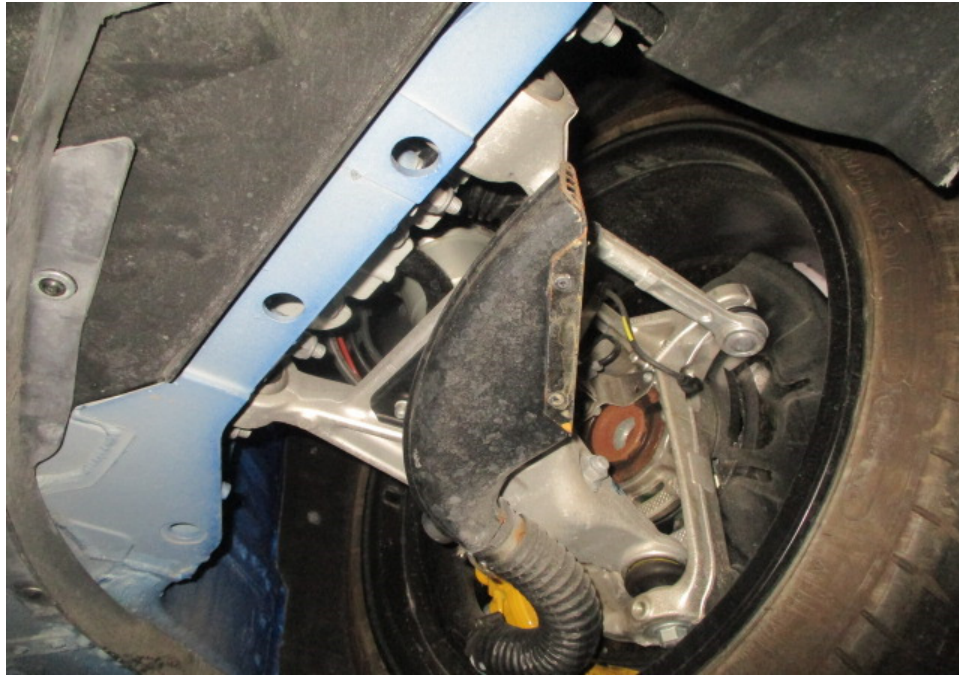
Photo 30 shows the various undercarriage components at the front left wheel of the Motor Car. The mechanical components, control arms and linkages were all found to be intact and secured in an appropriate manner.
