Your Ref: Ferrari 488 Pista
(chassis number ZFF90HMC000258332)
Our Ref : CI/TP23004393/D

01 May 2023

**INSPECTION REPORT OF AN UNREGISTERED FERRARI 488 PISTA
MOTOR CAR WITH CHASSIS NUMBER ZFF90HMC000258332**

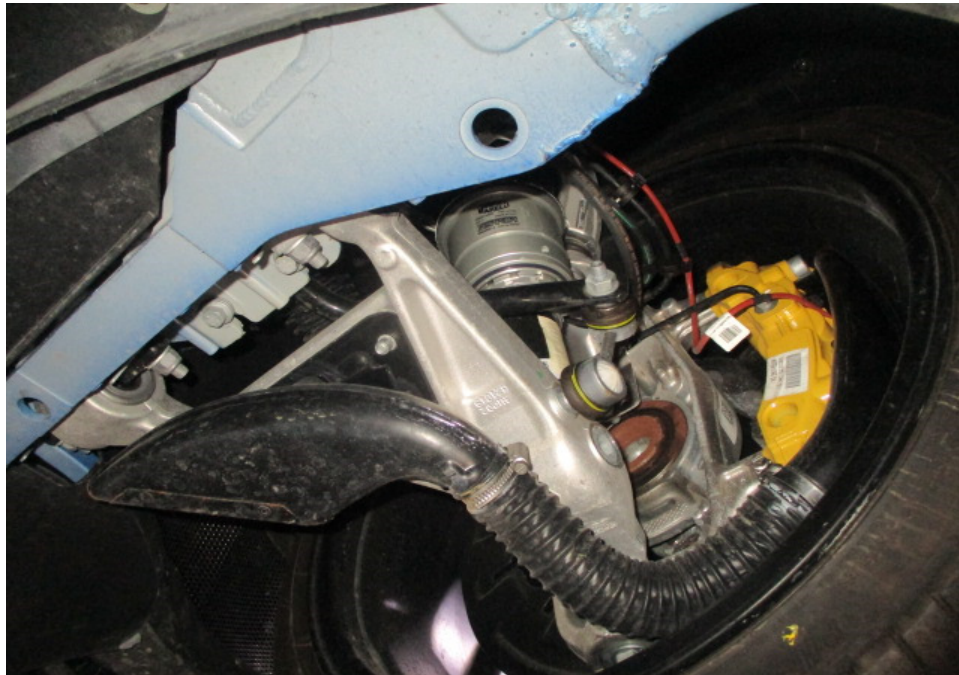
Photo 31 shows the various undercarriage components at the front right wheel of the Motor Car. The mechanical components, control arms and linkages were all found to be intact and secured in an appropriate manner. I also did not observe any fluid leak and/or fluid stain on the underside of the Motor Car.

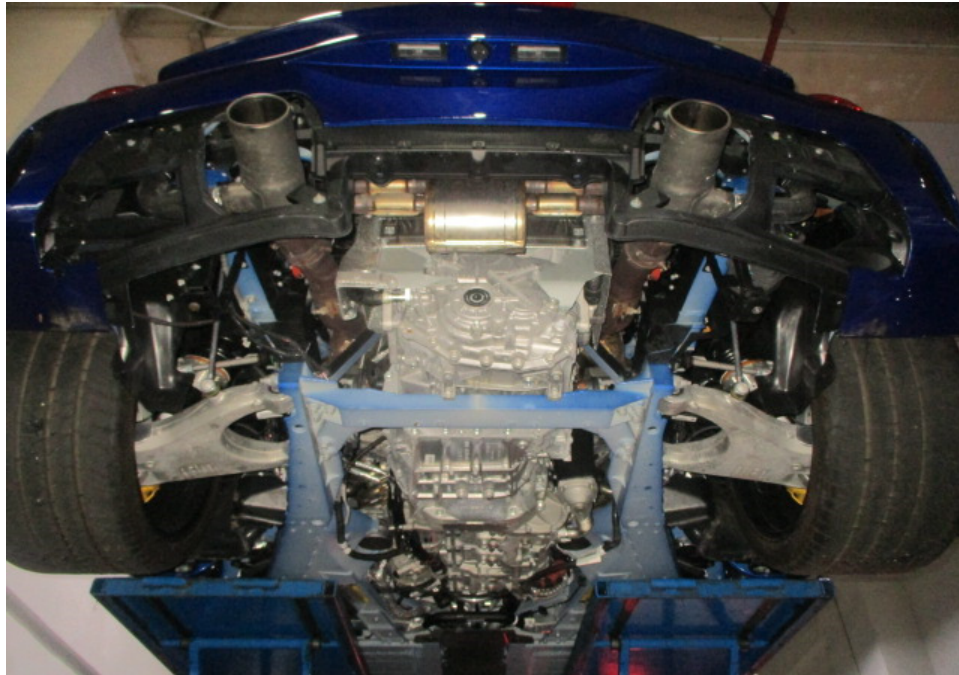
Photo 32 shows the Motor Car's exhaust system after removal of the rear bumper lower cover and rear under cover. In general, my examination of the Motor Car's exhaust system revealed no sign(s) or indication(s) of any cut or weld marks along its exhaust pipes, on its catalytic converters and on its rear muffler.

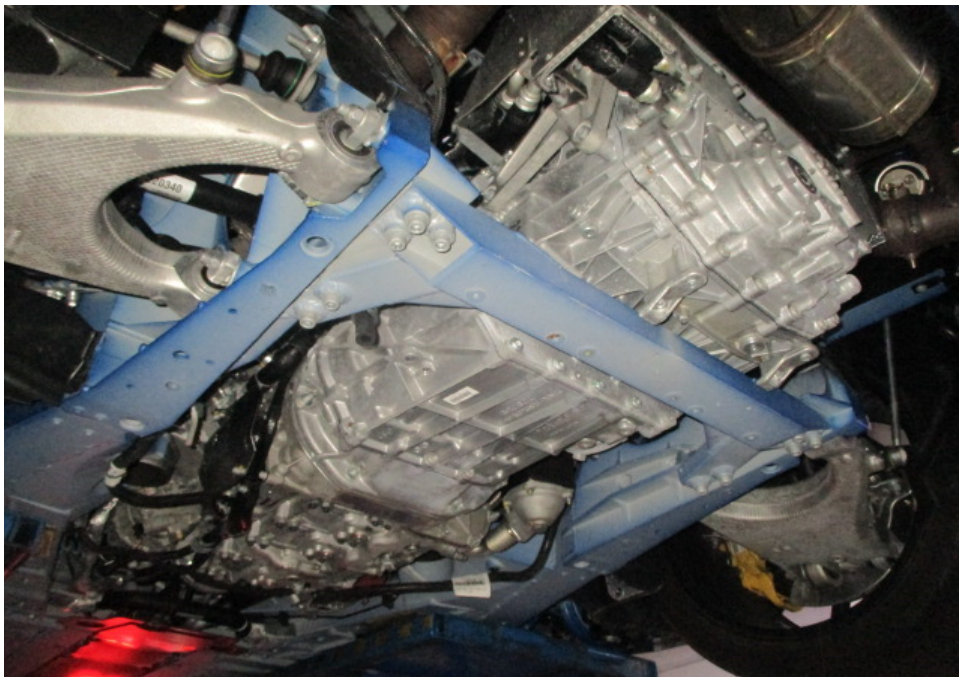
Photo 33 shows the Motor Car's engine compartment as viewed from the rear underside of the Motor Car. The various parts and components inside the engine compartment were all observed to be intact and properly fitted. There was also no sign(s) or indication(s) of fluid leak and/or fluid stain found inside the engine compartment.

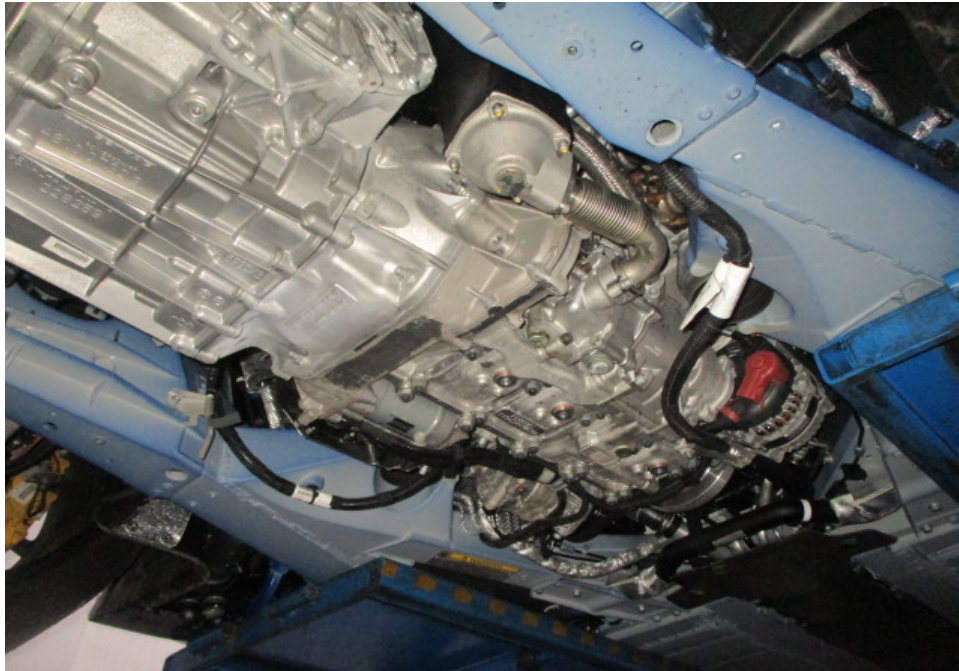
Photo 34 shows another view of the Motor Car's engine compartment as viewed from the rear underside of the Motor Car. The various parts and components inside the engine compartment were all observed to be intact and properly fitted. There was also no sign(s) or indication(s) of fluid leak and/or fluid stain found inside the engine compartment.

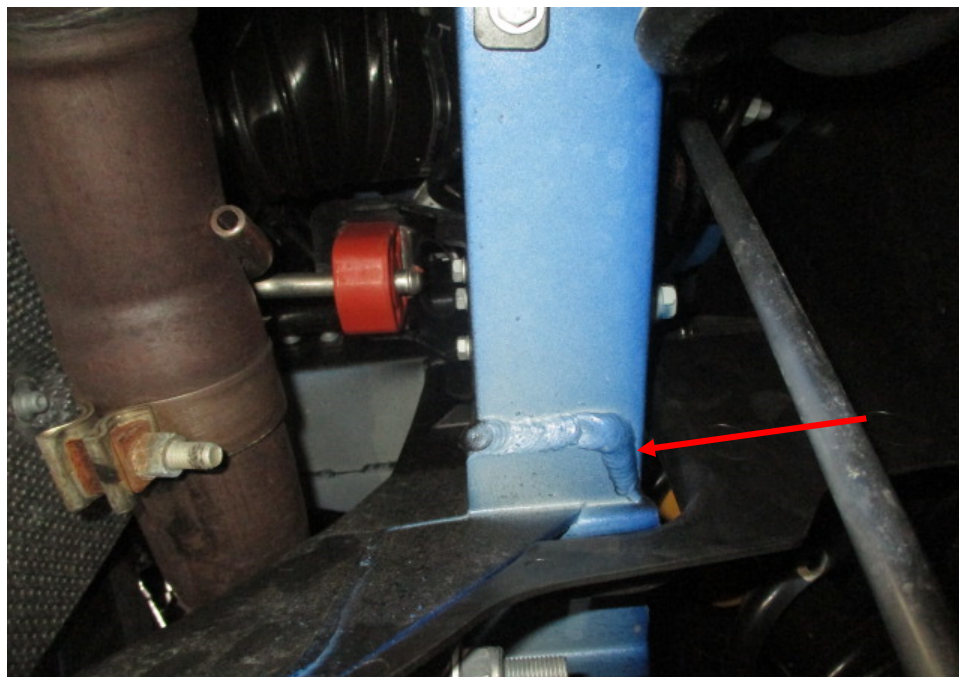
Photo 35 shows the aluminium chassis/structural body at the underside rear right of the Motor Car. The original factory sealant (arrowed) at the joints along the aluminium chassis/structural body of the Motor Car was observed to be untouched. In general, I had found no work was carried out on the aluminium chassis/structural body of the Motor Car. The aluminium chassis/structural body of the Motor Car was originally fitted.

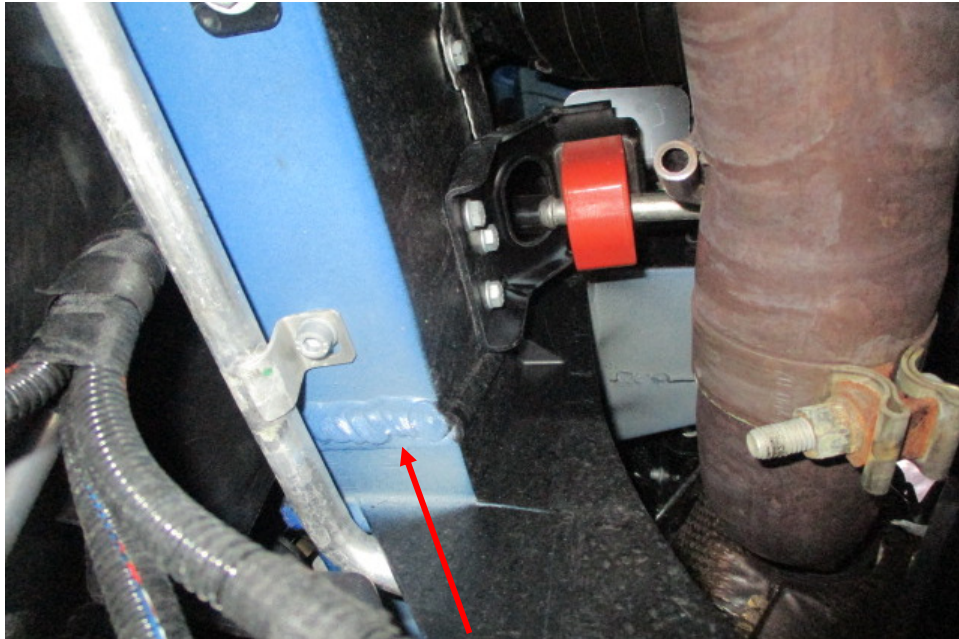
Photo 36 shows the aluminium chassis/structural body at the underside rear left of the Motor Car. I did not find any weld marks other than original spot weld marks on the aluminium chassis/structural body of the Motor Car. The original factory sealant (arrowed) at the joints along the aluminium chassis/structural body was untouched, indicating no work was done on the aluminium chassis/structural body of the Motor Car and that the aluminium chassis/structural body was originally fitted.

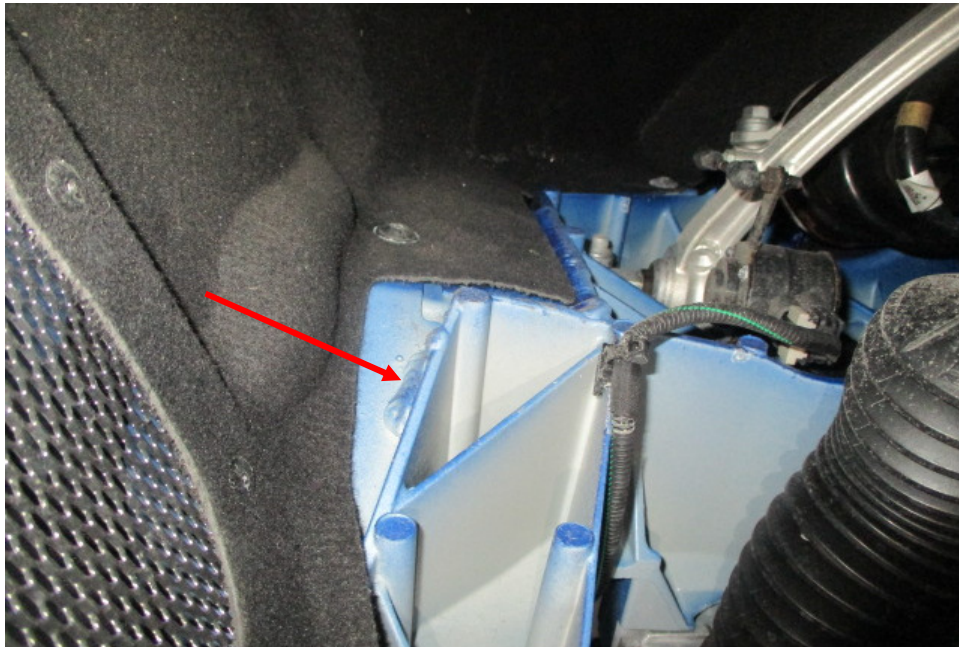
Photo 37 shows the aluminium chassis/structural body at the underside front left of the Motor Car. The original factory sealant (arrowed) at the joints along the aluminium chassis/structural body was observed to be untouched. In general, I had found no work was carried out on the aluminium chassis/structural body of the Motor Car. The aluminium chassis/structural body of the Motor Car was originally fitted.

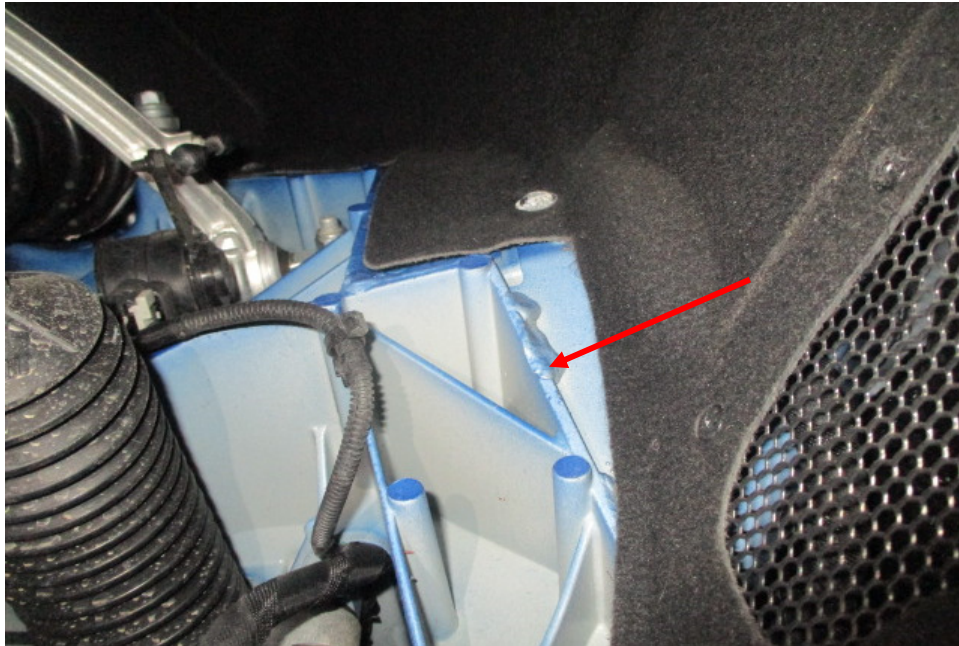
Photo 38 shows the aluminium chassis/structural body at the underside front right of the Motor Car. I did not find any weld marks other than original spot weld marks on the aluminium chassis/structural body of the Motor Car. The original factory sealant (arrowed) at the joints along the aluminium chassis/structural body was untouched, indicating no work was done on the aluminium chassis/structural body of the Motor Car and that the aluminium chassis/structural body was originally fitted.

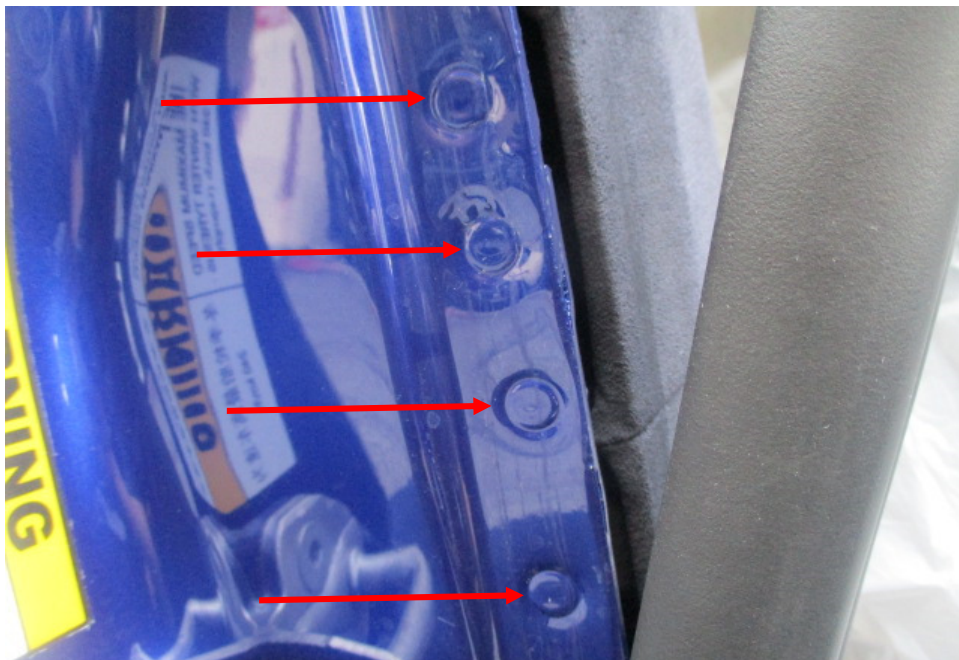
Photo 39 shows the right side rear body panel of the Motor Car. I did not find any weld marks other than original spot weld marks (arrowed) on the right side rear body panel of the Motor Car, which indicates that there was no re-welding works carried out. In general, I had found all the non-detachable body panels of the Motor Car to be originally fitted at the time of my inspection.

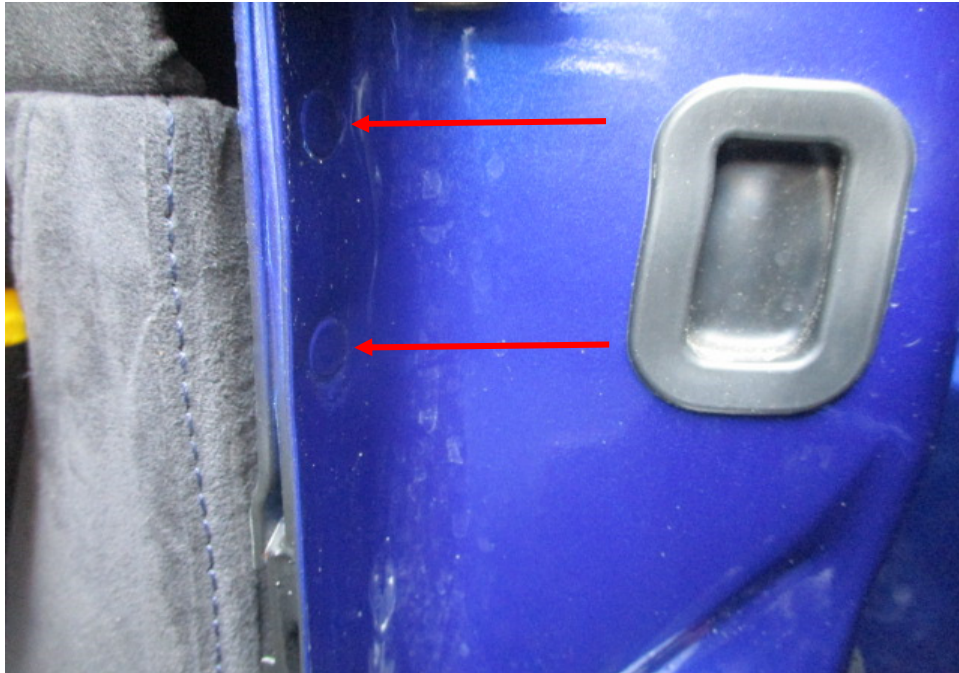
Photo 40 shows the right side "A" pillar of the Motor Car. I did not find any weld marks other than original spot weld marks (arrowed) on the right side "A" pillar of the Motor Car, which indicates that there was no re-welding works carried out. In general, I had found all the non-detachable body panels of the Motor Car to be originally fitted at the time of my inspection.

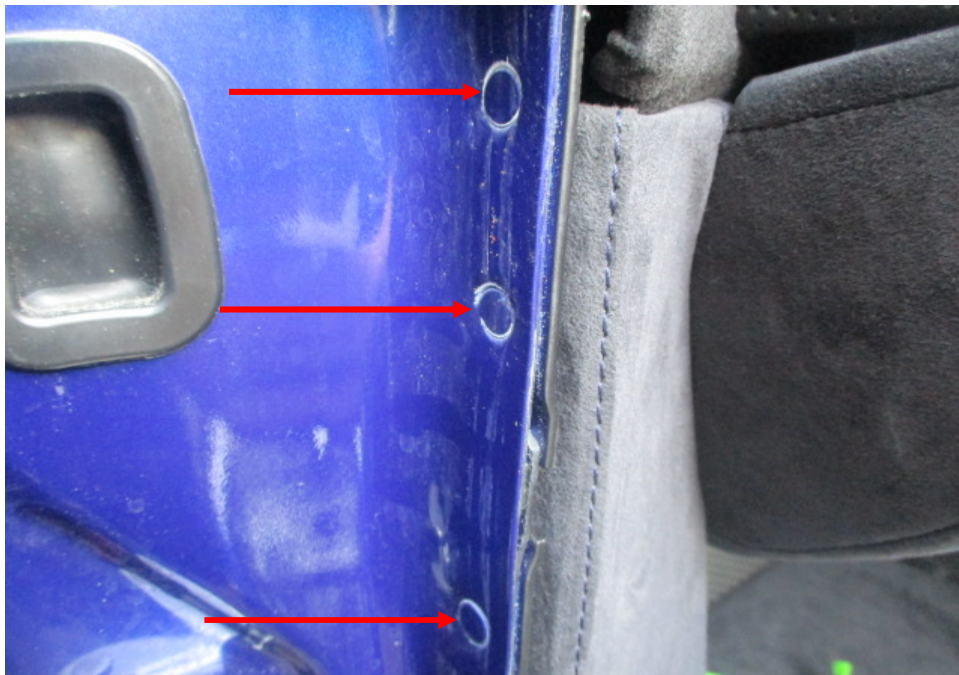
Photo 41 shows the left side "A" pillar of the Motor Car. I did not find any weld marks other than original spot weld marks (arrowed) on the left side "A" pillar of the Motor Car, which indicates that there was no re-welding works carried out. In general, I had found all the non-detachable body panels of the Motor Car to be originally fitted at the time of my inspection.

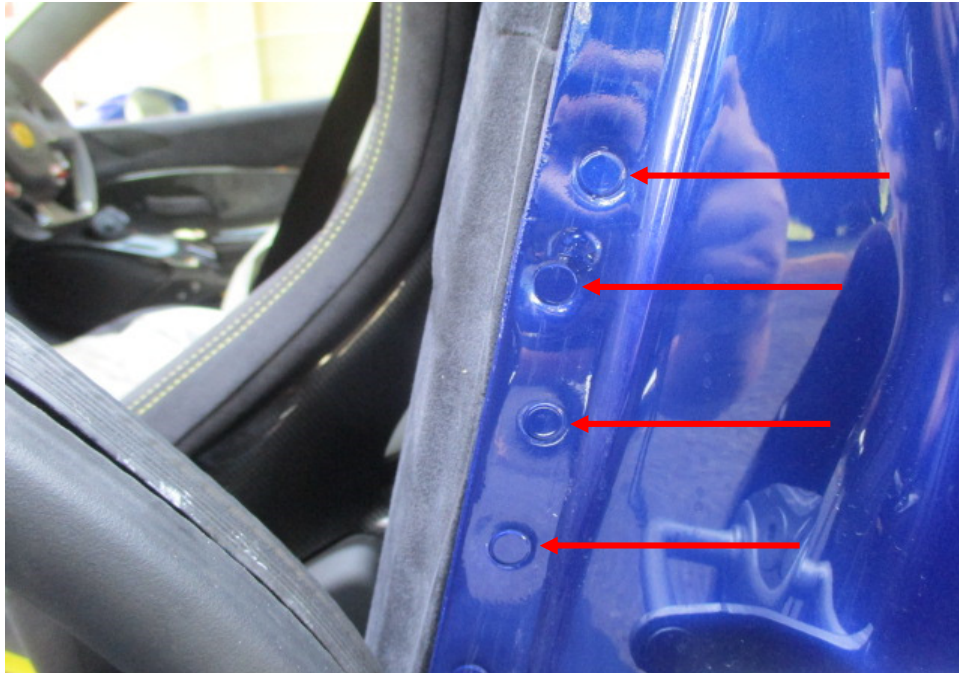
Photo 42 shows the left side rear body panel of the Motor Car. I did not find any weld marks other than original spot weld marks (arrowed) on the left side rear body panel of the Motor Car, which indicates that there was no re-welding works carried out. In general, I had found all the non-detachable body panels of the Motor Car to be originally fitted at the time of my inspection.
