Our Reference : KAAS/TA/6479/4834/TP/11.22  
Date : 16 December 2022

### VEHICLE APPRAISAL REPORT

Our Reference : KAAS/TA/6479/4834/TP/11.22  
 Vehicle Number : SMN 4834G

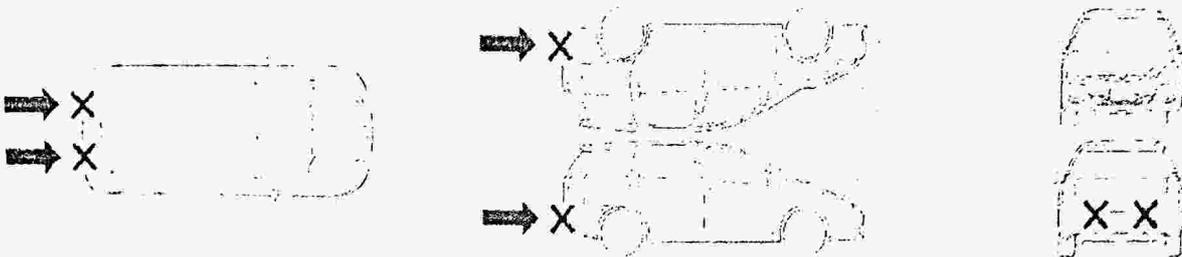
Damages sustained were consistent with the subject vehicle being involved in a collision with another vehicle and the impact was delivered **Squarely to the Rear** portion of the vehicle.

The general area of damages is at the **Rear portion**  
 ( Please refer to the parts list and photographs as attached for more information )

We have adjusted the cost to \$ 11,759.40 and the repairer has agreed to undertake the repairs at a **Contract Lump Sum of \$ 9,400.00** to a acceptable quality and standards.

The repairs should be completed within a reasonable period of **9** working days.
