Your Ref: SKJ 5356H  
Our Ref : CI/TP23004449/D

## **AUTOMOBILE INSPECTION REPORT OF MOTOR CAR SKJ 5356H**

Vehicle Registration No.	: SKJ 5356H
Make / Model	: Nissan Skyline 2.5A
Chassis No	: ER34021113
Year of Registration	: 1999 (May)
Mileage	: 240,331km

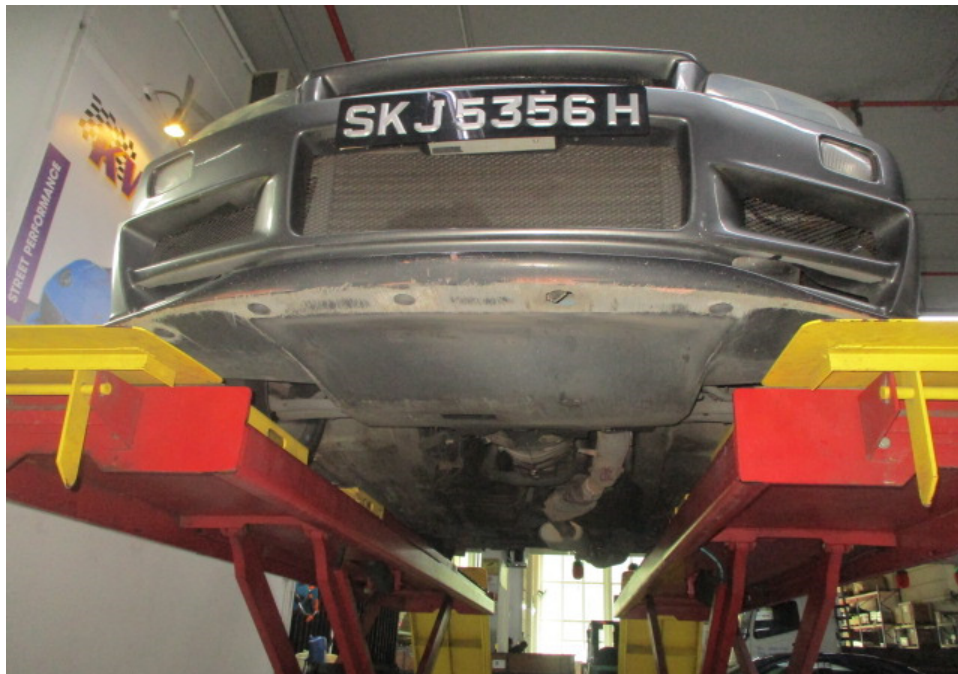
**Photo 1** shows the Motor Car hoisted up for checks on its undercarriage, in particular to its transmission assembly.

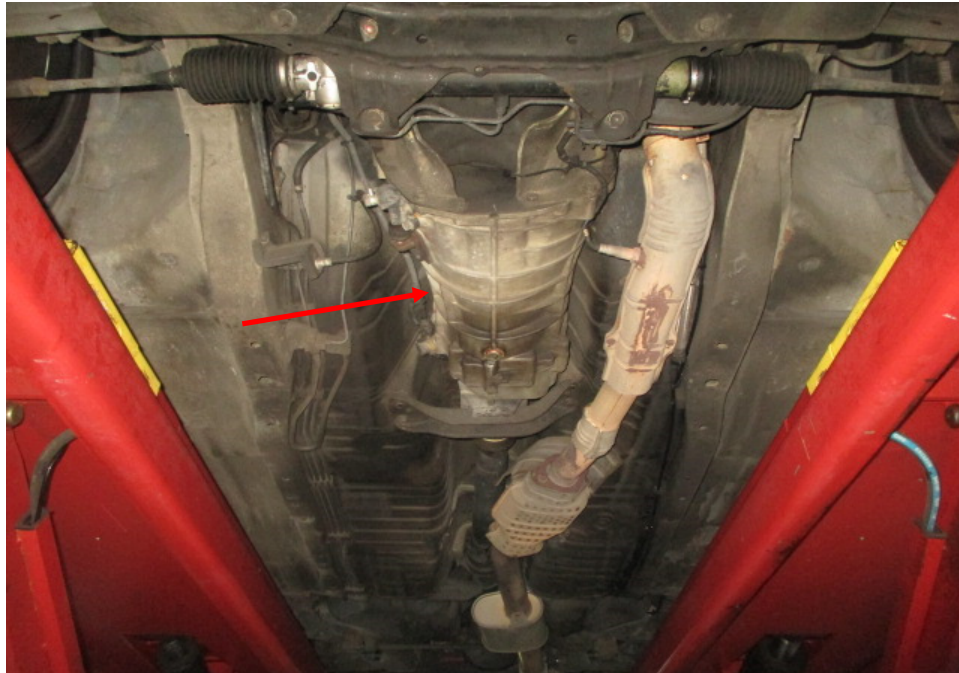
**Photo 2** shows a general view of the transmission assembly (arrowed) that was fitted on the Motor Car, as viewed from the front to rear. The front (input) side of the transmission assembly is bolted to the crankshaft side of the engine block while the rear (output) side of the transmission assembly, connects to the propeller shaft, which links to the differential at the rear axle of the Motor Car.

10. In general, the transmission assembly of the Motor Car was found to be secured properly. It was not mounted onto the chassis body or any integral body part of the Motor Car. The structural integrity of the Motor Car is not compromised by the fitment of this particular transmission assembly. Overall, the operating condition of the Motor Car's transmission system was satisfactory throughout the Motor Car's test drive.

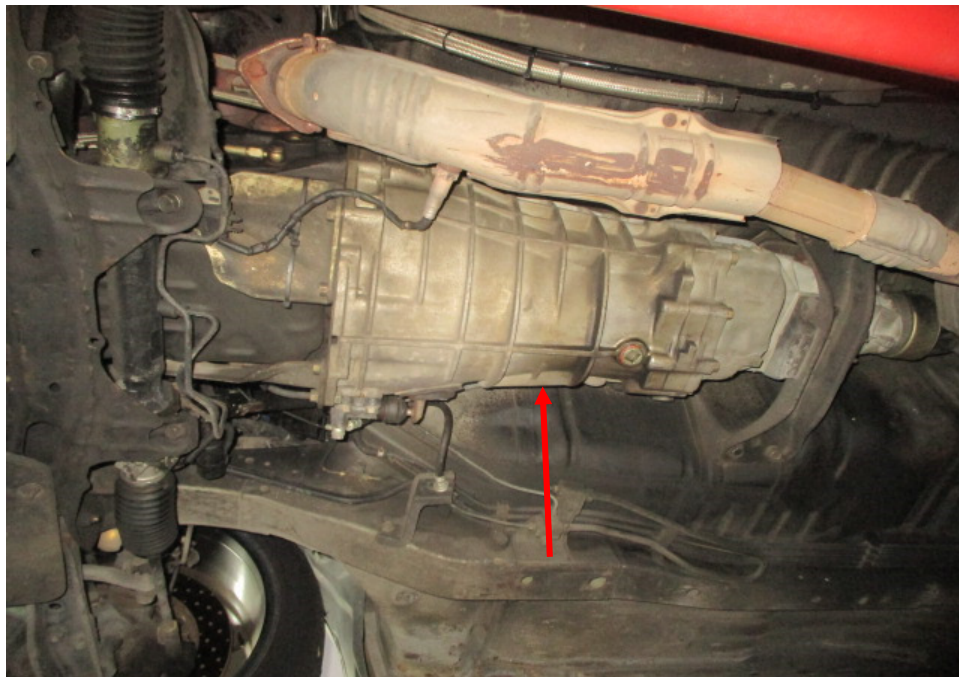
**Photo 3** shows another view of the transmission assembly (arrowed) that was fitted on the Motor Car, as viewed from the left to right. The front (input) side of the transmission assembly is bolted to the crankshaft side of the engine block while the rear (output) side of the transmission assembly, connects to the propeller shaft, which links to the differential at the rear axle of the Motor Car.

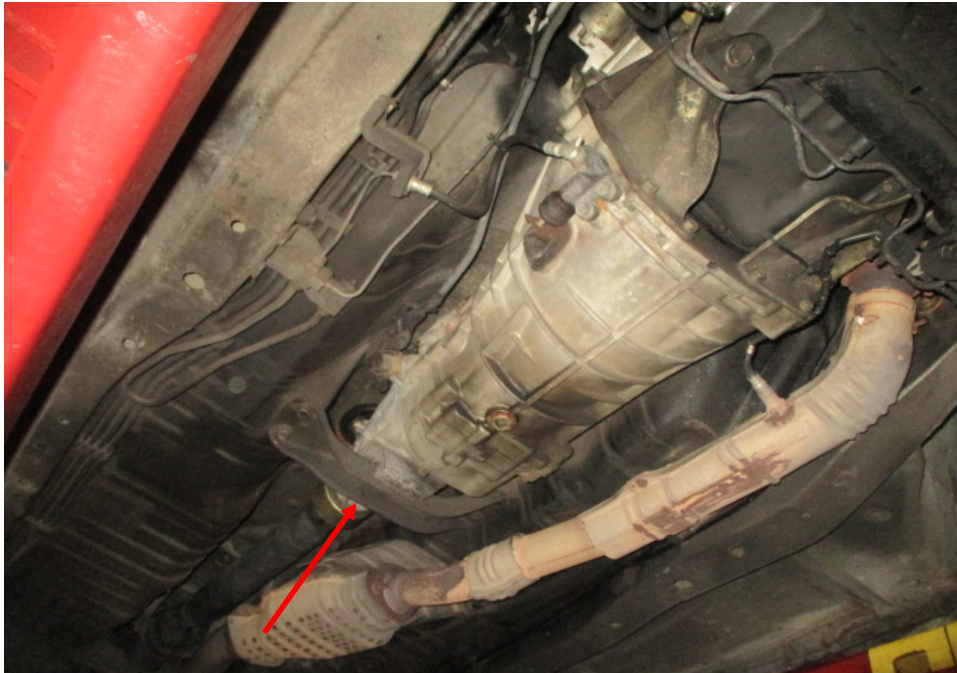
**Photo 4** shows a general view of the bracket (arrowed) that was mounted to the underside of the Motor Car's floorboard, via bolts and nuts. The bracket supports the rear (output) side of the transmission assembly.

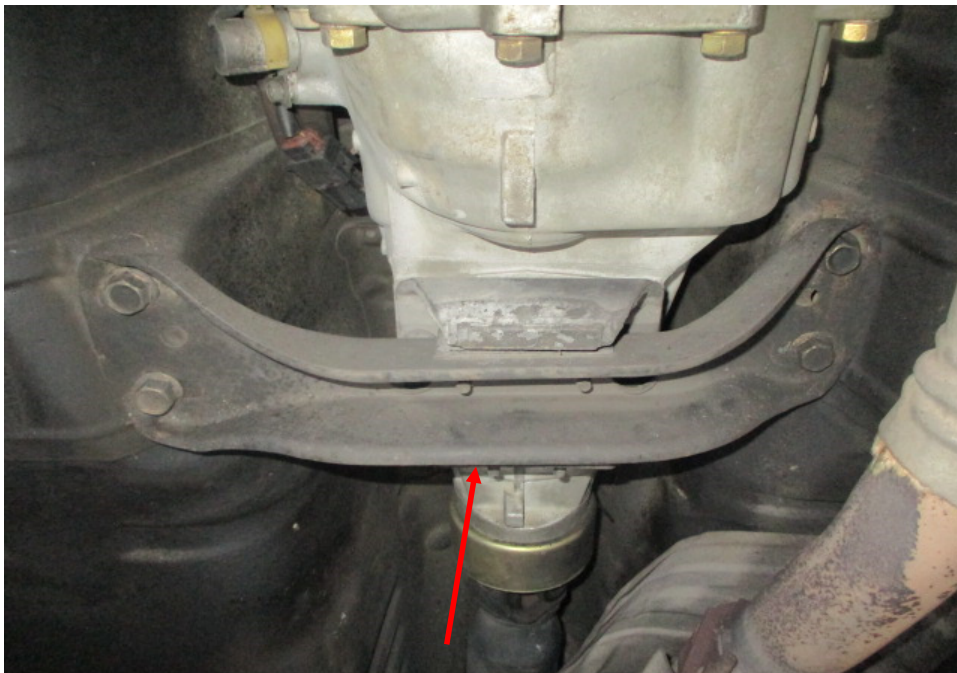
**Photo 5** shows a closer view of the bracket (arrowed) that was mounted to the underside of the Motor Car's floorboard, via bolts and nuts. The bracket supports the rear (output) side of the transmission assembly. The bracket was also with rubber bushings that absorb any vibrations arising from the rotation of the transmission gears, minimising any stress to the bracket.

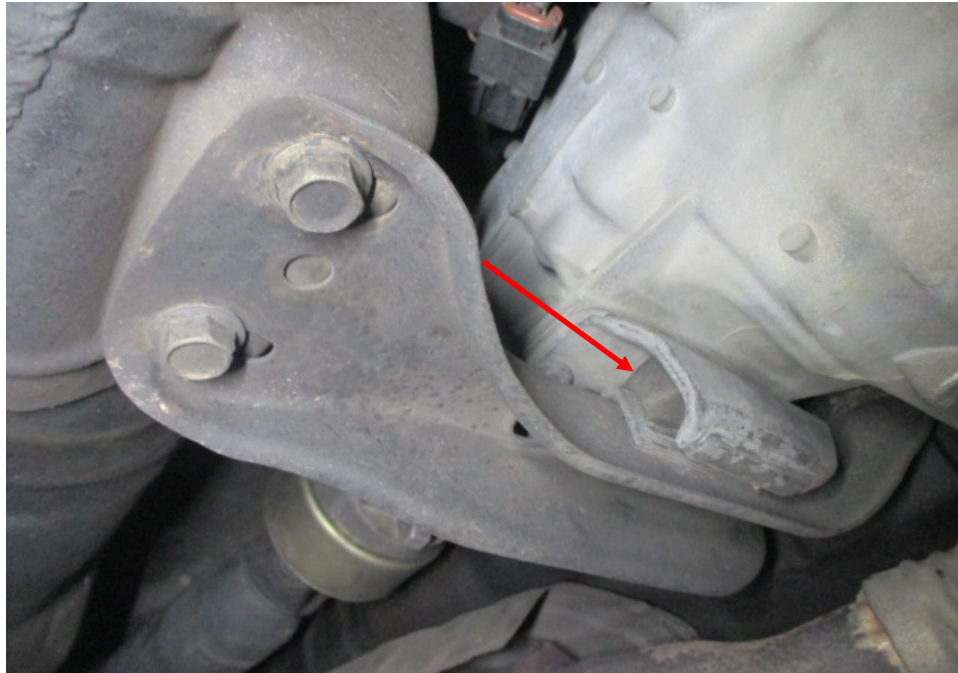
**Photo 6** shows the rubber bushing (arrowed), sitting between the transmission assembly and the bracket. The rubber bushing absorbs any vibrations arising from the rotation of the transmission gears, minimising any stress to the bracket.

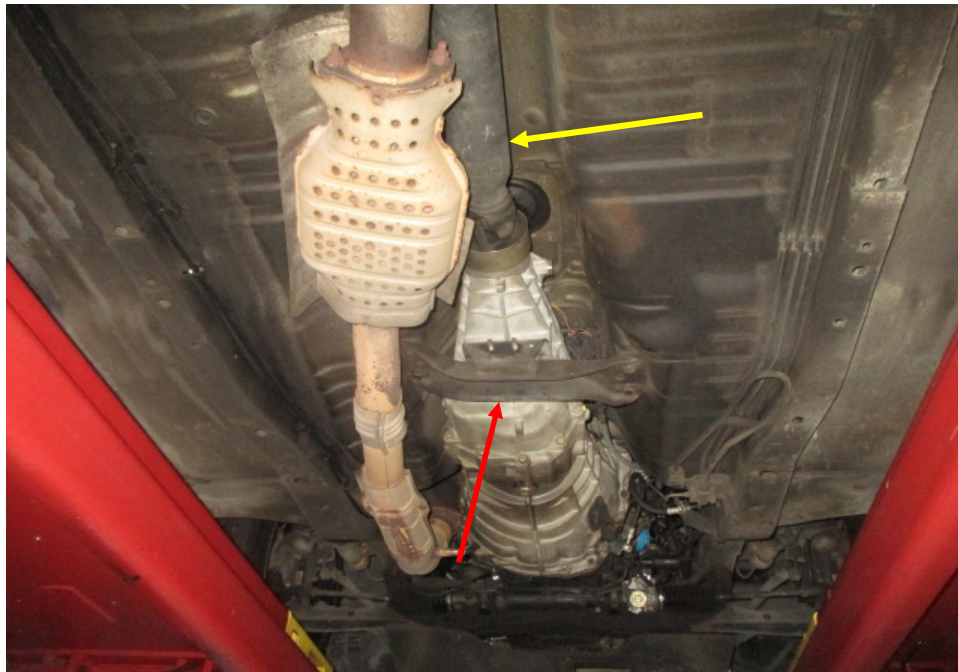
**Photo 7** shows a general view of the transmission assembly that was fitted on the Motor Car, as viewed from the rear to front. The transmission assembly is supported by a bracket (red arrow) that is mounted to the underside of the Motor Car's floorboard, via bolts and nuts. The front (input) side of the transmission assembly is bolted to the crankshaft side of the engine block while the rear (output) side of the transmission assembly, connects to the propeller shaft (yellow arrow), which links to the differential at the rear axle of the Motor Car.

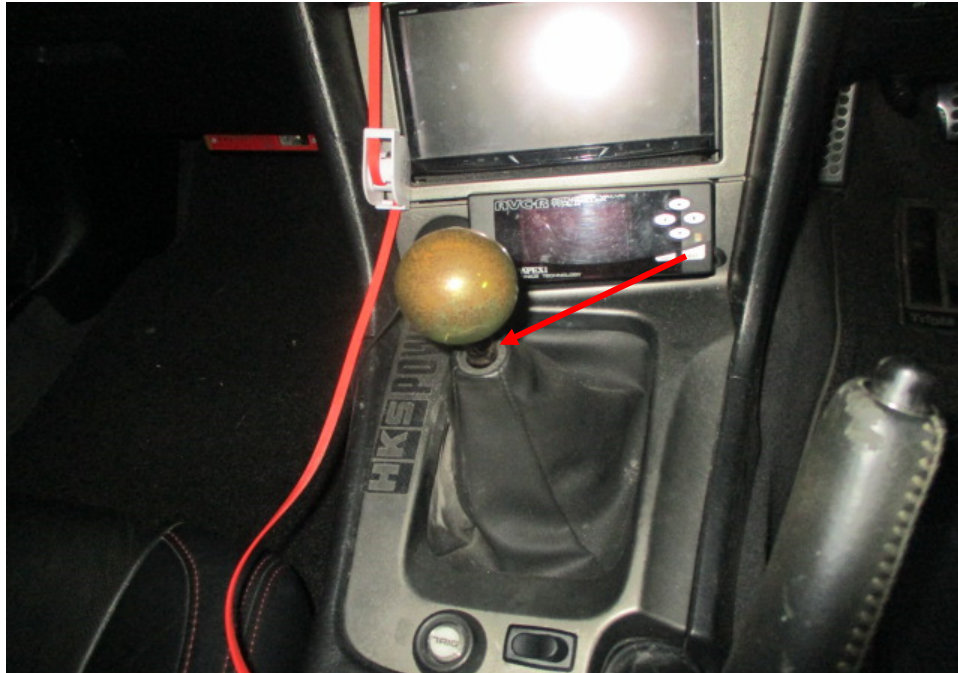
**Photo 8** shows the manual gear shifter (arrowed) for manually selecting the transmission gear to be engaged.

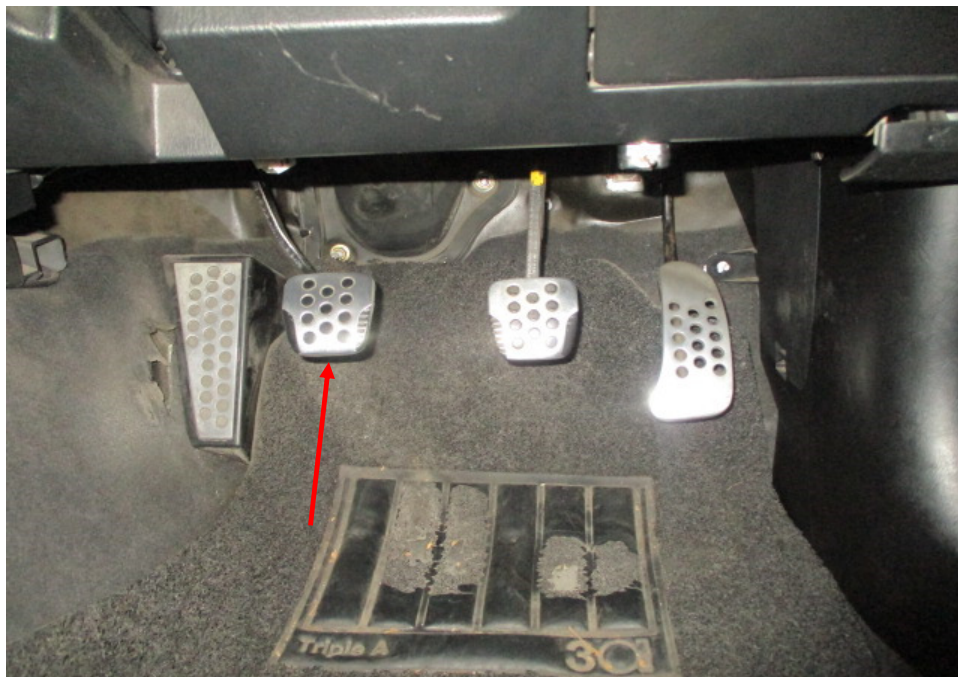
**Photo 9** shows the clutch pedal (arrowed) for engaging and disengaging the transmission gears.
