**SURVEY OF VEHICLE NO. ER7575H**

## **AUTOMOBILE ASSESSMENT REPORT**

**Assessment of Vehicle No** : **ER7575H**  
**Date of Accident** : **31.05.2022**  
**Date of Inspection** : **06.06.2022**  
**Address of Inspection** : **1 KAKI BUKIT AVE 6 #02-33/34/36 AUTOBAY@KB S(417883)**

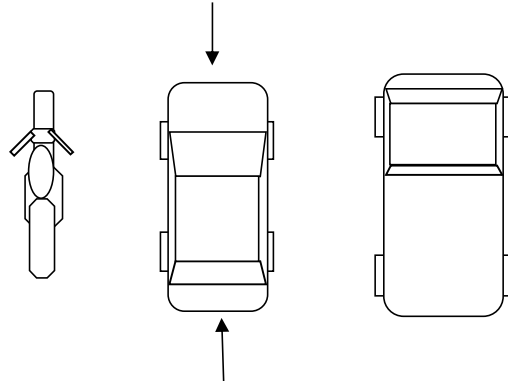
At the time of inspection, this vehicle sustained damages to the **Rear & Front Portion**. Please see attached scheduled for details.
