Your Ref: BMW 840i
(chassis number WBAGV22090CG58956)
Our Ref : CI/TP23004756/D

08 May 2023

**INSPECTION REPORT OF AN UNREGISTERED BMW 840i MOTOR CAR
WITH CHASSIS NUMBER WBAGV22090CG58956**

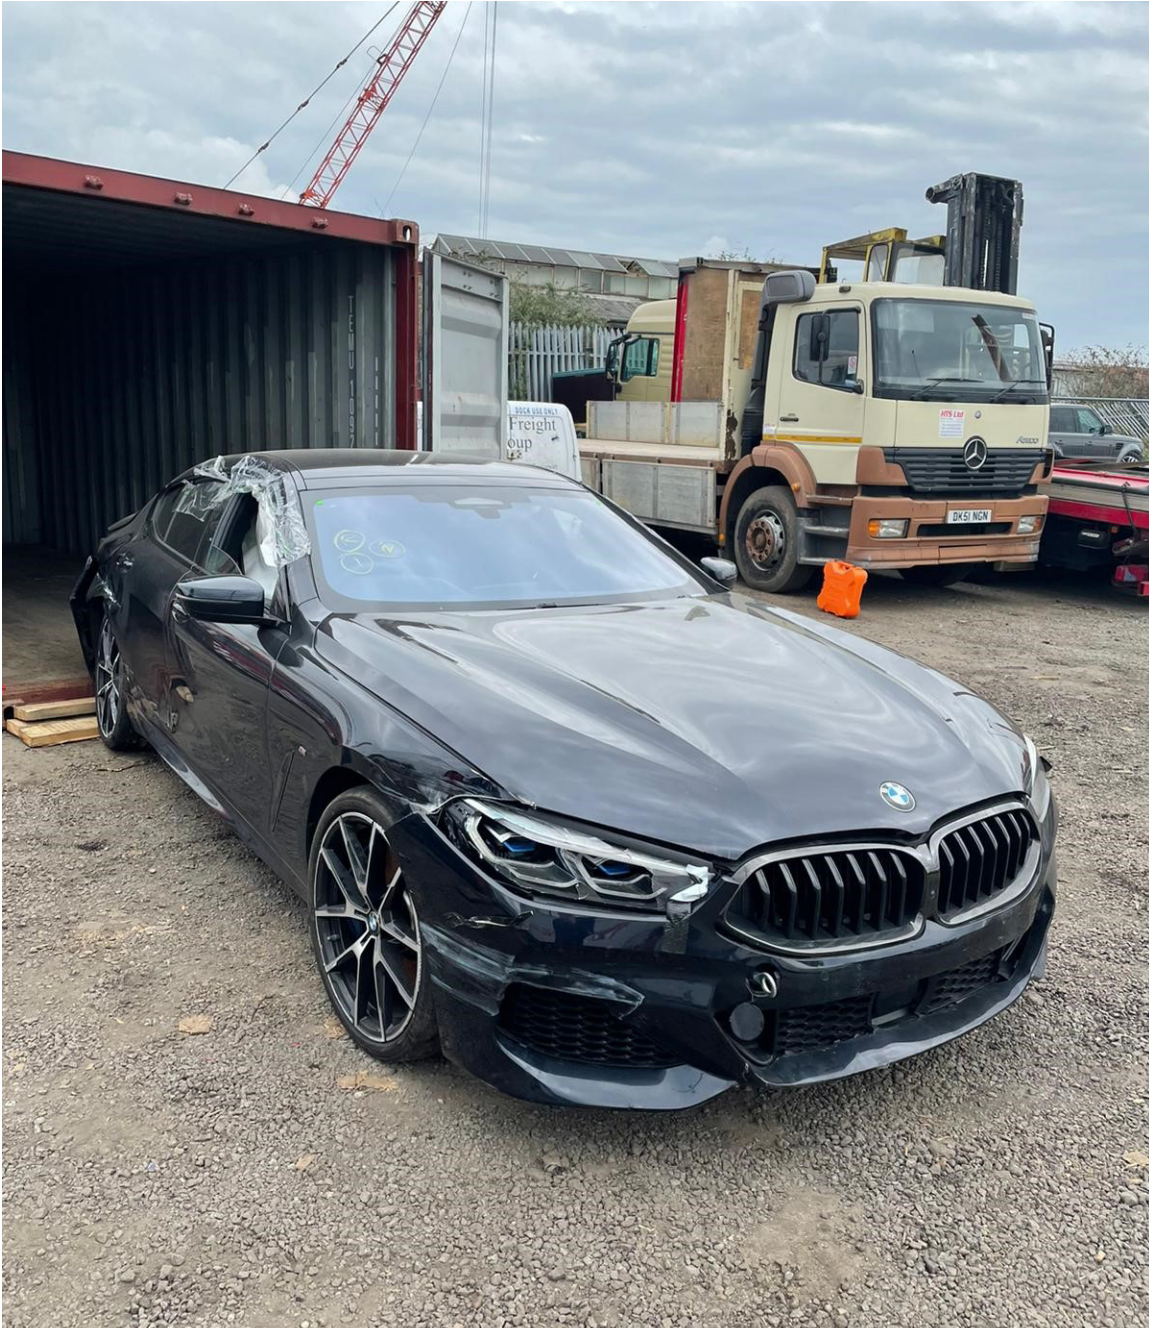
Photo 1 shows a general view of the front right body of the Motor Car (photograph provided to me). The Motor Car was observed to have sustained damage at its right side portion. The front bumper, front bonnet, front right headlamp, front right fender and front right wheel rim were amongst the body parts that were observed to have been damaged.

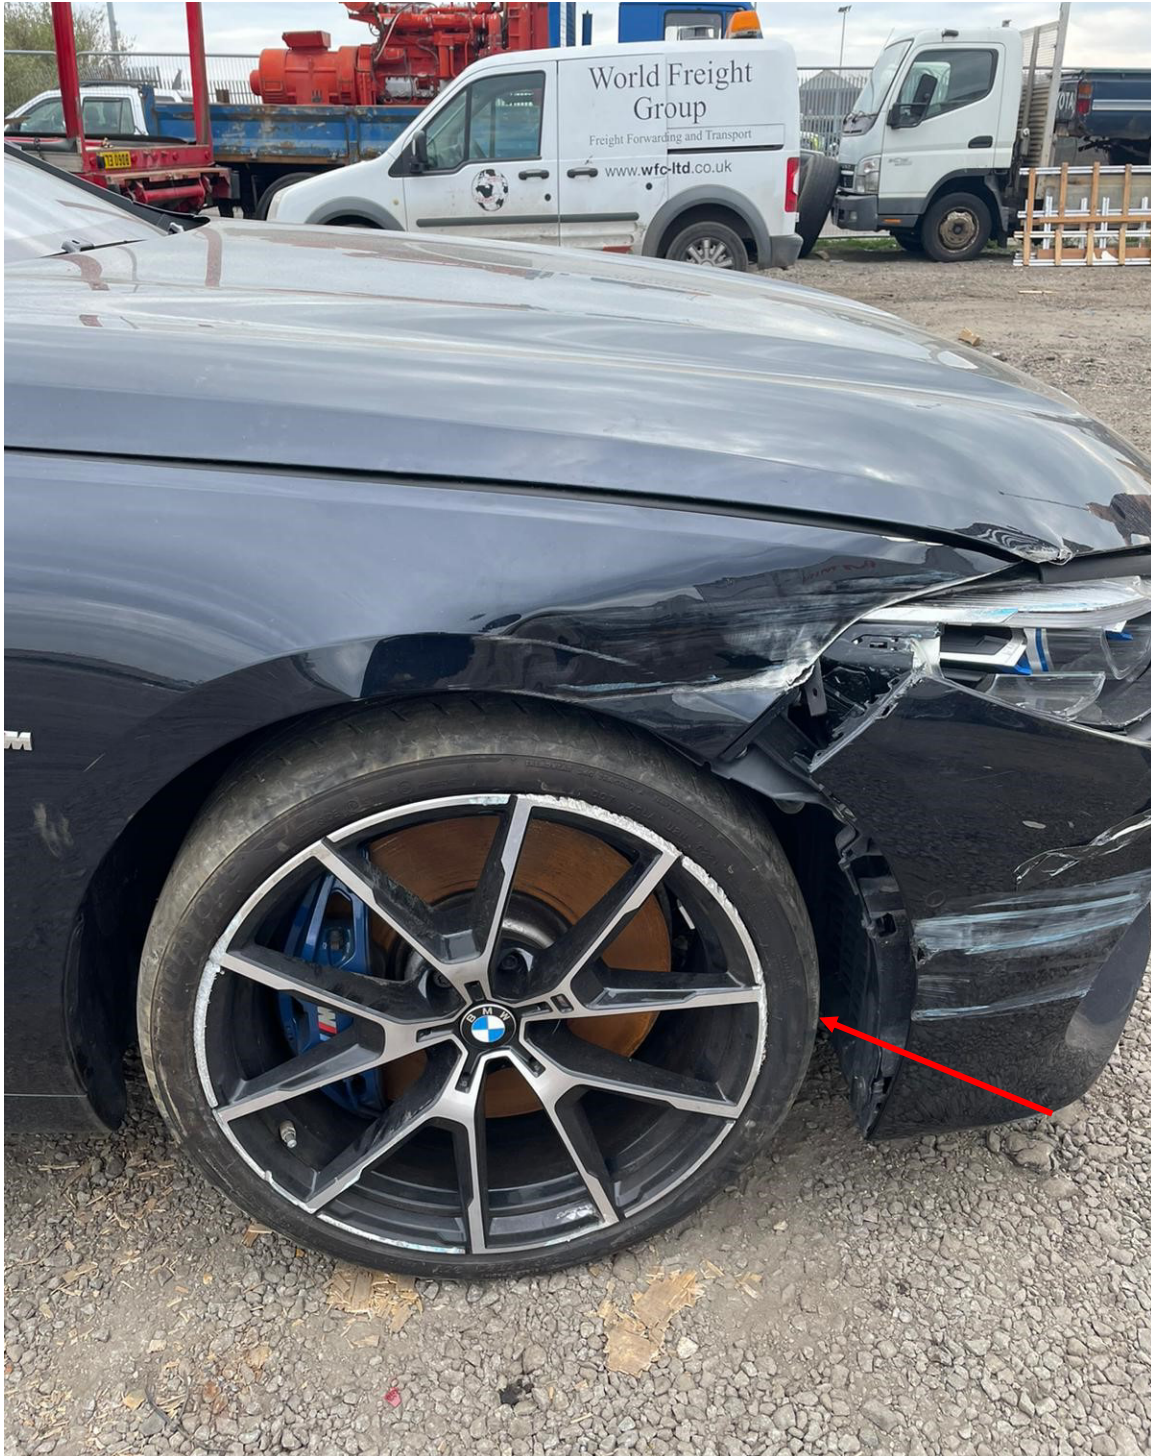
Photo 2 shows a closer view of the damage at the right side front portion of the Motor Car (photograph provided to me). The front bumper, front bonnet, front right headlamp, front right fender and front right wheel rim were amongst the body parts that were observed to have been damaged. The Motor Car's front right wheel (arrowed) and front left wheel (refer to photograph 6 below) were both orientated inwards. This would suggest damage to the undercarriage parts at the front right wheel of the Motor Car. Undercarriage parts that may possibly be damaged include the front right lower arm, front right knuckle arm, front right steering tie rod end and front right shock absorber amongst others.

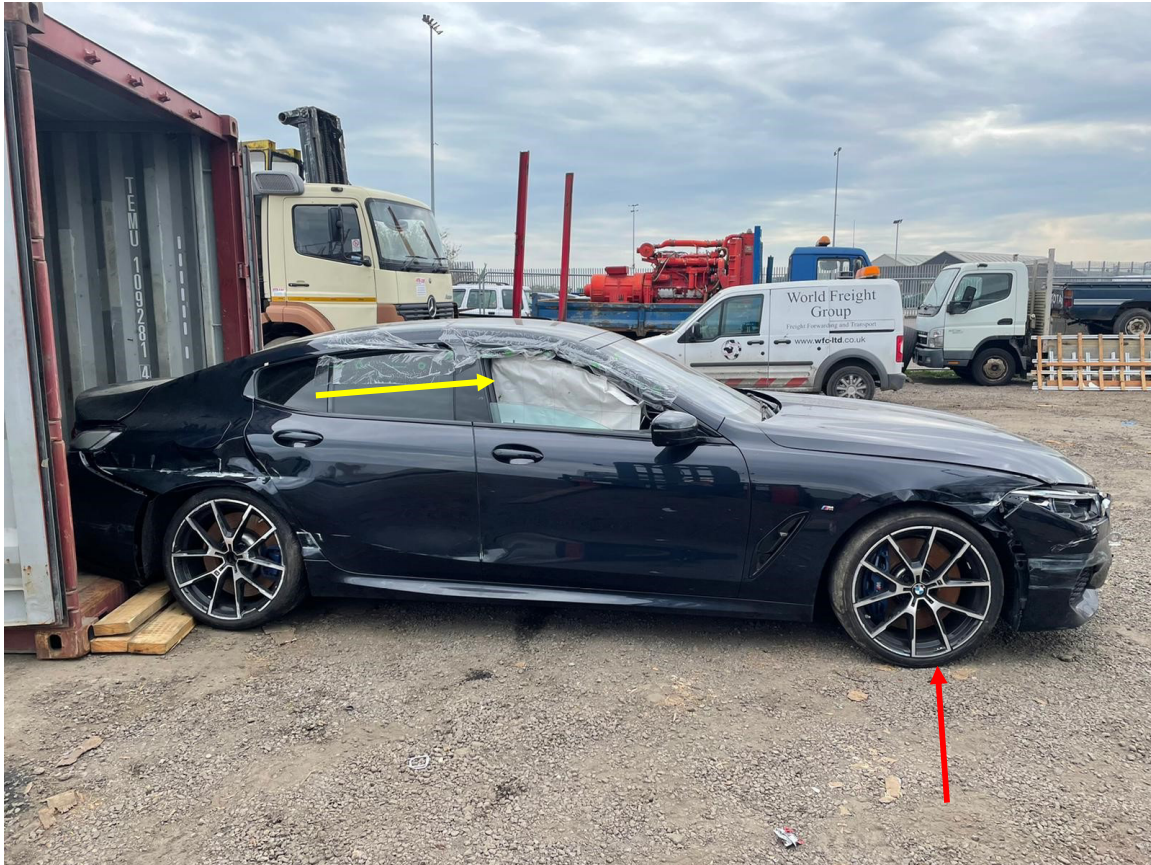
Photo 3 shows a general view of the right side body of the Motor Car (photograph provided to me). The Motor Car was observed to have sustained damage at its right side portion. The front bumper, front bonnet, front right headlamp, front right fender, front right wheel rim, front right door, rear right door, rear right fender, rear right wheel, rear right taillamp and rear bumper were amongst the body parts that were observed to have been damaged. The Motor Car's front right wheel (red arrow) and front left wheel (refer to photograph 6 below) were both orientated inwards. This would suggest damage to the undercarriage parts at the front right wheel of the Motor Car. Undercarriage parts that may possibly be damaged include the front right lower arm, front right knuckle arm, front right steering tie rod end and front right shock absorber amongst others. The Motor Car's right curtain airbag was also deployed (yellow arrow).

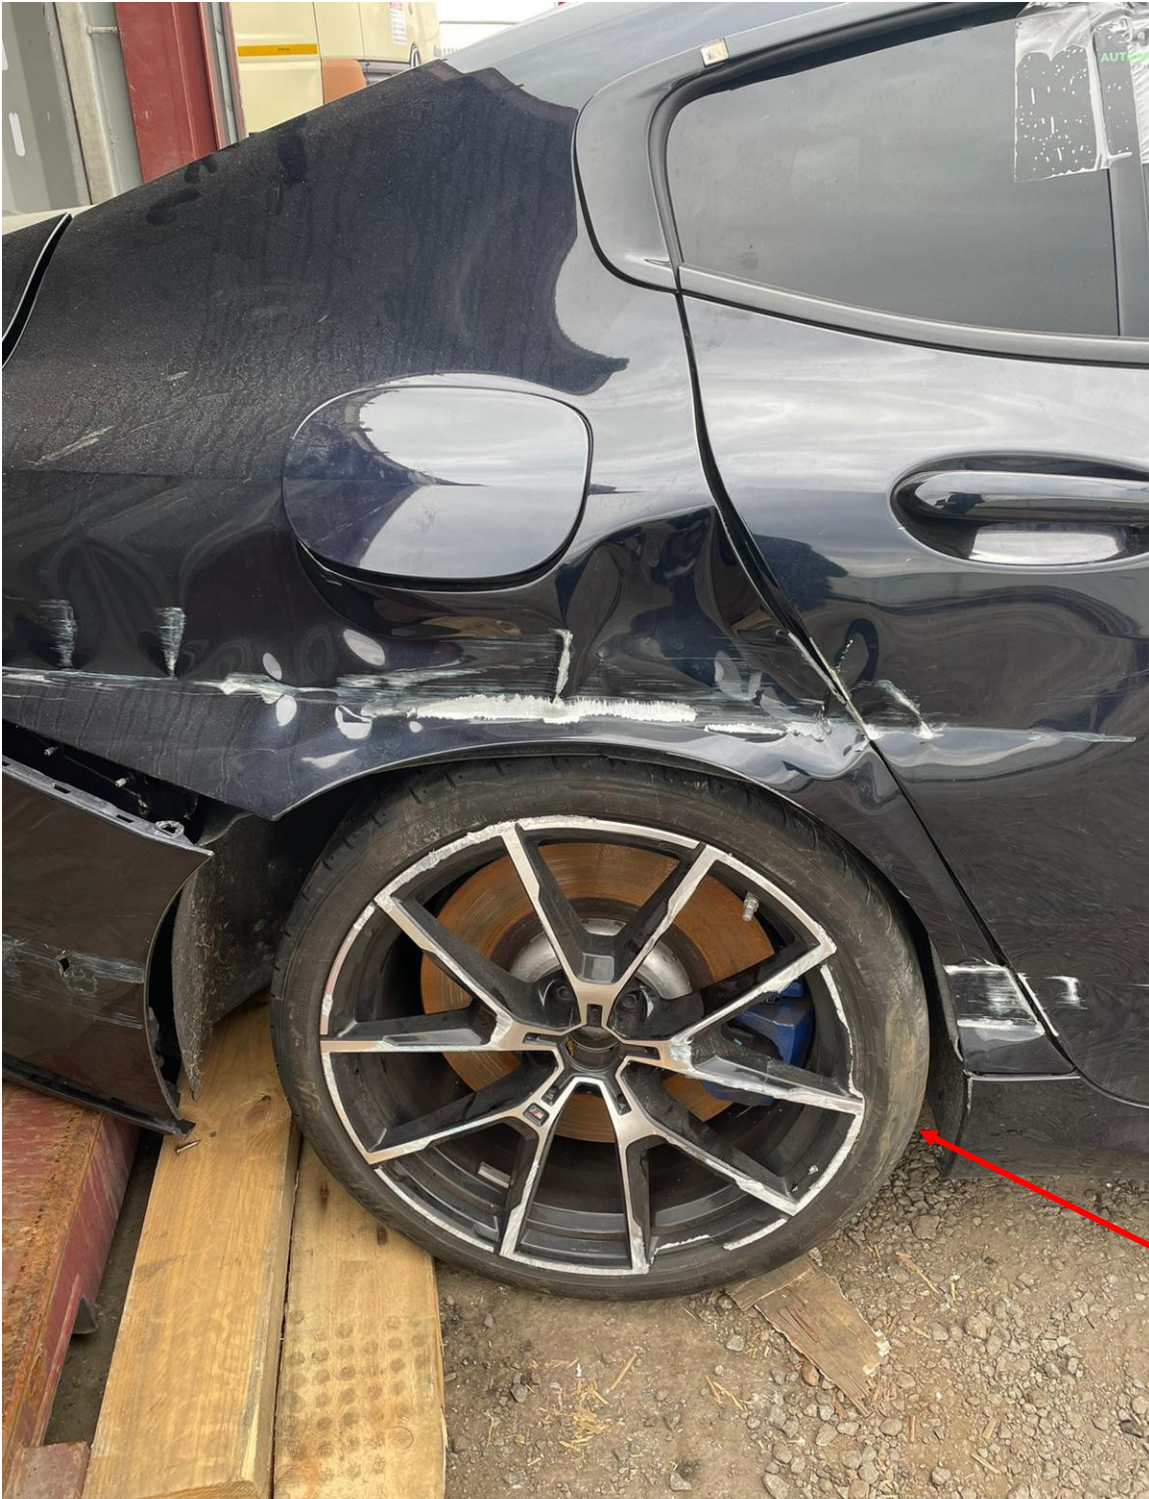
Photo 4 shows a closer view of the damage at the right side rear portion of the Motor Car (photograph provided to me). The rear right door, rear right fender, rear right wheel and rear bumper were amongst the body parts that were observed to have been damaged. The Motor Car's rear right wheel (arrowed) was also observed to be shifted forward. This would suggest damage to the undercarriage parts at the rear right wheel of the Motor Car. Undercarriage parts that may possibly be damaged include the rear right lower arm, rear right knuckle arm, rear right upper arm and rear right shock absorber amongst others.

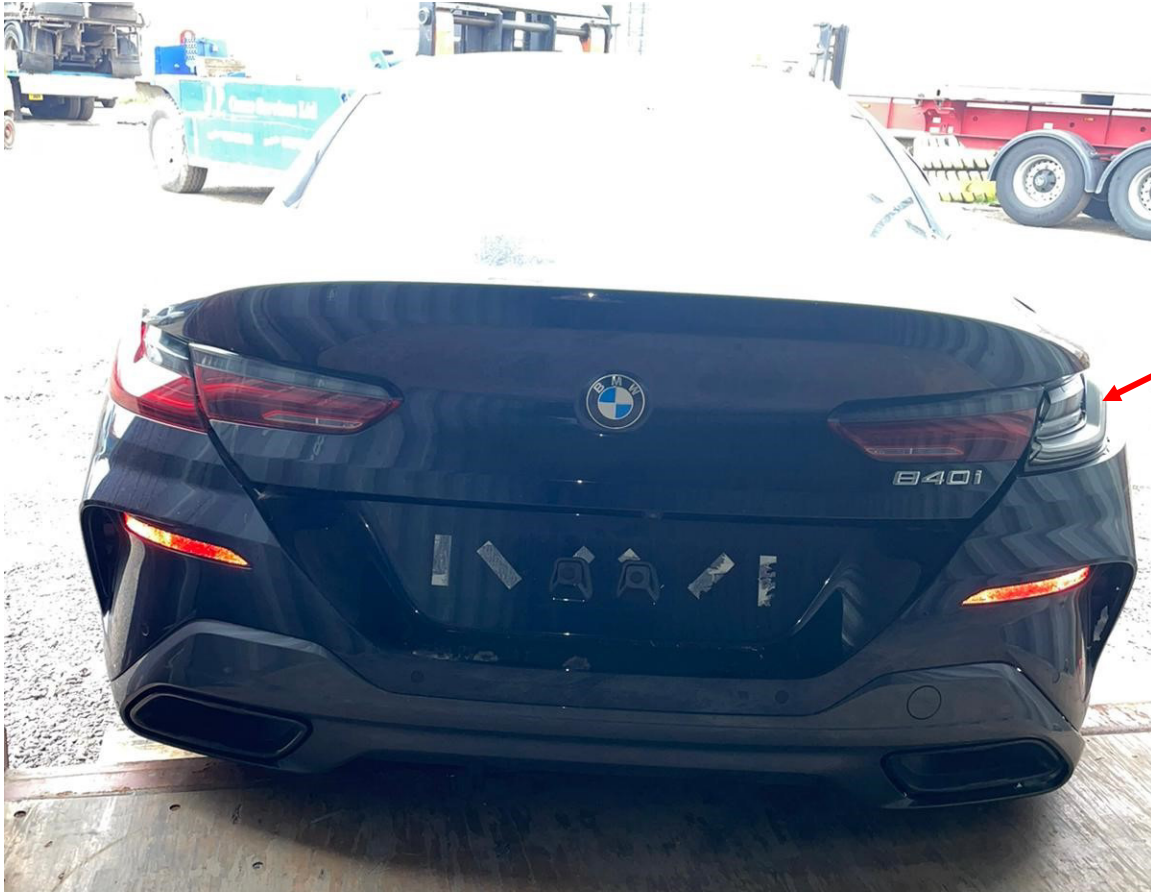
Photo 5 shows the rear body of the Motor Car (photograph provided to me). The rear right taillamp (arrowed) was observed to be broken. Apart for this, the rear body of the Motor Car was undamaged.

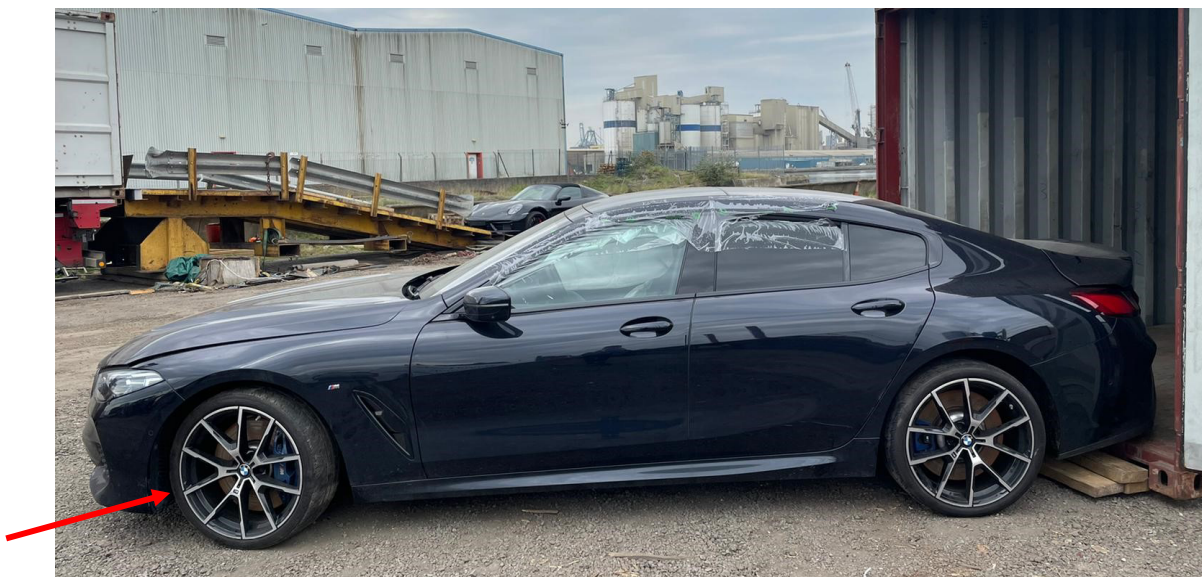
Photo 6 shows the left side body of the Motor Car (photograph provided to me). The left side portion of the Motor Car was observed to be undamaged. The Motor Car's front left wheel (arrowed) and front right wheel (refer to photograph 2 & 3 above) were both orientated inwards. This would suggest damage to the undercarriage parts at the front right wheel of the Motor Car.

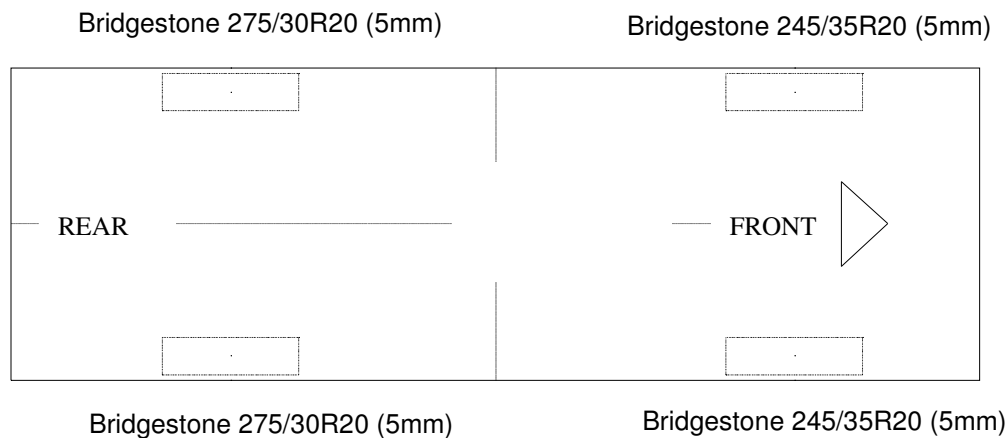
9. It was fitted with 20inch sport wheel rims that were wrapped with tyres that were observed to be of serviceable condition. The tyres were also sufficiently inflated for vehicular operation. The tyre brand, tyre size and approximate remaining tread depth of the 4 tyres of the Motor Car were recorded as follows: -

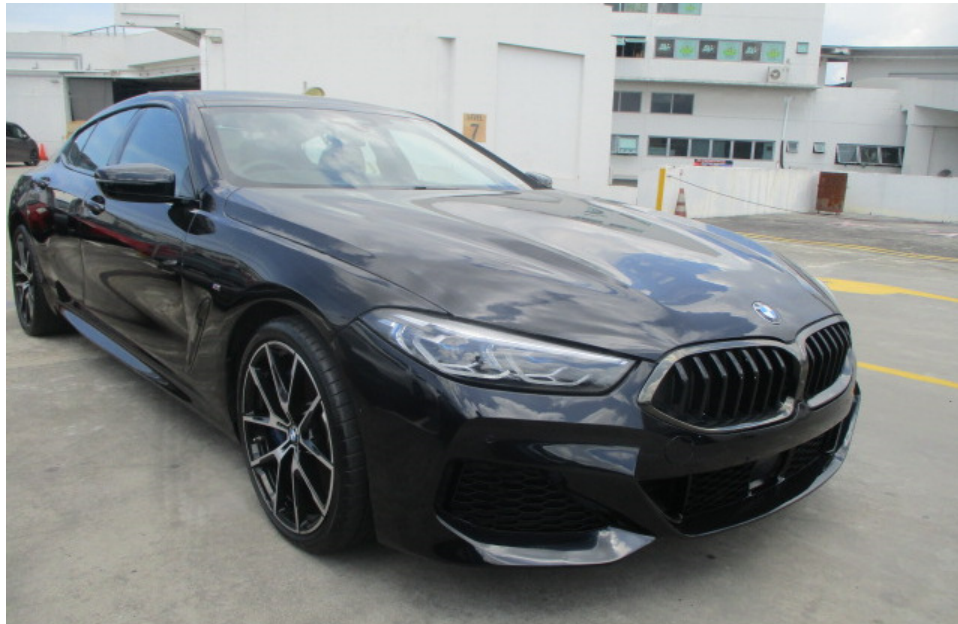
Photo 7 shows a general view of the front right body of the Motor Car at the time of my inspection. The Motor Car was observed to be in a relatively good general condition with no loose exterior fittings observed. The body parts at the right side front portion of the Motor Car were visually examined and it was observed that the repair/restoration works carried out to the damaged area of the Motor Car (refer to photograph 1 - 3 above) were reasonably adequate and in order.

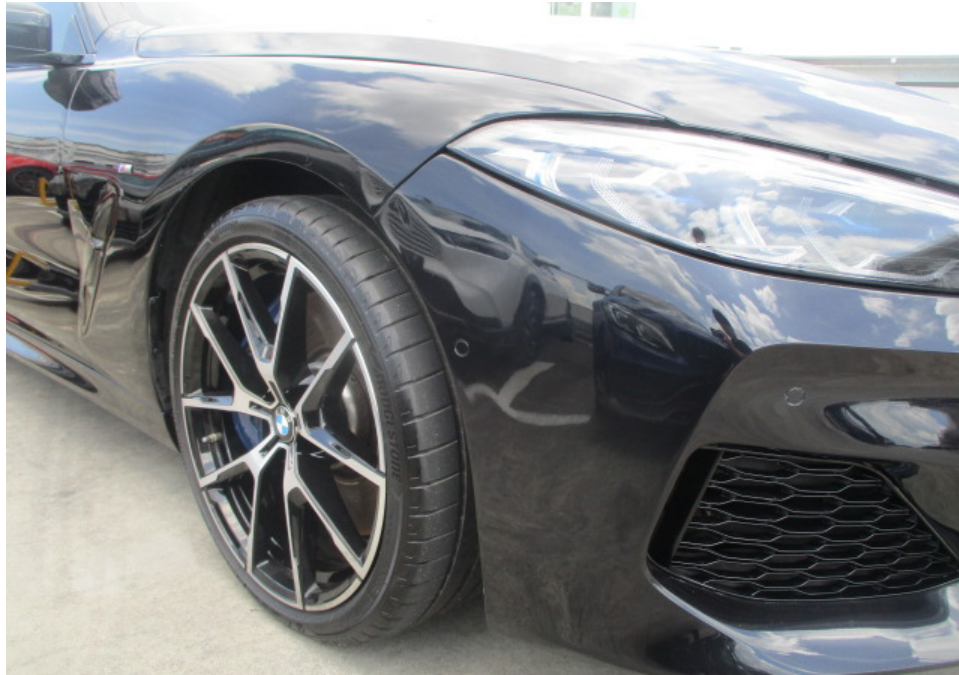
Photo 8 shows a closer view of the Motor Car's front bumper, front bonnet, front right fender, front right headlamp and front right wheel rim. The body parts at the right side front portion of the Motor Car were visually examined and it was observed that the repair/restoration works carried out to the damaged area of the Motor Car (refer to photograph 1 - 3 above) were reasonably adequate and in order.

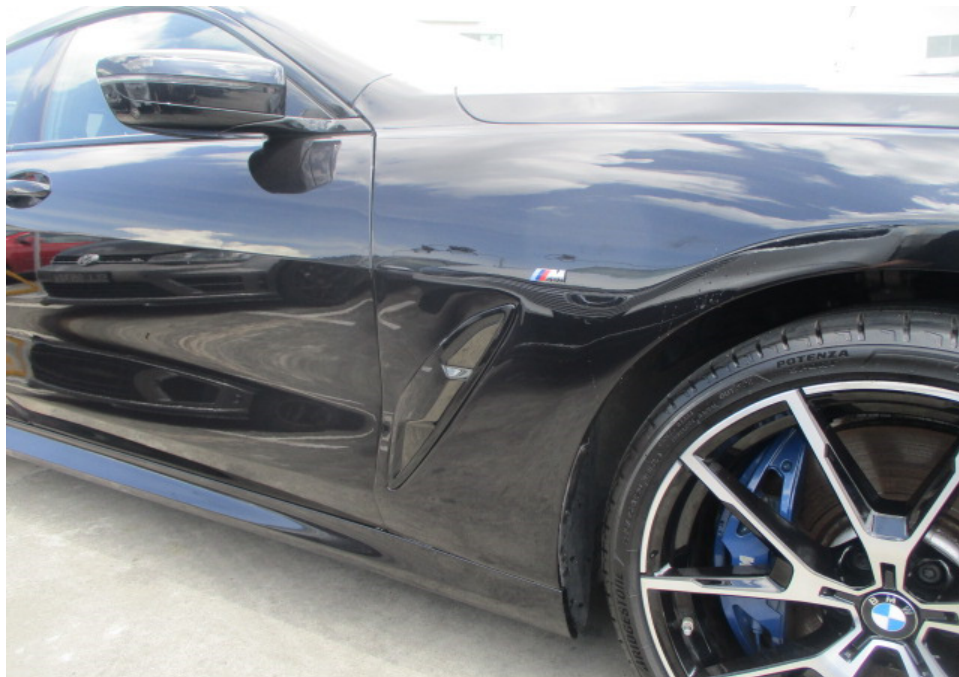
Photo 9 shows a closer view of the Motor Car's front right fender, front right door and right side rocker panel garnish. The body parts at the right side front portion of the Motor Car were visually examined and it was observed that the repair/restoration works carried out to the damaged area of the Motor Car (refer to photograph 1 - 3 above) were reasonably adequate and in order.

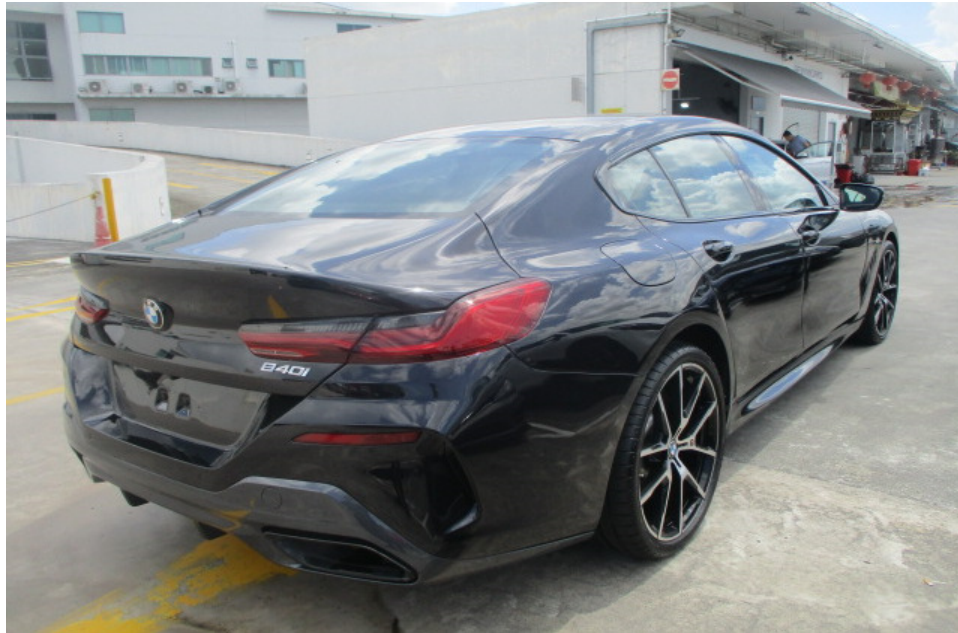
Photo 10 shows a general view of the rear right body of the Motor Car at the time of my inspection. The Motor Car was observed to be in a relatively good general condition with no loose exterior fittings observed. The body parts at the right side rear portion of the Motor Car were visually examined and it was observed that the repair/restoration works carried out to the damaged area of the Motor Car (refer to photograph 3 - 5 above) were reasonably adequate and in order.

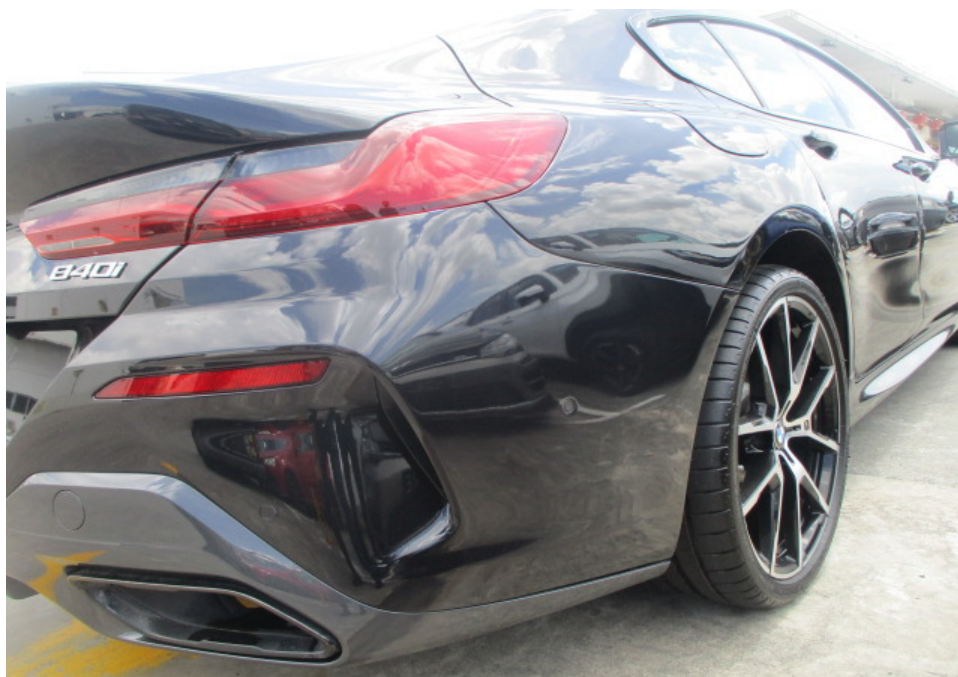
Photo 11 shows a closer view of the Motor Car's rear bumper, rear bumper lower cover and rear right taillamp. The body parts at the right side rear portion of the Motor Car were visually examined and it was observed that the repair/restoration works carried out to the damaged area of the Motor Car (refer to photograph 4 & 5 above) were reasonably adequate and in order.

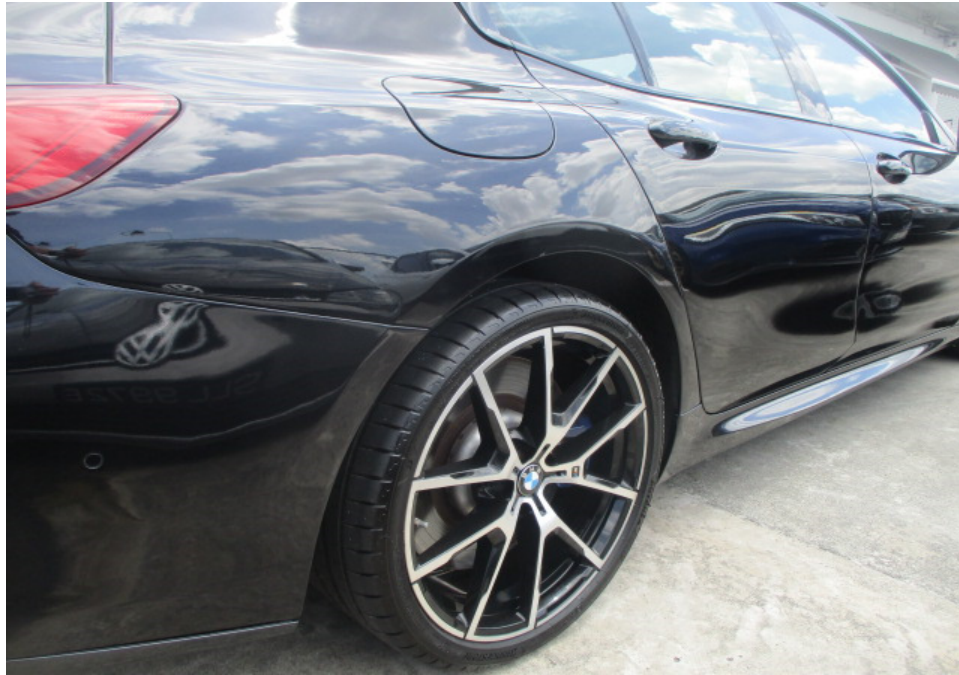
Photo 12 shows a closer view of the Motor Car's rear bumper, rear right taillamp, rear right fender and rear right wheel rim. The body parts at the right side rear portion of the Motor Car were visually examined and it was observed that the repair/restoration works carried out to the damaged area of the Motor Car (refer to photograph 4 & 5 above) were reasonably adequate and in order.

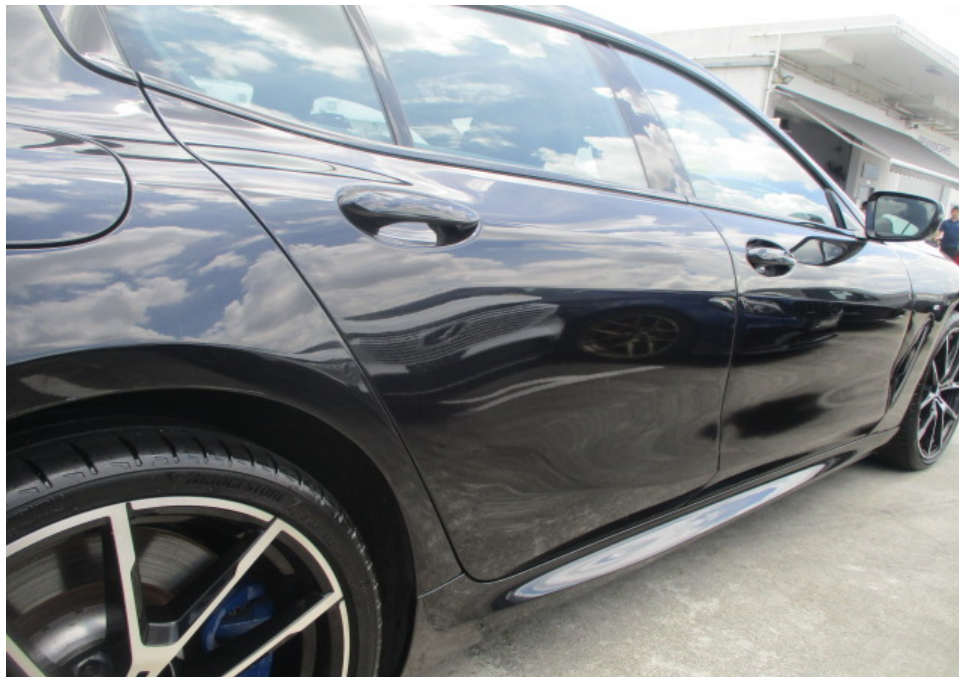
Photo 13 shows a closer view of the Motor Car's rear right fender, rear right door and right side rocker panel garnish. The body parts at the right side rear portion of the Motor Car were visually examined and it was observed that the repair/restoration works carried out to the damaged area of the Motor Car (refer to photograph 3 & 4 above) were reasonably adequate and in order.

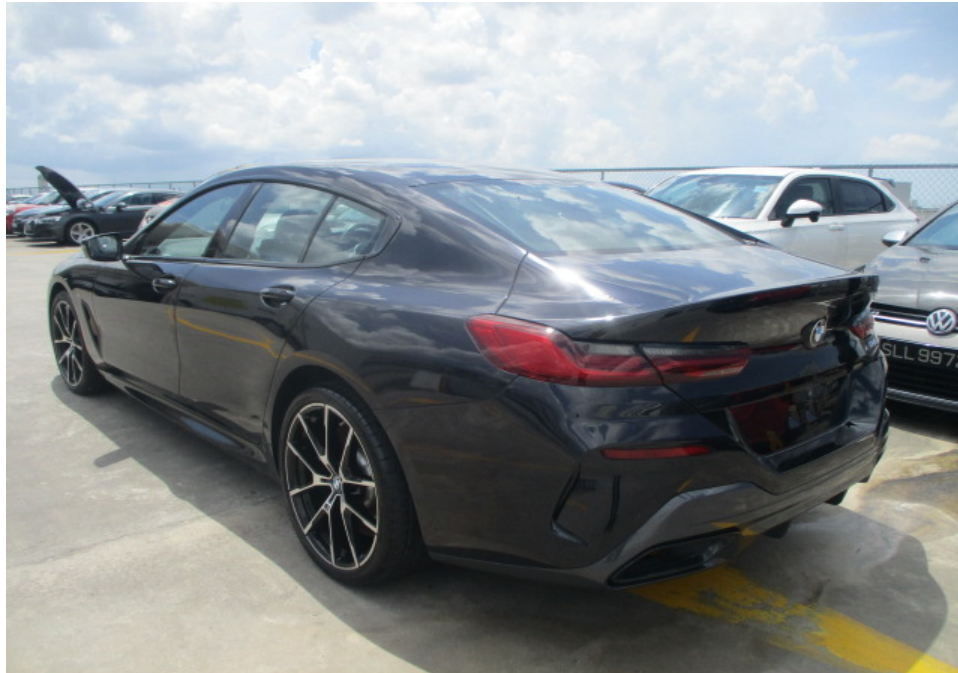
Photo 14 shows a general view of the rear left body of the Motor Car at the time of my inspection. The Motor Car was observed to be in a relatively good general condition with no loose exterior fittings observed. The mileage of the Motor Car recorded at the time of my inspection was 12,587km.

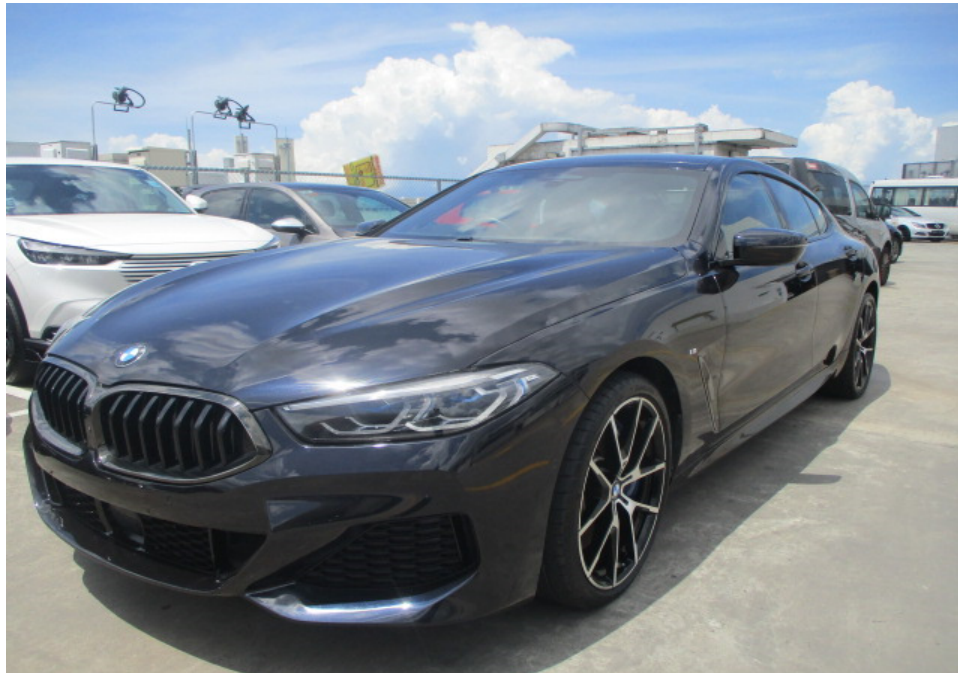
Photo 15 shows a general view of the front left body of the Motor Car at the time of my inspection. The Motor Car was observed to be in a relatively good general condition with no loose exterior fittings observed. The mileage of the Motor Car recorded at the time of my inspection was 12,587km.

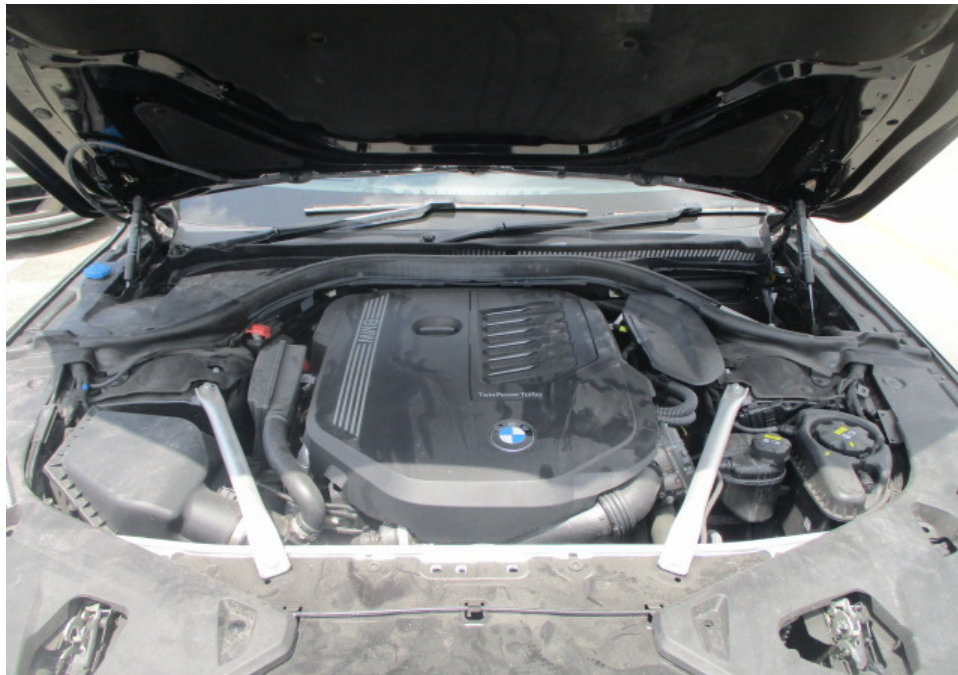
Photo 17 shows a general view of the engine compartment of the Motor Car at the time of my inspection. The various parts and components inside the engine compartment were all observed to be intact and properly fitted. There was also no sign(s) or indication(s) of fluid leak and/or fluid stain found inside the engine compartment.

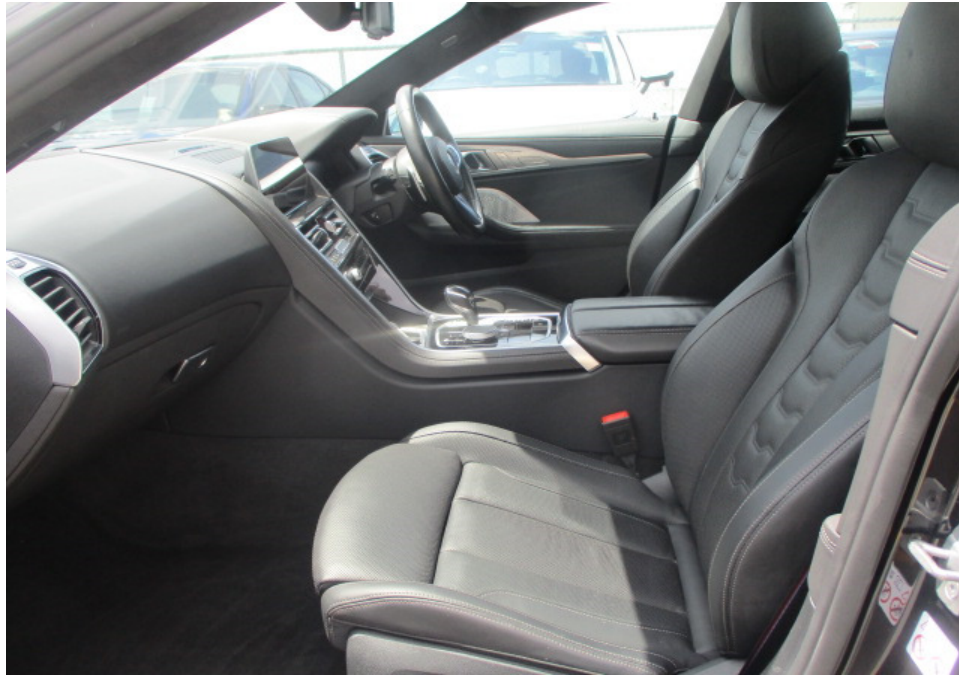
Photo 18 shows the interior compartment of the Motor Car at the time of my inspection. The various parts and components, trims, carpet, and upholstery inside the interior compartment were all observed to be intact and properly fitted.

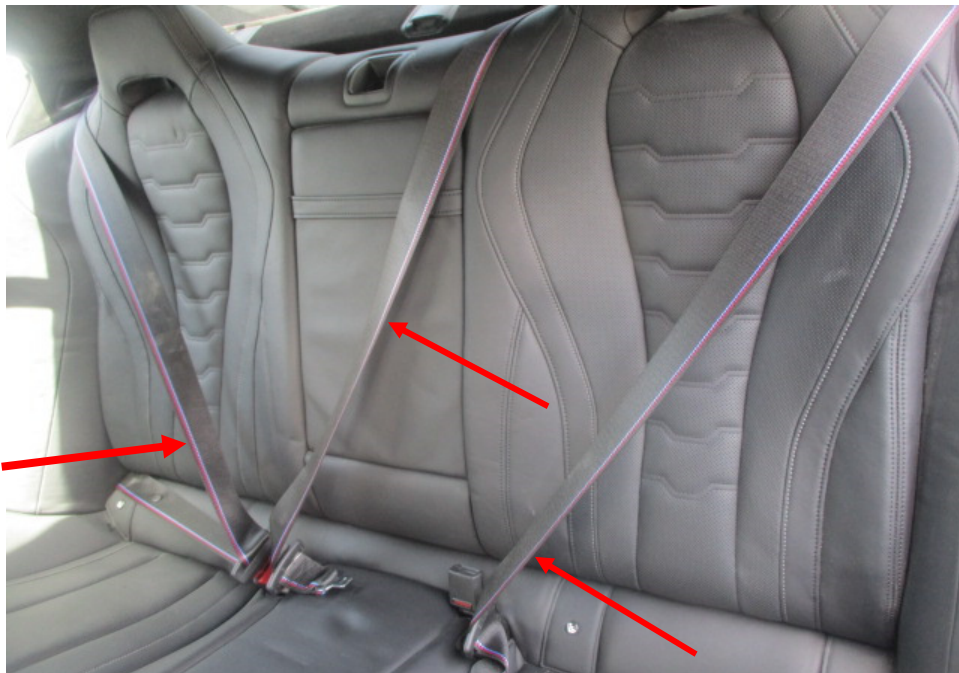
Photo 19 shows the rear seats of the Motor Car. All the seats of the Motor Car were secured via seat rails to the floorboard. They were also fitted with a retractable seat belt reel and a pre-tensioner. The seat belts (arrowed) were tested and were able to be fastened into the respective pre-tensions that were fitted on the side of each individual seat.

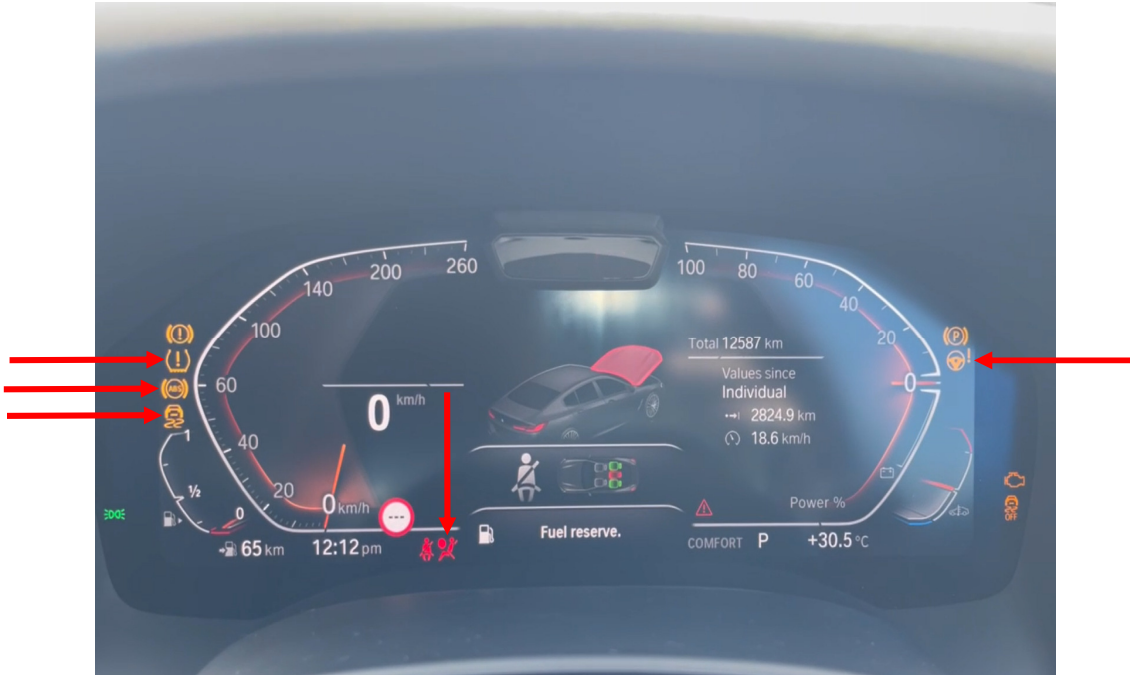
Photo 20 shows the warning lights for the various electronic safety features appearing on the instrument panel of the Motor Car during its self-test when the engine is cranked, in particular the ABS, SRS, IAS, TPM and DSC lights (arrowed).

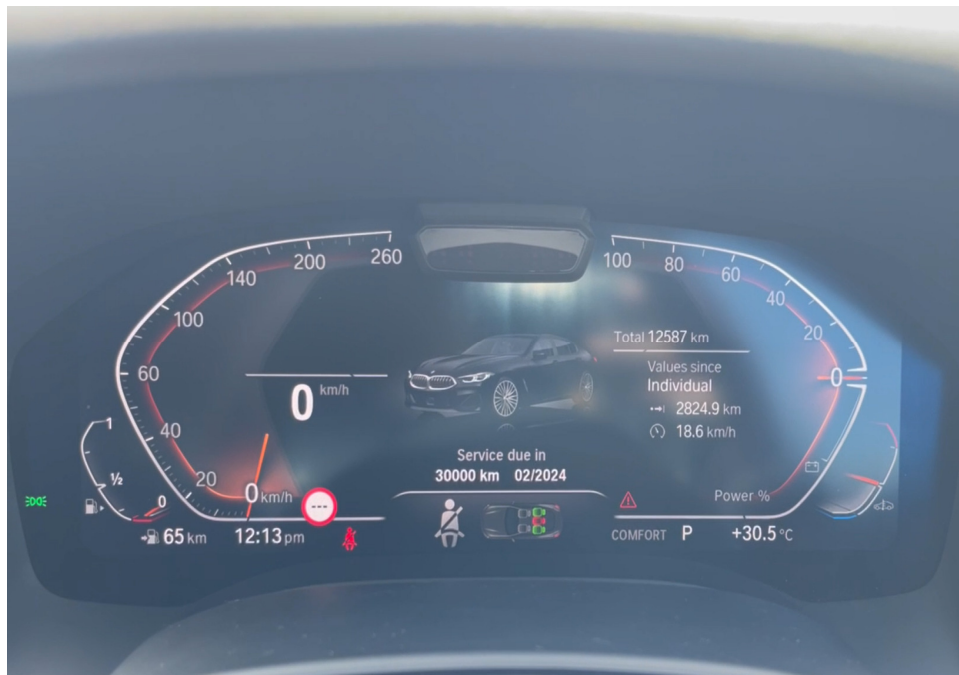
Photo 21 shows the respective warning lights no longer illuminated, indicating that there is no fault detected to the ABS, SRS, IAS, TPM and DSC systems of the Motor Car during the self-test. These electronic systems were hence in working condition at the time of my inspection.

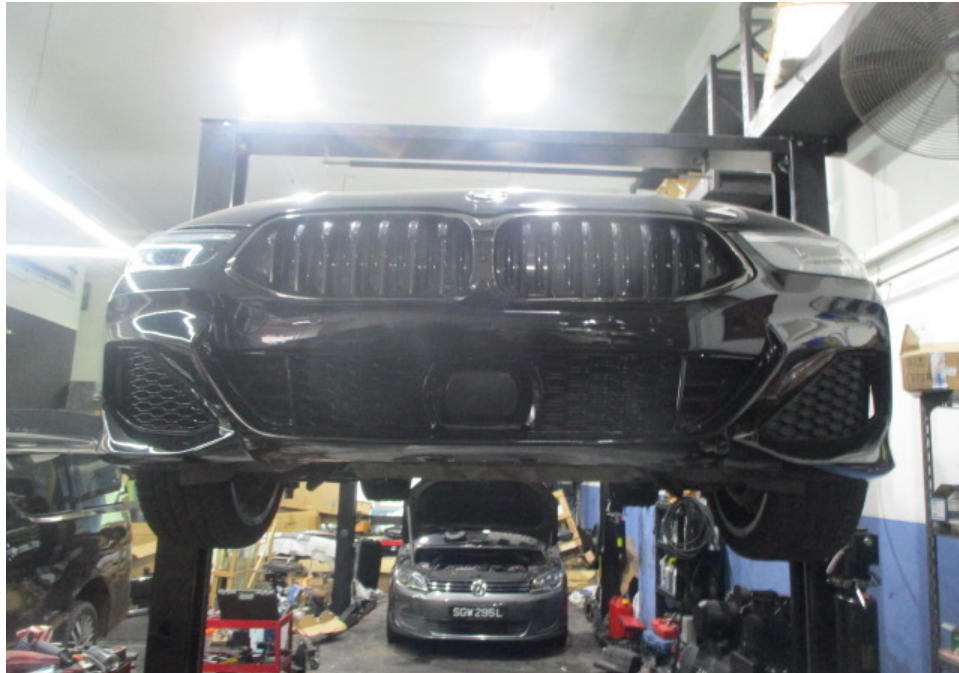
Photo 22 shows the Motor Car hoisted up for checks on its undercarriage. There was no sign(s) or indication(s) of fluid leakage and/or fluid stain(s) on the underside of the Motor Car. The undercarriage components of the Motor Car were also all observed to be intact and secured in an appropriate manner.

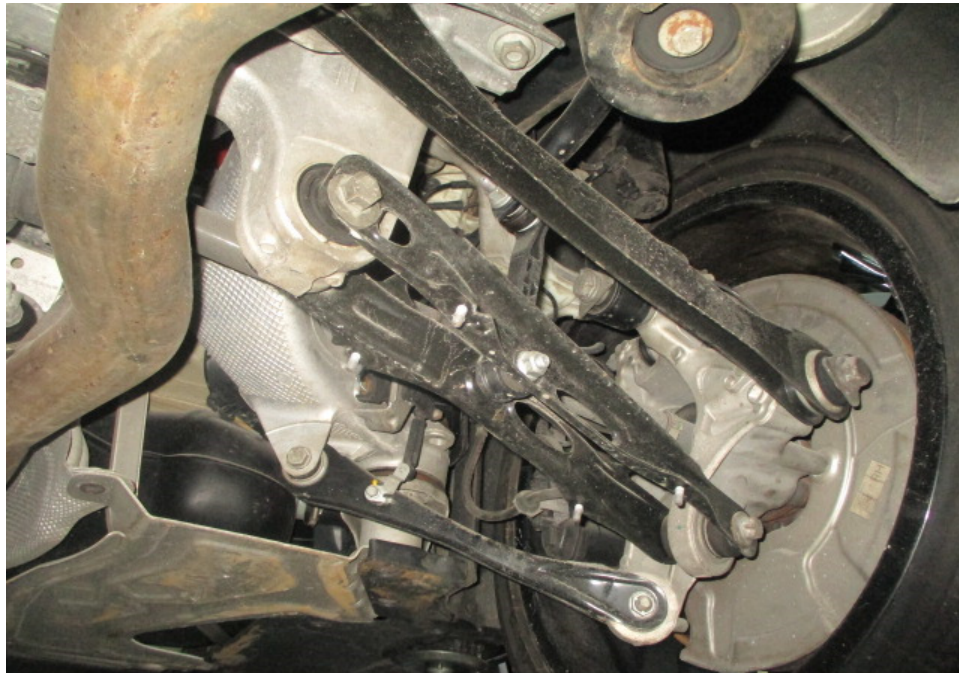
Photo 23 shows a general view of the control arms and linkages at the rear right wheel of the Motor Car. I did not observe any fluid leak and/or fluid stain on the underside of the Motor Car. All of the Motor Car's undercarriage components were observed to be intact and secured in an appropriate manner.

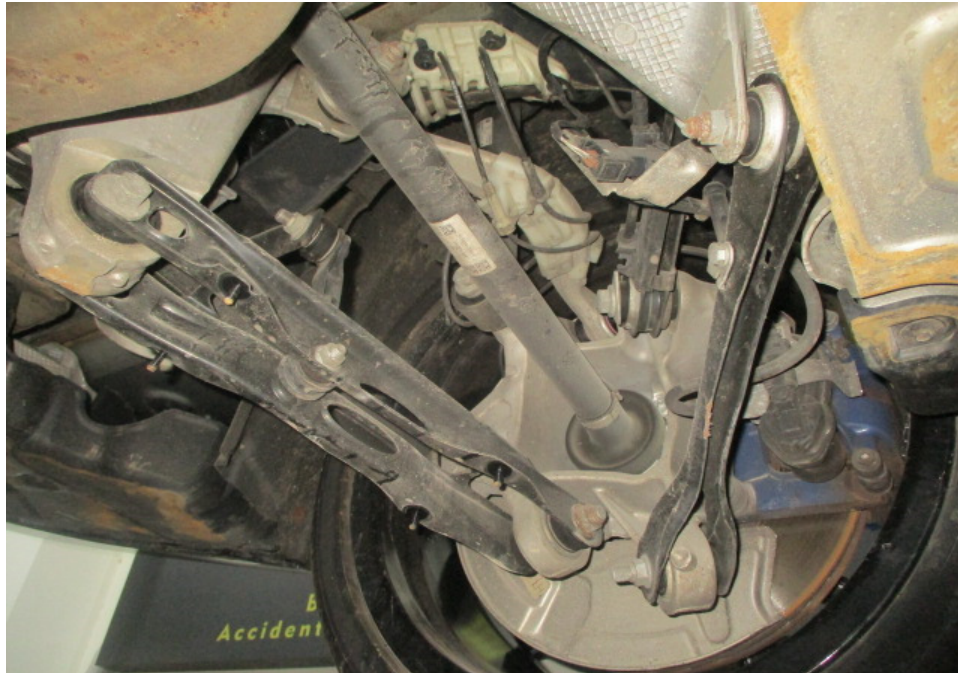
Photo 24 shows a general view of the control arms and linkages at the rear left wheel of the Motor Car. I did not observe any fluid leak and/or fluid stain on the underside of the Motor Car. All of the Motor Car's undercarriage components were observed to be intact and secured in an appropriate manner.

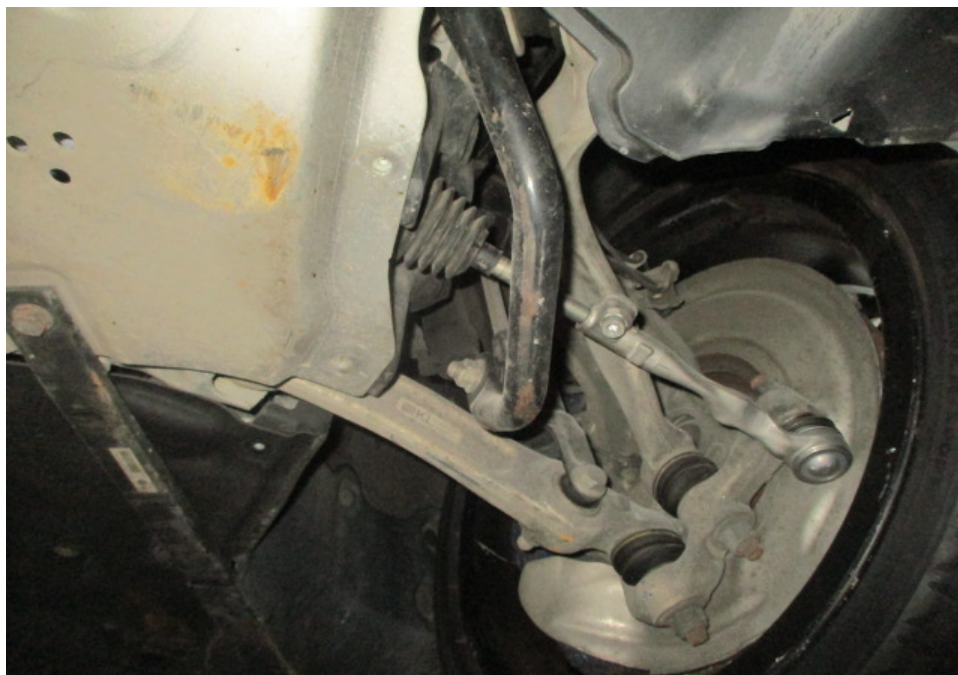
Photo 25 shows the various undercarriage components at the front left wheel of the Motor Car. The mechanical components, control arms and linkages were all found to be intact and secured in an appropriate manner.
