Your Ref: BMW 840i
(chassis number WBAGV22090CG58956)
Our Ref : CI/TP23004756/D

08 May 2023

**INSPECTION REPORT OF AN UNREGISTERED BMW 840i MOTOR CAR
WITH CHASSIS NUMBER WBAGV22090CG58956**

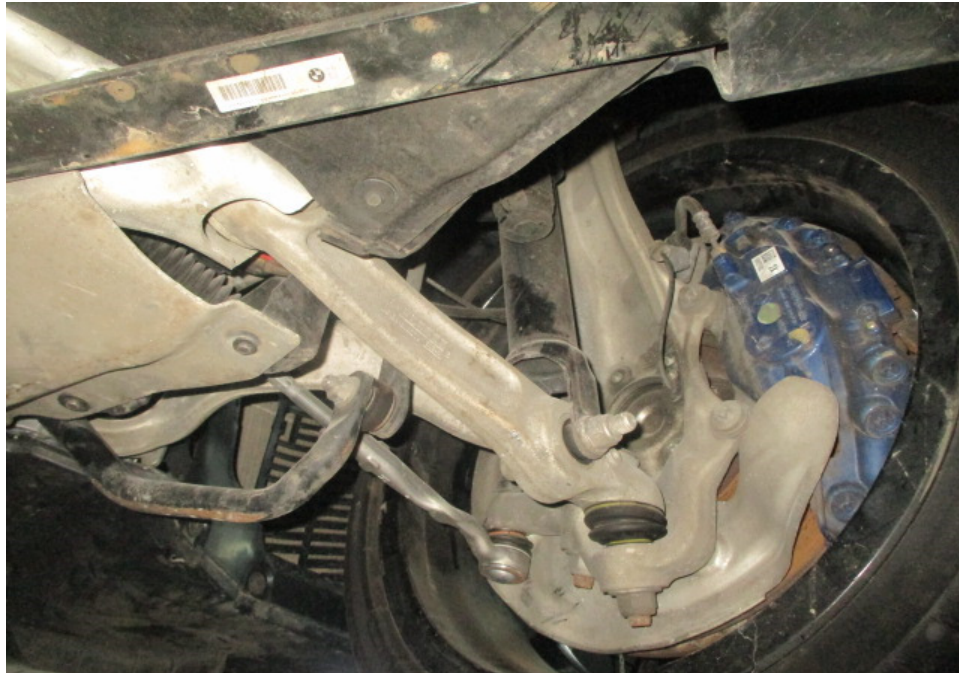
Photo 26 shows the various undercarriage components at the front right wheel of the Motor Car. The mechanical components, control arms and linkages were all found to be intact and secured in an appropriate manner. I also did not observe any fluid leak and/or fluid stain on the underside of the Motor Car.

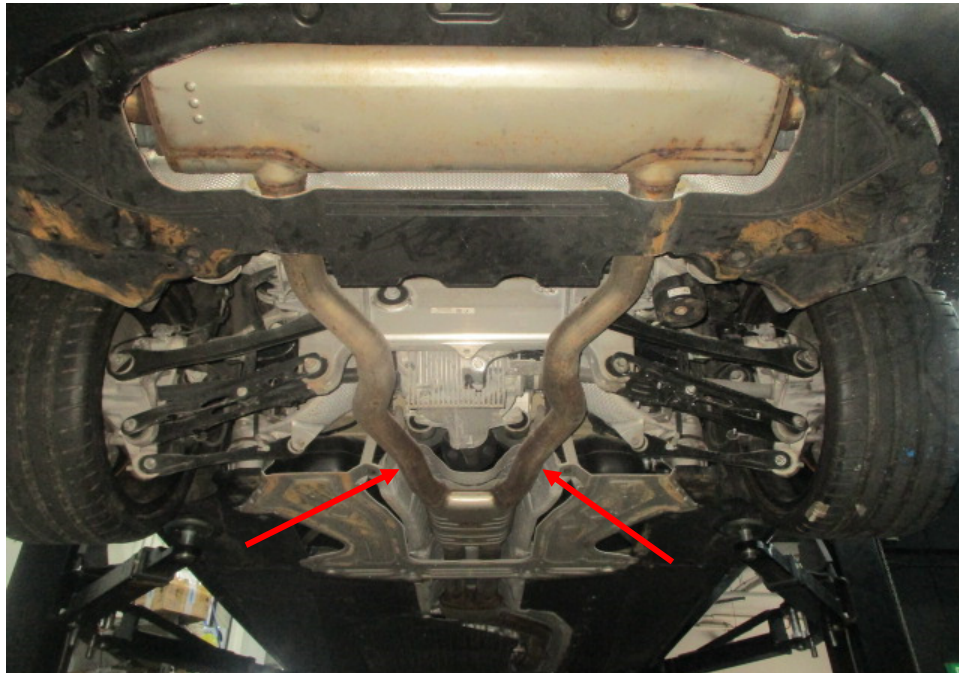
Photo 27 shows the rear section of the Motor Car's exhaust system. My examination of the Motor Car's exhaust system revealed no sign(s) or indication(s) of any cut or weld marks along its exhaust pipes (arrowed), on its rear muffler, on its centre resonator boxes and on its catalytic converter.

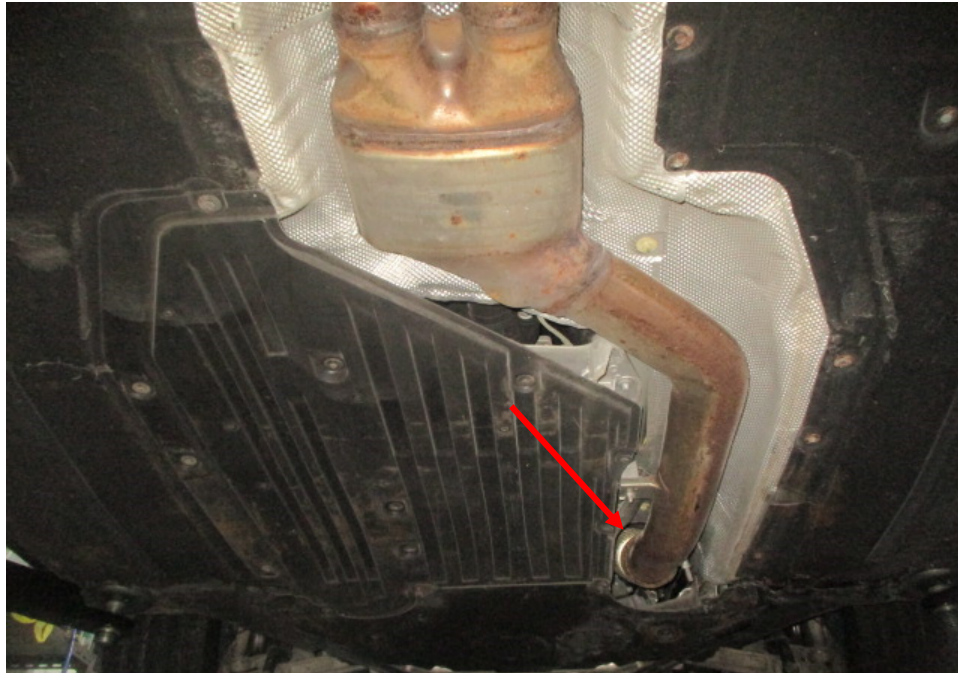
Photo 28 shows the front section of the Motor Car's exhaust system. My examination of the Motor Car's exhaust system revealed no sign(s) or indication(s) of any cut or weld marks along its exhaust pipes, on its rear muffler, on its centre resonator boxes and on its catalytic converter (arrowed).

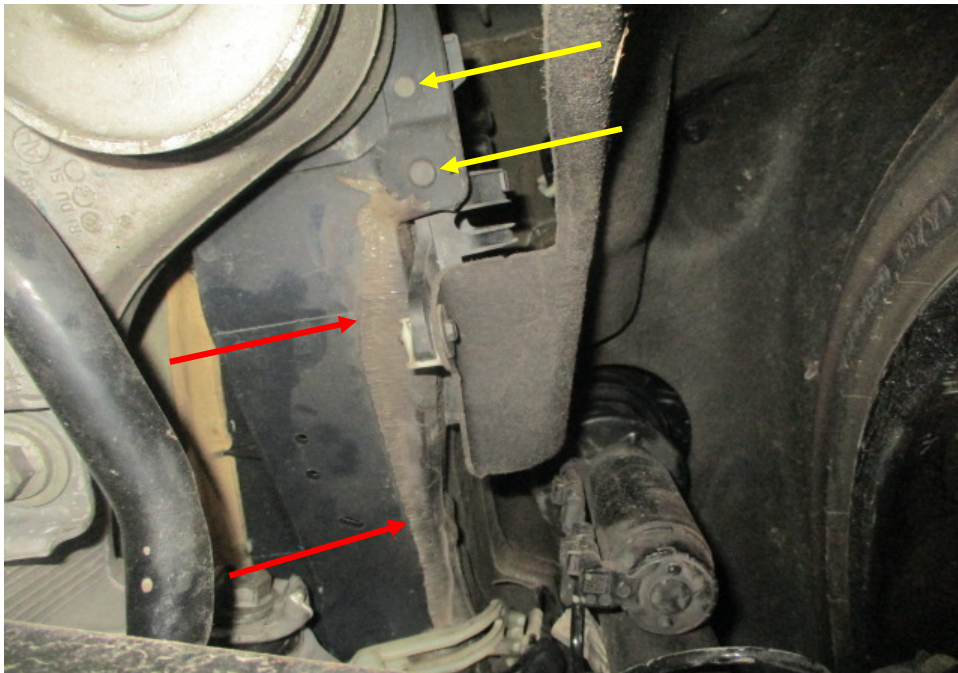
Photo 29 shows the chassis/structural body at the underside rear right of the Motor Car. I did not find any weld marks other than original spot weld marks (yellow arrow) on the chassis/structural body of the Motor Car. The original factory sealant (red arrow) at the joints along the chassis/structural body was untouched, indicating no work was done on the chassis/structural body of the Motor Car and that the chassis/structural body was originally fitted.

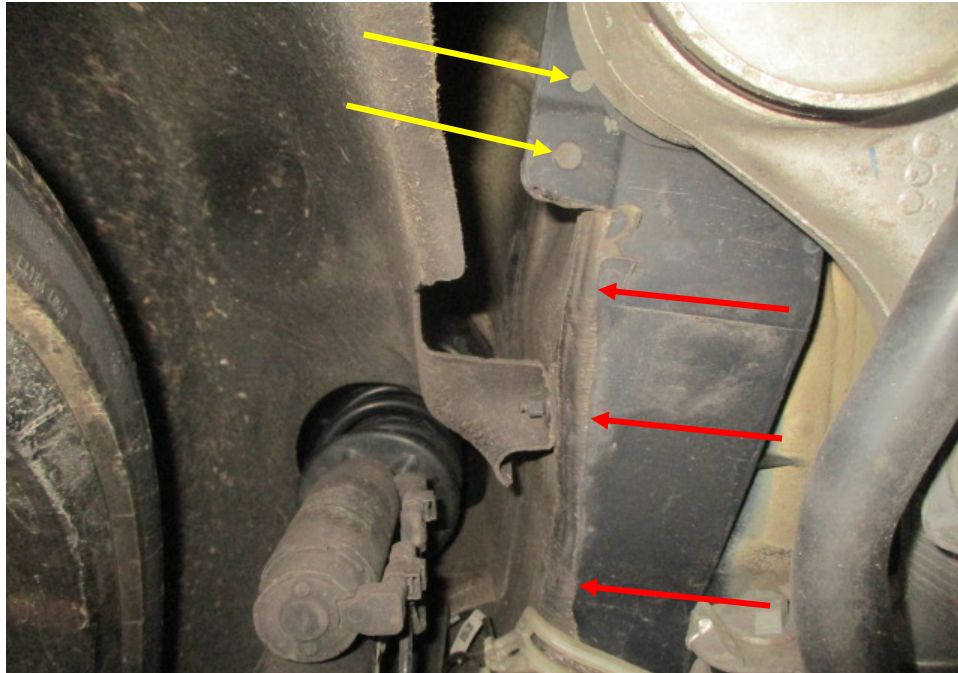
Photo 30 shows the chassis/structural body at the underside rear left of the Motor Car. I did not find any weld marks other than original spot weld marks (yellow arrow) on the chassis/structural body of the Motor Car. The original factory sealant (red arrow) at the joints along the chassis/structural body was untouched, indicating no work was done on the chassis/structural body of the Motor Car and that the chassis/structural body was originally fitted.

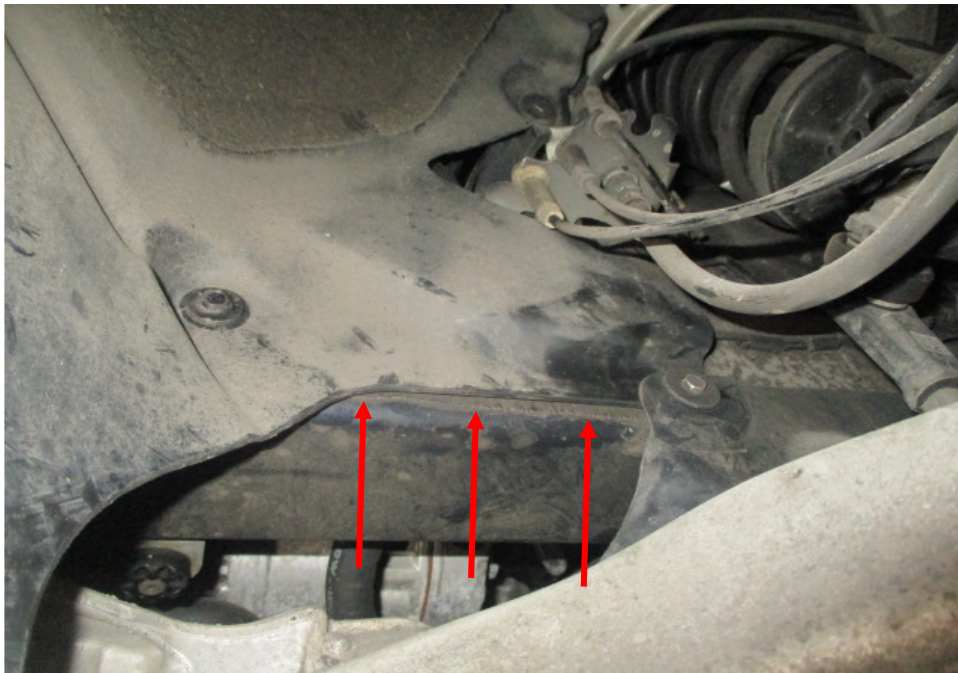
Photo 31 shows the chassis/structural body at the underside front left of the Motor Car. The original factory sealant (arrowed) at the joints along the chassis/structural body was observed to be untouched. In general, I had found no work was carried out on the chassis/structural body of the Motor Car. The chassis/structural body of the Motor Car was originally fitted.

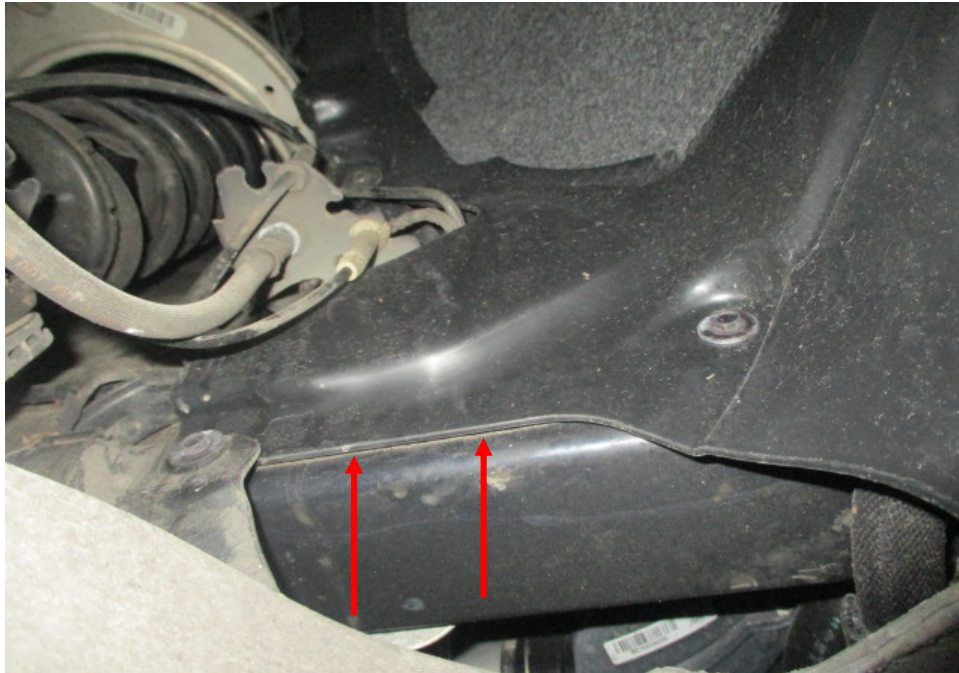
Photo 32 shows the chassis/structural body at the underside front right of the Motor Car. The original factory sealant (arrowed) at the joints along the chassis/structural body was observed to be untouched. In general, I had found no work was carried out on the chassis/structural body of the Motor Car. The chassis/structural body of the Motor Car was originally fitted.

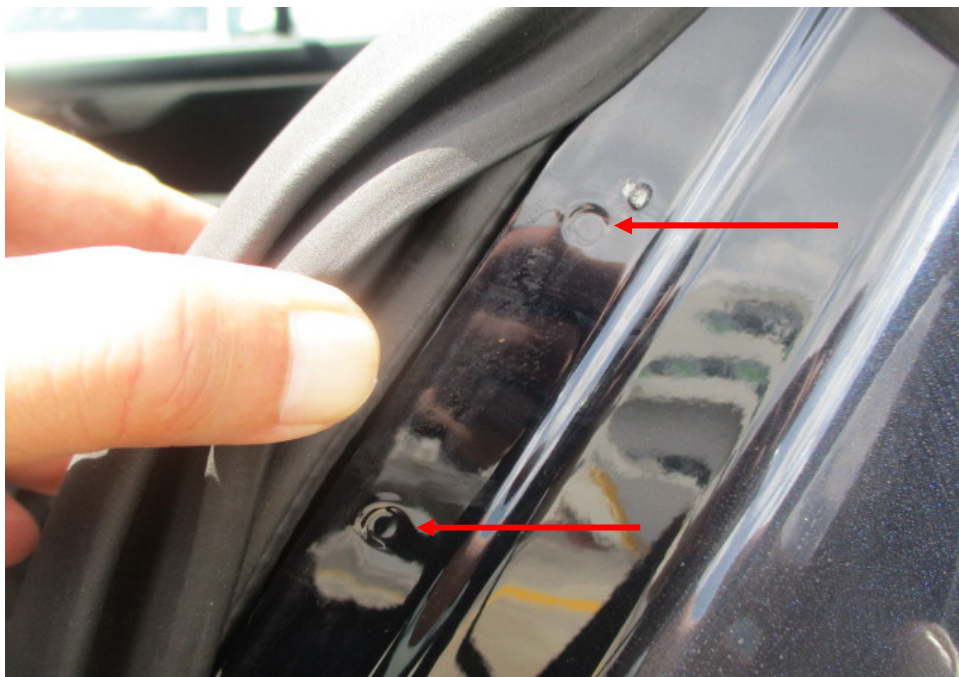
Photo 33 shows the left side "C" pillar of the Motor Car. I did not find any weld marks other than original spot weld marks (arrowed) on the left side "C" pillar of the Motor Car, which indicates that there was no re-welding works carried out. In general, I had found all the non-detachable body panels of the Motor Car to be originally fitted at the time of my inspection.

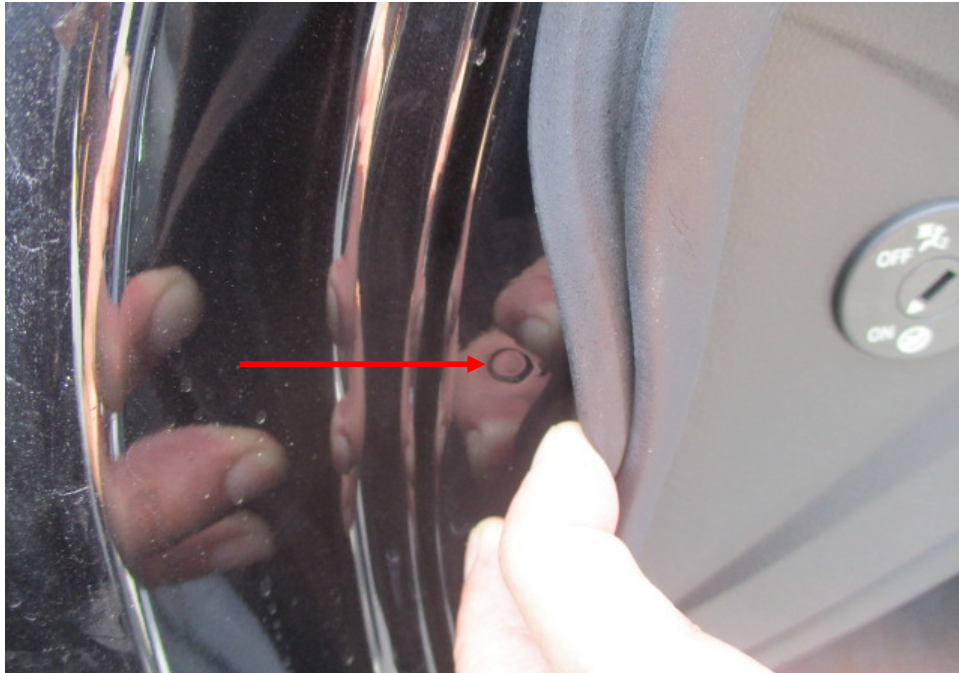
Photo 34 shows the left side "A" pillar of the Motor Car. I did not find any weld marks other than original spot weld marks (arrowed) on the left side "A" pillar of the Motor Car, which indicates that there was no re-welding works carried out. In general, I had found all the non-detachable body panels of the Motor Car to be originally fitted at the time of my inspection.

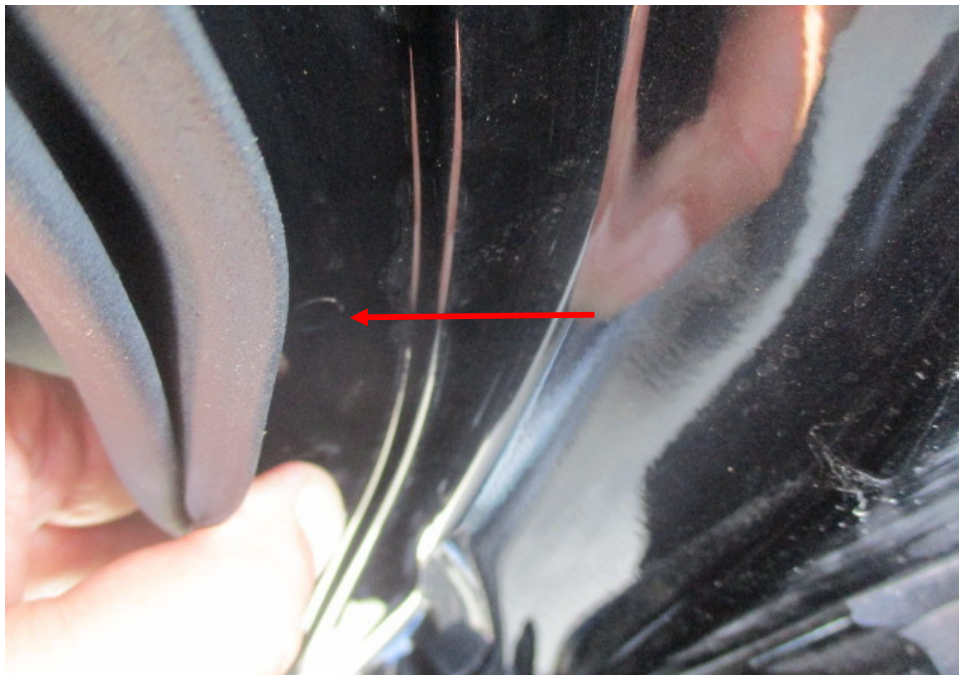
Photo 35 shows the right side "A" pillar of the Motor Car. I did not find any weld marks other than original spot weld marks (arrowed) on the right side "A" pillar of the Motor Car, which indicates that there was no re-welding works carried out. In general, I had found all the non-detachable body panels of the Motor Car to be originally fitted at the time of my inspection.

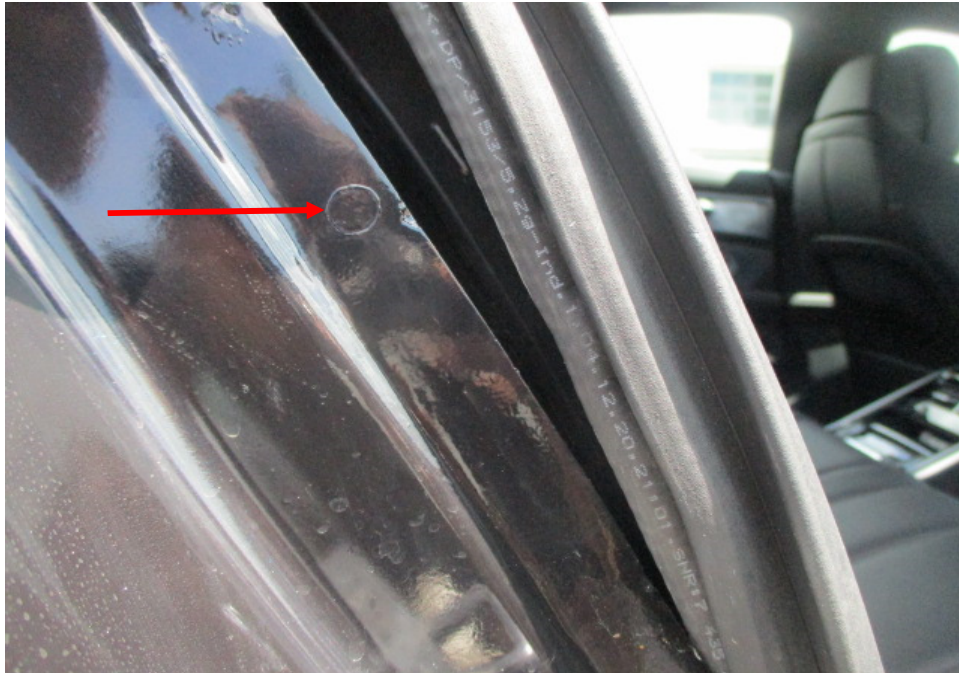
Photo 36 shows the right side "C" pillar of the Motor Car. I did not find any weld marks other than original spot weld marks (arrowed) on the right side "C" pillar of the Motor Car, which indicates that there was no re-welding works carried out. In general, I had found all the non-detachable body panels of the Motor Car to be originally fitted at the time of my inspection.
