Your Ref: SML 899G
Our Ref : CI/TP23004761/D

AUTOMOBILE INSPECTION REPORT OF MOTOR CAR SML 899G

Vehicle Registration No.	: SML 899G
Make / Model	: Suzuki Swift Sport CVT
Chassis No	: JSFZC32S00100307
Year of Registration	: 2012 (April)
Mileage	: 118,601km

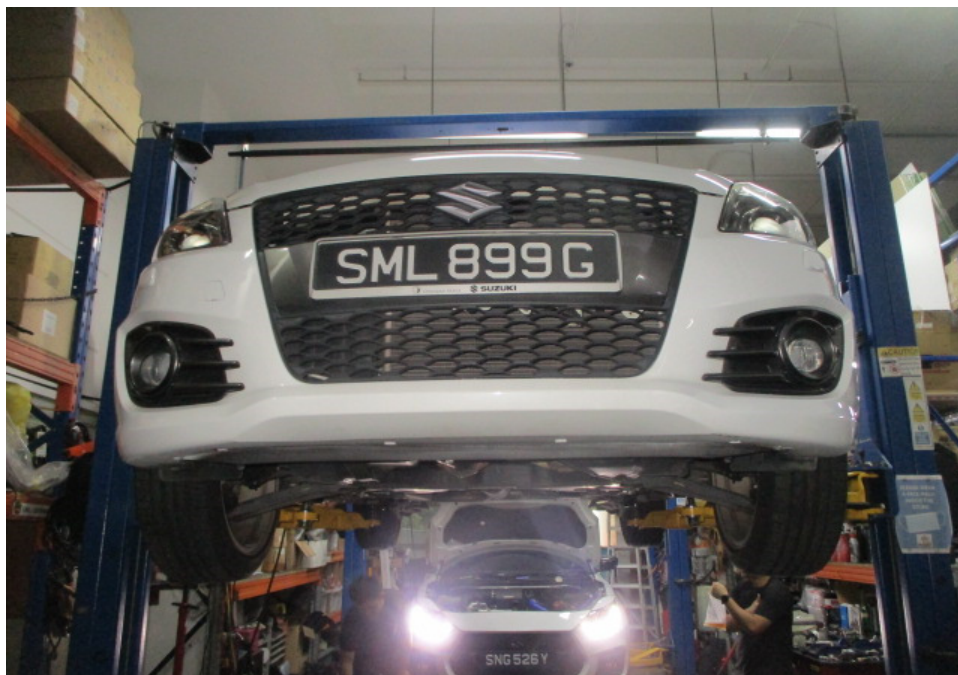
Photo 1 shows the Motor Car hoisted up for checks on its undercarriage, in particular to its transmission assembly.

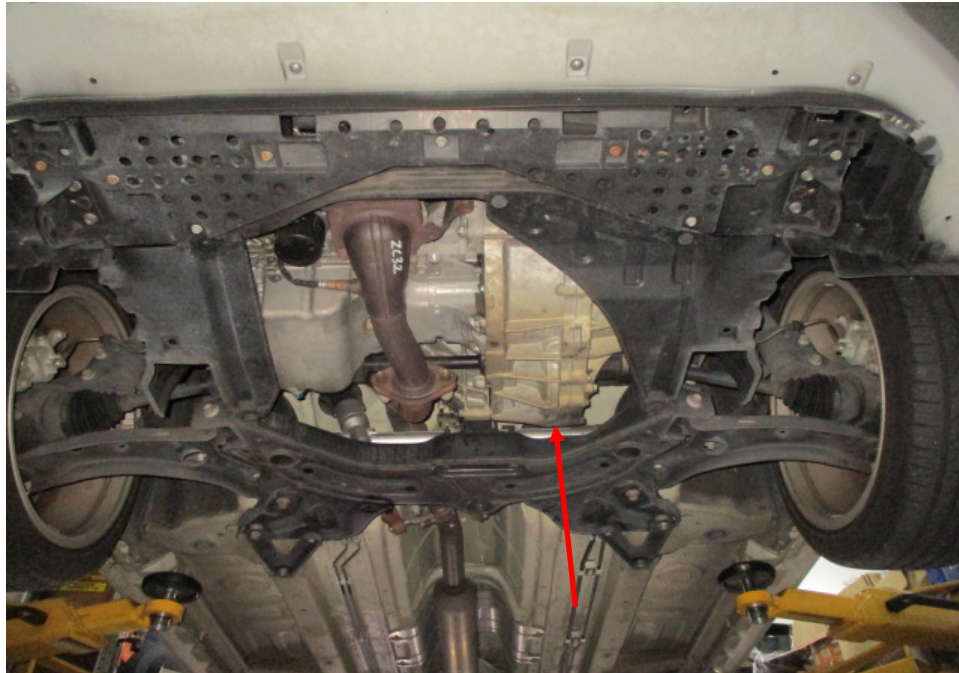
Photo 2 shows a general view of the transmission assembly (arrowed) that was fitted on the Motor Car. as viewed from the front to rear. The input side of the transmission assembly is bolted to the crankshaft side of the engine block. The left and right drive shafts were securely fitted from the main shaft, located inside the transmission assembly, to the front left wheel and front right wheel respectively. There was no crack and/or hole observed on the housing of the transmission assembly.

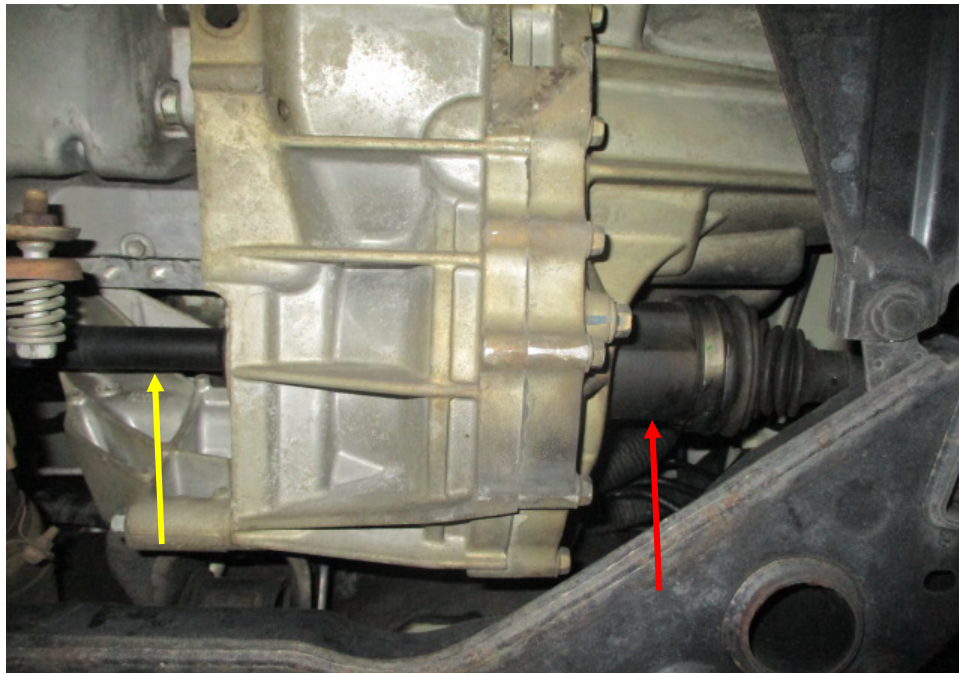
Photo 3 shows the left drive shaft (red arrow) and right drive shaft (yellow arrow) of the Motor Car. The left and right drive shafts were observed to be securely fitted from the main shaft, located inside the transmission assembly, to the Motor Car's front left wheel and front right wheel respectively.

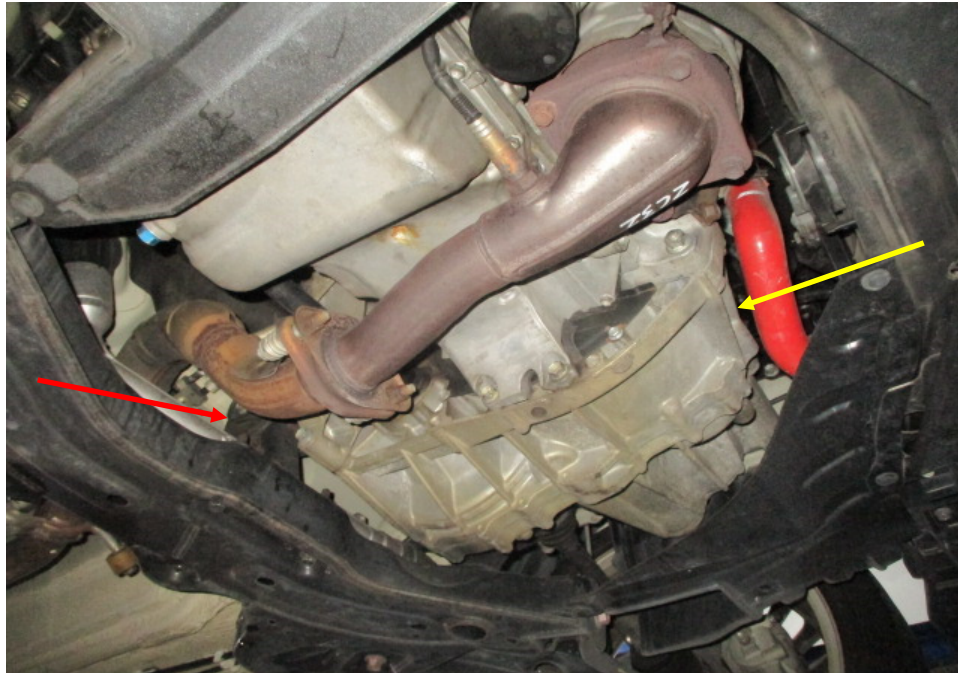
Photo 4 shows another view of the transmission assembly (yellow arrow) that was fitted on the Motor Car, as viewed from the right to left. The transmission assembly of the Motor Car was supported by 2 brackets. One bracket (red arrow) was at the rear of the transmission assembly while the other was at the left side of the transmission assembly (refer to photograph 7 & 8 below).

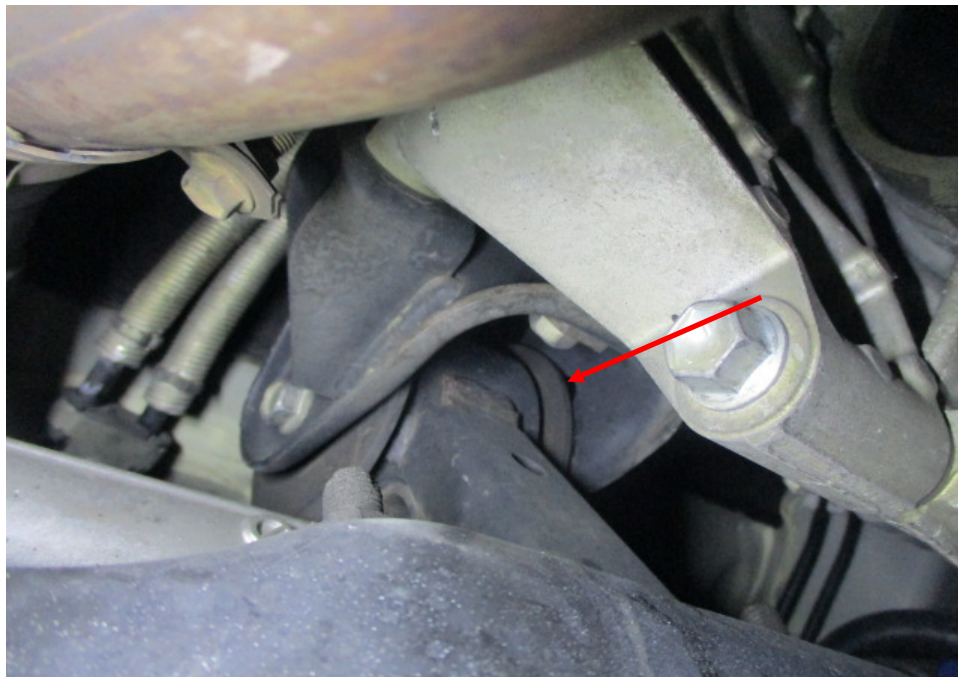
Photo 5 shows the bracket supporting the rear of the Motor Car's transmission assembly. This bracket was mounted onto the engine cross member. The bracket was with rubber bushings (arrowed) that absorbs any vibrations arising from the rotation of the transmission gears, minimising any stress to the bracket and correspondingly also minimise any stress to the engine crossmember.

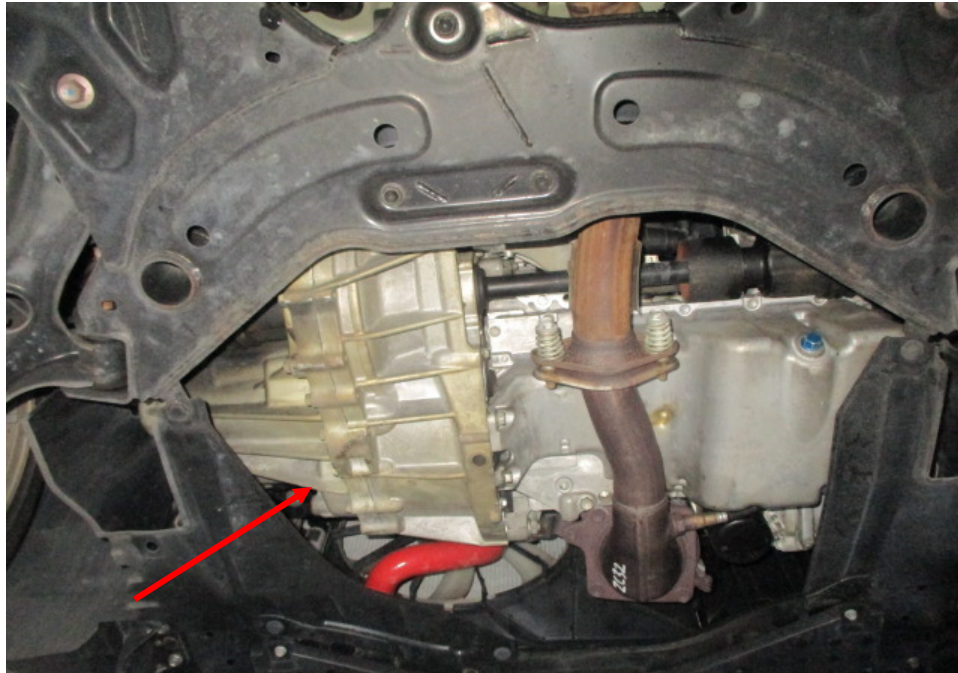
Photo 6 shows the transmission assembly (arrowed) that was fitted on the Motor Car, as viewed from the rear to front. The transmission assembly of the Motor Car was supported by 2 brackets. One bracket was at the rear of the transmission assembly (refer to photograph 4 & 5 above) while the other was at the left side of the transmission assembly (refer to photograph 7 & 8 below).

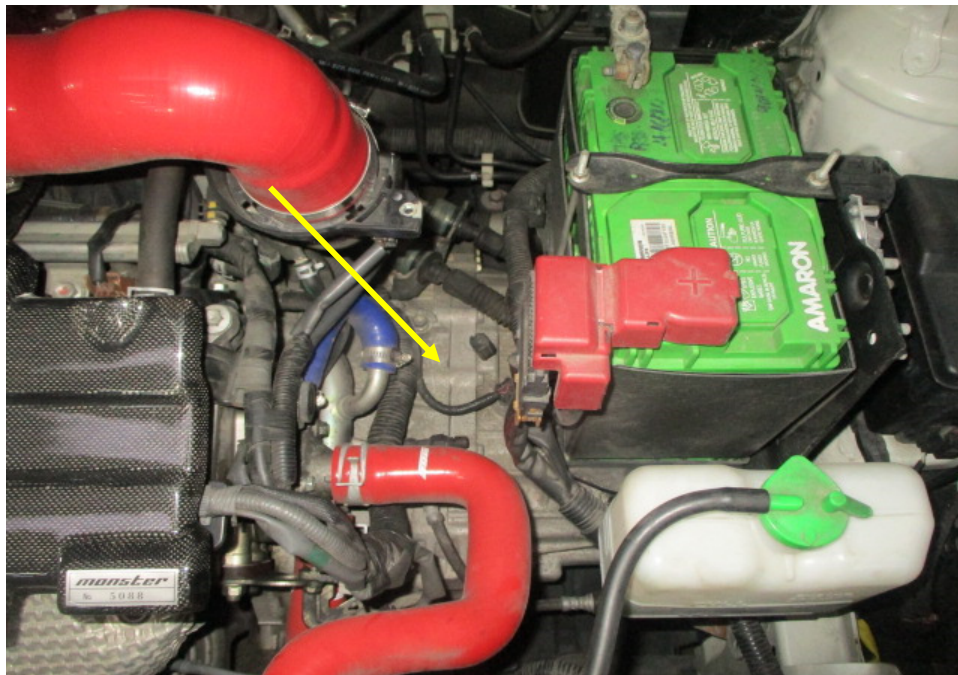
Photo 7 shows the Motor Car's transmission assembly (arrowed) as viewed from the engine compartment. The bracket supporting the left side of the Motor Car's transmission assembly is located below the battery (hidden from view). This bracket was mounted onto the left side front chassis, adjacent to the left side front wheel house of the Motor Car.

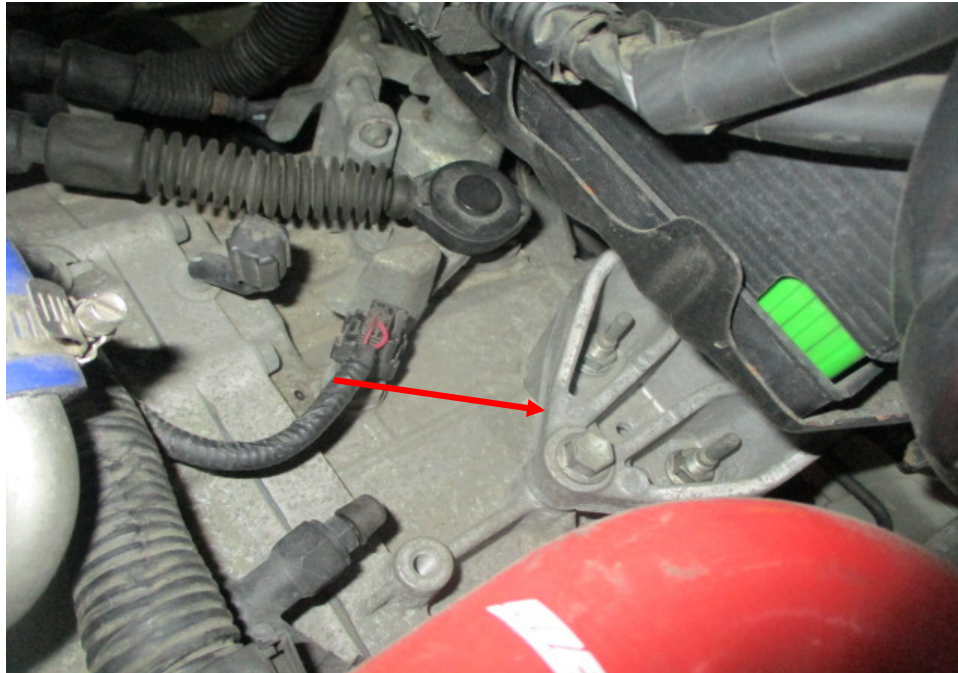
Photo 8 shows the bracket supporting the left side of the Motor Car's transmission assembly. This bracket was mounted onto the left side front chassis, adjacent to the left side front wheel house of the Motor Car. The bracket was with rubber bushings that absorbs any vibrations arising from the rotation of the transmission gears, minimising any stress to the bracket and correspondingly also minimise any stress to the engine crossmember.

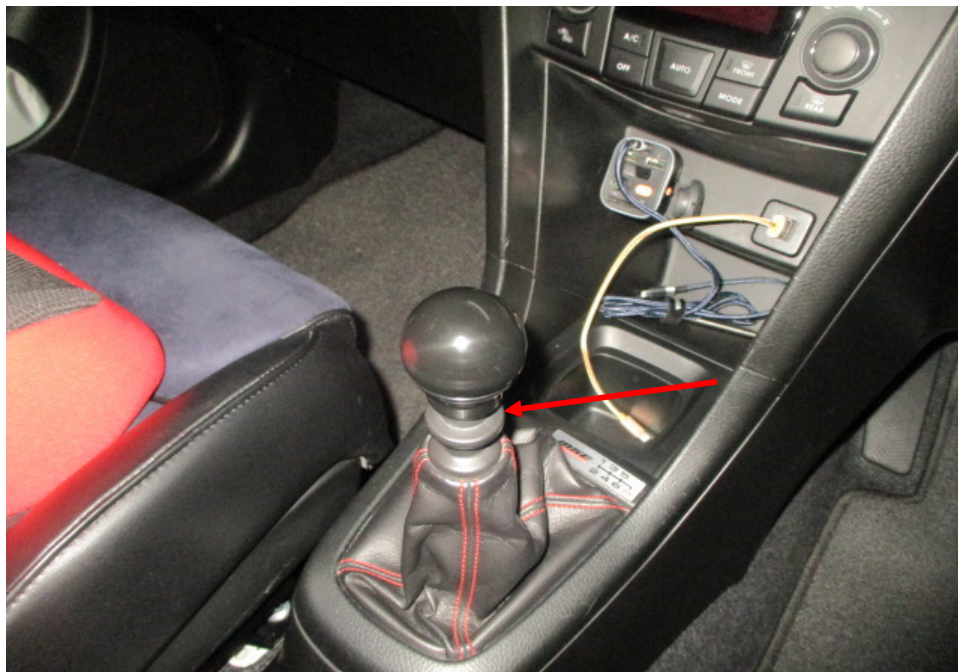
Photo 9 shows the Motor Car's manual gear shifter (arrowed) for manually selecting the transmission gear to be engaged.

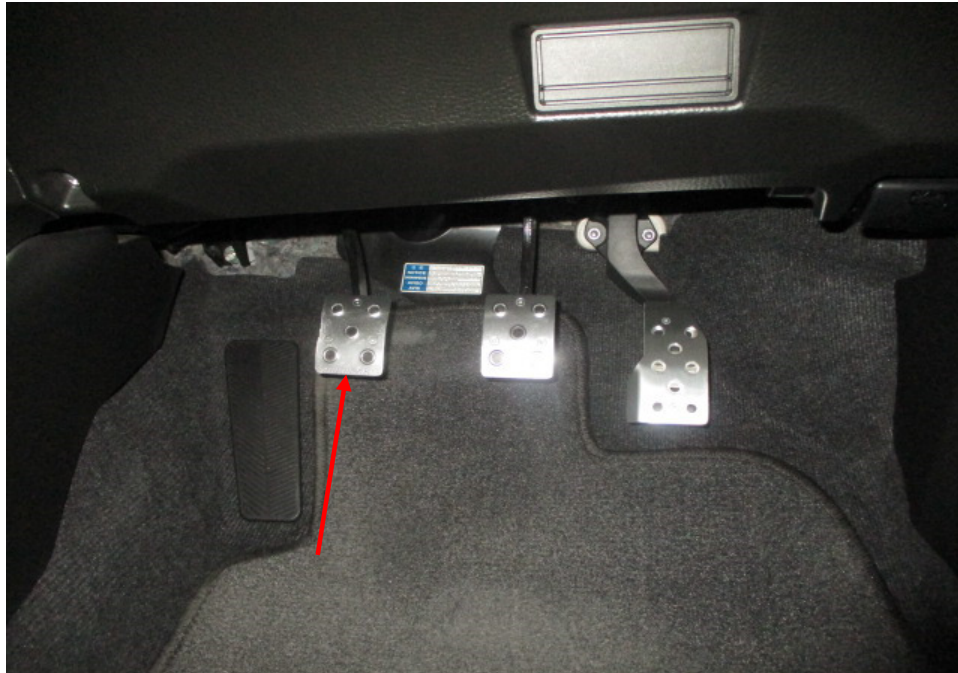
Photo 10 shows the Motor Car's clutch pedal (arrowed) for engaging and disengaging the transmission gears.
