Your Ref: Porsche Taycan
(chassis number WP0ZZZY1ZMSA04583)
Our Ref : CI/TP23004856/D

INSPECTION REPORT OF AN UNREGISTERED PORSCHE TAYCAN MOTOR CAR WITH CHASSIS NUMBER WP0ZZZY1ZMSA04583

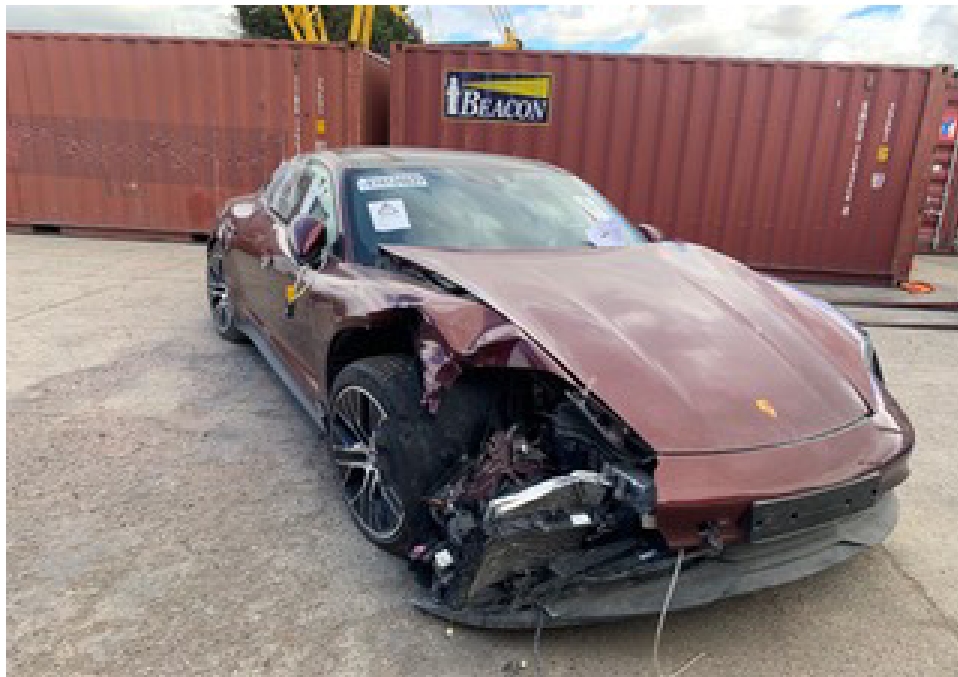
3. The photographs provided to me had showed damage to the right side front portion and right side rear portion of the Motor Car. Body parts damaged at the right side front portion include the front bumper, front bumper lower lip, front bumper right air guide, front bumper right lower grille, front bumper right sensor, front bumper right bracket, front bonnet, front bonnet right hinge, front right headlamp, front right signal lamp, front right fender, front right fender inner shield, front right aircon condenser, front right bracket and front support panel amongst others.

Photo 1 shows the front right body of the Motor Car (photograph provided to me). The Motor Car was observed to have sustained damage at its right side front portion. The front bumper, front bumper lower lip, front bumper right air guide, front bumper right lower grille, front bumper right sensor, front bumper right bracket, front bonnet, front bonnet right hinge, front right headlamp, front right signal lamp, front right fender, front right fender inner shield, front right aircon condenser, front right bracket and front support panel were amongst the body parts that were observed to have been damaged.

25. The body parts at the right side front portion, right side rear portion as well as the undercarriage parts at the front right wheel and undercarriage parts at the rear right wheel of the Motor Car were all visually examined and it was noted that the repair/restoration works carried out to the damaged area of the Motor Car (refer to photograph 1, 2, 4 & 5 above) were reasonably adequate and in order.

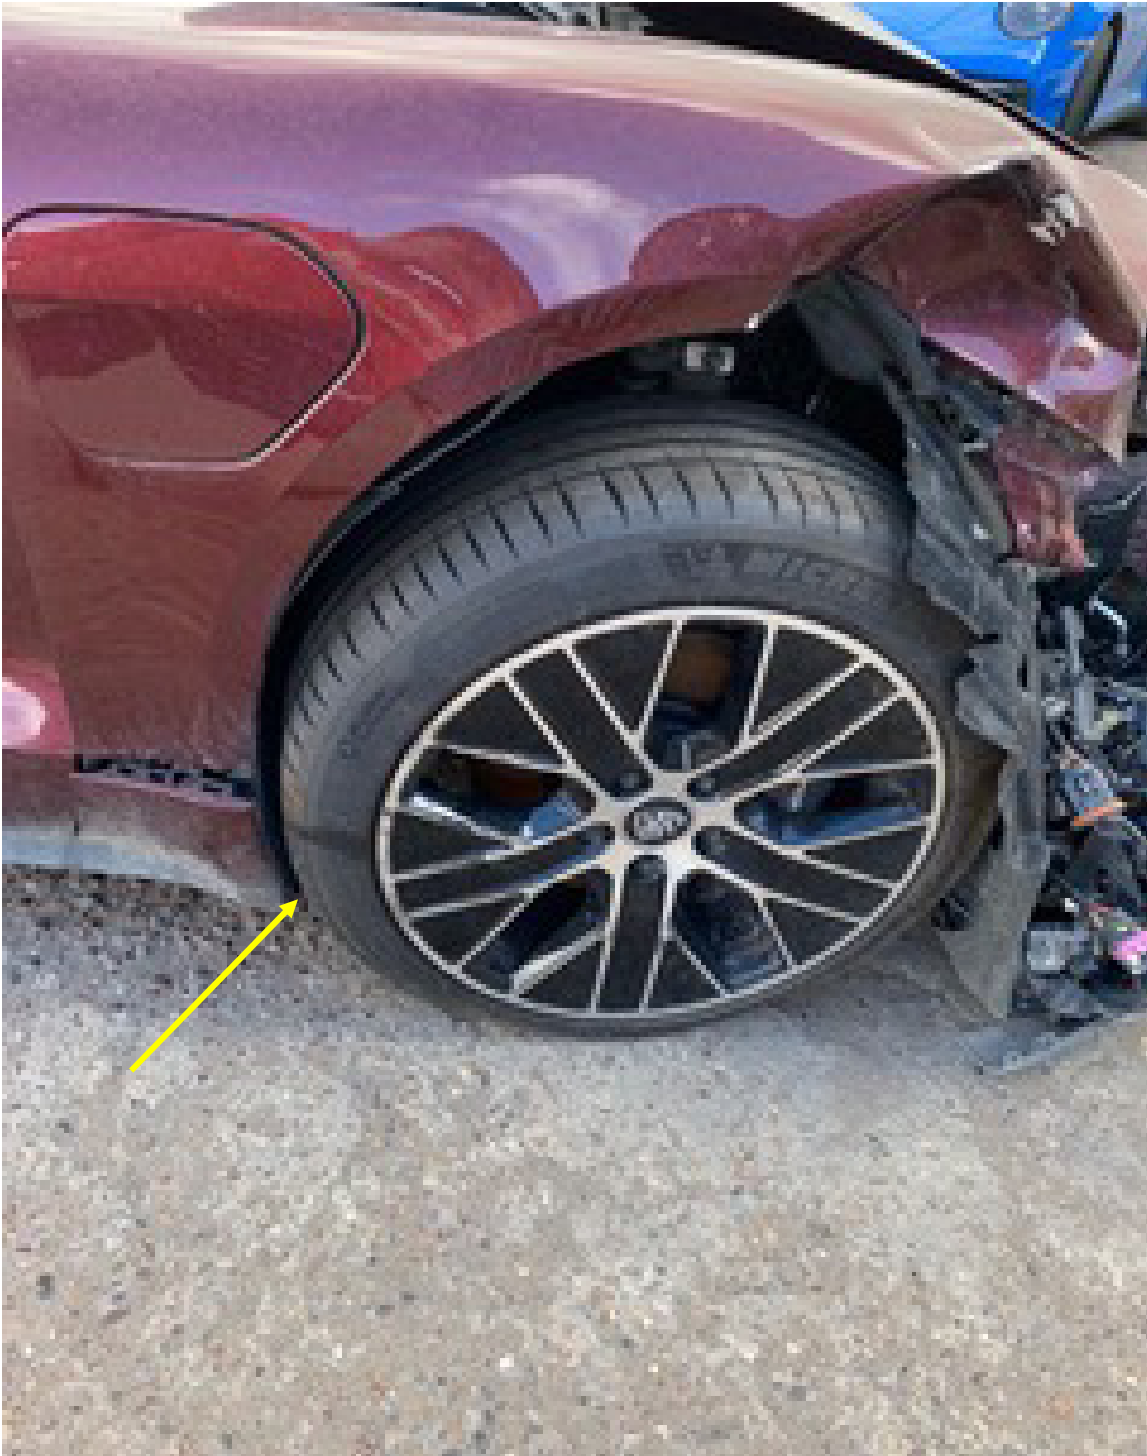
4. The Motor Car's front right wheel was also observed to be shifted backwards, which suggest damage to the undercarriage parts at the front right wheel of the Motor Car. Undercarriage parts that may possibly be damaged include the front right lower arm, front right knuckle arm, front right steering tie rod end and front right shock absorber amongst others.

Photo 2 shows another view of the damage at the right side front portion of the Motor Car (photograph provided to me). The front bumper, front bumper right bracket, front right headlamp, front right signal lamp, front right fender and front right fender inner shield were amongst the body parts that were observed to have been damaged. The Motor Car's front right wheel (arrowed) was also observed to be shifted backwards, which suggest damage to the undercarriage parts at the front right wheel of the Motor Car. Undercarriage parts that may possibly be damaged include the front right lower arm, front right knuckle arm, front right steering tie rod end and front right shock absorber amongst others.

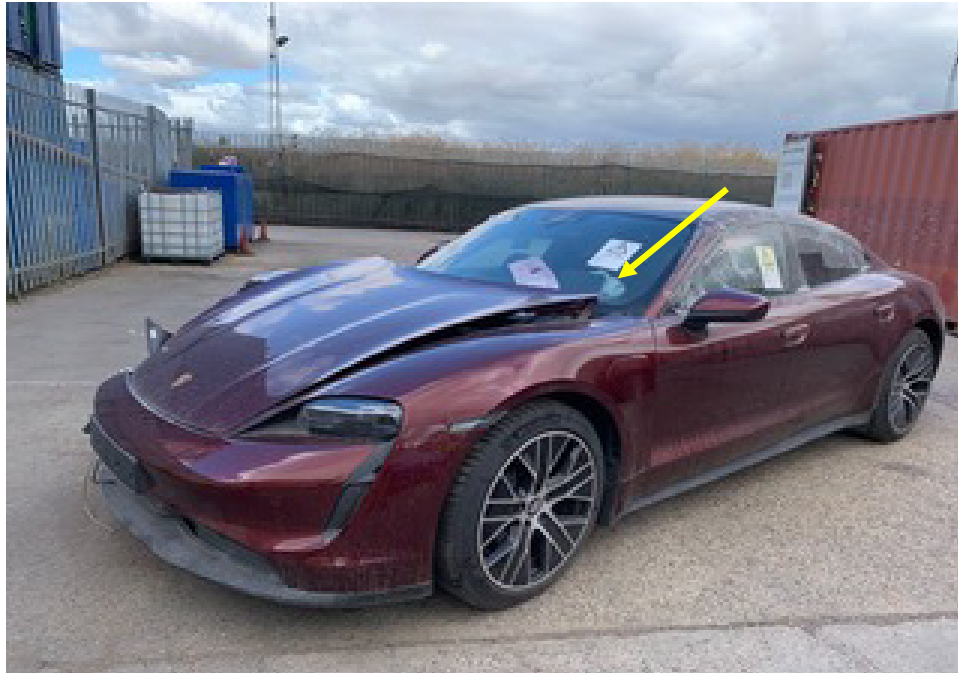
Photo 3 shows the front left body of the Motor Car (photograph provided to me). The left side portion of the Motor Car was observed to be unaffected. The front left passenger airbag was deployed (arrowed).

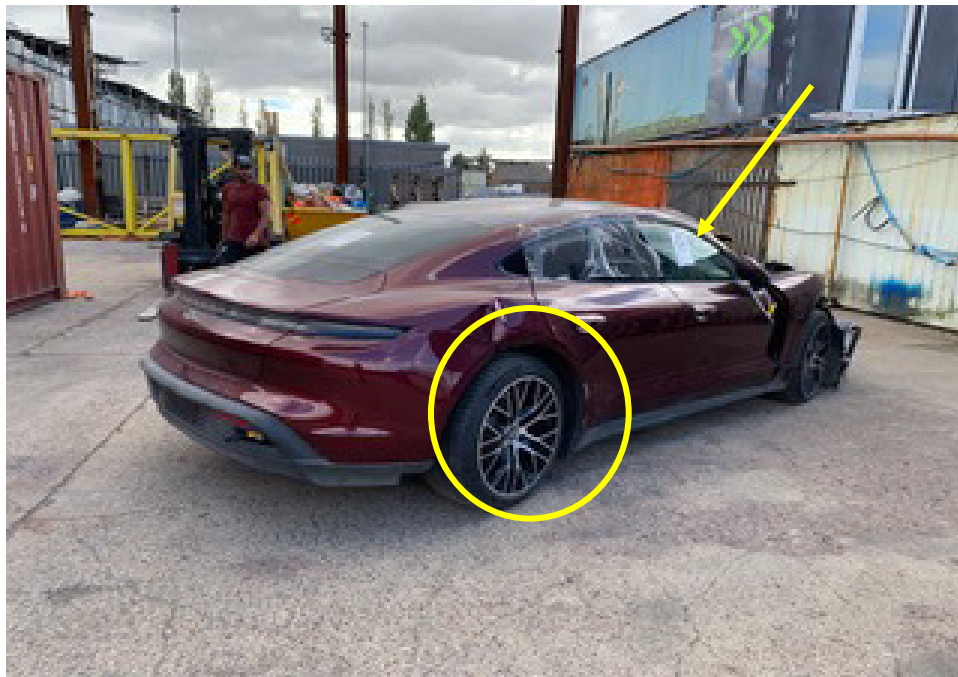
Photo 4 shows the rear right body of the Motor Car (photograph provided to me). Apart for the right side front portion, the photographs provided had also showed damage at the right side rear portion (circled). The Motor Car's right curtain airbag (arrowed) was deployed.

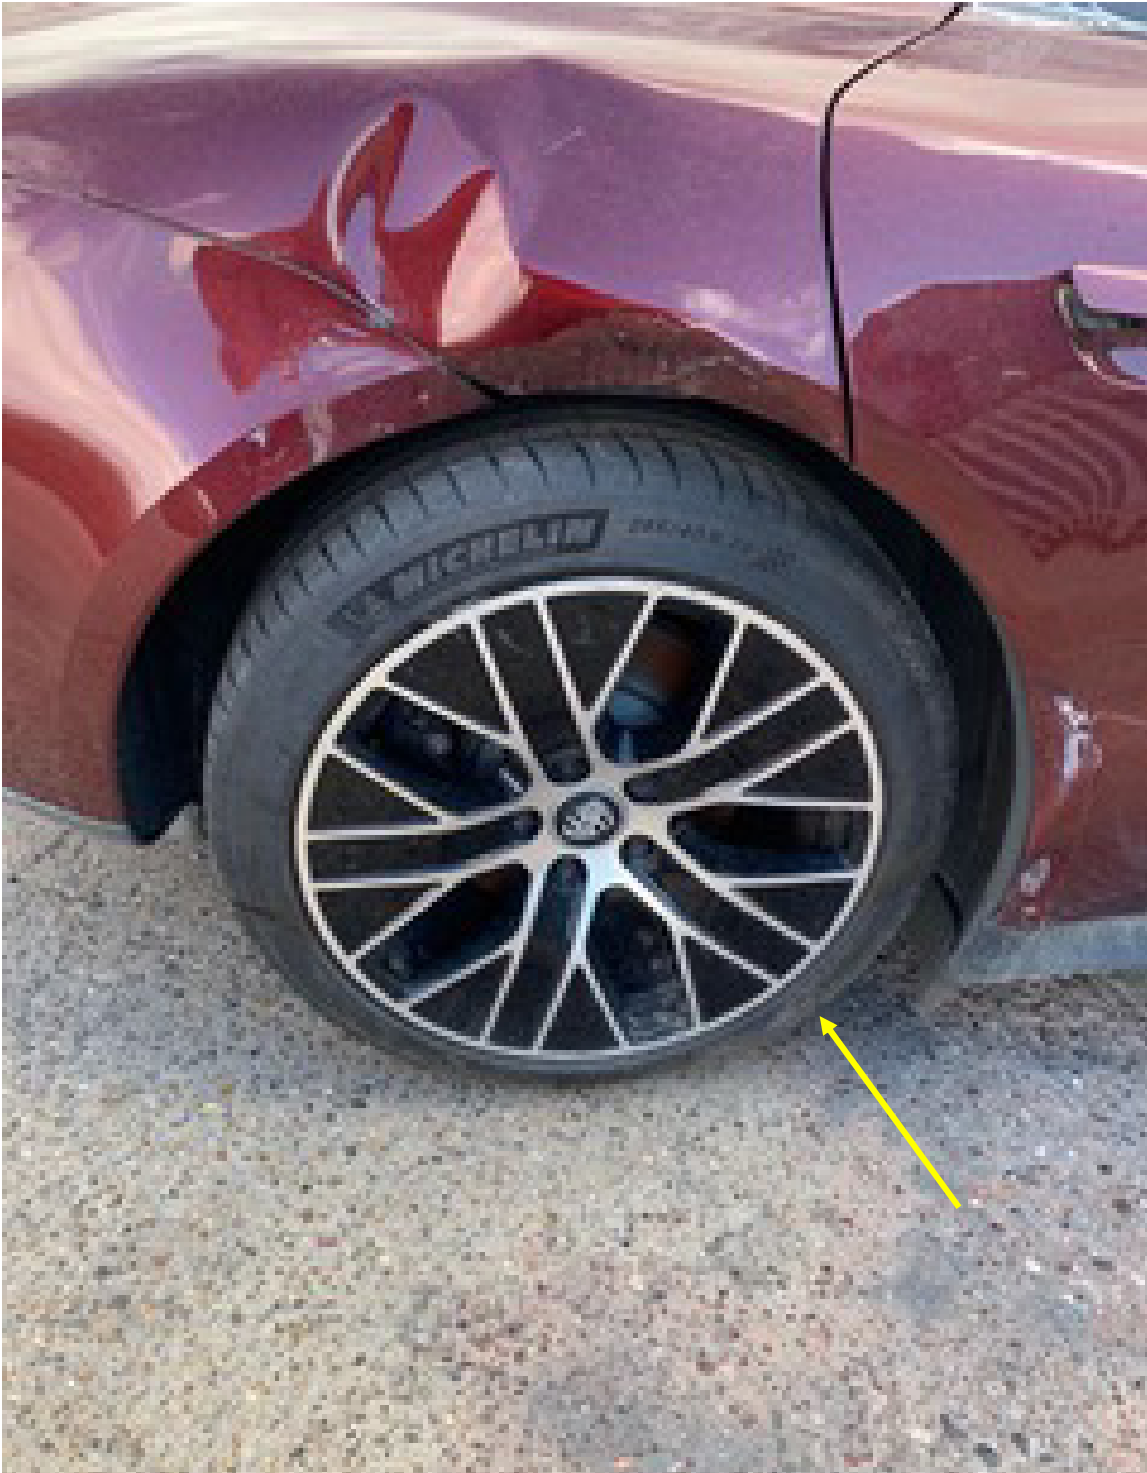
5. As for the right side rear portion, I had observed damage to the Motor Car's rear right door, rear right fender and rear bumper amongst others. Its rear right wheel was also observed to be shifted inwards, suggesting damage to the undercarriage parts at the rear right wheel of the Motor Car. Undercarriage parts that may possibly be damaged include the rear right lower arm, rear right knuckle arm, rear right upper arm and rear right shock absorber amongst others.
6. The Motor Car's right curtain airbag, driver's airbag, driver's knee airbag and front left passenger airbag were all deployed as seen from the photographs that were provided to me. See photo 1 – 7 below.

Photo 5 shows a closer view of the damage at the right side rear portion of the Motor Car (photograph provided to me). The rear right door, rear right fender and rear bumper were amongst the body parts that were observed to have been damaged. The Motor Car's rear right wheel (arrowed) was also observed to be shifted inwards, suggesting damage to the undercarriage parts at the rear right wheel of the Motor Car. Undercarriage parts that may possibly be damaged include the rear right lower arm, rear right knuckle arm, rear right upper arm and rear right shock absorber amongst others.

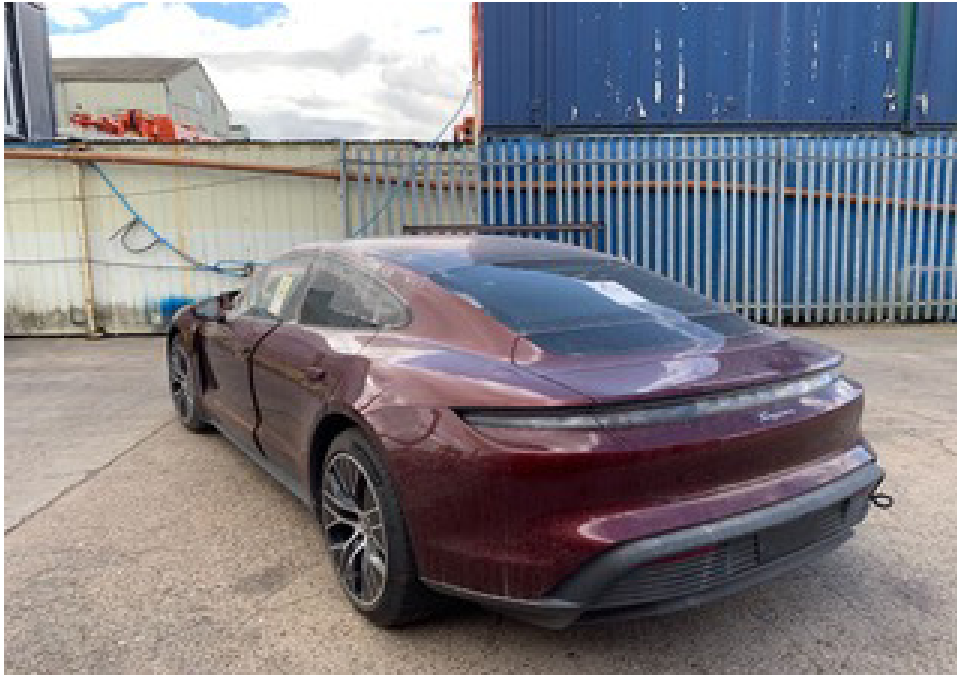
Photo 6 shows the rear left body of the Motor Car (photograph provided to me). Apart for the right side front portion and right side rear portion, there was no physical damage observed to other areas of the Motor Car.

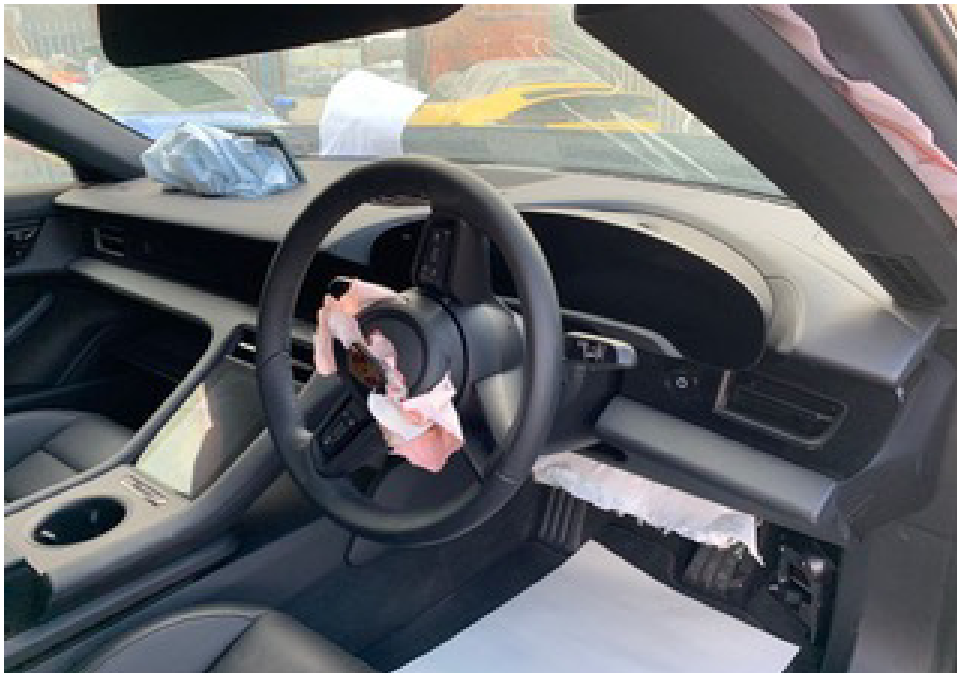
Photo 7 shows the interior compartment of the Motor Car (photograph provided to me). The various parts and components within the interior compartment were all intact and unaffected. The driver's airbag, driver's knee airbag and front left passenger airbag were deployed as seen from the photographs that were provided to me.

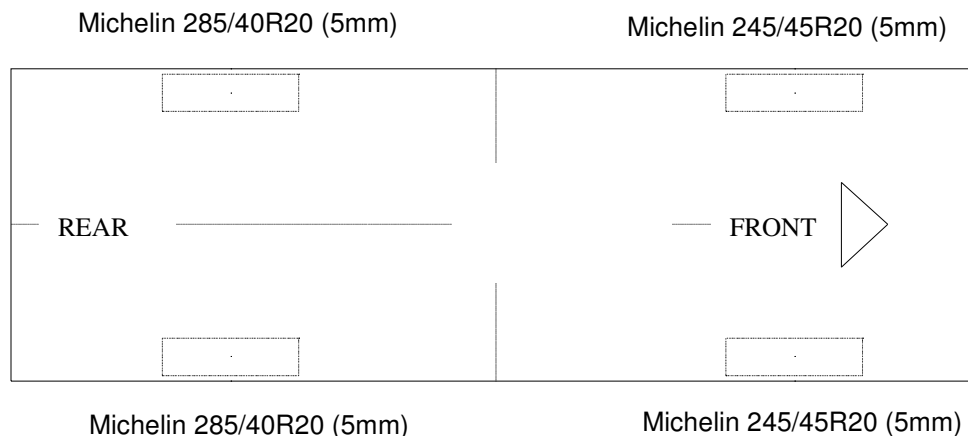
11. The Motor Car was fitted with 20inch sport wheel rims that were wrapped with tyres that were observed to be of serviceable condition. The tyres were also sufficiently inflated for vehicular operation. The tyre brand, tyre size and approximate remaining tread depth of the 4 tyres of the Motor Car were recorded as follows: -

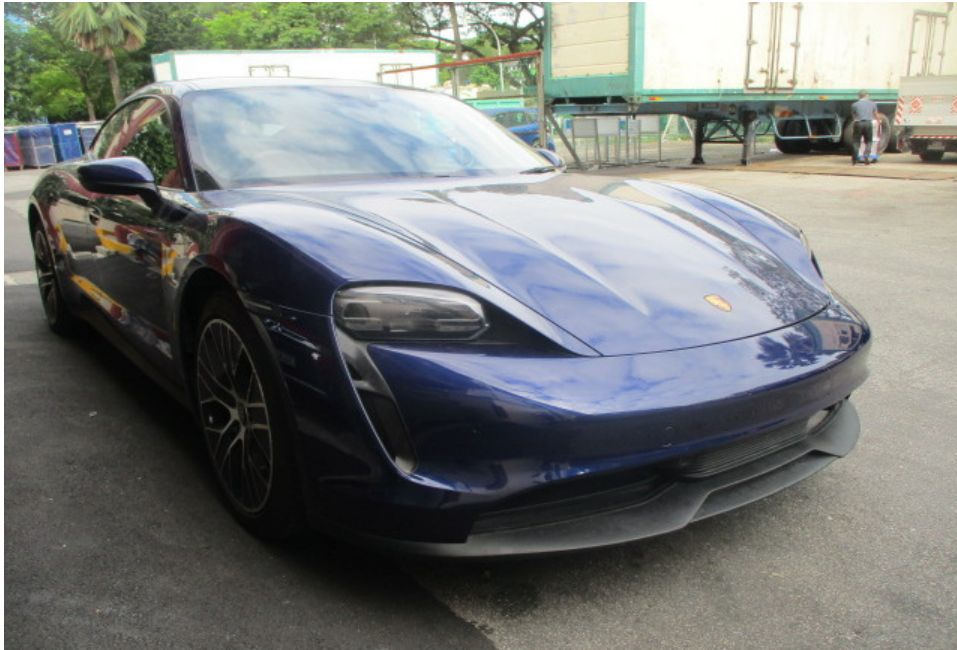
Photo 8 shows a general view of the front right body of the Motor Car at the time of my inspection. The Motor Car was observed to be in a relatively good general condition with no loose exterior fittings observed. The body parts at the right side front portion of the Motor Car were visually examined and it was observed that the repair/restoration works carried out to the damaged area of the Motor Car (refer to photograph 1 & 2 above) were reasonably adequate and in order.

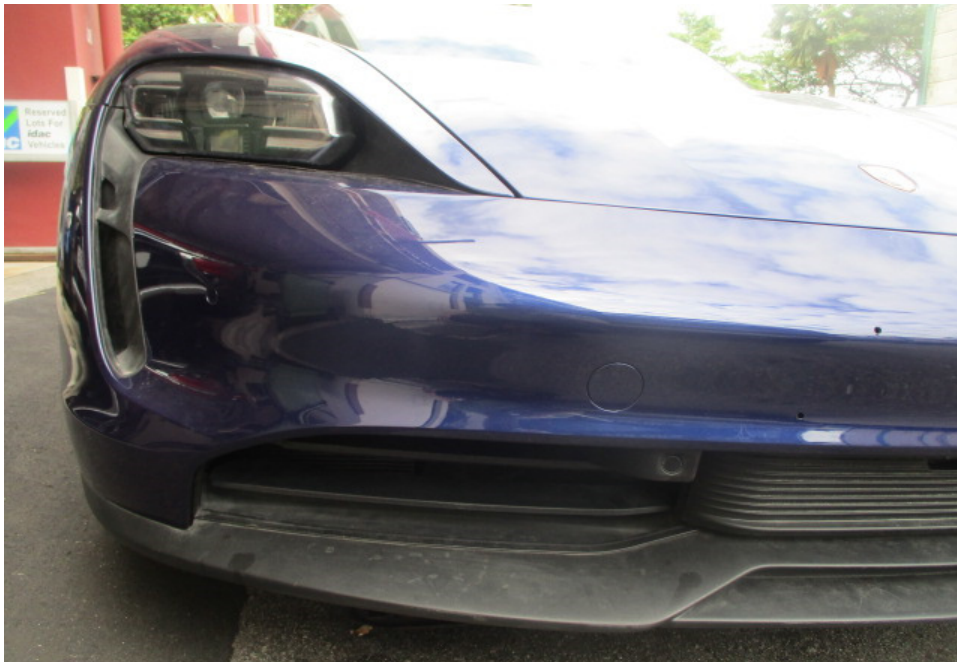
Photo 9 shows a closer view of the Motor Car's front bumper, front bumper lower lip, front bumper right air guide, front bumper right lower grille and front right headlamp. The body parts at the right side front portion of the Motor Car were visually examined and it was observed that the repair/restoration works carried out to the damaged area of the Motor Car (refer to photograph 1 & 2 above) were reasonably adequate and in order.

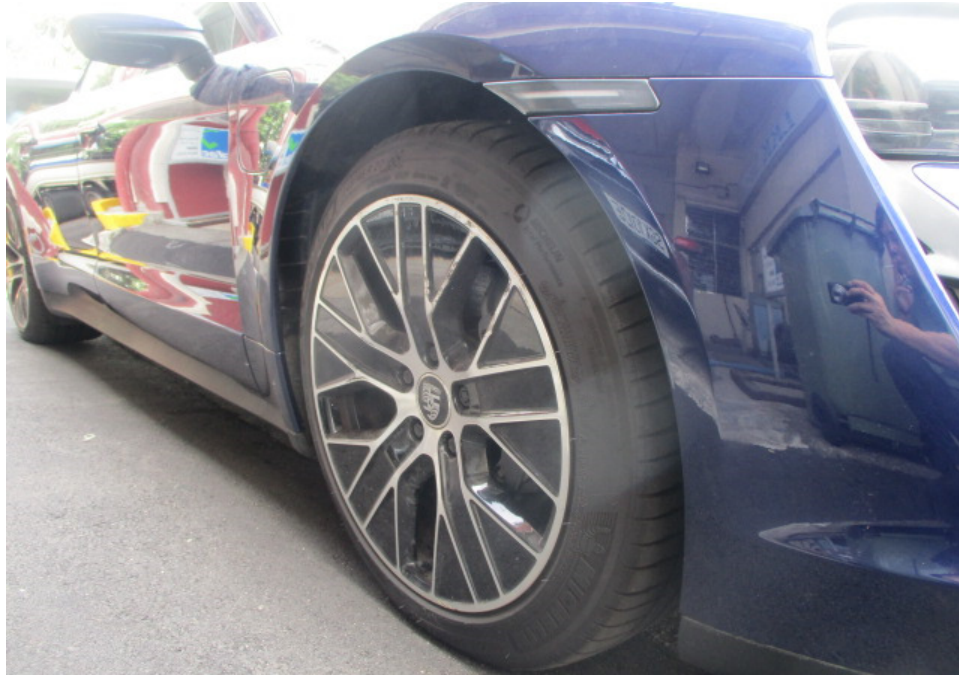
Photo 10 shows a closer view of the Motor Car's front bumper, front right signal lamp, front right fender and front right wheel rim. The body parts at the right side front portion of the Motor Car were visually examined and it was observed that the repair/restoration works carried out to the damaged area of the Motor Car (refer to photograph 1 & 2 above) were reasonably adequate and in order.

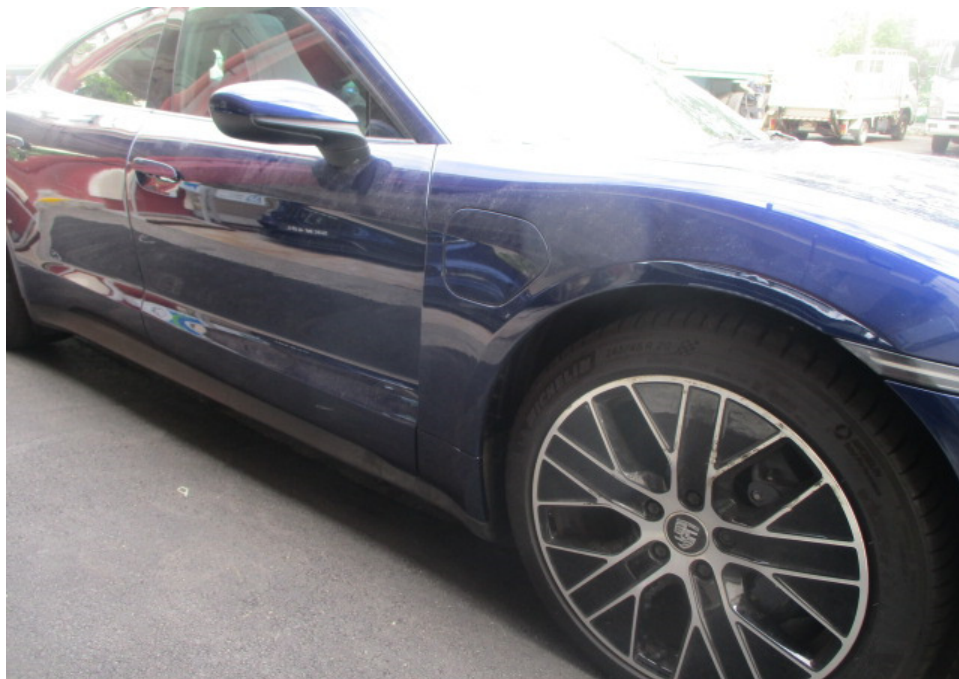
Photo 11 shows a closer view of the Motor Car's front right fender, front right wheel rim, front right door and right side wing mirror. The body parts at the right side front portion of the Motor Car were visually examined and it was observed that the repair/restoration works carried out to the damaged area of the Motor Car (refer to photograph 1 & 2 above) were reasonably adequate and in order.

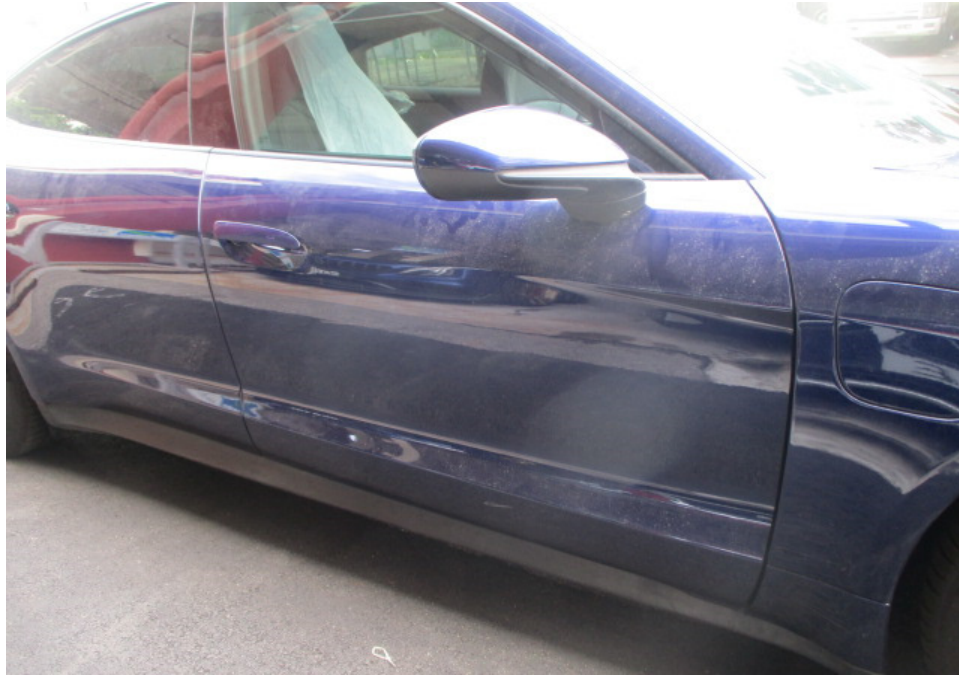
Photo 12 shows a closer view of the Motor Car's front right door, rear right door, right side wing mirror and right side rocker panel garnish. The body parts at the right side front portion of the Motor Car were visually examined and it was observed that the repair/restoration works carried out to the damaged area of the Motor Car (refer to photograph 1 & 2 above) were reasonably adequate and in order.

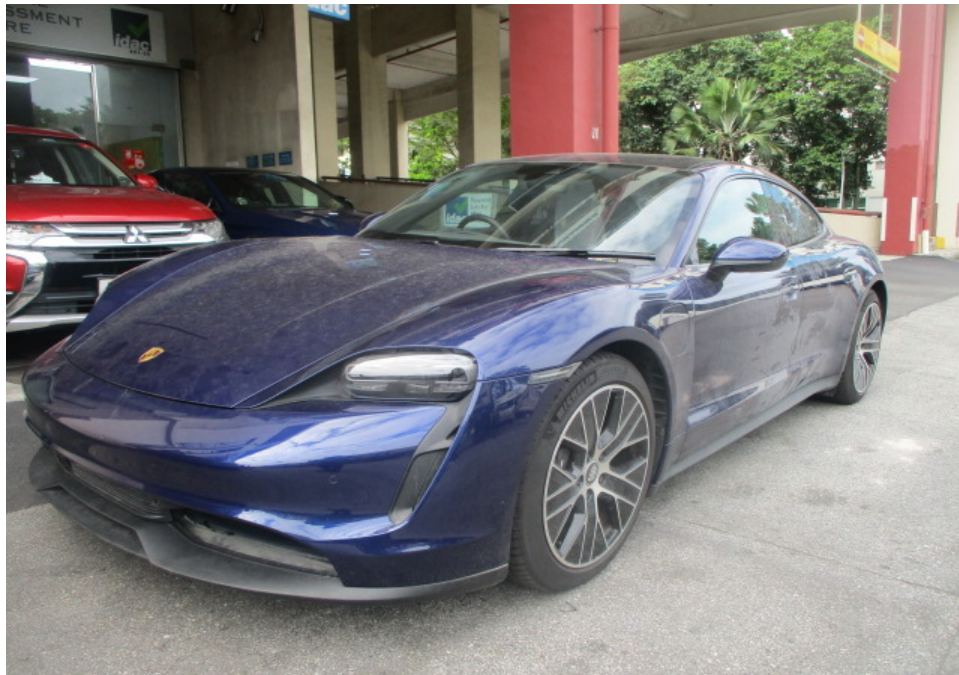
Photo 13 shows a general view of the front left body of the Motor Car at the time of my inspection. The Motor Car was observed to be in a relatively good general condition with no loose exterior fittings observed. Its body colour was observed to have been changed from a maroon colour tone to a blue colour tone. The mileage of the Motor Car recorded at the time of my inspection was 2,808km.

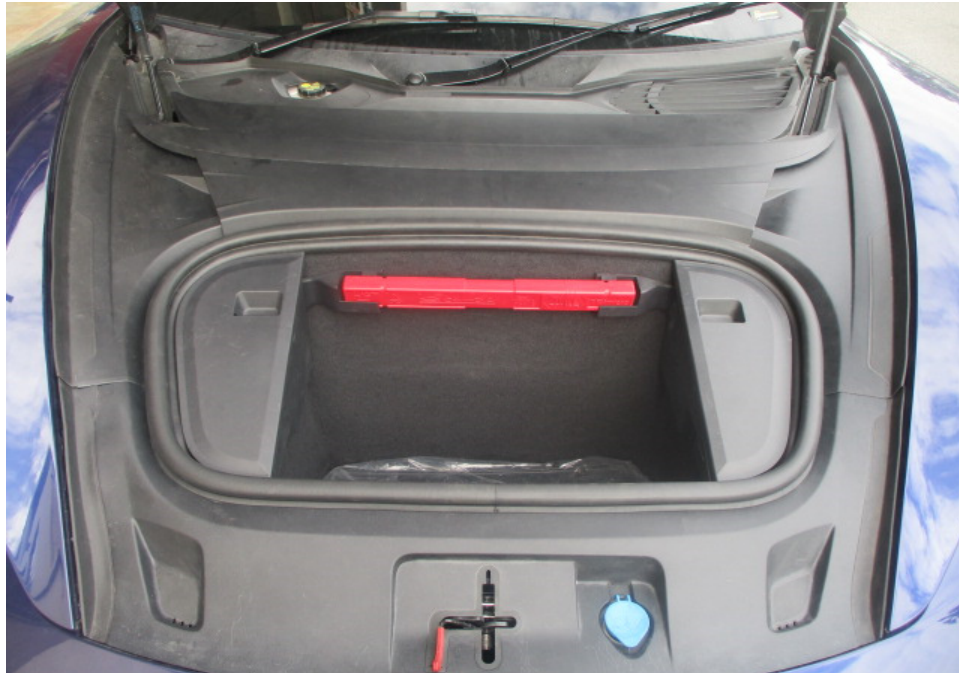
Photo 14 shows a general view of the Motor Car's front bonnet compartment at the time of my inspection. All inner trims, garnishes and upholstery etc were observed to be properly fitted.

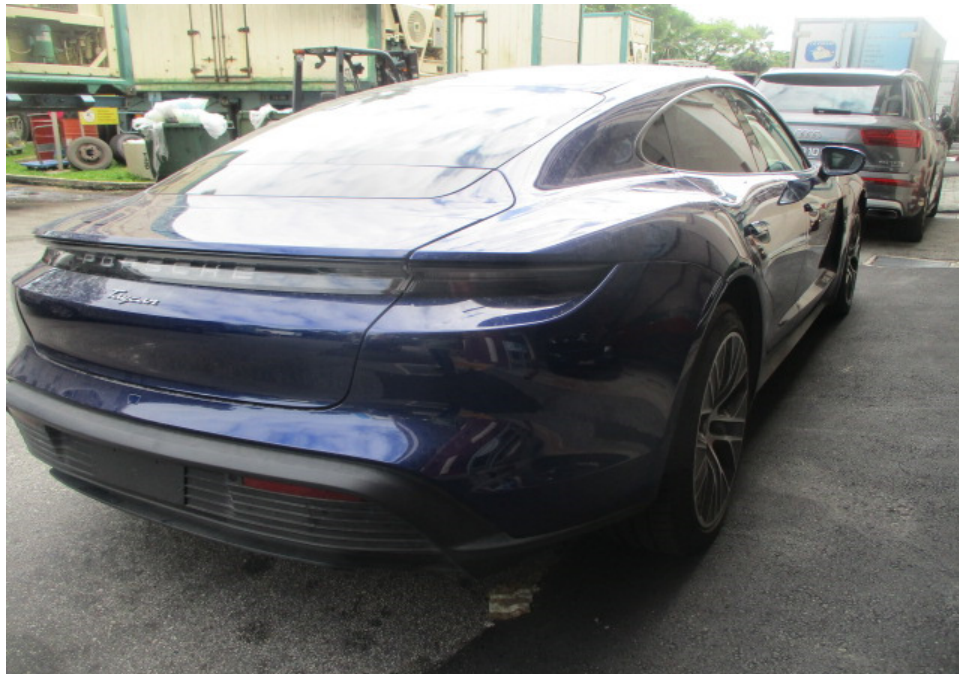
Photo 15 shows a general view of the rear right body of the Motor Car at the time of my inspection. The Motor Car was observed to be in a relatively good general condition with no loose exterior fittings observed. The body parts at the right side rear portion of the Motor Car were visually examined and it was observed that the repair/restoration works carried out to the damaged area of the Motor Car (refer to photograph 4 & 5 above) were reasonably adequate and in order.

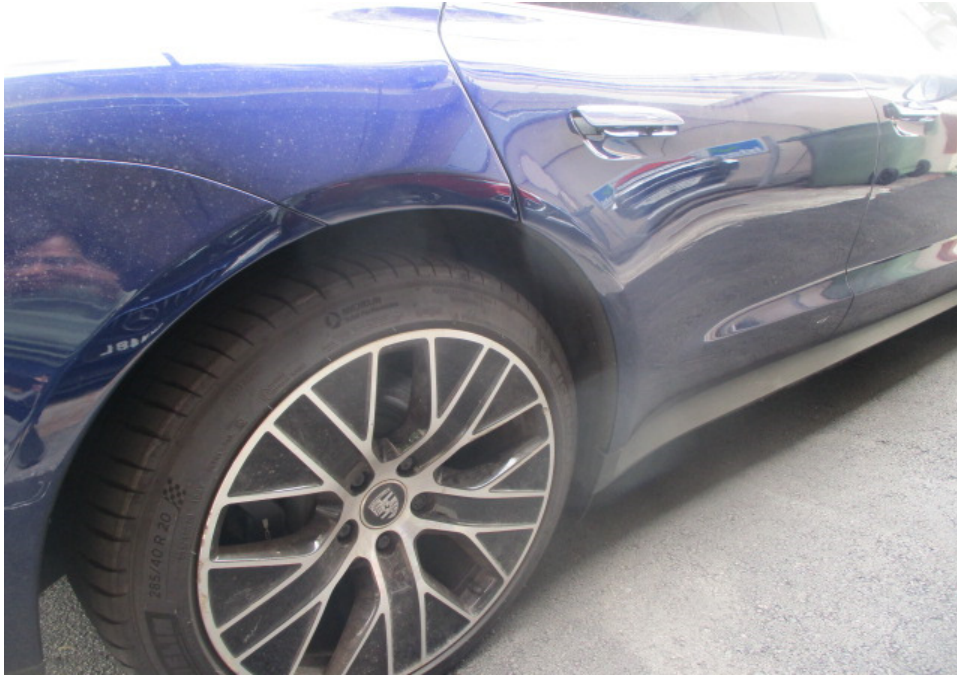
Photo 16 shows a closer view of the Motor Car's rear bumper, rear right fender, rear right wheel rim and rear right door. The body parts at the right side rear portion of the Motor Car were visually examined and it was observed that the repair/restoration works carried out to the damaged area of the Motor Car (refer to photograph 4 & 5 above) were reasonably adequate and in order.

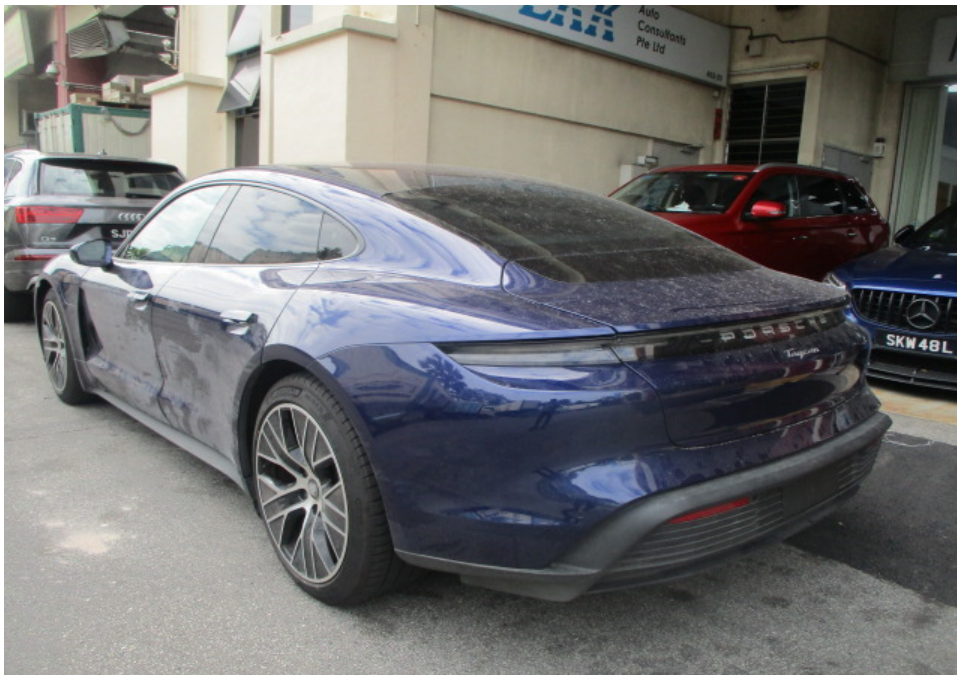
Photo 17 shows a general view of the rear left body of the Motor Car at the time of my inspection. The Motor Car was observed to be in a relatively good general condition with no loose exterior fittings observed. Its body colour was observed to have been changed from a maroon colour tone to a blue colour tone. The mileage of the Motor Car recorded at the time of my inspection was 2,808km.

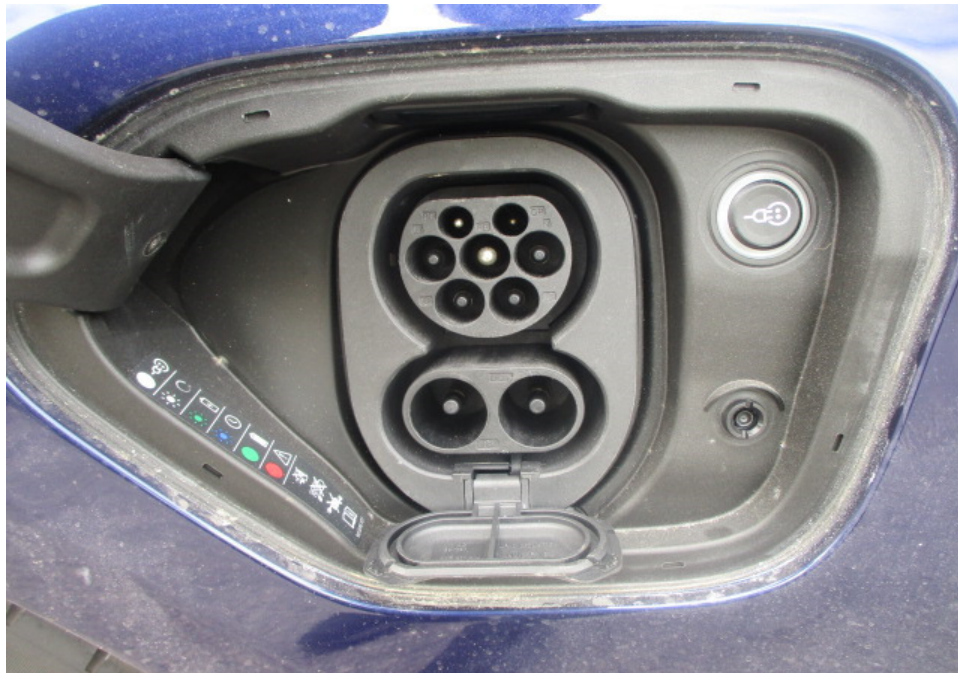
Photo 19 shows the high voltage charging port located at the front left fender of the Motor Car at the time of my inspection. A Combined Charging Standard 2 (CCS 2) for direct current (DC) charging was fitted on the front left fender of the Motor Car. No physical damage was observed to the charging head.

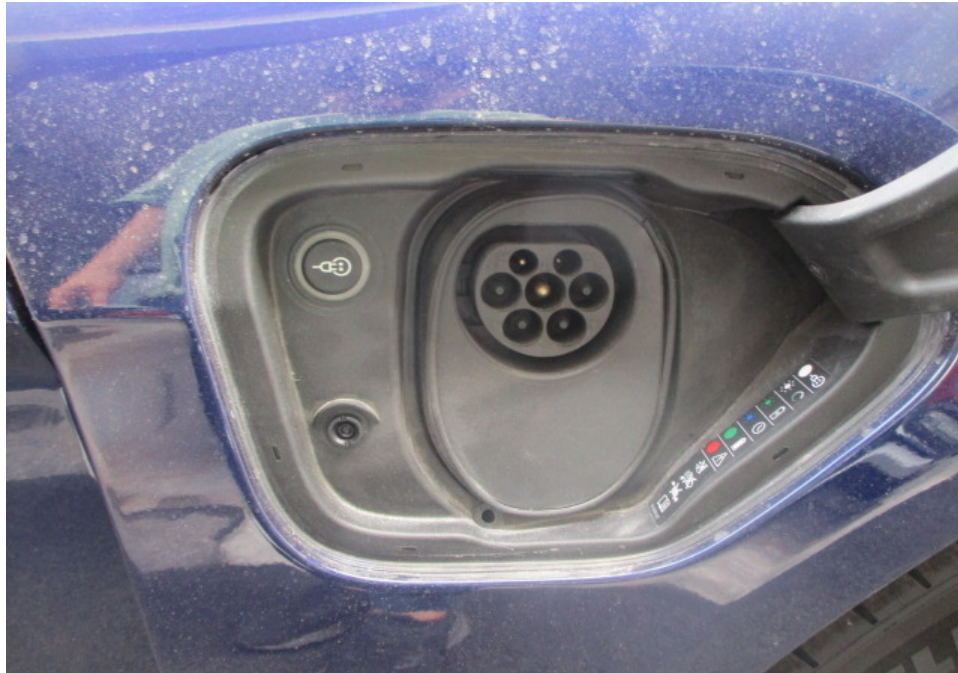
Photo 20 shows the high voltage charging port located at the front right fender of the Motor Car at the time of my inspection. A JS 1772 (Type 2) for alternating current (AC) charging was fitted on the front right fender of the Motor Car. No physical damage was observed to the charging head.

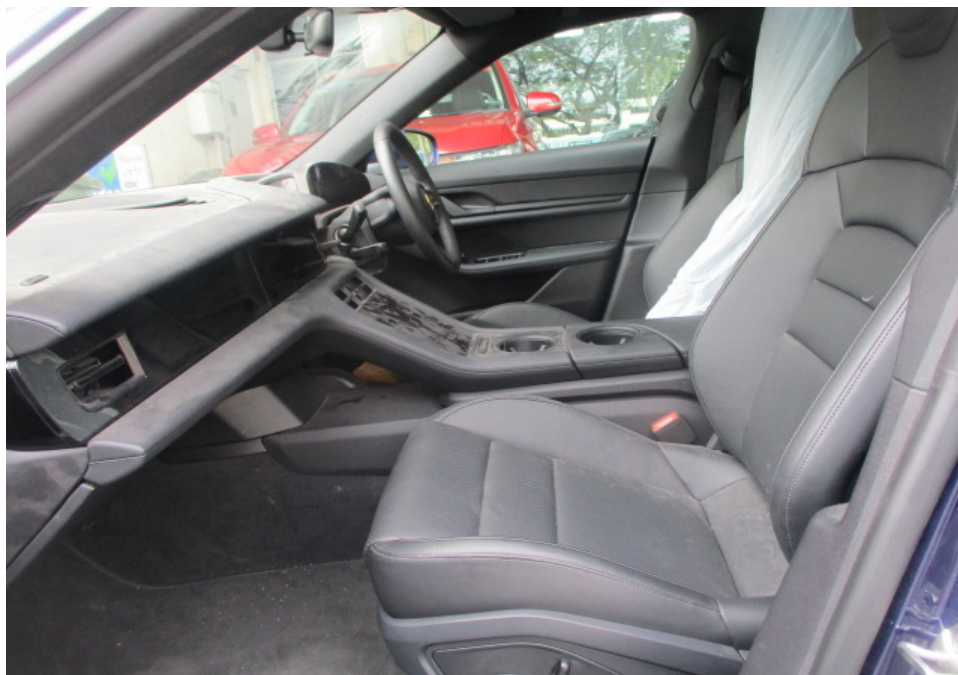
Photo 21 shows the interior compartment of the Motor Car at the time of my inspection. The various parts and components, trims, carpet, and upholstery inside the interior compartment were all observed to be intact and properly fitted.

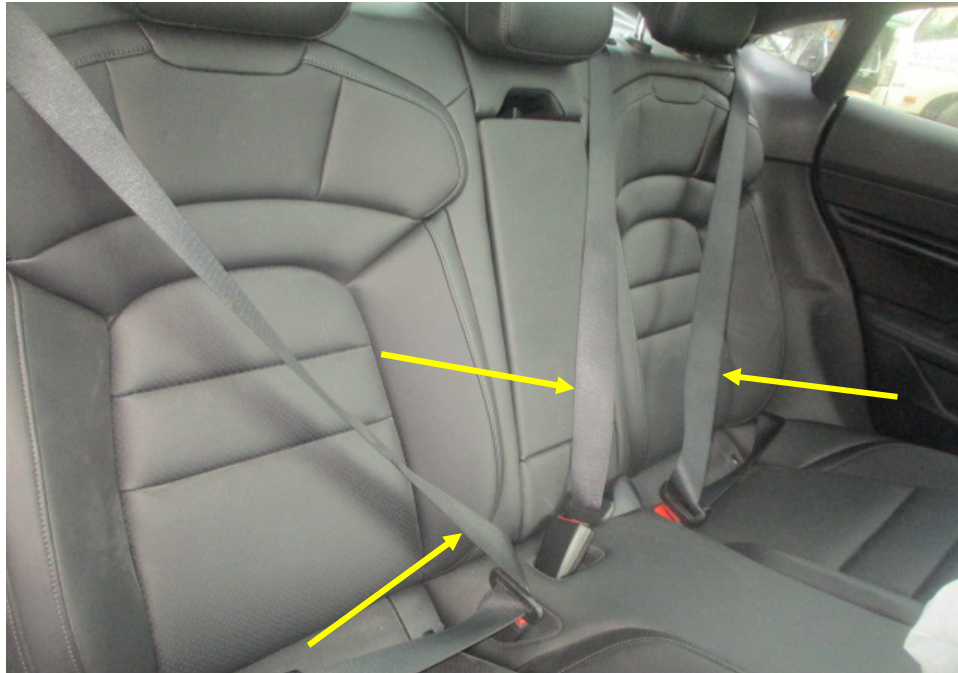
Photo 22 shows the rear seats of the Motor Car. All the seats of the Motor Car were secured via seat rails to the floorboard. They were also fitted with a retractable seat belt reel and a pre-tensioner. The seat belts (arrowed) were tested and were able to be fastened into the respective pre-tensions that were fitted on the side of each individual seat.

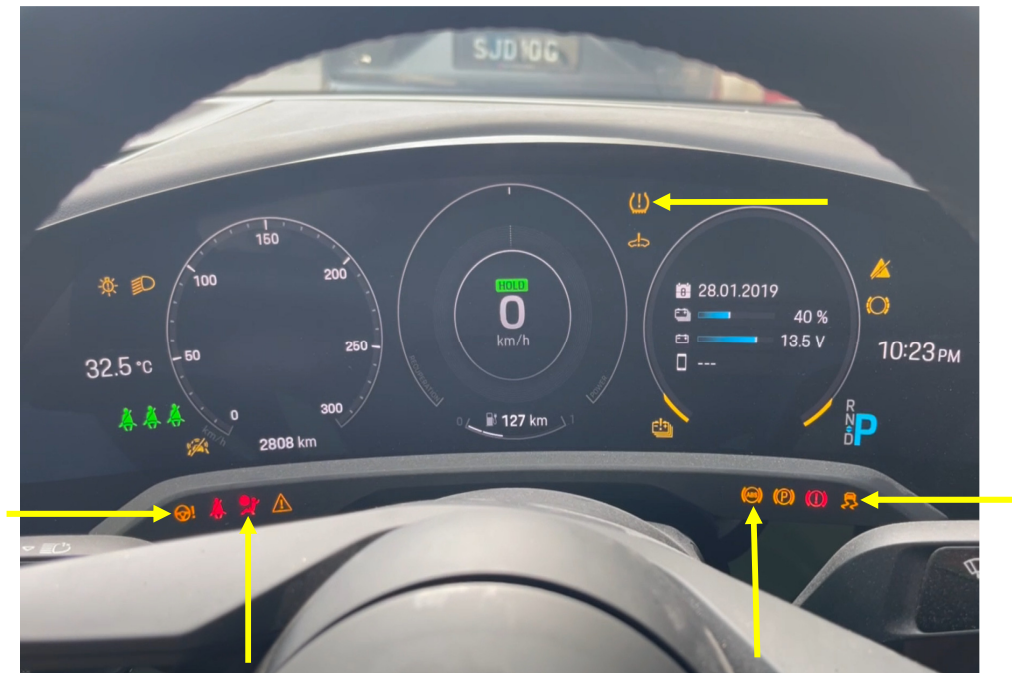
Photo 23 shows the warning lights for the various electronic safety features appearing on the instrument panel of the Motor Car during its self-test when the engine is cranked, in particular the ABS, SRS, EPS, TPM and SCS lights (arrowed).

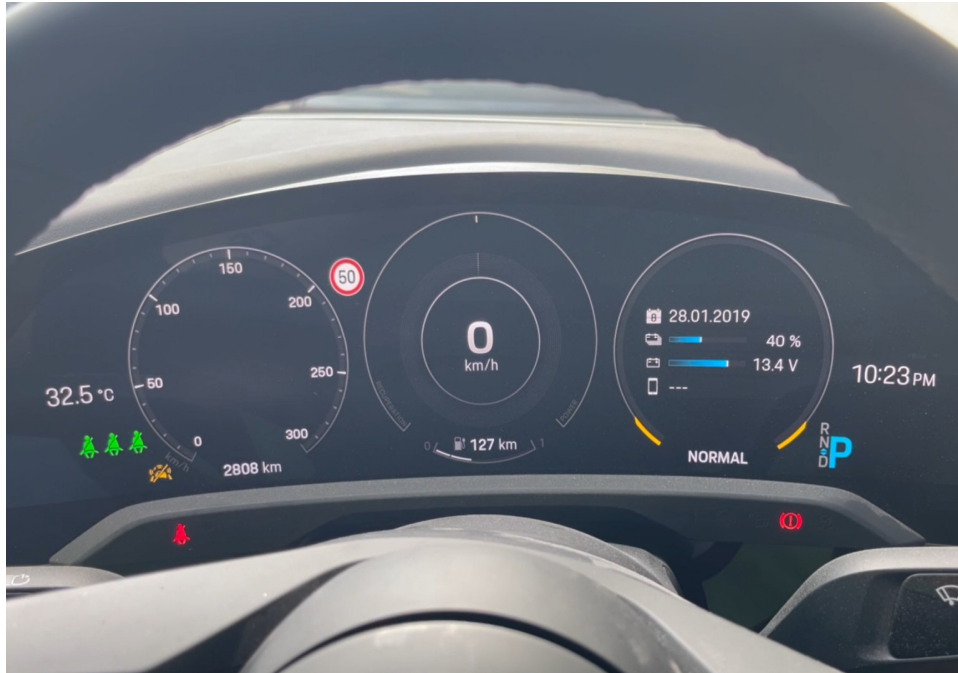
Photo 24 shows the respective warning lights no longer illuminated, indicating that there is no fault detected to the ABS, SRS, EPS, TPM and SCS systems of the Motor Car during the self-test. These electronic systems were hence in working condition at the time of my inspection.

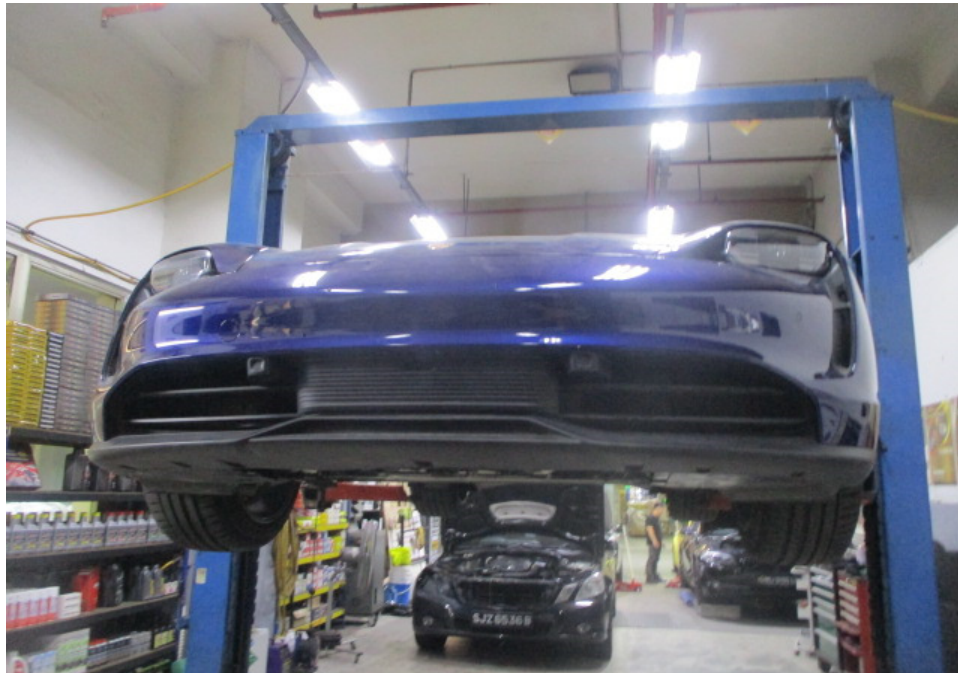
Photo 25 shows the Motor Car hoisted up for checks on its undercarriage. There was no sign(s) or indication(s) of fluid leakage and/or fluid stain(s) on the underside of the Motor Car. The undercarriage components of the Motor Car were also all observed to be intact and secured in an appropriate manner.

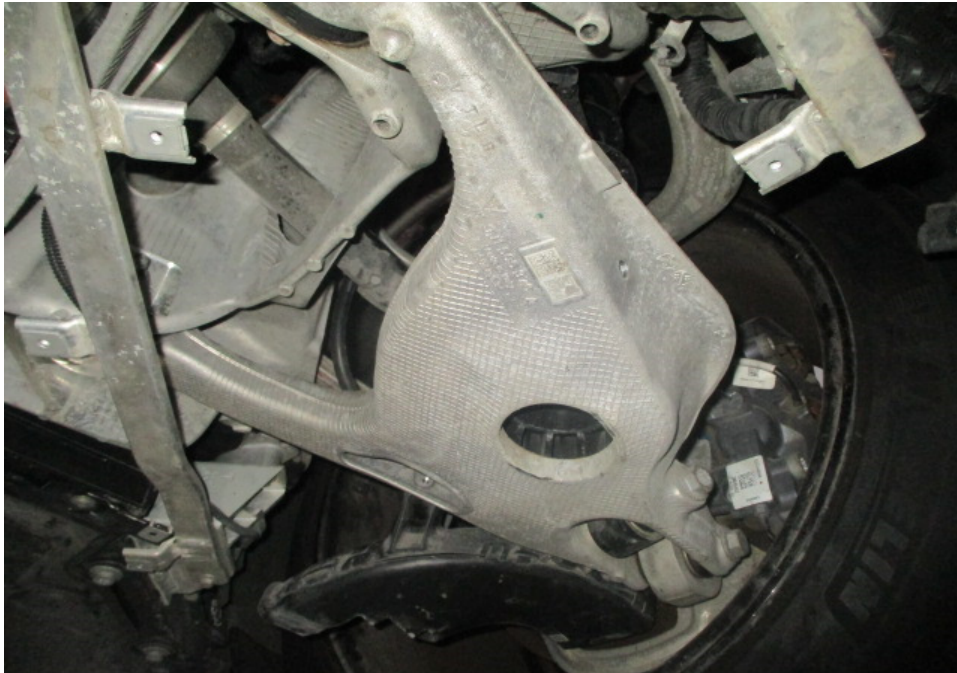
Photo 26 shows a general view of the control arms and linkages at the rear right wheel of the Motor Car. I did not observe any fluid leak and/or fluid stain on the underside of the Motor Car. All of the Motor Car's undercarriage components were observed to be intact and secured in an appropriate manner.

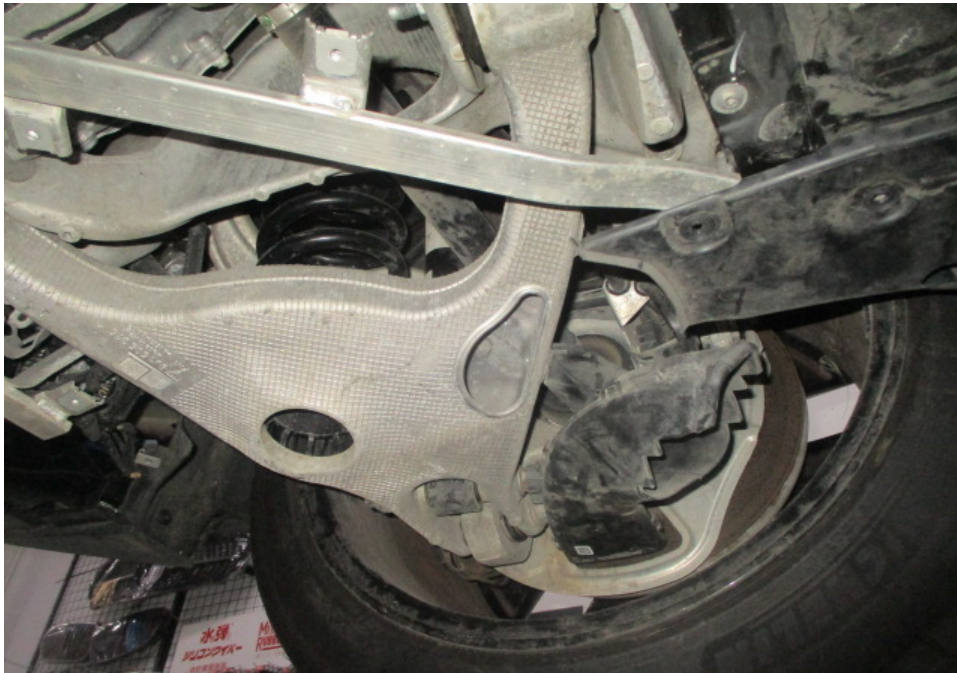
Photo 27 shows a general view of the control arms and linkages at the rear left wheel of the Motor Car. I did not observe any fluid leak and/or fluid stain on the underside of the Motor Car. All of the Motor Car's undercarriage components were observed to be intact and secured in an appropriate manner.
