Your Ref: Porsche Taycan
(chassis number WP0ZZZY1ZMSA04583)
Our Ref : CI/TP23004856/D

INSPECTION REPORT OF AN UNREGISTERED PORSCHE TAYCAN MOTOR CAR WITH CHASSIS NUMBER WP0ZZZY1ZMSA04583

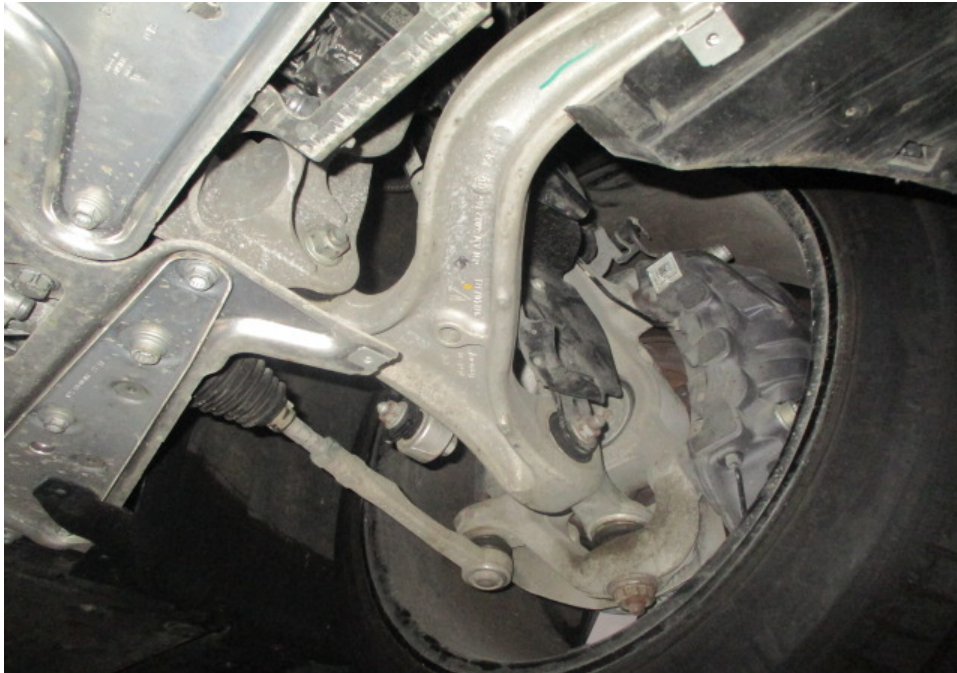
Photo 28 shows the various undercarriage components at the front left wheel of the Motor Car. The mechanical components, control arms and linkages were all found to be intact and secured in an appropriate manner.

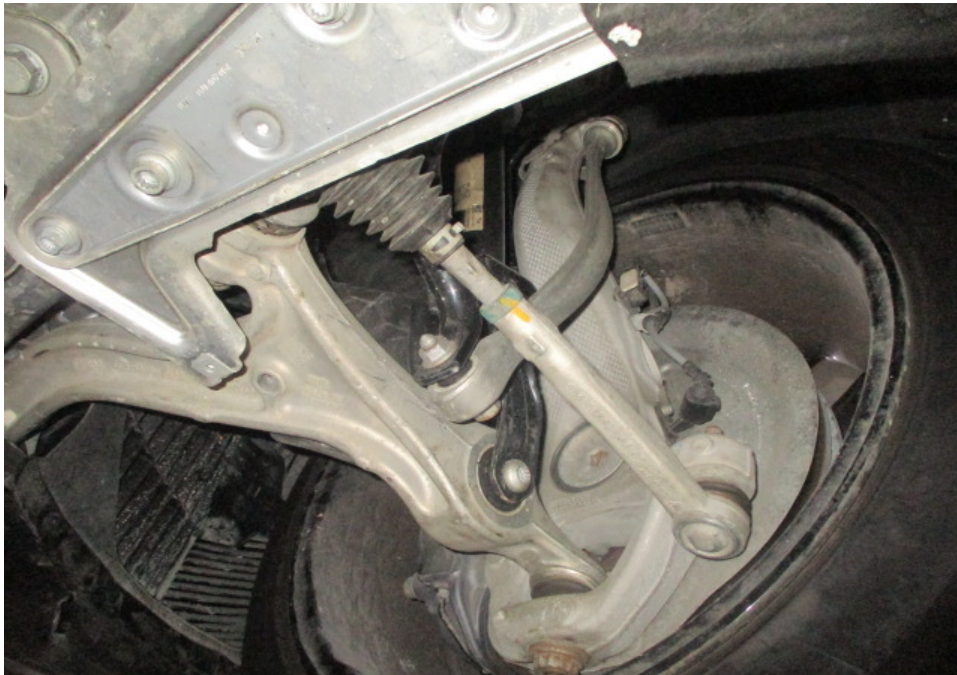
Photo 29 shows the various undercarriage components at the front right wheel of the Motor Car. The mechanical components, control arms and linkages were all found to be intact and secured in an appropriate manner. I also did not observe any fluid leak and/or fluid stain on the underside of the Motor Car.

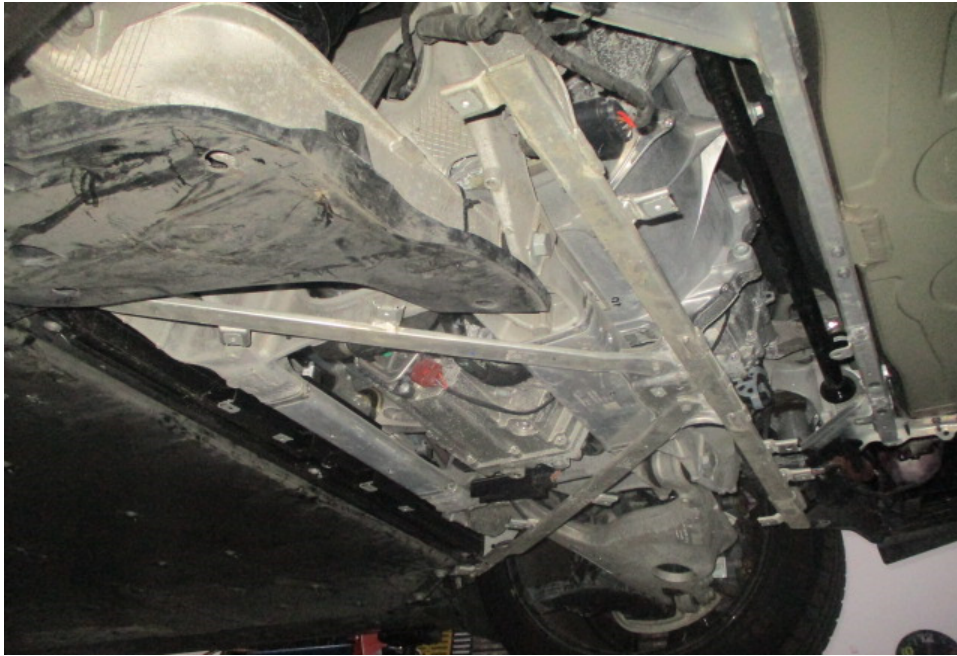
Photo 30 shows the underside rear of the Motor Car, at the location where the rear electric motor is fitted. The high voltage system of the Motor Car was visually checked, and it was observed that the various high voltage parts and components like the high voltage battery, inverter unit, converter unit, high voltage cables, electric motors and electric aircon compressor amongst others, were properly secured and without any physical damage.

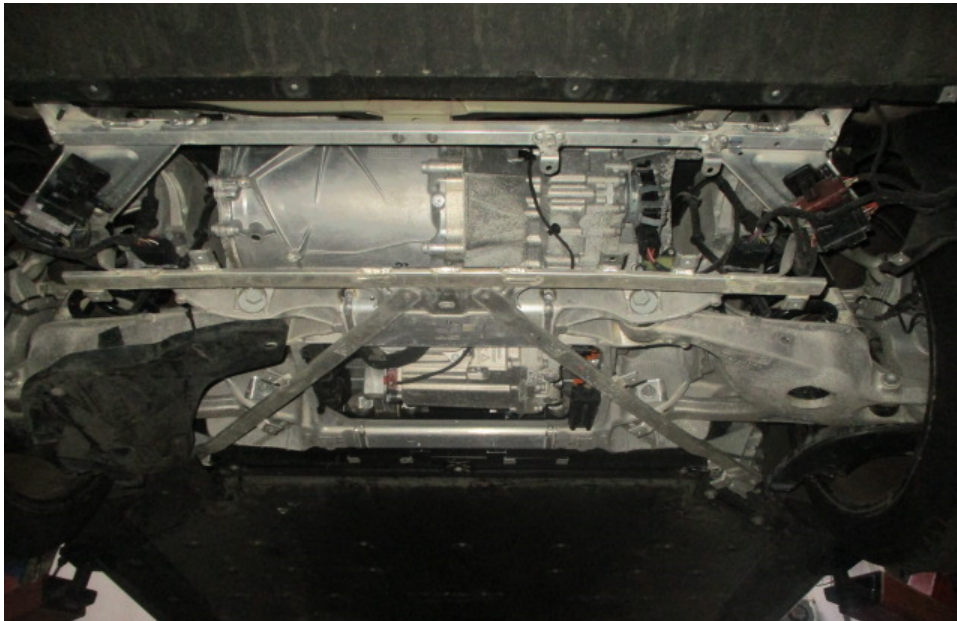
Photo 31 shows another view of the underside rear of the Motor Car, at the location where the rear electric motor is fitted. The high voltage system of the Motor Car was visually checked, and it was observed that the various high voltage parts and components like the high voltage battery, inverter unit, converter unit, high voltage cables, electric motors and electric aircon compressor amongst others, were properly secured and without any physical damage.

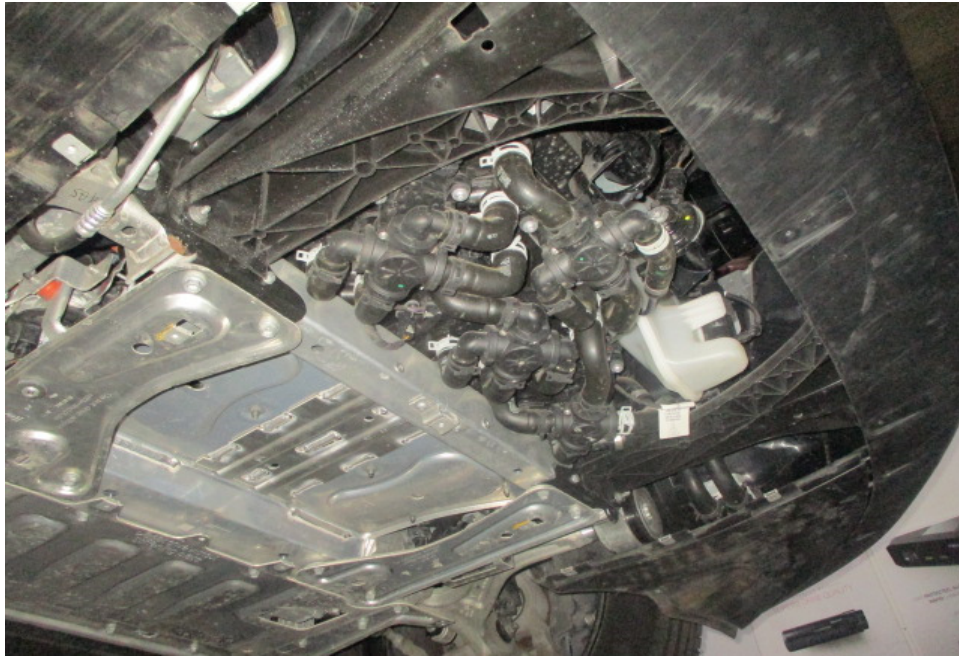
Photo 32 shows the underside front of the Motor Car, at the location where the front electric motor, is fitted. The high voltage system of the Motor Car was visually checked, and it was observed that the various high voltage parts and components like the high voltage battery, inverter unit, converter unit, high voltage cables, electric motors and electric aircon compressor amongst others, were properly secured and without any physical damage.

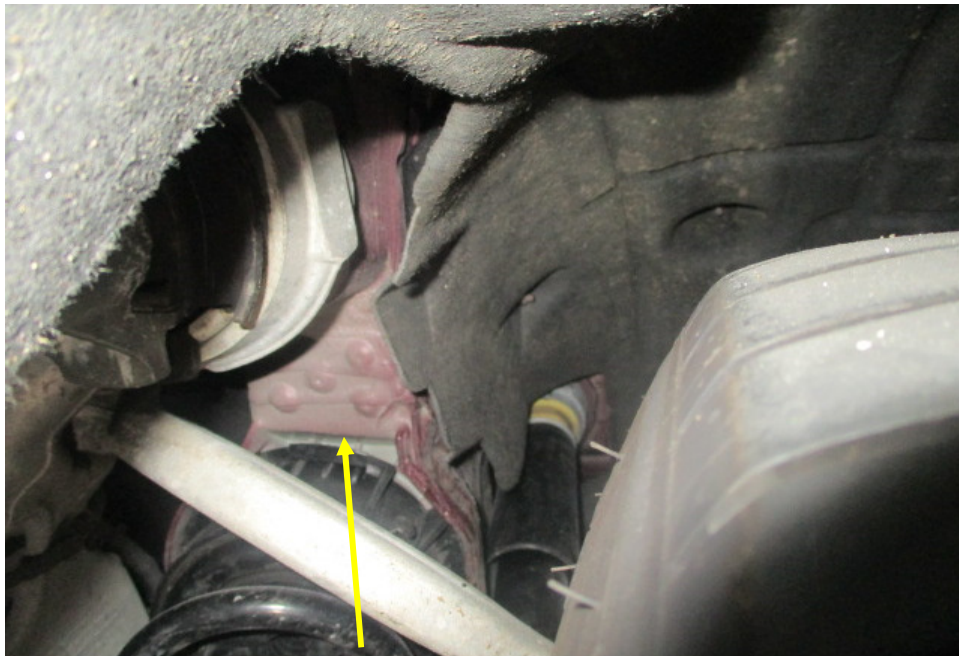
Photo 33 shows the chassis/structural body at the underside rear right of the Motor Car. I did not find any weld marks other than original spot weld marks on the chassis/structural body of the Motor Car. The original factory sealant (arrowed) at the joints along the chassis/structural body was untouched, indicating no work was done on the chassis/structural body of the Motor Car and that the chassis/structural body was originally fitted.

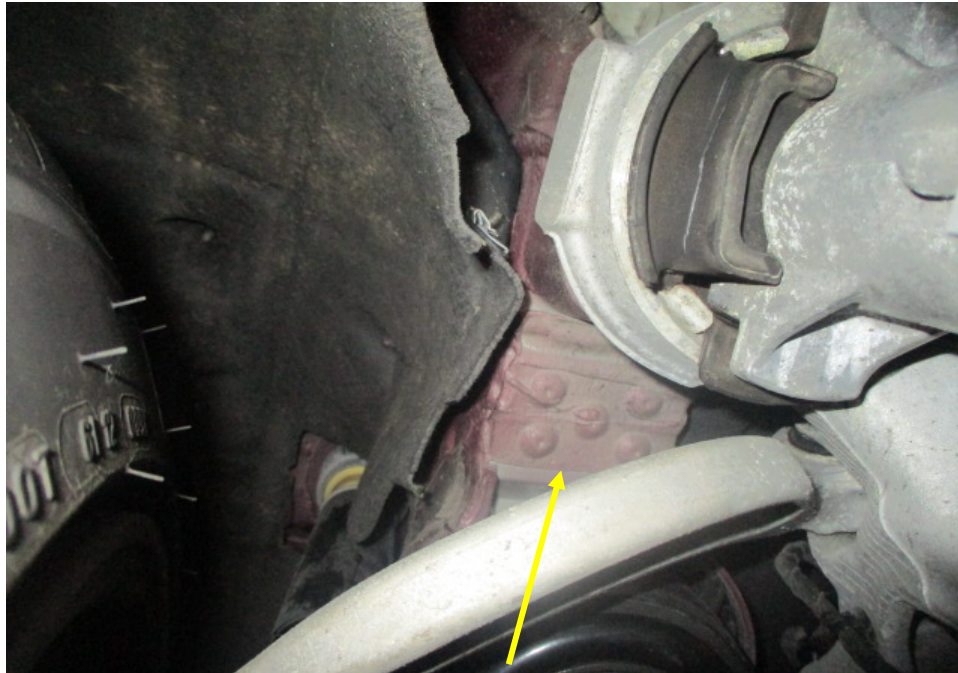
Photo 34 shows the chassis/structural body at the underside rear left of the Motor Car. The original factory sealant (arrowed) at the joints along the chassis/structural body was observed to be untouched. In general, I had found no work was carried out on the chassis/structural body of the Motor Car. The chassis/structural body of the Motor Car was originally fitted.

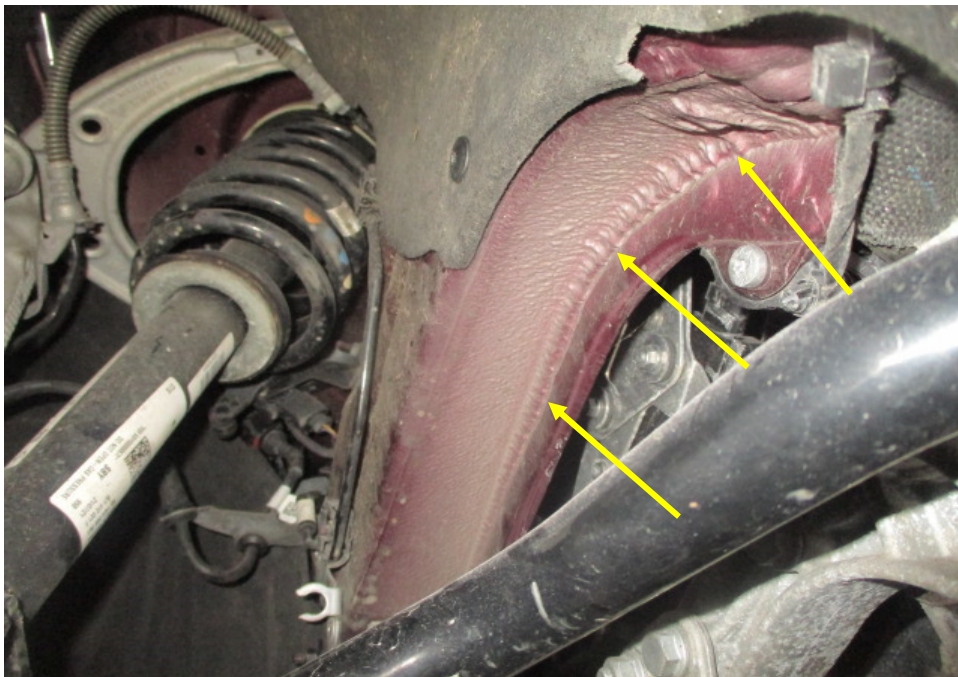
Photo 35 shows the chassis/structural body at the underside front left of the Motor Car. I did not find any weld marks other than original spot weld marks on the chassis/structural body of the Motor Car. The original factory sealant (arrowed) at the joints along the chassis/structural body was untouched, indicating no work was done on the chassis/structural body of the Motor Car and that the chassis/structural body was originally fitted.

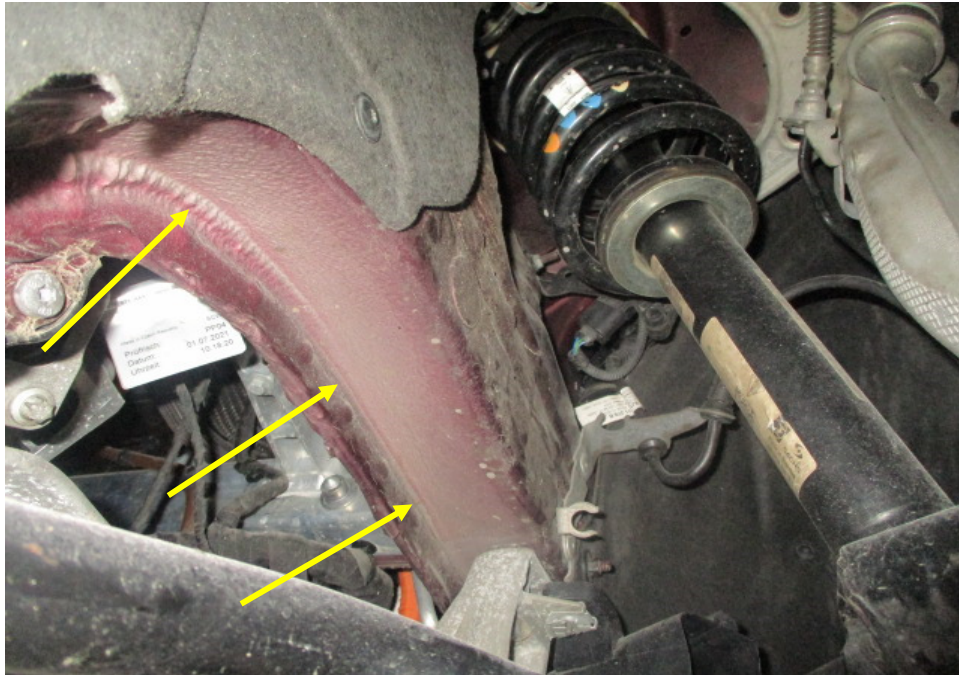
Photo 36 shows the chassis/structural body at the underside front right of the Motor Car. The original factory sealant (arrowed) at the joints along the chassis/structural body was observed to be untouched. In general, I had found no work was carried out on the chassis/structural body of the Motor Car. The chassis/structural body of the Motor Car was originally fitted.
