Your Ref: Porsche 911 Turbo S
(chassis number WP0ZZZ99ZNS251671)
Our Ref : CI/TP23004881/D

11 May 2023

**INSPECTION REPORT OF AN UNREGISTERED PORSCHE 911 TURBO S
MOTOR CAR WITH CHASSIS NUMBER WP0ZZZ99ZNS251671**

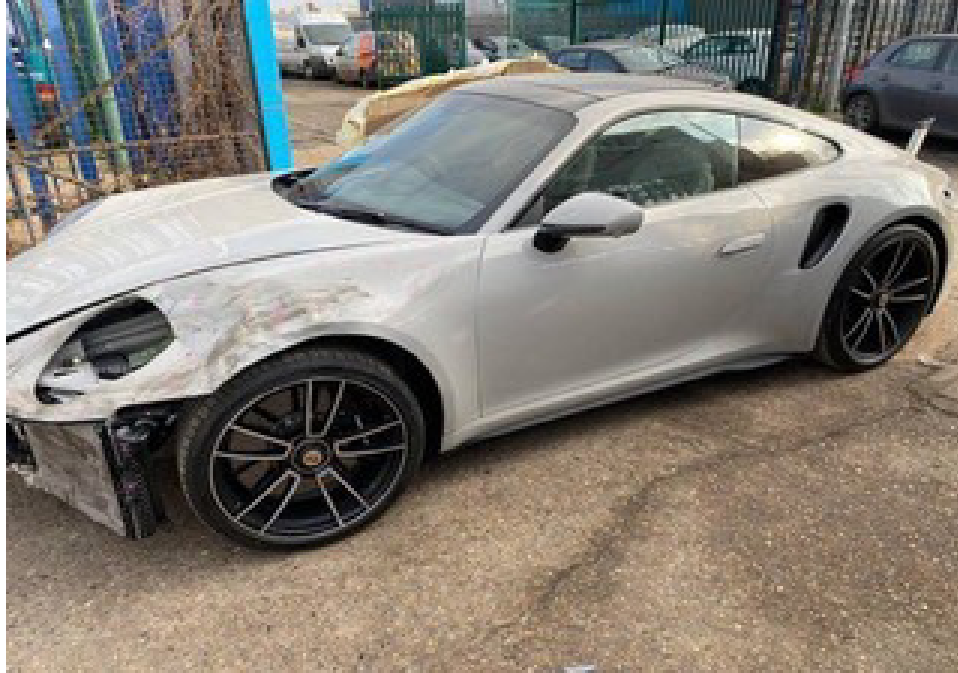
Photo 1 shows the front left body of the Motor Car (photograph provided to me). The front left fender was observed to be dented. The front left headlamp, front bumper and all its related parts and attachments like the front bumper lower lip, front bumper sensors, front bumper tow cover, front bumper centre lower air guide, front bumper left lower grille, front bumper right lower grille, front left day light, front right day light, front left signal lamp and front right signal lamp amongst others were observed to be missing/dislodged/damaged. The Motor Car's airbag(s) was not deployed as seen from the photographs that were provided to me.

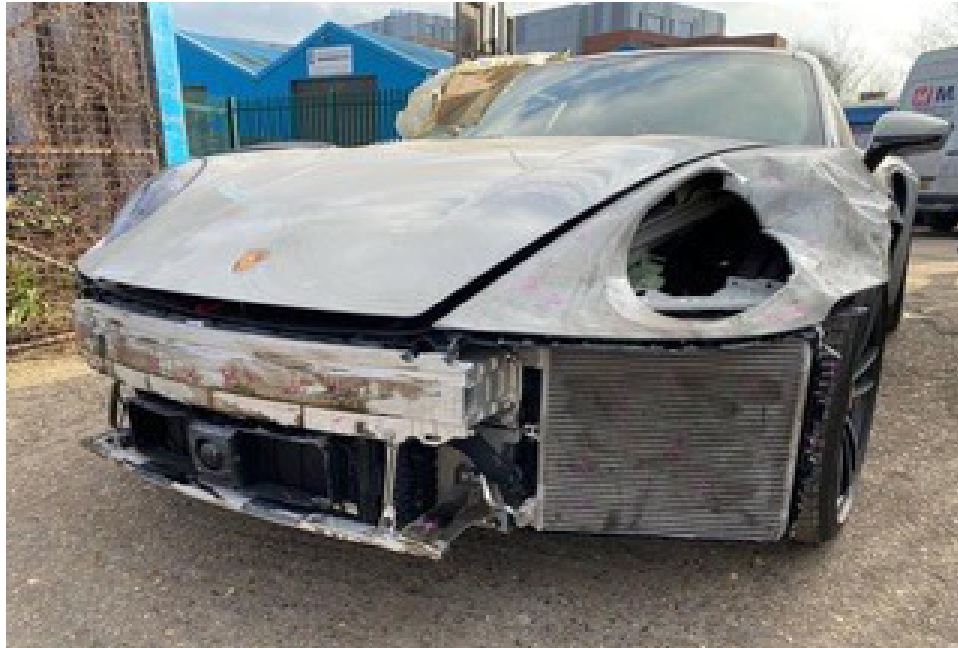
Photo 2 shows another view of the front left portion of the Motor Car (photograph provided to me). The Motor Car's front left fender was observed to be dented. The front left headlamp, front bumper and all its related parts and attachments like the front bumper lower lip, front bumper sensors, front bumper tow cover, front bumper centre lower air guide, front bumper left lower grille, front left day light and front left signal lamp amongst others, were observed to be missing/dislodged/damaged.

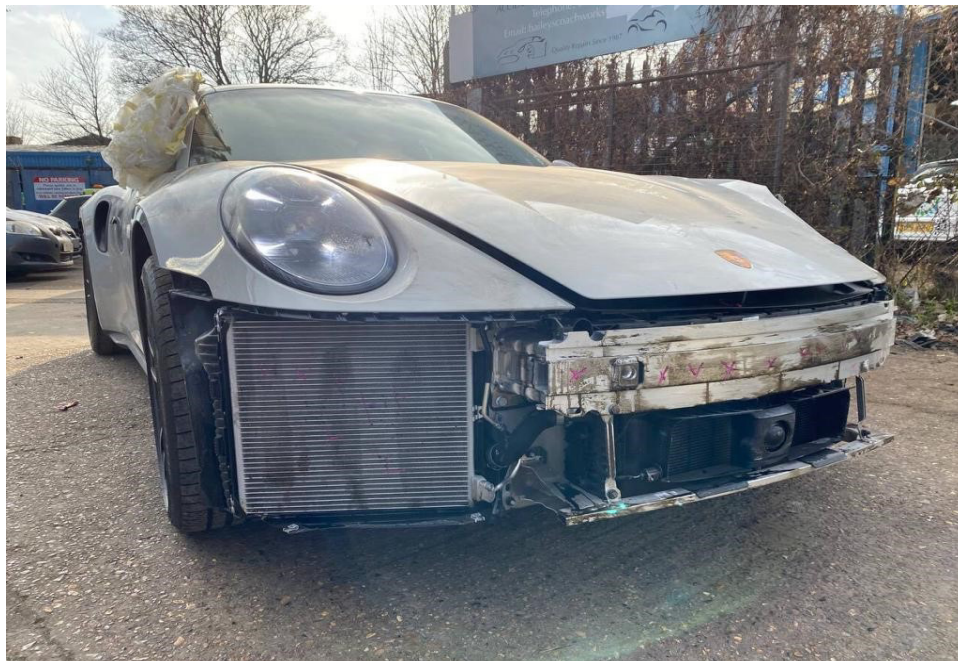
Photo 3 shows the front right body of the Motor Car (photograph provided to me). The front bumper and all its related parts and attachments like the front bumper lower lip, front bumper sensors, front bumper tow cover, front bumper centre lower air guide, front bumper right lower grille, front right day light and front right signal lamp amongst others, were observed to be missing/dislodged/damaged.

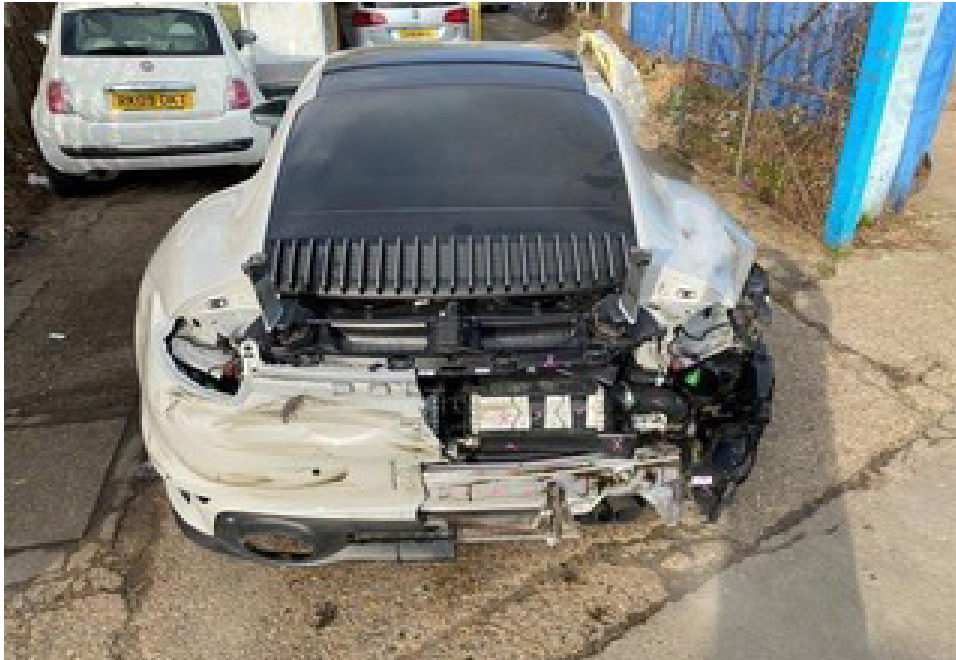
Photo 4 shows the rear body of the Motor Car (photograph provided to me). The photographs provided to me had showed damage to the rear portion of the Motor Car. Body parts that were either damaged, missing or dislodged include the rear bumper, rear bumper lower cover, rear bumper sensors, rear bumper left reflector, rear bumper right reflector, rear bumper right air duct, rear left exhaust garnish, rear right exhaust garnish, rear left taillamp, rear right taillamp, rear centre top reflector, rear centre top panel, rear top spoiler and third brake light amongst others.

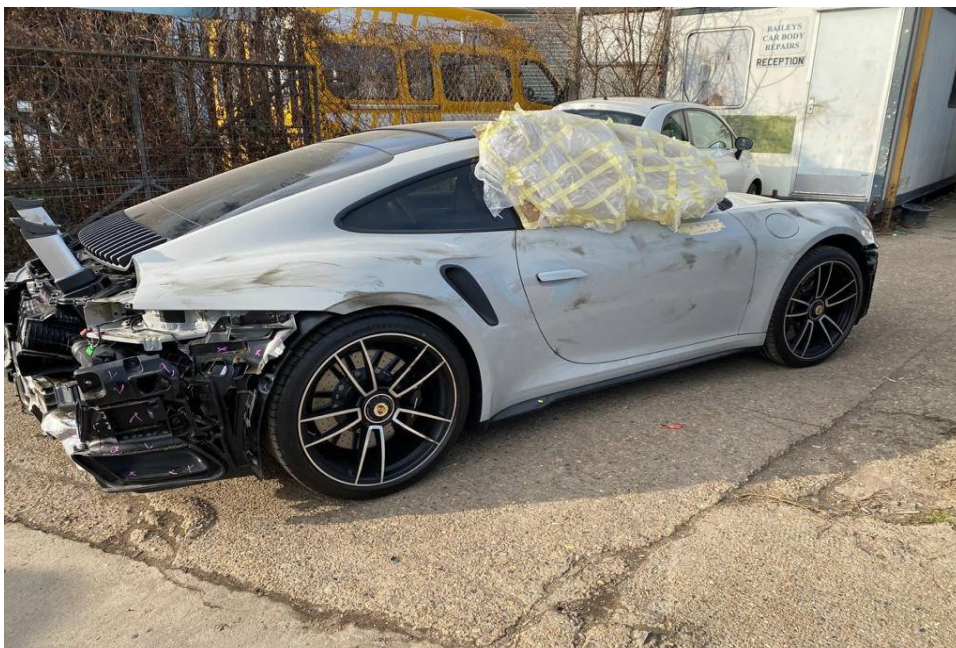
Photo 5 shows the right side body of the Motor Car (photograph provided to me). The right side portion of the Motor Car was seen to be unaffected except for the front right door window glass, which was observed to be shattered (refer to photograph 6 below).

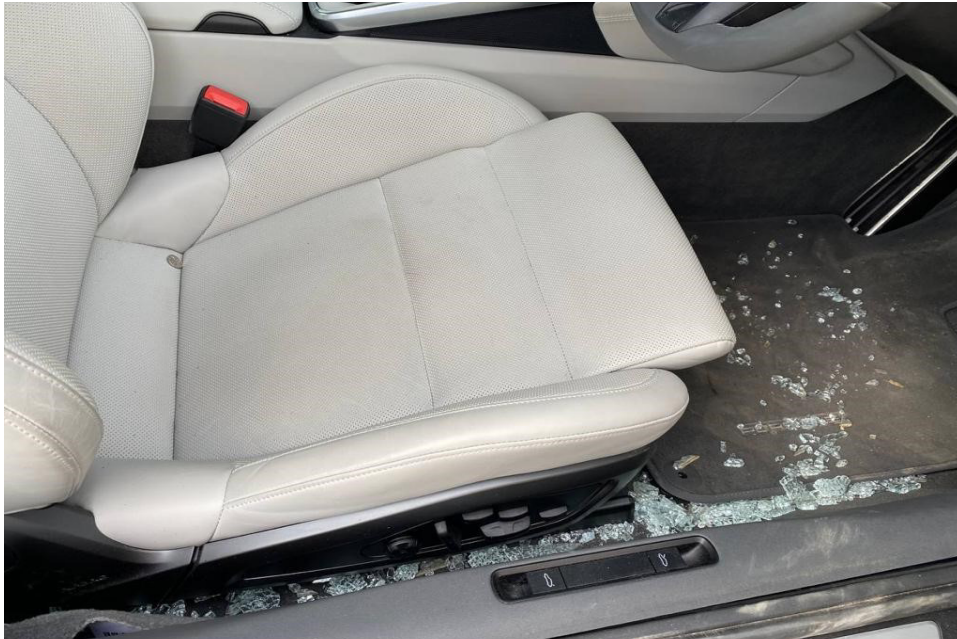
Photo 6 shows the interior compartment of the Motor Car (photograph provided to me). The various parts and components within the interior compartment were all intact and unaffected except for the front right door window glass, which was observed to be shattered.

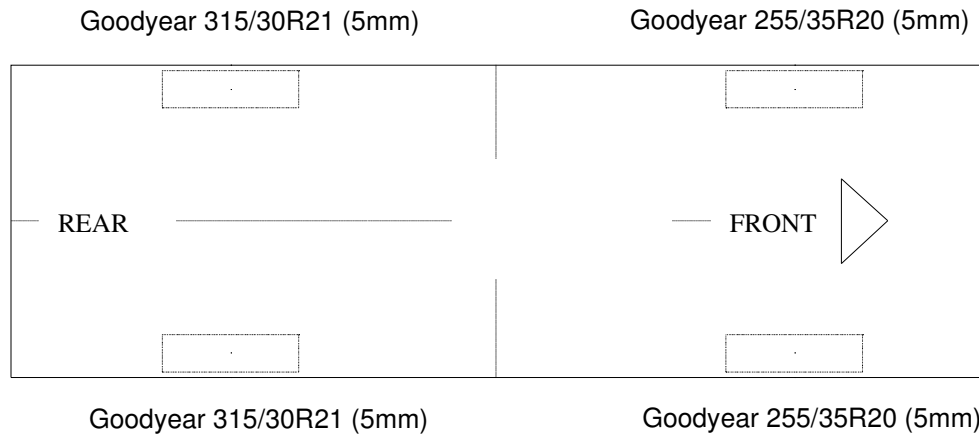
9. The Motor Car was fitted with 20inch (front) and 21inch (rear) sport wheel rims that were wrapped with tyres that were observed to be of serviceable condition. The tyres were also sufficiently inflated for vehicular operation. The tyre brand, tyre size and approximate remaining tread depth of the 4 tyres of the Motor Car were recorded as follows: -

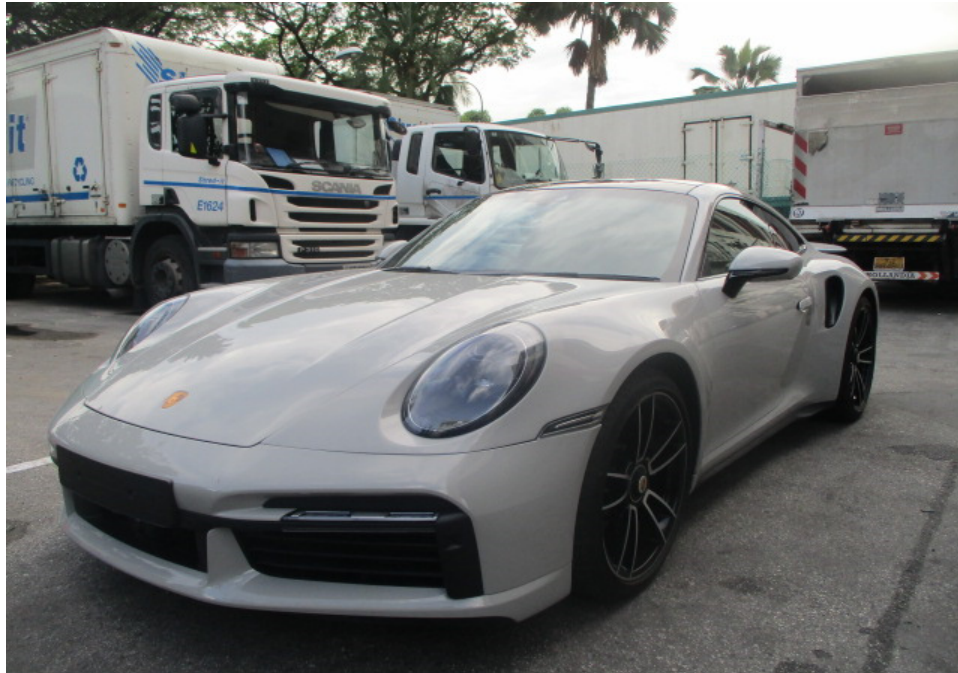
Photo 7 shows a general view of the front left body of the Motor Car at the time of my inspection. The Motor Car was observed to be in a relatively good general condition with no loose exterior fittings observed. The body parts at the frontal portion of the Motor Car were visually examined and it was observed that the repair/restoration works carried out to the damaged area of the Motor Car (refer to photograph 1 & 2 above) were reasonably adequate and in order.

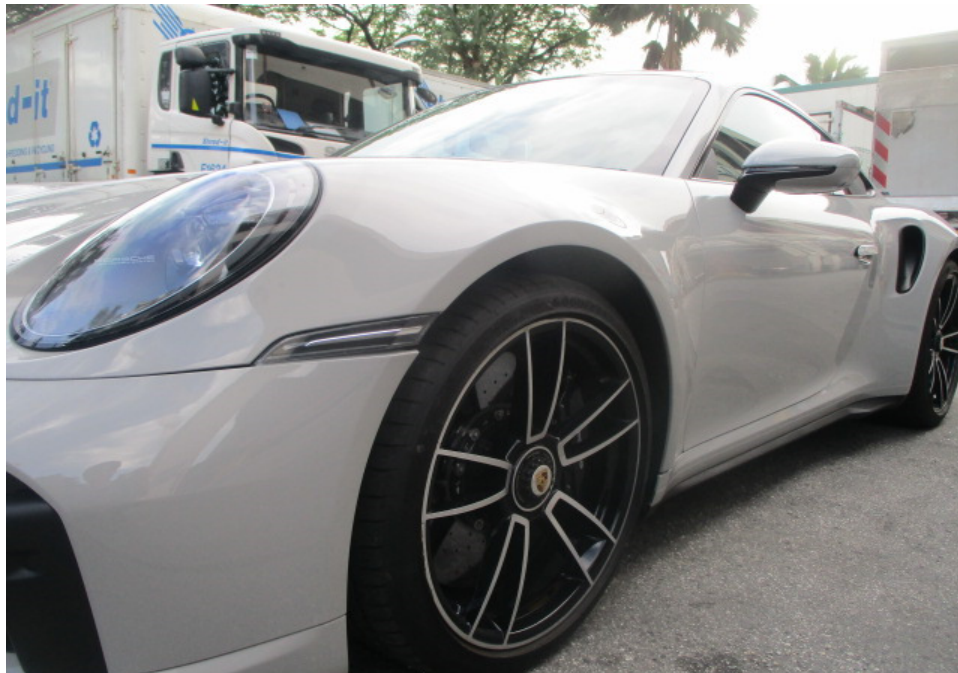
Photo 8 shows a closer view of the Motor Car's front left headlamp, front left signal lamp, front left fender and front left wheel rim. The body parts at the frontal portion of the Motor Car were visually examined and it was observed that the repair/restoration works carried out to the damaged area of the Motor Car (refer to photograph 1 & 2 above) were reasonably adequate and in order.

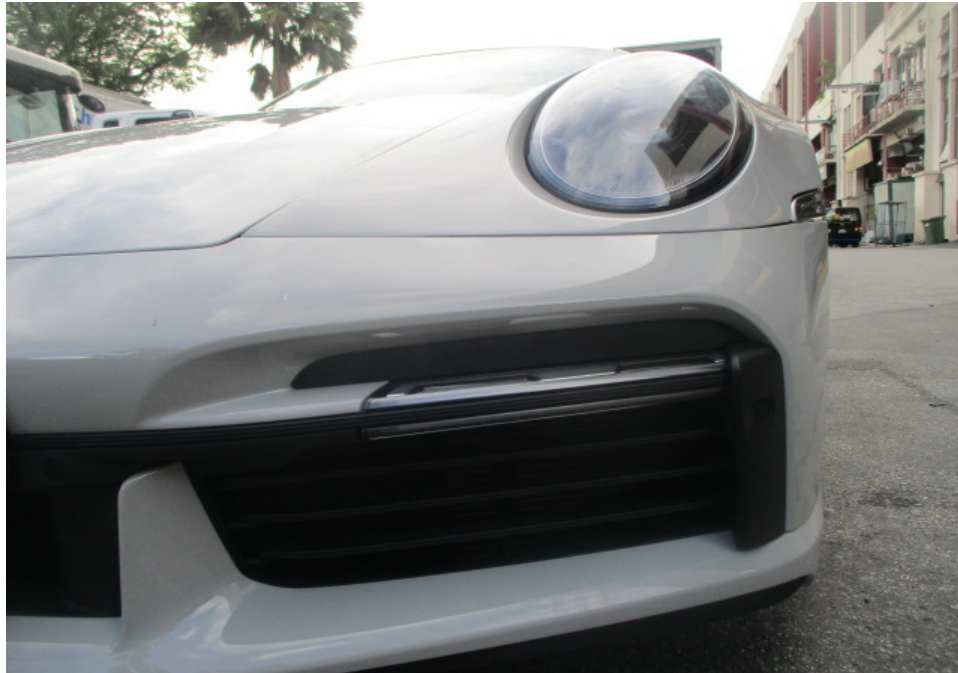
Photo 9 shows a closer view of the Motor Car's front bumper, front bumper left lower grille, front left day light and front left headlamp. The body parts at the frontal portion of the Motor Car were visually examined and it was observed that the repair/restoration works carried out to the damaged area of the Motor Car (refer to photograph 1 & 2 above) were reasonably adequate and in order.

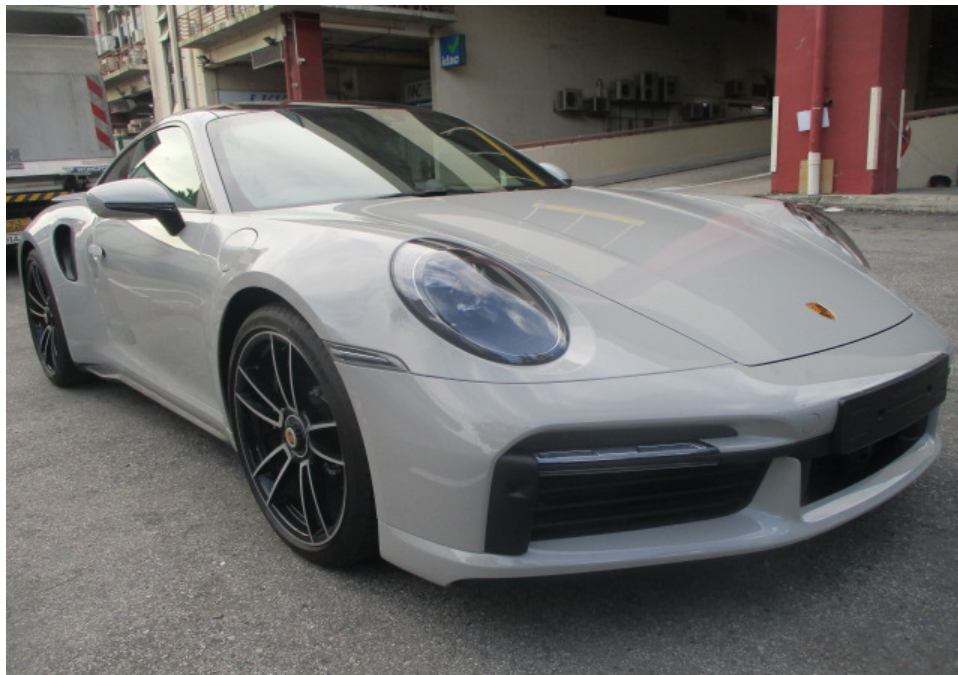
Photo 10 shows a general view of the front right body of the Motor Car at the time of my inspection. The Motor Car was observed to be in a relatively good general condition with no loose exterior fittings observed. The body parts at the frontal portion of the Motor Car were visually examined and it was observed that the repair/restoration works carried out to the damaged area of the Motor Car (refer to photograph 3 above) were reasonably adequate and in order.

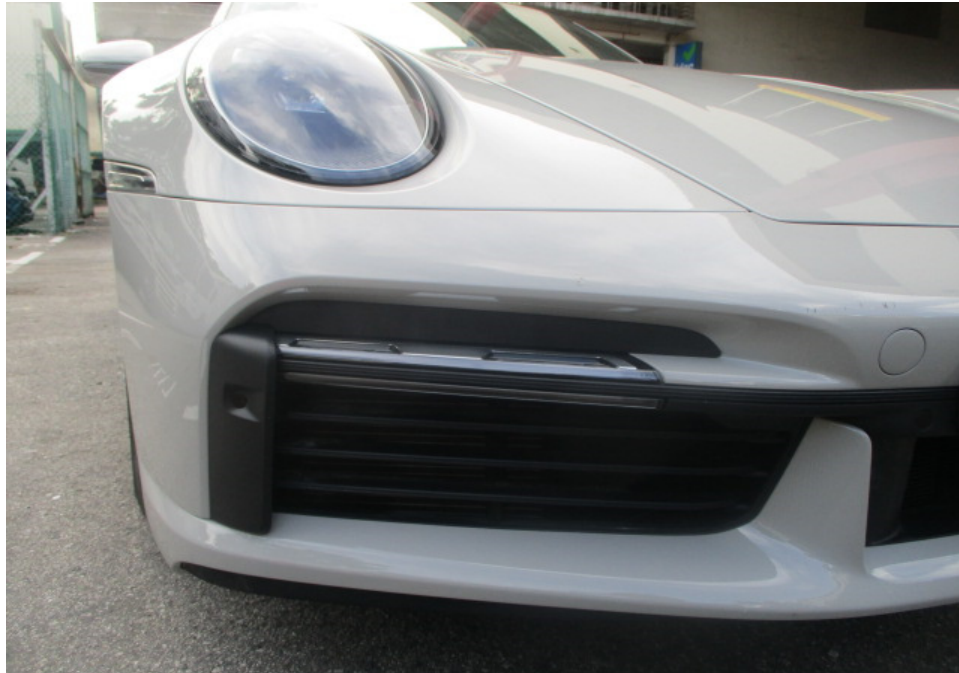
Photo 11 shows a closer view of the Motor Car's front bumper, front bumper right lower grille, front right day light, front right signal lamp and front right headlamp. The body parts at the frontal portion of the Motor Car were visually examined and it was observed that the repair/restoration works carried out to the damaged area of the Motor Car (refer to photograph 3 above) were reasonably adequate and in order.

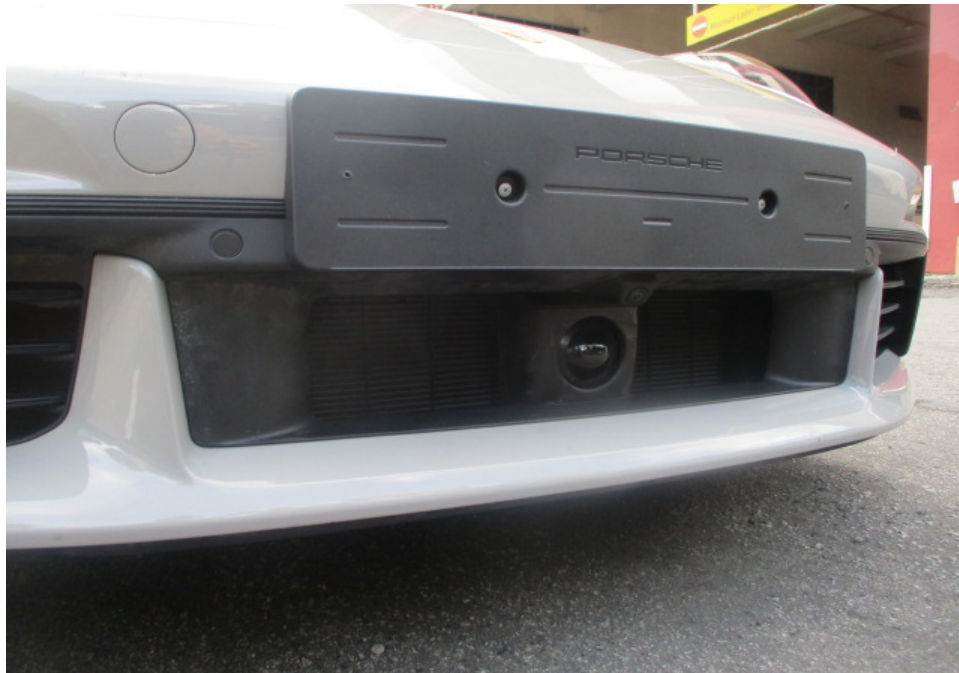
Photo 12 shows a closer view of the Motor Car's front bumper, front bumper sensors and front bumper centre lower air guide. The body parts at the frontal portion of the Motor Car were visually examined and it was observed that the repair/restoration works carried out to the damaged area of the Motor Car (refer to photograph 3 above) were reasonably adequate and in order.

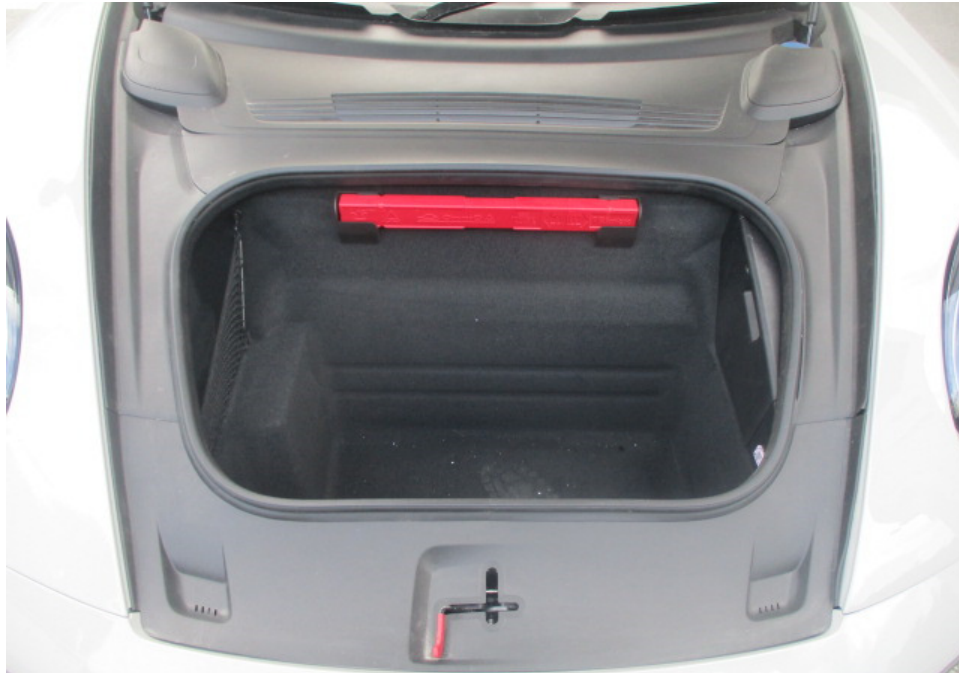
Photo 13 shows a general view of the Motor Car's front bonnet compartment at the time of my inspection. All inner trims, garnishes and upholstery etc were observed to be properly fitted.

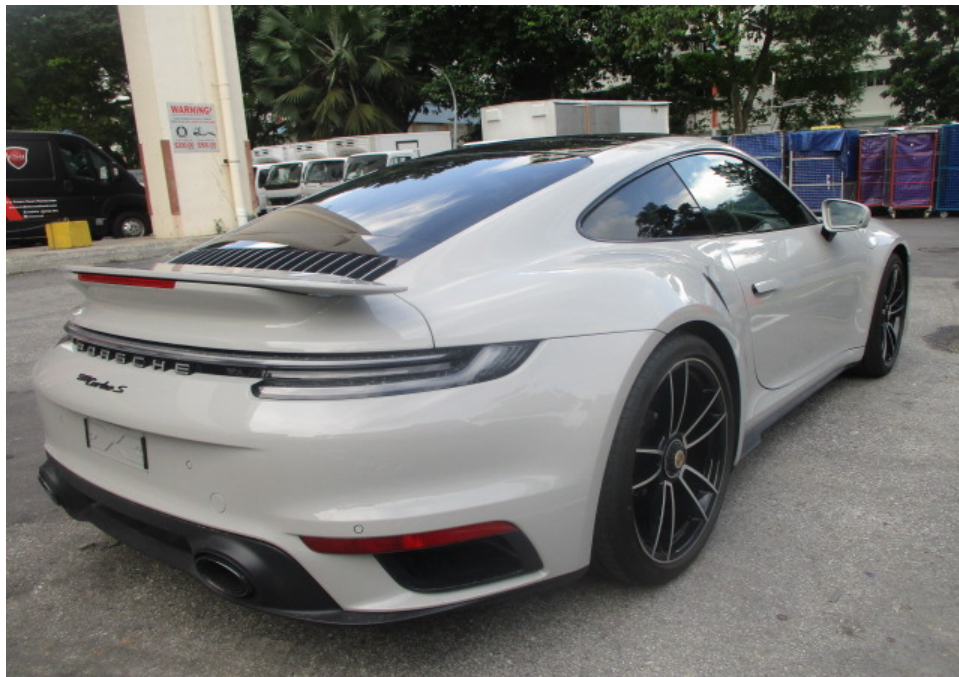
Photo 14 shows a general view of the rear right body of the Motor Car at the time of my inspection. The Motor Car was observed to be in a relatively good general condition with no loose exterior fittings observed. The body parts at the rear portion of the Motor Car were visually examined and it was observed that the repair/restoration works carried out to the damaged area of the Motor Car (refer to photograph 4 & 5 above) were reasonably adequate and in order.

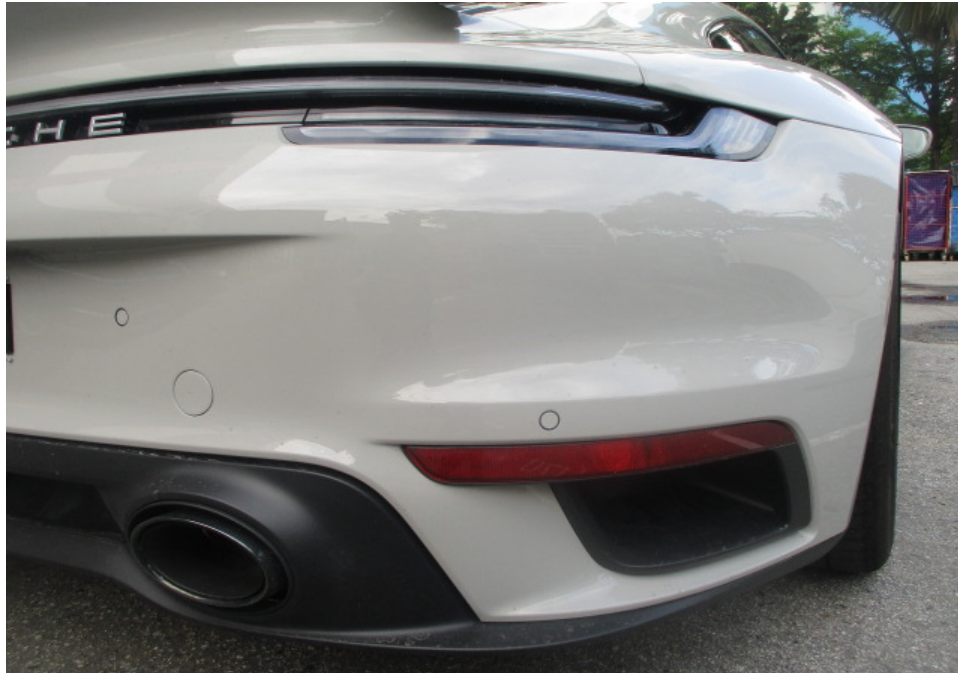
Photo 15 shows a closer view of the Motor Car's rear bumper, rear bumper lower cover, rear bumper tow cover, rear bumper right reflector, rear bumper right air duct, rear right exhaust garnish and rear right taillamp. The body parts at the rear portion of the Motor Car were visually examined and it was observed that the repair/restoration works carried out to the damaged area of the Motor Car (refer to photograph 4 & 5 above) were reasonably adequate and in order.

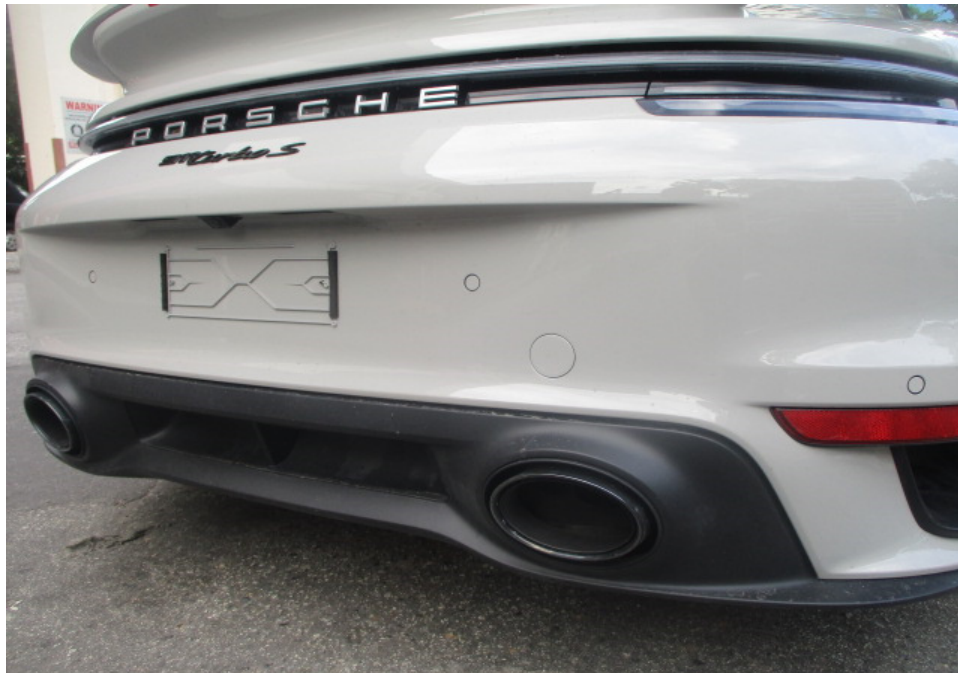
Photo 16 shows a closer view of the Motor Car's rear bumper, rear bumper lower cover, rear bumper sensors and rear centre top reflector. The body parts at the rear portion of the Motor Car were visually examined and it was observed that the repair/restoration works carried out to the damaged area of the Motor Car (refer to photograph 4 & 5 above) were reasonably adequate and in order.

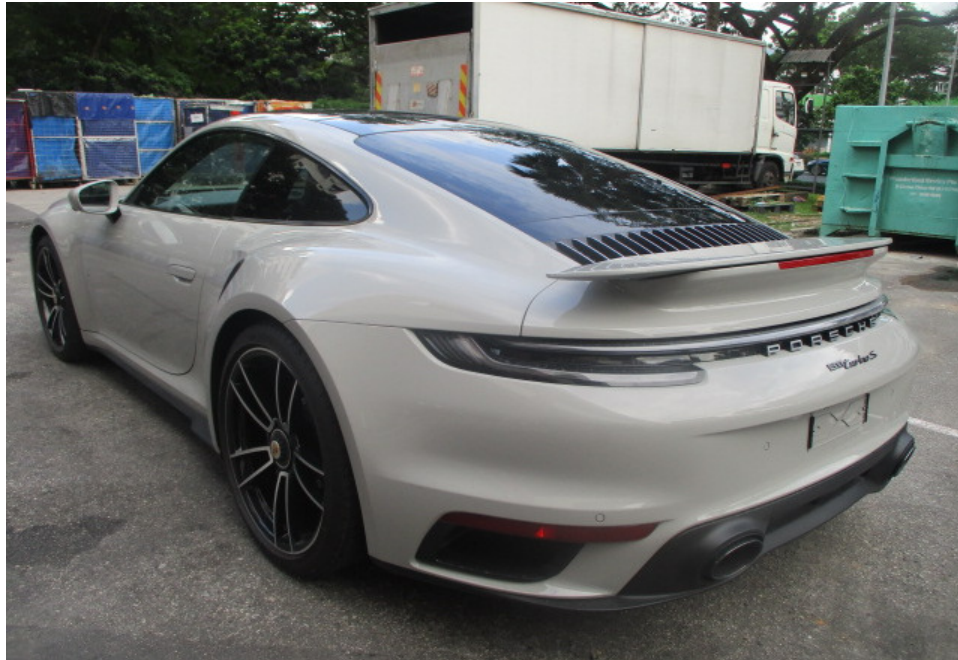
Photo 17 shows a general view of the rear left body of the Motor Car at the time of my inspection. The Motor Car was observed to be in a relatively good general condition with no loose exterior fittings observed. The body parts at the rear portion of the Motor Car were visually examined and it was observed that the repair/restoration works carried out to the damaged area of the Motor Car (refer to photograph 4 above) were reasonably adequate and in order.

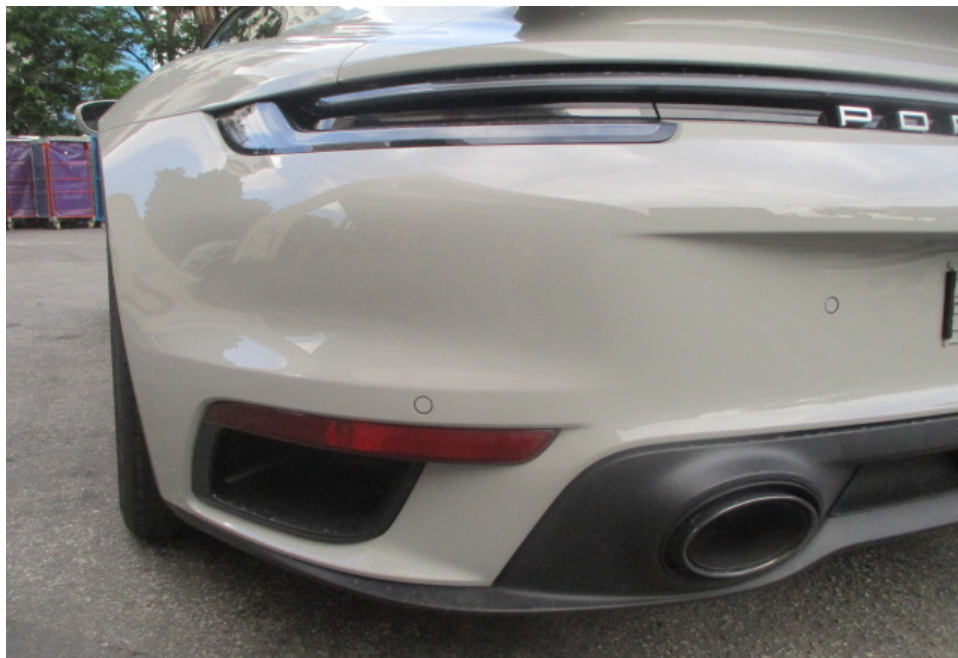
Photo 18 shows a closer view of the Motor Car's rear bumper, rear bumper lower cover, rear bumper left sensors, rear bumper left reflector, rear bumper left air duct, rear left exhaust garnish and rear left taillamp. The body parts at the rear portion of the Motor Car were visually examined and it was observed that the repair/restoration works carried out to the damaged area of the Motor Car (refer to photograph 4 above) were reasonably adequate and in order.

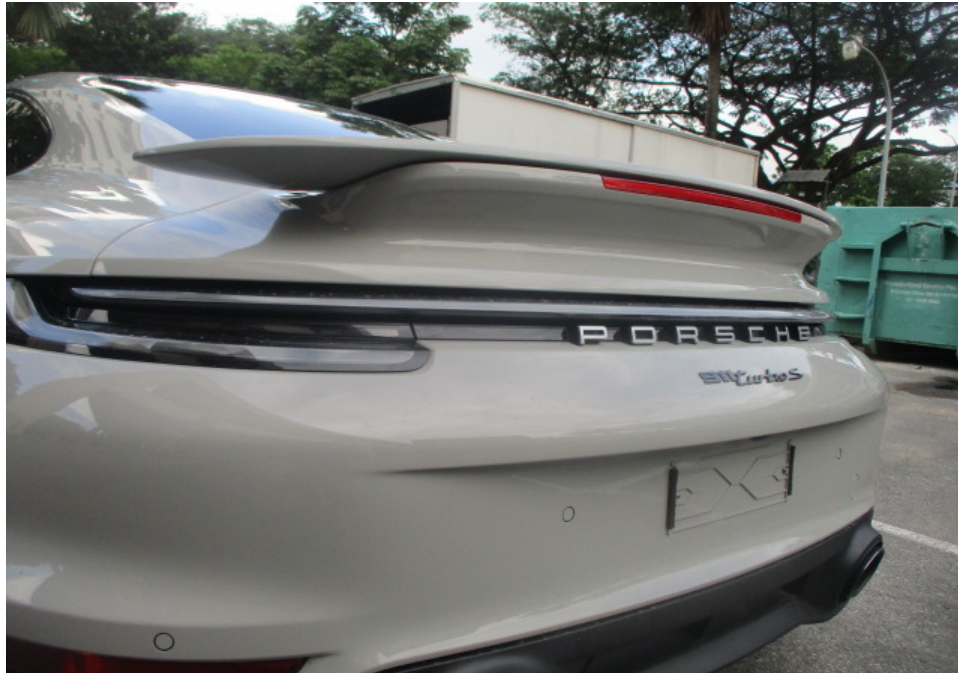
Photo 19 shows a closer view of the Motor Car's rear bumper, rear left taillamp, rear centre top reflector, rear centre top panel, rear top spoiler and third brake light. The body parts at the rear portion of the Motor Car were visually examined and it was observed that the repair/restoration works carried out to the damaged area of the Motor Car (refer to photograph 4 above) were reasonably adequate and in order.

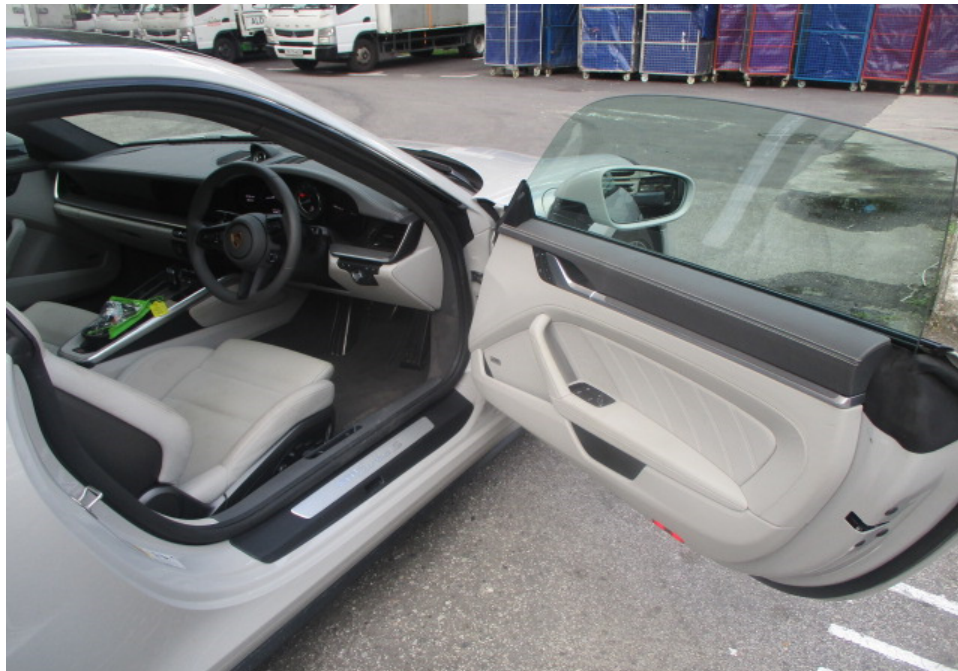
Photo 20 shows a closer view of the Motor Car's front right door inner trimboard and front right door window glass. The body parts at the right side portion of the Motor Car were visually examined and it was observed that the repair/restoration works carried out to the damaged area of the Motor Car (refer to photograph 6 above) were reasonably adequate and in order.

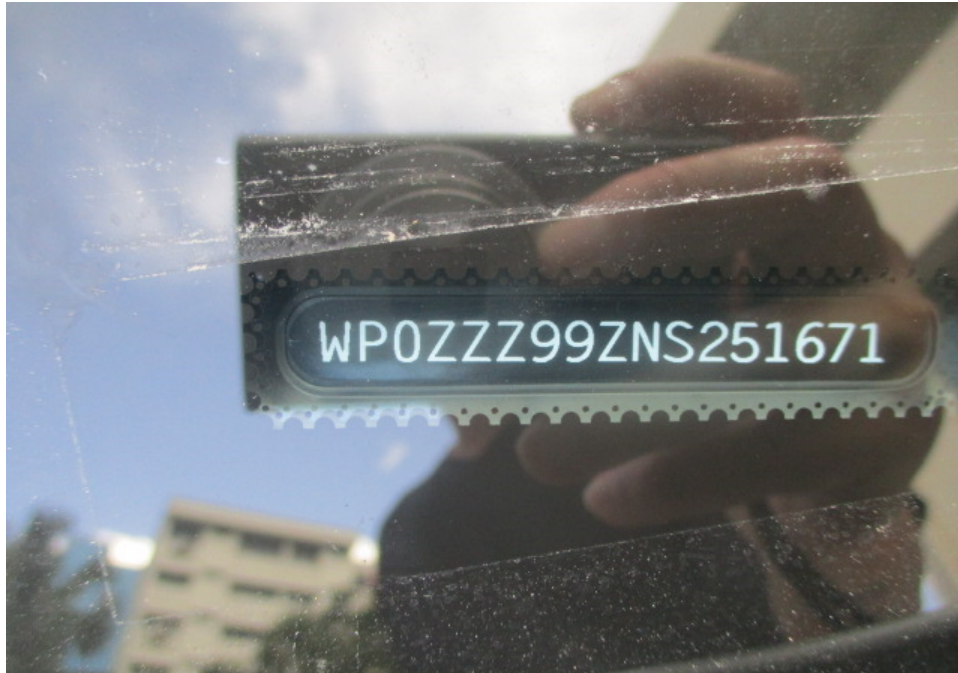
Photo 21 shows the chassis number of the Motor Car. The chassis number recorded was number WP0ZZZ99ZNS251671.

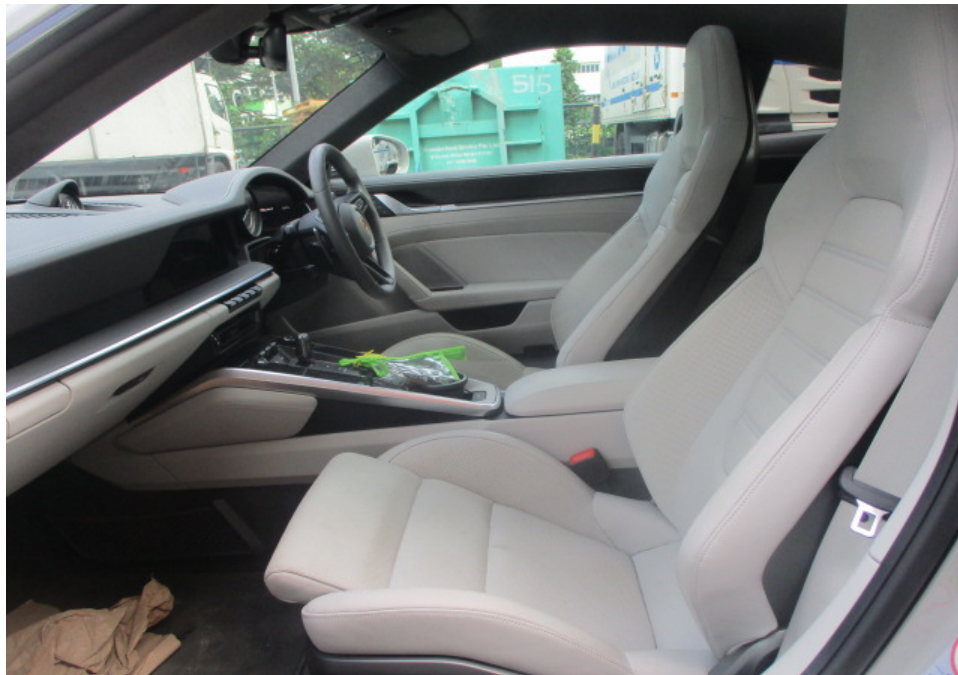
Photo 22 shows the interior compartment of the Motor Car. The front dashboard, steering wheel, seats, upholstery and trims etc were all observed to be intact and properly fitted.

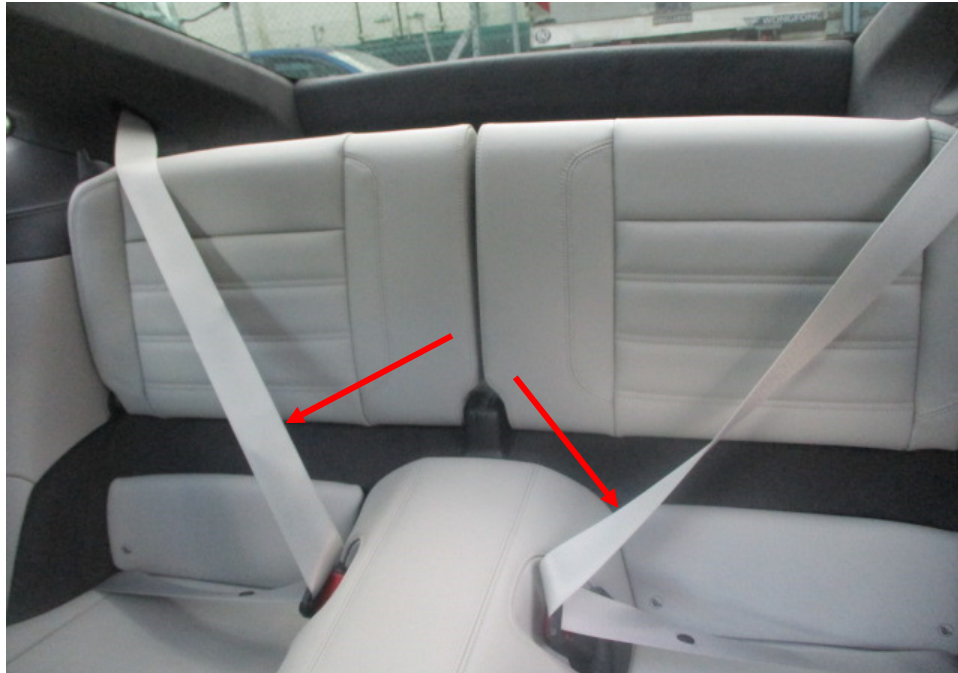
Photo 23 shows the rear seats of the Motor Car. All the seats of the Motor Car were secured via seat rails to the floorboard. They were also fitted with a retractable seat belt reel and a pre-tensioner. The seat belts (arrowed) were tested and were able to be fastened into the respective pre-tensions that were fitted on the side of each individual seat.

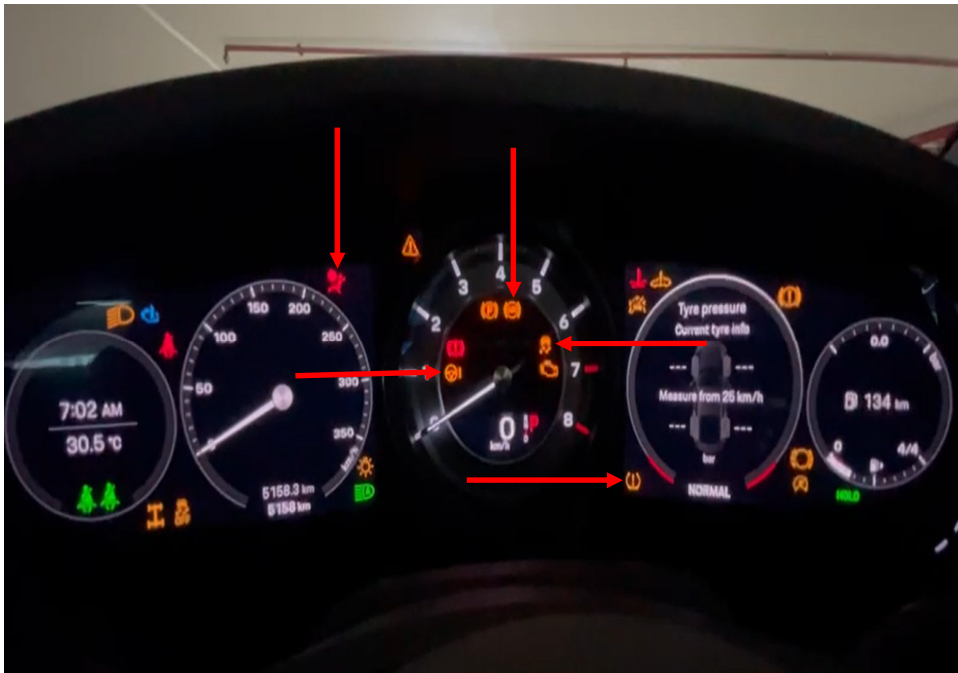
Photo 24 shows the warning lights for the various electronic safety features appearing on the instrument panel of the Motor Car during its self-test when the engine is cranked, in particular the ABS, SRS, EPS, TPM and TCS lights (arrowed).

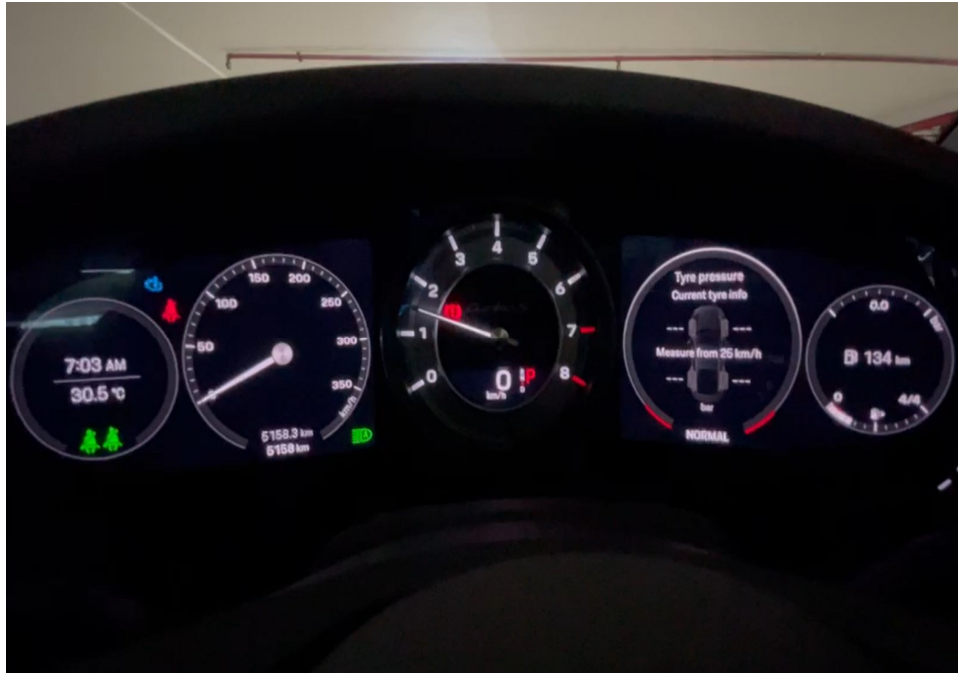
Photo 25 shows the respective warning lights no longer illuminated, indicating that there is no fault detected to the ABS, SRS, EPS, TPM and TCS systems of the Motor Car during the self-test. These electronic systems were hence in working condition at the time of my inspection.

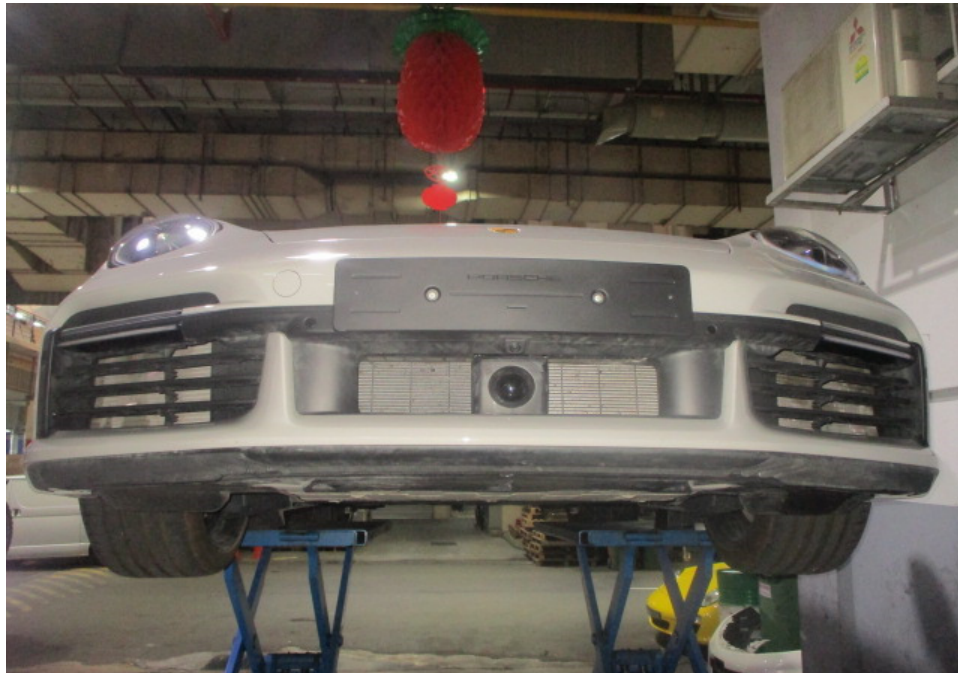
Photo 26 shows the Motor Car hoisted up for checks on its undercarriage. There was no sign(s) or indication(s) of fluid leakage and/or fluid stain(s) on the underside of the Motor Car. The undercarriage components of the Motor Car were also all observed to be intact and secured in an appropriate manner.

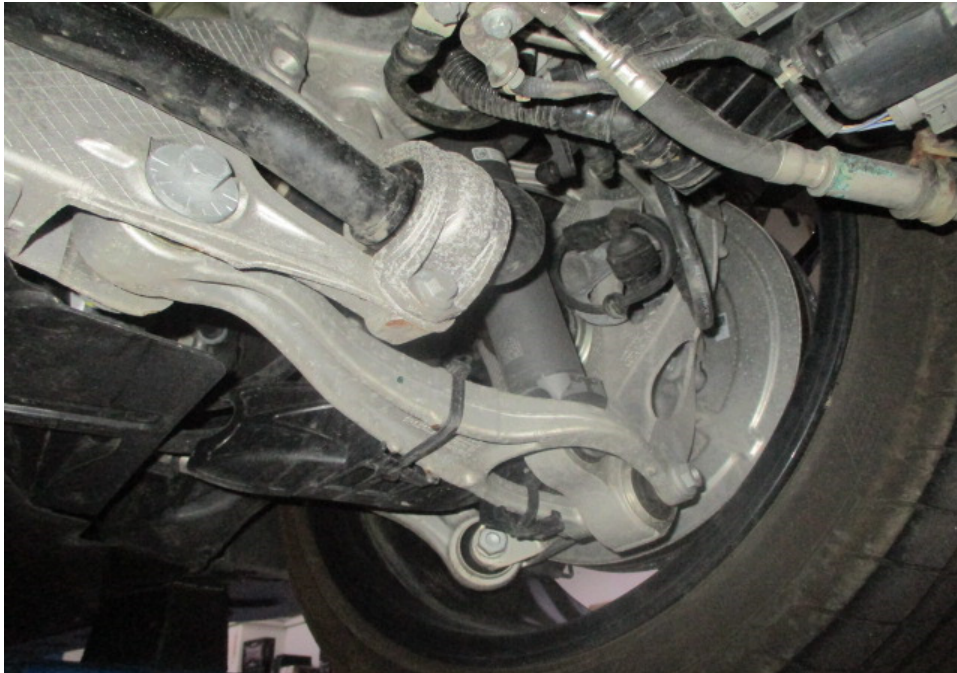
Photo 27 shows a general view of the control arms and linkages at the rear right wheel of the Motor Car. I did not observe any fluid leak and/or fluid stain on the underside of the Motor Car. All of the Motor Car's undercarriage components were observed to be intact and secured in an appropriate manner.

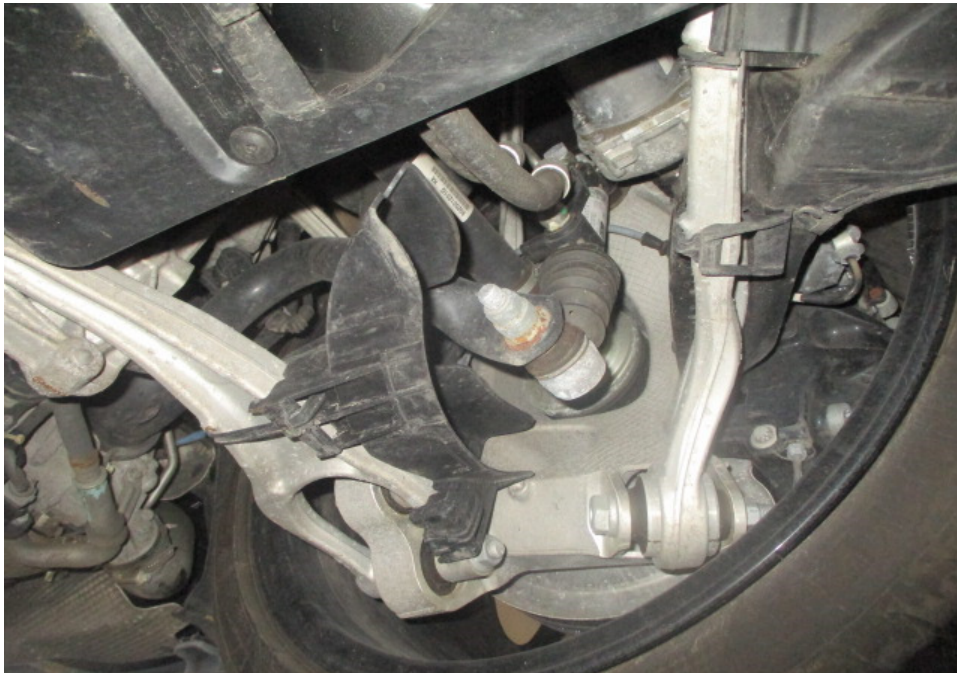
Photo 28 shows a general view of the control arms and linkages at the rear left wheel of the Motor Car. I did not observe any fluid leak and/or fluid stain on the underside of the Motor Car. All of the Motor Car's undercarriage components were observed to be intact and secured in an appropriate manner.

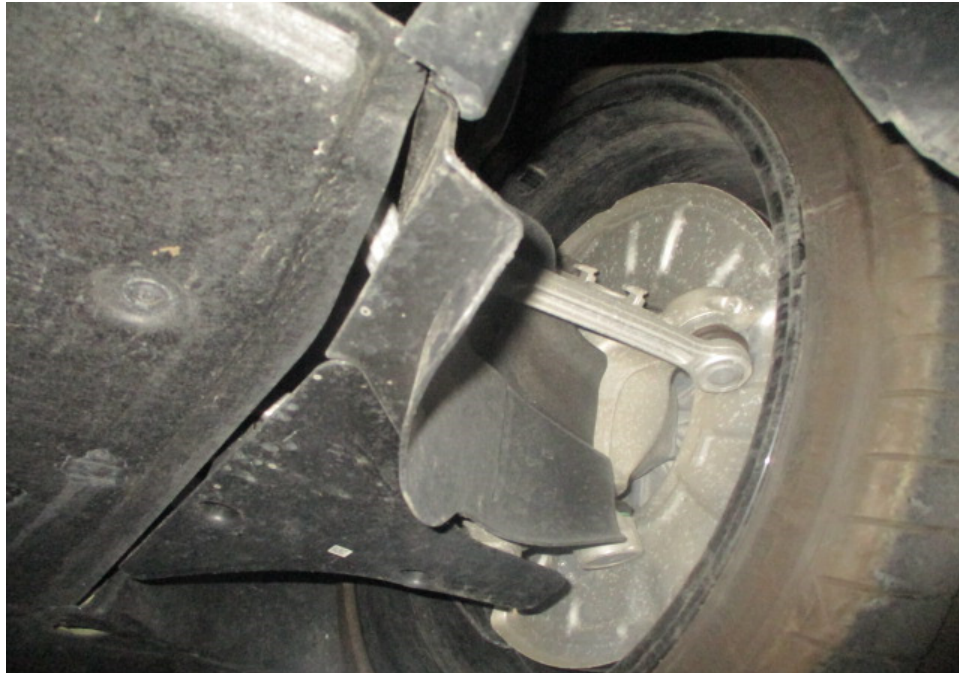
Photo 29 shows a general view of the control arms and linkages at the front left wheel of the Motor Car. I did not observe any fluid leak and/or fluid stain on the underside of the Motor Car. All of the Motor Car's undercarriage components were observed to be intact and secured in an appropriate manner.

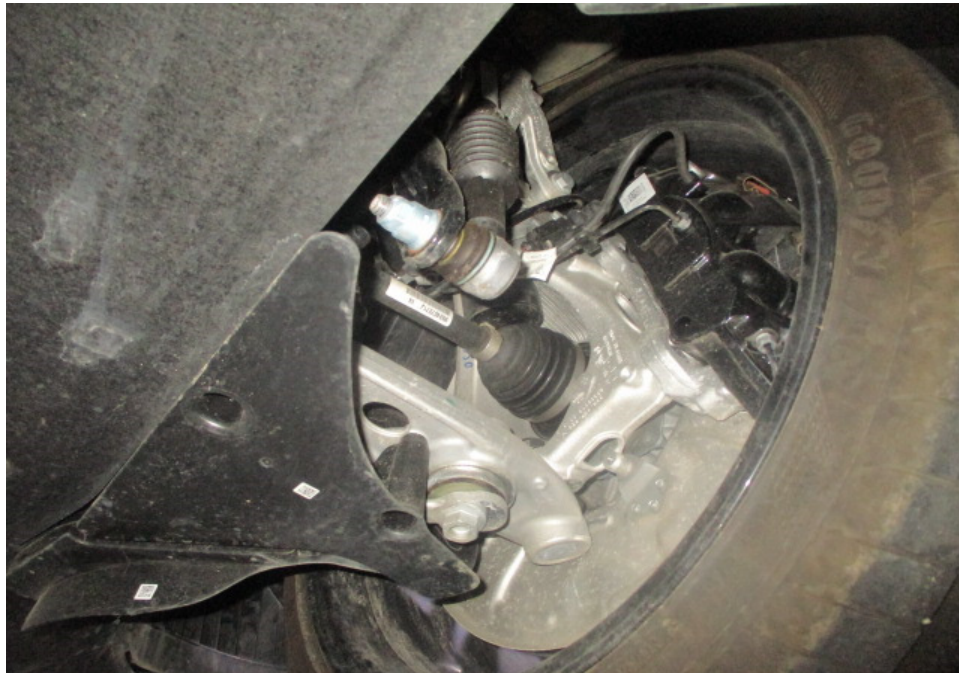
Photo 30 shows the various undercarriage components at the front right wheel of the Motor Car. The mechanical components, control arms and linkages were all found to be intact and secured in an appropriate manner. I also did not observe any fluid leak and/or fluid stain on the underside of the Motor Car.
