Your Ref: Porsche 911 Turbo S
(chassis number WP0ZZZ99ZNS251671)
Our Ref : CI/TP23004881/D

11 May 2023

**INSPECTION REPORT OF AN UNREGISTERED PORSCHE 911 TURBO S
MOTOR CAR WITH CHASSIS NUMBER WP0ZZZ99ZNS251671**

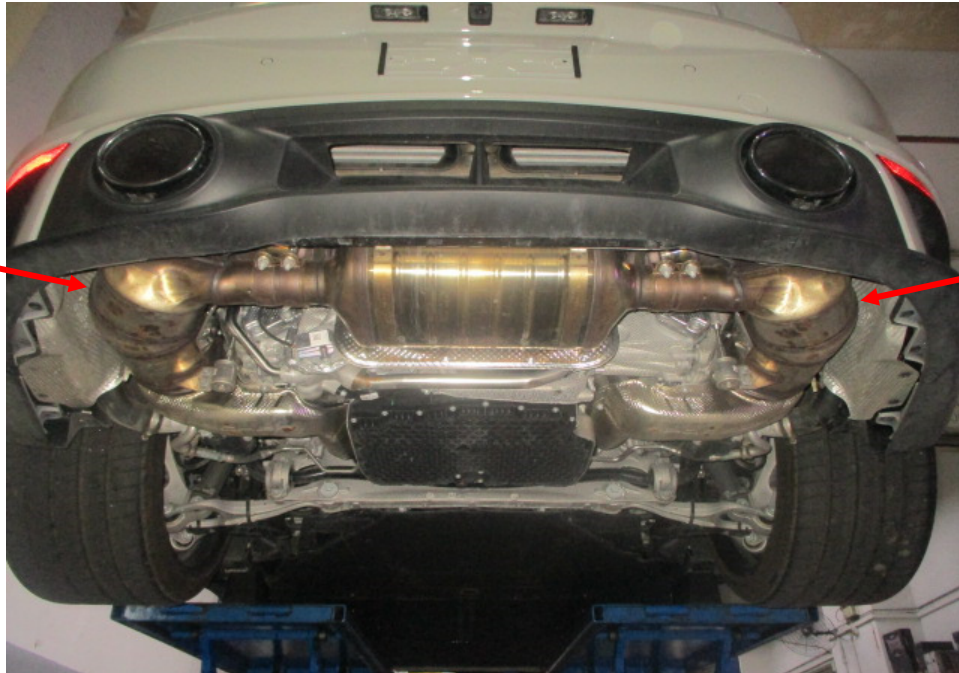
Photo 31 shows the Motor Car's exhaust system. My examination of the Motor Car's exhaust system revealed no sign(s) or indication(s) of any cut or weld marks along its exhaust pipes, on its catalytic converters (arrowed) and on its rear muffler.

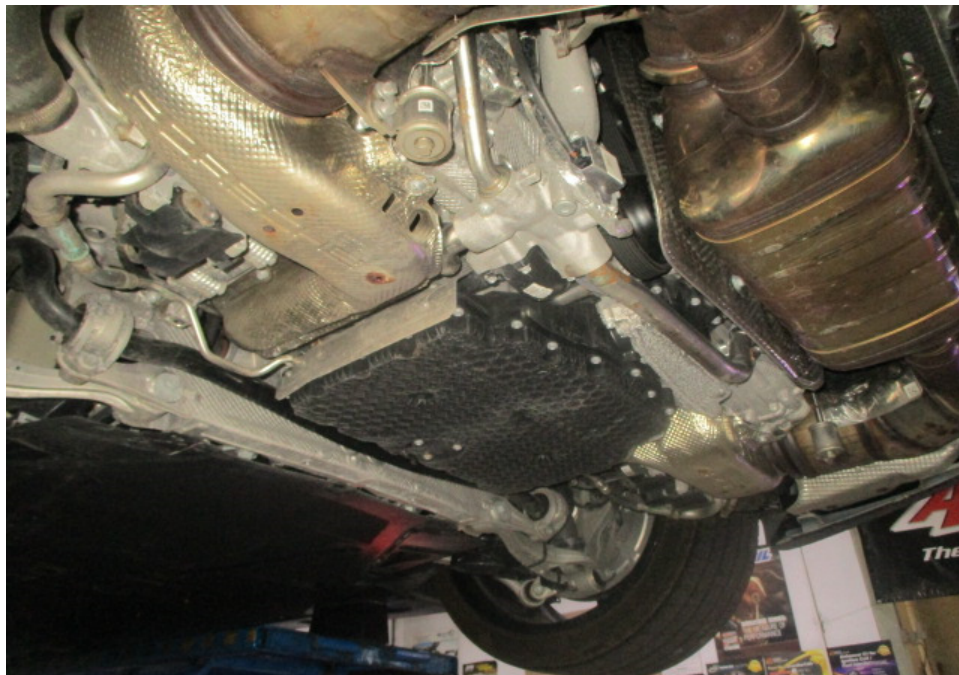
Photo 32 shows a general view of the Motor Car's engine compartment. The engine compartment was at the rear underside of the Motor Car. The various parts and components inside the engine compartment were all observed to be intact and properly fitted. There was also no sign(s) or indication(s) of fluid leak and/or fluid stain found inside the engine compartment.

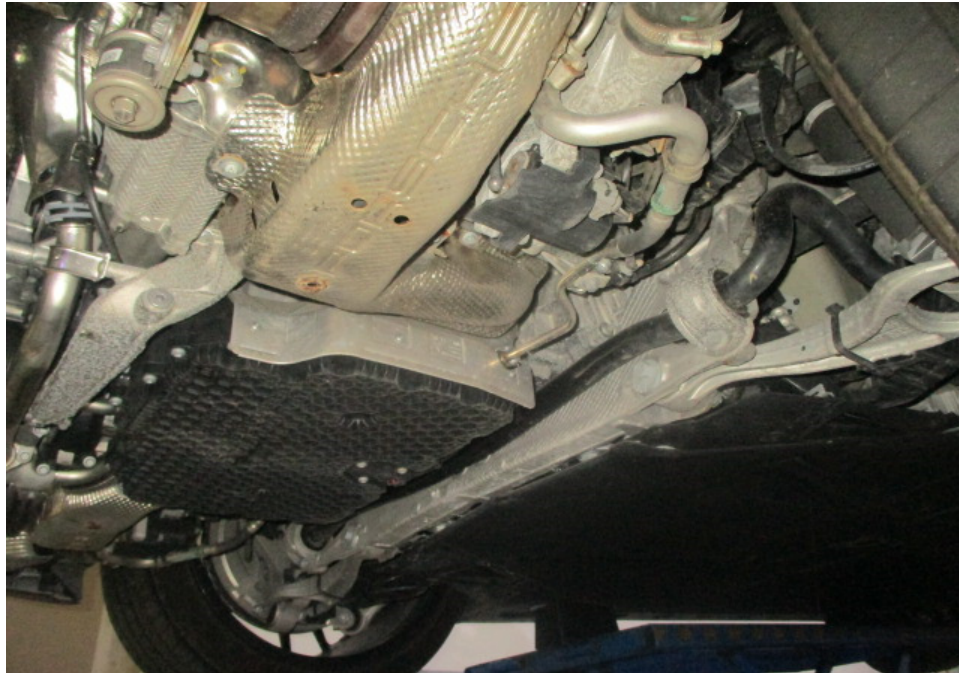
Photo 33 shows another view of the Motor Car's engine compartment. The engine compartment was at the rear underside of the Motor Car. The various parts and components inside the engine compartment were all observed to be intact and properly fitted. There was also no sign(s) or indication(s) of fluid leak and/or fluid stain found inside the engine compartment.

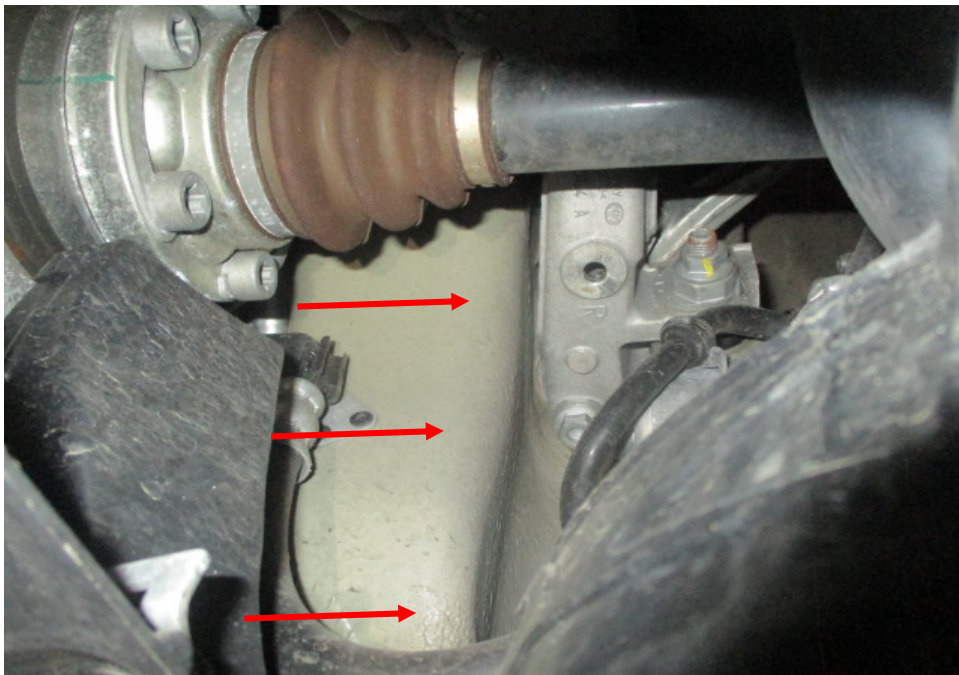
Photo 34 shows the chassis/structural body at the underside rear right of the Motor Car. I did not find any weld marks other than original spot weld marks on the chassis/structural body of the Motor Car. The original factory sealant (arrowed) at the joints along the chassis/structural body was untouched, indicating no work was done on the chassis/structural body of the Motor Car and that the chassis/structural body was originally fitted.

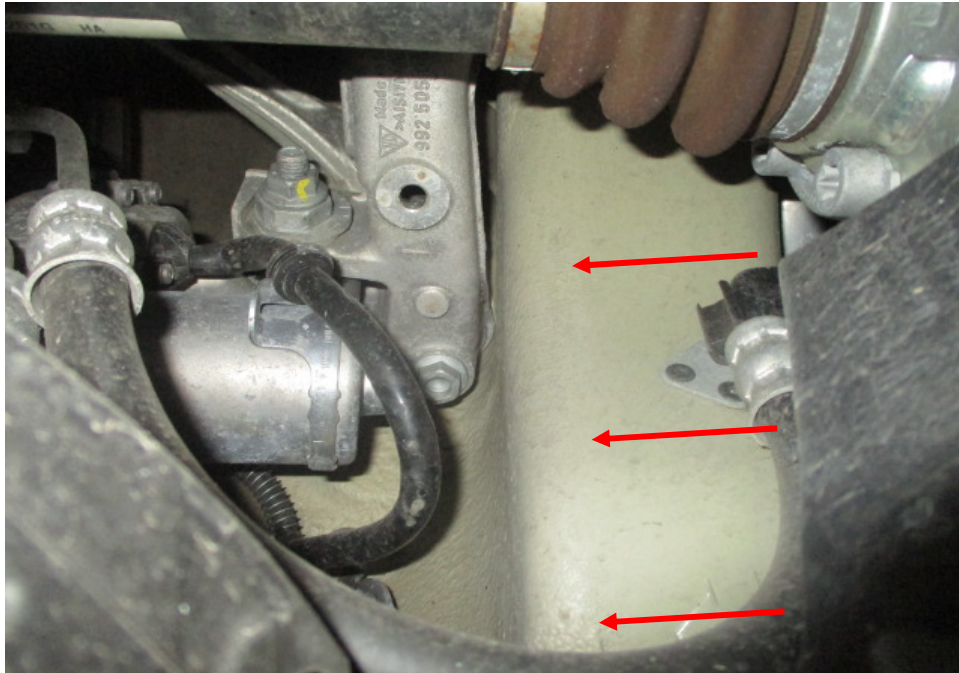
Photo 35 shows the chassis/structural body at the underside rear left of the Motor Car. I did not find any weld marks other than original spot weld marks on the chassis/structural body of the Motor Car. The original factory sealant (arrowed) at the joints along the chassis/structural body was untouched, indicating no work was done on the chassis/structural body of the Motor Car and that the chassis/structural body was originally fitted.

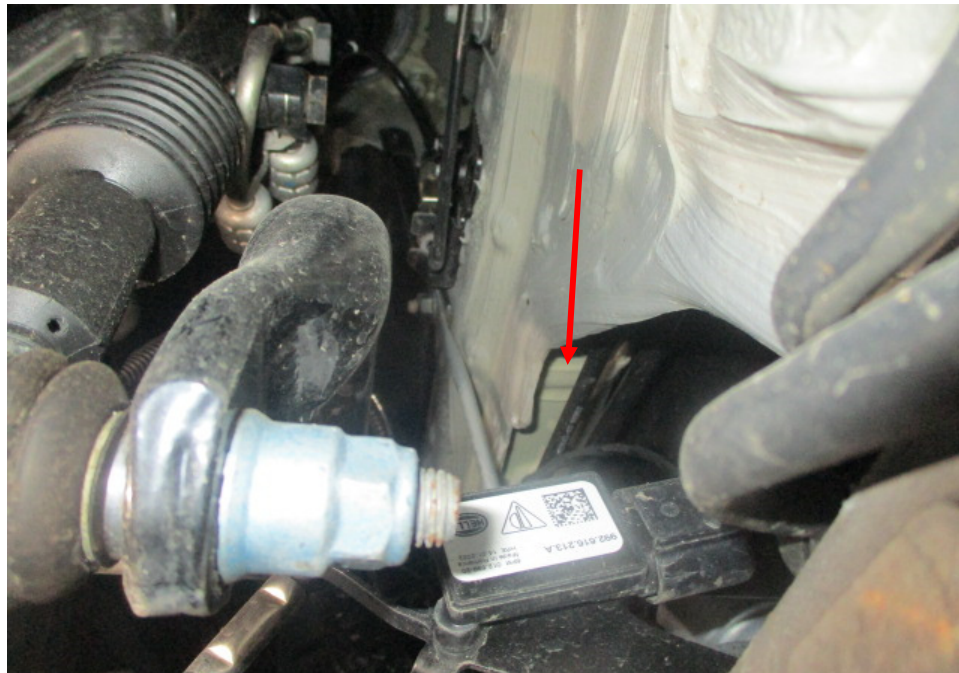
Photo 36 shows the chassis/structural body at the underside front left of the Motor Car. The original factory sealant (arrowed) at the joints along the chassis/structural body was observed to be untouched. In general, I had found no work was carried out on the chassis/structural body of the Motor Car. The chassis/structural body of the Motor Car was originally fitted.

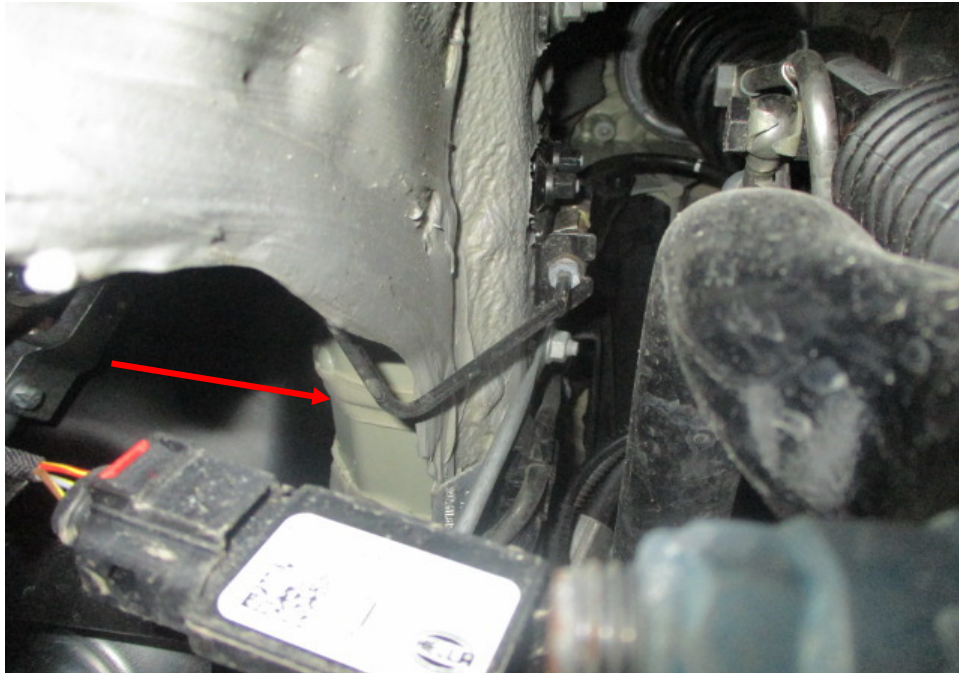
Photo 37 shows the chassis/structural body at the underside front right of the Motor Car. I did not find any weld marks other than original spot weld marks on the chassis/structural body of the Motor Car. The original factory sealant (arrowed) at the joints along the chassis/structural body was also untouched, indicating no work was done on the chassis/structural body of the Motor Car and that the chassis/structural body was originally fitted.
