Your Ref: Aston Martin Vantage Coupe
(chassis number SCFSLGAW4NGN06264)
Our Ref : CI/TP23004888/D

**INSPECTION REPORT OF AN UNREGISTERED ASTON MARTIN VANTAGE
COUPE MOTOR CAR WITH CHASSIS NUMBER SCFSLGAW4NGN06264**

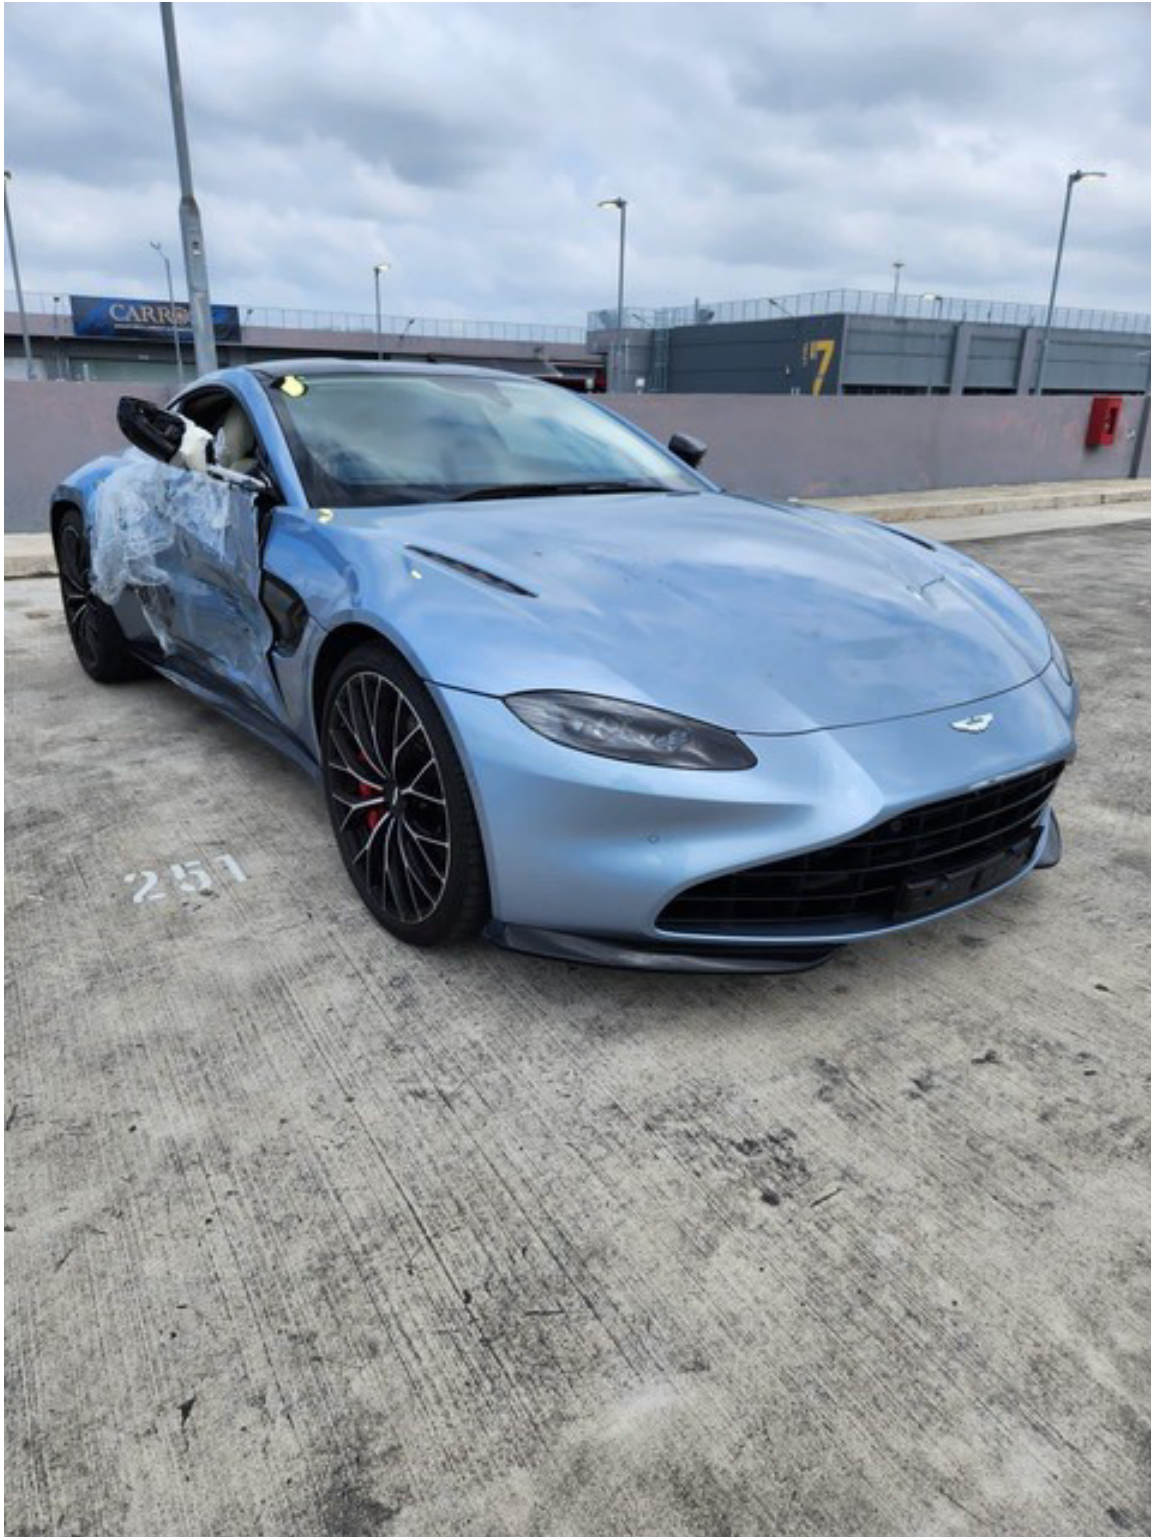
Photo 1 shows the front right body of the Motor Car (photograph provided to me). The Motor Car was observed to have sustained damage at its right side centre portion. The front right door, rear right body panel, rear right wheel rim and right side wing mirror were amongst the body parts that were observed to have been damaged.

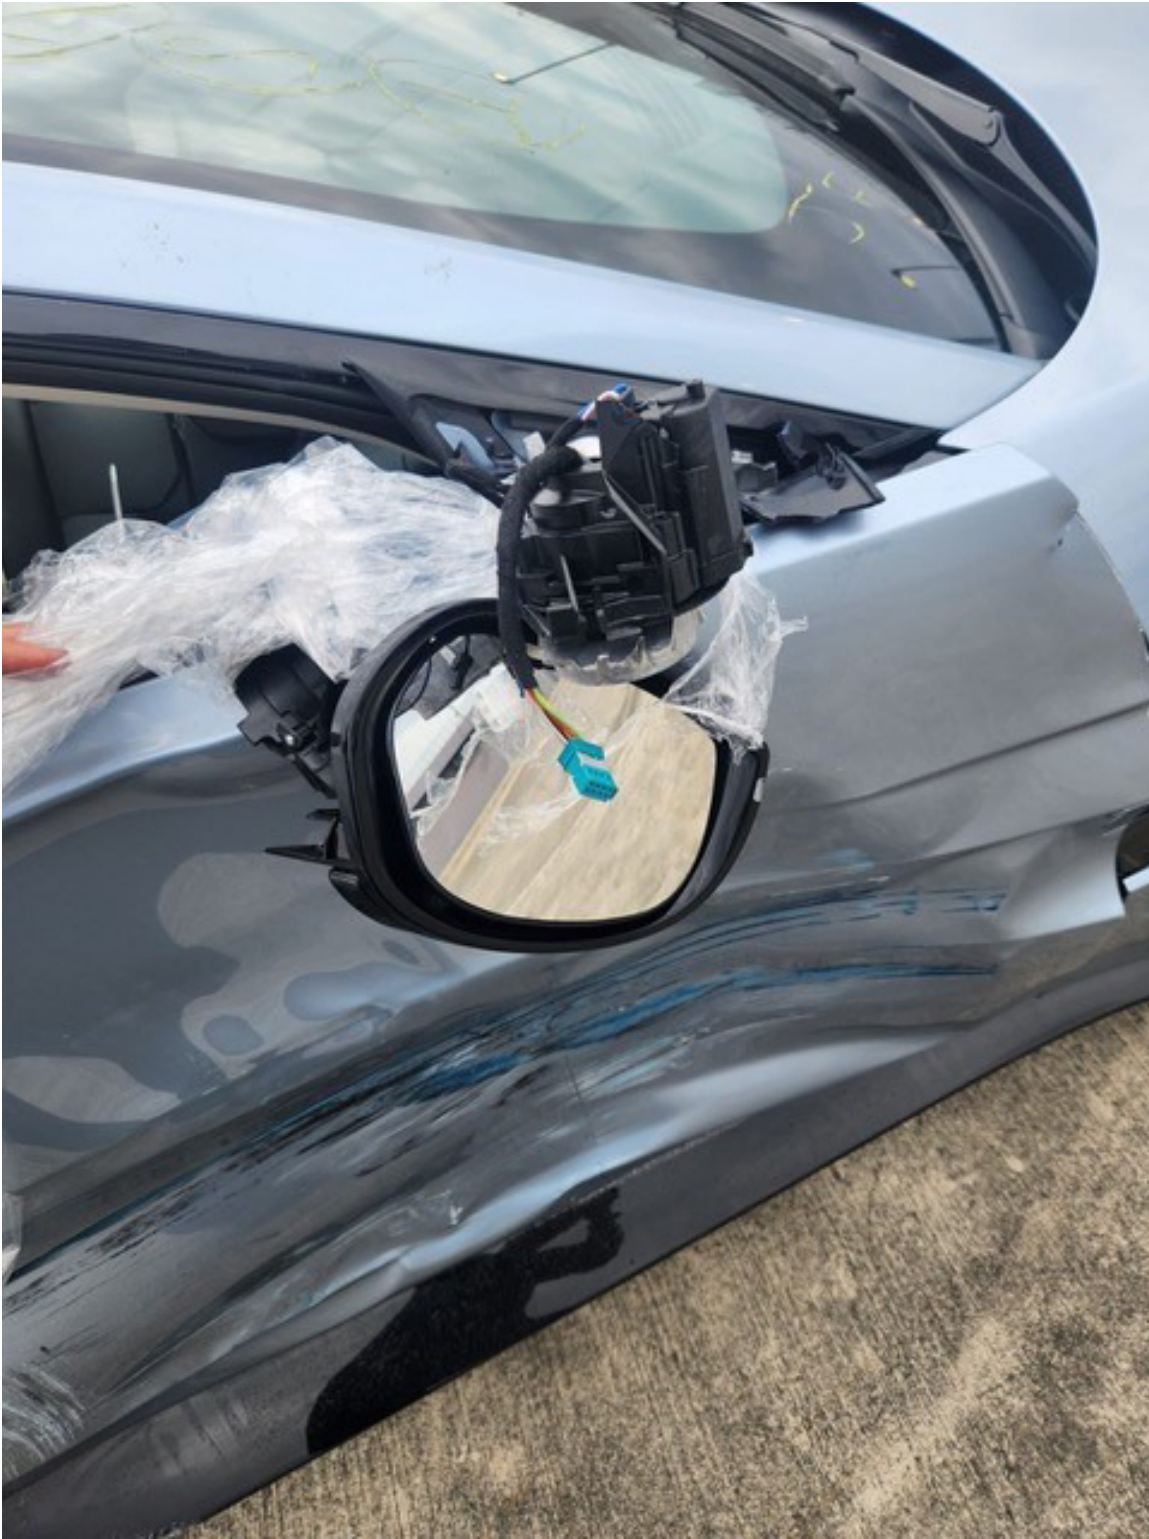
Photo 2 shows a closer view of the damage to the front right door and right side wing mirror of the Motor Car (photograph provided to me).

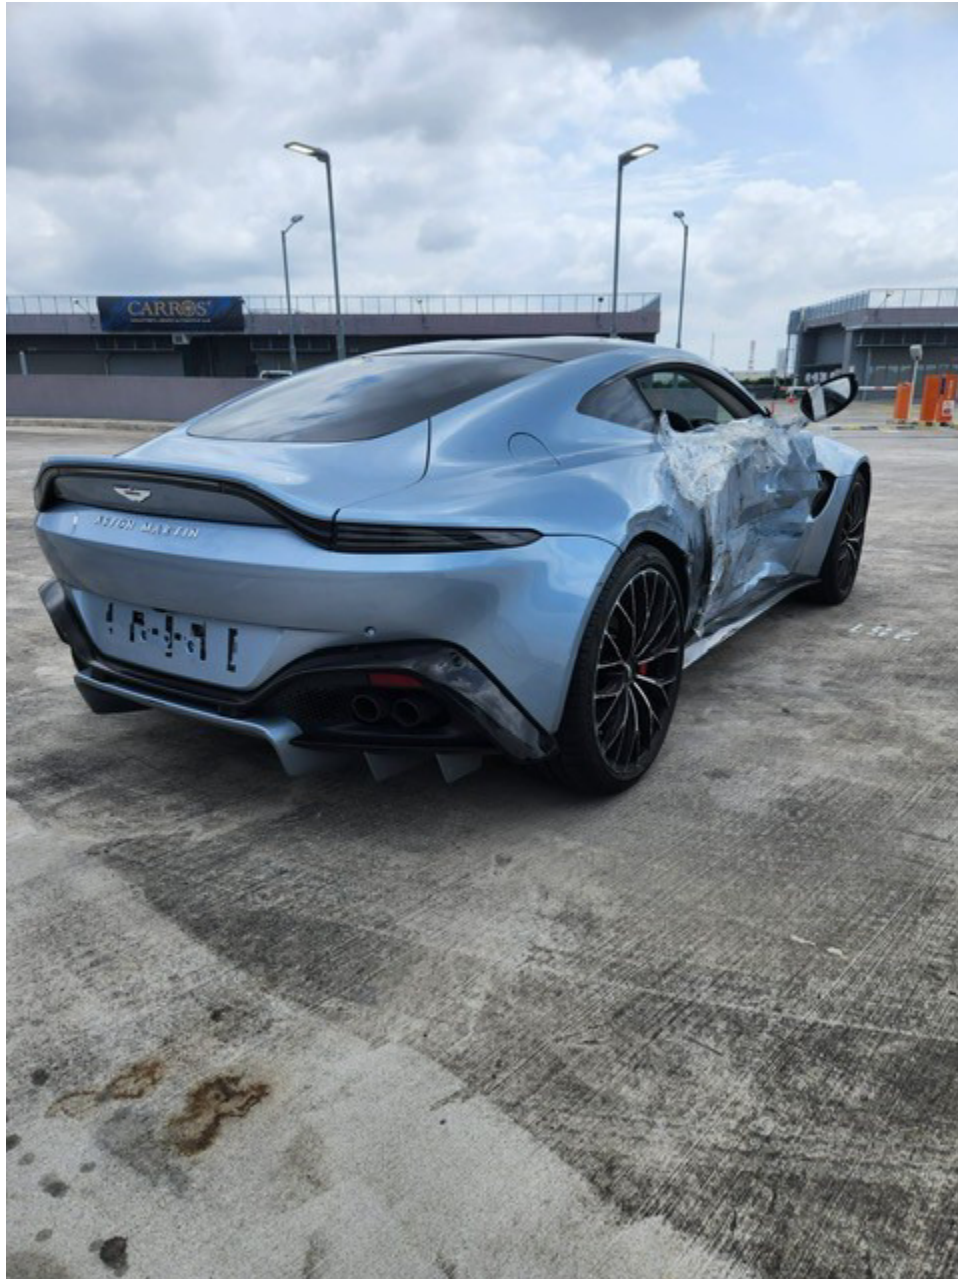
Photo 3 shows the rear right body of the Motor Car (photograph provided to me). The Motor Car was observed to have sustained damage at its right side centre portion. The front right door, rear right body panel, rear right wheel rim and right side wing mirror were amongst the body parts that were observed to have been damaged.

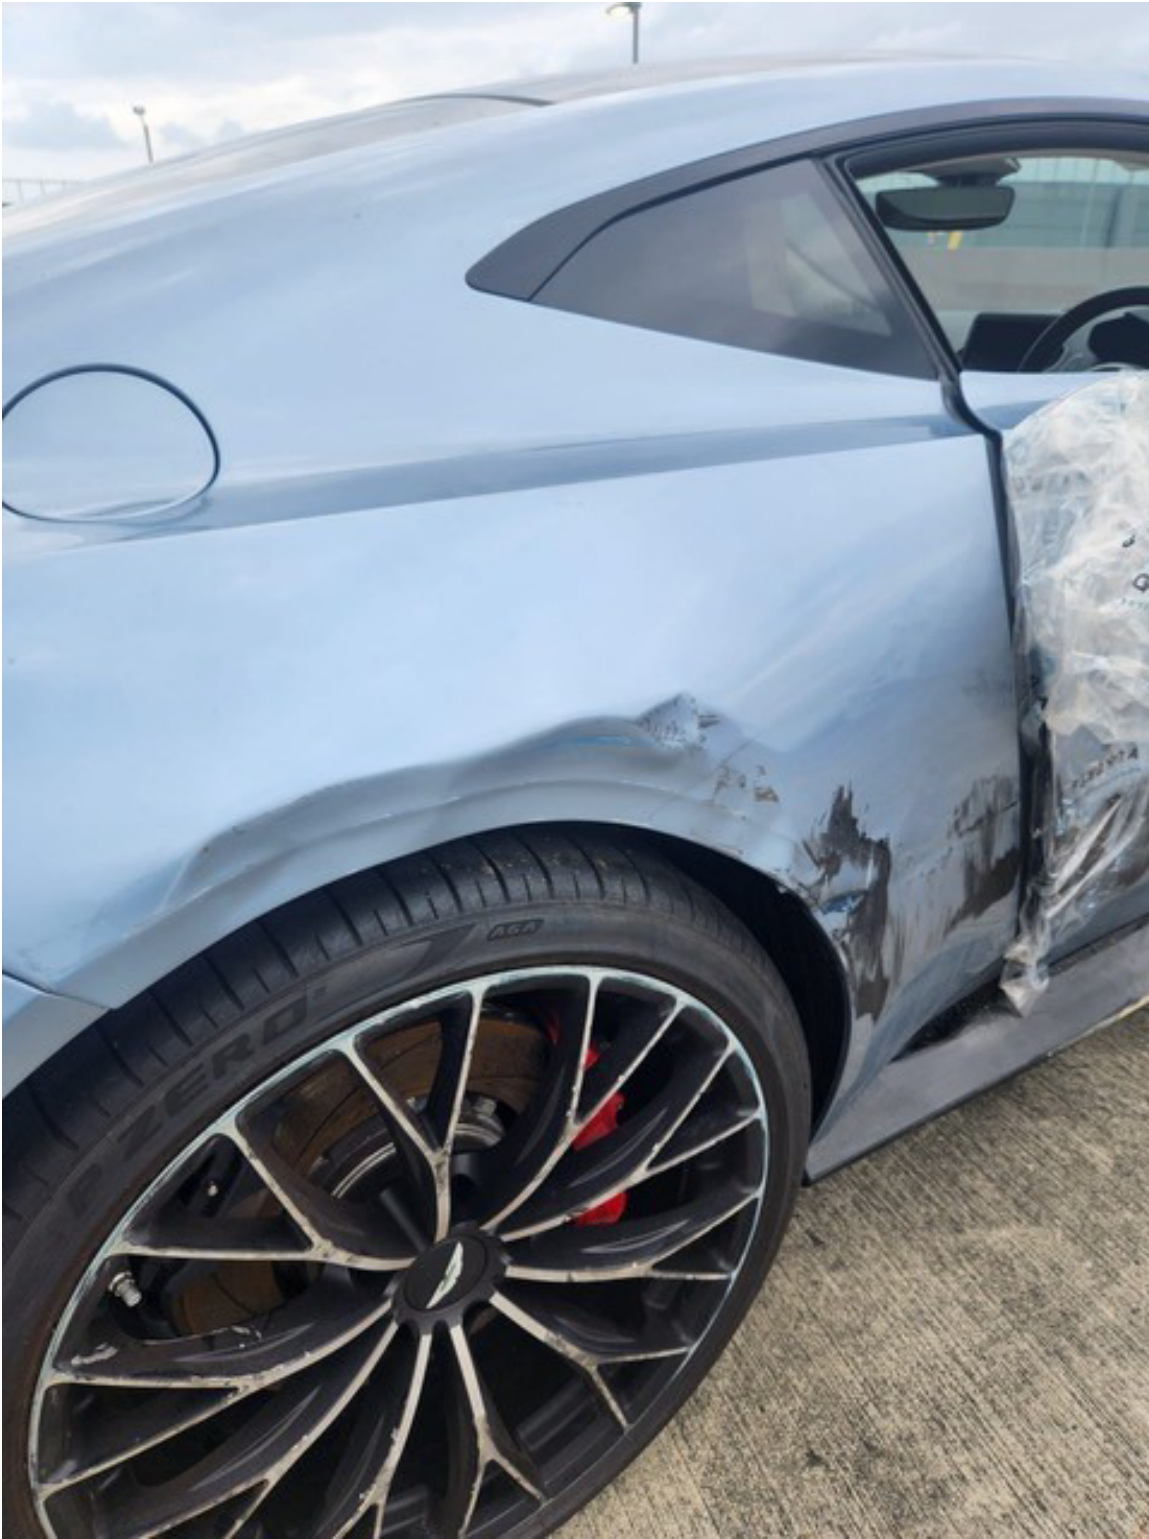
Photo 4 shows a closer view of the damage to the rear right wheel rim and rear right body panel of the Motor Car (photograph provided to me).

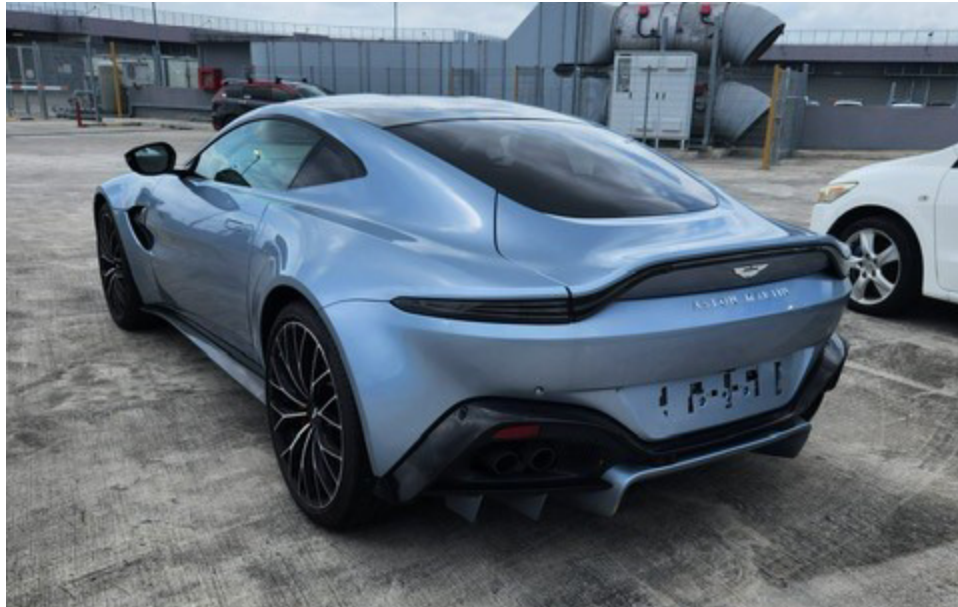
Photo 5 shows the rear left body of the Motor Car (photograph provided to me). Apart for the right side centre portion, the photographs provided to me did not show physical damage to other areas of the Motor Car.

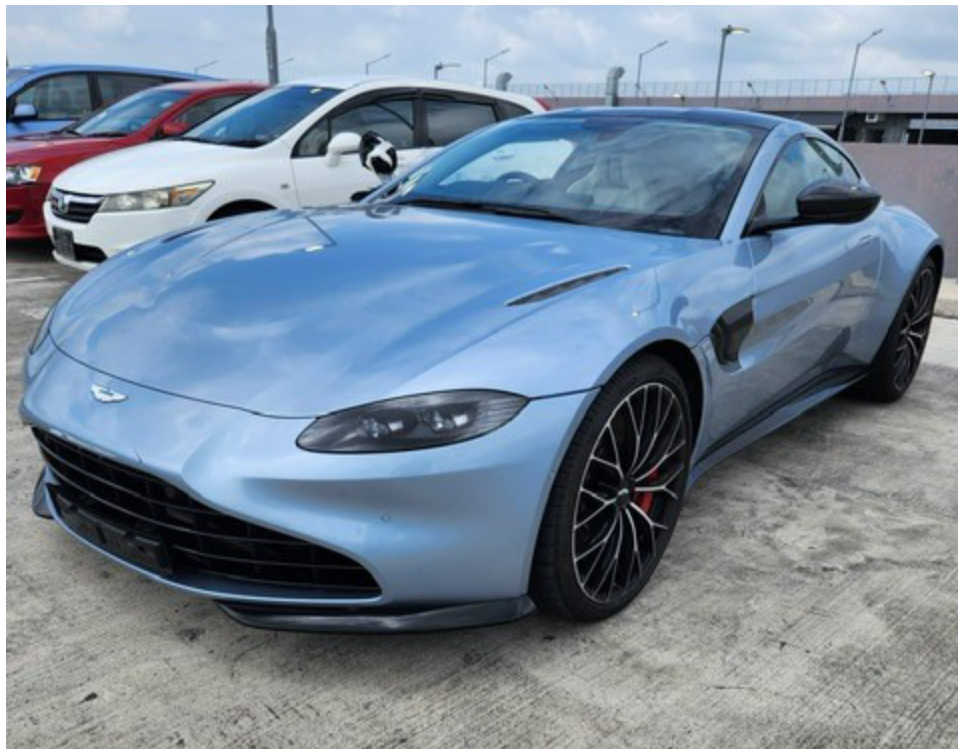
Photo 6 shows the front left body of the Motor Car (photograph provided to me). Apart for the right side centre portion, the photographs provided to me did not show physical damage to other areas of the Motor Car. The airbag(s) of the Motor Car was not deployed.

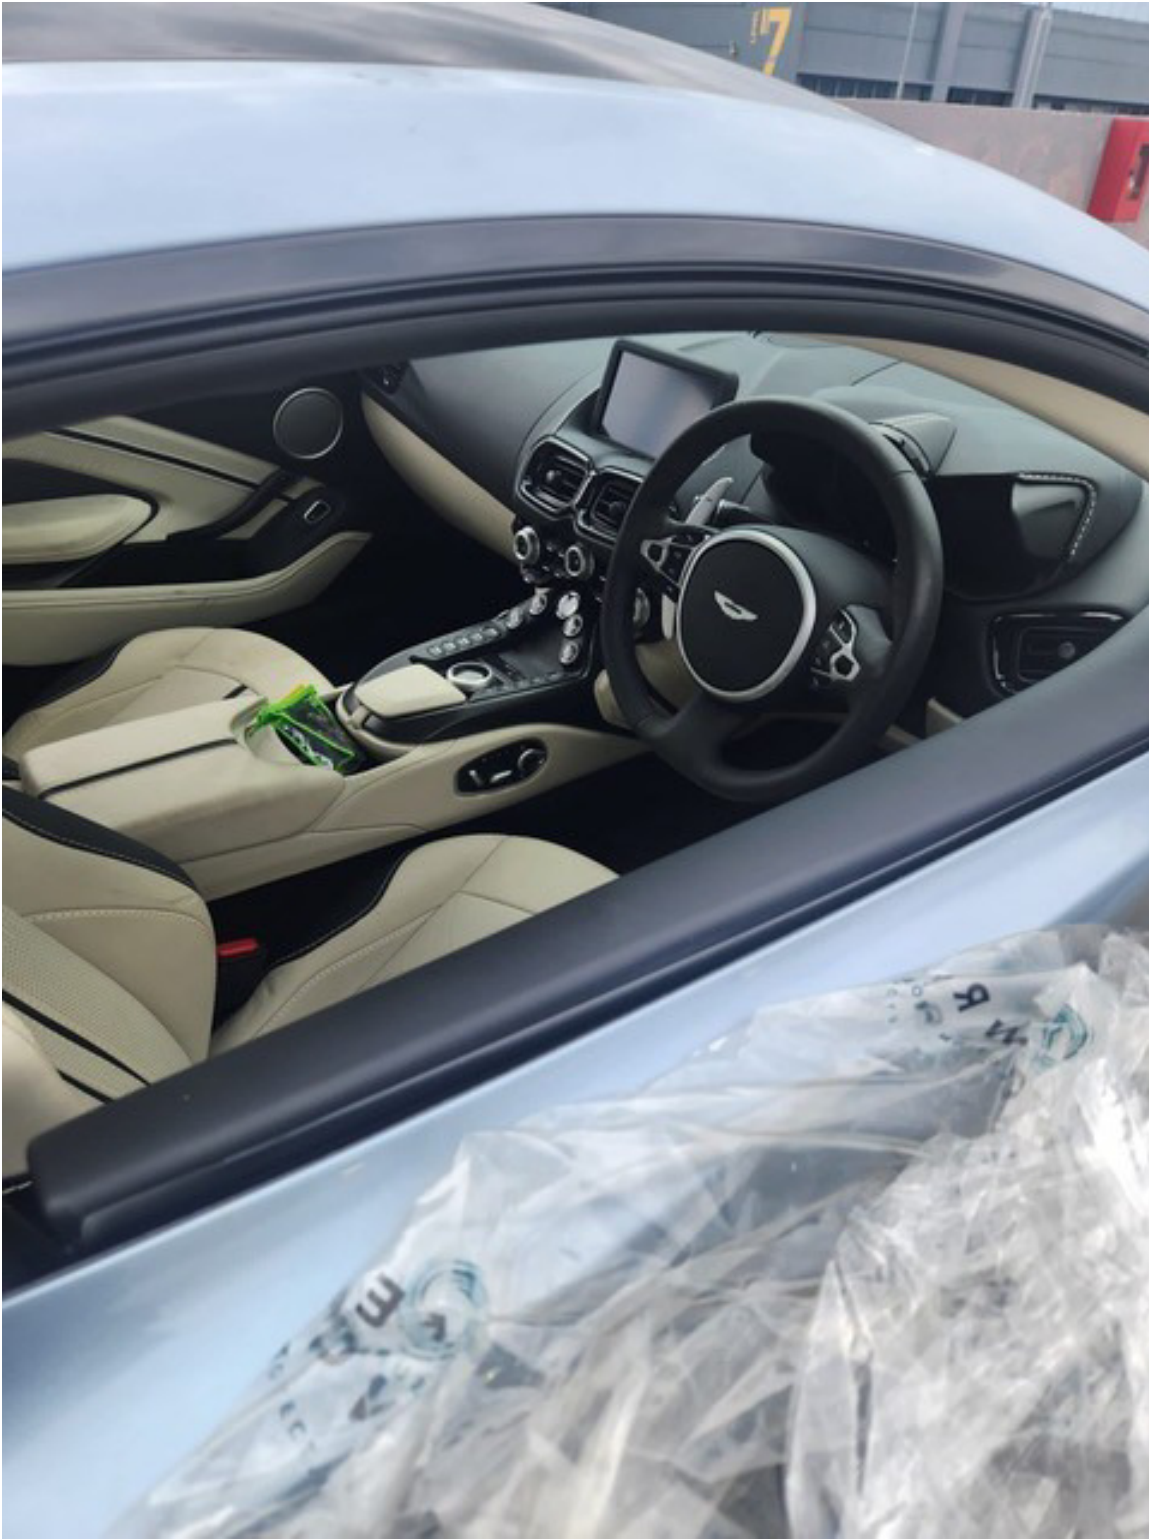
Photo 7 shows the interior compartment of the Motor Car (photograph provided to me). The various parts and components within the interior compartment were all intact and unaffected. The Motor Car's airbag(s) was not deployed as seen from the photographs that were provided to me.

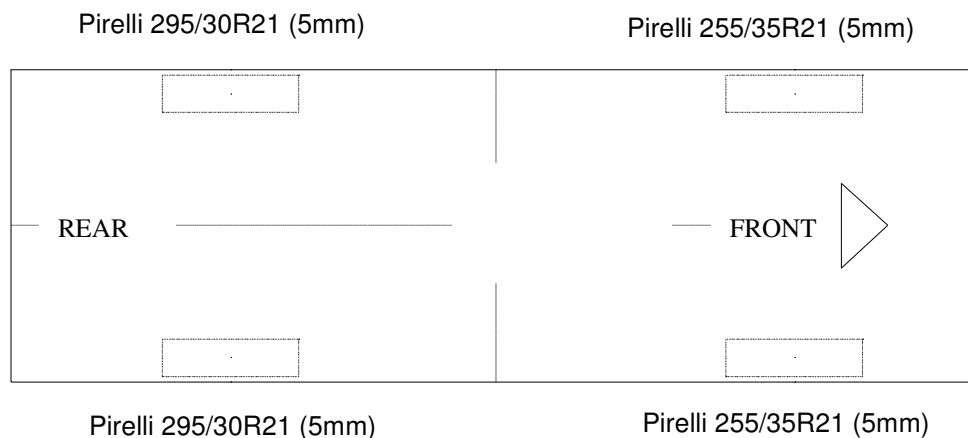
8. It was fitted with 21inch sport wheel rims that were wrapped with tyres that were observed to be of serviceable condition. The tyres were also sufficiently inflated for vehicular operation. The tyre brand, tyre size and approximate remaining tread depth of the 4 tyres of the Motor Car were recorded as follows: -

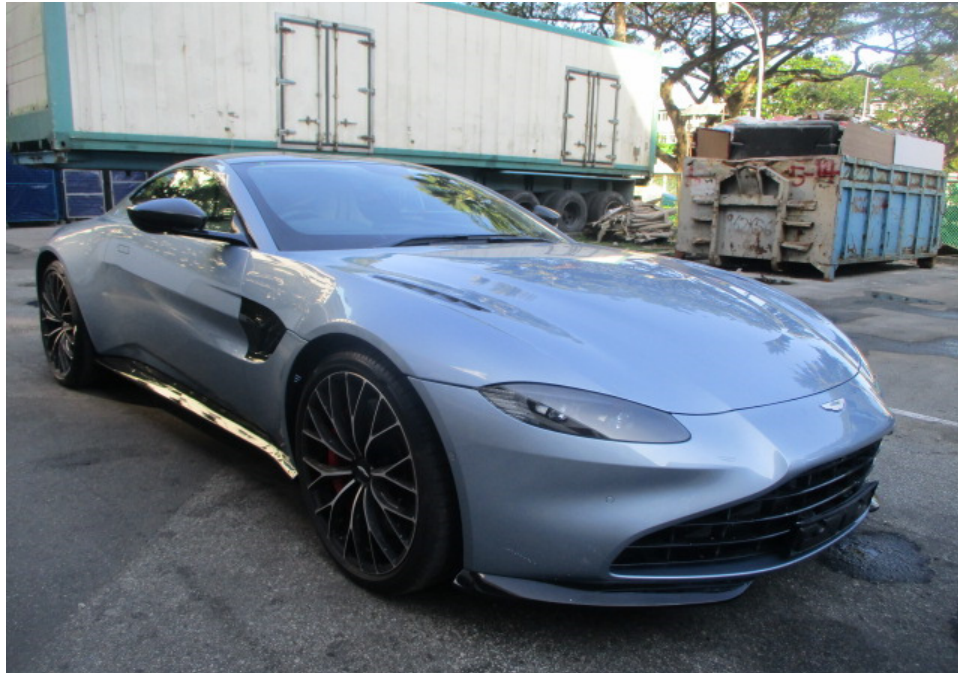
Photo 8 shows a general view of the front right body of the Motor Car at the time of my inspection. The Motor Car was observed to be in a relatively good general condition with no loose exterior fittings observed. The body parts at the right side centre portion of the Motor Car were visually examined and it was observed that the repair/restoration works carried out to the damaged area of the Motor Car (refer to photograph 1 & 2 above) were reasonably adequate and in order.

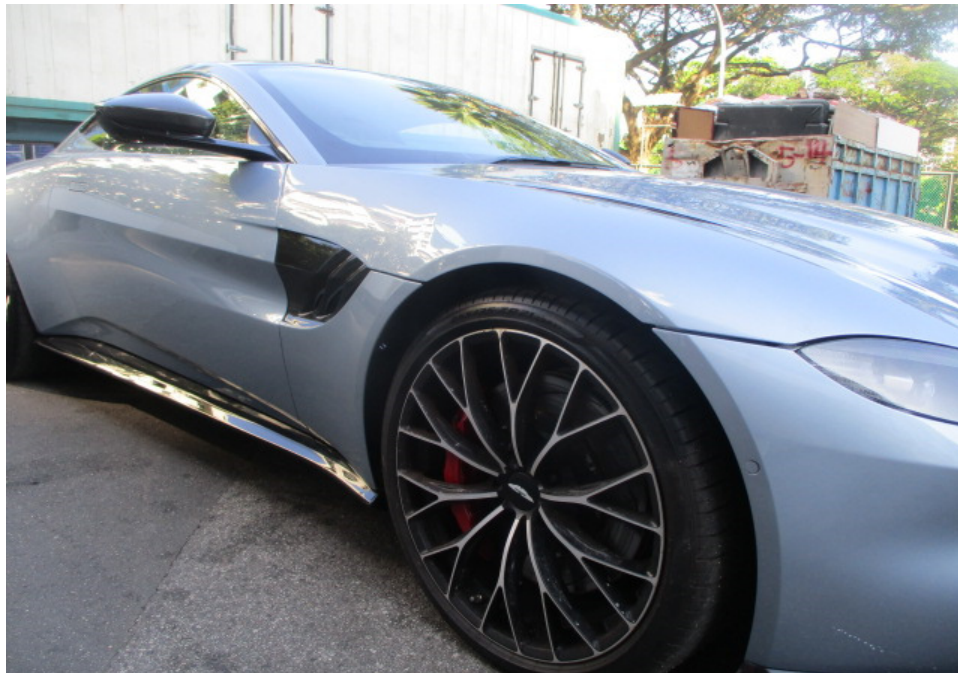
Photo 9 shows a closer view of the Motor Car's front bumper, front bonnet, front right fender and front right wheel rim. The body parts at the right side centre portion of the Motor Car were visually examined and it was observed that the repair/restoration works carried out to the damaged area of the Motor Car (refer to photograph 1 & 2 above) were reasonably adequate and in order.

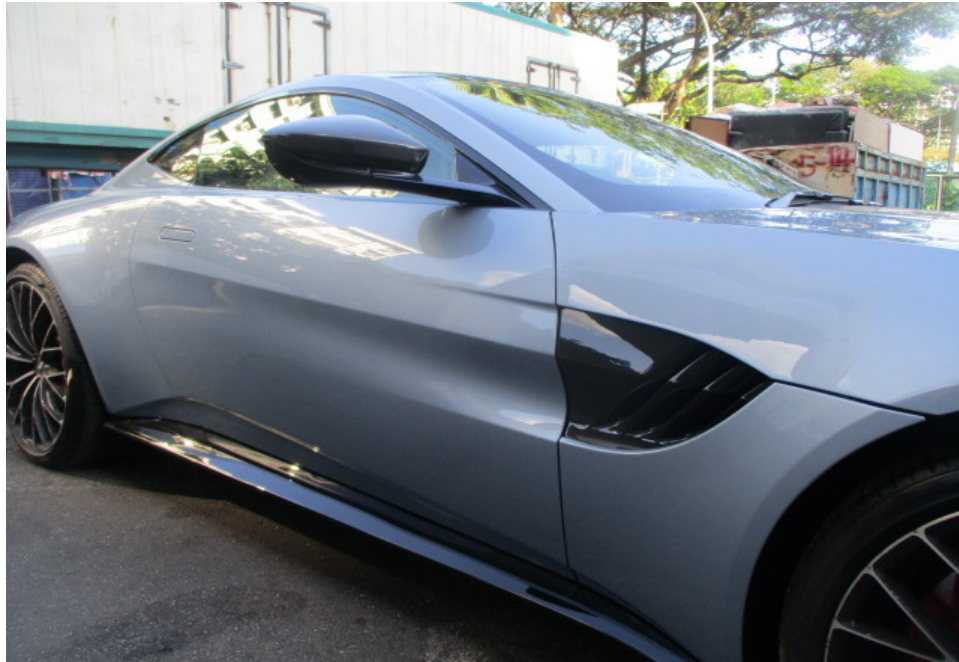
Photo 10 shows a closer view of the Motor Car's front right fender, front right door and right side wing mirror. The body parts at the right side centre portion of the Motor Car were visually examined and it was observed that the repair/restoration works carried out to the damaged area of the Motor Car (refer to photograph 1 & 2 above) were reasonably adequate and in order.

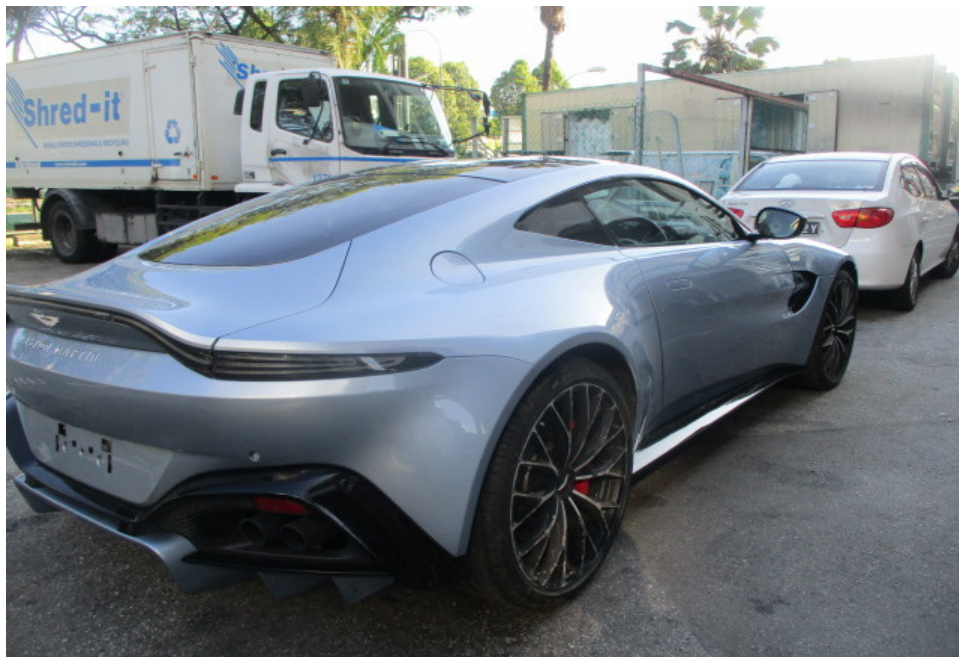
Photo 11 shows a general view of the rear right body of the Motor Car at the time of my inspection. The Motor Car was observed to be in a relatively good general condition with no loose exterior fittings observed. The body parts at the right side centre portion of the Motor Car were visually examined and it was observed that the repair/restoration works carried out to the damaged area of the Motor Car (refer to photograph 3 & 4 above) were reasonably adequate and in order.

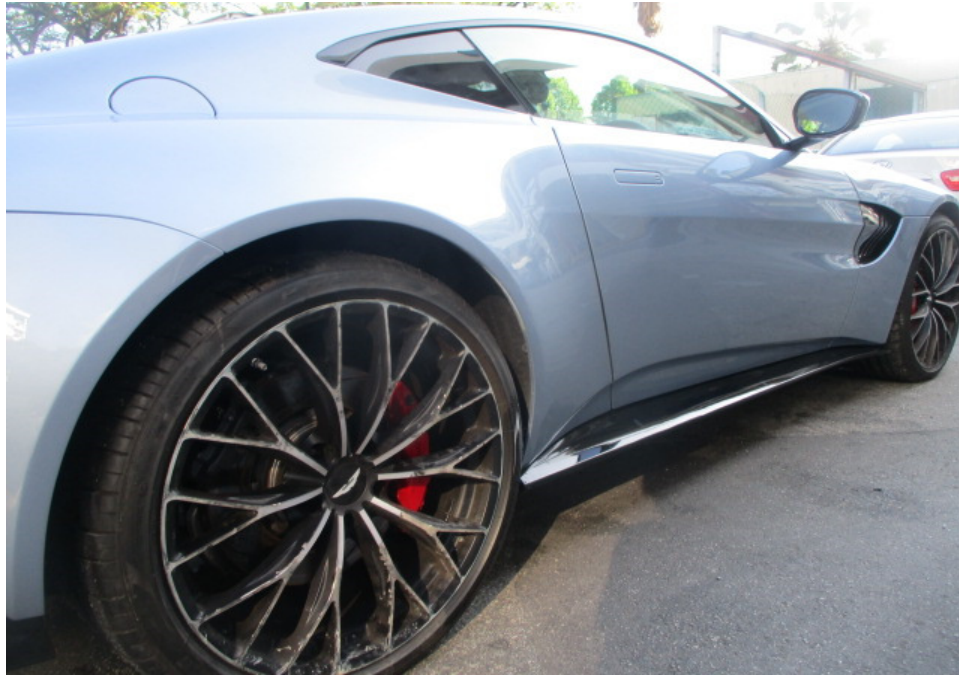
Photo 12 shows a closer view of the Motor Car's rear right wheel rim, rear right body panel and front right door. The body parts at the right side centre portion of the Motor Car were visually examined and it was observed that the repair/restoration works carried out to the damaged area of the Motor Car (refer to photograph 3 & 4 above) were reasonably adequate and in order.

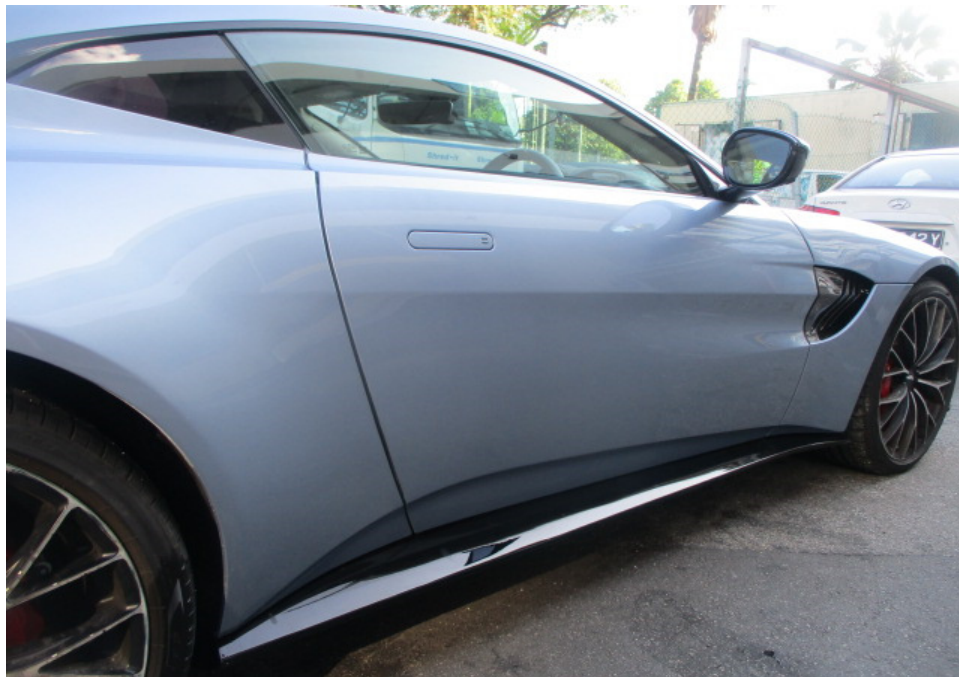
Photo 13 shows a closer view of the Motor Car's rear right body panel, front right door and right side wing mirror. The body parts at the right side centre portion of the Motor Car were visually examined and it was observed that the repair/restoration works carried out to the damaged area of the Motor Car (refer to photograph 3 & 4 above) were reasonably adequate and in order.

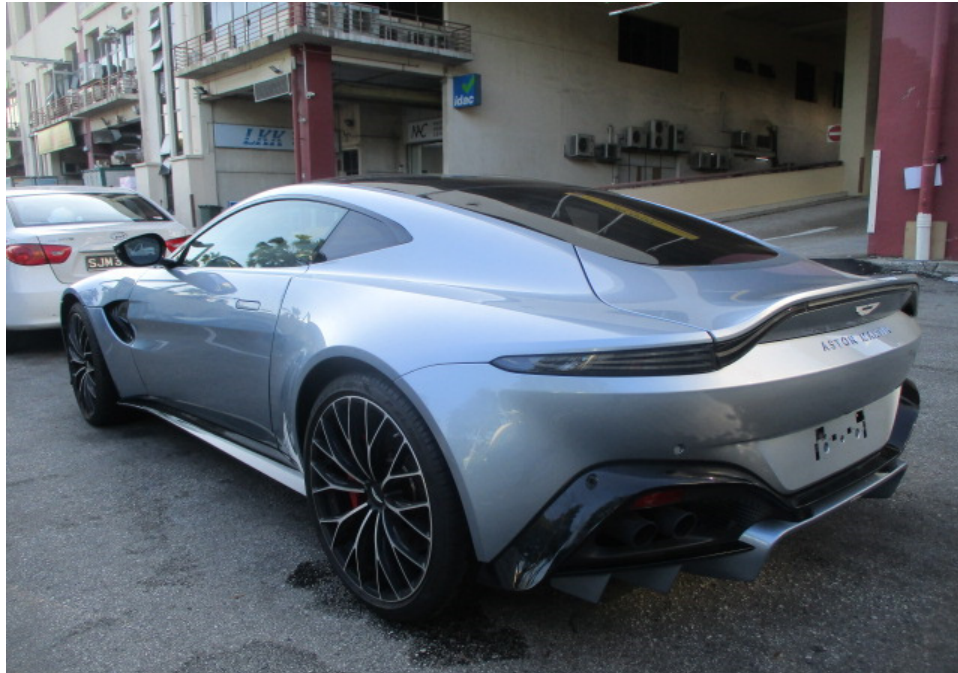
Photo 14 shows a general view of the rear left body of the Motor Car at the time of my inspection. The Motor Car was observed to be in a relatively good general condition with no loose exterior fittings observed. The mileage of the Motor Car recorded at the time of my inspection was 3,132km.

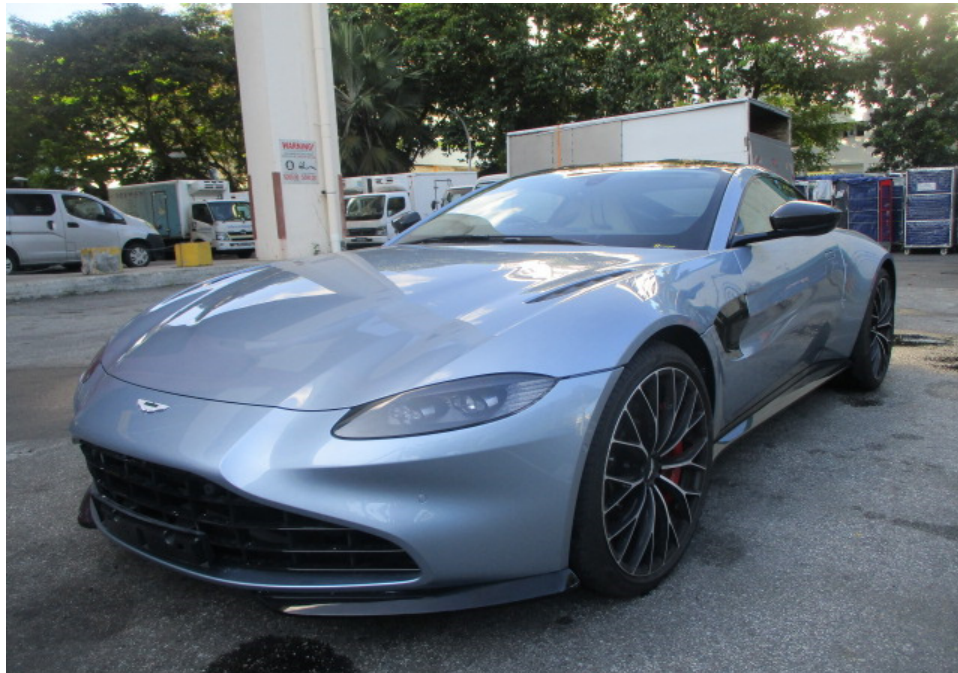
Photo 15 shows a general view of the front left body of the Motor Car at the time of my inspection. The Motor Car was observed to be in a relatively good general condition with no loose exterior fittings observed. The mileage of the Motor Car recorded at the time of my inspection was 3,132km.

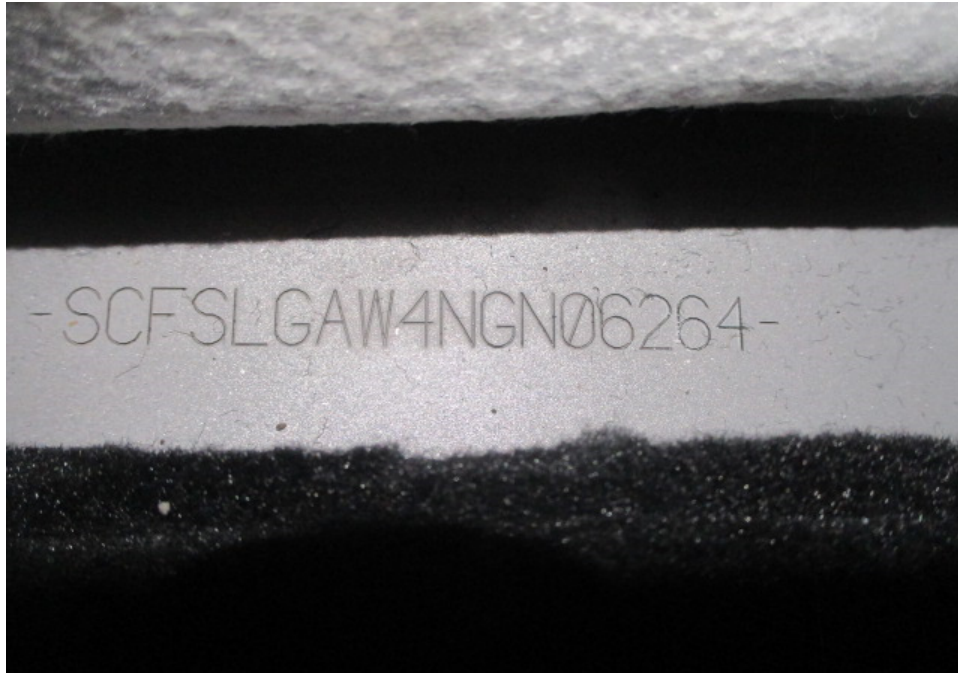
Photo 16 shows the chassis number of the Motor Car. The chassis number recorded was SCFSLGAW4NGN06264.

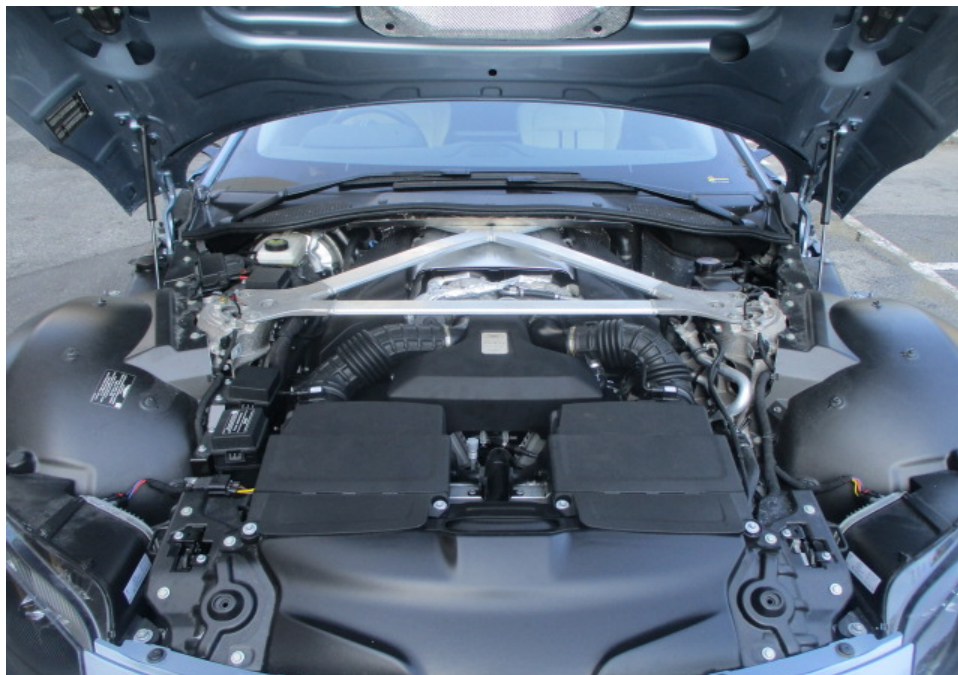
Photo 17 shows a general view of the Motor Car's engine compartment at the time of my inspection. I had found the various parts and components inside the engine compartment to be intact and properly fitted. There was also no sign(s) or indication(s) of fluid leak and/or fluid stain found inside the engine compartment.

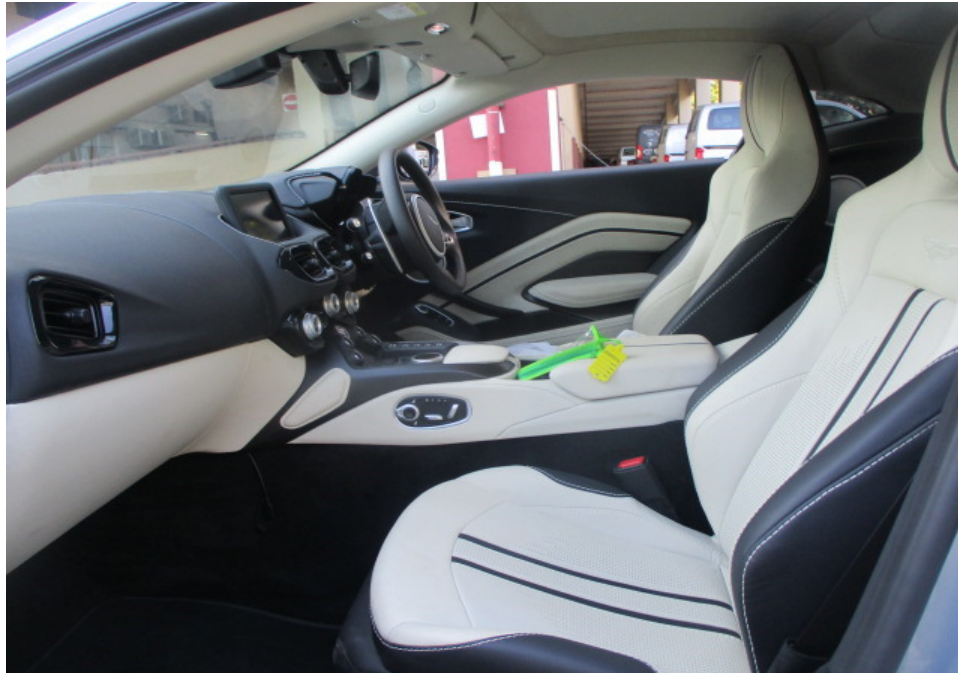
Photo 18 shows the interior compartment of the Motor Car at the time of my inspection. The various parts and components, trims, carpet, and upholstery inside the interior compartment were all observed to be intact and properly fitted.

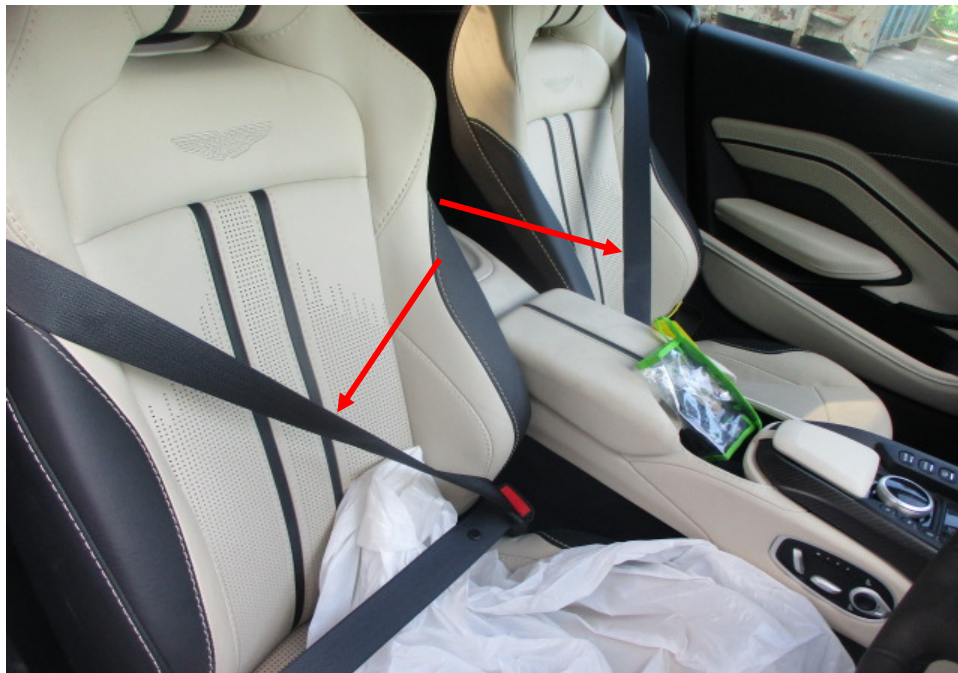
Photo 19 shows the seats of the Motor Car. All the seats of the Motor Car were secured via seat rails to the floorboard. They were also fitted with a retractable seat belt reel and a pre-tensioner. The seat belts (arrowed) were tested and were able to be fastened into the respective pre-tensions that were fitted on the side of each individual seat.

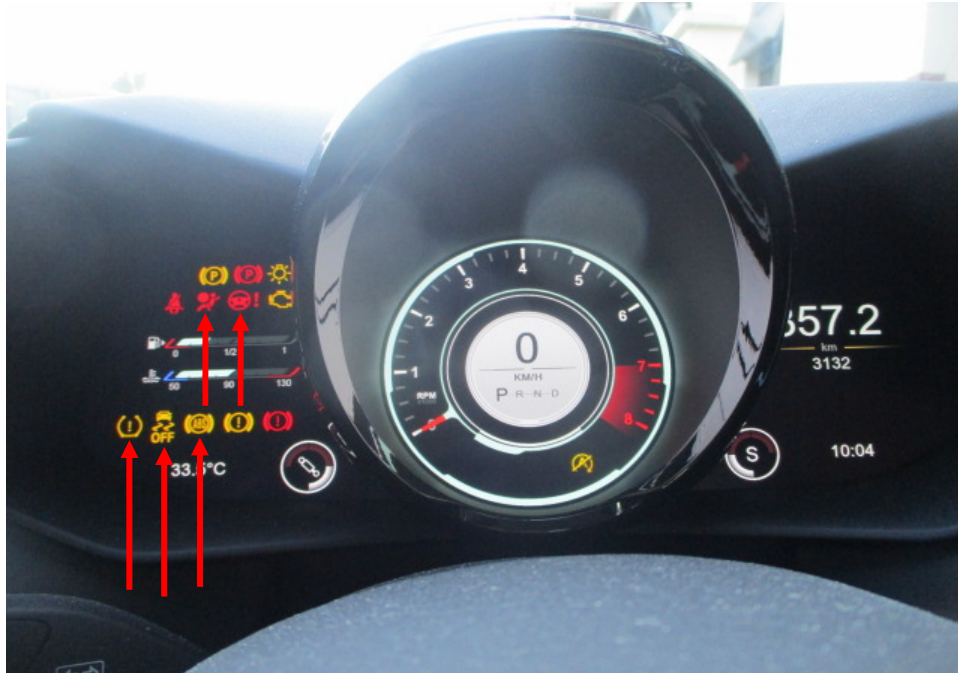
Photo 20 shows the warning lights for the various electronic safety features appearing on the instrument panel of the Motor Car during its self-test when the engine is cranked, in particular the ABS, SRS, PSS, TPM and TCS (arrowed).

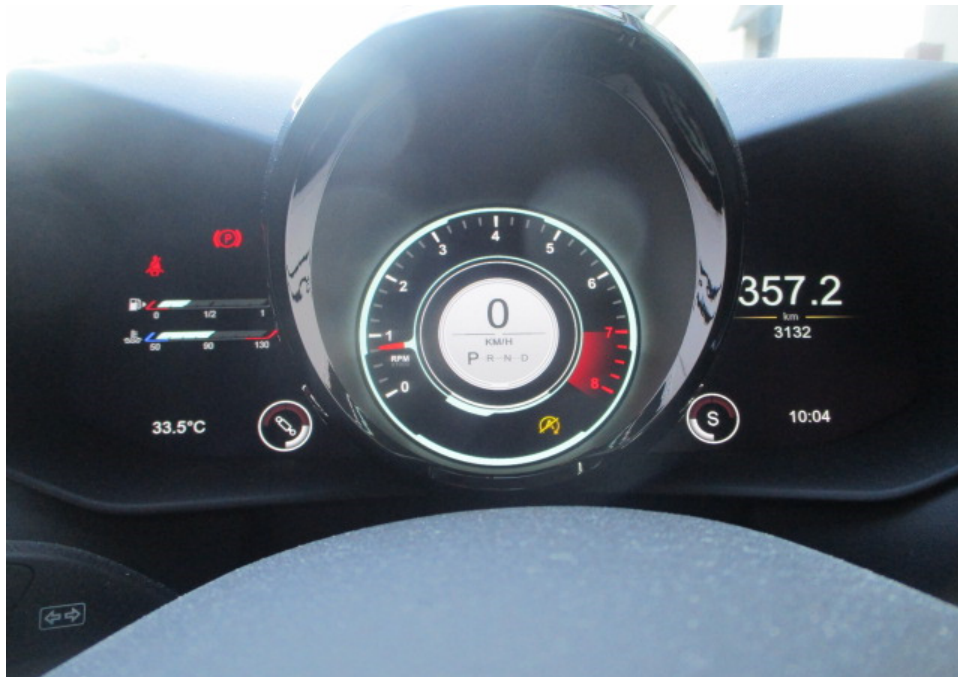
Photo 21 shows the respective warning lights no longer illuminated, indicating that there is no fault detected to the ABS, SRS, PSS, TPM and TCS systems of the Motor Car during the self-test. These electronic systems were hence in working condition at the time of my inspection.

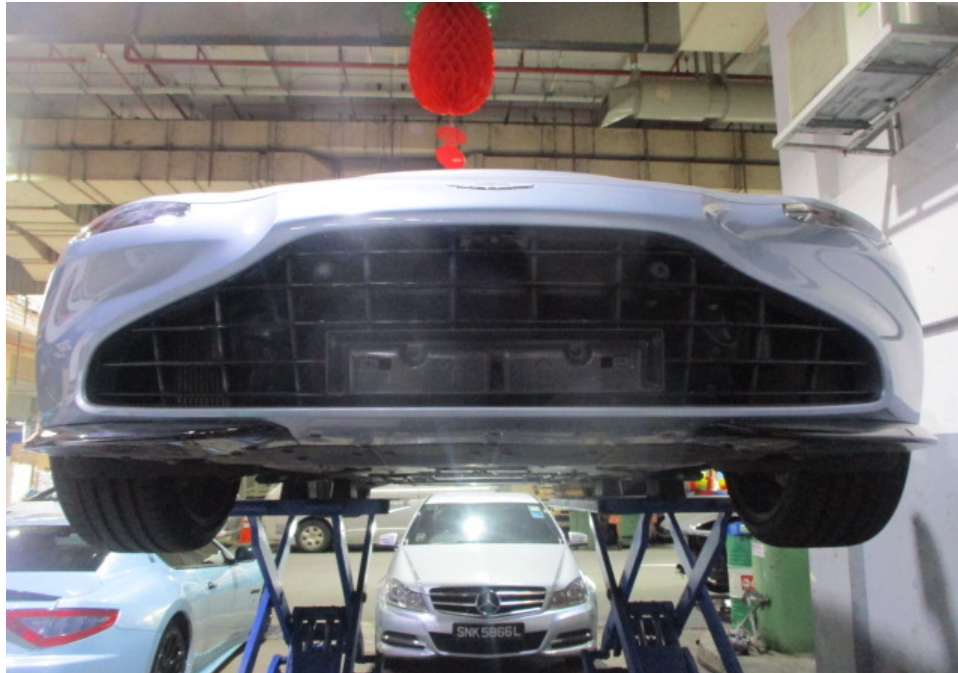
Photo 22 shows the Motor Car hoisted up for checks on its undercarriage. There was no sign(s) or indication(s) of fluid leakage and/or fluid stain(s) on the underside of the Motor Car. The undercarriage components of the Motor Car were also all observed to be intact and secured in an appropriate manner.

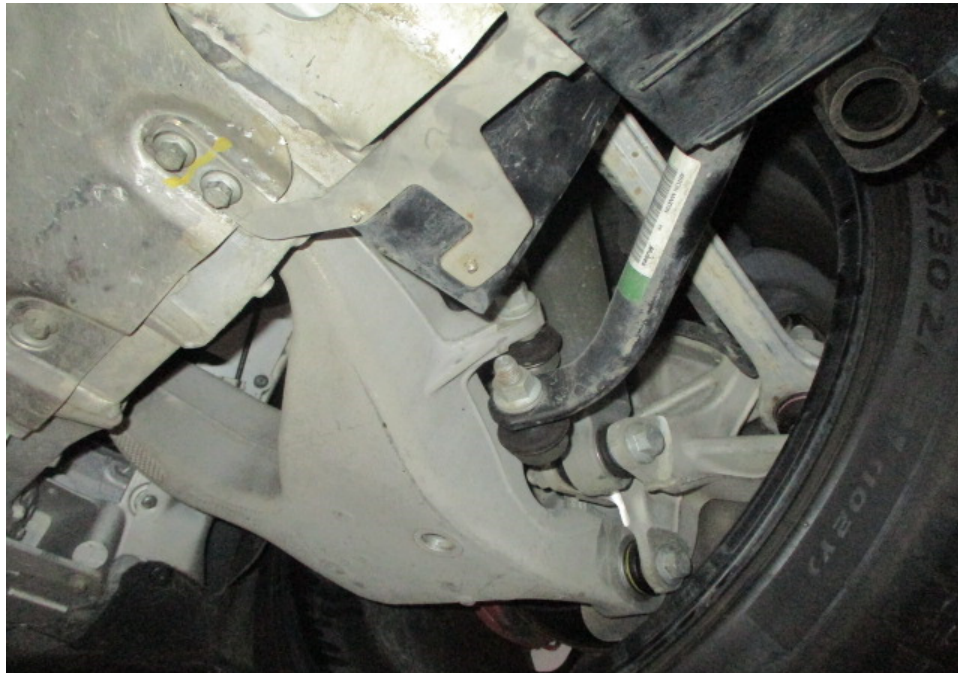
Photo 23 shows a general view of the control arms and linkages at the rear right wheel of the Motor Car. I did not observe any fluid leak and/or fluid stain on the underside of the Motor Car. All of the Motor Car's undercarriage components were observed to be intact and secured in an appropriate manner.

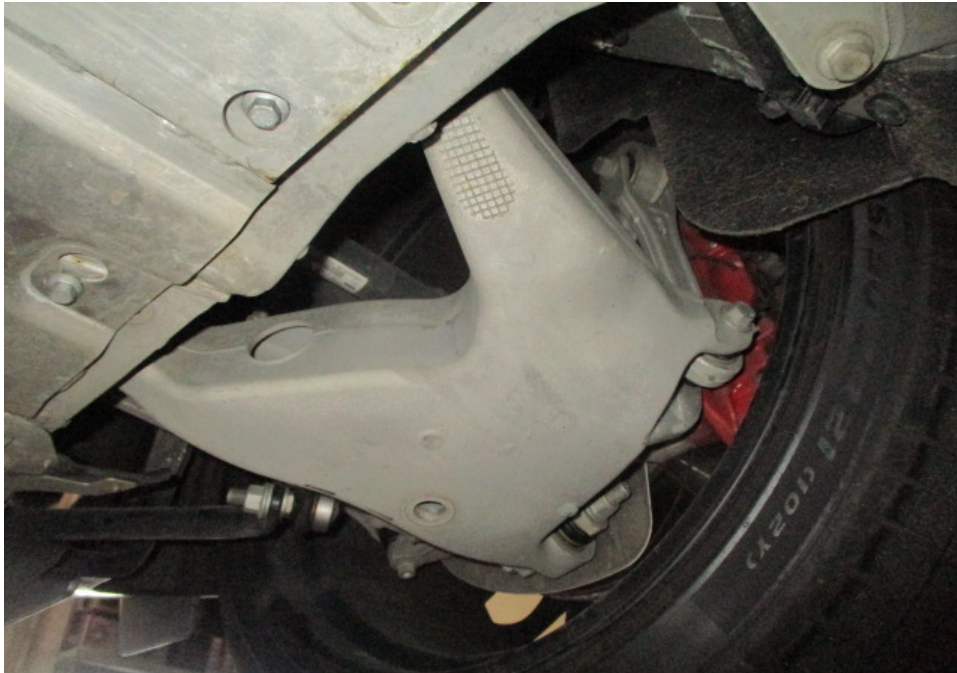
Photo 24 shows a general view of the control arms and linkages at the rear left wheel of the Motor Car. I did not observe any fluid leak and/or fluid stain on the underside of the Motor Car. All of the Motor Car's undercarriage components were observed to be intact and secured in an appropriate manner.
