Your Ref: Aston Martin Vantage Coupe
(chassis number SCFSLGAW4NGN06264)
Our Ref : CI/TP23004888/D

**INSPECTION REPORT OF AN UNREGISTERED ASTON MARTIN VANTAGE
COUPE MOTOR CAR WITH CHASSIS NUMBER SCFSLGAW4NGN06264**

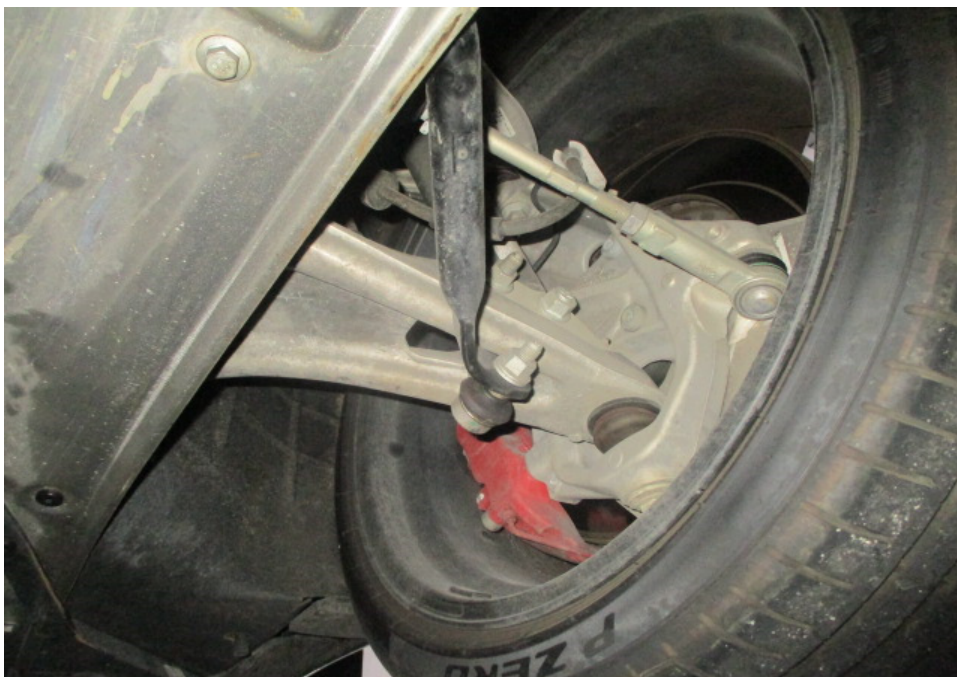
Photo 25 shows the various undercarriage components at the front left wheel of the Motor Car. The mechanical components, control arms and linkages were all found to be intact and secured in an appropriate manner.

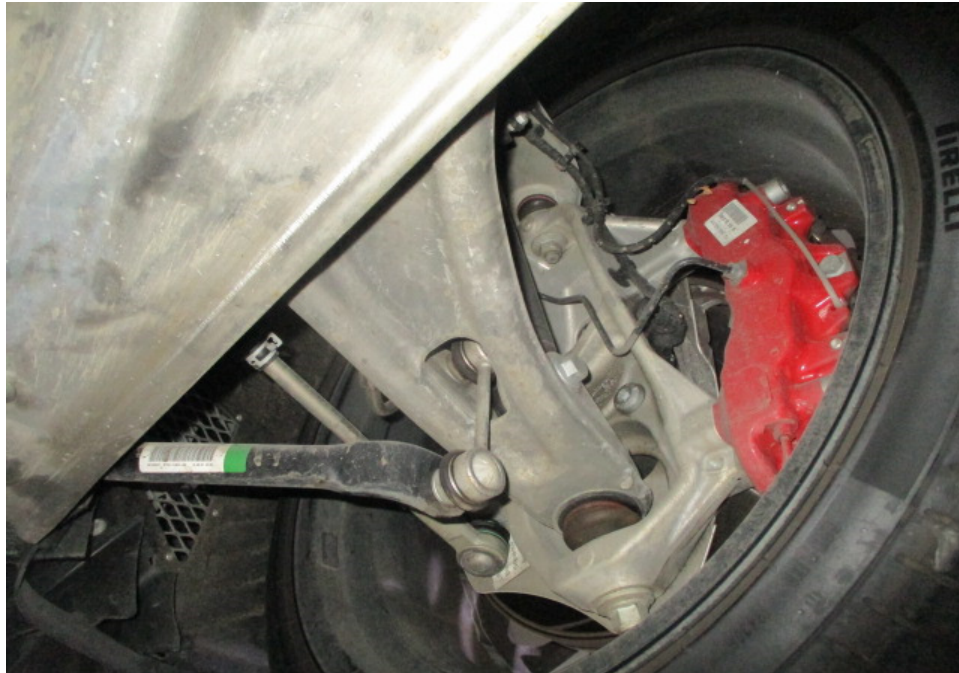
Photo 26 shows the various undercarriage components at the front right wheel of the Motor Car. The mechanical components, control arms and linkages were all found to be intact and secured in an appropriate manner. I also did not observe any fluid leak and/or fluid stain on the underside of the Motor Car.

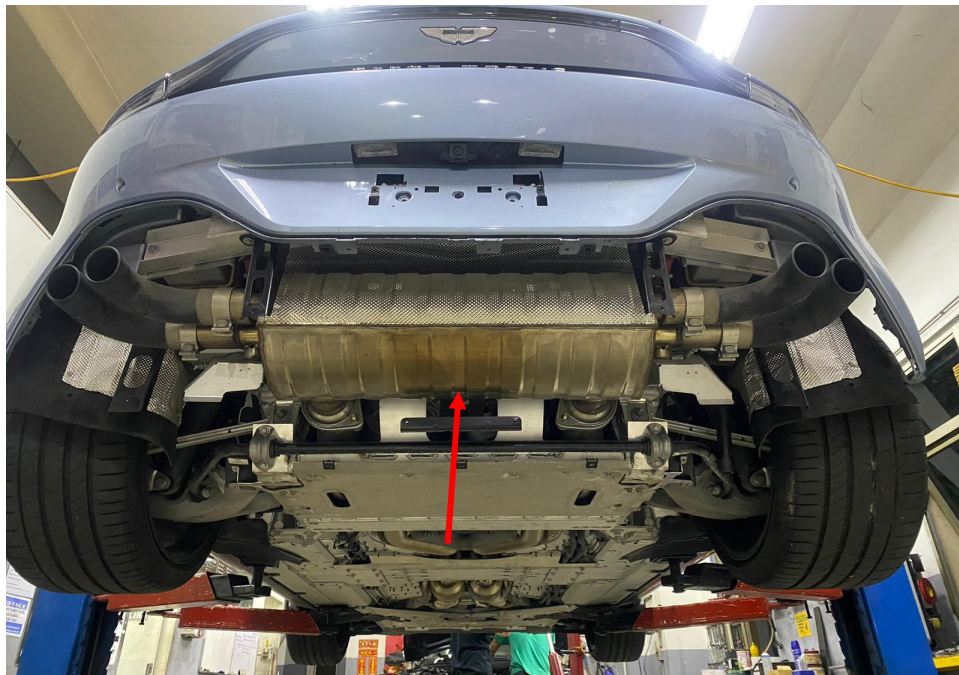
Photo 27 shows the Motor Car with its rear bumper lower diffuser removed to facilitate my examination of its exhaust system. My examination of the Motor Car's exhaust system revealed no sign(s) or indication(s) of any cut or weld marks along its exhaust pipes, on its rear muffler (arrowed), on its centre resonator boxes and on its catalytic converters.

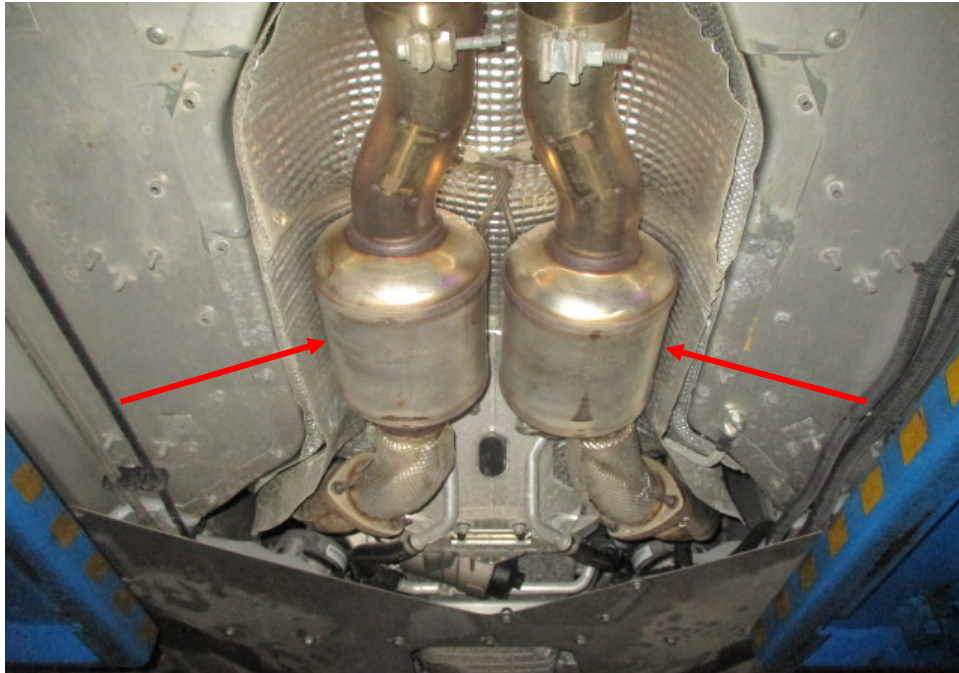
Photo 28 shows the front section of the Motor Car's exhaust system. My examination of the Motor Car's exhaust system revealed no sign(s) or indication(s) of any cut or weld marks along its exhaust pipes, on its rear muffler, on its centre resonator boxes (arrowed) and on its catalytic converters.

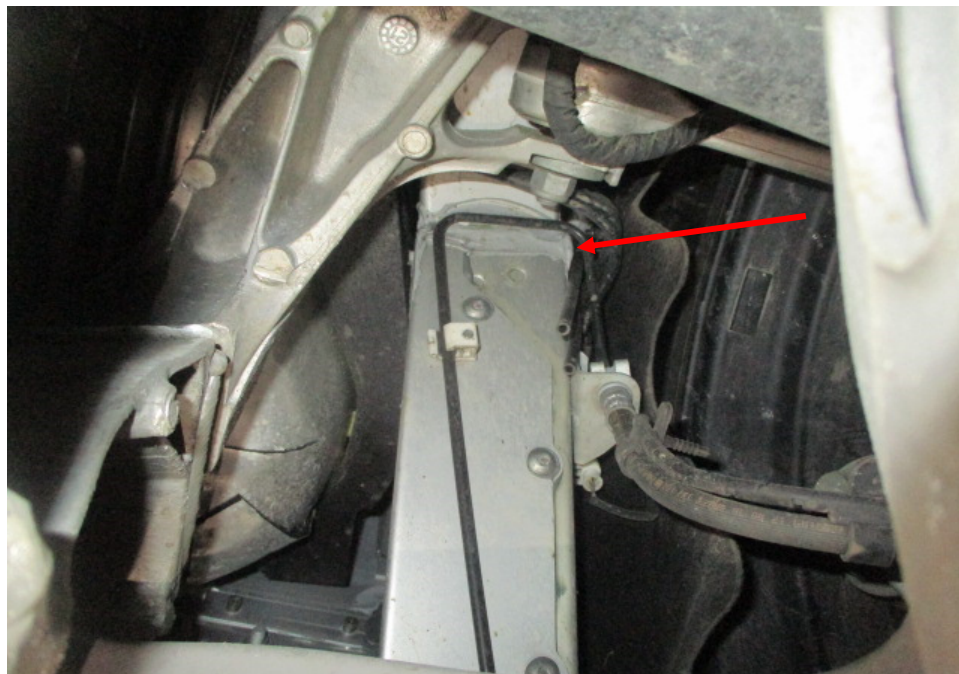
Photo 29 shows the aluminium chassis/structural body at the underside rear right of the Motor Car. The original factory sealant (arrowed) at the joints along the aluminium chassis/structural body of the Motor Car was observed to be untouched. In general, I had found no work was carried out on the aluminium chassis/structural body of the Motor Car. The aluminium chassis/structural body of the Motor Car was originally fitted.

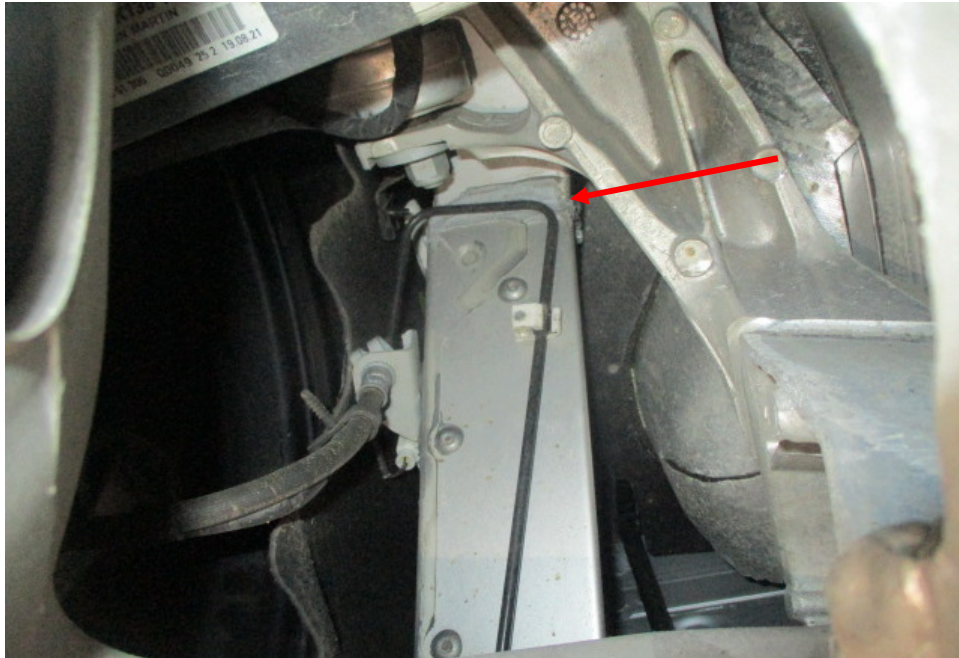
Photo 30 shows the aluminium chassis/structural body at the underside rear left of the Motor Car. I did not find any weld marks other than original spot weld marks on the aluminium chassis/structural body of the Motor Car. The original factory sealant (arrowed) at the joints along the aluminium chassis/structural body was untouched, indicating no work was done on the aluminium chassis/structural body of the Motor Car and that the aluminium chassis/structural body was originally fitted.

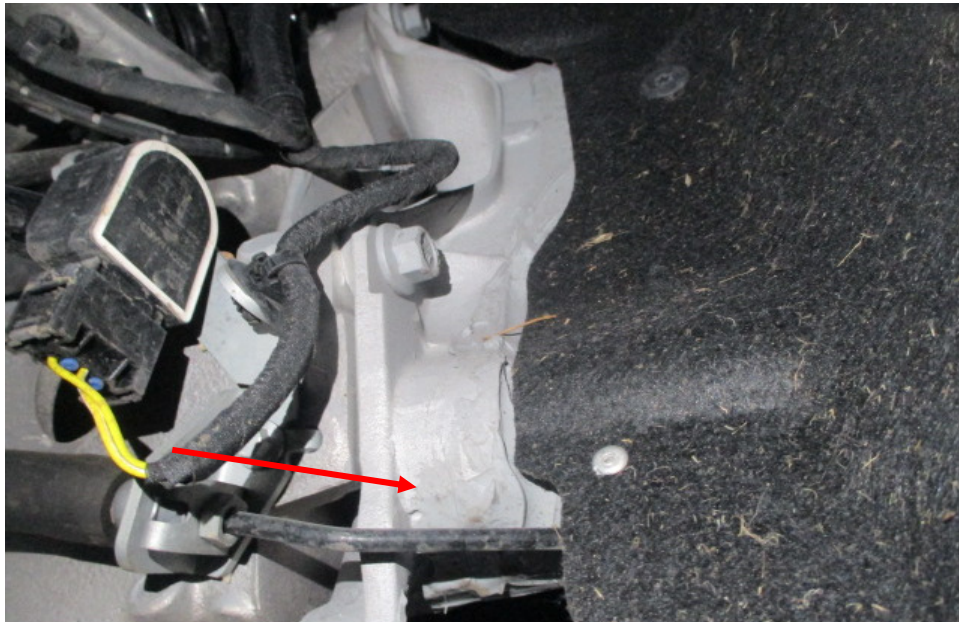
Photo 31 shows the aluminium chassis/structural body at the underside front left of the Motor Car. The original factory sealant (arrowed) at the joints along the aluminium chassis/structural body was observed to be untouched. In general, I had found no work was carried out on the aluminium chassis/structural body of the Motor Car. The aluminium chassis/structural body of the Motor Car was originally fitted.

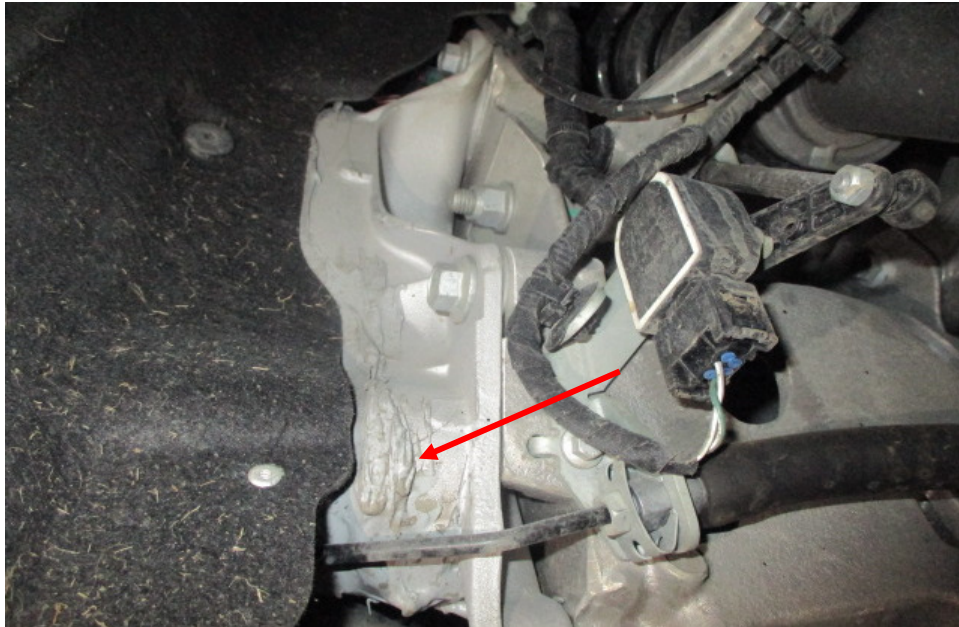
Photo 32 shows the aluminium chassis/structural body at the underside front right of the Motor Car. I did not find any weld marks other than original spot weld marks on the aluminium chassis/structural body of the Motor Car. The original factory sealant (arrowed) at the joints along the aluminium chassis/structural body was untouched, indicating no work was done on the aluminium chassis/structural body of the Motor Car and that the aluminium chassis/structural body was originally fitted.

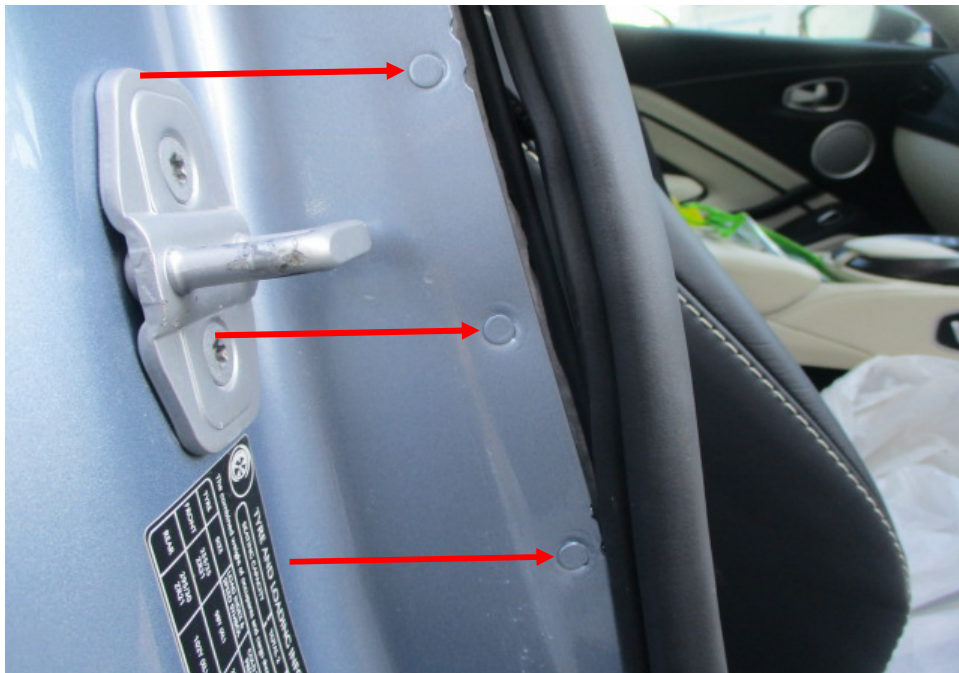
Photo 33 shows the right side rear body panel of the Motor Car. I did not find any weld marks other than original spot weld marks (arrowed) on the right side rear body panel of the Motor Car, which indicates that there was no re-welding works carried out. In general, I had found all the non-detachable body panels of the Motor Car to be originally fitted at the time of my inspection.

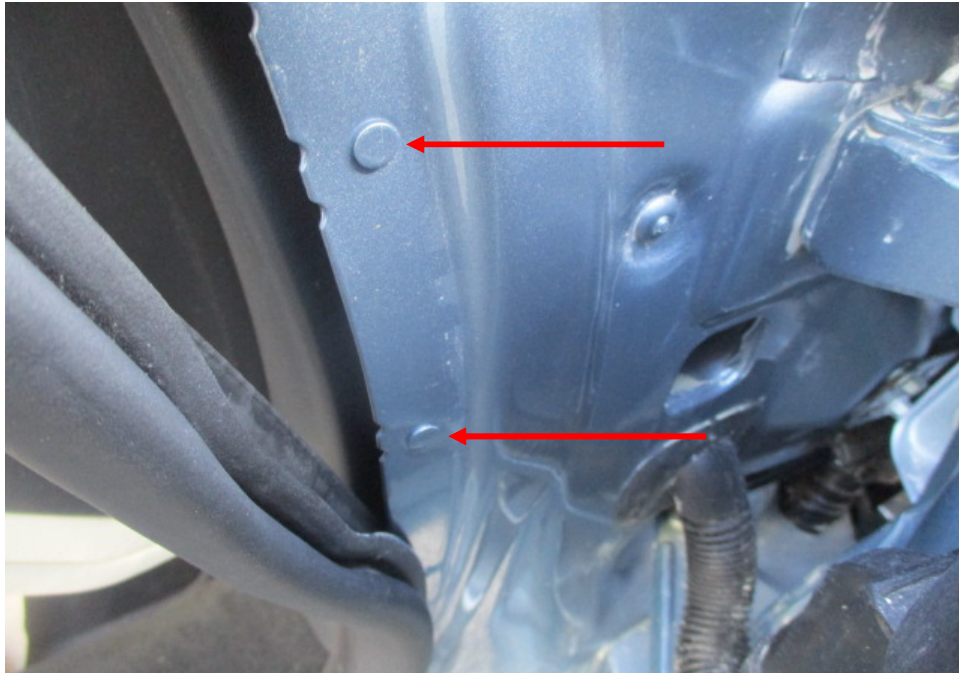
Photo 34 shows the right side "A" pillar of the Motor Car. I did not find any weld marks other than original spot weld marks (arrowed) on the right side "A" pillar of the Motor Car, which indicates that there was no re-welding works carried out. In general, I had found all the non-detachable body panels of the Motor Car to be originally fitted at the time of my inspection.

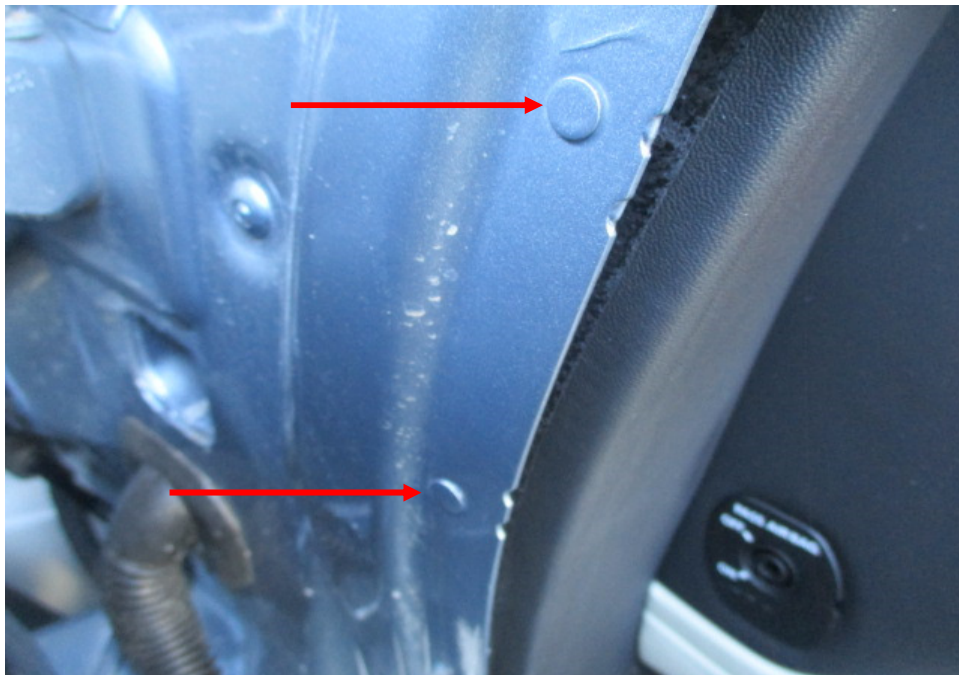
Photo 35 shows the left side "A" pillar of the Motor Car. I did not find any weld marks other than original spot weld marks (arrowed) on the left side "A" pillar of the Motor Car, which indicates that there was no re-welding works carried out. In general, I had found all the non-detachable body panels of the Motor Car to be originally fitted at the time of my inspection.

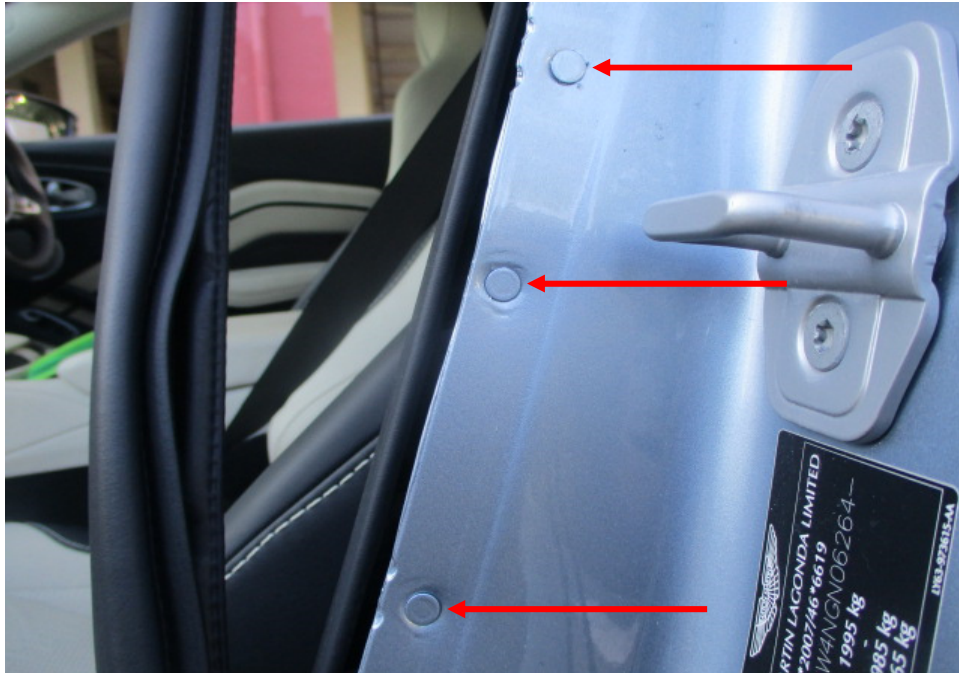
Photo 36 shows the left side rear body panel of the Motor Car. I did not find any weld marks other than original spot weld marks (arrowed) on the left side rear body panel of the Motor Car, which indicates that there was no re-welding works carried out. In general, I had found all the non-detachable body panels of the Motor Car to be originally fitted at the time of my inspection.
