Your Ref: 5294413474SG  
Our Ref : CI/AIG23004932/N

**M/s AIG Asia Pacific Insurance Pte. Ltd.**

**TECHNICAL INVESTIGATION REPORT OF ENGINE DAMAGE TO THE INSURED VEHICLE SJW 1567K**

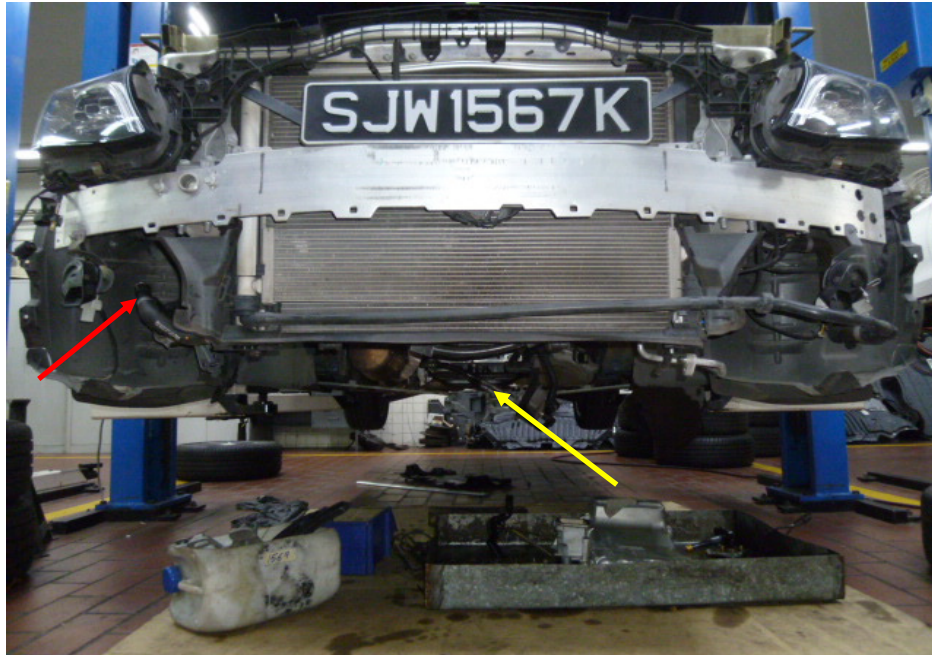
9. The Insured Vehicle was observed to be in good general condition with no visible damage to the exterior body. We did however observe that the front bumper, undercarriage mounting and engine oil sump had been dismantled.

**Photo 1** shows the general view of the Insured Vehicle at the time of our inspection. The Insured Vehicle was observed to be in good general condition with no visible damage to the exterior body. We did however observe that the front bumper (red arrow) and undercarriage mounting (yellow arrow) had been dismantled.

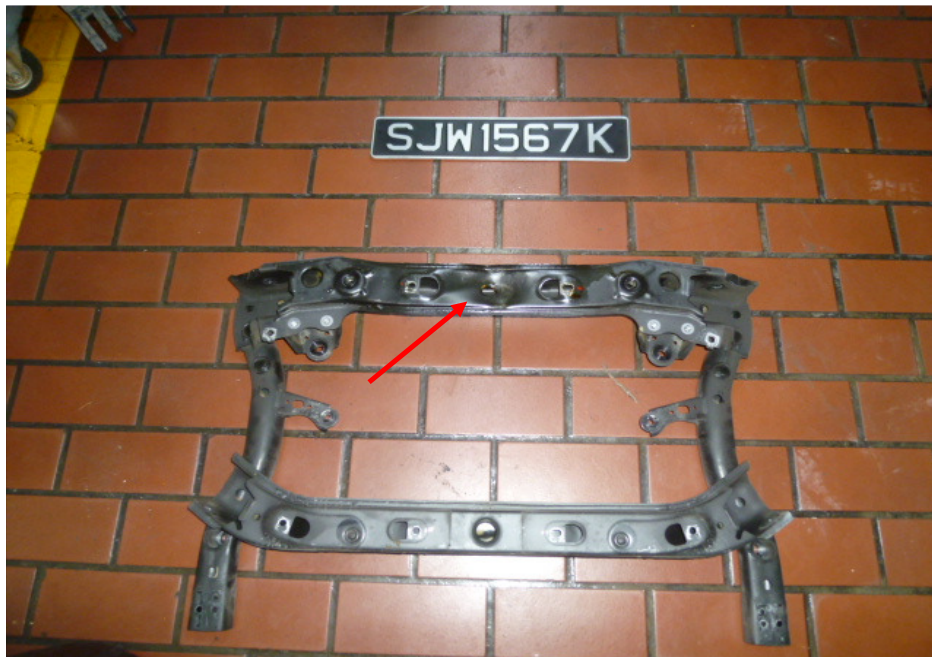
10. Upon examination of the dismantled undercarriage mounting of the Insured Vehicle, we had found damages. The undercarriage mounting was found to be dented. We also observed damages on the exhaust midpipe and rear undercarriage brace.

**Photo 2** shows the dented dismantled engine mounting (red arrow) of the Insured Vehicle at the time of our inspection.

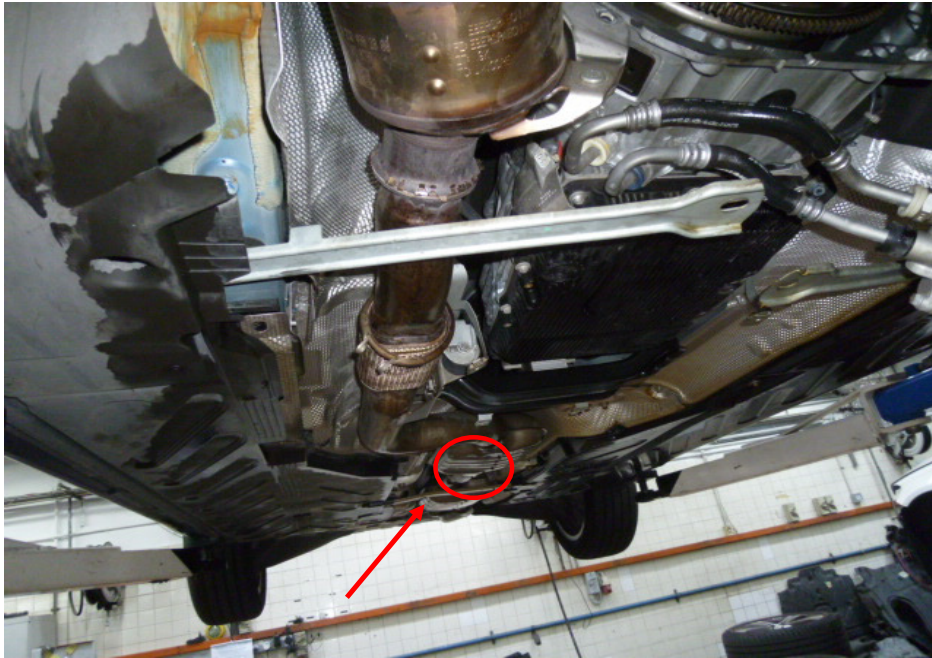
**Photo 3** shows the dents that were found on the midpipe (circled) and rear undercarriage brace (red arrow) of the Insured Vehicle.

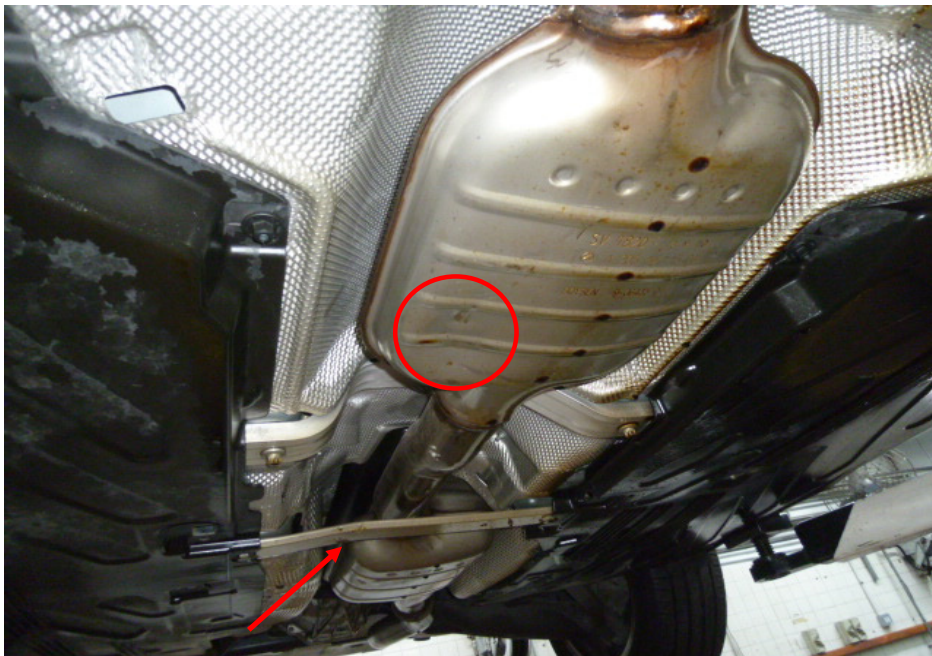
**Photo 4** shows a closer view of the dents that were found on the midpipe (circled) and rear undercarriage brace (red arrow) of the Insured Vehicle.

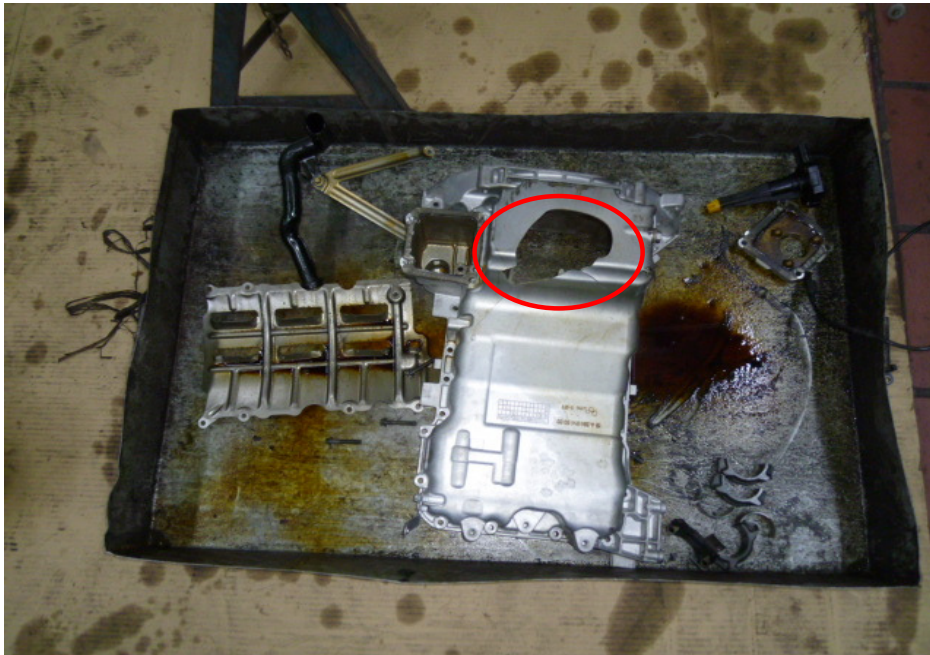
11. Upon examination of the dismantled engine oil sump, we had found a crack and a significantly sized puncture/hole on the underside of the engine oil sump. Engine oil was observed to have leaked from this damaged area. The undercarriage parts and components that were immediately after the punctured engine oil sump were further observed to be covered with engine oil stains. As a result of insufficient engine oil, the engine of the Insured Vehicle could not be started.

**Photo 5** shows the dismantled broken engine oil sump (circled) of the Insured Vehicle at the time of our inspection.

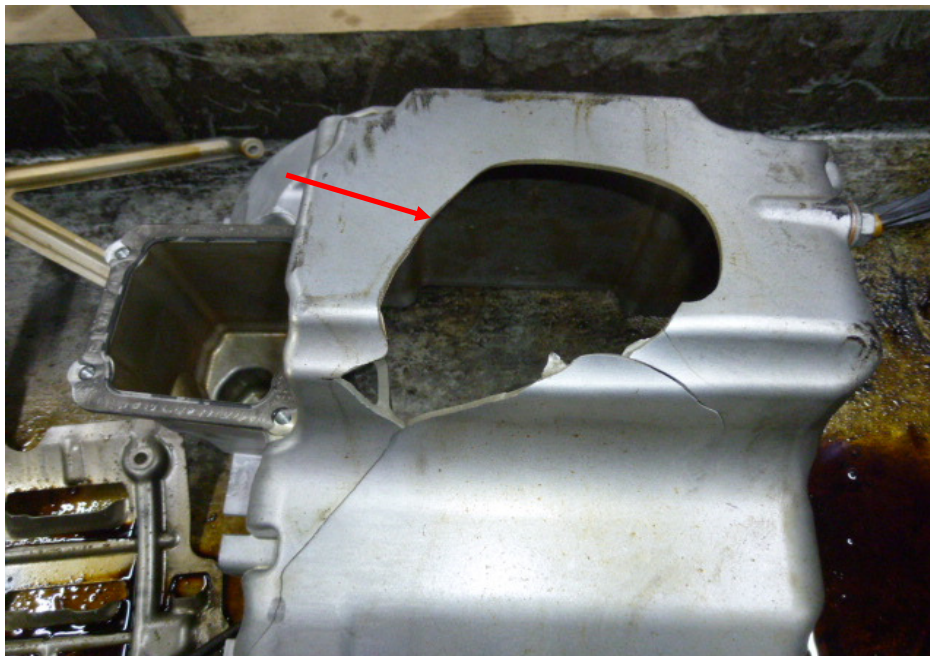
**Photo 6** shows a closer view of the crack (arrowed) on the underside of the engine oil sump of the Insured Vehicle. The damage profile of the engine oil sump corresponds to the possibility of the Insured Vehicle going over an object.

13. For this case, the damage profile of the Insured Vehicle's underside corresponds to the Insured Vehicle going over an object(s), leading to the engine oil sump puncturing. However in such going over object(s) type of incidents, the engine of the vehicle will not be affected by the vehicle going over the object(s), provided that there was no further operation of the engine and/or continued driving after it had gone over the object(s), and also provided that there was no engine oil leakage.
14. For this case, the Insured Vehicle was continued to be driven to 525 West Camp Road, where it was only towed to C & C later that day after the engine of the Insured Vehicle could not be started up.
15. From the document relating to the towing work that was carried out by Island Recovery Services Pte. Ltd., it was recorded that the Insured Vehicle was towed from 525 West Camp Road.

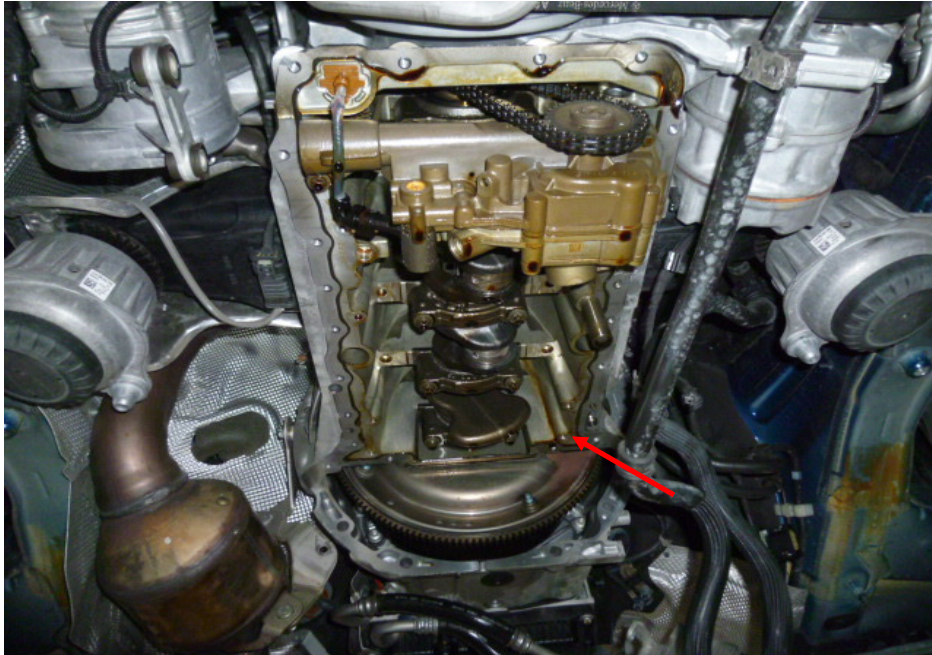
**Photo 7** shows the undercarriage parts and components that were immediately after the punctured engine oil sump, covered with engine oil stains (arrowed).

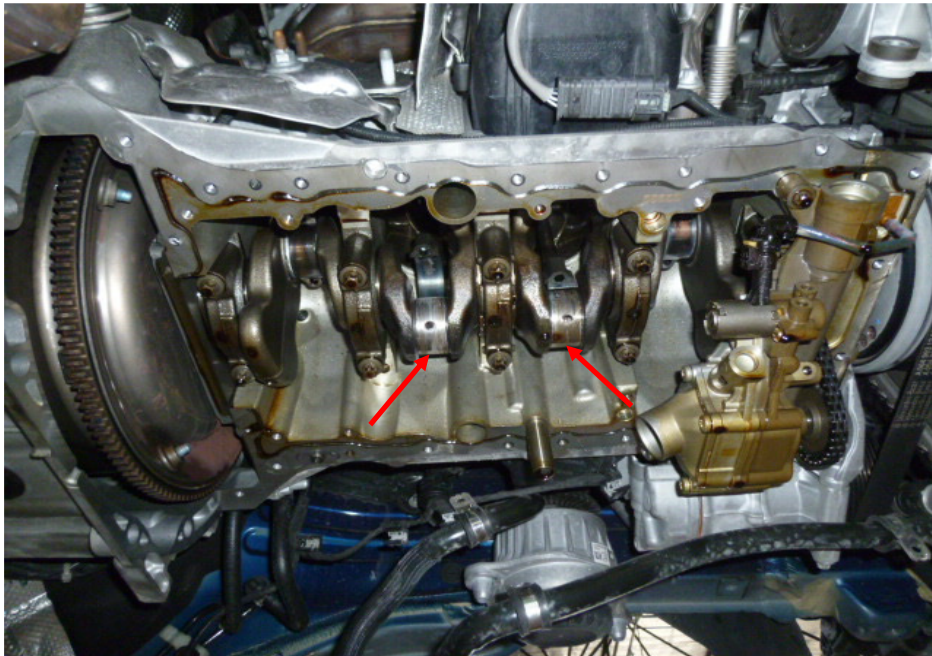
12. Upon examination of the engine components of the Insured Vehicle, we had found damages to the crankshaft. Upon further examination, we had found the crankshaft to be partially burnt and/or melted. The damage profile of these parts corresponds to the Insured Vehicle overheating. See photos 1 – 11 below.

**Photo 8** shows the crankshaft of the Insured Vehicle which was observed to be partially burnt and/or melted (arrowed).

21. Having carried out a review and analysis of the material evidence, we are of the opinion that the damage to the engine of the Insured Vehicle was due to operating of the engine with insufficient engine oil for lubrication and heat removal purposes. Due to the insufficient engine oil, the oil film (protection layer) between the mechanical parts was inadequate, resulting in direct contact between moving/rotating mechanical parts inside the engine.

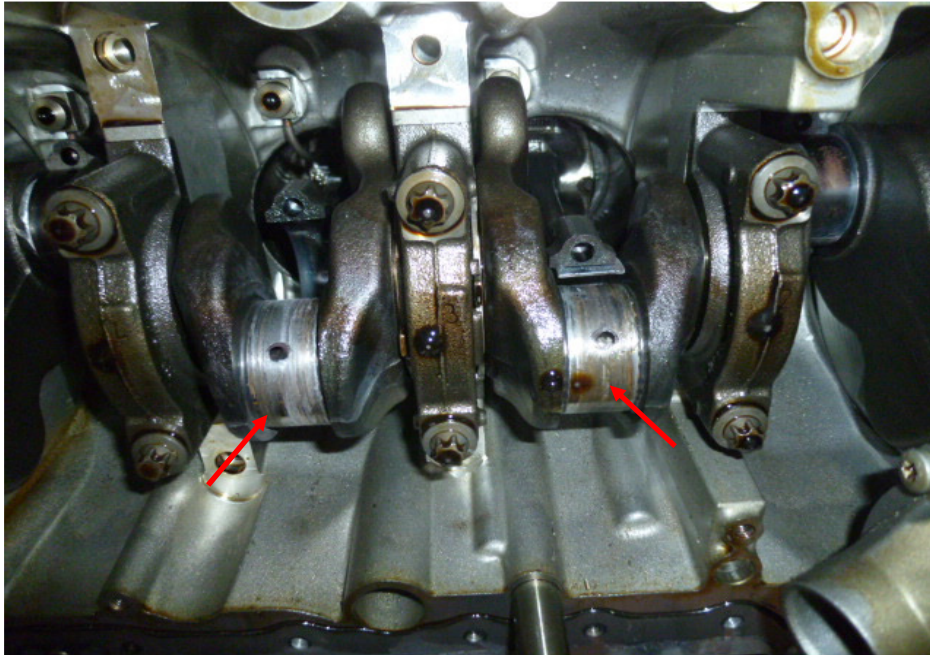
**Photo 9** shows a closer view of the crankshaft of the Insured Vehicle which was observed to be partially burnt and/or melted (arrowed).

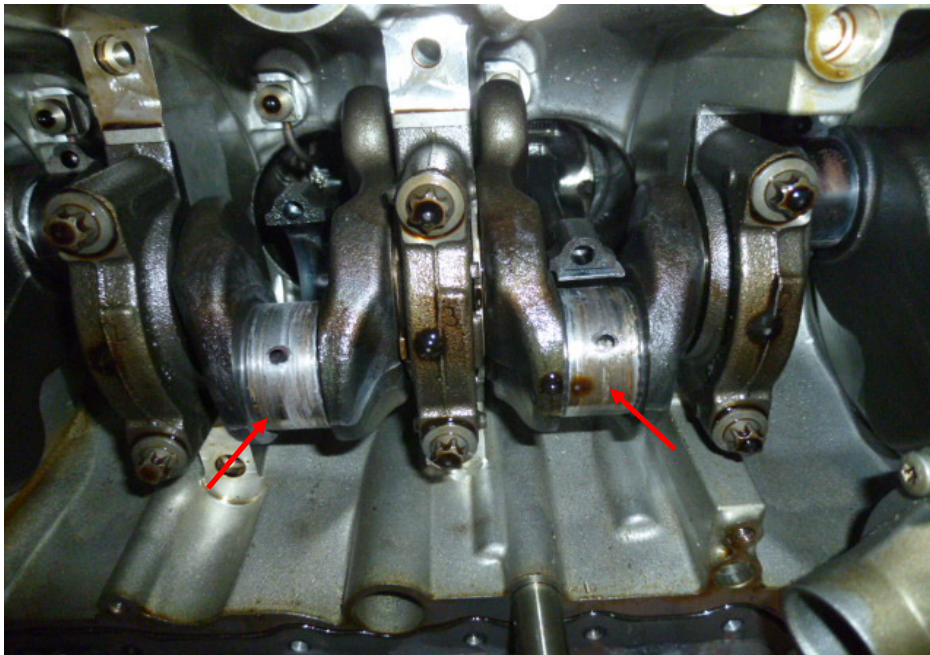
**Photo 10** shows a closer view of the crankshaft of the Insured Vehicle which was observed to be partially burnt and/or melted (arrowed).

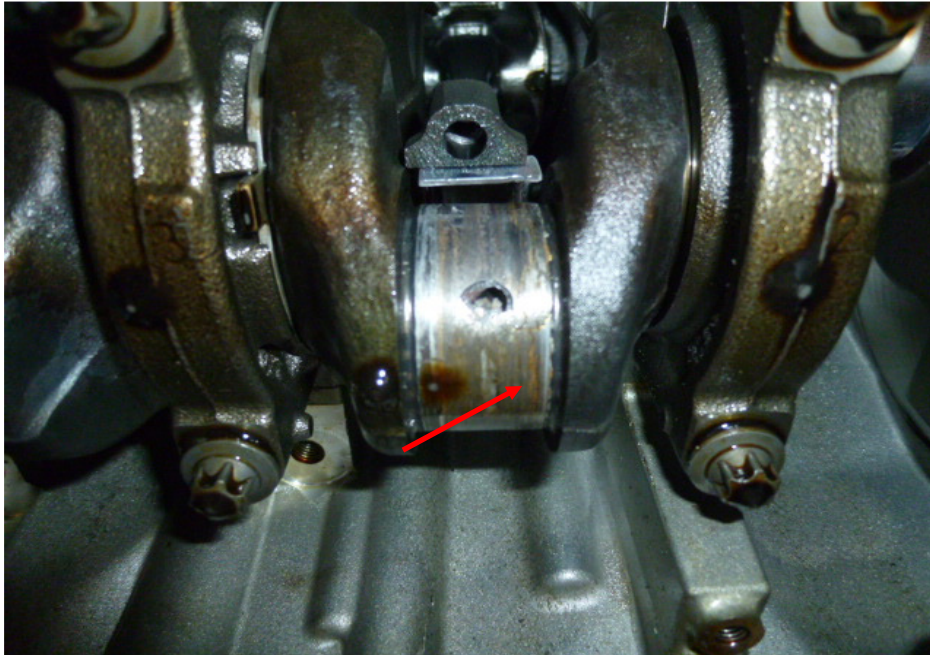
**Photo 11** shows a close up view of the burn marks observed on the crankshaft of the Insured Vehicle (arrowed).

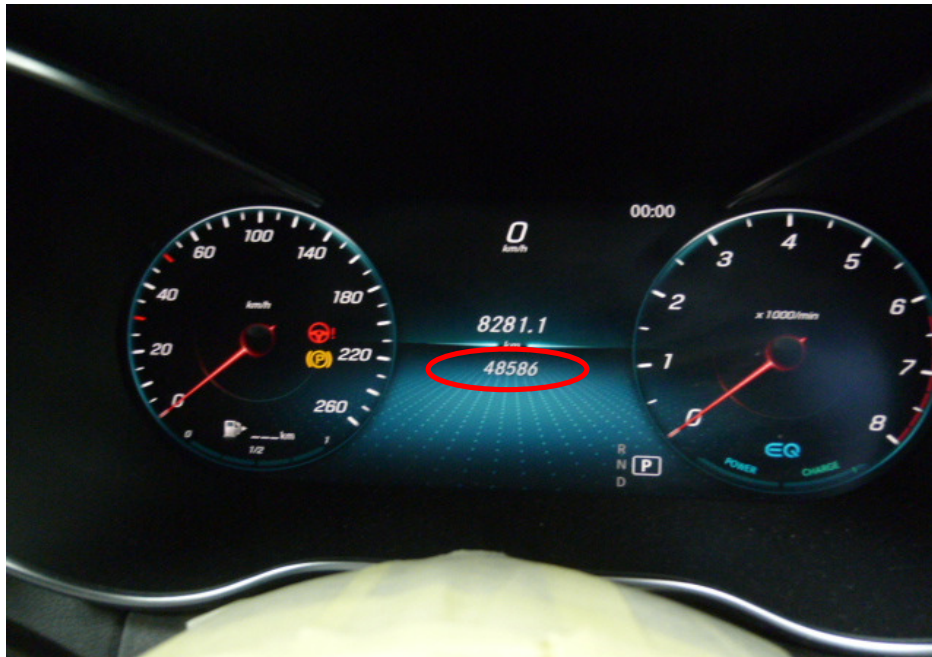
**Photo 13** shows 48,586km (circled), the mileage displayed on the odometer of the Insured Vehicle upon our inspection at C&C, the approximate distance from the reported location where the Insured Vehicle had gone over an object to 525 West Camp Road where it was towed was approximately 10km.

23. Our investigations revealed that the Insured Vehicle was driven for approximately 10km after going over the object before it was eventually brought to a stop by Mr Tan at 525 West Camp Road. The hole on the underside of the engine oil sump was relatively large which would have resulted in engine oil flowing out rather than seeping/dripping out. Hence there was engine damage as the Insured Vehicle had travelled for 10km, which we note is a relatively long distance.
