Your Ref: Toyota Alphard  
(chassis number AYH300130616)  
Our Ref : CI/TP23005044/D

17 May 2023

**Edmund Motor Private Limited**

**INSPECTION REPORT OF AN UNREGISTERED TOYOTA ALPHARD MOTOR CAR WITH CHASSIS NUMBER AYH300130616**

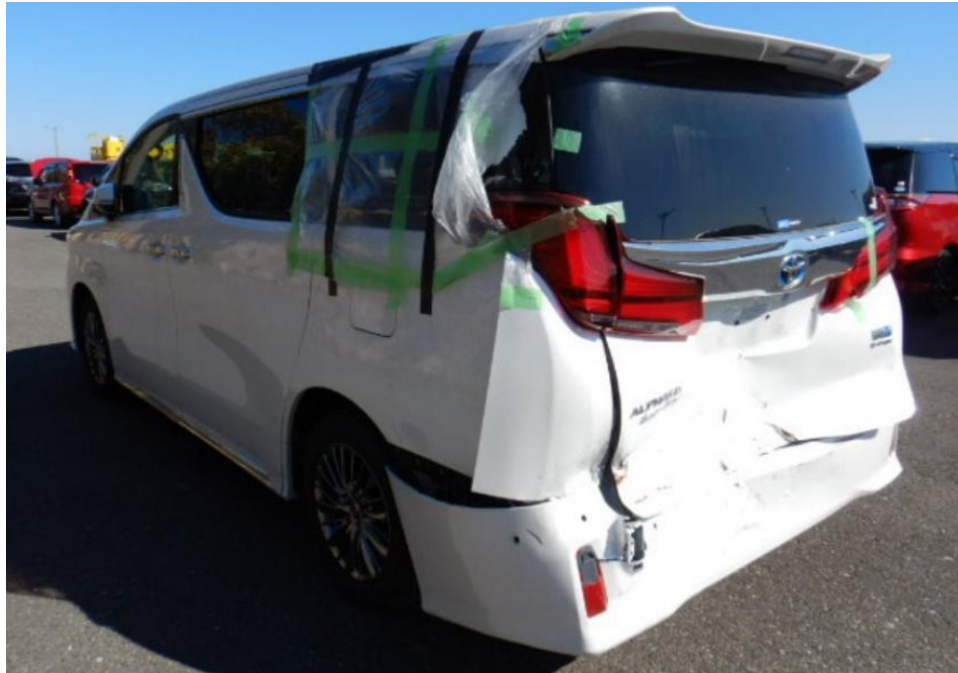
3. The photographs provided to me had showed damage to the rear portion of the Motor Car. Body parts damaged include the rear bumper, rear bumper left reflector, rear bumper sensors, rear left taillamp lower garnish, rear tailgate, rear tailgate lock, rear tailgate upper chrome moulding, rear left tailgate lamp, rear right tailgate lamp and rear end panel amongst others.
4. No physical damage was observed to other areas of the Motor Car. The airbag(s) of the Motor Car was not deployed as seen from the photographs that were provided to me. See photo 1 – 4 below.

**Photo 1** shows the rear left body of the Motor Car (photograph provided to me). The Motor Car was observed to have sustained damage at its rear portion (circled). The rear bumper, rear bumper left reflector, rear bumper sensors, rear left taillamp lower garnish, rear tailgate, rear tailgate lock, rear tailgate upper chrome moulding, rear left tailgate lamp and rear end panel were amongst the body parts that were observed to have been damaged.

22. The body parts at the rear portion of the Motor Car were visually examined and it was noted that the repair/restoration works carried out to the damaged area of the Motor Car (refer to photograph 1 & 2 above) were reasonably adequate and in order.

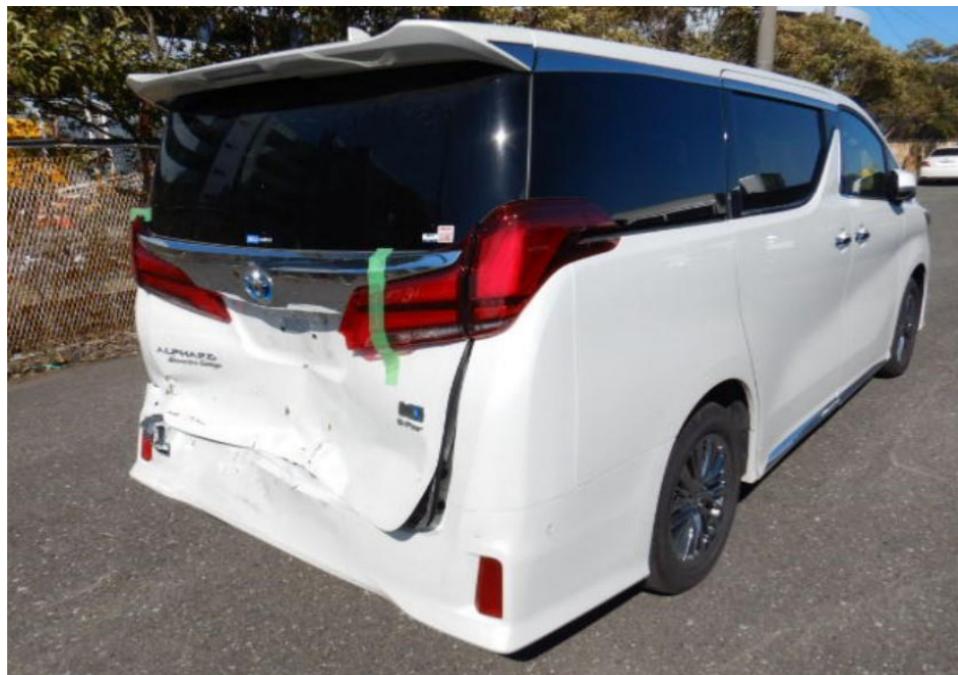
**Photo 2** shows the rear right body of the Motor Car (photograph provided to me). The Motor Car was observed to have sustained damage at its rear portion (circled). The rear bumper, rear tailgate, rear tailgate lock, rear tailgate upper chrome moulding, rear right tailgate lamp and rear end panel were amongst the body parts that were observed to have been damaged.

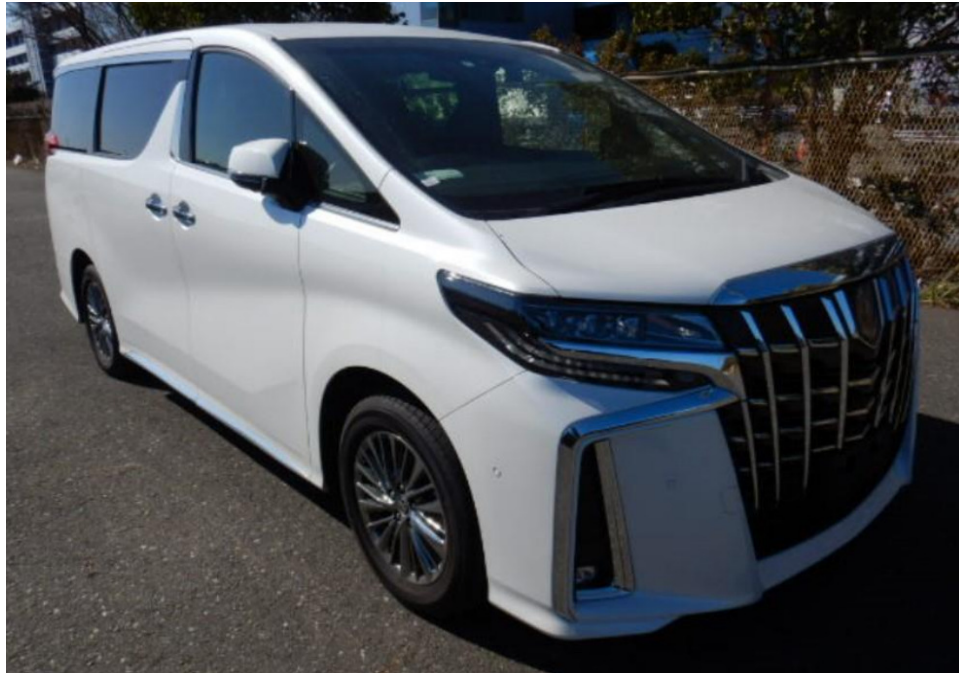
**Photo 3** shows the front right body of the Motor Car (photograph provided to me). Apart for the rear portion, the photographs provided to me did not show physical damage to other areas of the Motor Car. The airbag(s) of the Motor Car was not deployed.

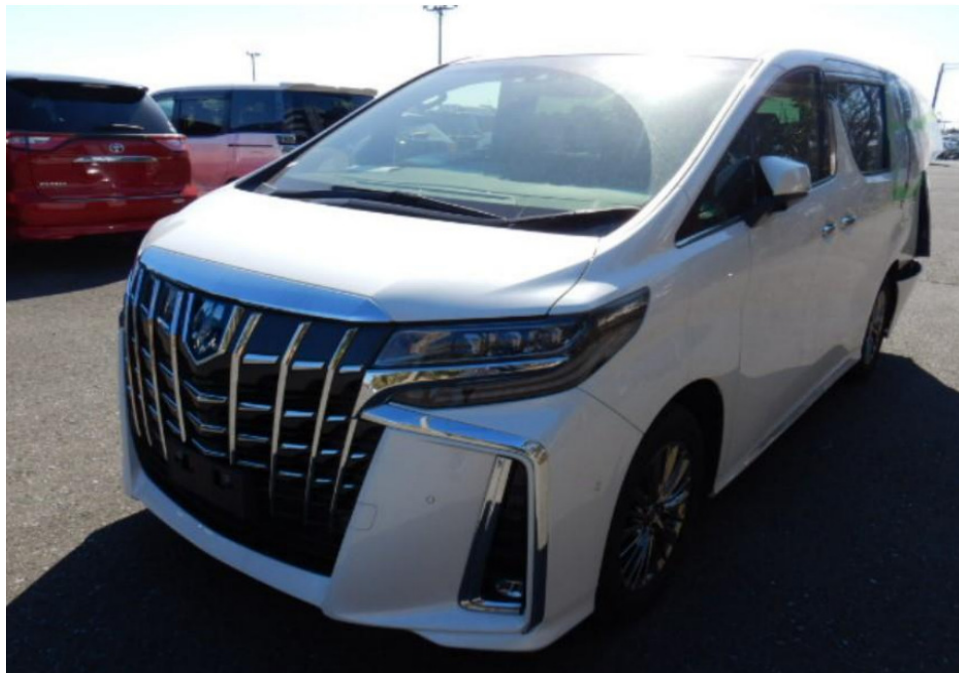
**Photo 4** shows the front left body of the Motor Car (photograph provided to me). Apart for the rear portion, the photographs provided to me did not show physical damage to other areas of the Motor Car. The airbag(s) of the Motor Car was not deployed.

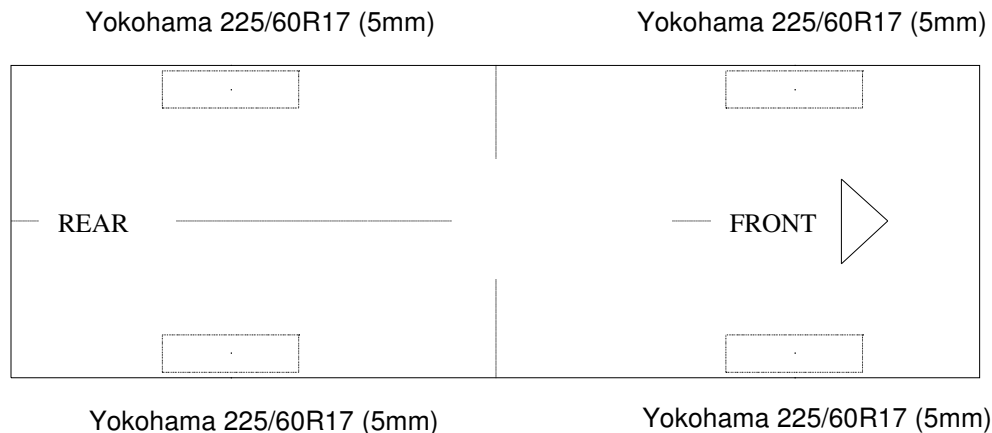
8. It was fitted with 17inch sport wheel rims that were wrapped with tyres that were observed to be of serviceable condition. The tyres were also sufficiently inflated for vehicular operation. The tyre brand, tyre size and approximate remaining tread depth of the 4 tyres of the Motor Car were recorded as follows: -

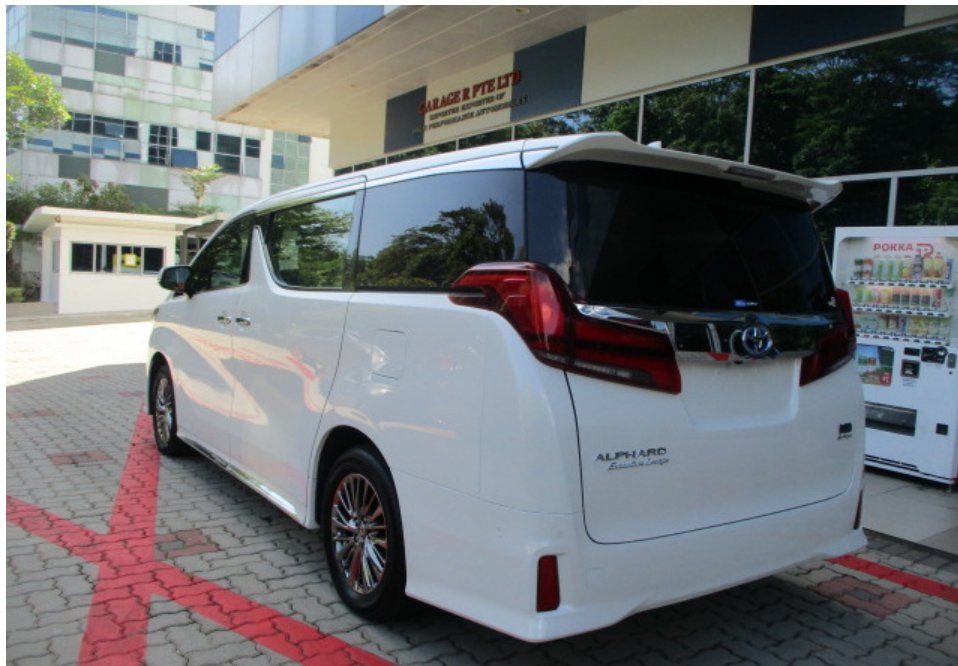
**Photo 5** shows a general view of the rear left body of the Motor Car at the time of my inspection. The Motor Car was observed to be in a relatively good general condition with no loose exterior fittings observed. The body parts at the rear portion of the Motor Car were visually examined and it was observed that the repair/restoration works carried out to the damaged area of the Motor Car (refer to photograph 1 & 2 above) were reasonably adequate and in order.

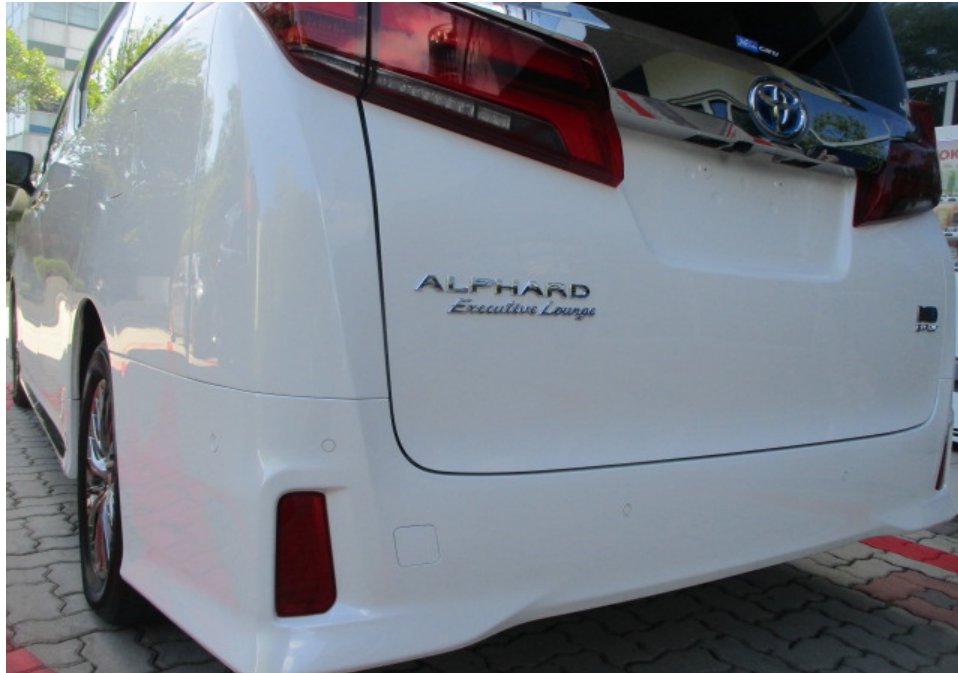
**Photo 6** shows a closer view of the Motor Car's rear bumper, rear bumper left reflector, rear bumper sensors, rear bumper left tow cover and rear left taillamp lower garnish. The body parts at the rear portion of the Motor Car were visually examined and it was observed that the repair/restoration works carried out to the damaged area of the Motor Car (refer to photograph 1 & 2 above) were reasonably adequate and in order.

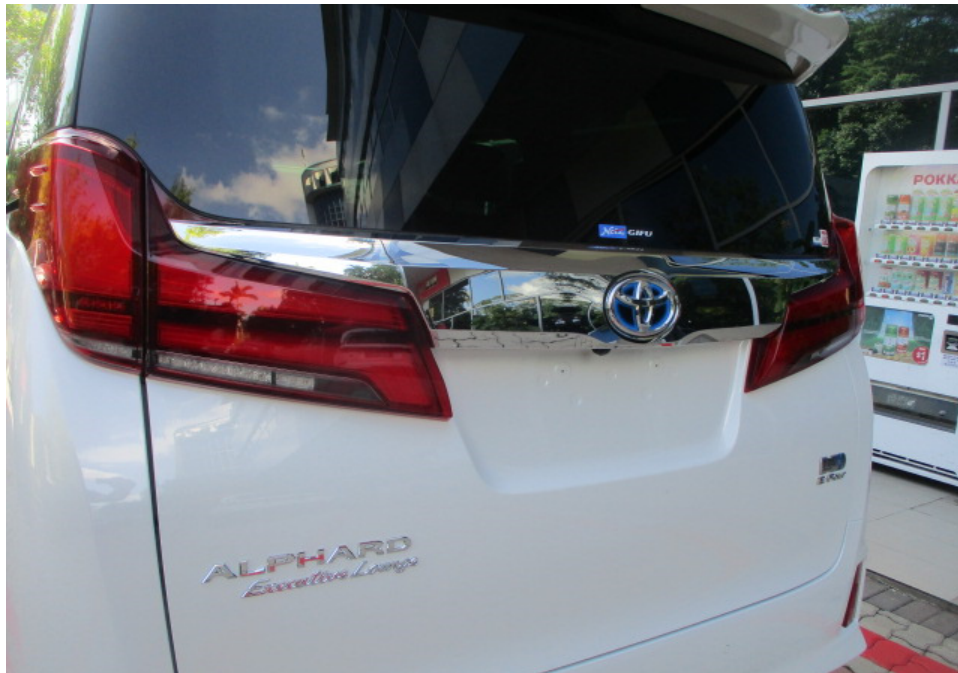
**Photo 7** shows a closer view of the Motor Car's rear tailgate, rear tailgate upper chrome moulding, rear left tailgate lamp and rear left taillamp. The body parts at the rear portion of the Motor Car were visually examined and it was observed that the repair/restoration works carried out to the damaged area of the Motor Car (refer to photograph 1 & 2 above) were reasonably adequate and in order.

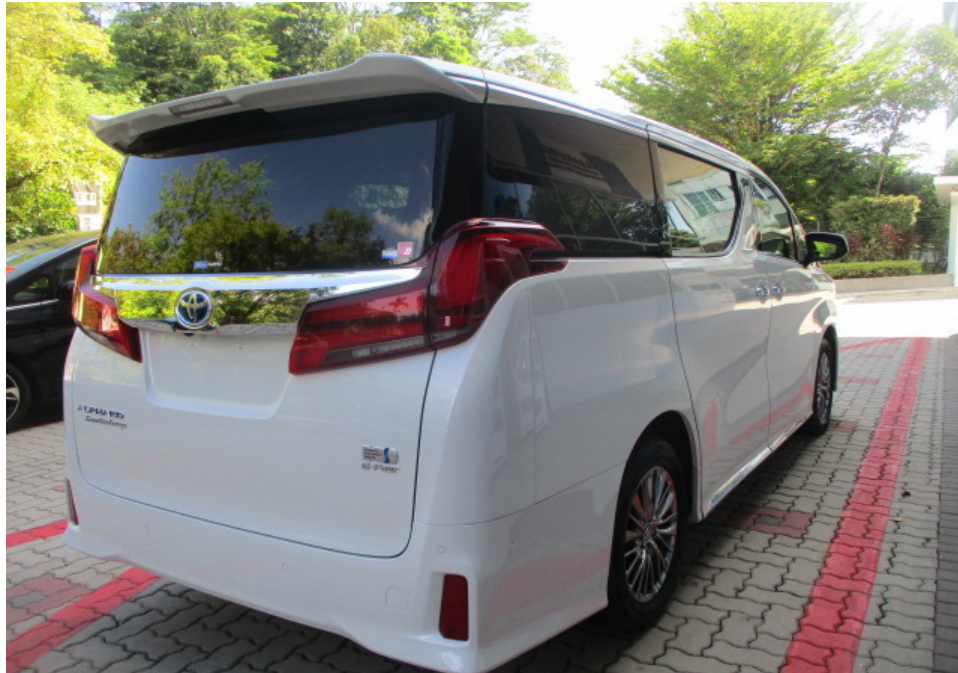
**Photo 8** shows a general view of the rear right body of the Motor Car at the time of my inspection. The Motor Car was observed to be in a relatively good general condition with no loose exterior fittings observed. The body parts at the rear portion of the Motor Car were visually examined and it was observed that the repair/restoration works carried out to the damaged area of the Motor Car (refer to photograph 1 & 2 above) were reasonably adequate and in order.

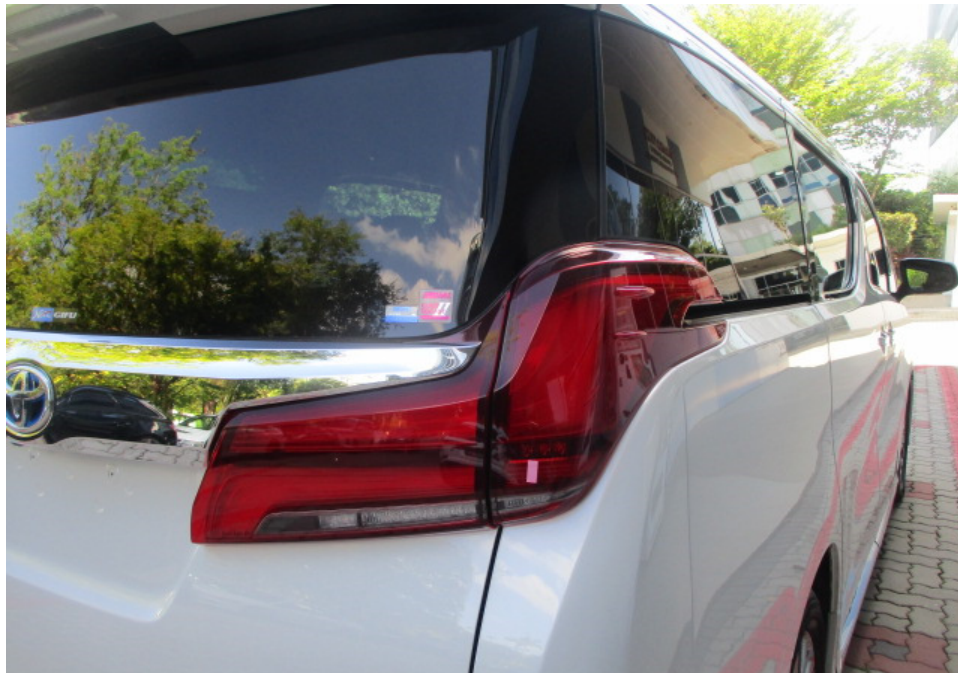
**Photo 9** shows a closer view of the Motor Car's rear tailgate upper chrome moulding, rear right tailgate lamp and rear right taillamp. The body parts at the rear portion of the Motor Car were visually examined and it was observed that the repair/restoration works carried out to the damaged area of the Motor Car (refer to photograph 1 & 2 above) were reasonably adequate and in order.

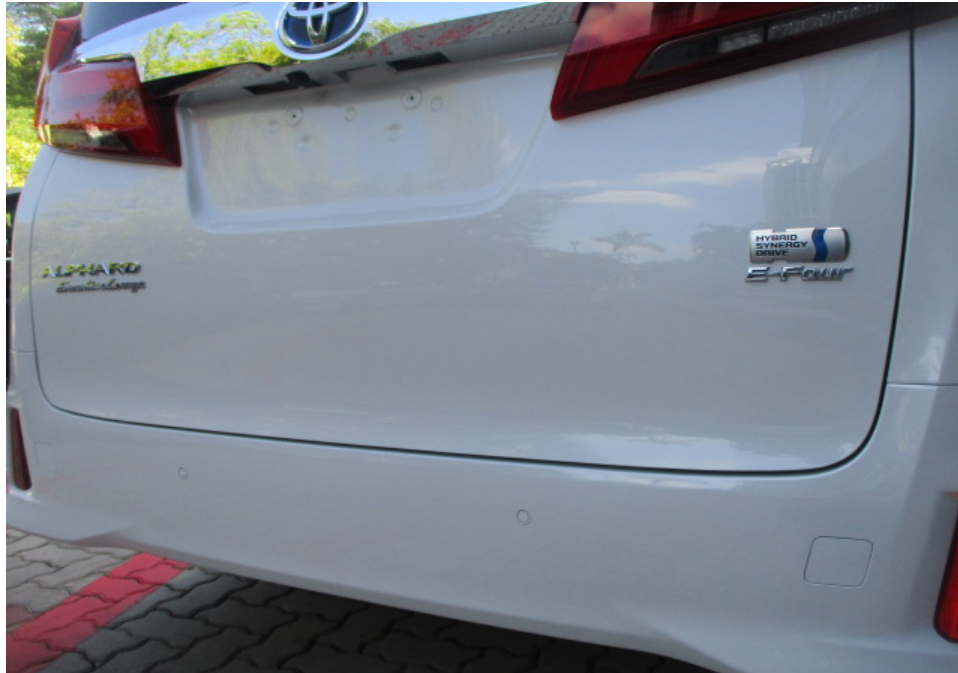
**Photo 10** shows a closer view of the Motor Car's rear bumper, rear bumper right tow cover, rear tailgate and rear tailgate emblems. The body parts at the rear portion of the Motor Car were visually examined and it was observed that the repair/restoration works carried out to the damaged area of the Motor Car (refer to photograph 1 & 2 above) were reasonably adequate and in order.

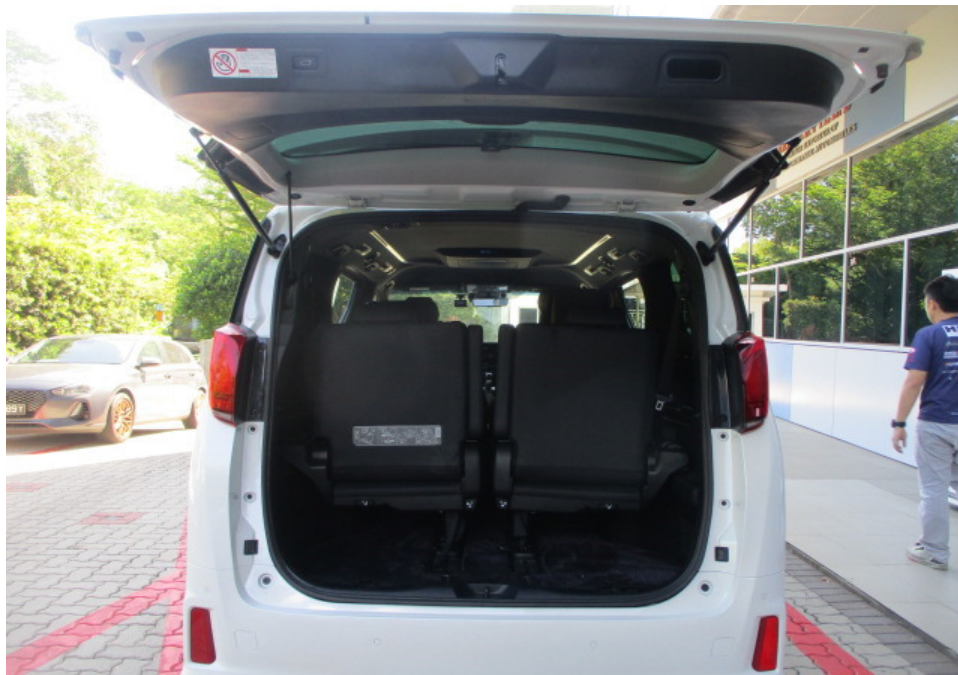
**Photo 11** shows a general view of the Motor Car's rear interior compartment. The various parts and components, trims, carpet and upholstery inside the rear interior compartment were all observed to be intact and properly fitted. The repair/restoration works carried out to the damaged rear portion of the Motor Car (refer to photograph 1 & 2 above) were reasonably adequate and in order.

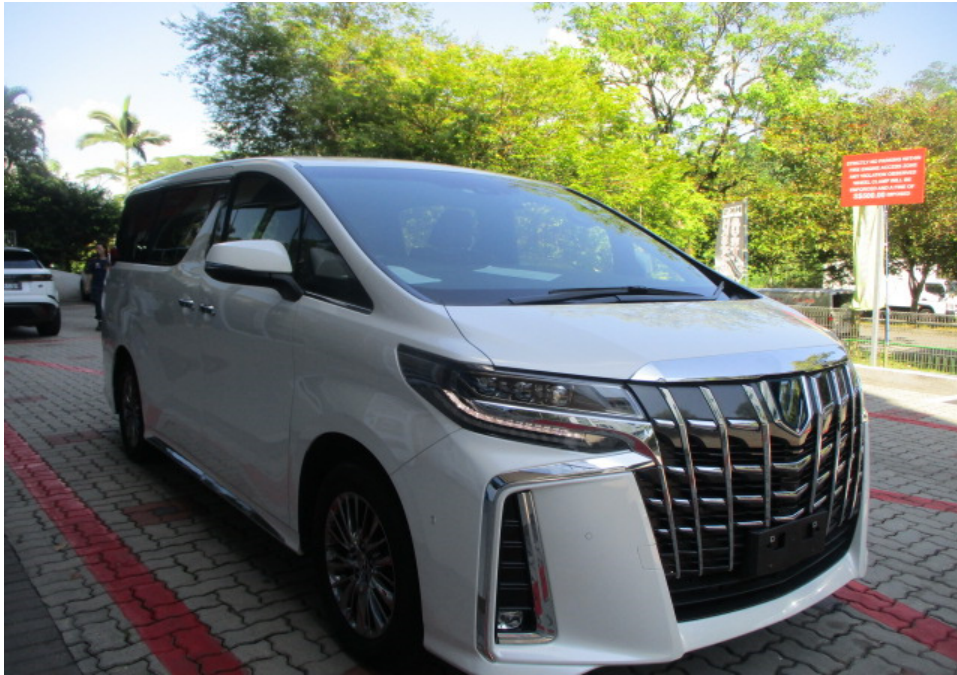
**Photo 12** shows a general view of the front right body of the Motor Car at the time of my inspection. The Motor Car was observed to be in a relatively good general condition with no loose exterior fittings observed. The mileage of the Motor Car recorded at the time of my inspection was 13,301km.

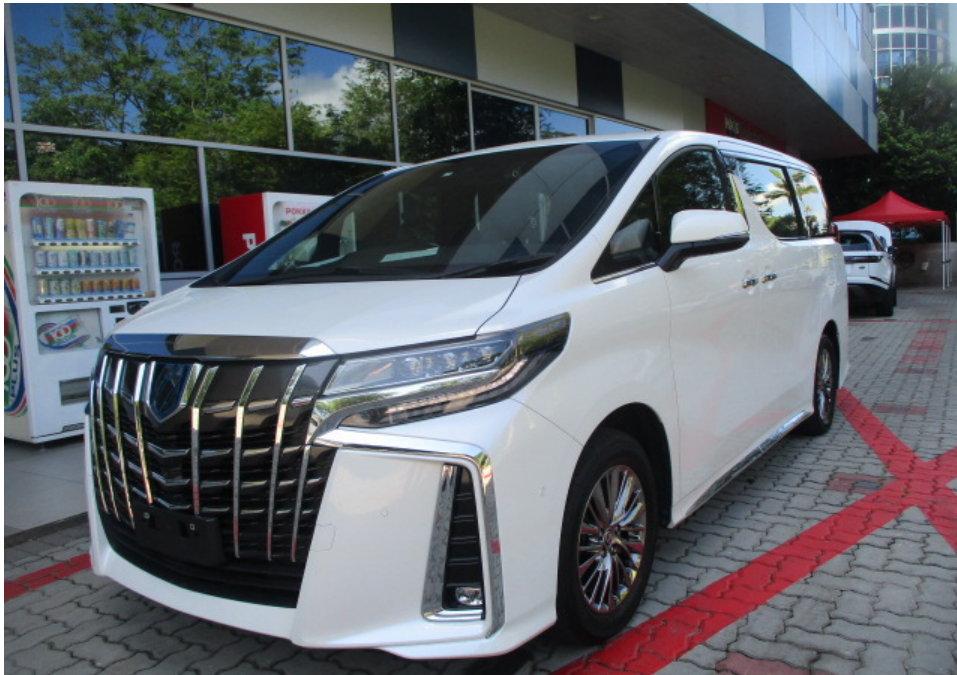
**Photo 13** shows a general view of the front left body of the Motor Car at the time of my inspection. The Motor Car was observed to be in a relatively good general condition with no loose exterior fittings observed. The mileage of the Motor Car recorded at the time of my inspection was 13,301km.

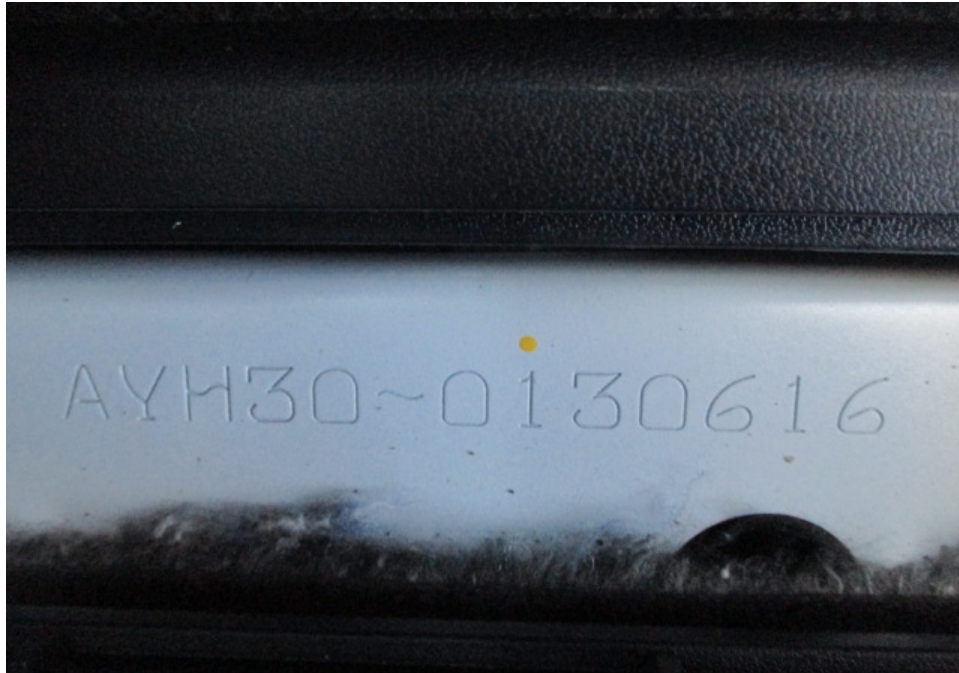
**Photo 14** shows the chassis number of the Motor Car. The chassis number recorded was AYH300130616.

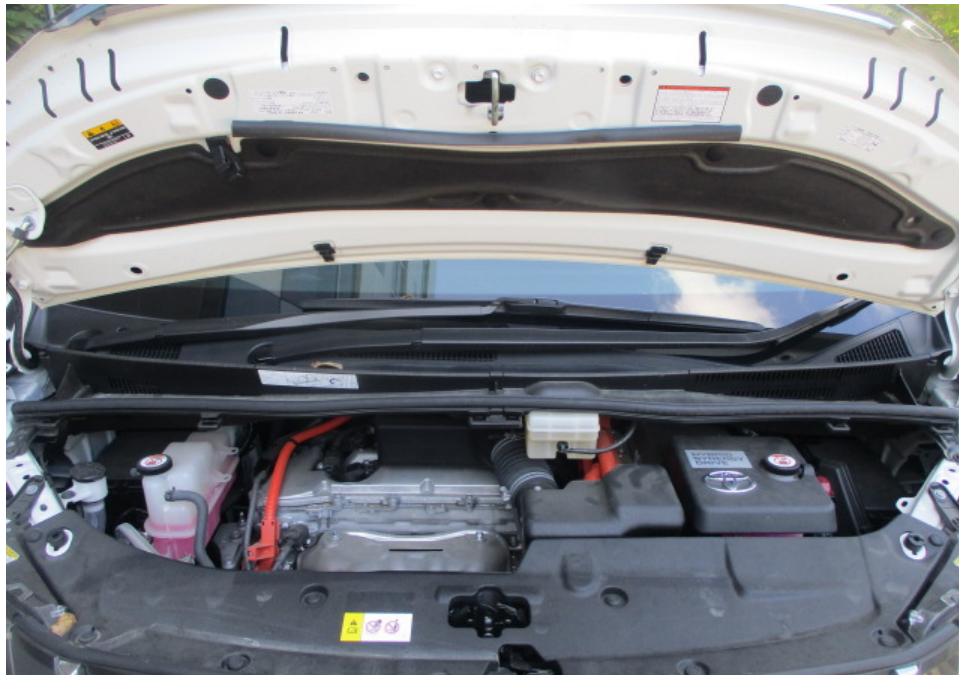
**Photo 15** shows a general view of the engine compartment of the Motor Car at the time of my inspection. The various parts and components inside the engine compartment were all observed to be intact and properly fitted. There was no sign(s) or indication(s) of fluid leak and/or fluid stain found inside the engine compartment.

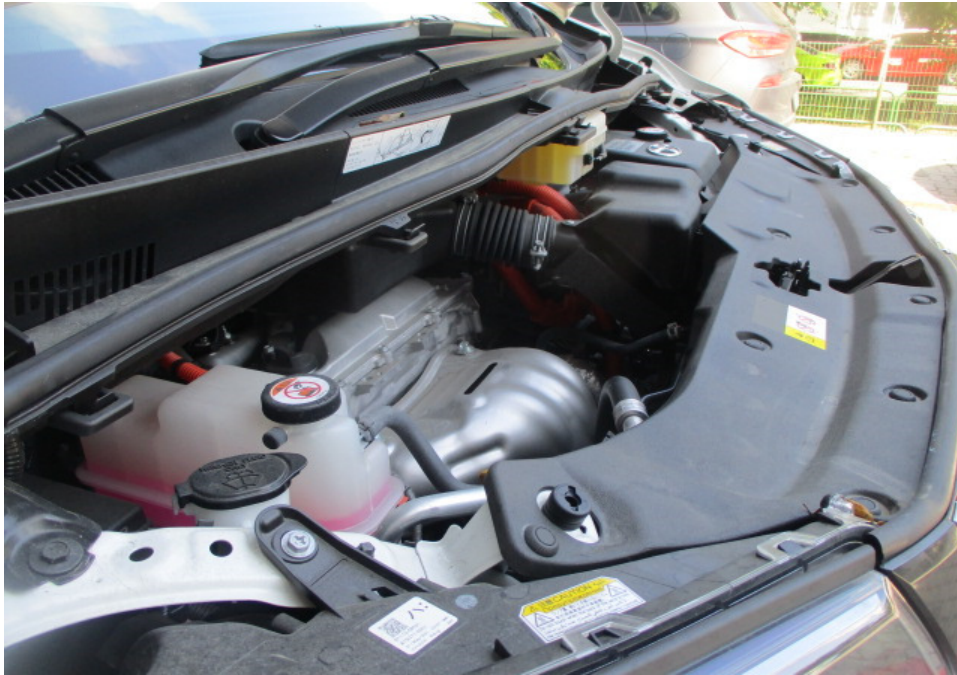
**Photo 16** shows another view of the engine compartment of the Motor Car at the time of my inspection. The various parts and components inside the engine compartment were all observed to be intact and properly fitted. There was no sign(s) or indication(s) of fluid leak and/or fluid stain found inside the engine compartment.

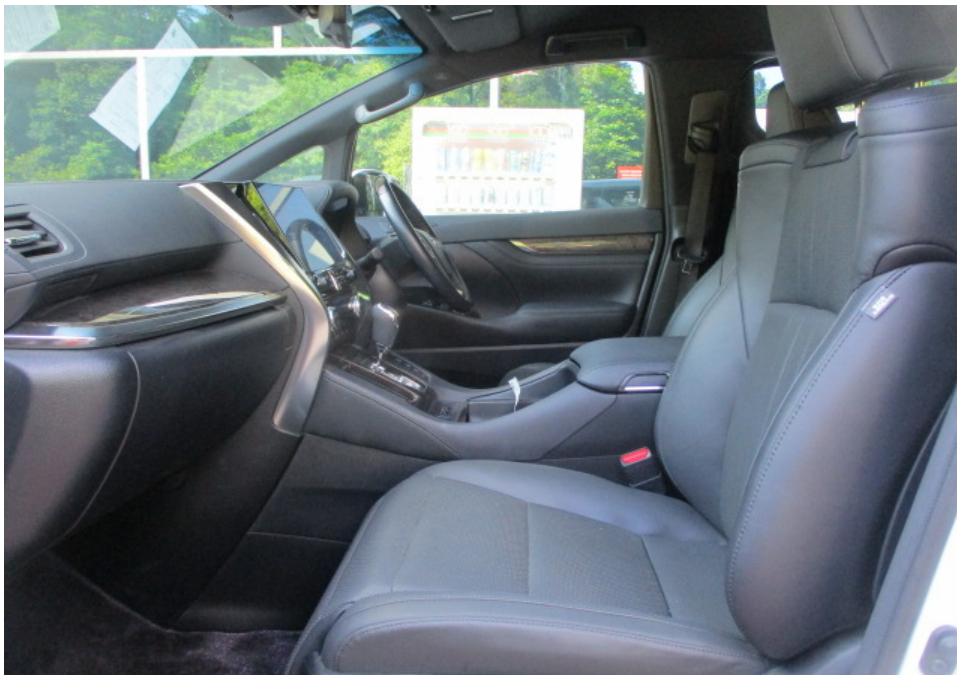
**Photo 17** shows the interior compartment of the Motor Car at the time of my inspection. The various parts and components, trims, carpet and upholstery inside the interior compartment were all observed to be intact and properly fitted.

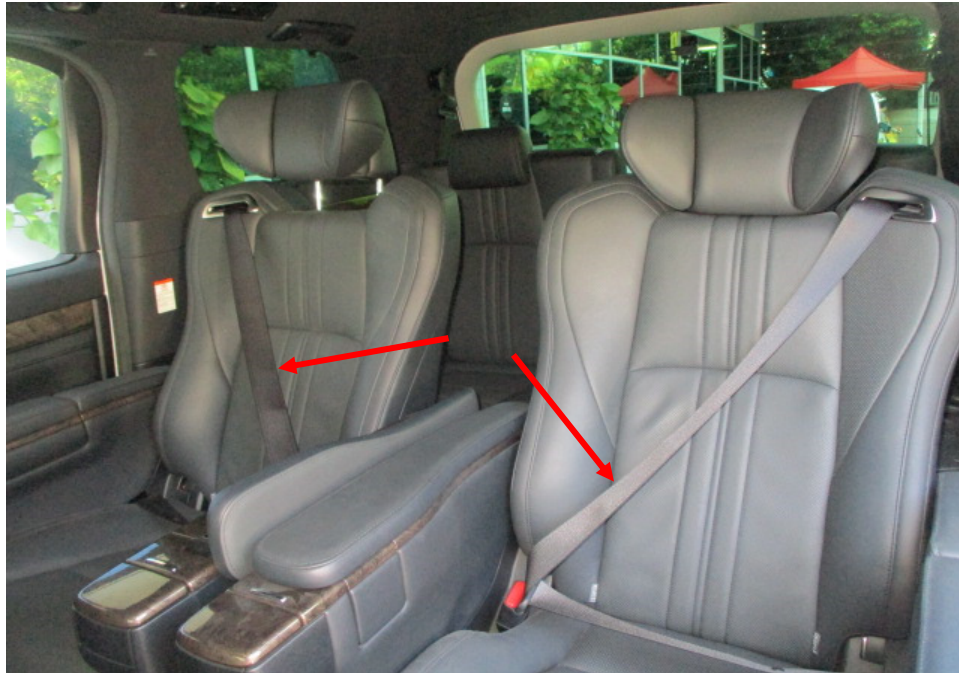
**Photo 18** shows the rear seats at the 1<sup>st</sup> row of the Motor Car. All the seats of the Motor Car were secured via seat rails to the floorboard. They were also fitted with a retractable seat belt reel and a pre-tensioner. The seat belts (arrowed) were tested and were able to be fastened into the respective pre-tensions that were fitted on the side of each individual seat.

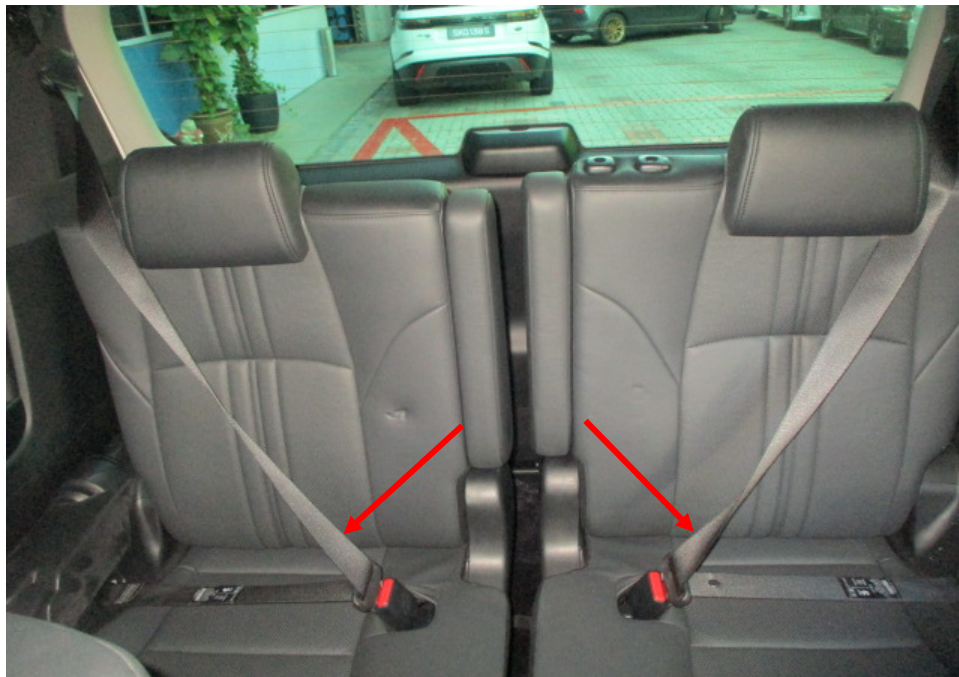
**Photo 19** shows the rear seats at the 2<sup>nd</sup> row of the Motor Car. All the seats of the Motor Car were secured via seat rails to the floorboard. They were also fitted with a retractable seat belt reel and a pre-tensioner. The seat belts (arrowed) were tested and were able to be fastened into the respective pre-tensions that were fitted on the side of each individual seat.

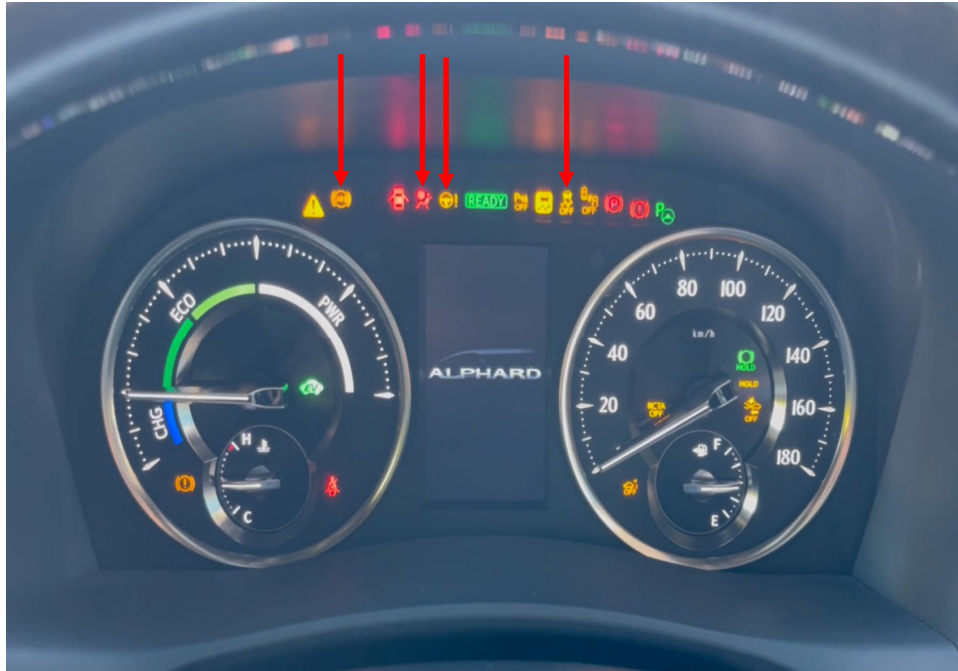
**Photo 20** shows the warning lights for the various electronic safety features appearing on the instrument panel of the Motor Car during its self-test when the engine is cranked, in particular the lights for the ABS, SRS, EPS, VSC (arrowed) and the various collision prevention systems.

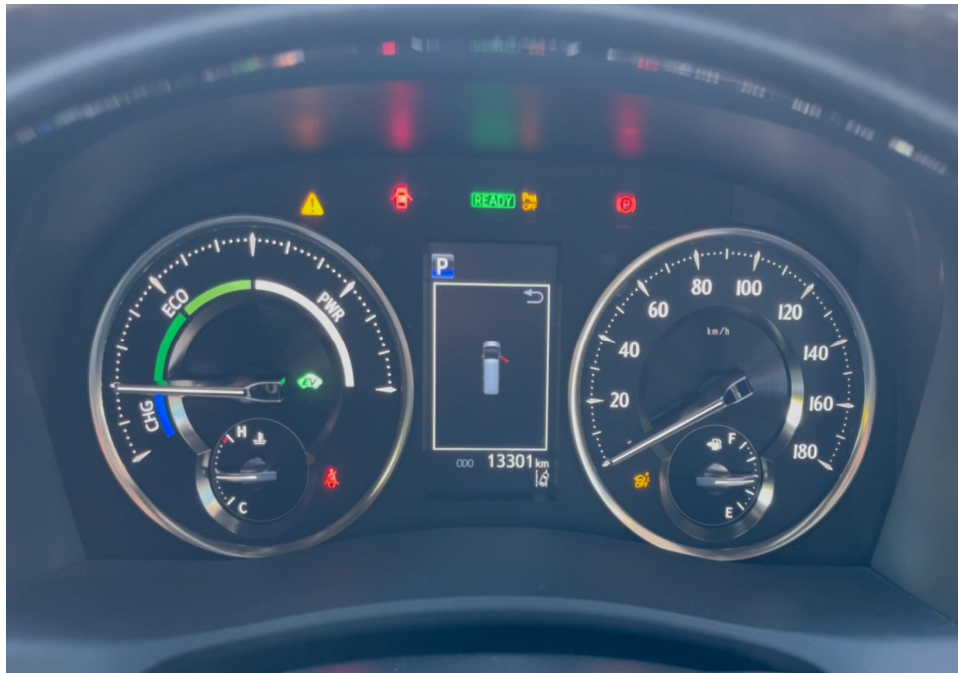
**Photo 21** shows the respective warning lights no longer illuminated, indicating that there is no fault detected to the ABS, SRS, EPS, VSC and the various collision prevention systems of the Motor Car during the self-test. These electronic systems were hence in working condition at the time of my inspection.

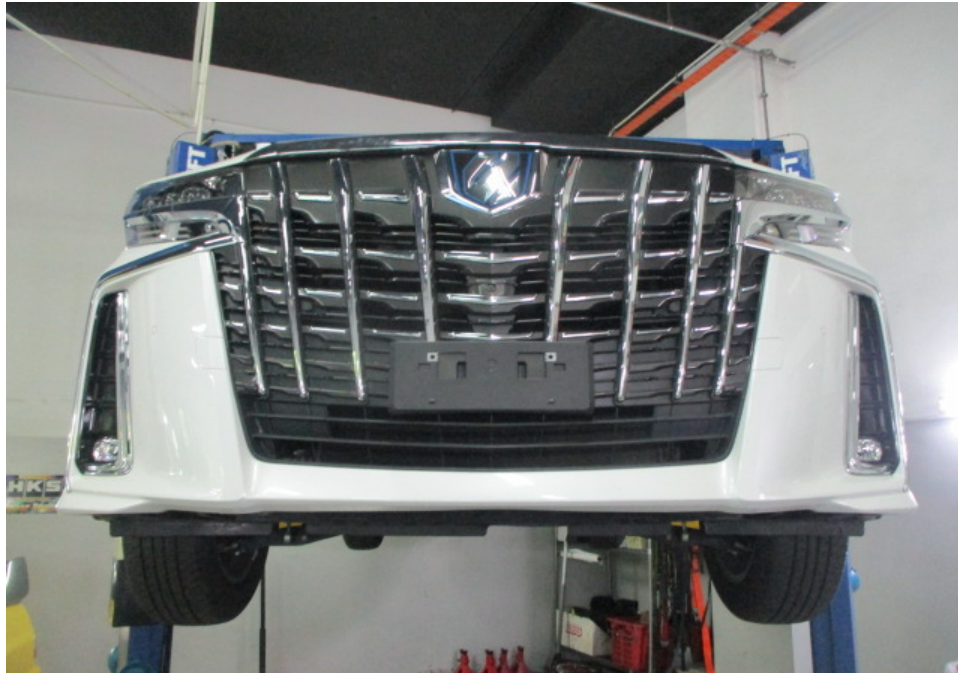
**Photo 22** shows the Motor Car hoisted up for checks on its undercarriage. There was no sign(s) or indication(s) of fluid leakage and/or fluid stain(s) on the underside of the Motor Car. The undercarriage components of the Motor Car were also all observed to be intact and secured in an appropriate manner.

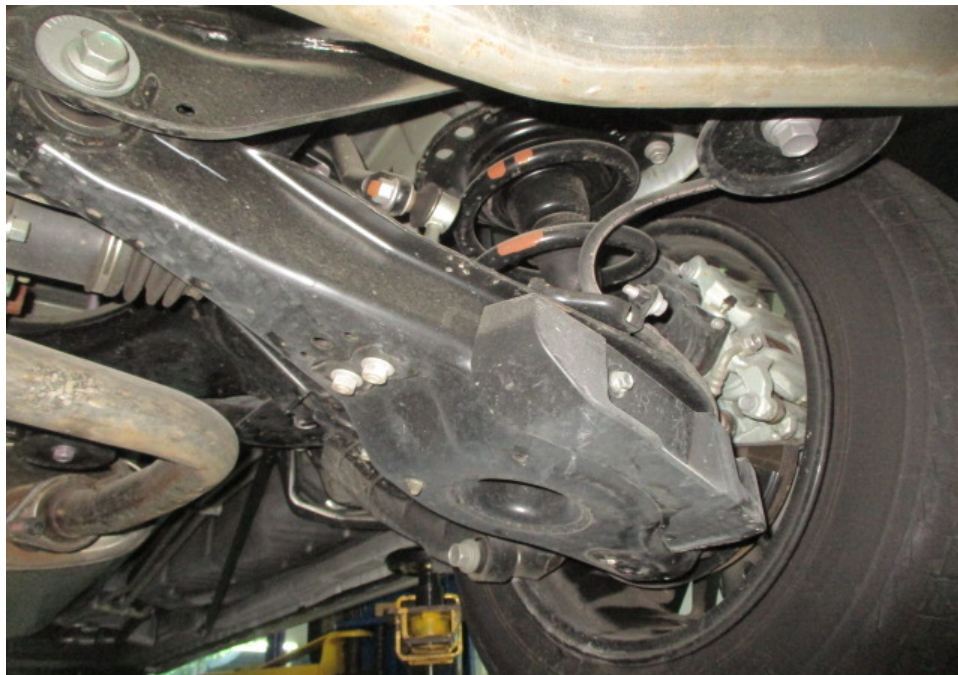
**Photo 23** shows a general view of the control arms and linkages at the rear right wheel of the Motor Car. I did not observe any fluid leak and/or fluid stain on the underside of the Motor Car. All of the Motor Car's undercarriage components were observed to be intact and secured in an appropriate manner.

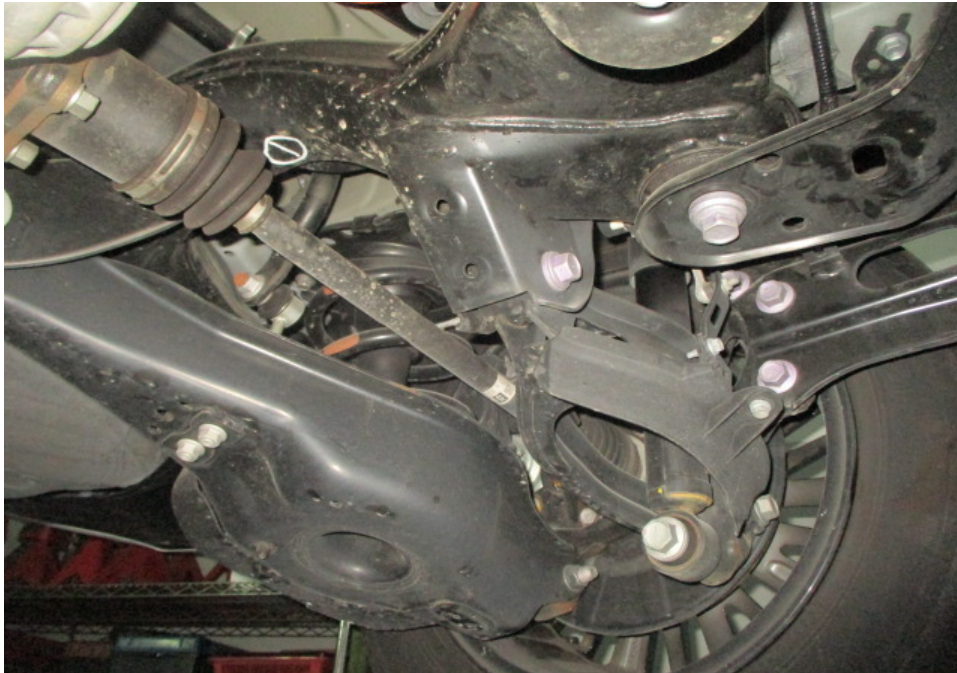
**Photo 24** shows a general view of the control arms and linkages at the rear left wheel of the Motor Car. I did not observe any fluid leak and/or fluid stain on the underside of the Motor Car. All of the Motor Car's undercarriage components were observed to be intact and secured in an appropriate manner.

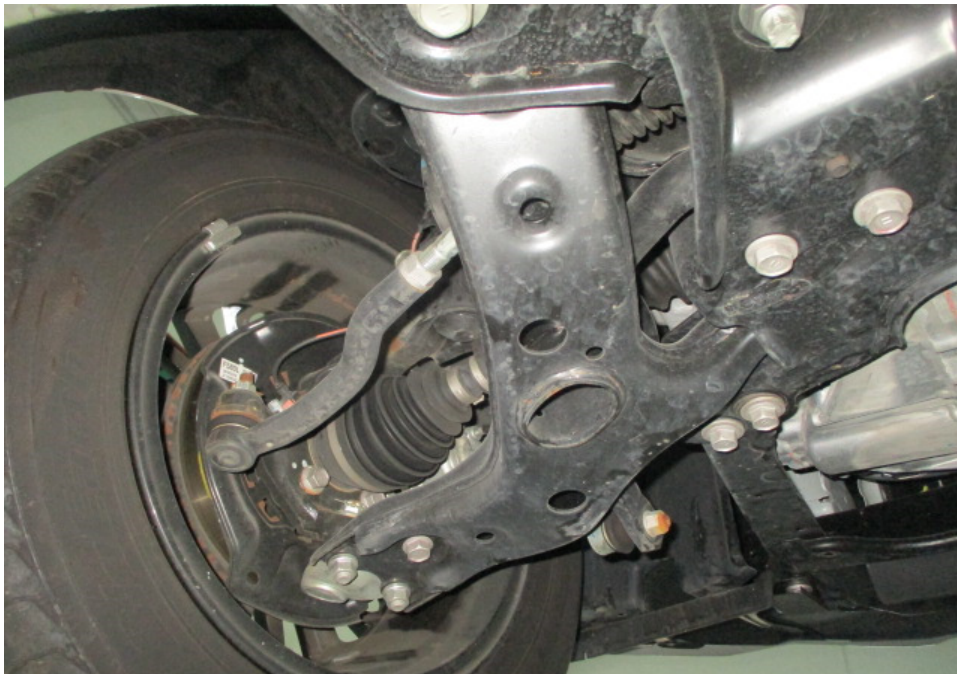
**Photo 25** shows the various undercarriage components at the front left wheel of the Motor Car. The mechanical components, control arms and linkages were all found to be intact and secured in an appropriate manner.

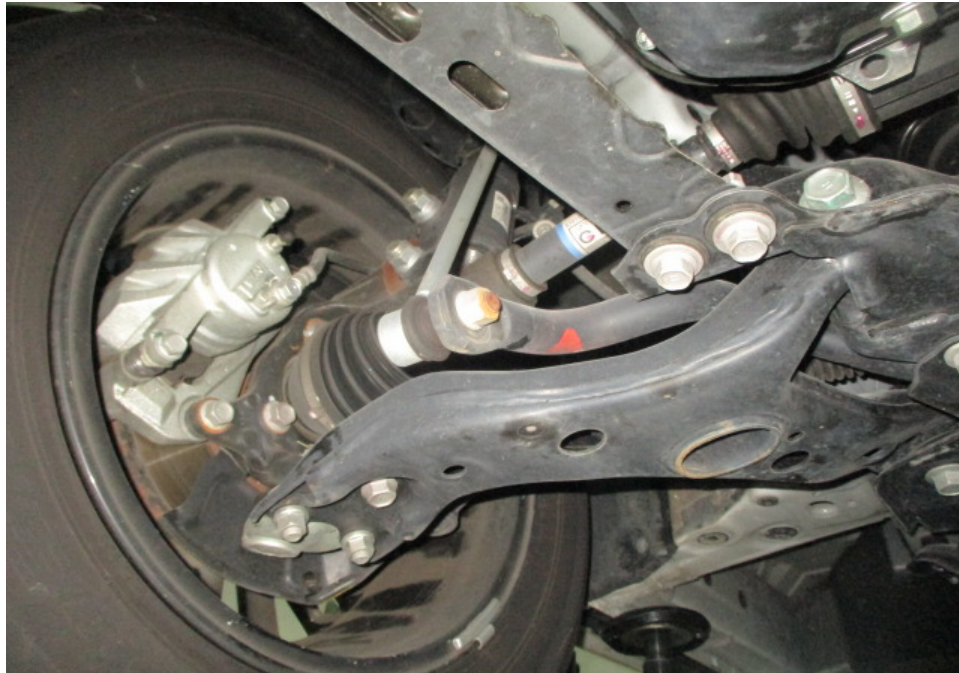
**Photo 26** shows the various undercarriage components at the front right wheel of the Motor Car. The mechanical components, control arms and linkages were all found to be intact and secured in an appropriate manner. I also did not observe any fluid leak and/or fluid stain on the underside of the Motor Car.

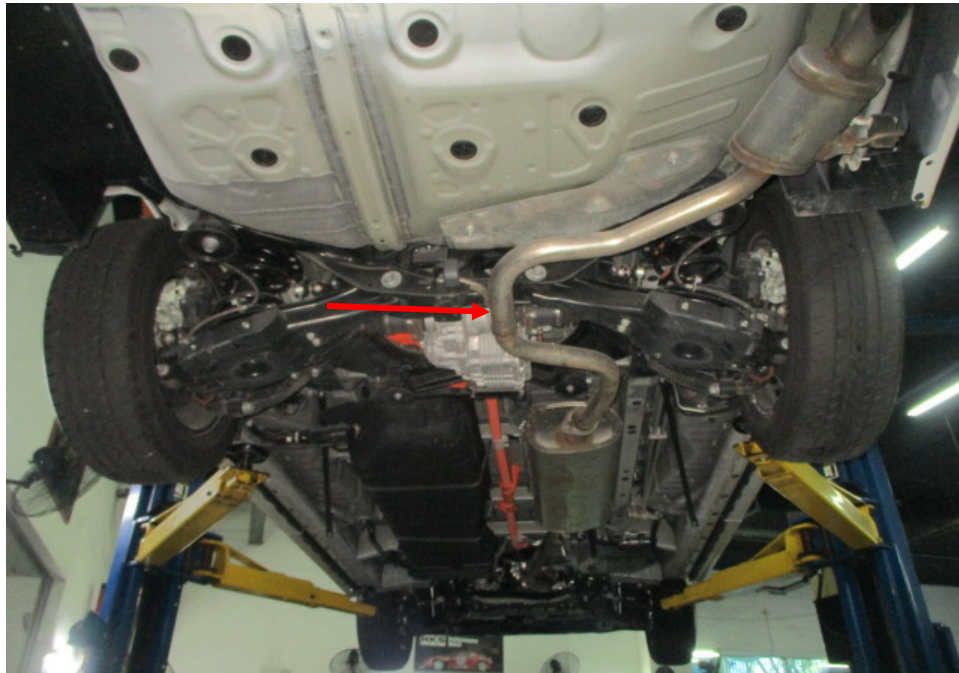
**Photo 27** shows a general view of the rear section of the Motor Car's exhaust system. My examination of the Motor Car's exhaust system revealed no sign(s) or indication(s) of any cut or weld marks along its exhaust pipe (arrowed), on its catalytic converter, on its centre resonator box and on its rear muffler.

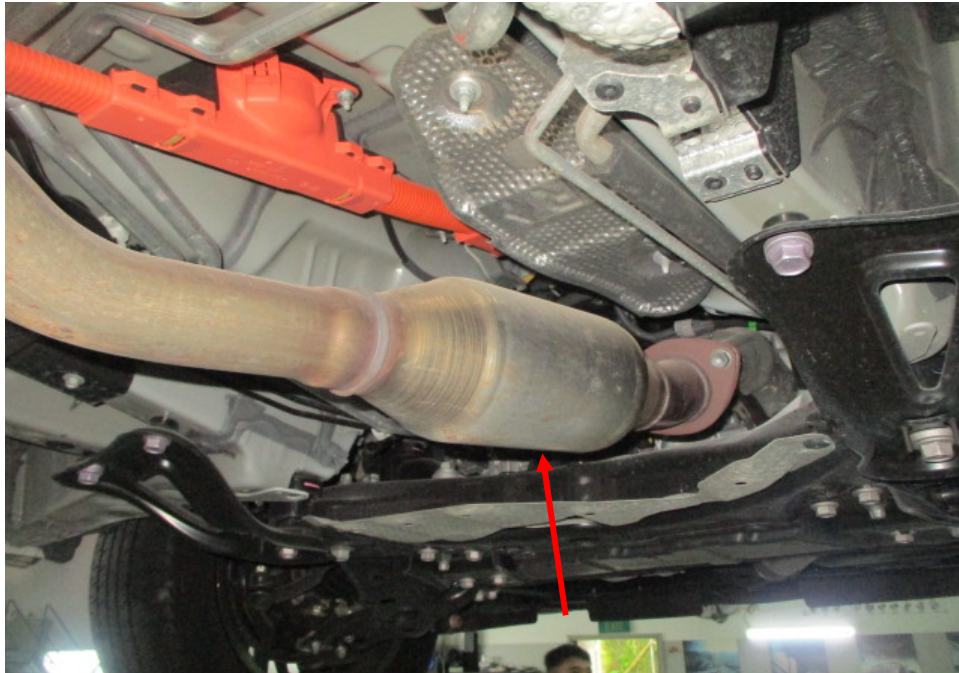
**Photo 28** shows a general view of the front section of the Motor Car's exhaust system. My examination of the Motor Car's exhaust system revealed no sign(s) or indication(s) of any cut or weld marks along its exhaust pipe, on its catalytic converter (arrowed), on its centre resonator box and on its rear muffler.

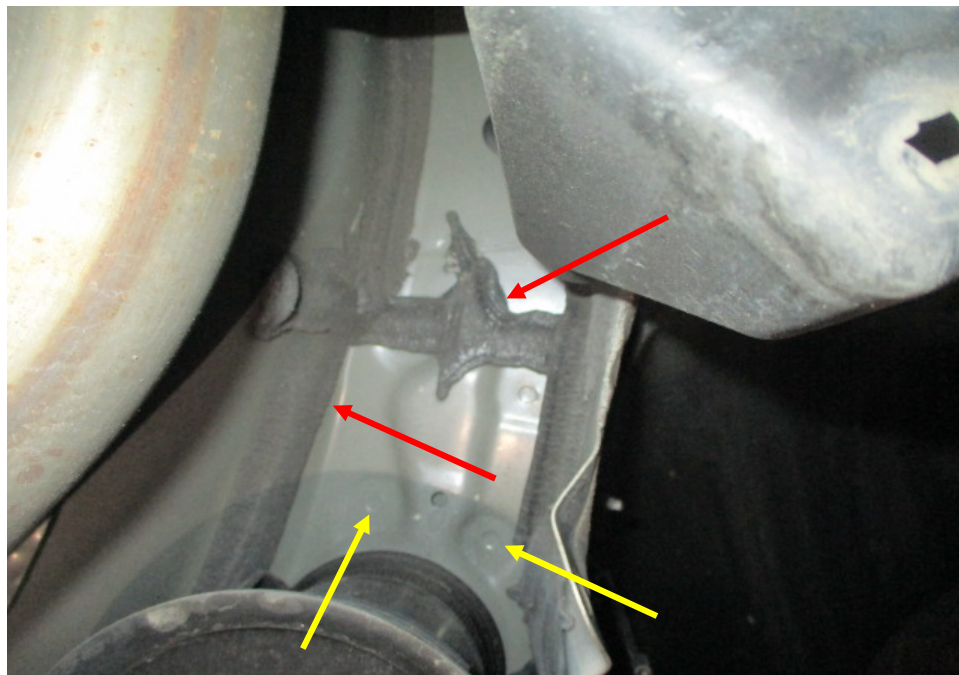
**Photo 29** shows the chassis/structural body at the underside rear right of the Motor Car. I did not find any weld marks other than original spot weld marks (yellow arrow) on the chassis/structural body of the Motor Car. The original factory sealant (red arrow) at the joints along the chassis/structural body was untouched, indicating no work was done on the chassis/structural body of the Motor Car and that the chassis/structural body was originally fitted.

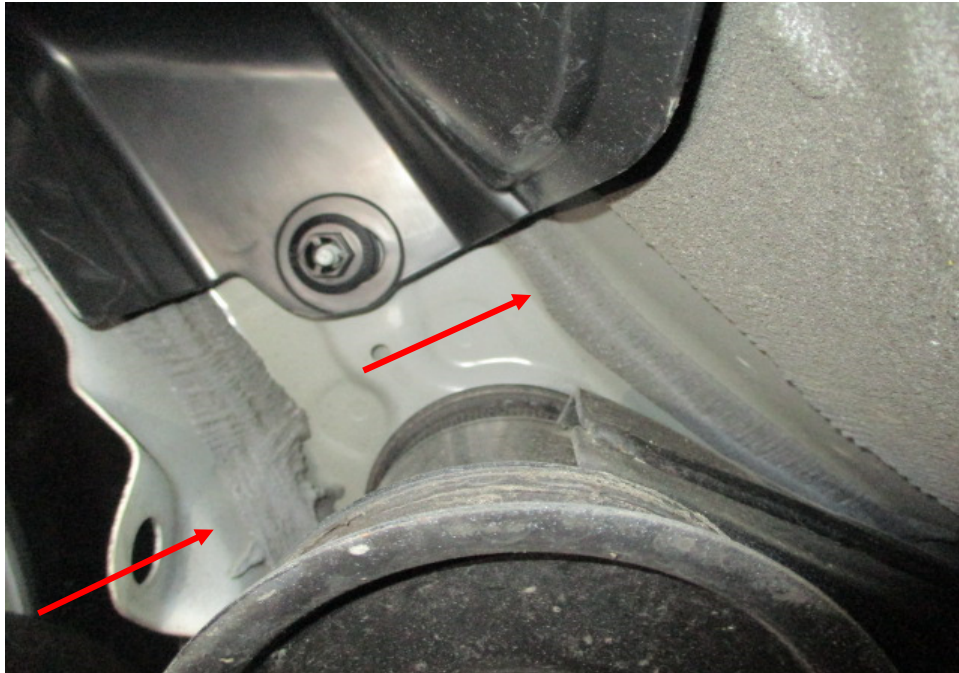
**Photo 30** shows the chassis/structural body at the underside rear left of the Motor Car. The original factory sealant (arrowed) at the joints along the chassis/structural body was observed to be untouched. In general, I had found no work was carried out on the chassis/structural body of the Motor Car. The chassis/structural body of the Motor Car was originally fitted.
