Your Ref: Toyota Alphard  
(chassis number AYH300130616)  
Our Ref : CI/TP23005044/D

17 May 2023

**Edmund Motor Private Limited**

**INSPECTION REPORT OF AN UNREGISTERED TOYOTA ALPHARD MOTOR CAR WITH CHASSIS NUMBER AYH300130616**

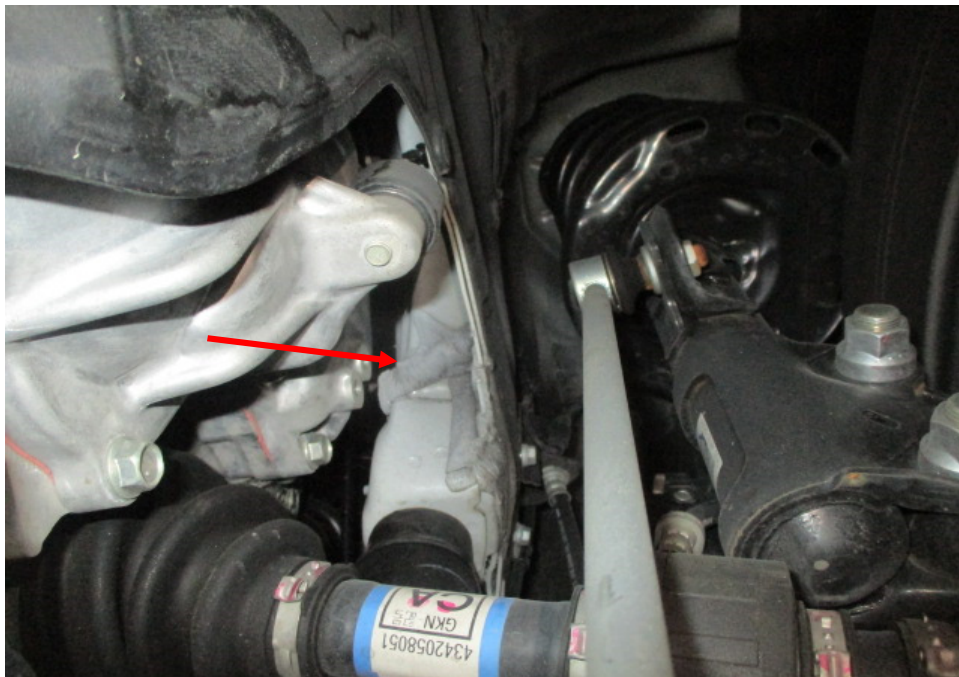
**Photo 31** shows the chassis/structural body at the underside front left of the Motor Car. The original factory sealant (arrowed) at the joints along the chassis/structural body was observed to be untouched. In general, I had found no work was carried out on the chassis/structural body of the Motor Car. The chassis/structural body of the Motor Car was originally fitted.

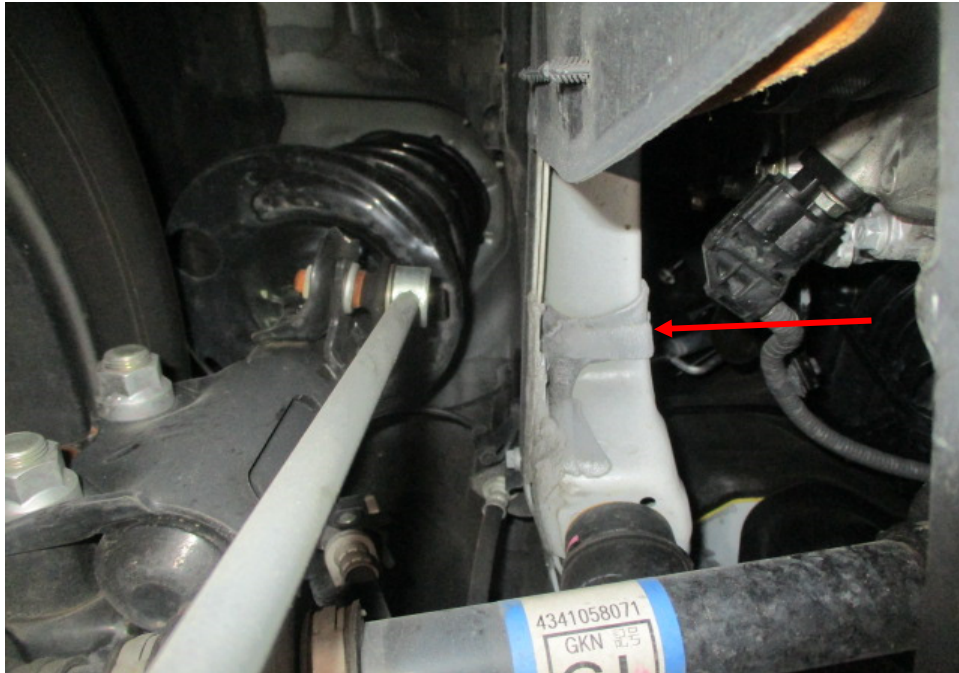
**Photo 32** shows the chassis/structural body at the underside front right of the Motor Car. I did not find any weld marks other than original spot weld marks on the chassis/structural body of the Motor Car. The original factory sealant (arrowed) at the joints along the chassis/structural body was untouched, indicating no work was done on the chassis/structural body of the Motor Car and that the chassis/structural body was originally fitted.

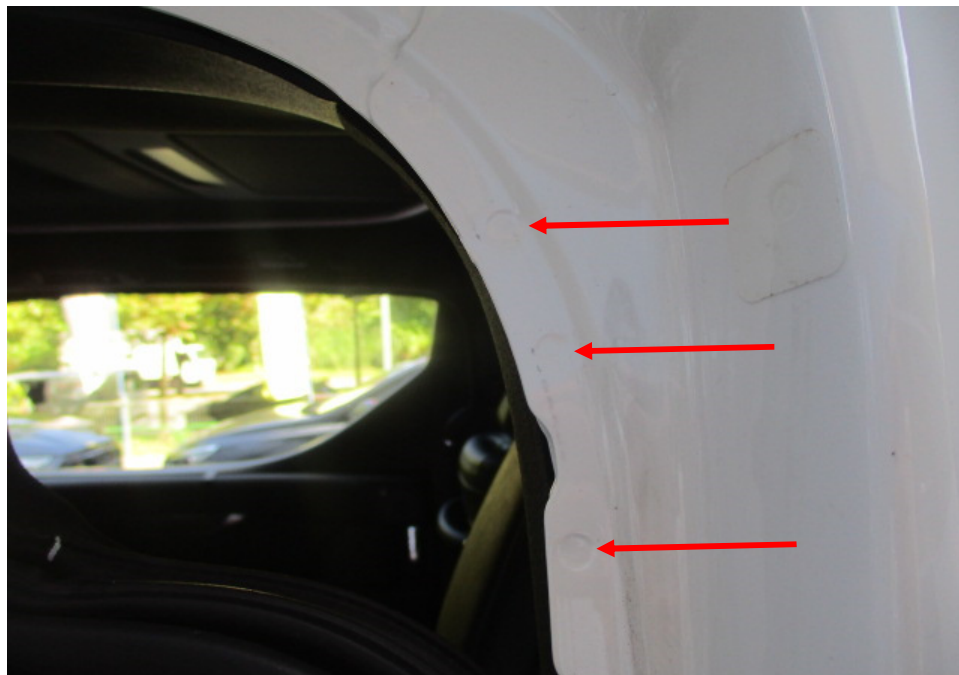
**Photo 33** shows the right side "B" pillar of the Motor Car. I did not find any weld marks other than original spot weld marks (arrowed) on the right side "B" pillar of the Motor Car, which indicates that there was no re-welding works carried out. In general, I had found all the non-detachable body panels of the Motor Car to be originally fitted at the time of my inspection.

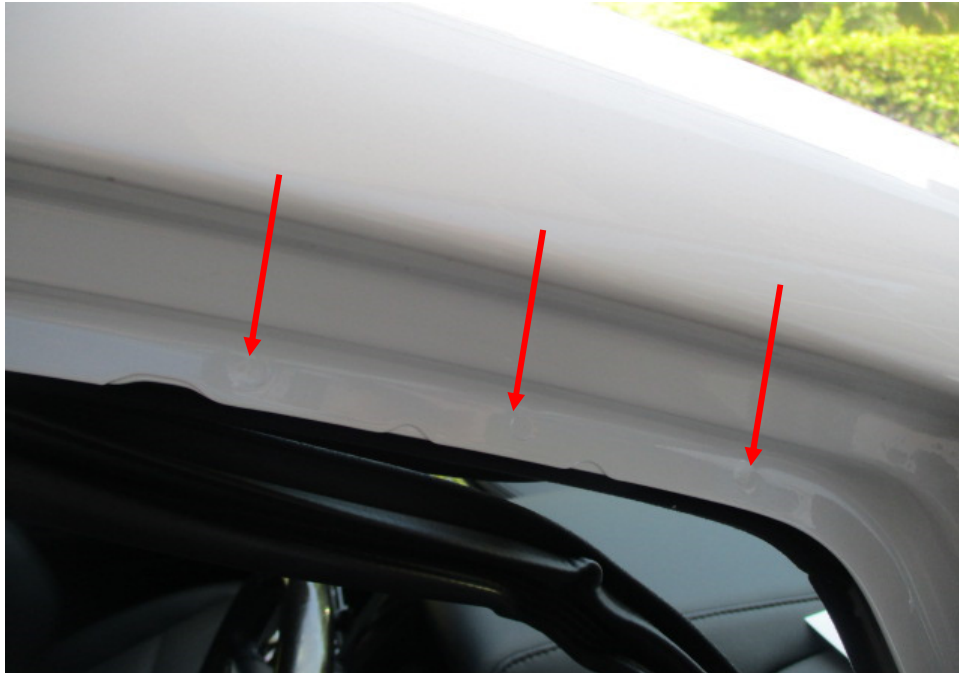
**Photo 34** shows the right side "A" pillar of the Motor Car. I did not find any weld marks other than original spot weld marks (arrowed) on the right side "A" pillar of the Motor Car, which indicates that there was no re-welding works carried out. In general, I had found all the non-detachable body panels of the Motor Car to be originally fitted at the time of my inspection.

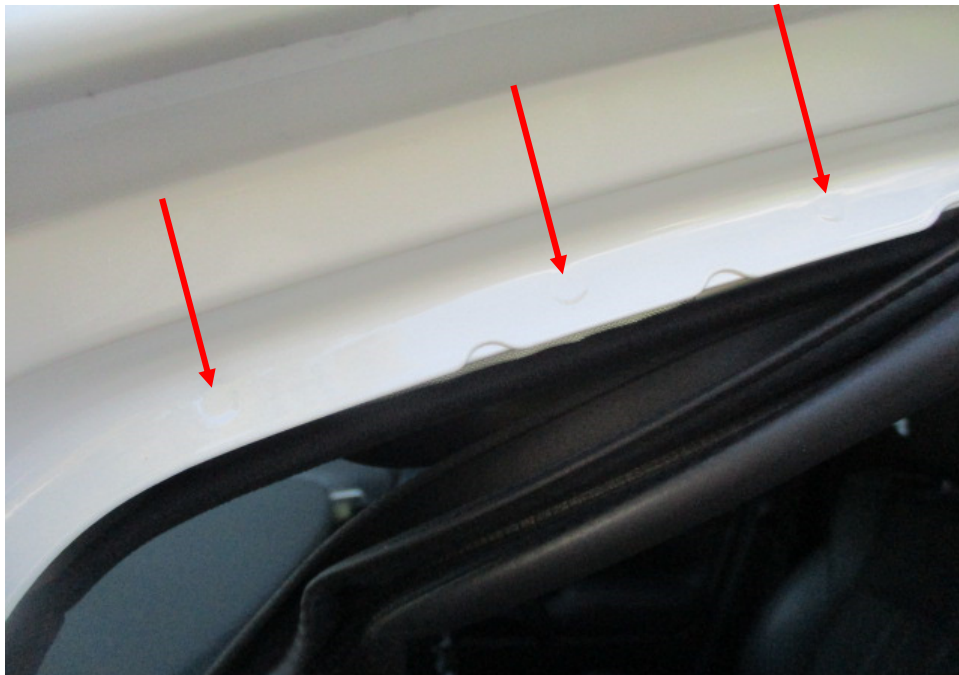
**Photo 35** shows the left side "A" pillar of the Motor Car. I did not find any weld marks other than original spot weld marks (arrowed) on the left side "A" pillar of the Motor Car, which indicates that there was no re-welding works carried out. In general, I had found all the non-detachable body panels of the Motor Car to be originally fitted at the time of my inspection.

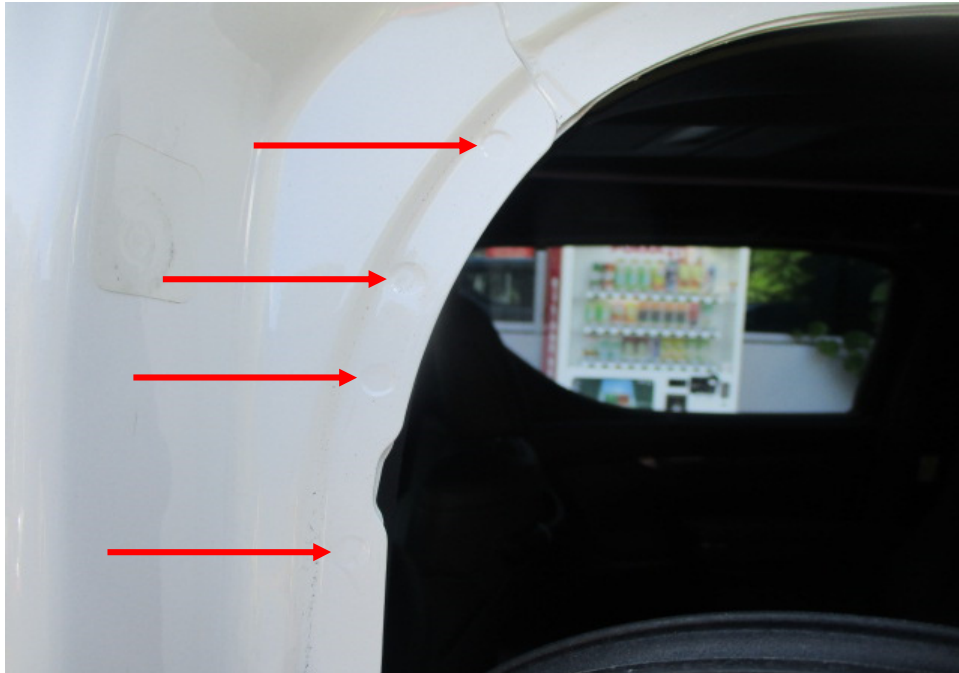
**Photo 36** shows the left side "B" pillar of the Motor Car. I did not find any weld marks other than original spot weld marks (arrowed) on the left side "B" pillar of the Motor Car, which indicates that there was no re-welding works carried out. In general, I had found all the non-detachable body panels of the Motor Car to be originally fitted at the time of my inspection.
