Our Ref : TP / ATP GBE5621A/ 12.20/22

DAMAGED VEHICLE (GBE 5621 A) INSPECTION REPORT (WITHOUT PREJUDICE)

Registration No	: GBE 5621 A	Mileage	: 277807 Km
Make & Model	: TOYOTA DYNA MANUAL	Engine No	: 1KD2572988
Date of Registration	: 15 th Jan 2016	Chassis No.	: JTFAT35Y40K205554
Colour	: Silver	Engine Capacity.	: 2,982 cc

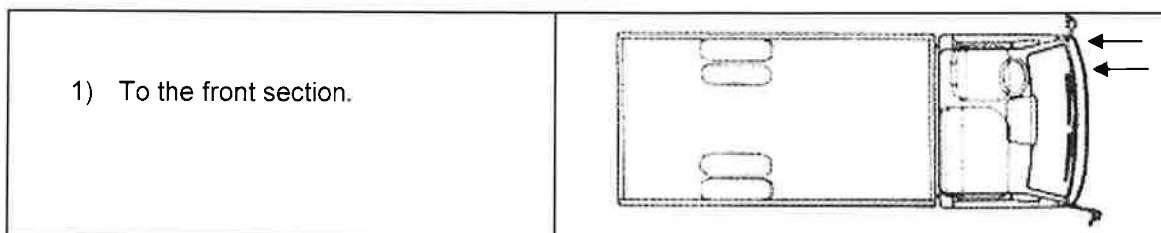
(E) Point of Impact

The impact of the collision has damaged/affected the front windscreen, side view mirror, LH door panel and etc.

Our adjusted cost of lump sum repair is **\$5,000.00** and an estimated **4** days is required to repair the vehicle. Please refer to the Annex for a detailed account of the cost estimates.
