Vehicle No. SHD 3135J  
Insured Veh. SNF 1398Z  
Claim No. SNM23D203580/C02  
Policy No. DMPCSNW00035152300  
Accident Date 07/05/2023  
Inspection Date 09/05/2023

## LKK Auto Consultants Pte Ltd

## ADJUSTMENT ON REPAIR COST FOR VEHICLE NO. SHD 3135J

PHOTOGRAPHS FOR VEHICLE NO. SHD 3135J

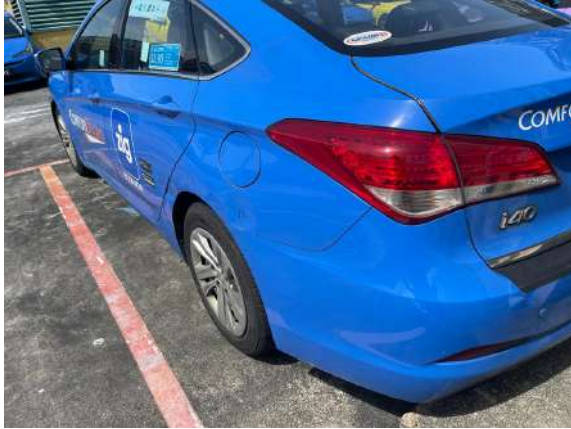
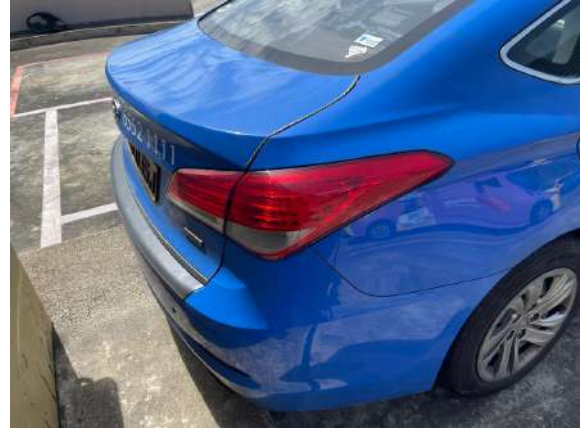
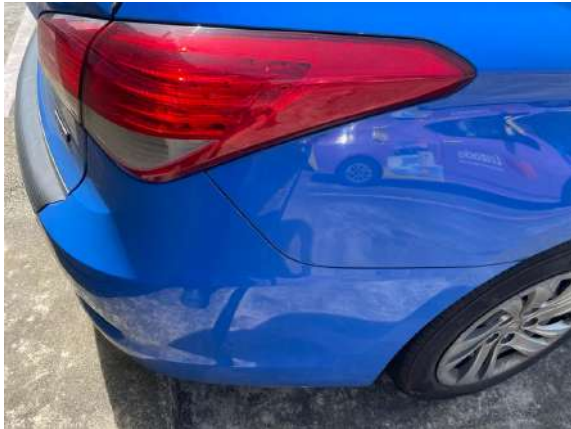
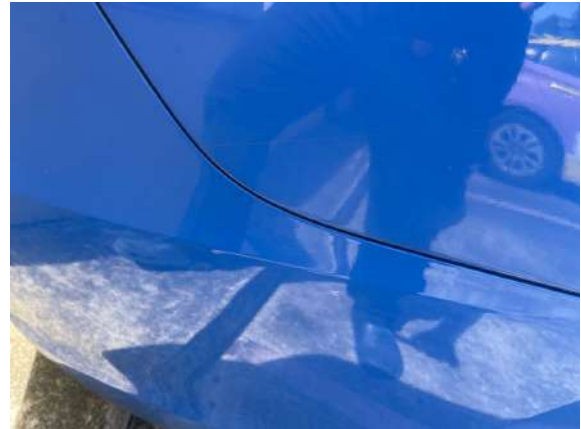
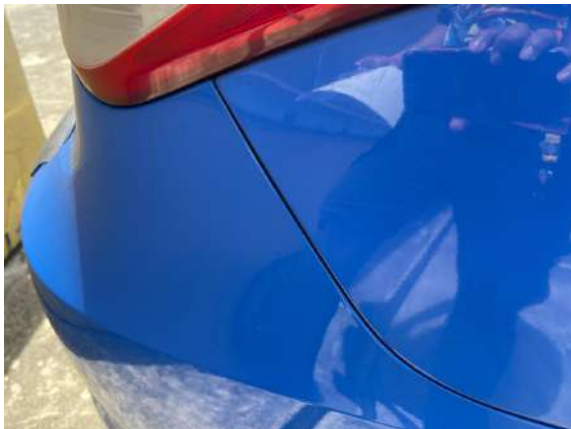
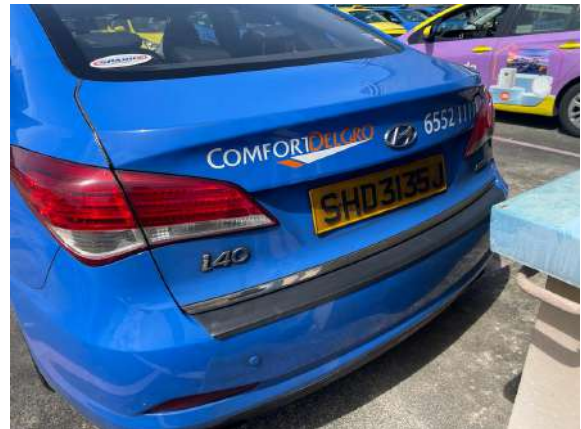
INSPECTION

| Affiliated to Federation Internationale Des Experts En Automobile | | | | |
|---|---|---|---|---|
| | THE VEHICLE SUSTAINED DAMAGES AT THE REAR PORTION.<br><br>DAMAGES SEE DETAILS. | | | |
