ACCIDENT VEHICLE INSPECTION REPORT

Report no : 109M0323.PMG
Vehicle no : GBL7620C

Make/model : **NISSAN NV350 URVAN PANEL VAN 5MT**
Chassis no : JN1MA2E26Z0000418
Engine no : QR20020948R
Date of registration : 28 March 2022 *COE Expiry Date:* 27 March 2032
Engine capacity : 1998 cc
Odometer reading : 11327 km
Colour : Grey

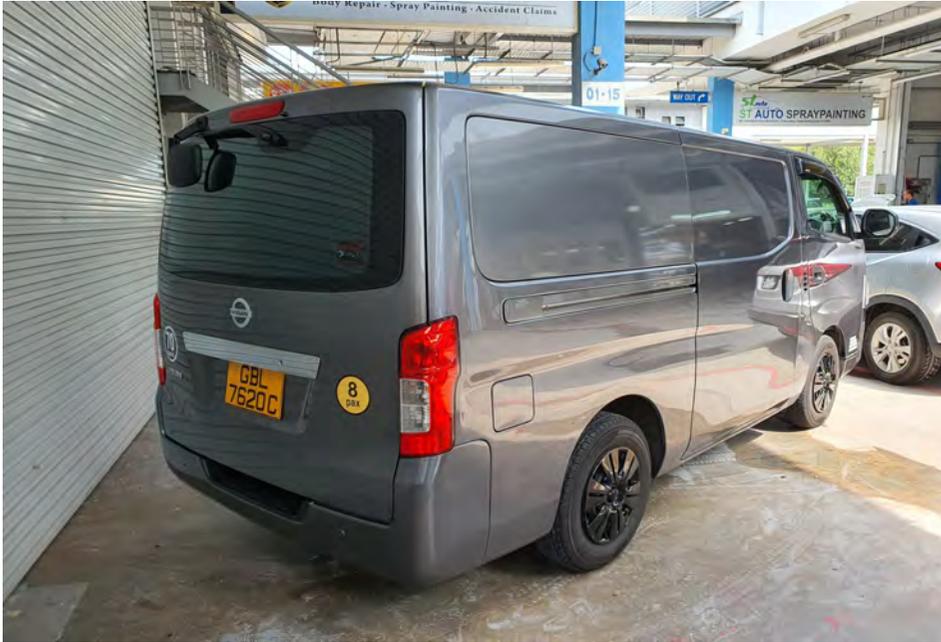
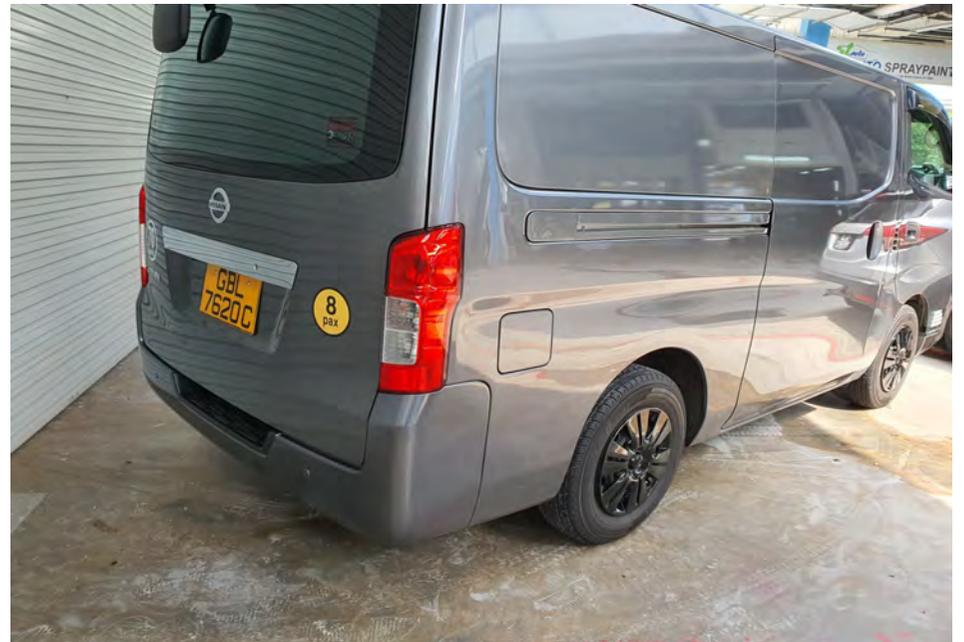
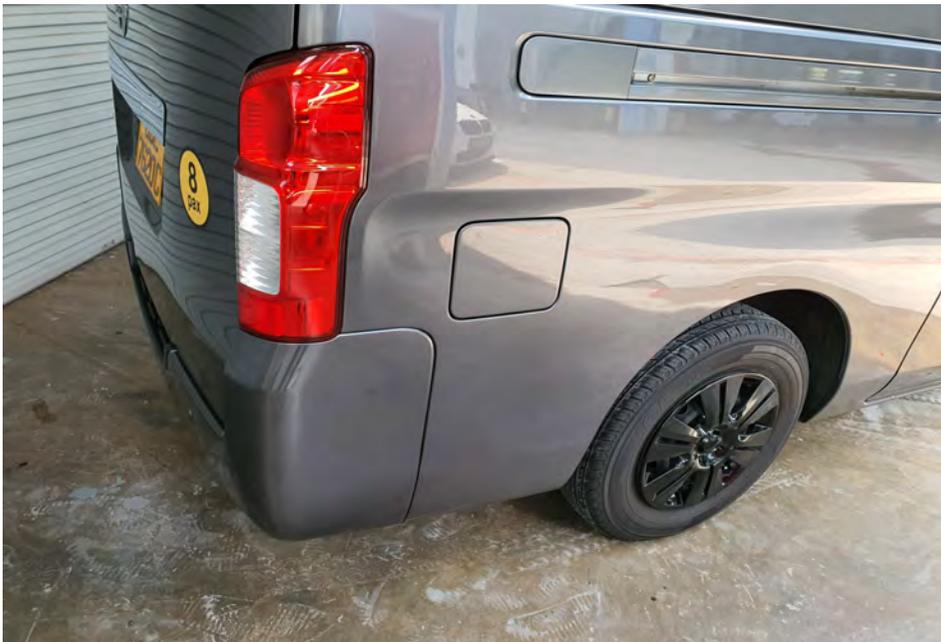
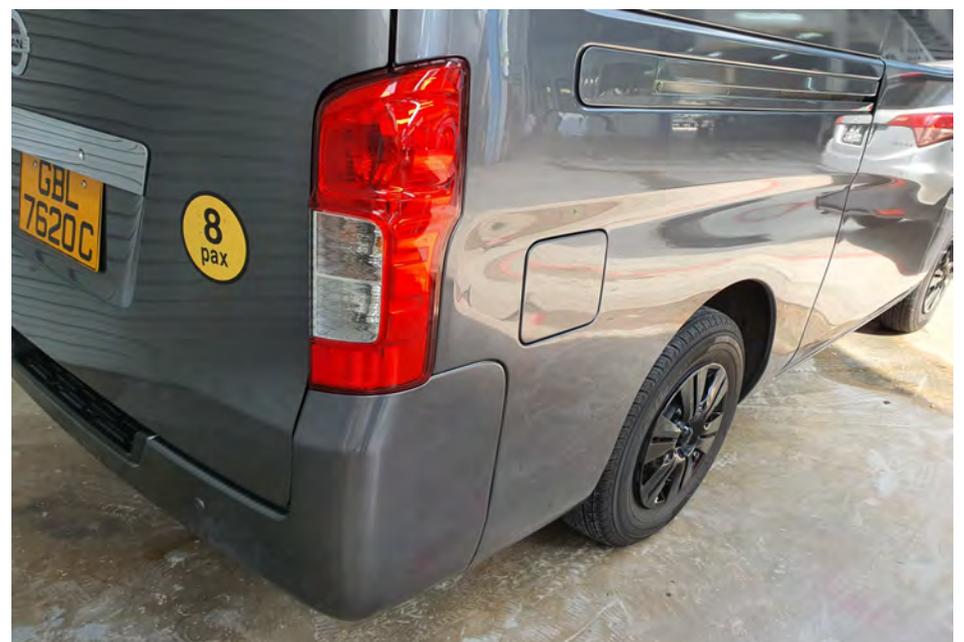
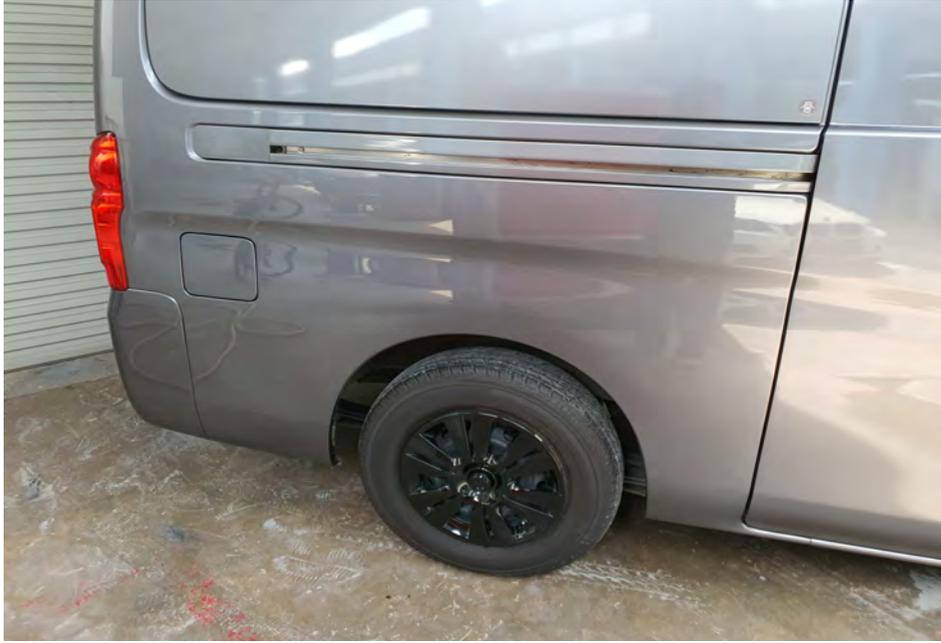
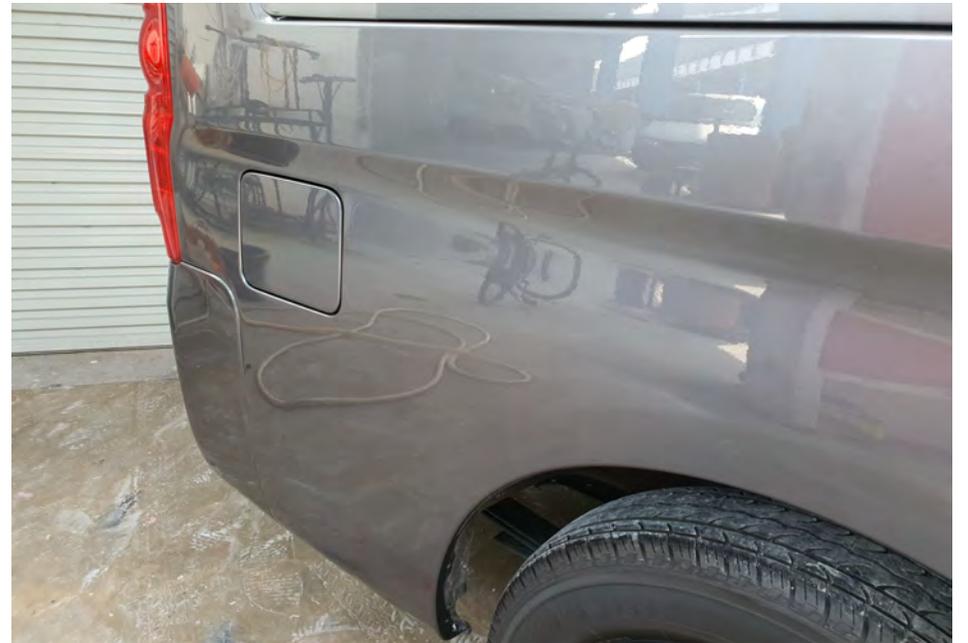
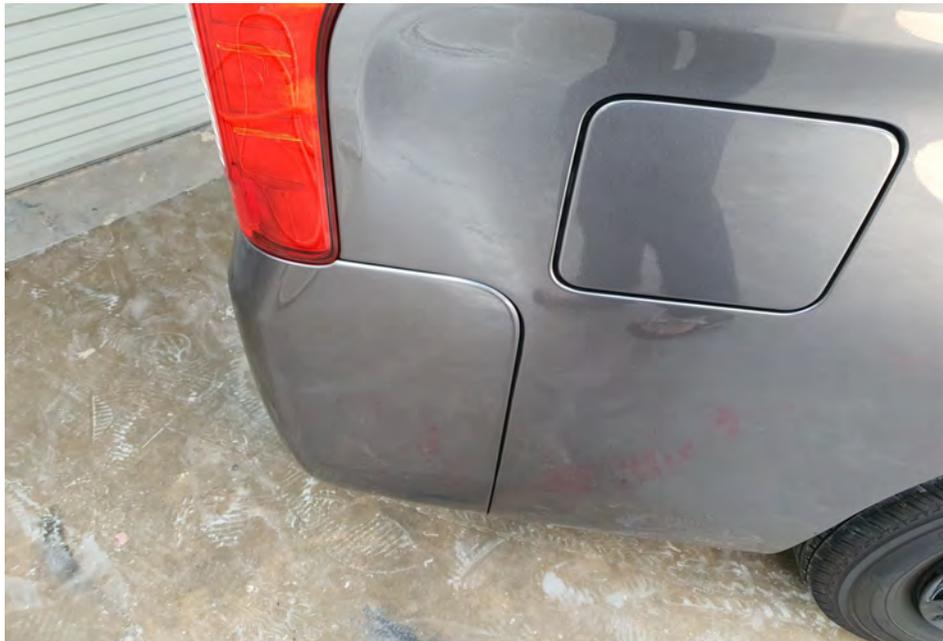
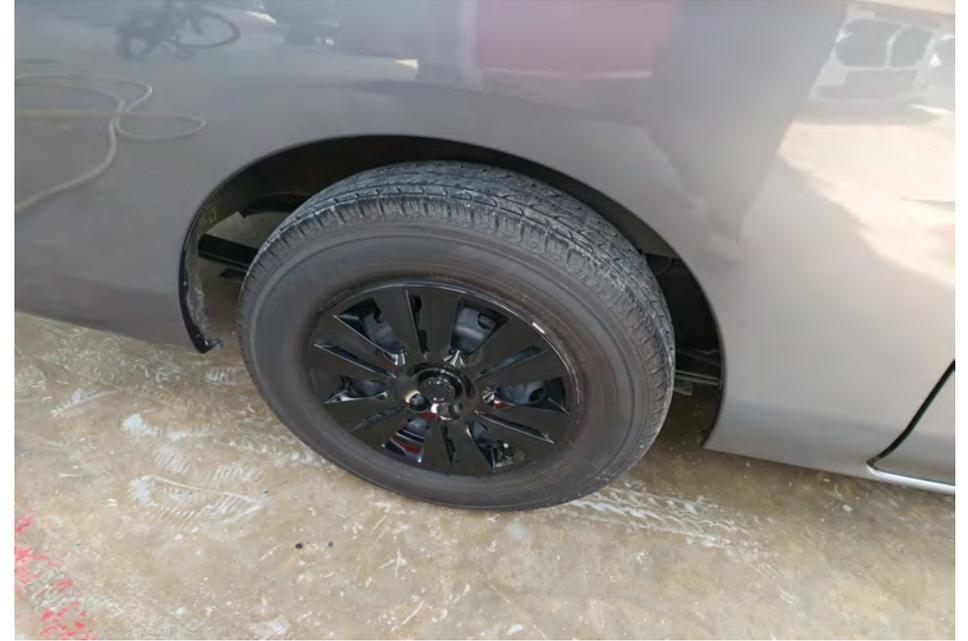
POST REPAIR

(Post Repair Inspection conducted on 1 April 2023)
