Your Ref: C10022597  
Our Ref : CI/AGI23006710/P

**TECHNICAL INVESTIGATION REPORT OF FIRE INCIDENT INVOLVING THE INSURED VEHICLE SLM 9385U ON 29<sup>th</sup> MAY 2023**

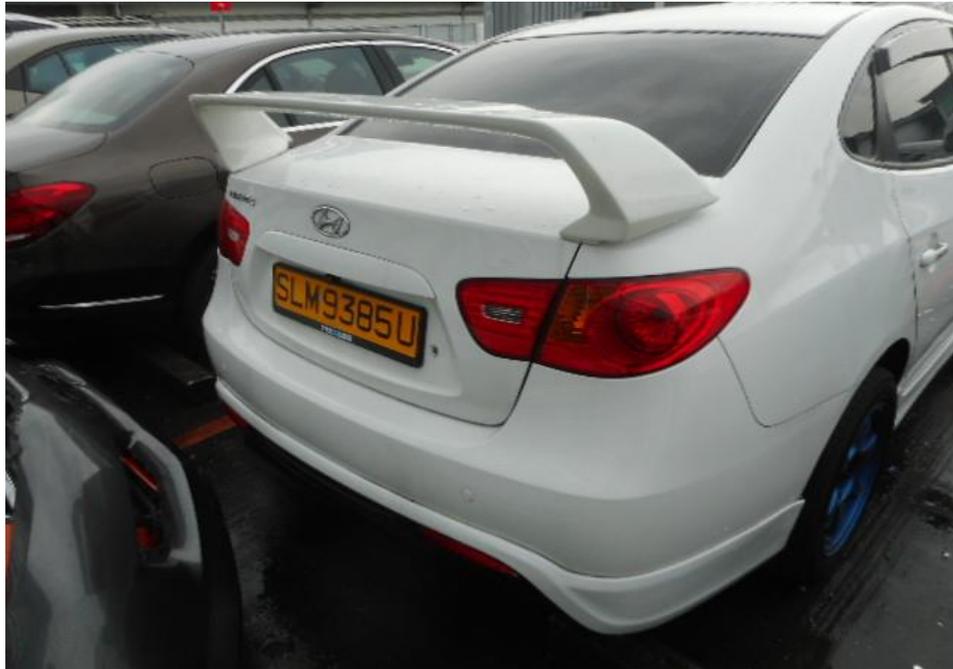
**Photo 1** shows the rear portion of the Insured Vehicle, which was observed to be unaffected by the fire.

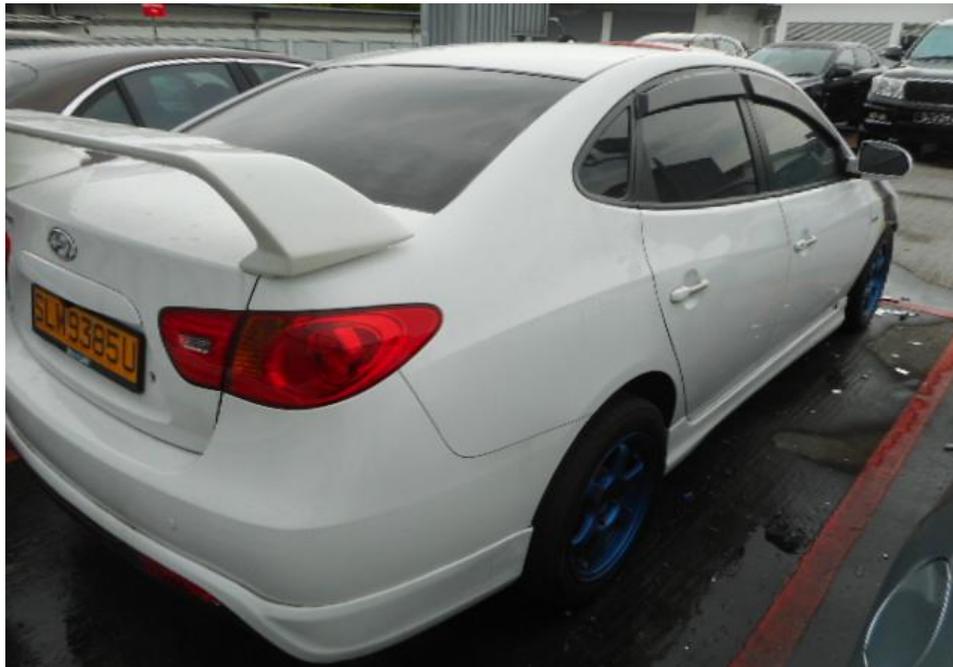
**Photo 2** shows the rear right body of the Insured Vehicle, which was observed to be unaffected by the fire.

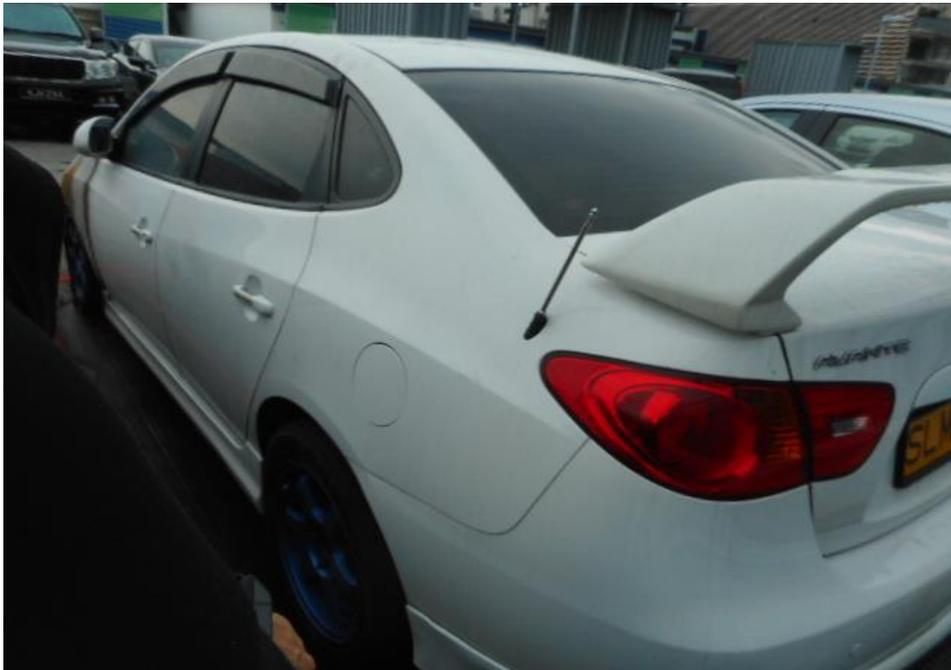
**Photo 3** shows the rear left body of the Insured Vehicle, which was observed to be unaffected by the fire.

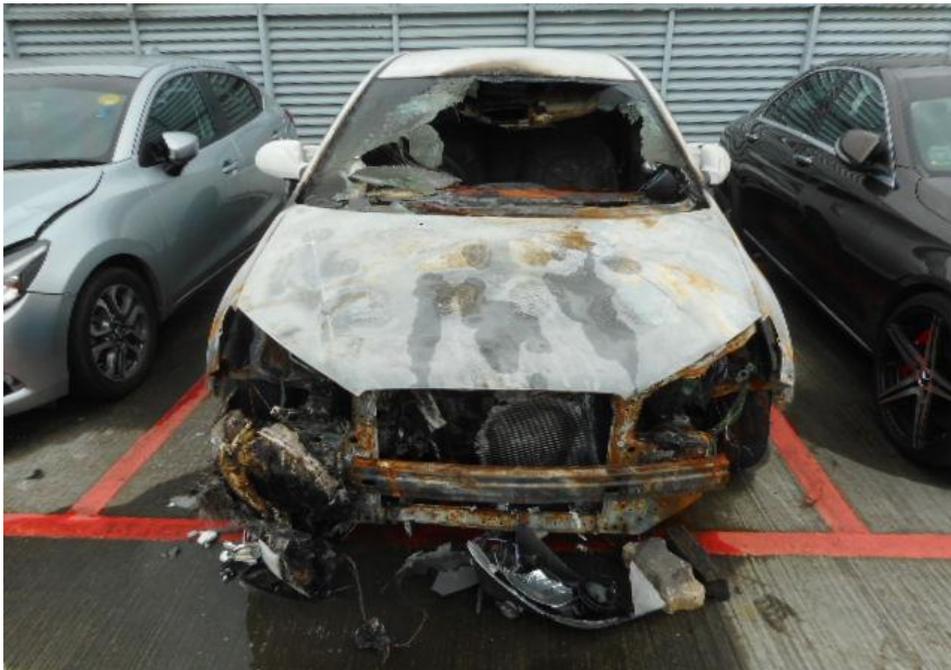
5. The Insured Vehicle was observed to have sustained severe fire damage. Its engine compartment was completely burnt and interior compartment had sustained heat and smoke damage. Rust had accumulated around the engine compartment of the Insured Vehicle as a result of exposure to environmental condition for a period of time. See photos 1 – 6 below.

**Photo 4** shows the general view of the front portion of the Insured Vehicle at the time of our inspection. The Insured Vehicle was observed to have sustained severe fire damage. Its engine compartment was completely burnt. Rust had accumulated around the engine compartment of the Insured Vehicle as a result of exposure to environmental condition for a period of time.

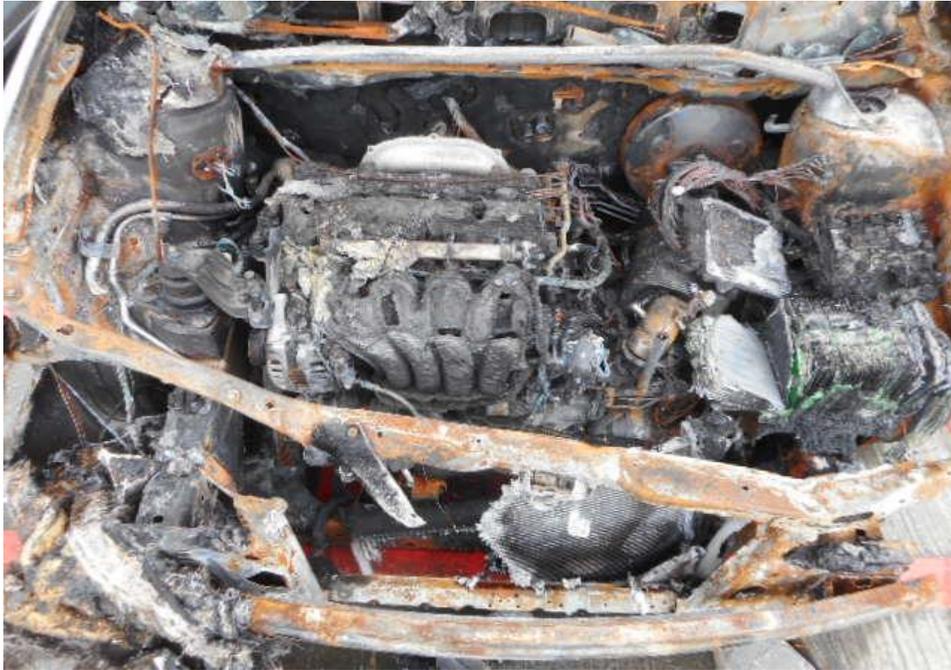
**Photo 5** shows the engine compartment of the Insured Vehicle at the time of our inspection. The entire engine compartment of the Insured Vehicle was observed to be severely burnt. Most of the parts inside the engine compartment were found to be burnt and/or melted as a result of the fire.

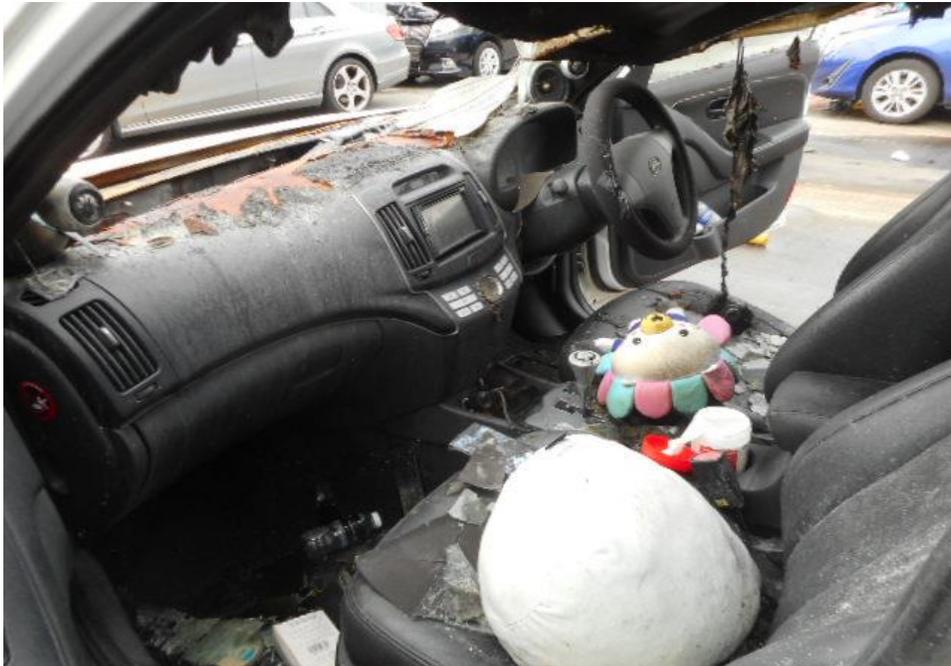
**Photo 6** shows the interior view from the right side of the Insured Vehicle at the time of our inspection. The interior of the Insured Vehicle was observed to be affected by heat & smoke damage as the result of the fire.

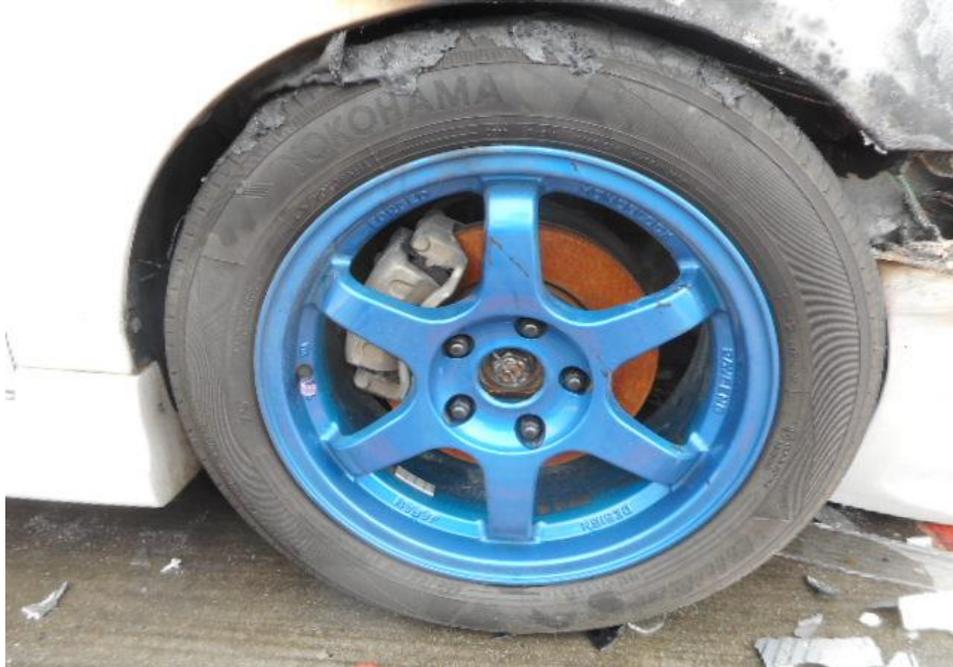
**Photo 7** shows the tyre and wheel rims of the Insured Vehicle it was observed to be fitted with aftermarket wheel rims, which was observed to be unaffected by the fire.

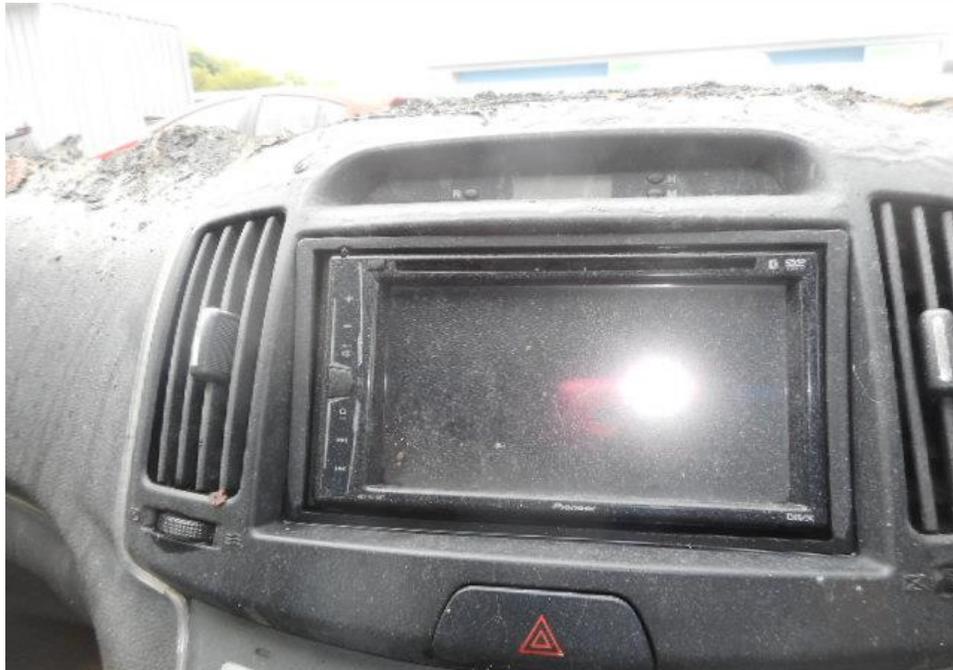
**Photo 8** shows the interior centre dashboard of the Insured Vehicle an aftermarket infotainment unit on the Insured Vehicle, which was observed to be unaffected by the fire.

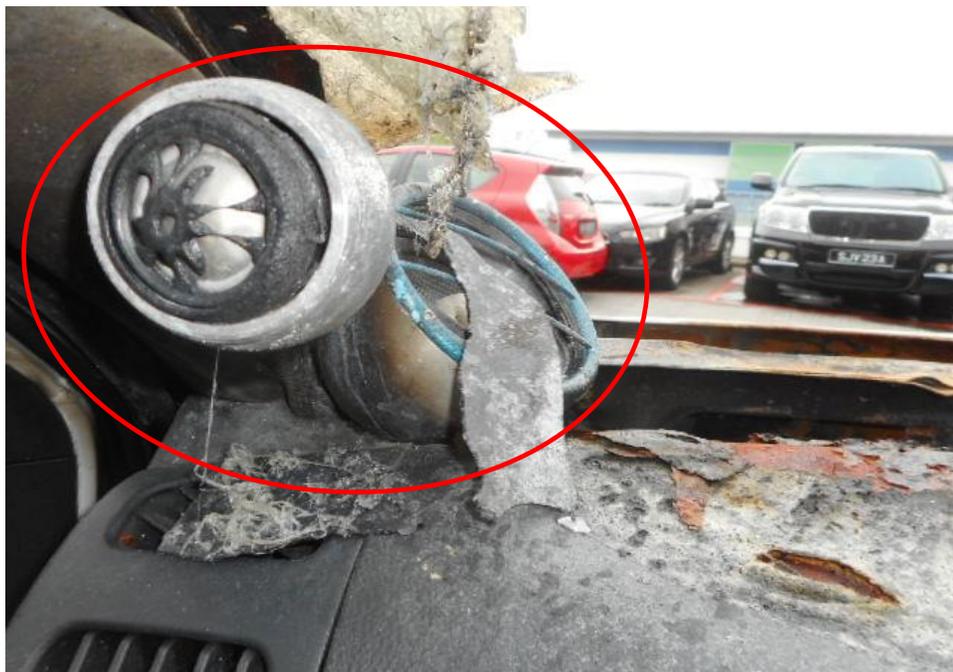
**Photo 9** shows the left side of the interior dashboard of the Insured Vehicle an additionally fitted audio speakers and tweeters (circled) on the Insured Vehicle, which was observed to be affected by the fire.

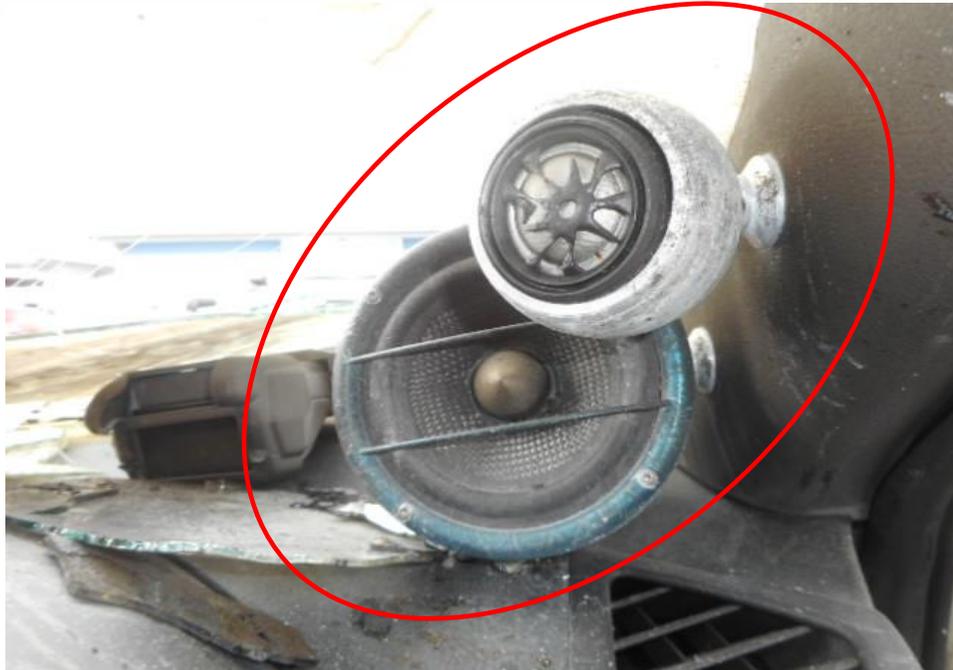
**Photo 10** shows the right side of the interior dashboard of the Insured Vehicle an additionally fitted audio speakers and tweeters (circled) which was observed to be affected by the fire.

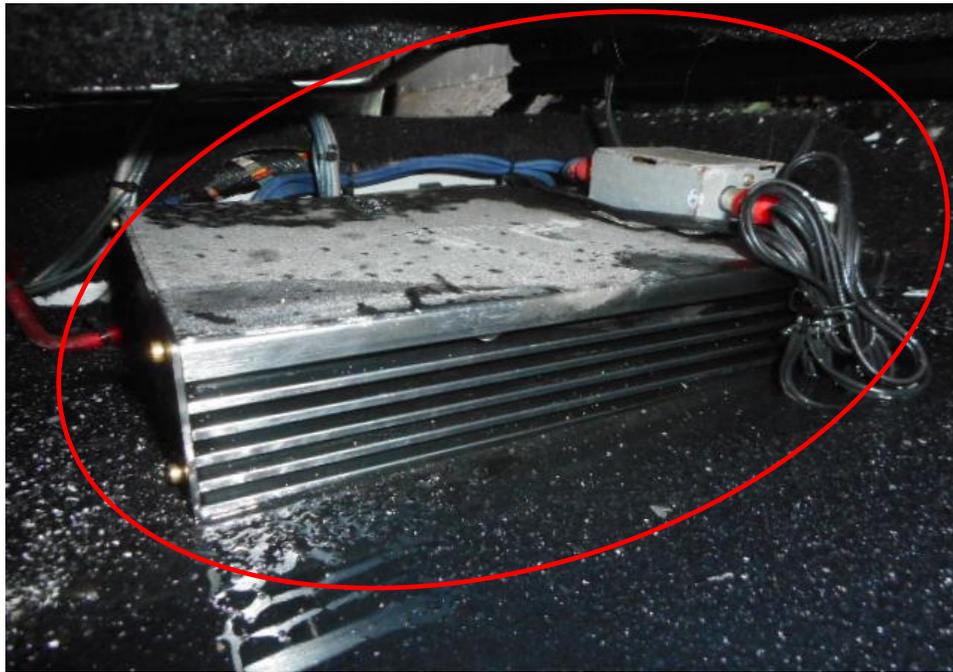
**Photo 11** shows the bottom of the left front seat of the interior of the Insured Vehicle an additionally fitted audio amplifier (circled) which was observed to be unaffected by the fire.

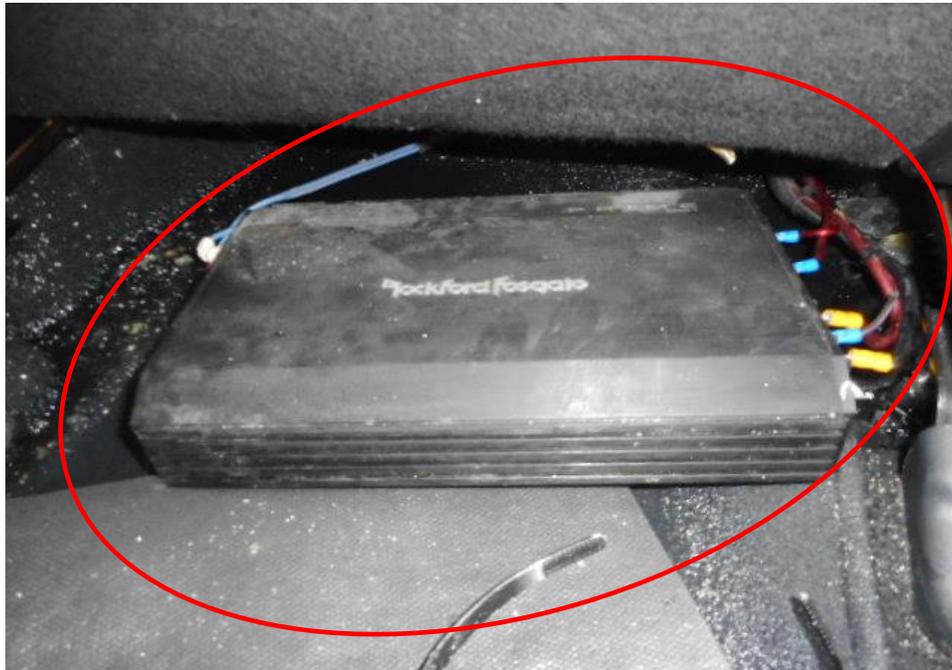
**Photo 12** shows the bottom of the right front seat of the interior of the Insured Vehicle an additionally fitted audio amplifier (circled) which was observed to be unaffected by the fire.

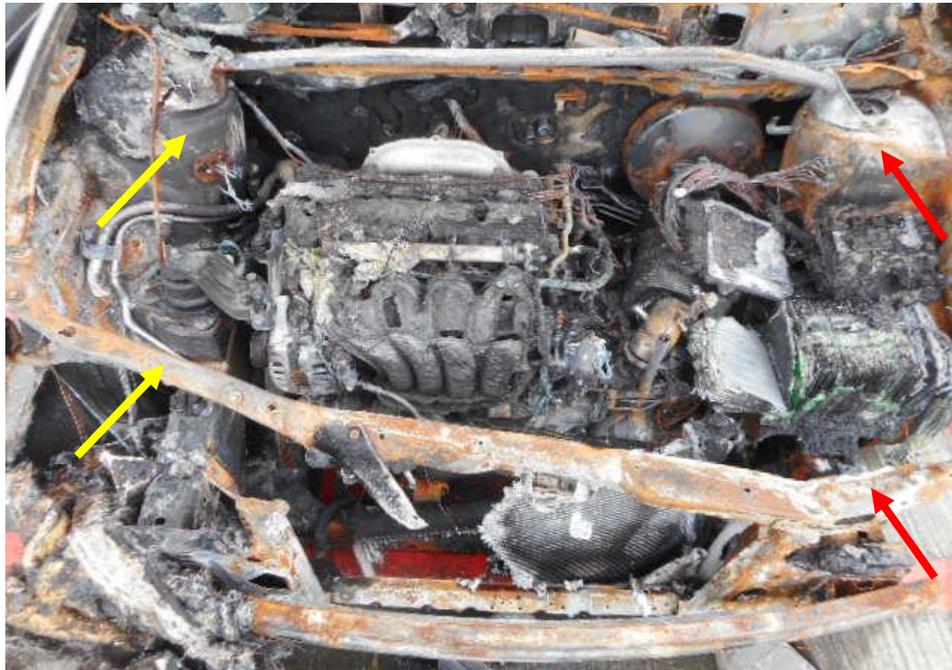
7. For this particular case, the fire appears to have originated from the front right portion of the engine compartment of the Insured Vehicle. This can be determined from the burn pattern of the various components in the engine compartment and also the left and right tyres, which were observed to have been partly melted and burn from the high heat intensity and the high heat intensity burn marks (whitish burn marks) found on the metal parts around the Insured Vehicle. Rust had also developed on these metal parts.

8. The whitish burn marks are a result of exposure to prolonged heat intensity. Rust would normally start to develop around these areas soon after a fire as prolonged exposure to high heat intensity usually causes steel/metal material body parts to be exposed to natural environmental condition. The rust that had developed on the metal brackets is an indication that the front right position of the Insured Vehicle had sustained exposure to prolonged high heat intensity. See photos 13 - 15 below.

**Photo 13** shows the engine compartment of the Insured Vehicle at the time of our inspection. The high heat intensity burn marks (whitish burn marks) and rust that had development all around the engine compartment indicates that the fire had originated from the engine compartment of the Insured Vehicle. However we observed that the right side of the engine compartment (red arrow) had sustained more high head intensity burn marks as compared to the left side engine compartment (yellow arrow)

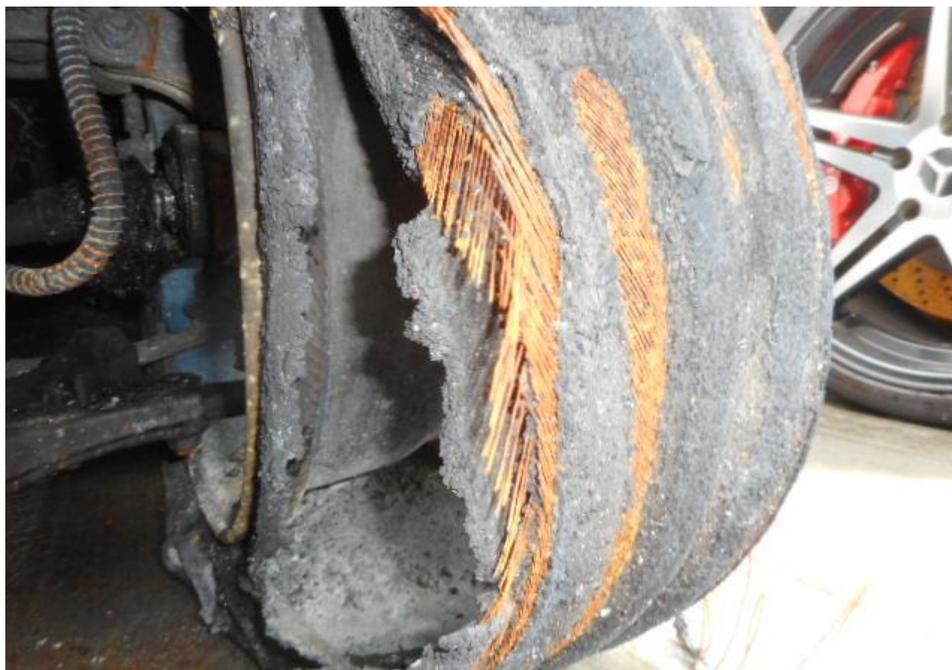
**Photo 14** shows the front left tyre which was closest to the engine compartment of the Insured Vehicle at the time of our inspection. The tyre had sustained high heat intensity burn and melted where rust that had development all around it indicates that the fire had originated from the right engine compartment of the Insured Vehicle.

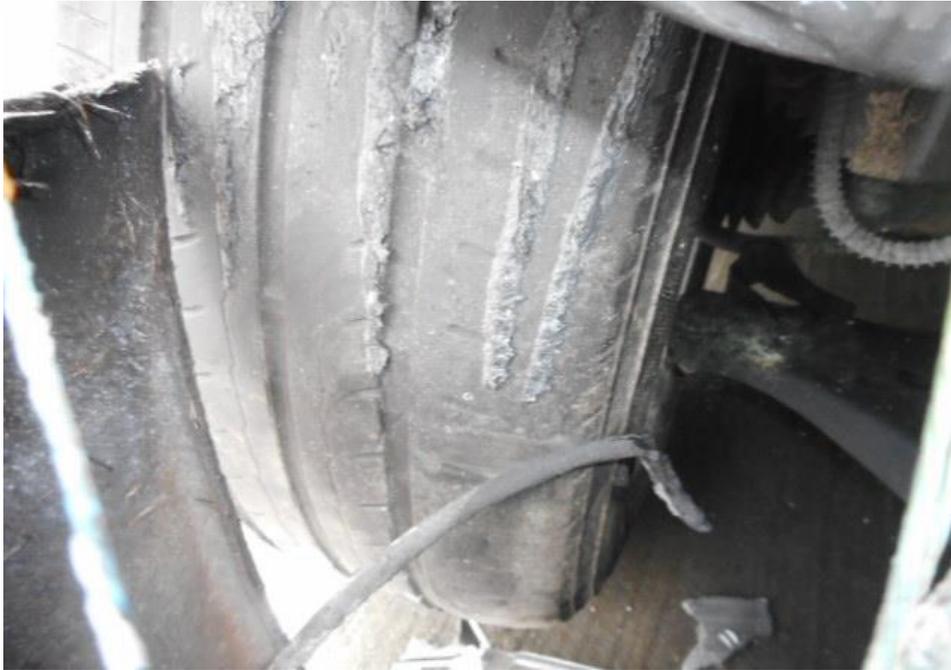
**Photo 15** shows the front right tyre which was also closest to the engine compartment of the Insured Vehicle at the time of our inspection. The tyre had sustained high heat intensity burn and melted however, there was no rust that development all around it indicates that the fire had originated from the right engine compartment of the Insured Vehicle.

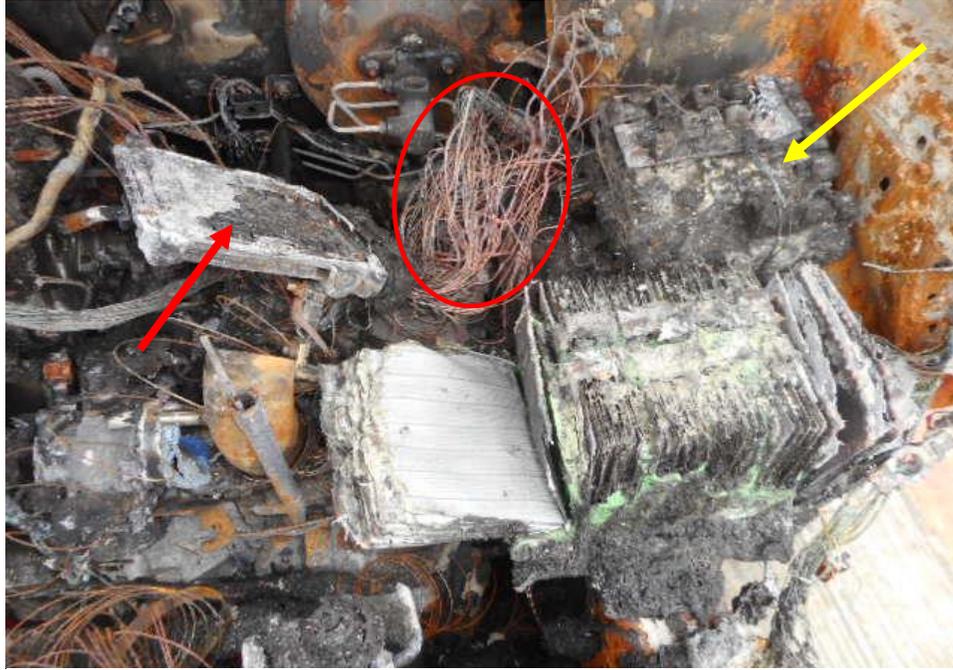
9. Upon closer examination of the engine compartment of the Insured Vehicle which was where the fire had started, we had found traces of greenish residue on the wirings harnesses leading from the Electrical Control Unit (ECU) to the fuse box. These wirings were original wirings fitting from manufacturer. The presence of greenish residue indicates internal heating of copper wires, a sign of an electrical short circuit occurring. The greenish residue is normally left behind from the oxidation as a result of chemical reaction involving the copper wires. This physical evidence would then appear to suggest that the cause of fire to the Insured Vehicle could have possibly been due to electrical in nature. See photos 16 - 19 below.

**Photo 16** shows a general view of the original wiring harness in the engine compartment. There were greenish residue observed on the original wiring harness (circled) leading from the Electrical Control Unit (ECU) (red arrow) to the fuse box (yellow arrow). The presence of greenish residue indicates internal heating of copper wires, a sign of an electrical short circuit occurring. The greenish residue is normally left behind from oxidation as a result of chemical reaction involving the copper wires.

23. The possibility of the fire being due to electrical in nature would then seem more likely given that engine overheating and external factors would both seem unlikely. The fire being due to electrical nature is also supported by the condition of the wiring harness that were found leading from the Electrical Control Unit (ECU) to the fuse box on the Insured Vehicle, which was earlier discussed in paragraph 9 above.

25. Having investigated and technically analysed the damages of burnt nature to the Insured Vehicle, we are of the view that the cause of fire to the Insured Vehicle was of electrical nature. For this particular case, the fire had originated along the wirings harnesses of the Electrical Control Unit (ECU) leading to the fuse box of the Insured Vehicle.
26. We did not find any evidence which had suggested that the cause of fire to the Insured Vehicle was due to poor maintenance and/or recurring electrical problem.
27. Upon investigation, the fire had started from the wirings harnesses of the Electrical Control Unit (ECU) leading to the fuse box of the Insured Vehicle. And not from the aftermarket wheel rims, aftermarket infotainment unit or the additionally fitted components are 2 audio speakers and 2 audio tweeters as well as 2 audio amplifiers.

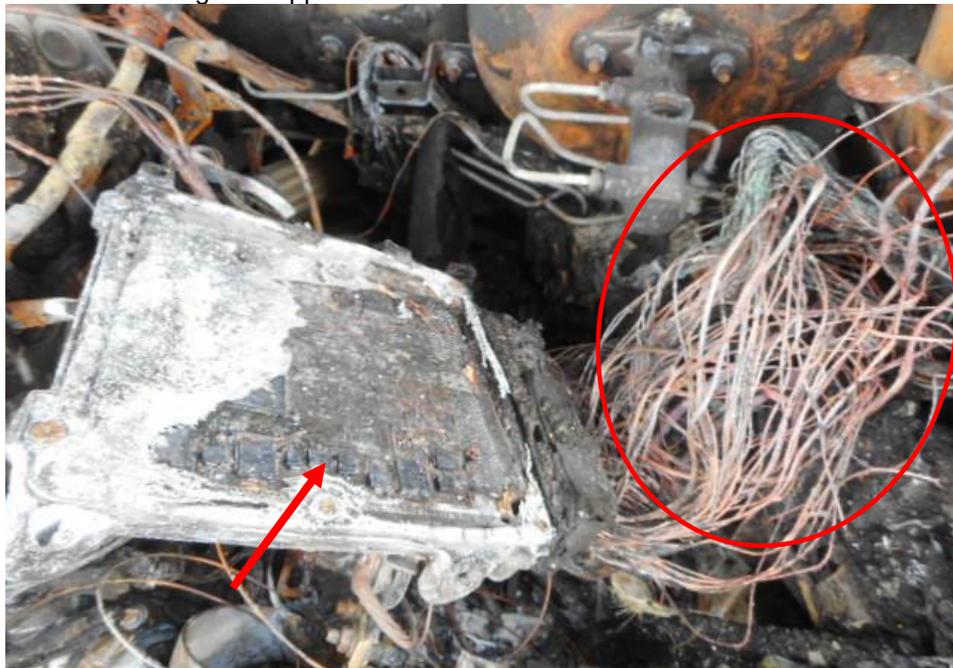
**Photo 17** shows a close up view of the original wiring harness in the engine compartment. There were greenish residue observed on the original wiring harness (circled) leading from the Electrical Control Unit (ECU) (red arrow) to the fuse box. The presence of greenish residue indicates internal heating of copper wires, a sign of an electrical short circuit occurring. The greenish residue is normally left behind from oxidation as a result of chemical reaction involving the copper wires.

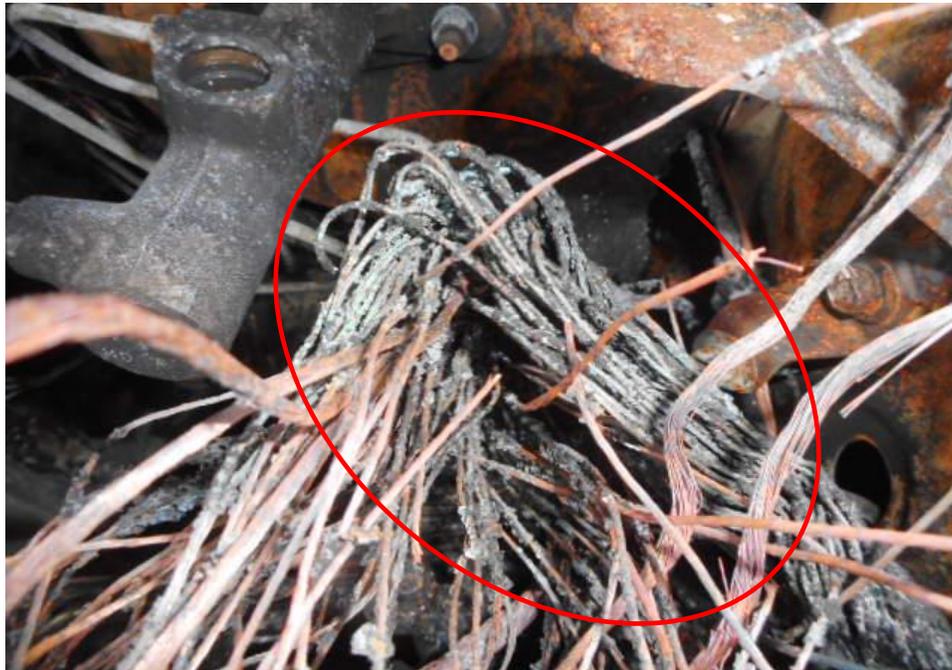
**Photo 18** shows a close up view of the original wiring harness in the engine compartment. There were greenish residue observed on the original wiring harness (circled) leading from the Electrical Control Unit (ECU) to the fuse box. The presence of greenish residue indicates internal heating of copper wires, a sign of an electrical short circuit occurring. The greenish residue is normally left behind from oxidation as a result of chemical reaction involving the copper wires.

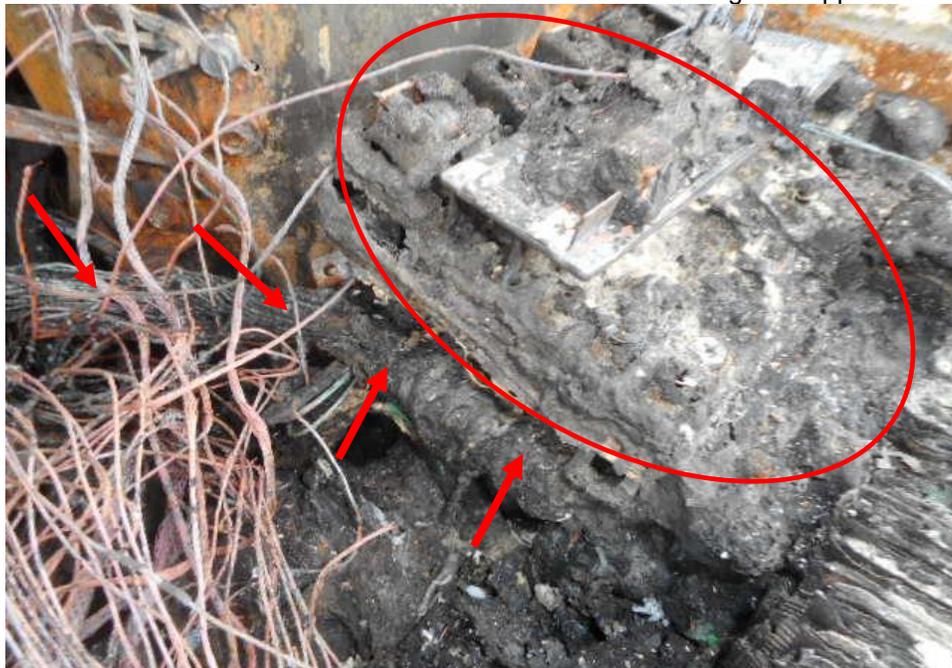
**Photo 19** shows a close up view of the original wiring harness in the engine compartment. There were greenish residue observed on the original wiring harness (arrowed) leading from the Electrical Control Unit (ECU) to the fuse box (circled). The presence of greenish residue indicates internal heating of copper wires, a sign of an electrical short circuit occurring. The greenish residue is normally left behind from oxidation as a result of chemical reaction involving the copper wires.

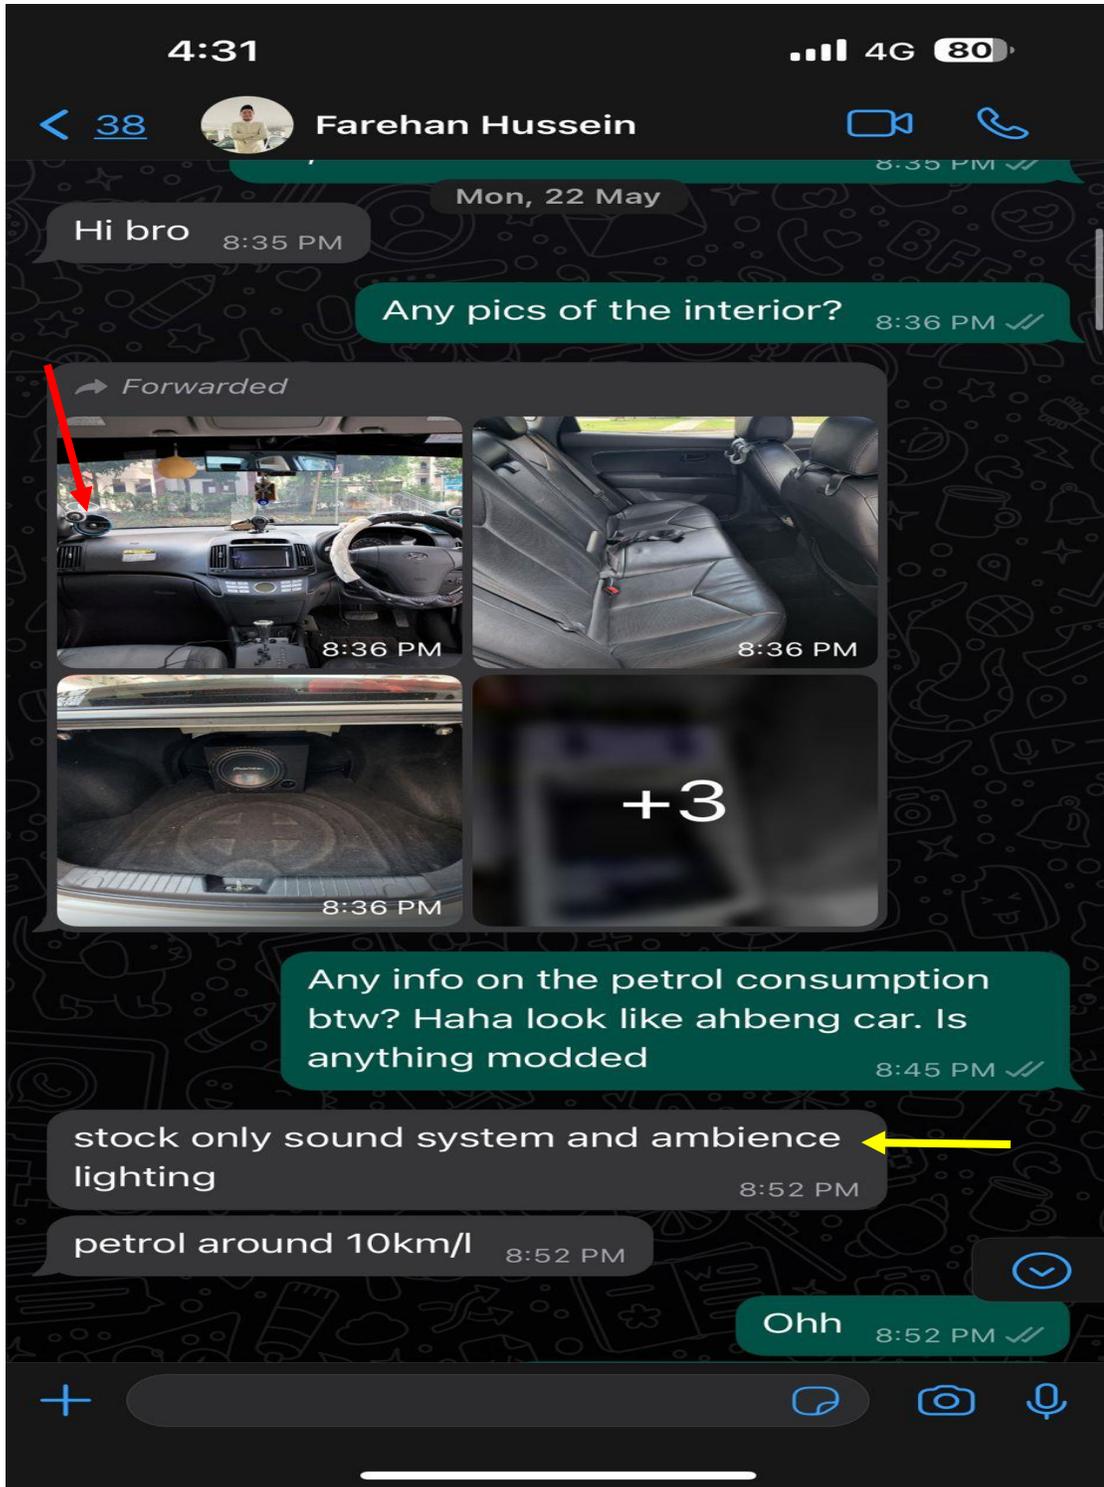
**Photo 20** shows the conversations between Mr Rayhan and the car dealer before he bought the Insured Vehicle. In the conversations the car dealer had sent over the interior pictures for Mr Rayhan to view and it shows that the Vehicle had already been fitted with the additional audio speakers and audio tweeters (red arrow) and the car dealer had also mentioned that the Vehicle had already been fitted with additional sound system (yellow arrow).

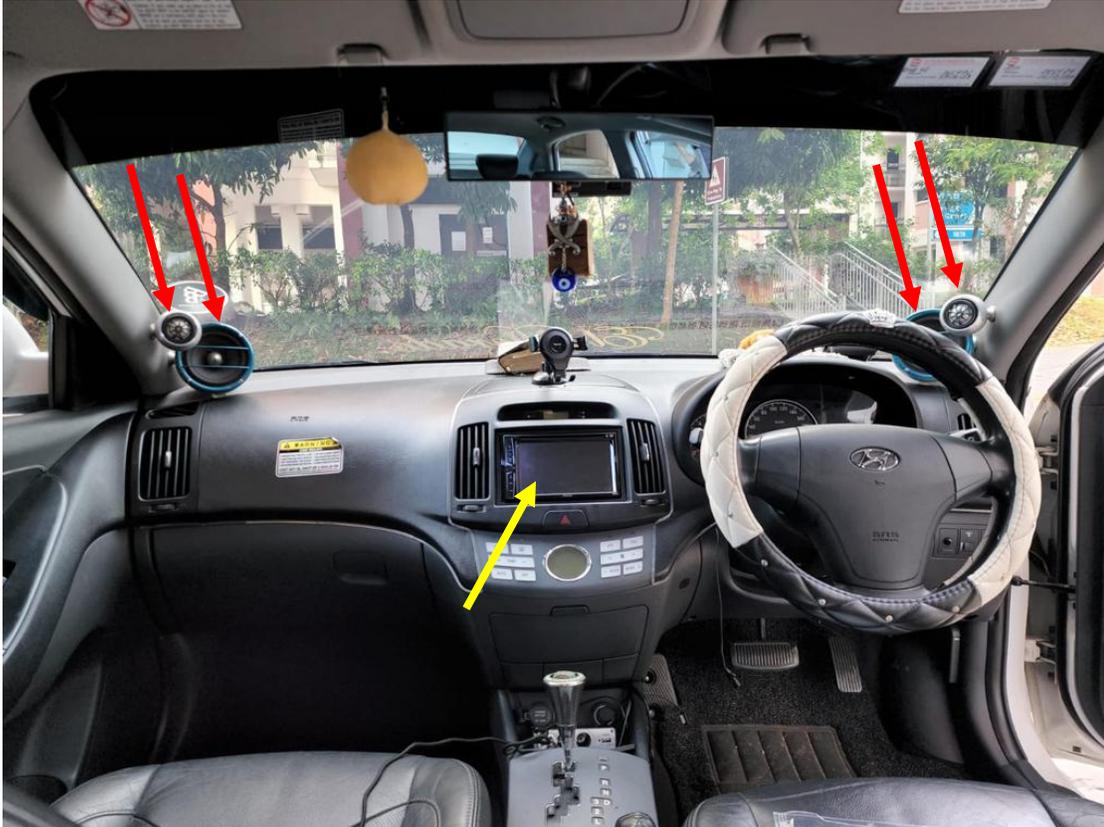
**Photo 21** shows photos that the car dealer had sent to Mr Rayhan before he bought the Insured Vehicle. The car dealer had sent over the interior pictures for Mr Rayhan to view and it shows that the Vehicle had already been fitted with the additional audio speakers and audio tweeters (arrowed) and also the aftermarket infotainment unit (yellow arrow).

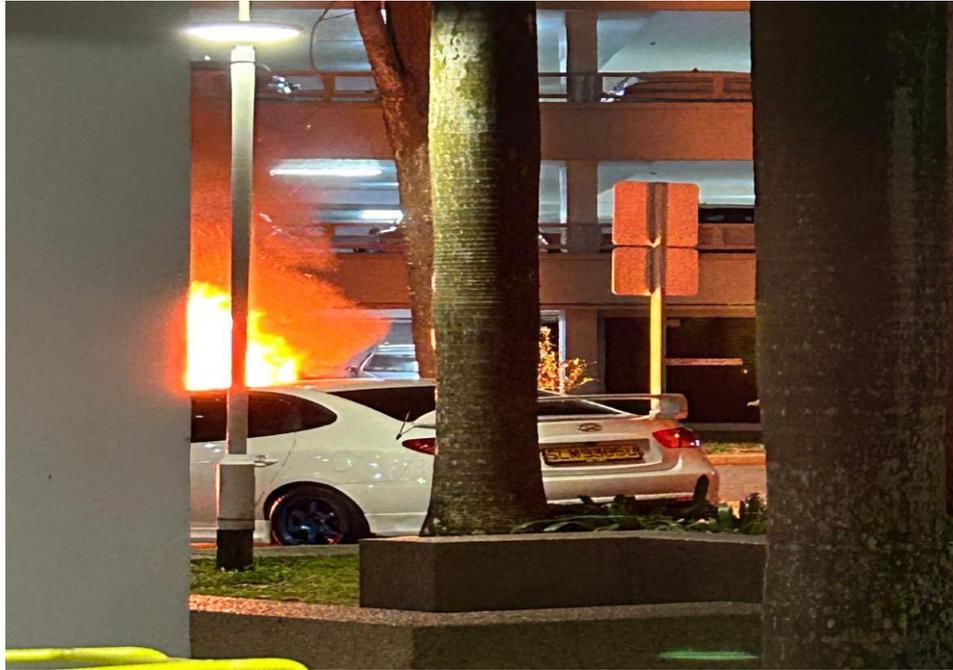
**Photo 22** shows the smoke and flames emitting from the front of the Insured Vehicle before the arrival of the SCDF. In general, the information that could be gathered from this photograph had corresponded to the events that were related to us by Mr Rayhan, location when the fire broke out.

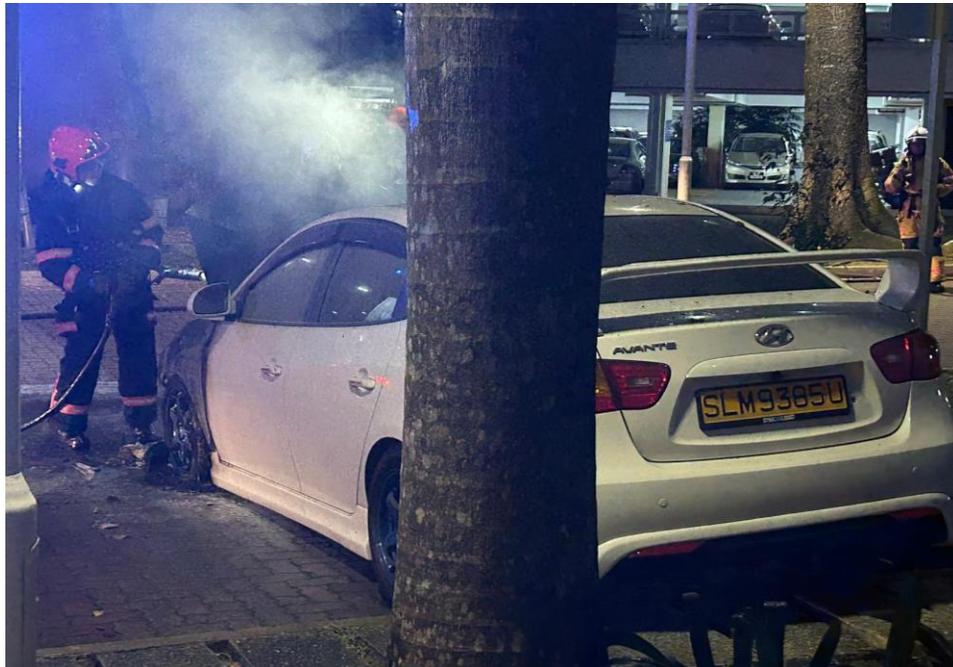
**Photo 23** shows the Insured Vehicle at the incident location as the fire was extinguished by SCDF personnel. In general, the information that could be gathered from this photograph had corresponded to the events that were related to us by Mr Rayhan, location when the fire broke out.

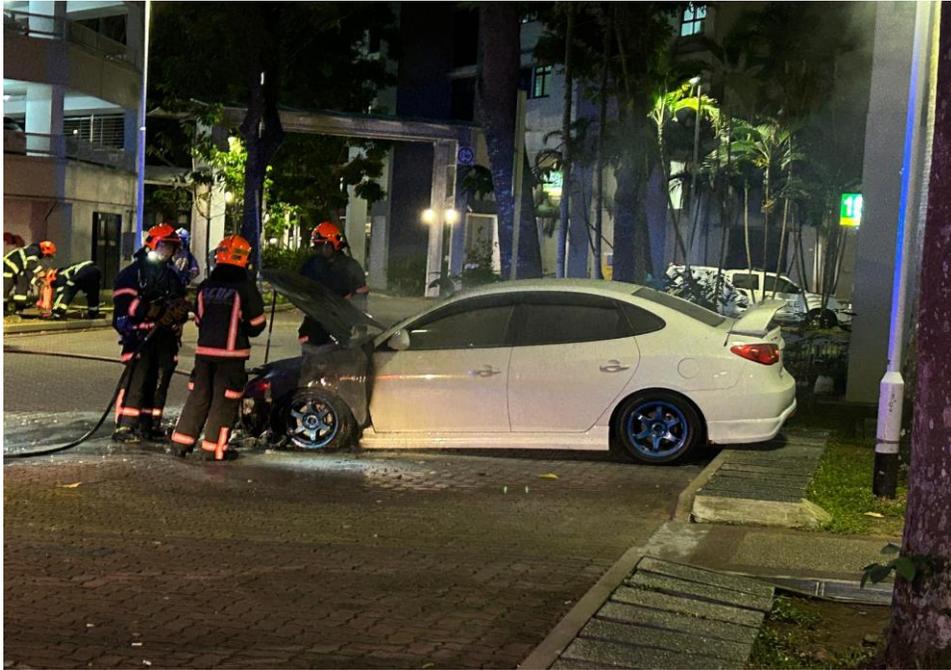
**Photo 24** shows the Insured Vehicle at the incident location as after the fire was extinguished by SCDF personnel and conducting their inspection. In general, the information that could be gathered from this photograph had corresponded to the events that were related to us by Mr Rayhan, location when the fire broke out.
