Your Ref: 8420399346SG  
Our Ref : CI/TP21007165/P

**M/s AIG ASIA PACIFIC INSURANCE PTE LTD**

**TECHNICAL INVESTIGATION REPORT OF FIRE INCIDENT INVOLVING THE  
Insured Vehicle YP 2381G ON 22<sup>nd</sup> APRIL 2023**

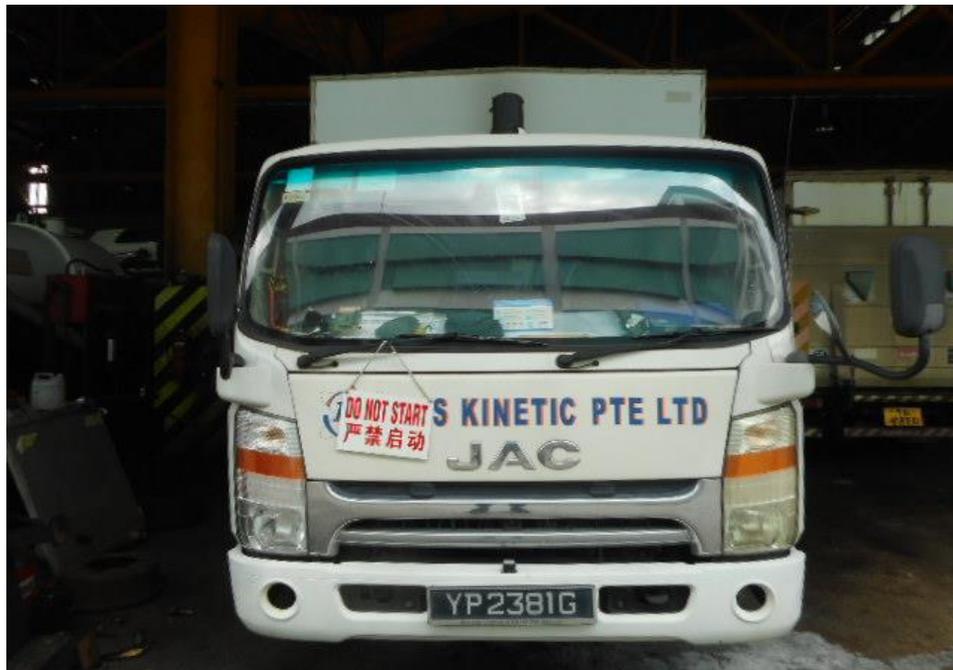
**Photo 1** shows the front portion of the Insured Vehicle, which was observed to be unaffected by the fire.

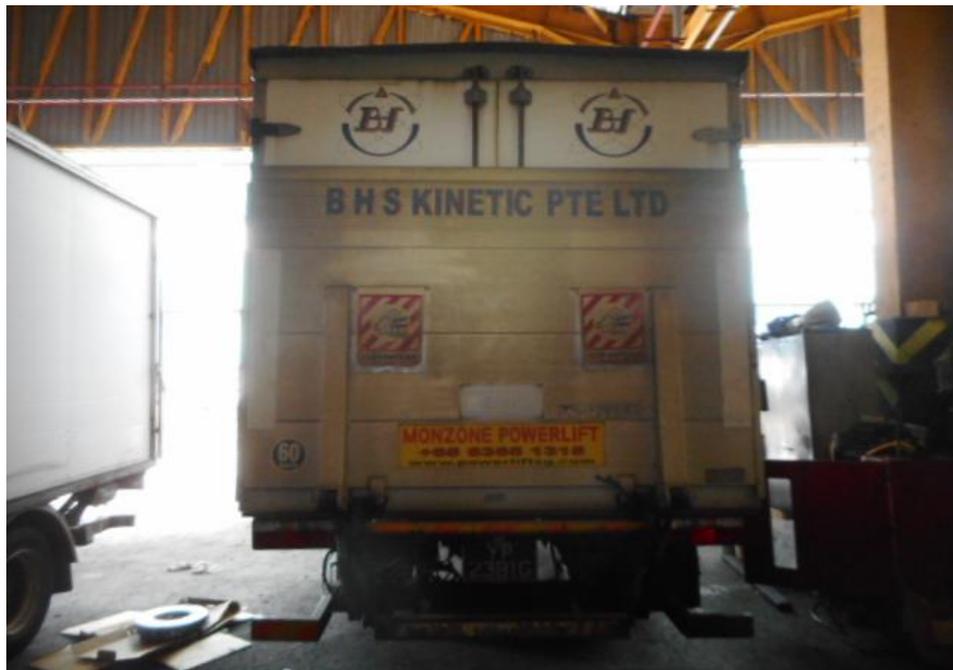
**Photo 2** shows the rear portion of the Insured Vehicle, which was observed to be unaffected by the fire.

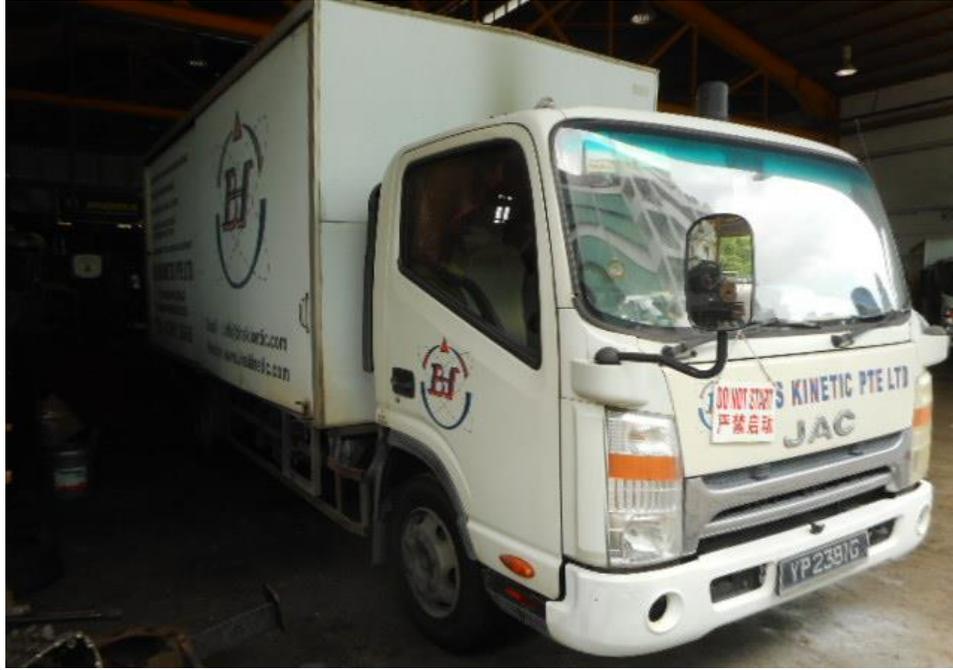
**Photo 3** shows the right body of the Insured Vehicle, which was observed to be unaffected by the fire.

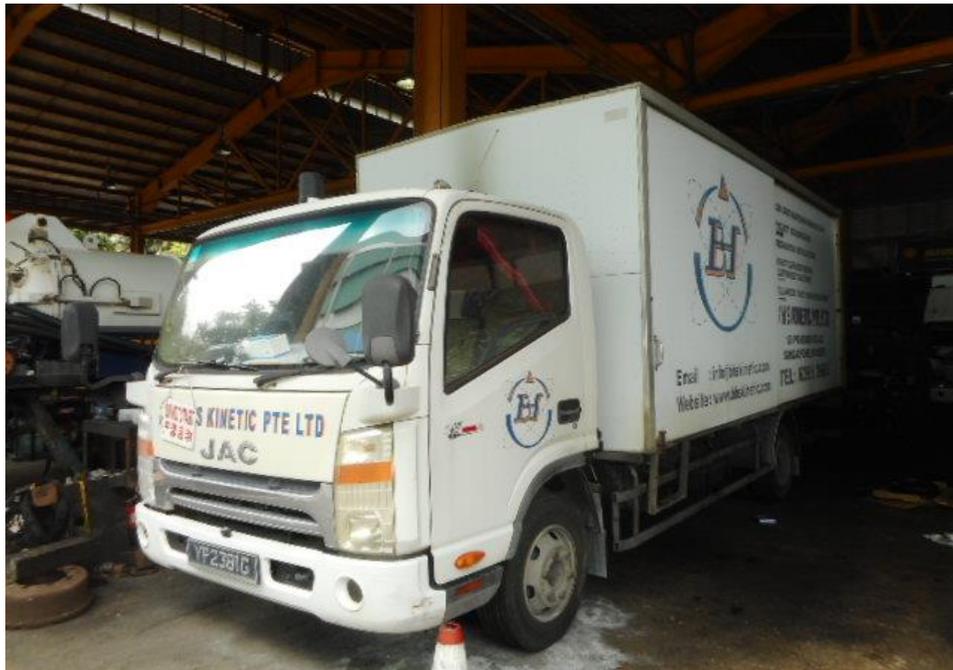
**Photo 4** shows the left body of the Insured Vehicle, which was observed to be unaffected by the fire.

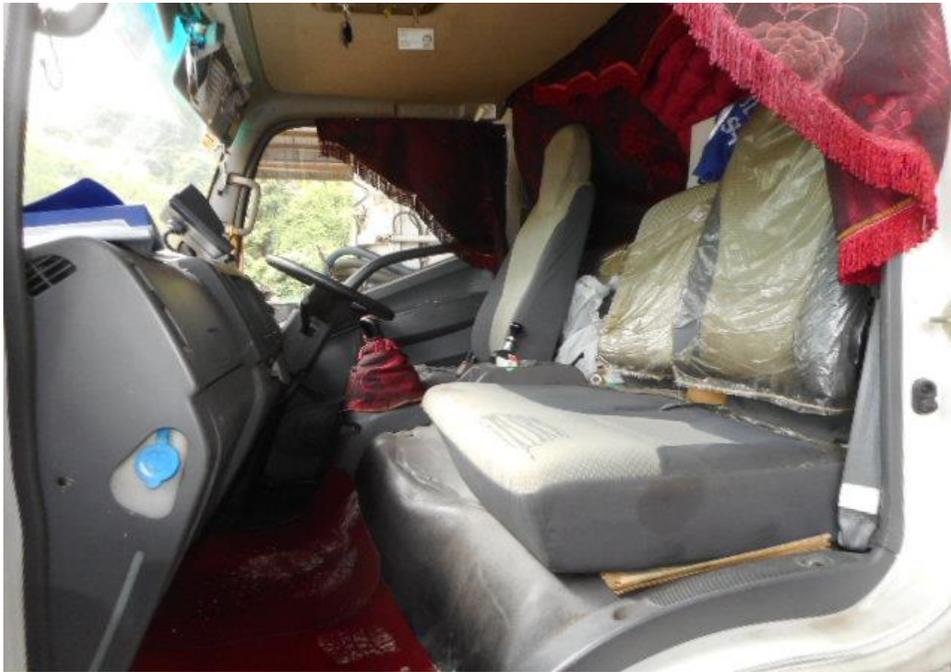
**Photo 5** shows the interior portion of the Insured Vehicle, which was observed to be unaffected by the fire.

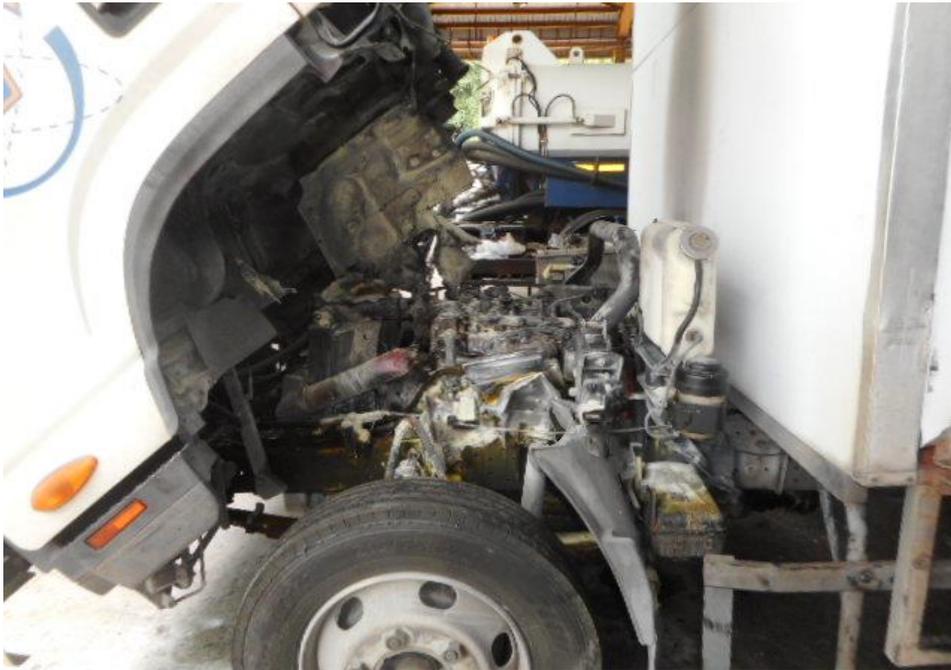
**Photo 6** shows the engine compartment at the left engine portion of the Insured Vehicle at the time of our inspection. The engine compartment of the Insured Vehicle was observed to be burnt. The electrical wirings and electrical components around the left engine area was damaged as a result of the fire.

7. Based on the circumstances for this particular case, the fire appears to have originated from the left engine compartment area of the Insured Vehicle, somewhere around the left engine portion of the Insured Vehicle. This can be determined basing on the area where the extent of fire damage was most severe, the circumstances of the fires' origin at the material time of incident and also the burn marks and melting of material that were found at the left engine portion. around the left engine portion of the Insured Vehicle.

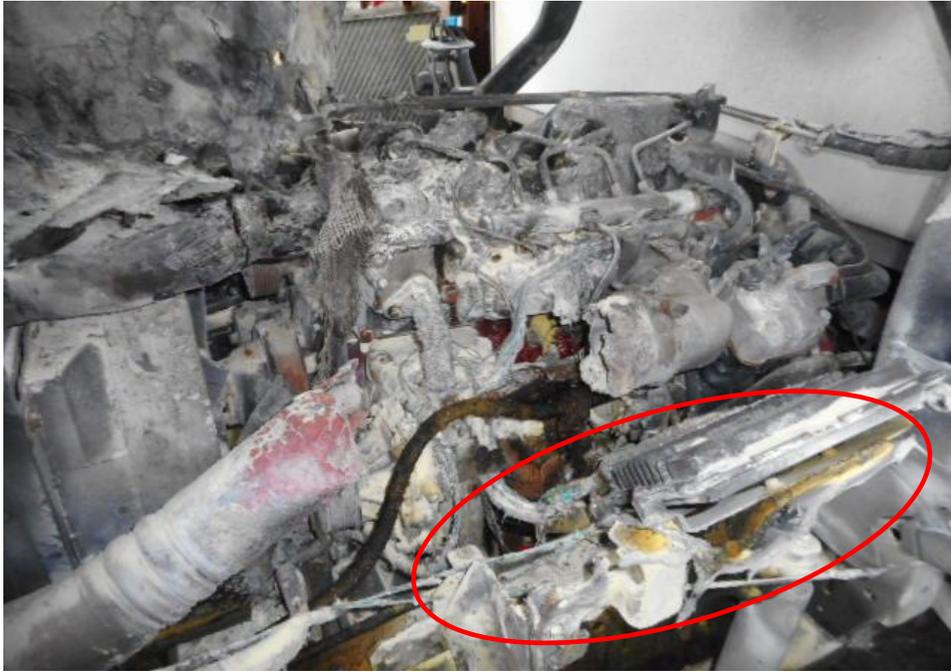
**Photo 7** shows the left engine compartment in the middle of the Insured Vehicle at the time of our inspection. The engine compartment of the Insured Vehicle was observed to be burnt. The electrical wirings and electrical components (circled) around the engine area was damaged as a result of the fire.

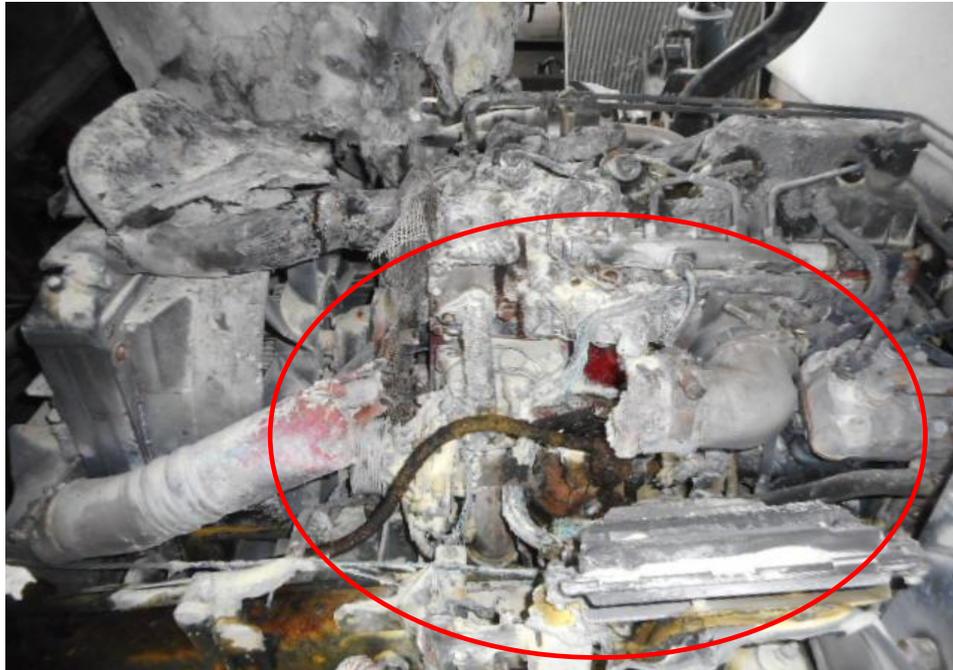
8. Upon closer observations, the wirings in the left engine compartment portion were observed to be where the fire had started, we had found traces of greenish residue on the original wirings leading from the Electronic Control Unit (ECU) to the electrical components. The wirings were original wirings fitting from manufacturer. The presence of greenish residue indicates internal heating of copper wires, a sign of an electrical short circuit occurring. The greenish residue is normally left behind from the oxidation as a result of chemical reaction involving the copper wires. This physical evidence would then appear to suggest that the cause of fire to the Insured Vehicle could have possibly been due to electrical in nature. See photo 8- 10 below.

**Photo 8** shows the general view of the left engine compartment of the Insured Vehicle at the time of our inspection. Observed that the engine component & electrical components in the left engine portion had sustain heat & smoke damaged.

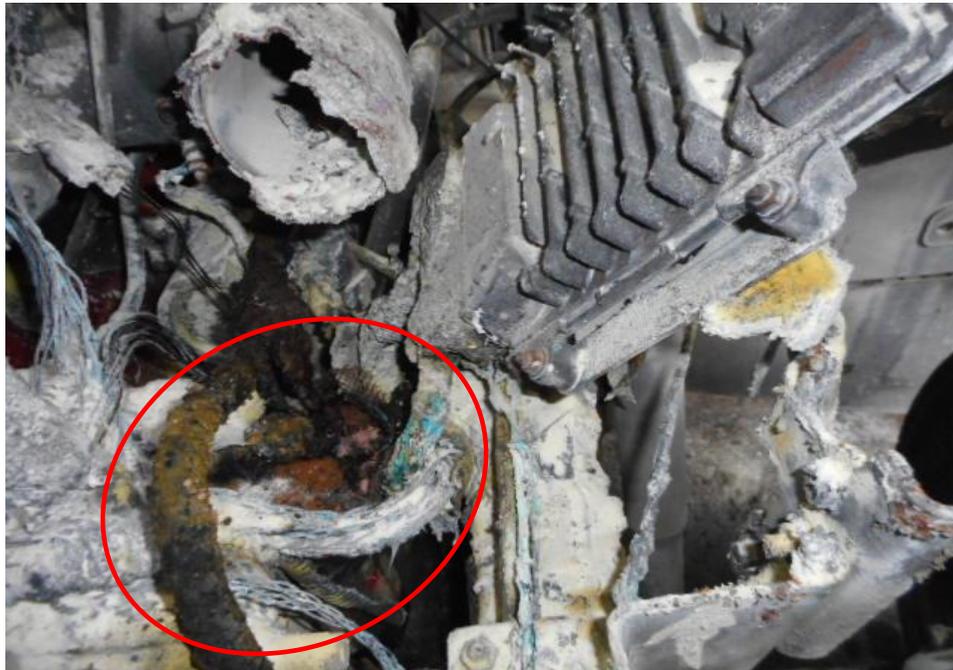
**Photo 9** shows a close up view of the original wiring harness from electrical components to the Electronic Control Unit (ECU) (circled) was observed with greenish residue on the surface. The presence of greenish residue indicates internal heating of copper wires, a sign of an electrical short circuit occurring. The greenish residue is normally left behind from oxidation as a result of chemical reaction involving the copper wires. This is likely where the fire had started from.

20. The possibility of the fire being due to electrical in nature would then seem more likely given that engine overheating and external factors would both seem unlikely. The fire being due to electrical nature is also supported by the condition of the several stretches of original wirings from the electrical components to its Electronic Control Unit which was burnt internally to its bare copper state on the Insured Vehicle which was a sign of short circuit that which was earlier discussed in paragraph 8 above.

22. Having investigated and technically analysed the damages of burnt nature to the Insured Vehicle, we are of the view that the cause of fire to the Insured Vehicle was of electrical nature. For this particular case, the fire had originated from the factory original wiring harnesses of the Electronic Control Unit (ECU) leading to its electrical components in the engine compartment of the Insured Vehicle.
23. We did not find any evidence which had suggested that the cause of fire to the Insured Vehicle was due to poor maintenance and/or recurring electrical problem.

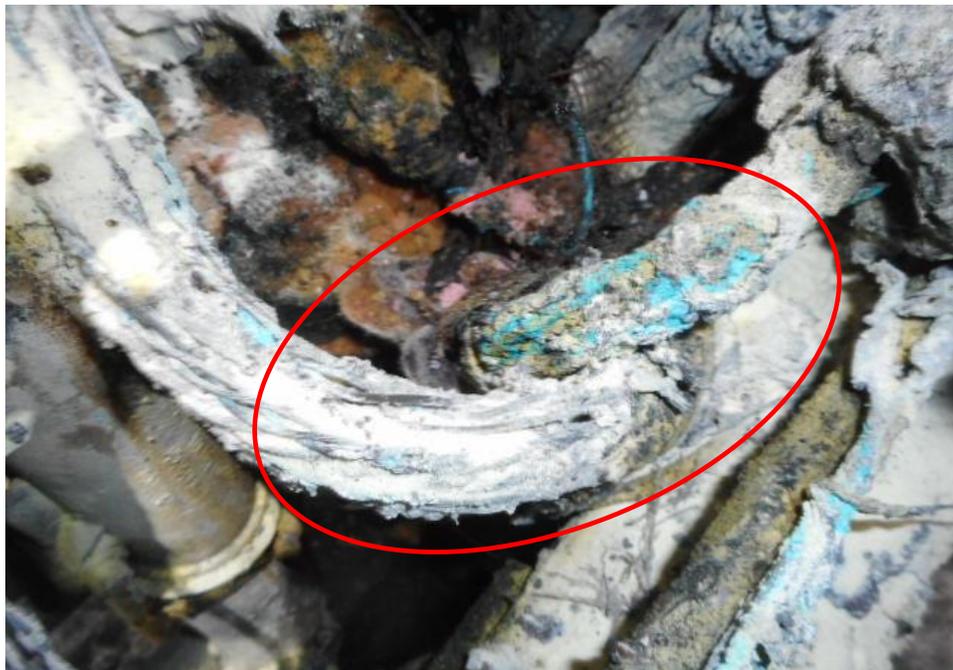
**Photo 10** shows the close up view of the original wiring harness from electrical components to the Electronic Control Unit (ECU) (circled) was observed with greenish residue on the surface. The presence of greenish residue indicates internal heating of copper wires, a sign of an electrical short circuit occurring. The greenish residue is normally left behind from oxidation as a result of chemical reaction involving the copper wires. This is likely where the fire had started from.

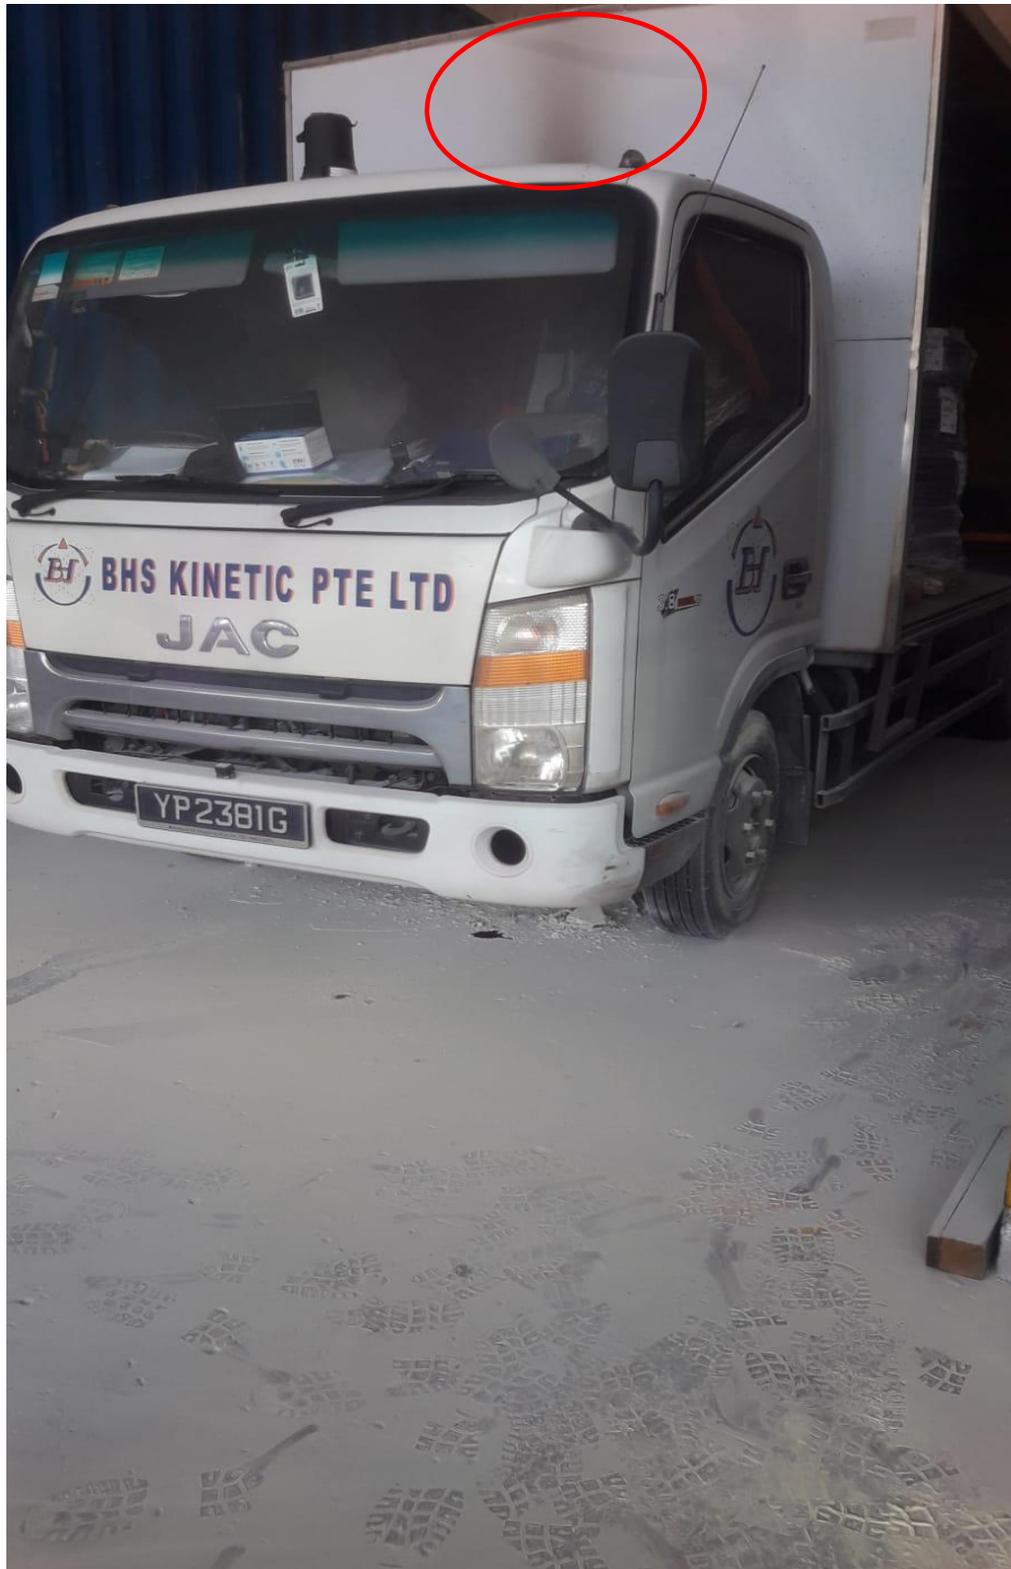
17. Our examination of these photographs revealed that the fire had started from the front of the Insured Vehicle. The photographs had also showed the Insured Vehicle on fire and similar extent of damage and burn pattern to the Insured Vehicle as per what we had observed during our physical inspection of the Insured Vehicle. Apart from the aforesaid; there was no further notable information that could be gathered from these photographs. See photo 11 below which were provided to us by Mr Jamal.

**Photo 11** shows where the fire had started on the Insured Vehicle. Observed is smoke emitting out from the engine compartment area (circled). In general, the information that could be gathered from this photograph had corresponded to the events that were related to us by Mr Jamal, location when the fire broke out.
