## VEHICLE DAMAGE INSPECTION REPORT

Our Ref: 225/TP/2021

Date of loss: 9/10/2021  
Claimant: Law Wai Keong

Reg No:	JQA3386	Make &	Toyota
Reg date:	26/3/2014	Model	Camry 2.0
Colour:	Black	Engine No:	1AZE282417
Type:	Motor Car	Chassis No:	PN153BK5107009011
Type of Claims:	Third Party	Odometer No:	120393km
		Engine Cap:	1998cc

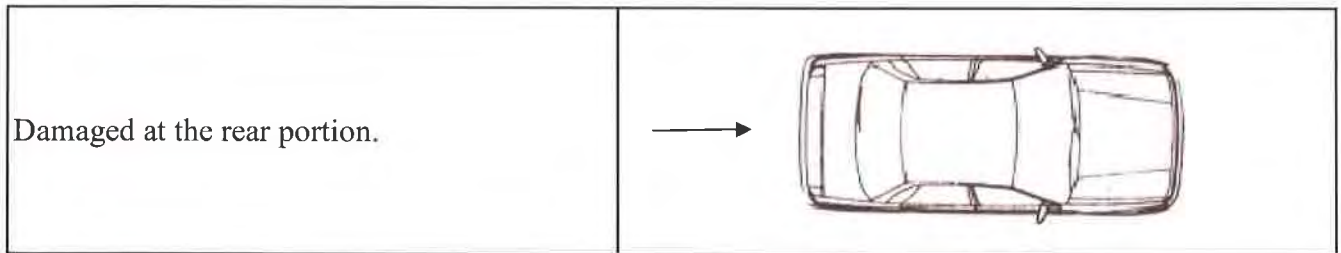
### POINT OF IMPACT

Our visual inspection of the vehicle revealed that the damages noted are at the rear portion.
