Your Ref: BMW M4 Coupe
(chassis number WBS32AZ010CH55247)
Our Ref : CI/TP23005443/D

28 May 2023

INSPECTION REPORT OF AN UNREGISTERED BMW M4 COUPE MOTOR CAR WITH CHASSIS NUMBER WBS32AZ010CH55247

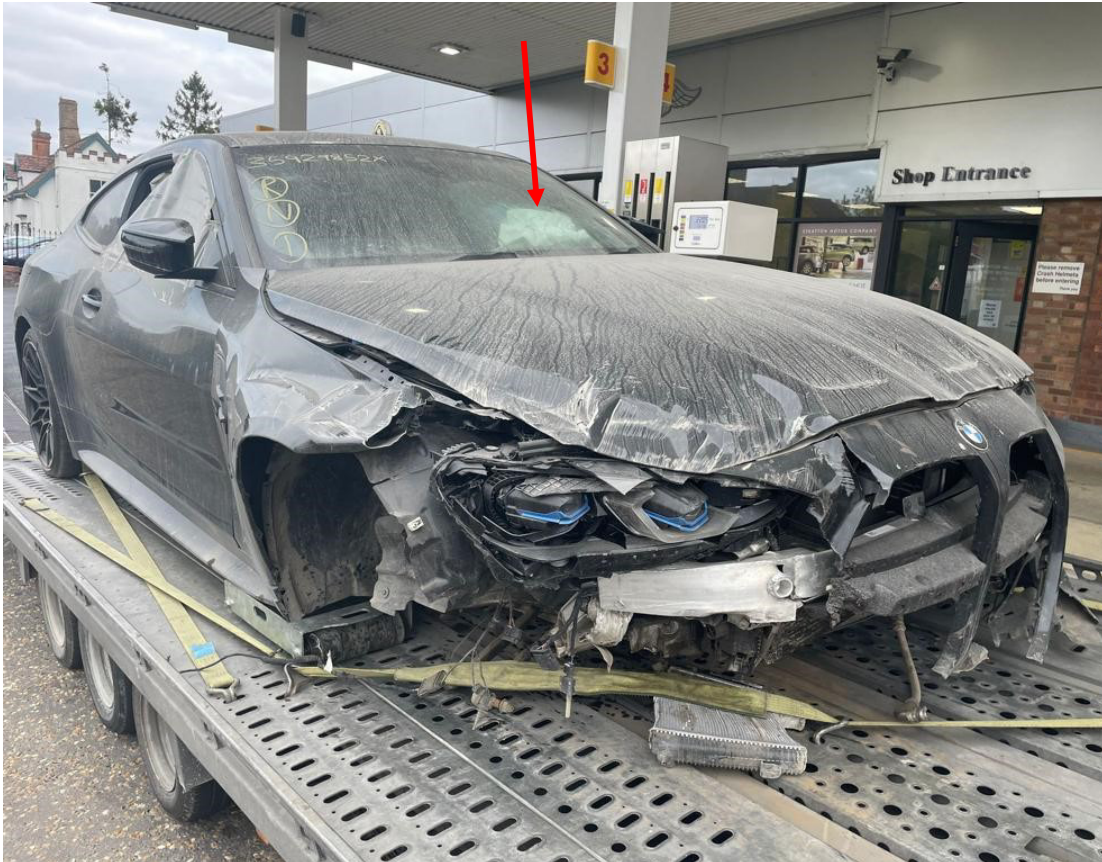
Photo 1 shows the front right body of the Motor Car (photograph provided to me). The Motor Car was observed to have sustained damage at its frontal portion. The front bumper, front bumper right lower grille, front bumper sensors, front bumper tow cover, front bumper sponge, front bumper reinforcement, front bumper under cover, front grilles, front bonnet, front right headlamp, front right headlamp lower bracket, front right oil cooler, front right fender and front right fender inner shield were amongst the body parts that were observed to have been damaged. The Motor Car's front right wheel along with its front right tyre and undercarriage parts at the front right wheel that included the front right lower arm, front right knuckle arm, front right steering tie rod end, front right shock absorber, front right brake caliper and front right brake rotor amongst others, were also all detached from the Motor Car. The front left passenger airbag (arrowed) of the Motor Car was deployed.

24. The body parts at the frontal portion and left rear portion, as well as the undercarriage parts at the front right wheel of the Motor Car were all visually examined, and it was noted that the repair/restoration works carried out to the damaged area of the Motor Car (refer to photograph 1 - 3 above) were reasonably adequate and in order.

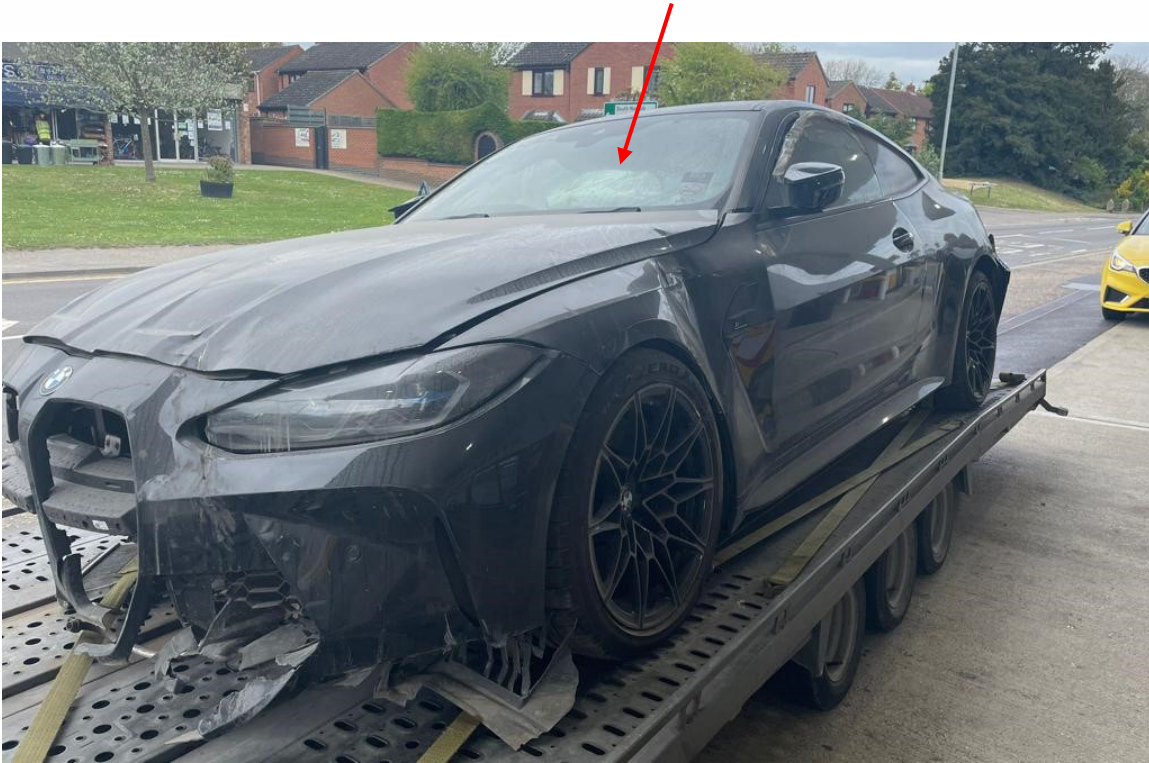
Photo 2 shows the front left body of the Motor Car (photograph provided to me). The Motor Car was observed to have sustained damage at its frontal portion. The front bumper, front bumper left lower grille, front bumper sensors, front bumper under cover, front grilles, front bonnet, front left headlamp and front left fender were amongst the body parts that were observed to have been damaged. The front left passenger airbag (arrowed) of the Motor Car was deployed.

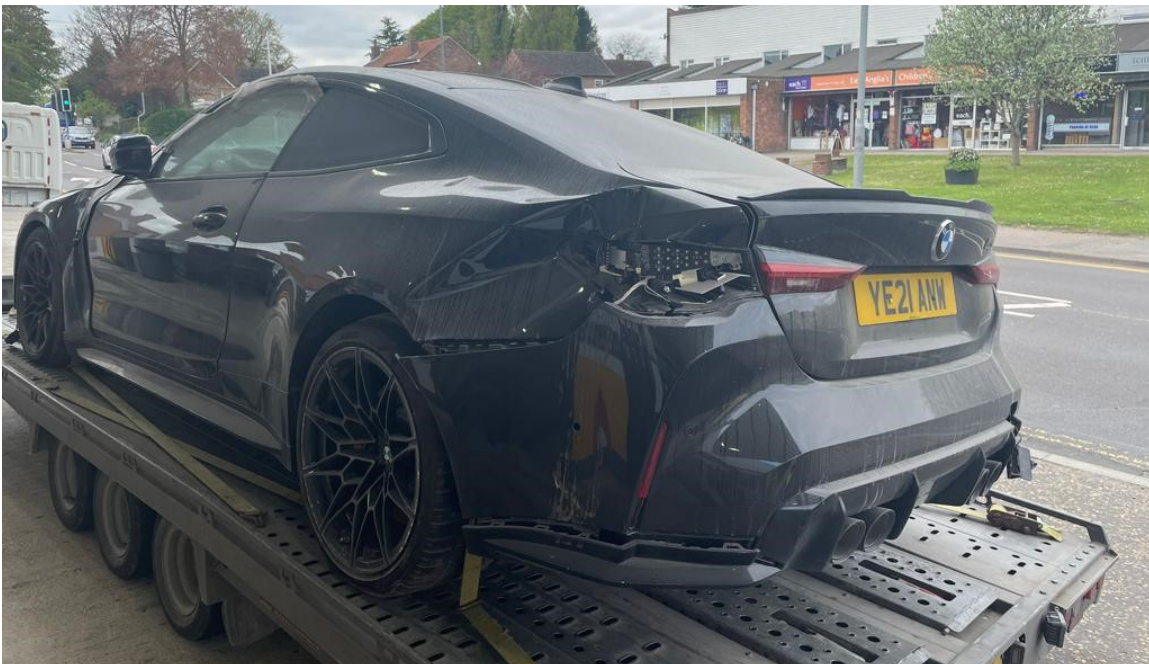
Photo 3 shows the rear left body of the Motor Car (photograph provided to me). The Motor Car's left rear portion was also observed to be damaged. The rear left fender, rear left taillamp and rear bumper were amongst the body parts that were damaged.

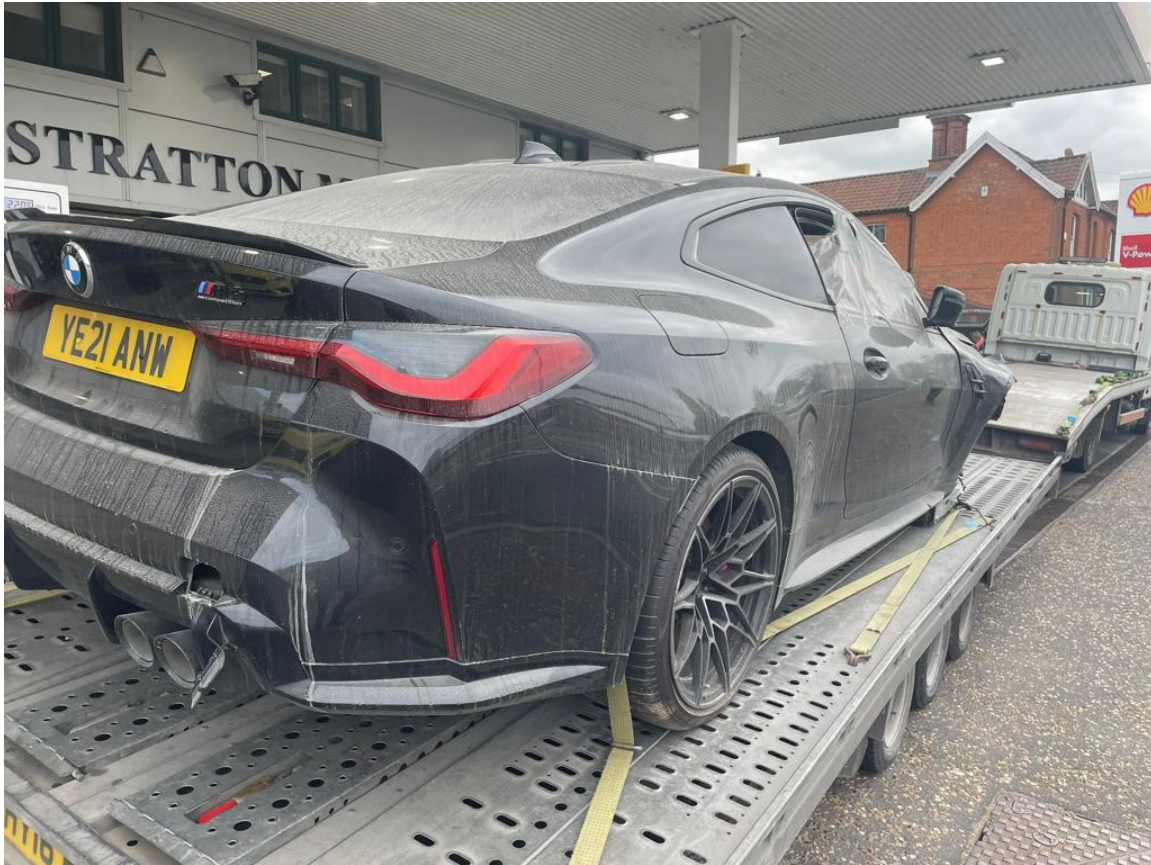
Photo 4 shows the rear right body of the Motor Car (photograph provided to me). Apart for the frontal portion and left rear portion, the photographs provided to me did not show physical damage to other areas of the Motor Car.

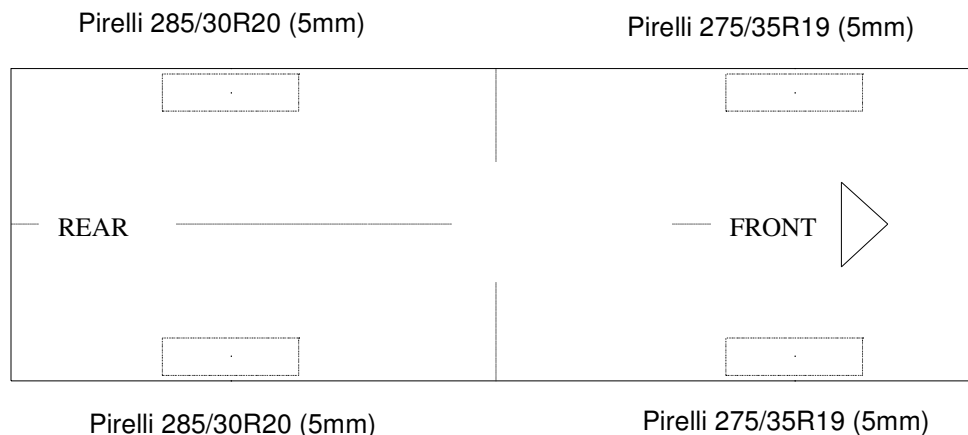
10. It was fitted with 19inch (front) and 20inch (rear) sport wheel rims that were wrapped with tyres that were observed to be of serviceable condition. The tyres were also sufficiently inflated for vehicular operation. The tyre brand, tyre size and approximate remaining tread depth of the 4 tyres of the Motor Car were recorded as follows: -

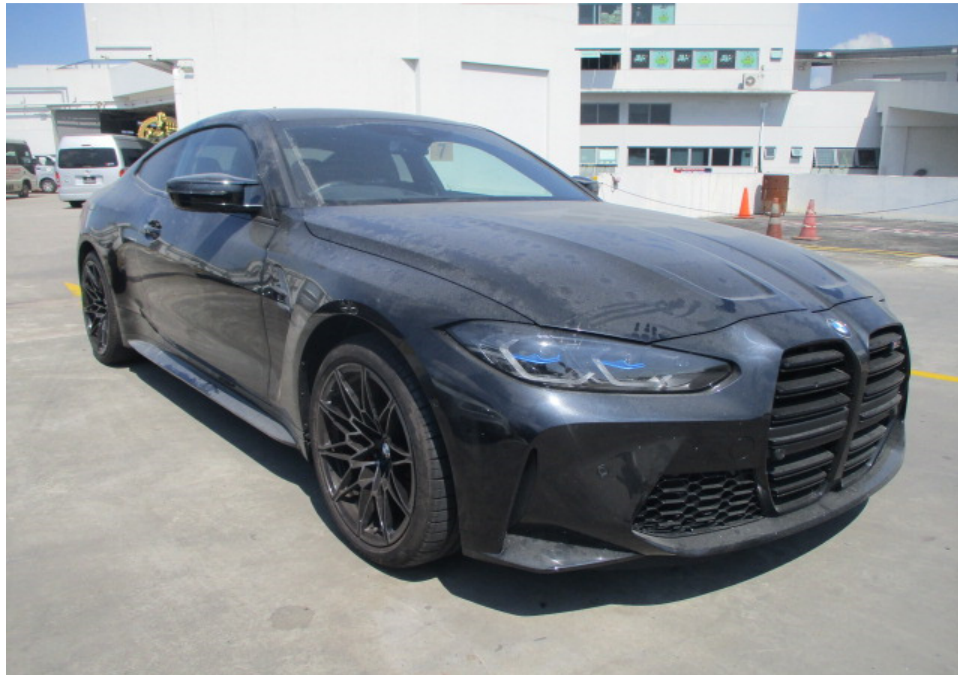
Photo 5 shows a general view of the front right body of the Motor Car at the time of my inspection. The Motor Car was observed to be in a relatively good general condition with no loose exterior fittings observed. The body parts at the frontal portion of the Motor Car were visually examined and it was observed that the repair/restoration works carried out to the damaged area of the Motor Car (refer to photograph 1 & 2 above) were reasonably adequate and in order.

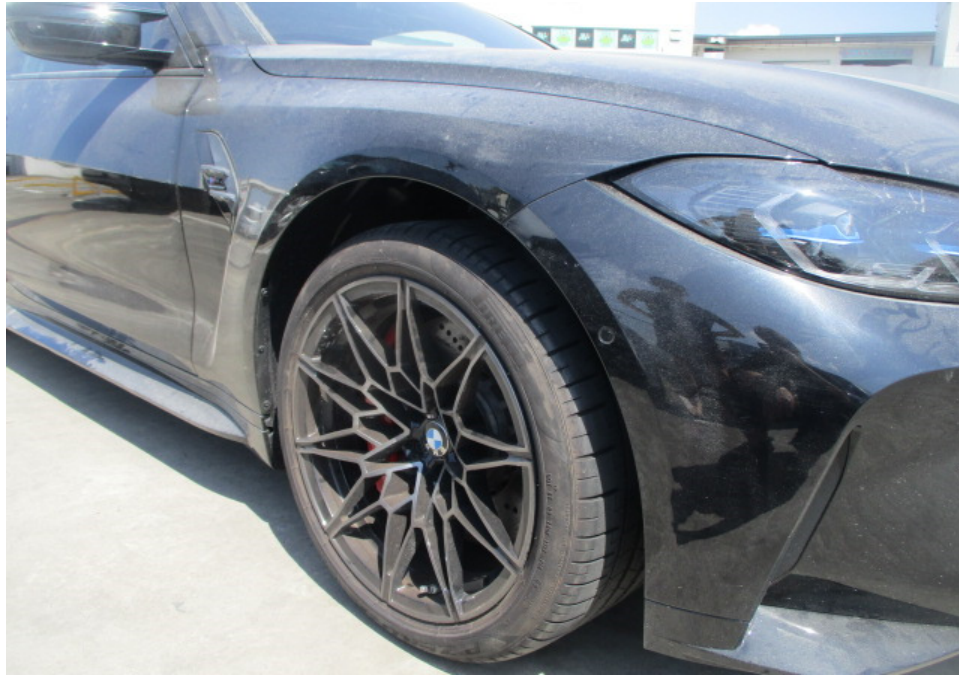
Photo 6 shows a closer view of the Motor Car's front right headlamp, front right fender, front right wheel rim and front right tyre at the time of my inspection. The body parts at the frontal portion of the Motor Car were visually examined and it was observed that the repair/restoration works carried out to the damaged area of the Motor Car (refer to photograph 1 & 2 above) were reasonably adequate and in order.

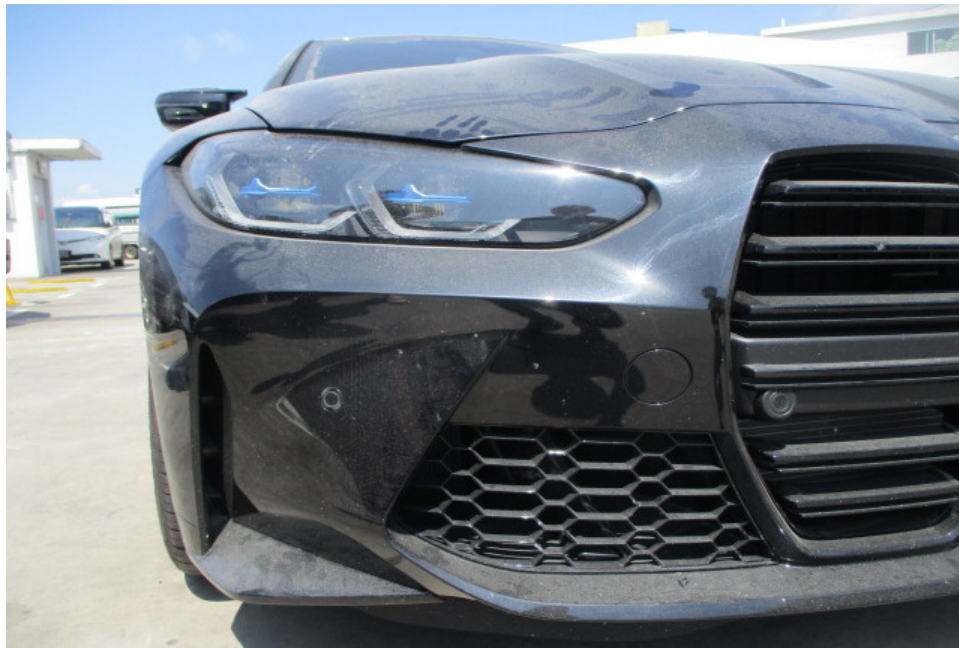
Photo 7 shows a closer view of the Motor Car's front bumper, front bumper right lower grille, front bumper right sensors and front right headlamp. The body parts at the frontal portion of the Motor Car were visually examined and it was observed that the repair/restoration works carried out to the damaged area of the Motor Car (refer to photograph 1 & 2 above) were reasonably adequate and in order.

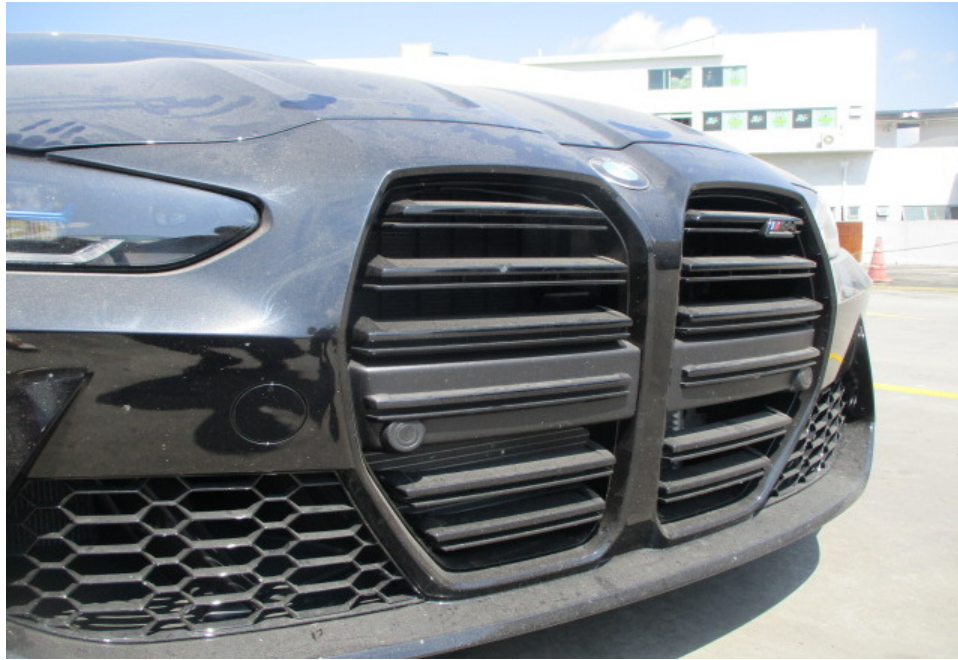
Photo 8 shows a closer view of the Motor Car's front bumper, front bumper right lower grille, front bumper left lower grille, front bonnet and front grilles. The body parts at the frontal portion of the Motor Car were visually examined and it was observed that the repair/restoration works carried out to the damaged area of the Motor Car (refer to photograph 1 & 2 above) were reasonably adequate and in order.

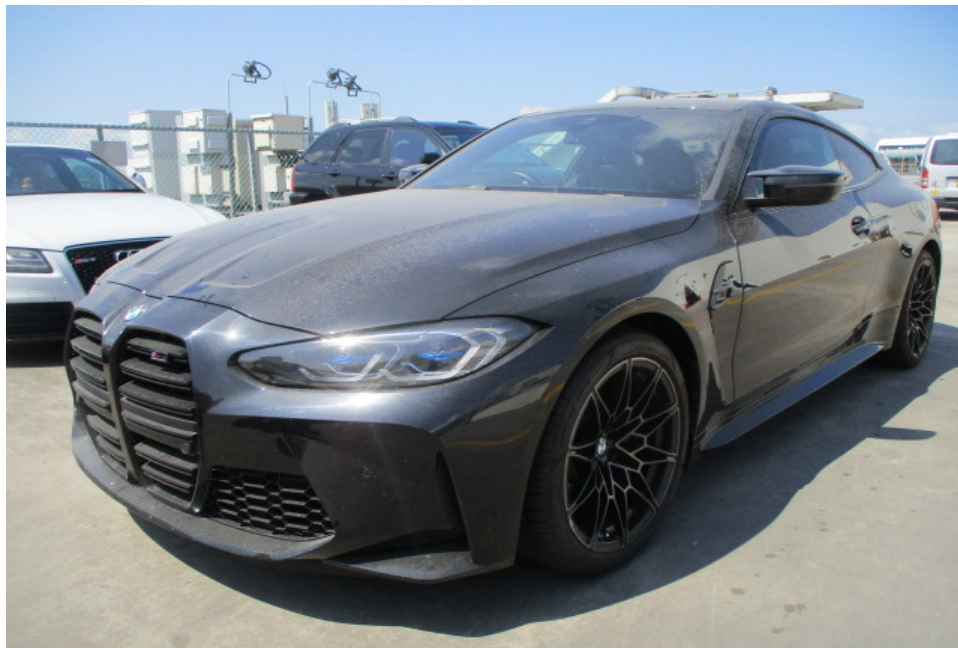
Photo 9 shows a general view of the front left body of the Motor Car at the time of my inspection. The Motor Car was observed to be in a relatively good general condition with no loose exterior fittings observed. The body parts at the frontal portion of the Motor Car were visually examined and it was observed that the repair/restoration works carried out to the damaged area of the Motor Car (refer to photograph 1 & 2 above) were reasonably adequate and in order.

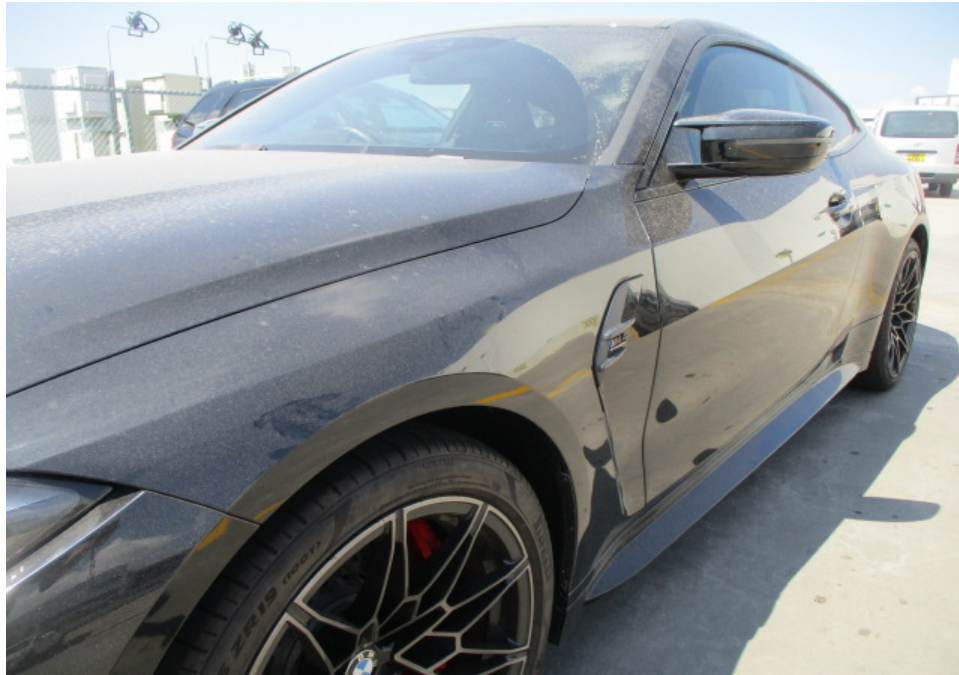
Photo 10 shows a closer view of the Motor Car's front bonnet, front left fender, front left door and left side wing mirror. The body parts at the frontal portion of the Motor Car were visually examined and it was observed that the repair/restoration works carried out to the damaged area of the Motor Car (refer to photograph 2 above) were reasonably adequate and in order.

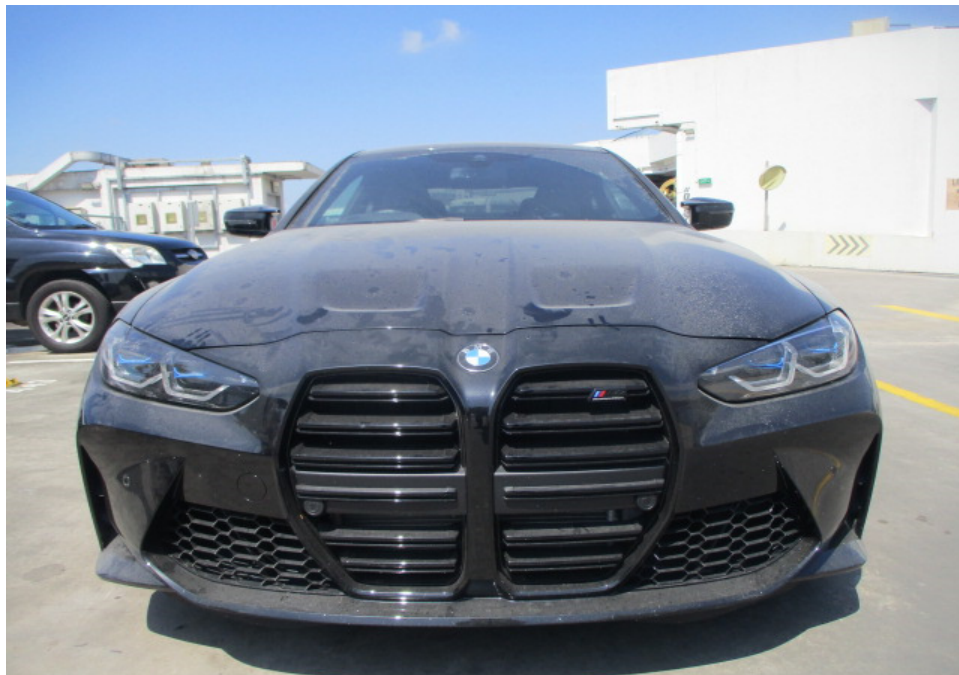
Photo 11 shows a general view of the frontal body of the Motor Car at the time of my inspection. The Motor Car was observed to be in a relatively good general condition with no loose exterior fittings observed. The body parts at the frontal portion of the Motor Car were visually examined and it was observed that the repair/restoration works carried out to the damaged area of the Motor Car (refer to photograph 1 & 2 above) were reasonably adequate and in order.

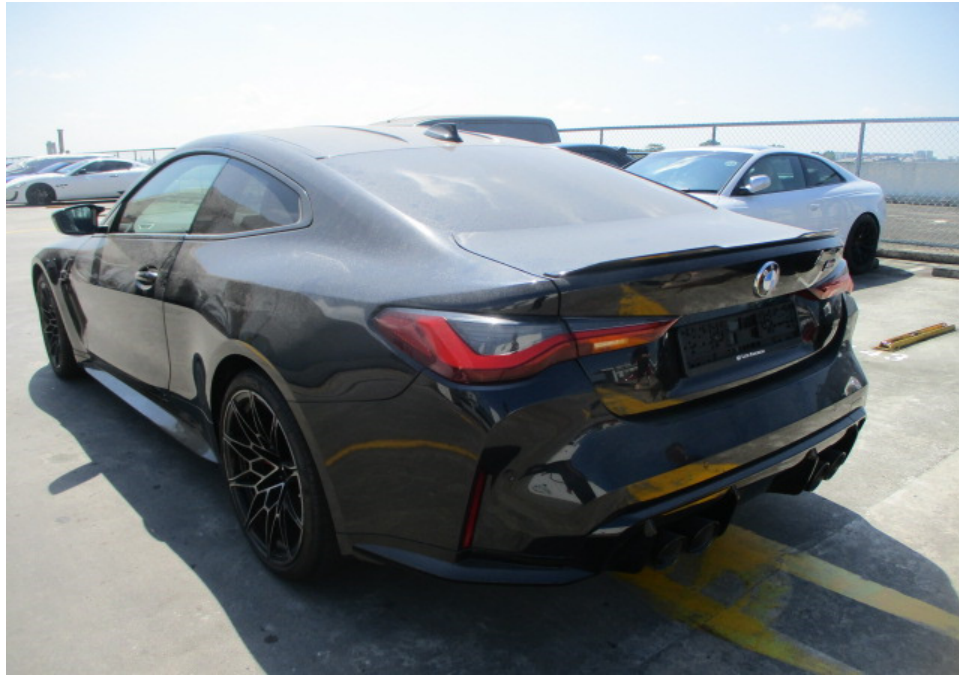
Photo 12 shows a general view of the rear left body of the Motor Car at the time of my inspection. The Motor Car was observed to be in a relatively good general condition with no loose exterior fittings observed. The body parts at the left rear portion of the Motor Car were visually examined and it was observed that the repair/restoration works carried out to the damaged area of the Motor Car (refer to photograph 3 above) were reasonably adequate and in order.

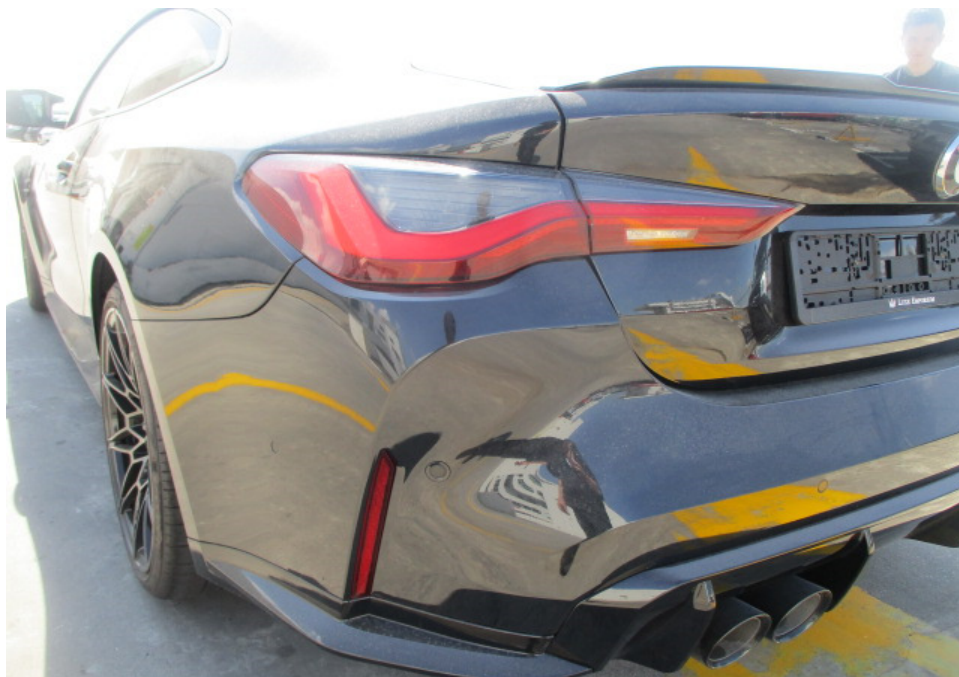
Photo 13 shows a closer view of the Motor Car's rear bumper, rear bumper left reflector and rear left taillamp. The body parts at the left rear portion of the Motor Car were visually examined and it was observed that the repair/restoration works carried out to the damaged area of the Motor Car (refer to photograph 3 above) were reasonably adequate and in order.

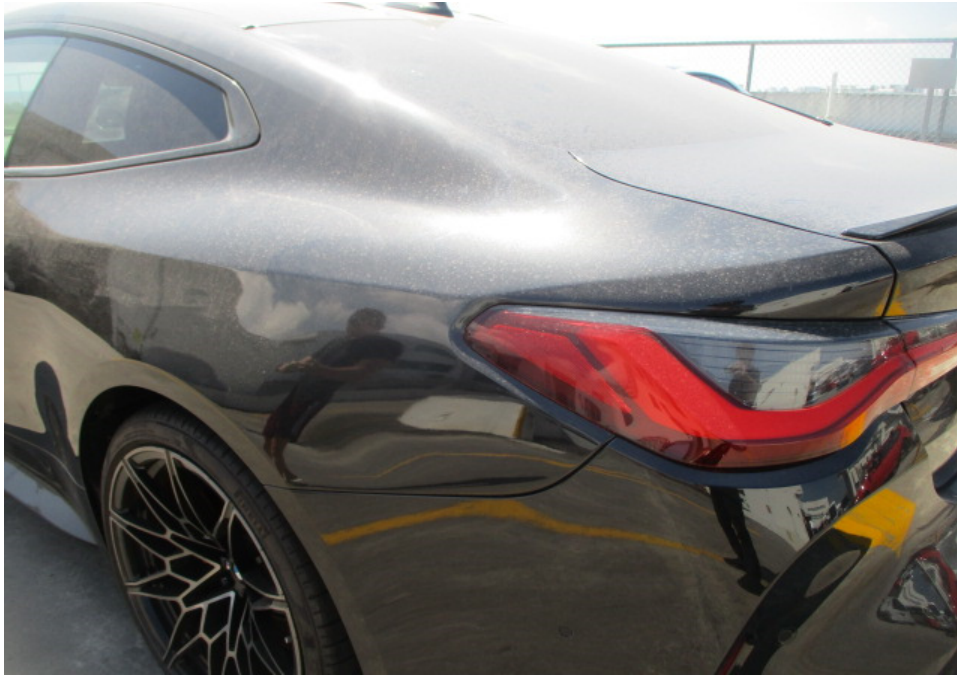
Photo 14 shows a closer view of the Motor Car's rear bumper, rear left fender, rear left taillamp and rear left wheel rim. The body parts at the left rear portion of the Motor Car were visually examined and it was observed that the repair/restoration works carried out to the damaged area of the Motor Car (refer to photograph 3 above) were reasonably adequate and in order.

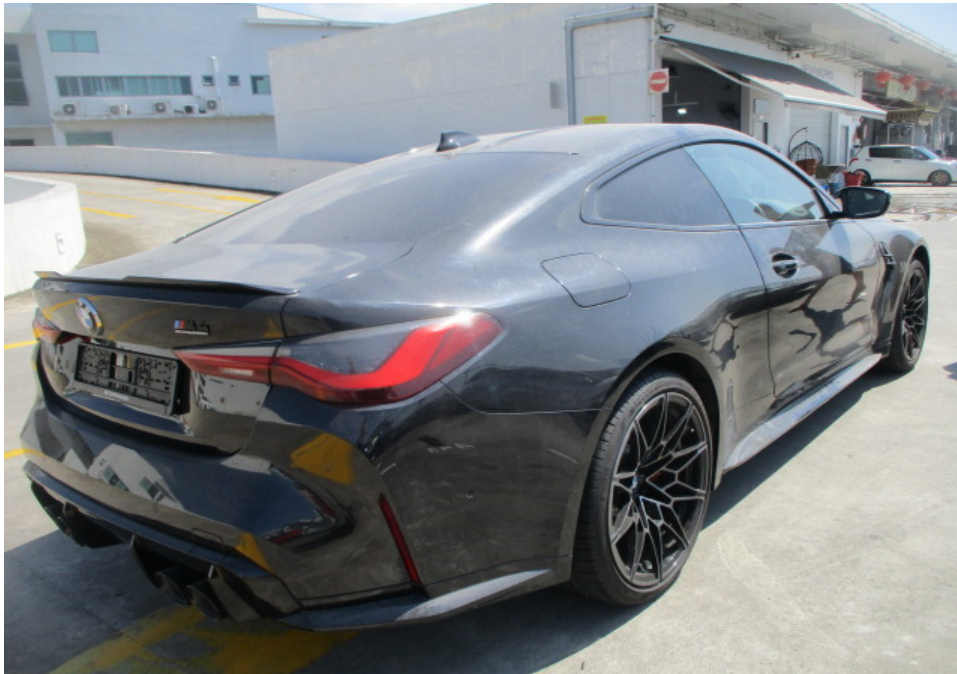
Photo 15 shows a general view of the rear right body of the Motor Car at the time of my inspection. The Motor Car was observed to be in a relatively good general condition with no loose exterior fittings observed. The mileage of the Motor Car recorded at the time of my inspection was 9,544km.

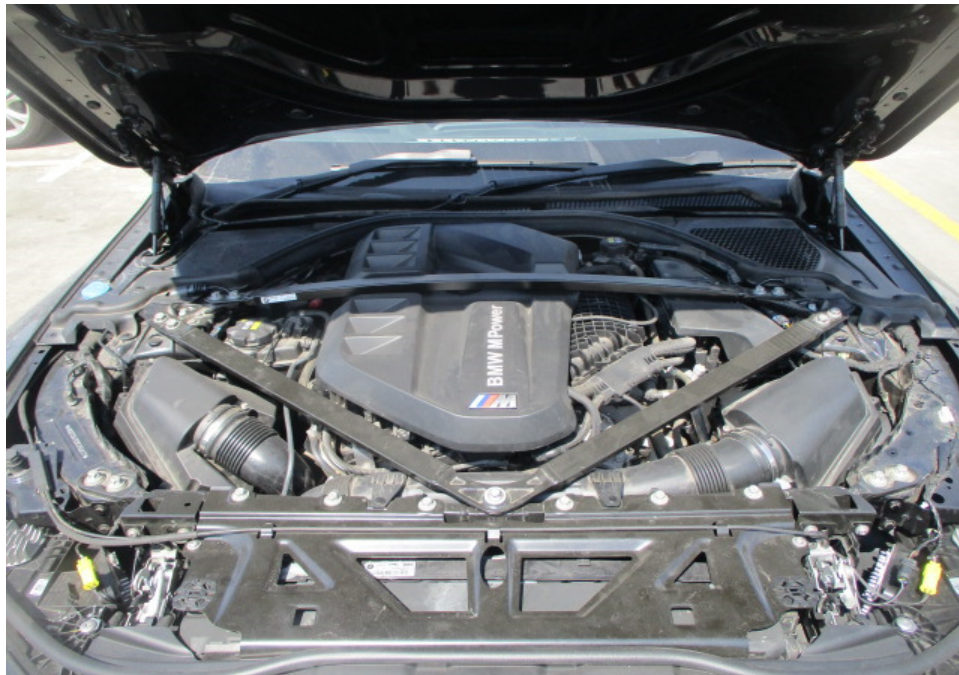
16. My examination of the engine compartment of the Motor Car revealed that the various parts and components inside the engine compartment were all intact and properly fitted. The engine oil, brake fluid and engine coolant were all found to be of sufficient level for operating purposes. Visually, there was also no contamination found to these fluids.
17. My checks on the underside of the Motor Car revealed no sign(s) or indication(s) of fluid leakage and/or fluid stain(s). The engine block and automatic transmission assembly were both secured properly. All undercarriage components of the Motor Car were also observed to be intact and secured in an appropriate manner.

Photo 17 shows a general view of the engine compartment of the Motor Car at the time of my inspection. The various parts and components inside the engine compartment were all observed to be intact and properly fitted. There was also no sign(s) or indication(s) of fluid leak and/or fluid stain found inside the engine compartment.

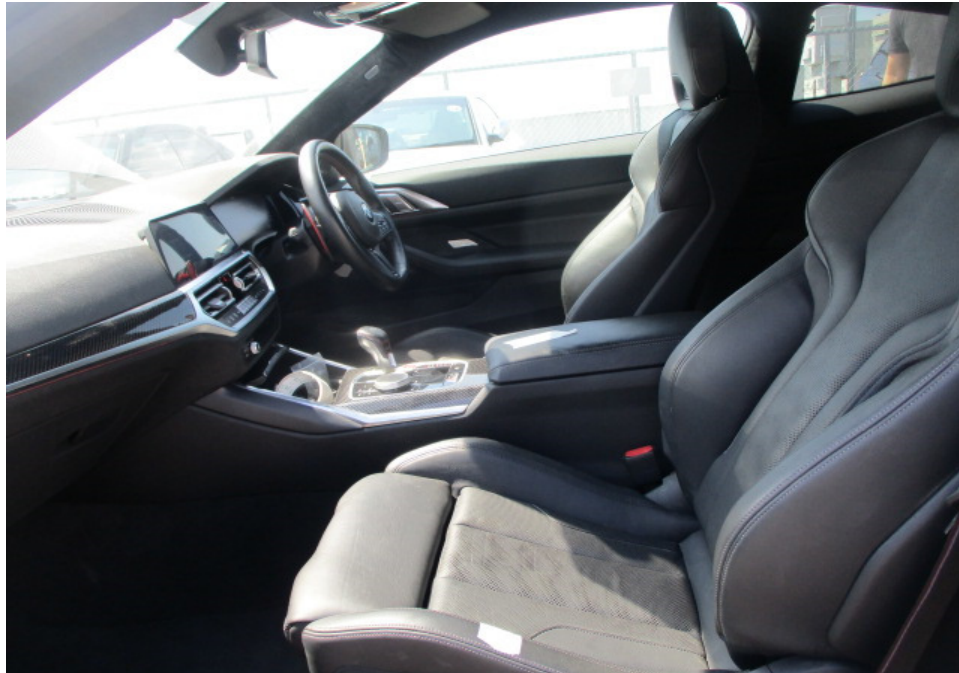
Photo 18 shows the interior compartment of the Motor Car at the time of my inspection. The various parts and components, trims, carpet, and upholstery inside the interior compartment were all observed to be intact and properly fitted.

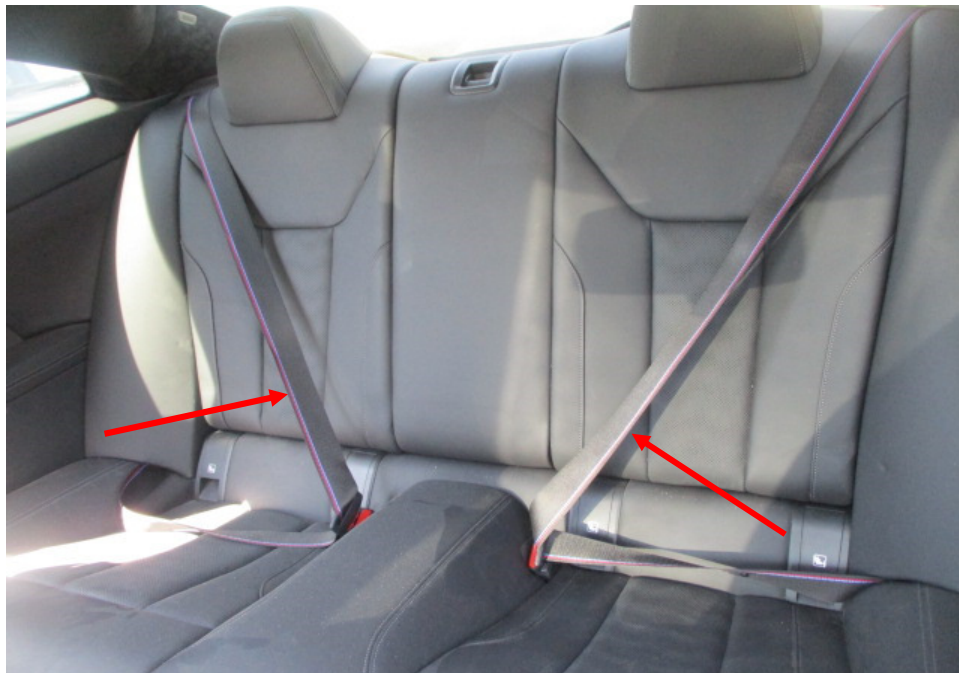
14. The seats of the Motor Car were found to be secured to the floorboard of the Motor Car via seat rails bolted onto the floorboard. Retractable seat belt reels and pre-tensioners were fitted on all seats of the Motor Car. The seat belts were tested and were able to be fastened securely into the respective pre-tensioners that were fixed to the side of all the seats.

Photo 19 shows the rear seats of the Motor Car. All the seats of the Motor Car were secured via seat rails to the floorboard. They were also fitted with a retractable seat belt reel and a pre-tensioner. The seat belts (arrowed) were tested and were able to be fastened into the respective pre-tensions that were fitted on the side of each individual seat.

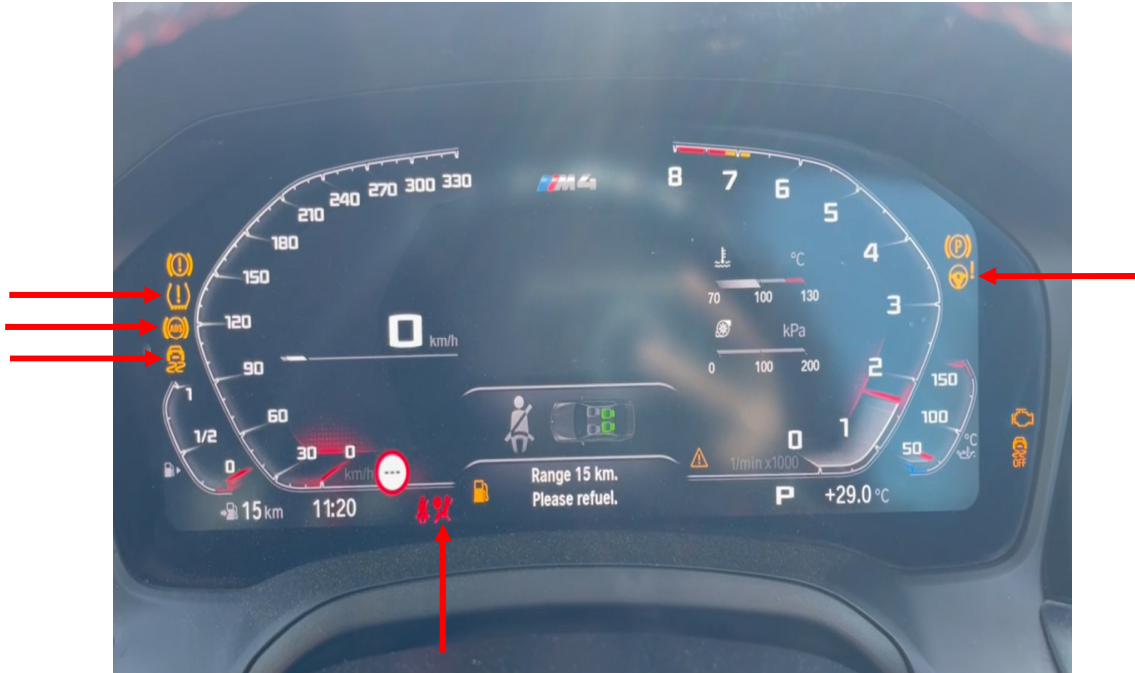
Photo 20 shows the warning lights for the various electronic safety features appearing on the instrument panel of the Motor Car during its self-test when the engine is cranked, in particular the ABS, SRS, IAS, TPM and DSC lights (arrowed).

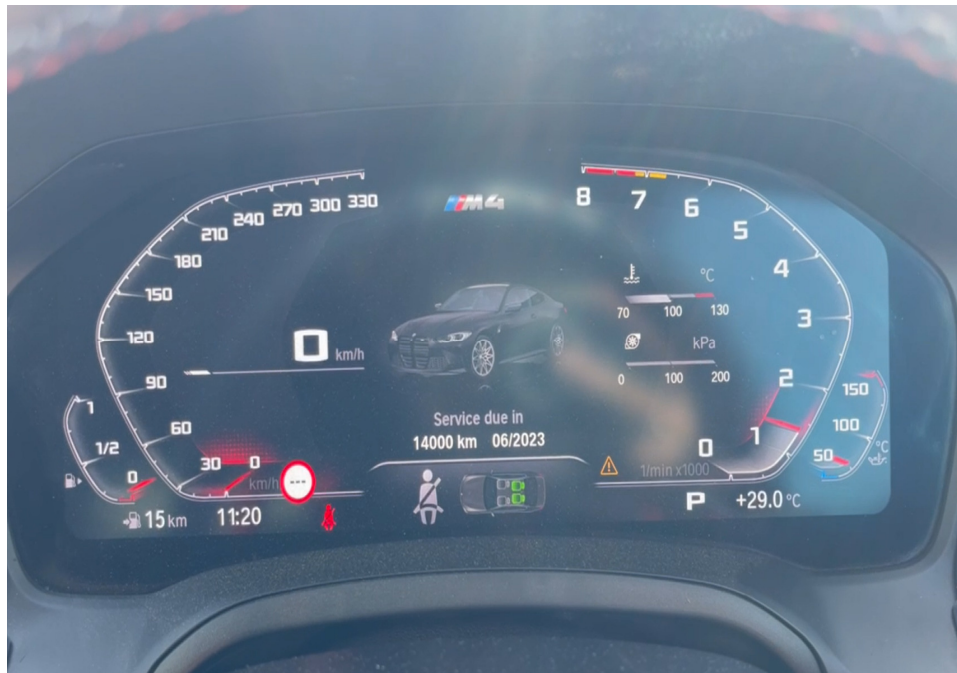
15. The Motor Car's automatic self-test of the functionality of its various electronic safety features like the Anti-Lock Brake System (ABS), Supplemental Restraint System (SRS), Integral Active Steering (IAS), Tyre Pressure Monitor (TPM) and Dynamic Stability Control (DSC) during cranking of the engine had indicated that these electronic systems were in working condition. This was determined from the respective warning lights disappearing from the instrument panel after the self-test.

Photo 21 shows the respective warning lights no longer illuminated, indicating that there is no fault detected to the ABS, SRS, IAS, TPM and DSC systems of the Motor Car during the self-test. These electronic systems were hence in working condition at the time of my inspection.

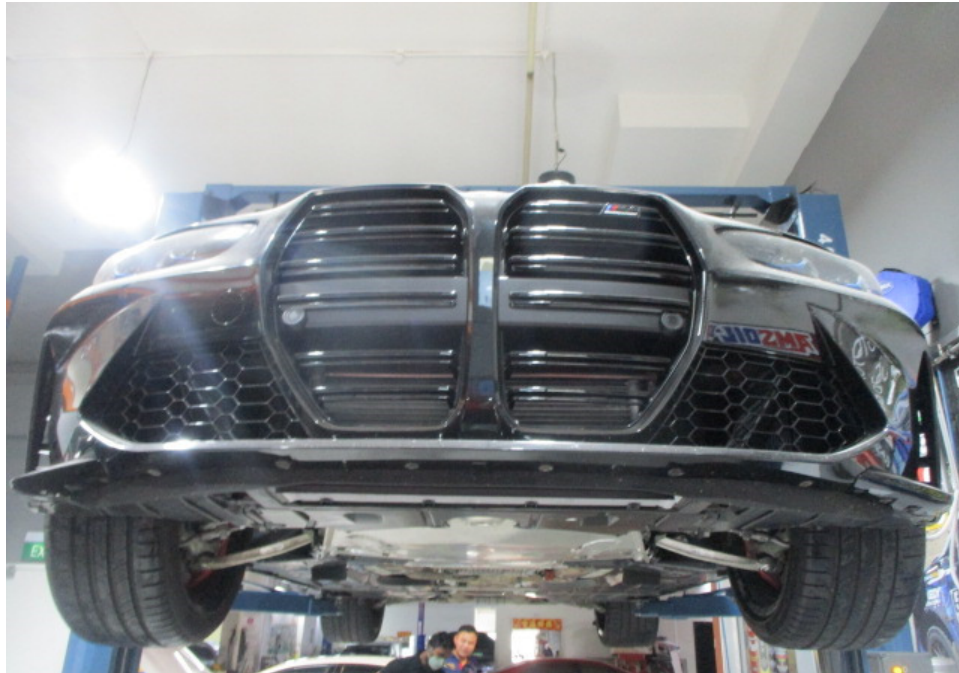
Photo 22 shows the Motor Car hoisted up for checks on its undercarriage. There was no sign(s) or indication(s) of fluid leakage and/or fluid stain(s) on the underside of the Motor Car. The undercarriage components of the Motor Car were also all observed to be intact and secured in an appropriate manner.

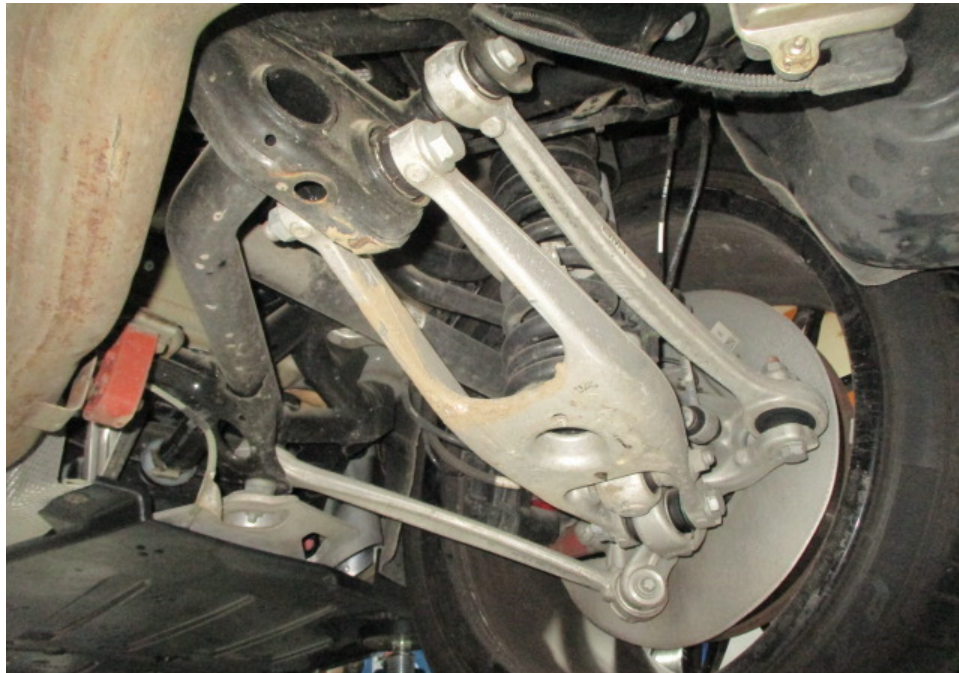
Photo 23 shows a general view of the control arms and linkages at the rear right wheel of the Motor Car. I did not observe any fluid leak and/or fluid stain on the underside of the Motor Car. All of the Motor Car's undercarriage components were observed to be intact and secured in an appropriate manner.

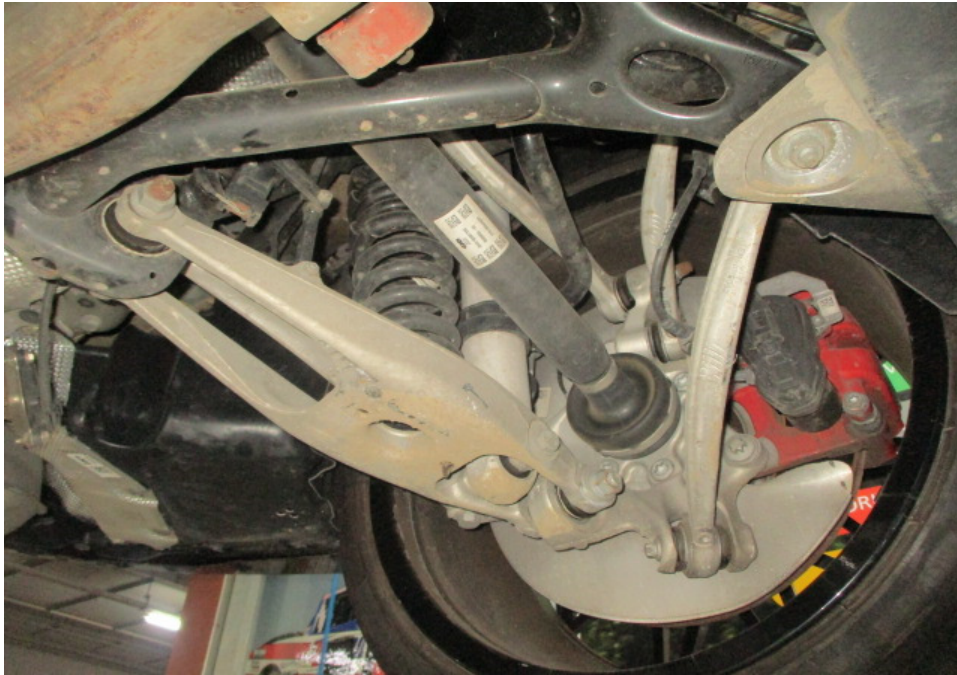
Photo 24 shows a general view of the control arms and linkages at the rear left wheel of the Motor Car. I did not observe any fluid leak and/or fluid stain on the underside of the Motor Car. All of the Motor Car's undercarriage components were observed to be intact and secured in an appropriate manner.

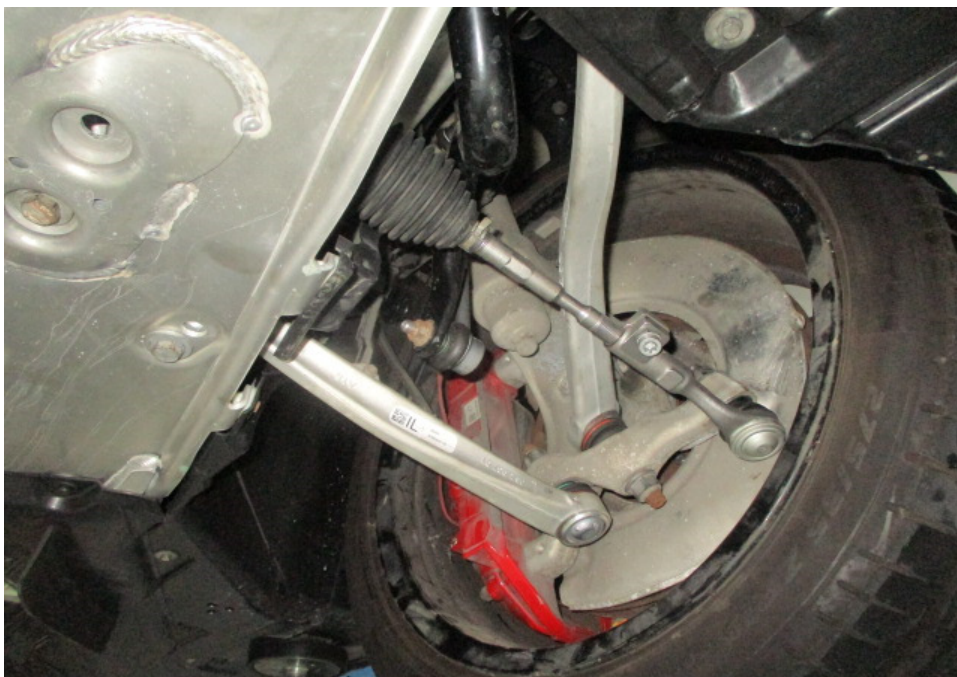
Photo 25 shows the various undercarriage components at the front left wheel of the Motor Car. The mechanical components, control arms and linkages were all found to be intact and secured in an appropriate manner.

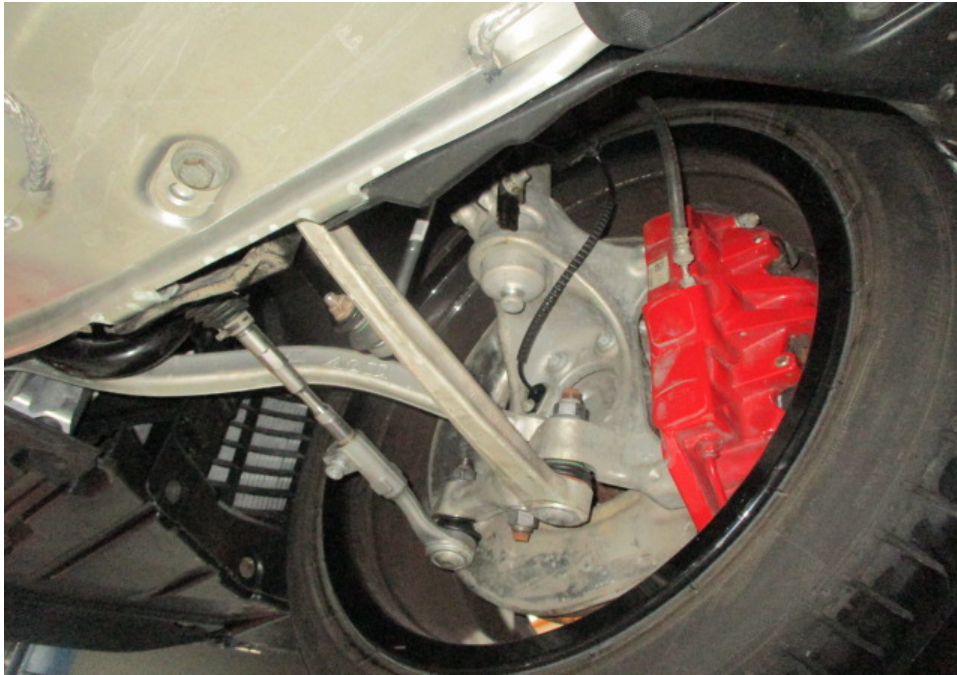
Photo 26 shows the various undercarriage components at the front right wheel of the Motor Car. The mechanical components, control arms and linkages were all found to be intact and secured in an appropriate manner. I also did not observe any fluid leak and/or fluid stain on the underside of the Motor Car.

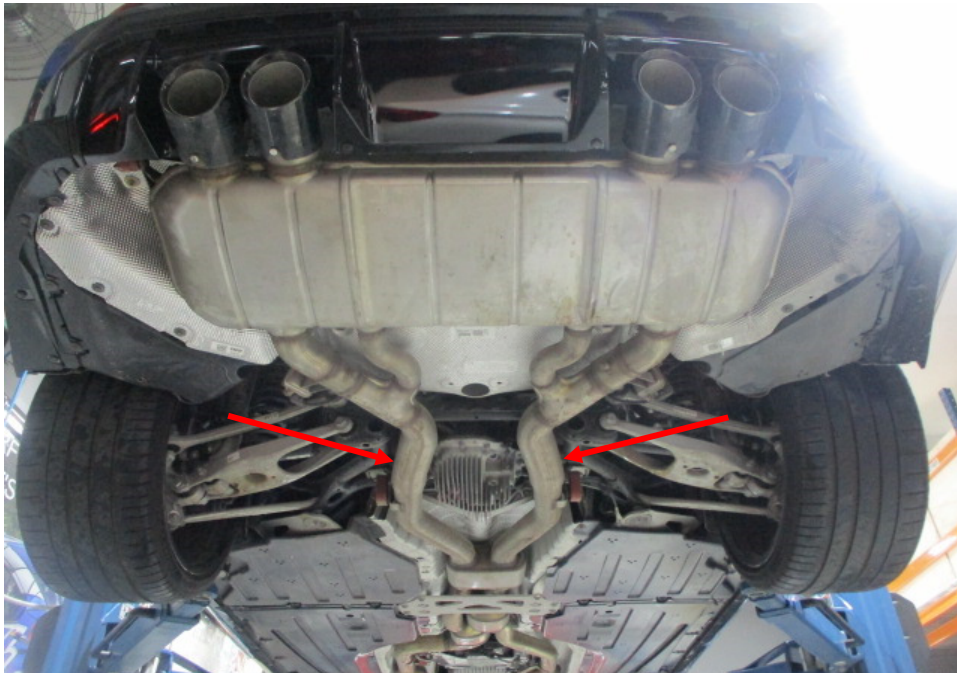
Photo 27 shows the rear section of the Motor Car's exhaust system. My examination of the Motor Car's exhaust system revealed no sign(s) or indication(s) of any cut or weld marks along its exhaust pipes (arrowed), on its rear muffler, on its centre resonator boxes and on its catalytic converters.

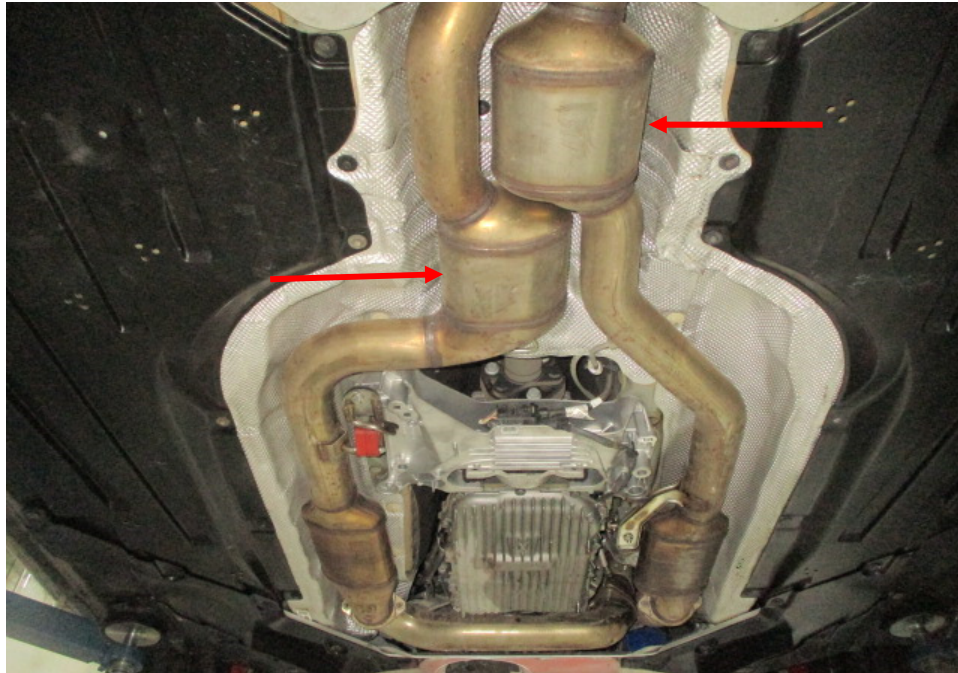
Photo 28 shows the front section of the Motor Car's exhaust system. My examination of the Motor Car's exhaust system revealed no sign(s) or indication(s) of any cut or weld marks along its exhaust pipes, on its rear muffler, on its centre resonator boxes (arrowed) and on its catalytic converters.
