Your Ref: BMW M4 Coupe
(chassis number WBS32AZ010CH55247)
Our Ref : CI/TP23005443/D

28 May 2023

INSPECTION REPORT OF AN UNREGISTERED BMW M4 COUPE MOTOR CAR WITH CHASSIS NUMBER WBS32AZ010CH55247

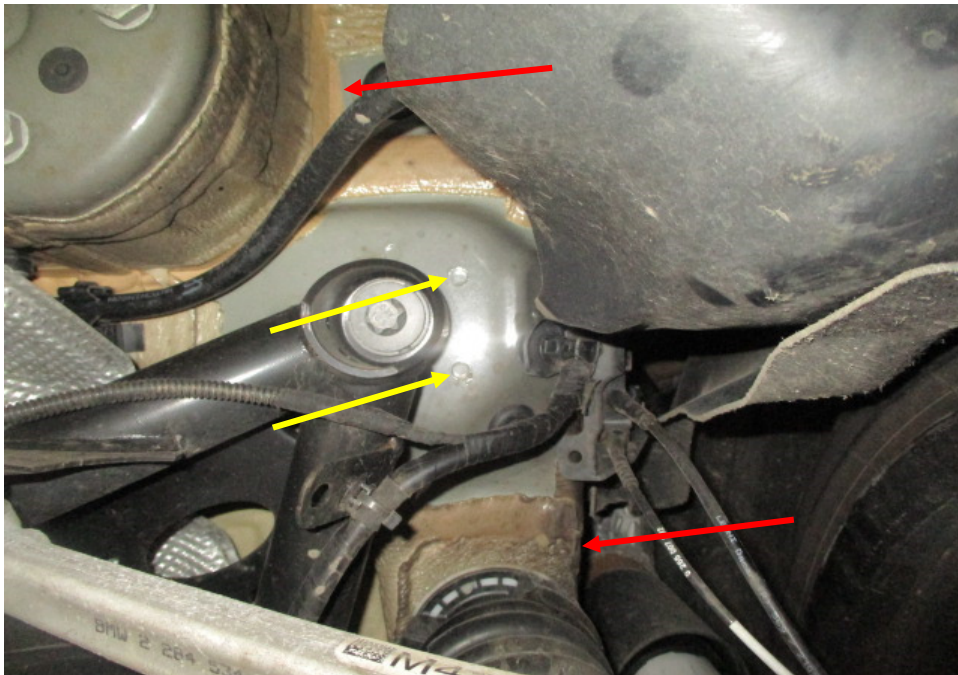
Photo 29 shows the chassis/structural body at the underside rear right of the Motor Car. I did not find any weld marks other than original spot weld marks (yellow arrow) on the chassis/structural body of the Motor Car. The original factory sealant (red arrow) at the joints along the chassis/structural body was untouched, indicating no work was done on the chassis/structural body of the Motor Car and that the chassis/structural body was originally fitted.

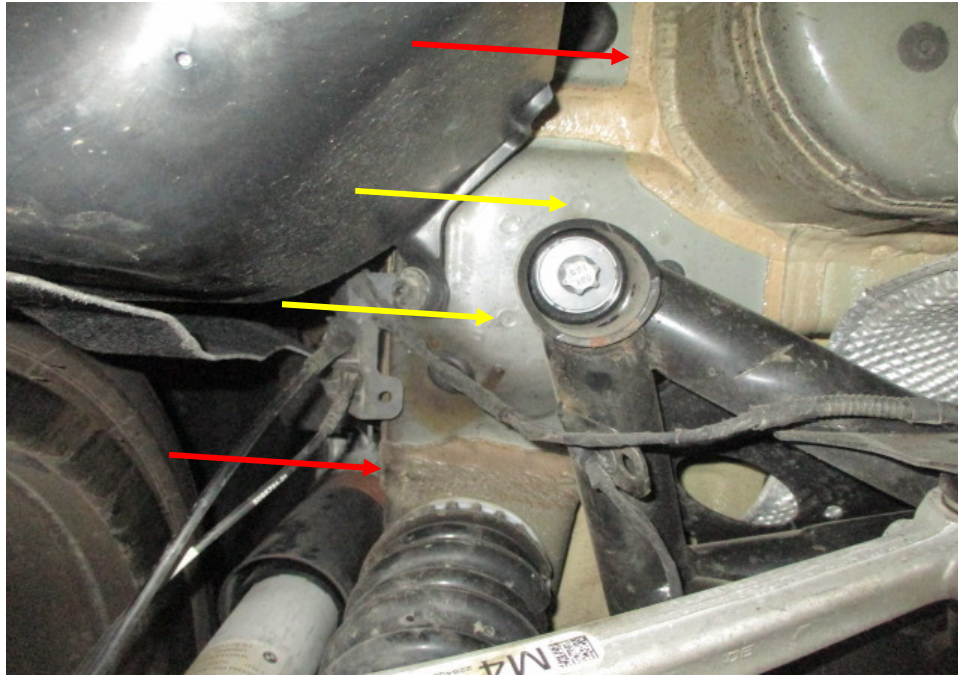
Photo 30 shows the chassis/structural body at the underside rear left of the Motor Car. I did not find any weld marks other than original spot weld marks (yellow arrow) on the chassis/structural body of the Motor Car. The original factory sealant (red arrow) at the joints along the chassis/structural body was untouched, indicating no work was done on the chassis/structural body of the Motor Car and that the chassis/structural body was originally fitted.

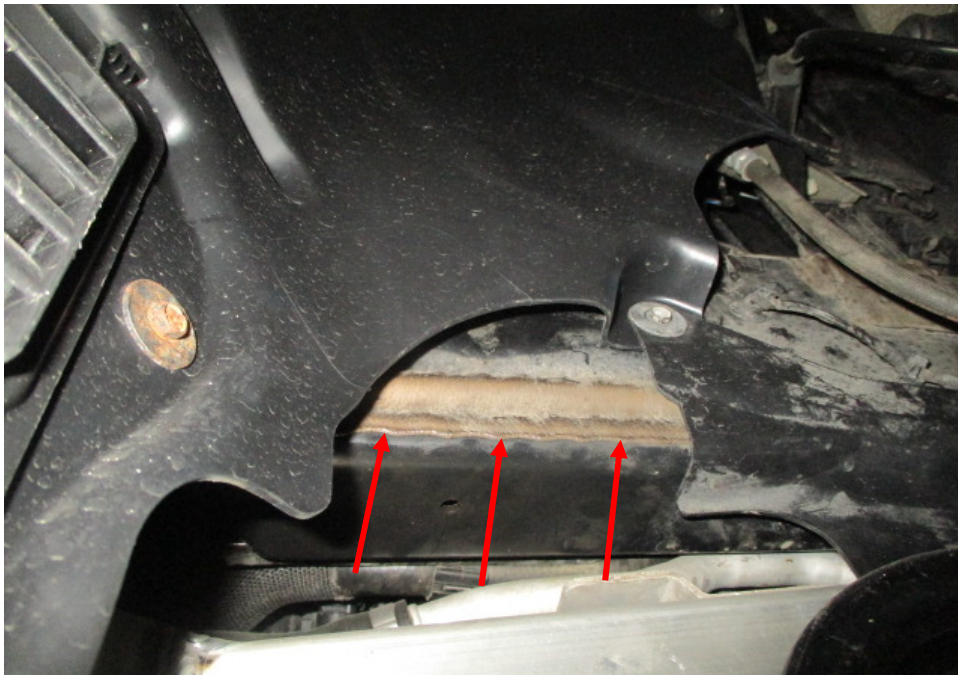
Photo 31 shows the chassis/structural body at the underside front left of the Motor Car. The original factory sealant (arrowed) at the joints along the chassis/structural body was observed to be untouched. In general, I had found no work was carried out on the chassis/structural body of the Motor Car. The chassis/structural body of the Motor Car was originally fitted.

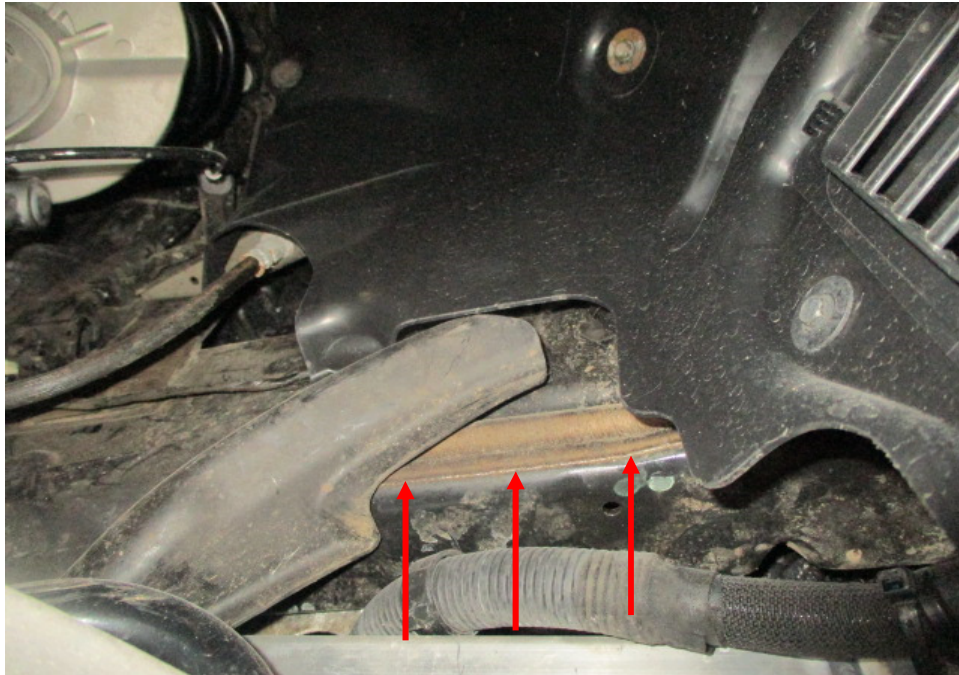
Photo 32 shows the chassis/structural body at the underside front right of the Motor Car. The original factory sealant (arrowed) at the joints along the chassis/structural body was observed to be untouched. In general, I had found no work was carried out on the chassis/structural body of the Motor Car. The chassis/structural body of the Motor Car was originally fitted.

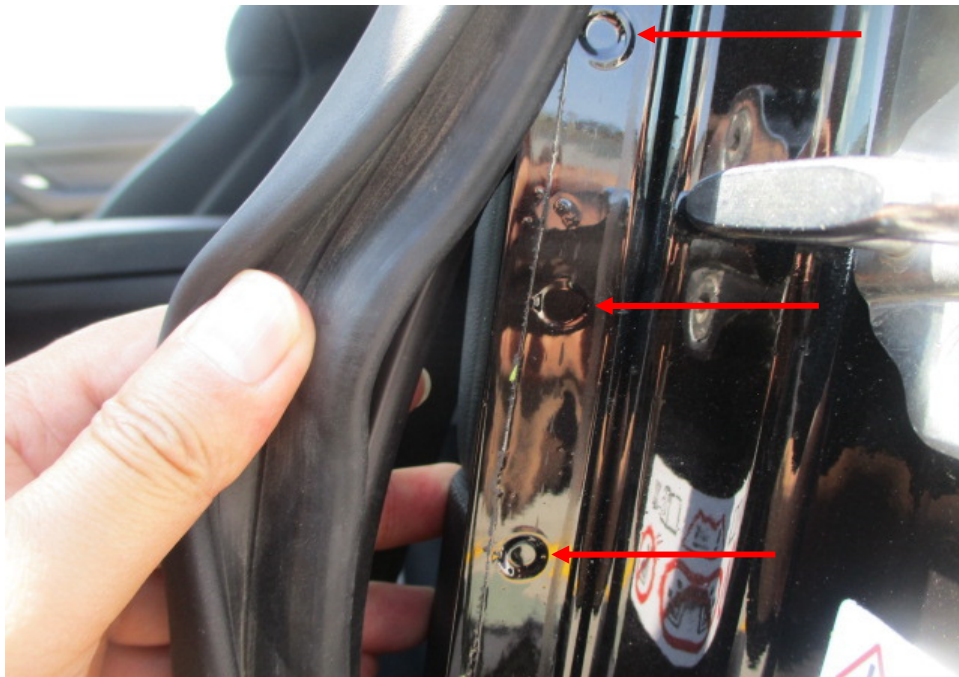
Photo 33 shows the left side rear body panel of the Motor Car. I did not find any weld marks other than original spot weld marks (arrowed) on the left side rear body panel of the Motor Car, which indicates that there was no re-welding works carried out. In general, I had found all the non-detachable body panels of the Motor Car to be originally fitted at the time of my inspection.

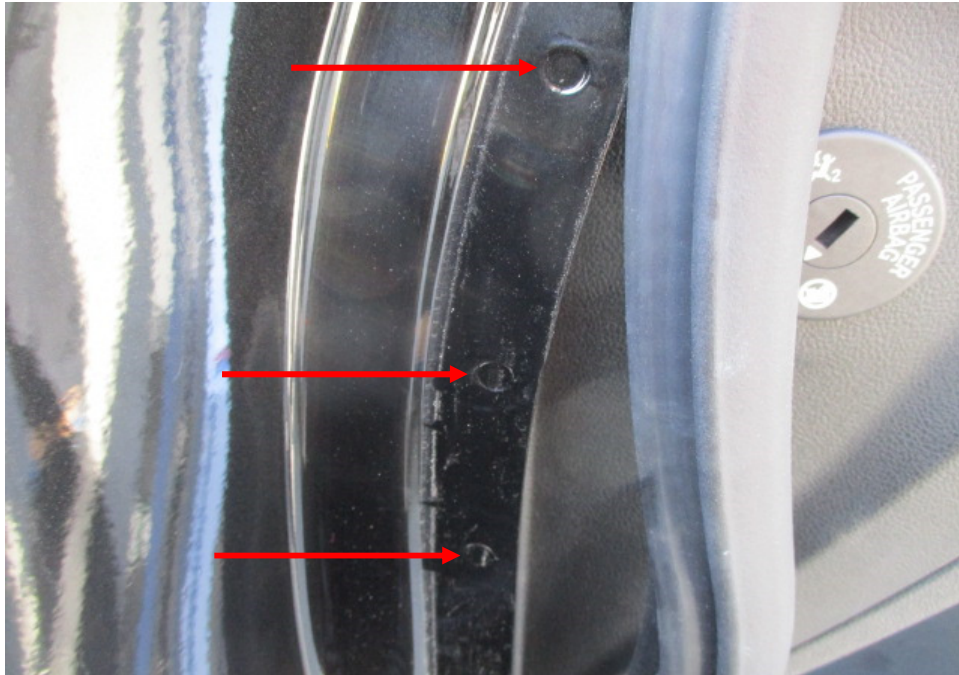
Photo 34 shows the left side “A” pillar of the Motor Car. I did not find any weld marks other than original spot weld marks (arrowed) on the left side “A” pillar of the Motor Car, which indicates that there was no re-welding works carried out. In general, I had found all the non-detachable body panels of the Motor Car to be originally fitted at the time of my inspection.

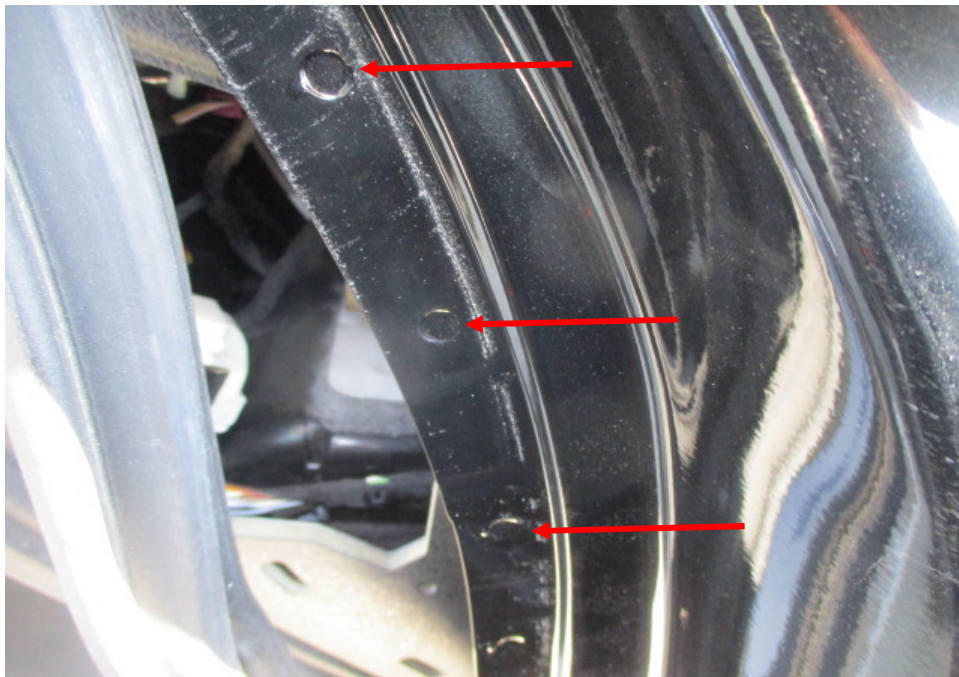
Photo 35 shows the right side “A” pillar of the Motor Car. I did not find any weld marks other than original spot weld marks (arrowed) on the right side “A” pillar of the Motor Car, which indicates that there was no re-welding works carried out. In general, I had found all the non-detachable body panels of the Motor Car to be originally fitted at the time of my inspection.

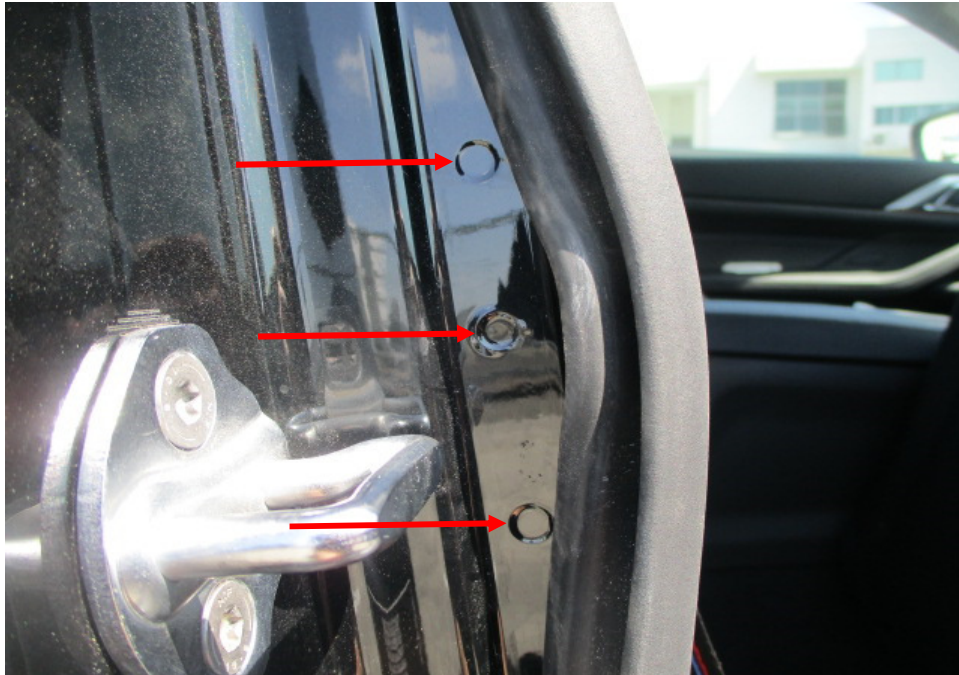
Photo 36 shows the right side rear body panel of the Motor Car. I did not find any weld marks other than original spot weld marks (arrowed) on the right side rear body panel of the Motor Car, which indicates that there was no re-welding works carried out. In general, I had found all the non-detachable body panels of the Motor Car to be originally fitted at the time of my inspection.
