Your Ref: Toyota Alphard  
(chassis number AYH300117935)  
Our Ref : CI/TP23005457/D

30 May 2023

**GC International Import Pte Ltd**

**INSPECTION REPORT OF AN UNREGISTERED TOYOTA ALPHARD MOTOR CAR WITH CHASSIS NUMBER AYH300117935**

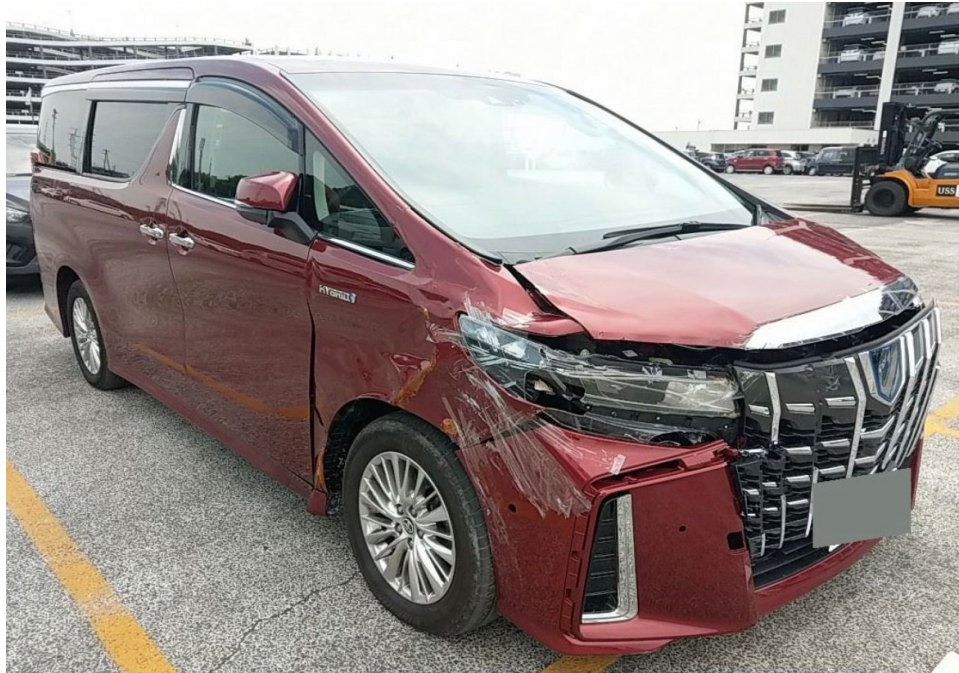
3. The photographs provided to me had showed damage to the front right portion of the Motor Car. Body parts damaged include the front bumper, front bumper right chrome moulding, front bumper right sensors, front right fog lamp, front right headlamp, front right headlamp chrome moulding, front right fender, front grille, front bonnet and front bonnet right hinge amongst others.
4. No physical damage was observed to other areas of the Motor Car. The airbag(s) of the Motor Car was not deployed as seen from the photographs that were provided to me. See photo 1 – 4 below.

**Photo 1** shows the front right body of the Motor Car (photograph provided to me). The Motor Car was observed to have sustained damage at its front right portion. The front bumper, front bumper right chrome moulding, front bumper right sensors, front right fog lamp, front right headlamp, front right headlamp chrome moulding, front right fender, front grille, front bonnet and front bonnet right hinge were amongst the body parts that were observed to have been damaged.

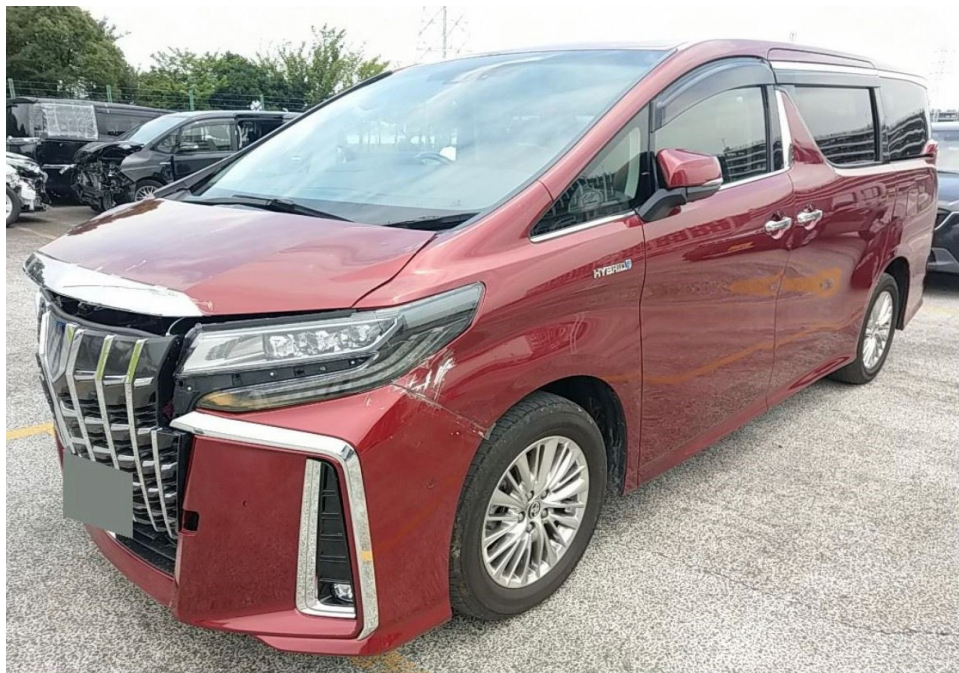
**Photo 2** shows the front left body of the Motor Car (photograph provided to me). Apart for the front right portion, there was no physical damage observed to other areas of the Motor Car. The Motor Car's airbag(s) was not deployed.

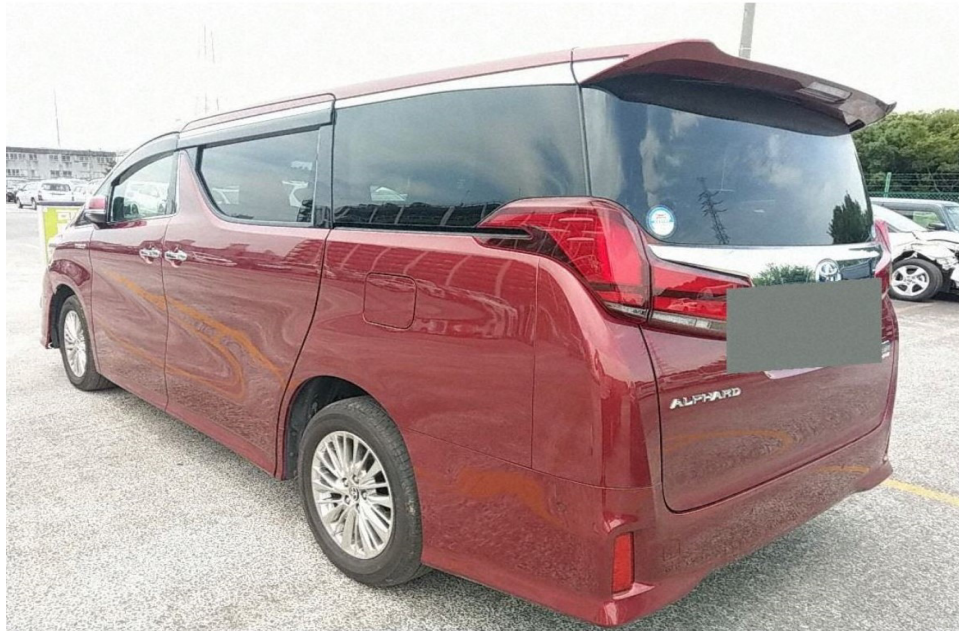
**Photo 3** shows the rear left body of the Motor Car (photograph provided to me). Apart for the front right portion, there was no physical damage observed to other areas of the Motor Car. The Motor Car's airbag(s) was not deployed.

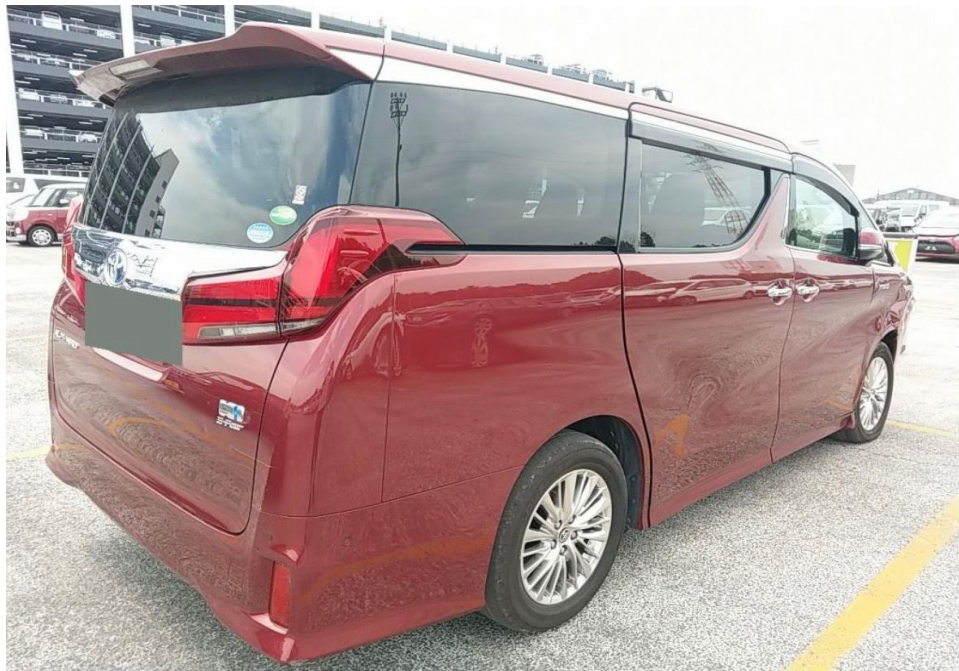
**Photo 4** shows the rear right body of the Motor Car (photograph provided to me). Apart for the front right portion, there was no physical damage observed to other areas of the Motor Car. The Motor Car's airbag(s) was not deployed.

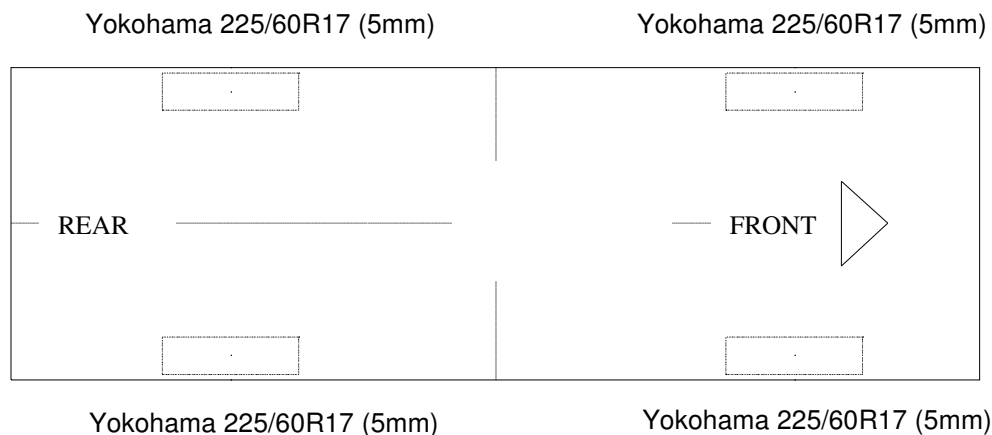
8. It was fitted with 17inch sport wheel rims that were wrapped with tyres that were observed to be of serviceable condition. The tyres were also sufficiently inflated for vehicular operation. The tyre brand, tyre size and approximate remaining tread depth of the 4 tyres of the Motor Car were recorded as follows: -

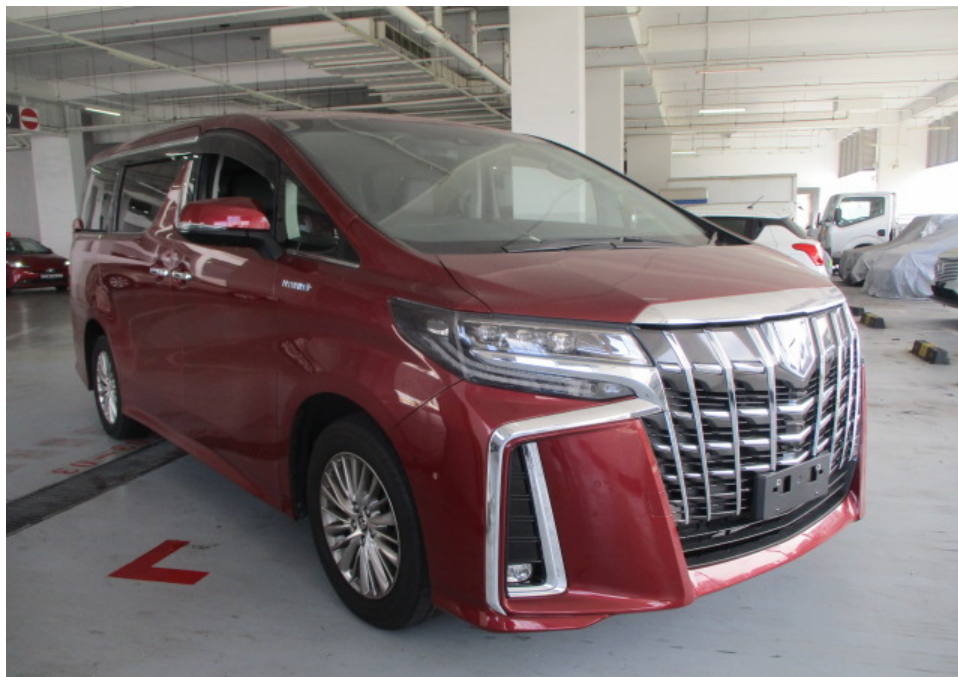
**Photo 5** shows a general view of the front right body of the Motor Car at the time of my inspection. The Motor Car was observed to be in a relatively good general condition with no loose exterior fittings observed. The body parts at the front right portion of the Motor Car were visually examined and it was observed that the repair/restoration works carried out to the damaged area of the Motor Car (refer to photograph 1 above) were reasonably adequate and in order.

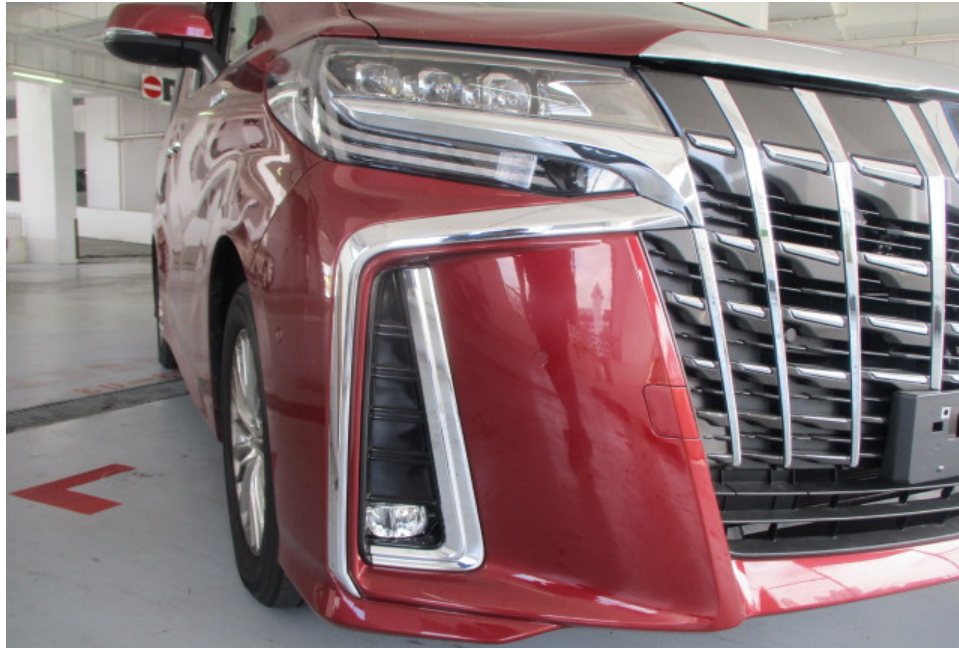
**Photo 6** shows a closer view of the Motor Car's front bumper, front bumper right chrome moulding, front grille, front right fog lamp, front right headlamp and front right headlamp chrome moulding. The body parts at the front right portion of the Motor Car were visually examined and it was observed that the repair/restoration works carried out to the damaged area of the Motor Car (refer to photograph 1 above) were reasonably adequate and in order.

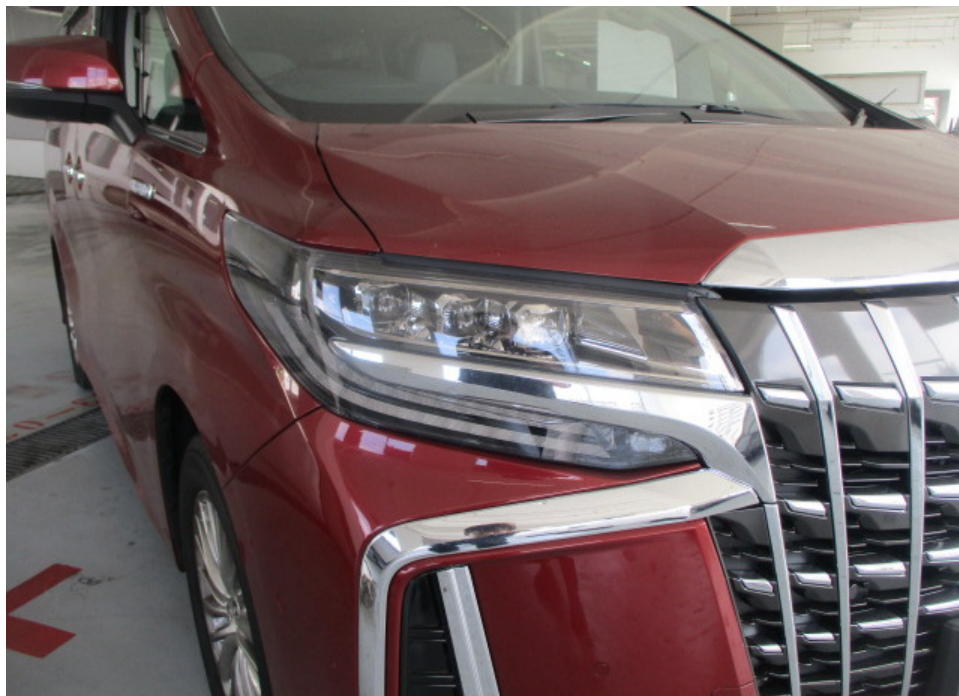
**Photo 7** shows a closer view of the Motor Car's front bonnet, front right headlamp and front right headlamp chrome moulding. The body parts at the front right portion of the Motor Car were visually examined and it was observed that the repair/restoration works carried out to the damaged area of the Motor Car (refer to photograph 1 above) were reasonably adequate and in order.

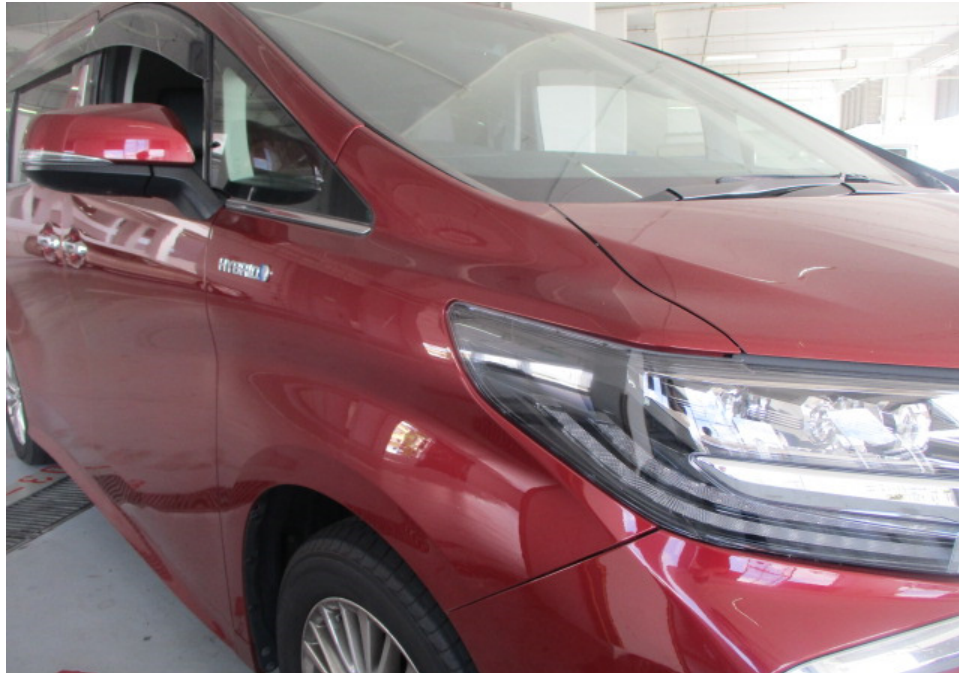
**Photo 8** shows a closer view of the Motor Car's front bonnet, front right headlamp and front right fender. The body parts at the front right portion of the Motor Car were visually examined and it was observed that the repair/restoration works carried out to the damaged area of the Motor Car (refer to photograph 1 above) were reasonably adequate and in order.

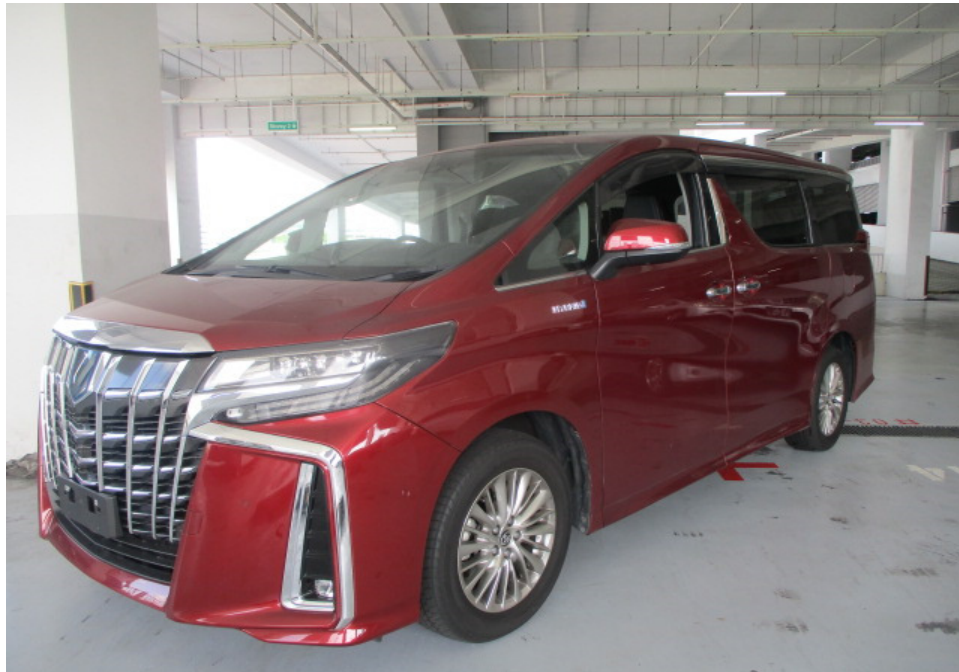
**Photo 9** shows a general view of the front left body of the Motor Car at the time of my inspection. The Motor Car was observed to be in a relatively good general condition with no loose exterior fittings observed. The mileage of the Motor Car recorded at the time of my inspection was 21,159km.

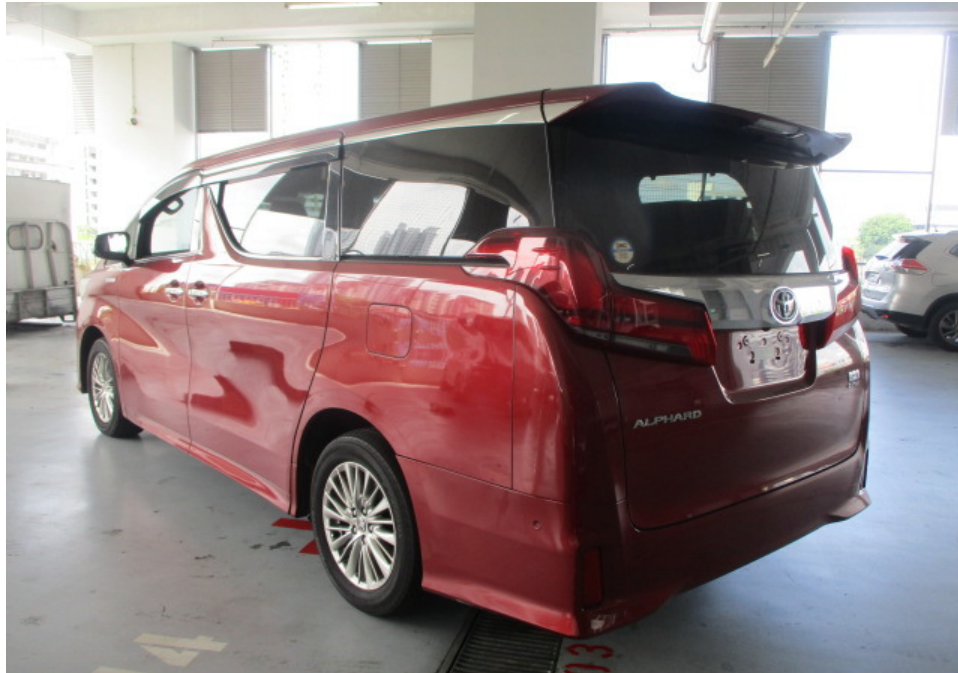
**Photo 10** shows a general view of the rear left body of the Motor Car at the time of my inspection. The Motor Car was observed to be in a relatively good general condition with no loose exterior fittings observed. The mileage of the Motor Car recorded at the time of my inspection was 21,159km.

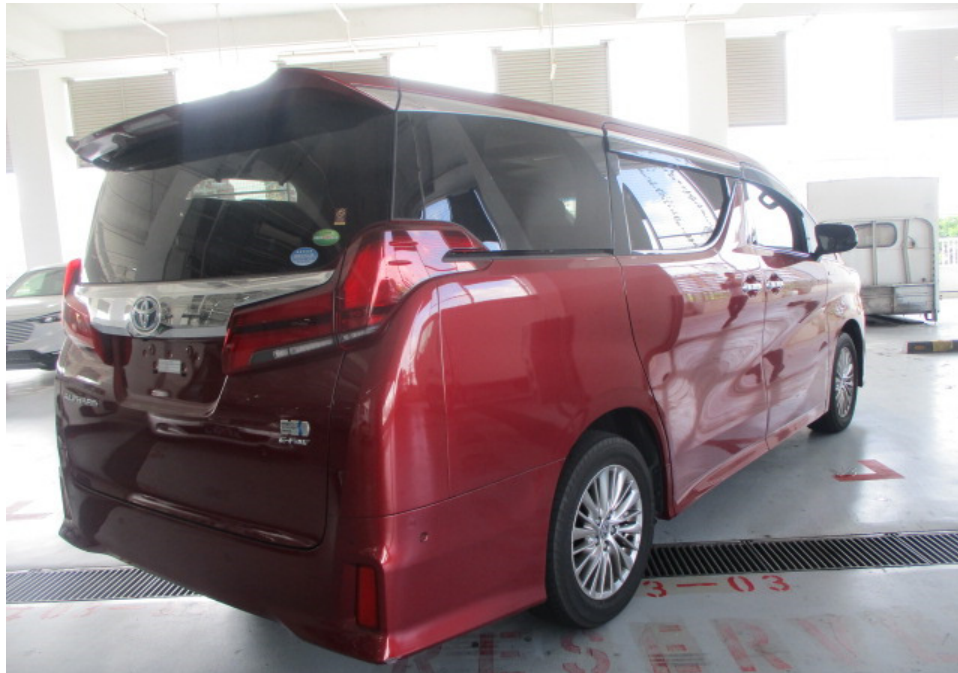
**Photo 11** shows a general view of the rear right body of the Motor Car at the time of my inspection. The Motor Car was observed to be in a relatively good general condition with no loose exterior fittings observed. The mileage of the Motor Car recorded at the time of my inspection was 21,159km.

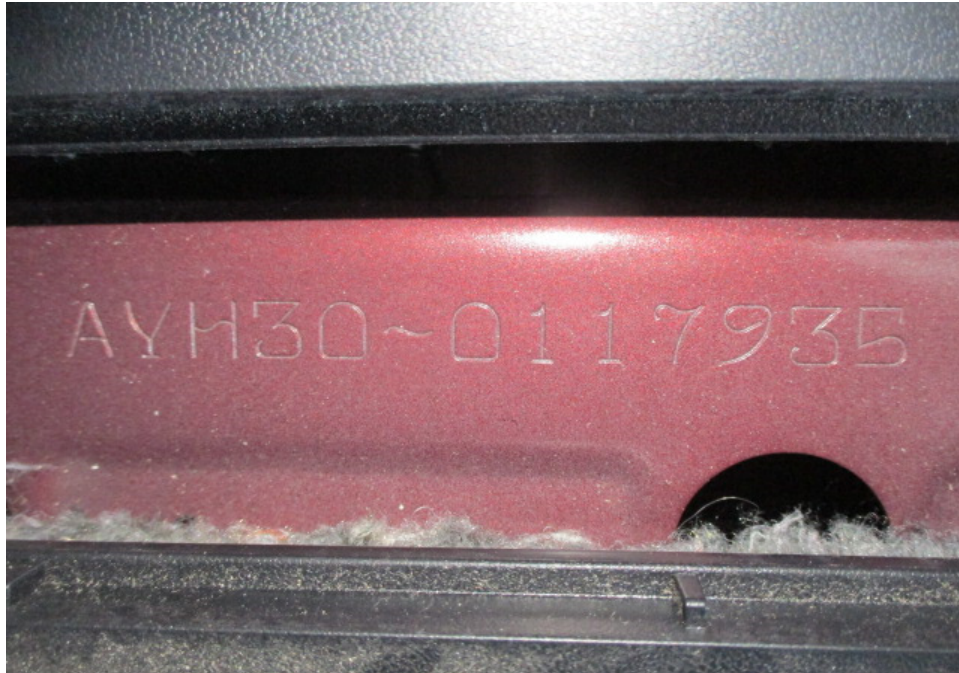
**Photo 12** shows the chassis number of the Motor Car. The chassis number recorded was AYH300117935.

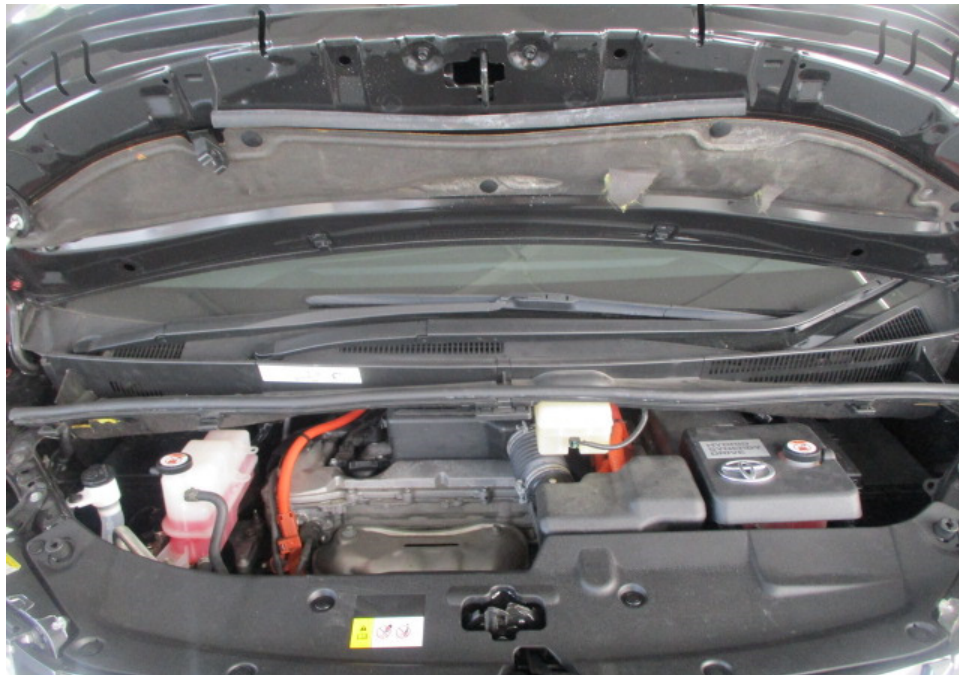
**Photo 13** shows a general view of the engine compartment of the Motor Car at the time of my inspection. The various parts and components inside the engine compartment were all observed to be intact and properly fitted. There was also no sign(s) or indication(s) of fluid leak and/or fluid stain found inside the engine compartment.

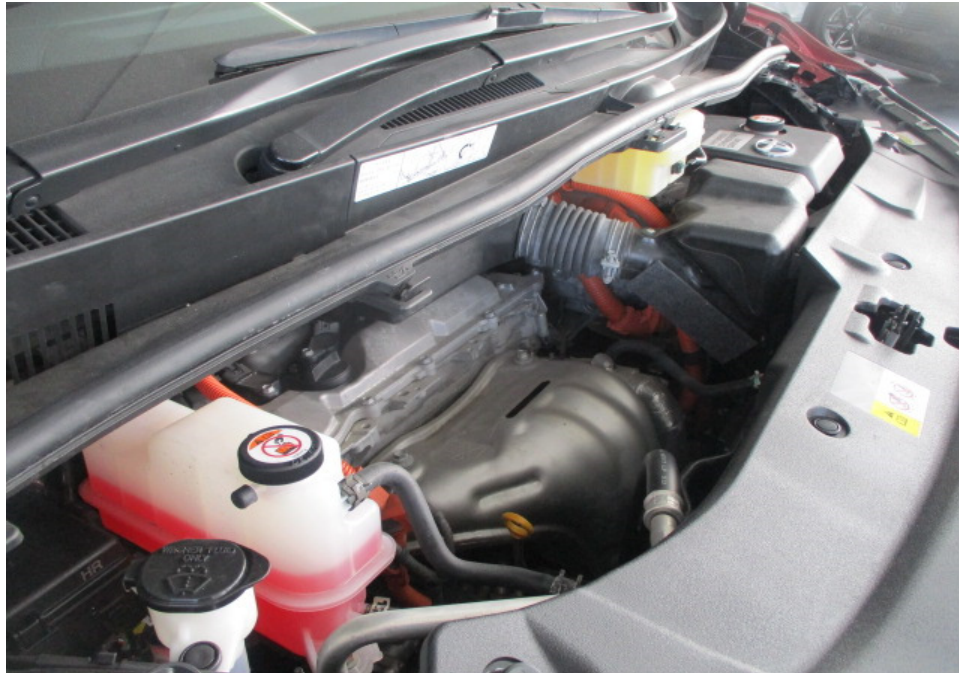
**Photo 14** shows another view of the engine compartment of the Motor Car at the time of my inspection. The various parts and components inside the engine compartment were all observed to be intact and properly fitted. There was also no sign(s) or indication(s) of fluid leak and/or fluid stain found inside the engine compartment.

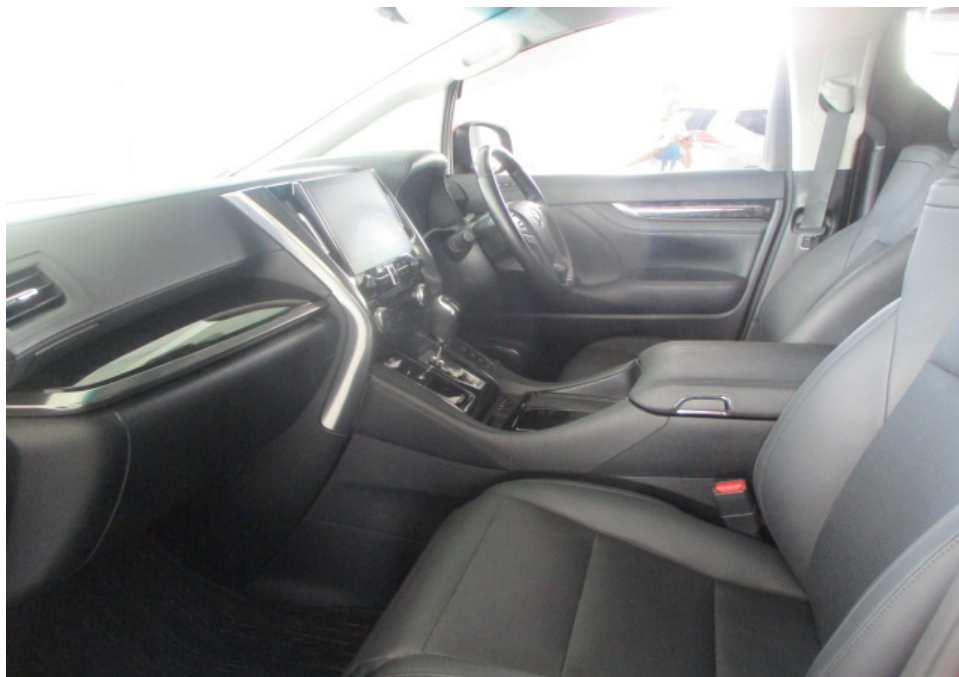
**Photo 15** shows the interior compartment of the Motor Car at the time of my inspection. The various parts and components, trims, carpet and upholstery inside the interior compartment were all observed to be intact and properly fitted.

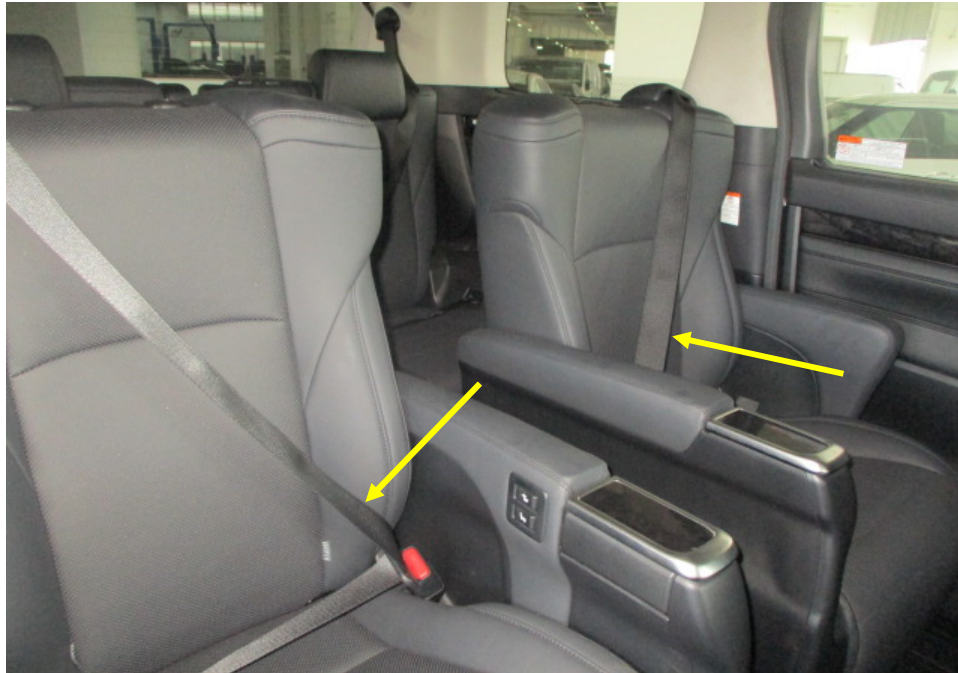
**Photo 16** shows the rear seats at the 1<sup>st</sup> row of the Motor Car. All the seats of the Motor Car were secured via seat rails to the floorboard. They were also fitted with a retractable seat belt reel and a pre-tensioner. The seat belts (arrowed) were tested and were able to be fastened into the respective pre-tensions that were fitted on the side of each individual seat.

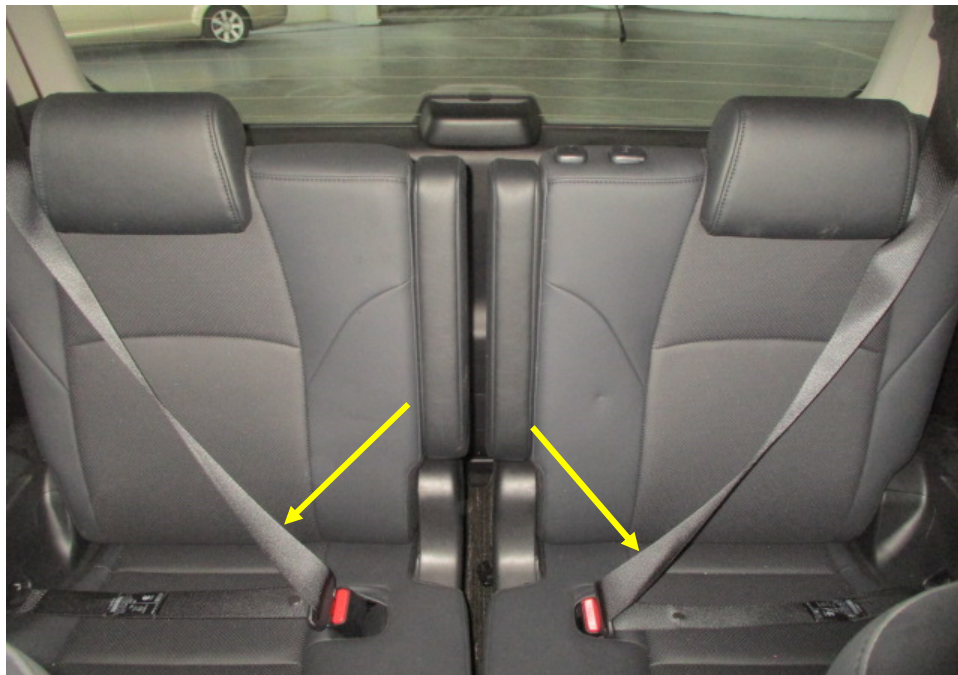
**Photo 17** shows the rear seats at the 2<sup>nd</sup> row of the Motor Car. All the seats of the Motor Car were secured via seat rails to the floorboard. They were also fitted with a retractable seat belt reel and a pre-tensioner. The seat belts (arrowed) were tested and were able to be fastened into the respective pre-tensions that were fitted on the side of each individual seat.

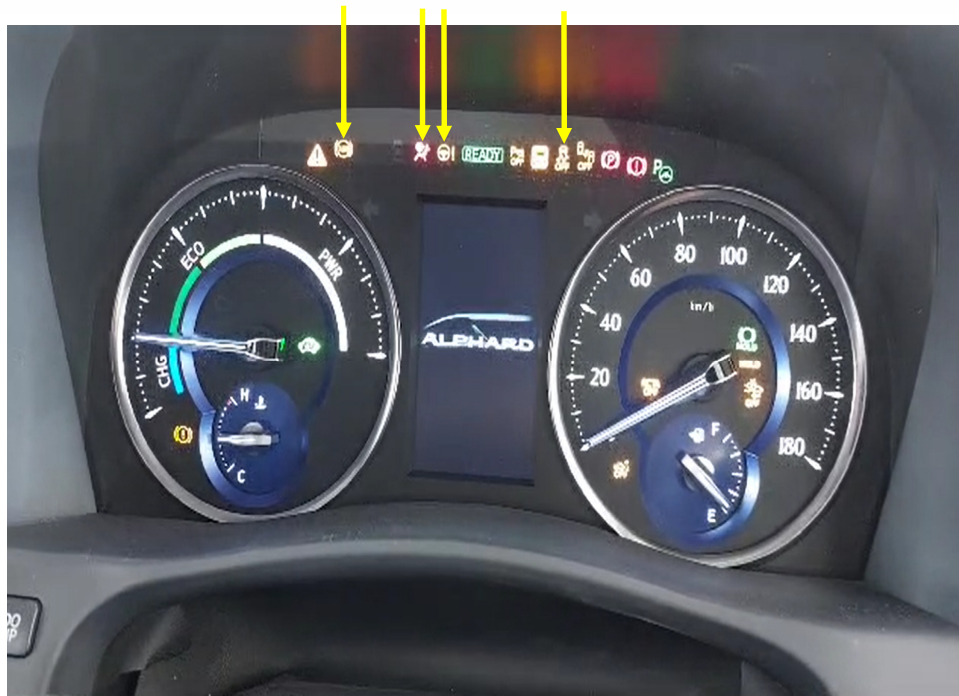
**Photo 18** shows the warning lights for the various electronic safety features appearing on the instrument panel of the Motor Car during its self-test when the engine is cranked, in particular the lights for the ABS, SRS, EPS, VSC (arrowed) and the various collision prevention systems.

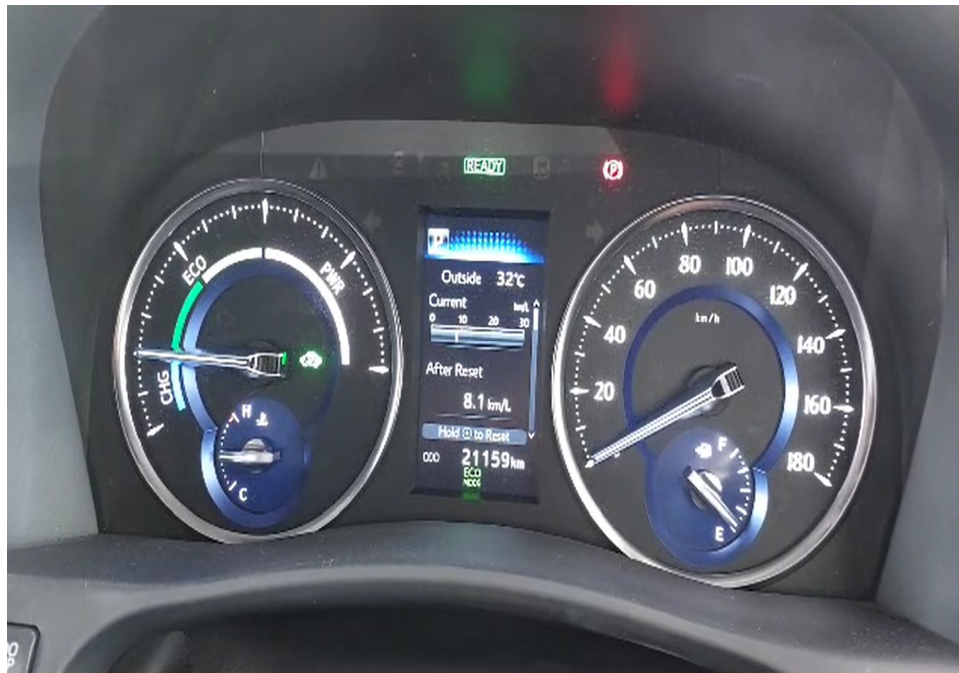
**Photo 19** shows the respective warning lights no longer illuminated, indicating that there is no fault detected to the ABS, SRS, EPS, VSC and the various collision prevention systems of the Motor Car during the self-test. These electronic systems were hence in working condition at the time of my inspection.

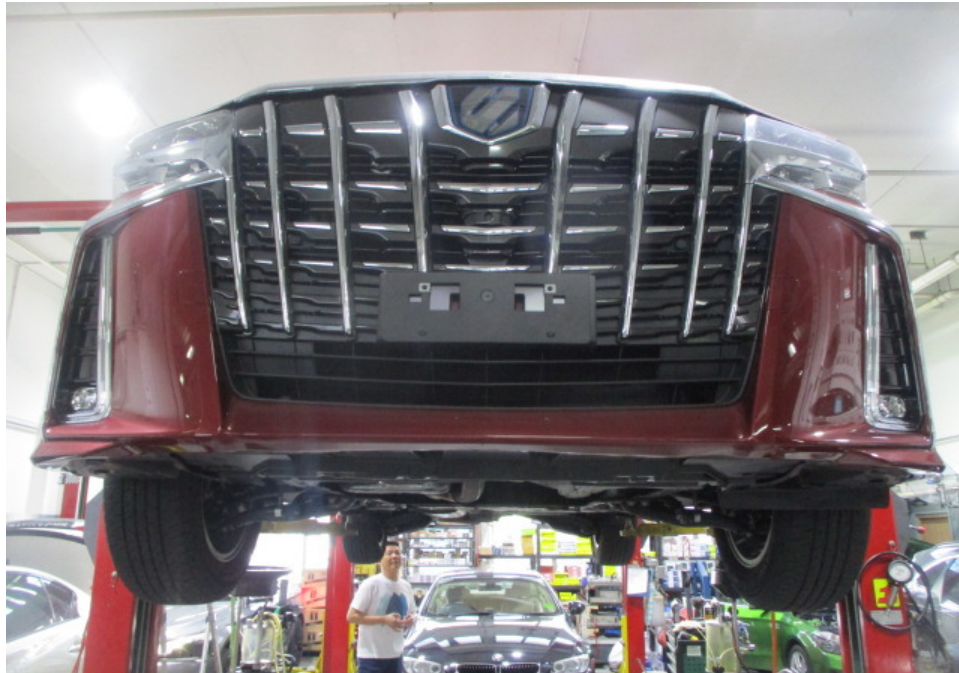
**Photo 20** shows the Motor Car hoisted up for checks on its undercarriage. There was no sign(s) or indication(s) of fluid leakage and/or fluid stain(s) on the underside of the Motor Car. The undercarriage components of the Motor Car were also all observed to be intact and secured in an appropriate manner.

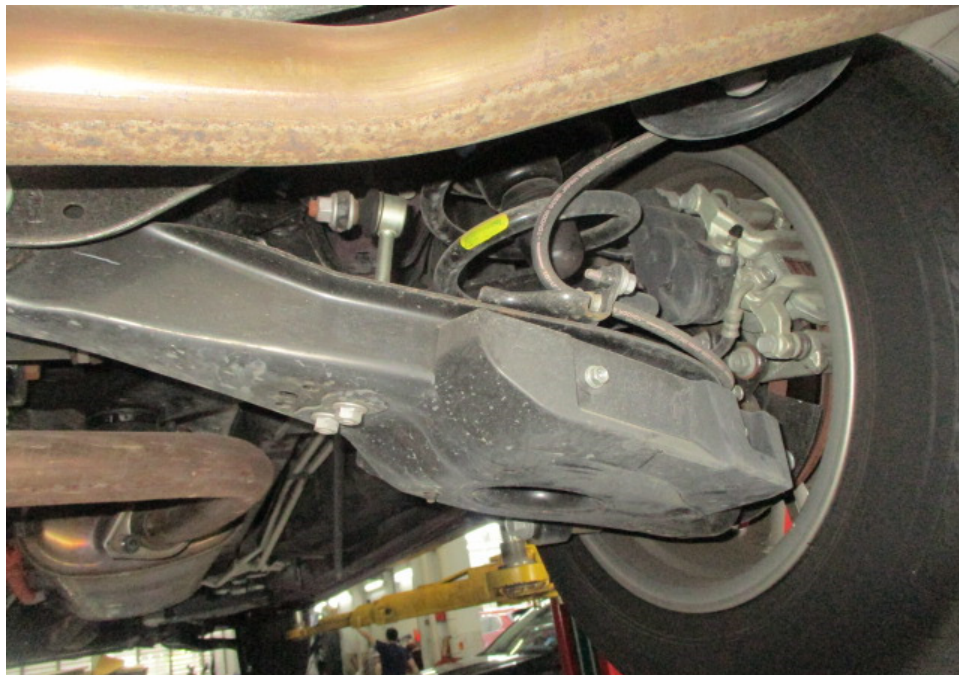
**Photo 21** shows a general view of the control arms and linkages at the rear right wheel of the Motor Car. I did not observe any fluid leak and/or fluid stain on the underside of the Motor Car. All of the Motor Car's undercarriage components were observed to be intact and secured in an appropriate manner.

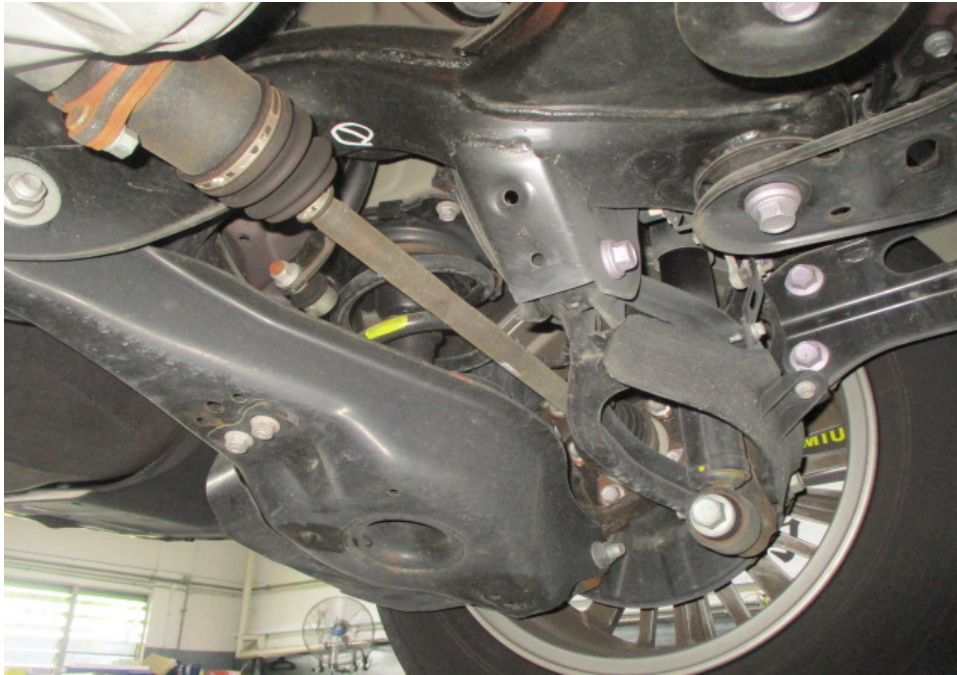
**Photo 22** shows a general view of the control arms and linkages at the rear left wheel of the Motor Car. I did not observe any fluid leak and/or fluid stain on the underside of the Motor Car. All of the Motor Car's undercarriage components were observed to be intact and secured in an appropriate manner.

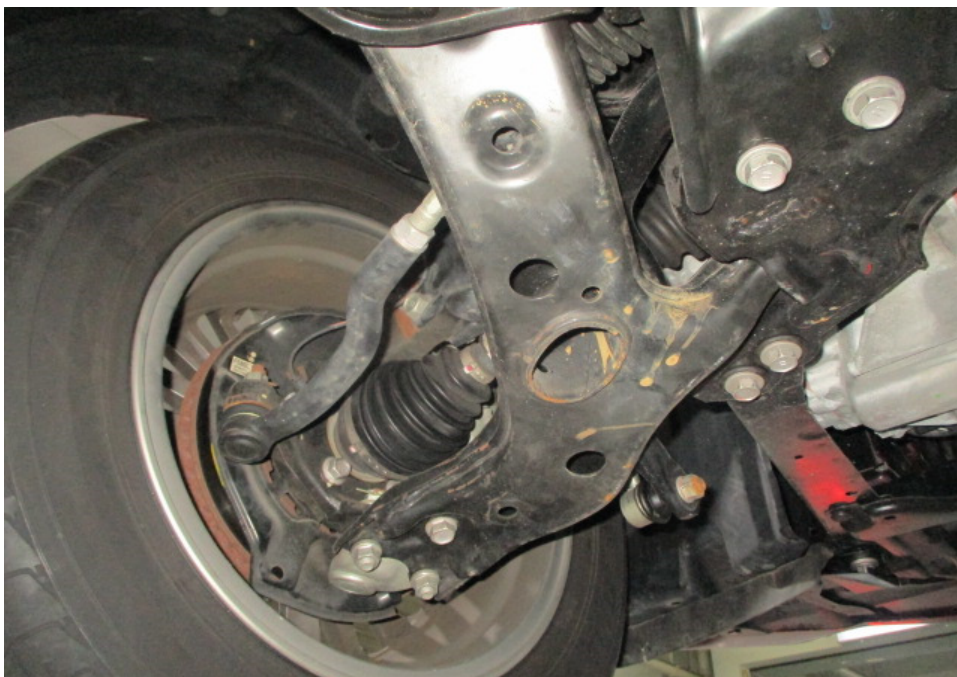
**Photo 23** shows the various undercarriage components at the front left wheel of the Motor Car. The mechanical components, control arms and linkages were all found to be intact and secured in an appropriate manner.

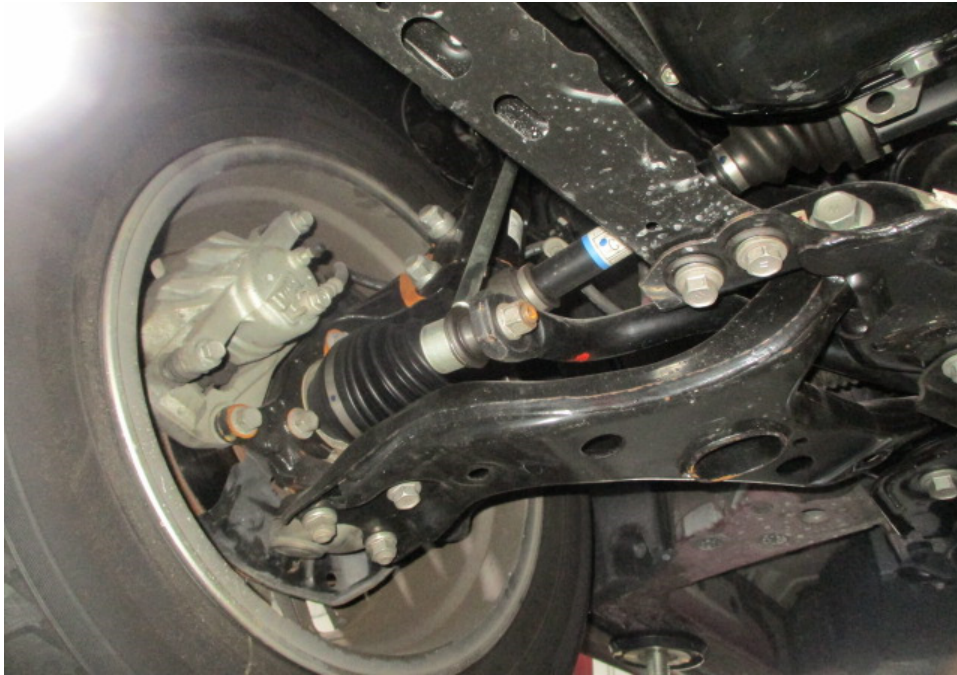
**Photo 24** shows the various undercarriage components at the front right wheel of the Motor Car. The mechanical components, control arms and linkages were all found to be intact and secured in an appropriate manner. I also did not observe any fluid leak and/or fluid stain on the underside of the Motor Car.

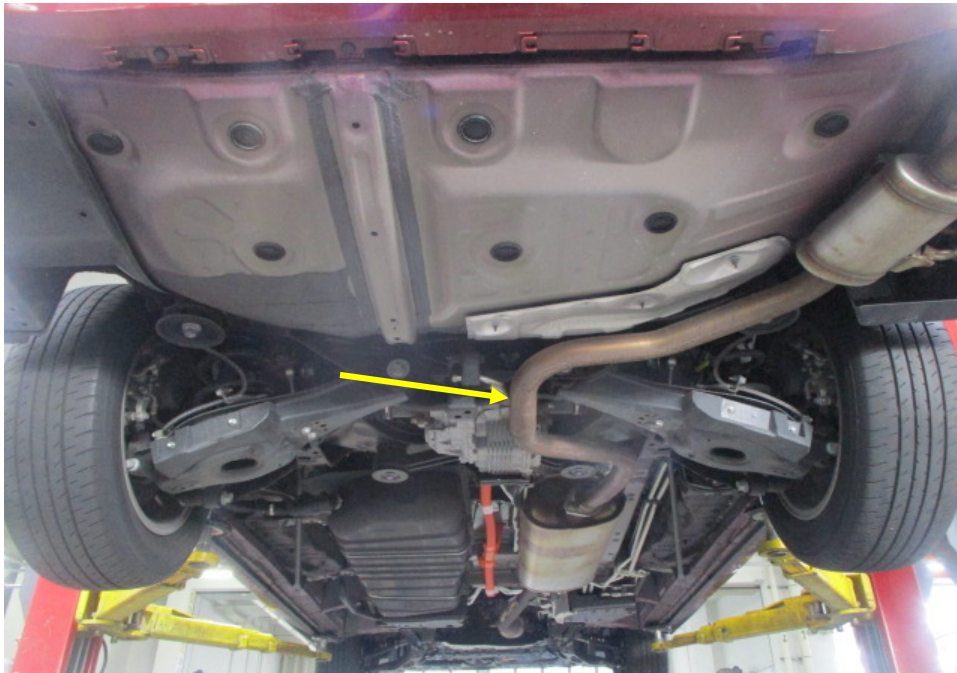
**Photo 25** shows a general view of the rear section of the Motor Car's exhaust system. My examination of the Motor Car's exhaust system revealed no sign(s) or indication(s) of any cut or weld marks along its exhaust pipe (arrowed), on its catalytic converter, on its centre resonator box and on its rear muffler.

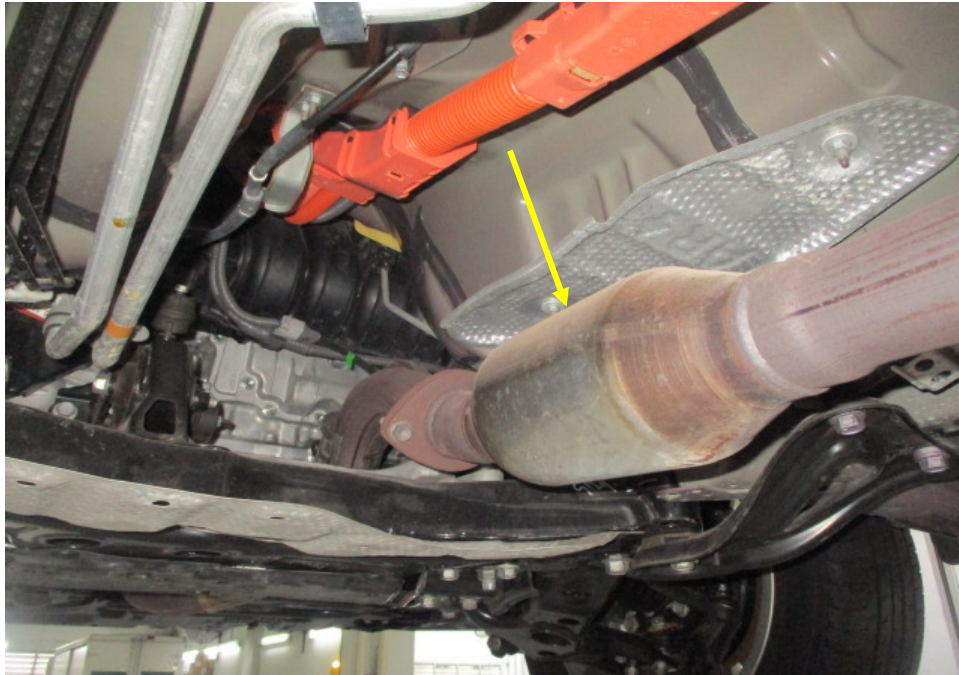
**Photo 26** shows a general view of the front section of the Motor Car's exhaust system. My examination of the Motor Car's exhaust system revealed no sign(s) or indication(s) of any cut or weld marks along its exhaust pipe, on its catalytic converter (arrowed), on its centre resonator box and on its rear muffler.

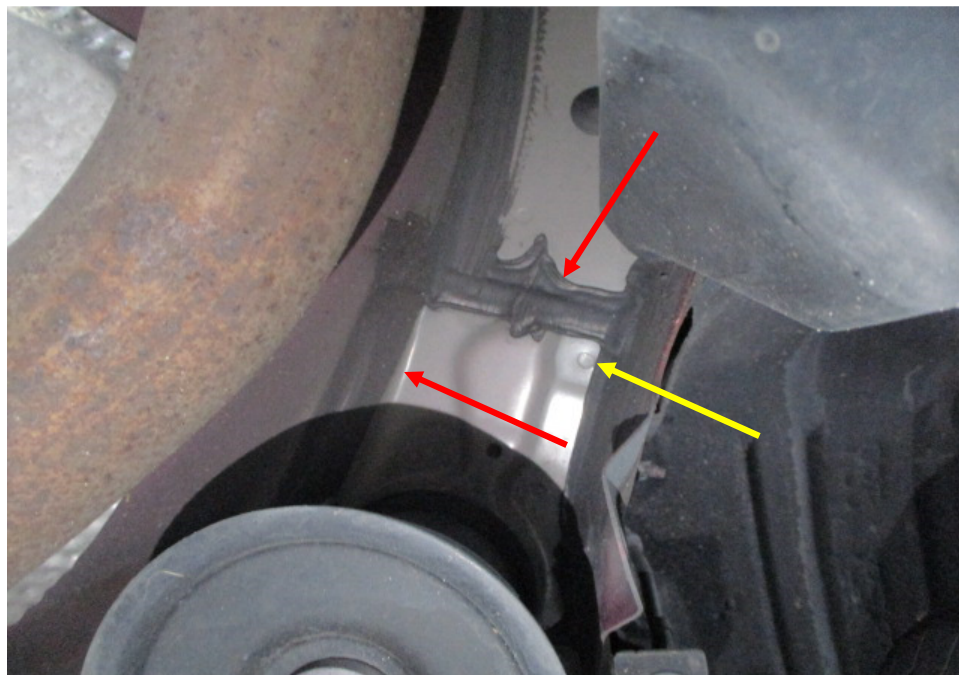
**Photo 27** shows the chassis/structural body at the underside rear right of the Motor Car. I did not find any weld marks other than original spot weld marks (yellow arrow) on the chassis/structural body of the Motor Car. The original factory sealant (red arrow) at the joints along the chassis/structural body was untouched, indicating no work was done on the chassis/structural body of the Motor Car and that the chassis/structural body was originally fitted.

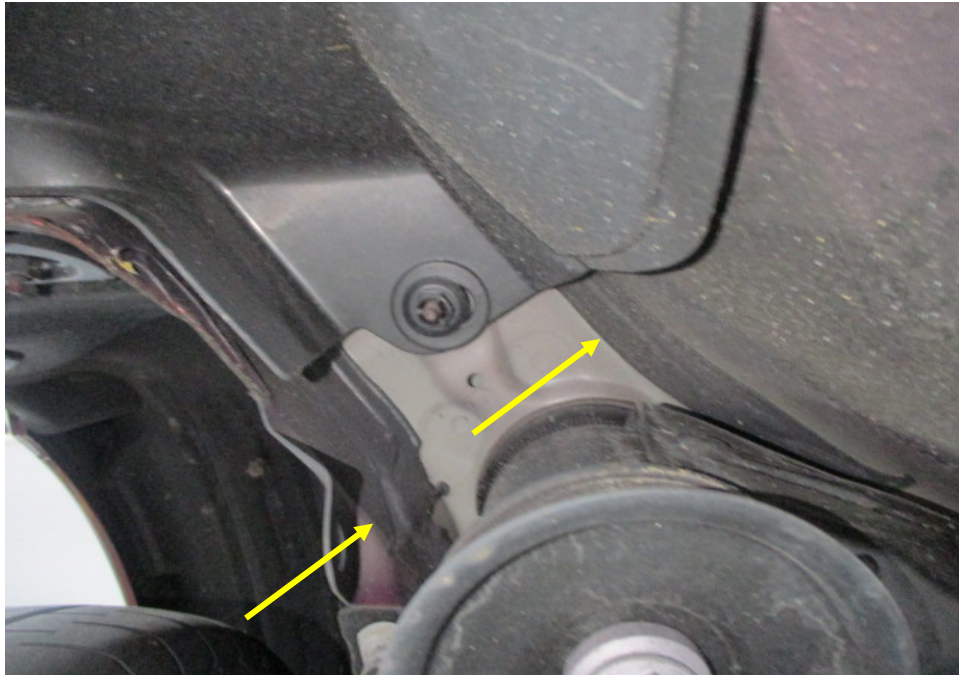
**Photo 28** shows the chassis/structural body at the underside rear left of the Motor Car. The original factory sealant (arrowed) at the joints along the chassis/structural body was observed to be untouched. In general, I had found no work was carried out on the chassis/structural body of the Motor Car. The chassis/structural body of the Motor Car was originally fitted

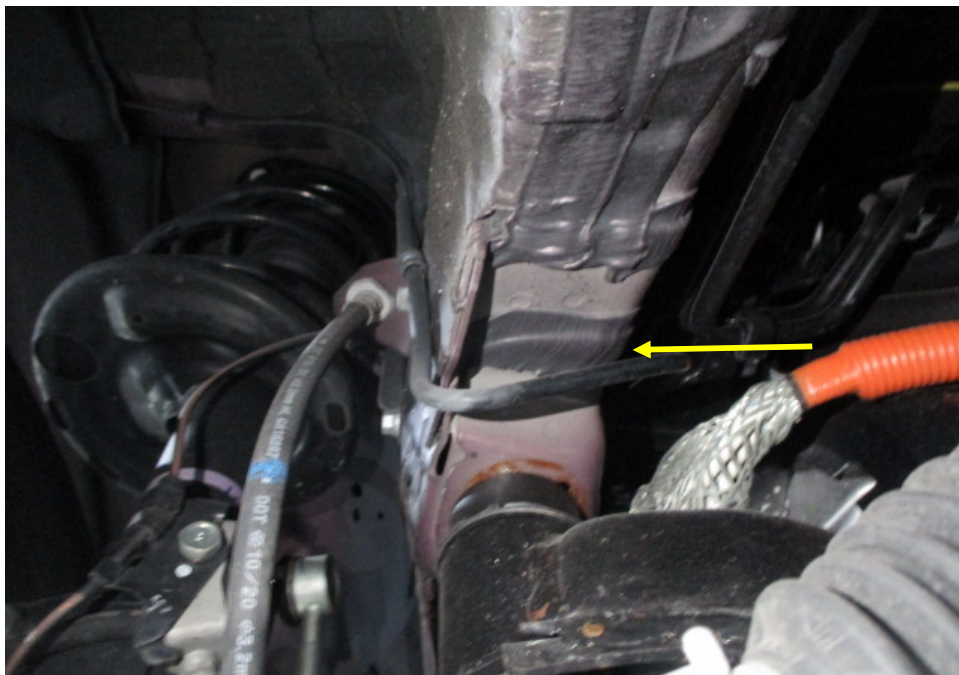
**Photo 29** shows the chassis/structural body at the underside front left of the Motor Car. The original factory sealant (arrowed) at the joints along the chassis/structural body was observed to be untouched. In general, I had found no work was carried out on the chassis/structural body of the Motor Car. The chassis/structural body of the Motor Car was originally fitted.

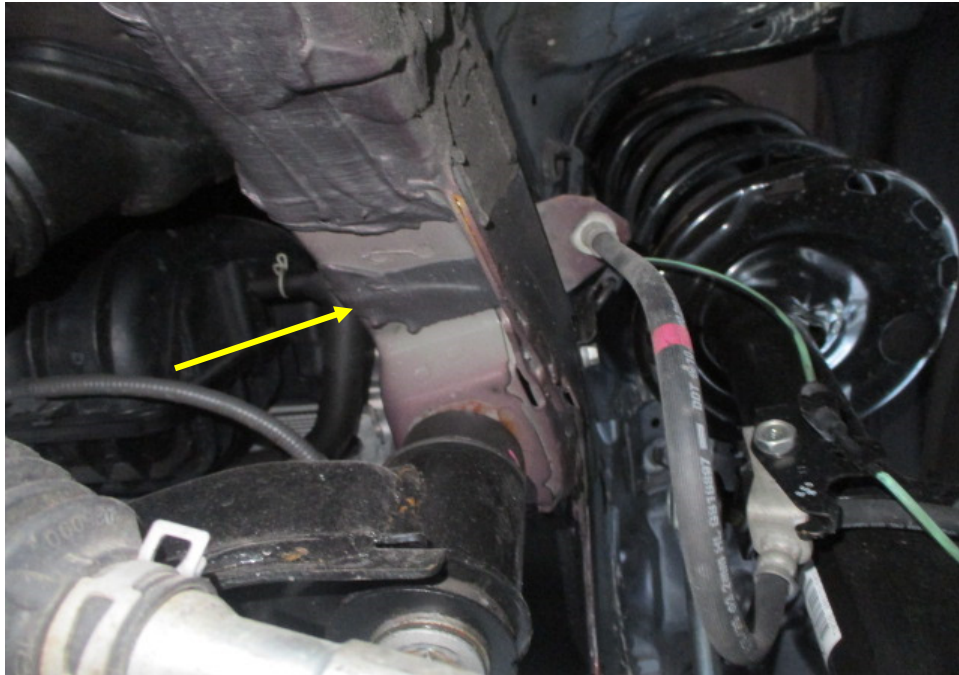
**Photo 30** shows the chassis/structural body at the underside front right of the Motor Car. The original factory sealant (arrowed) at the joints along the chassis/structural body was observed to be untouched. In general, I had found no work was carried out on the chassis/structural body of the Motor Car. The chassis/structural body of the Motor Car was originally fitted.
