Your Ref: Toyota Alphard  
(chassis number AYH300117935)  
Our Ref : CI/TP23005457/D

30 May 2023

**GC International Import Pte Ltd**

**INSPECTION REPORT OF AN UNREGISTERED TOYOTA ALPHARD MOTOR CAR WITH CHASSIS NUMBER AYH300117935**

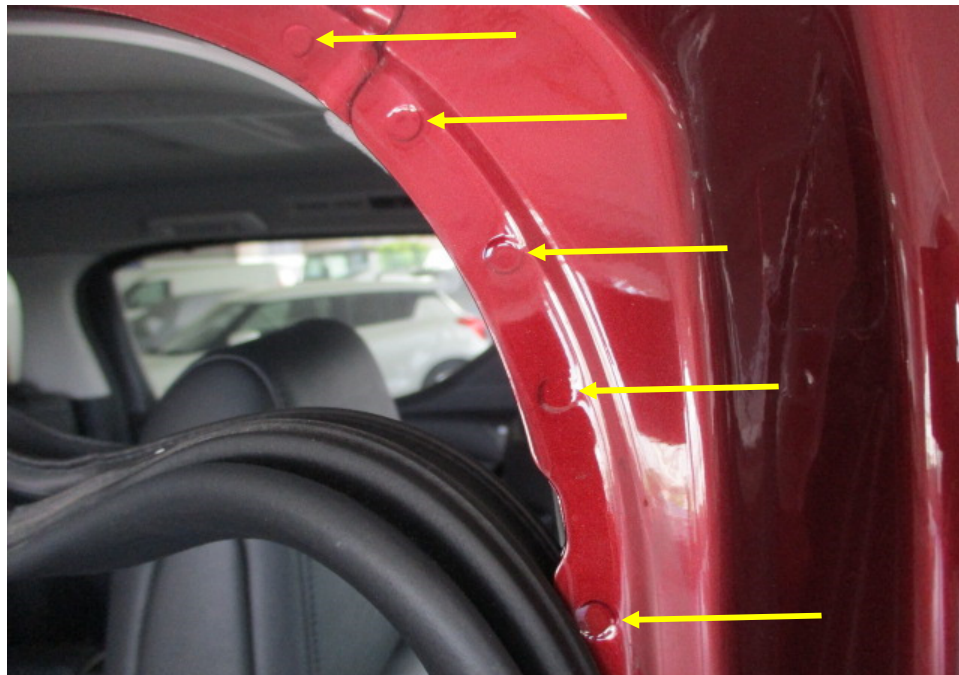
**Photo 31** shows the right side "B" pillar of the Motor Car. I did not find any weld marks other than original spot weld marks (arrowed) on the right side "B" pillar of the Motor Car, which indicates that there was no re-welding works carried out. In general, I had found all the non-detachable body panels of the Motor Car to be originally fitted at the time of my inspection.

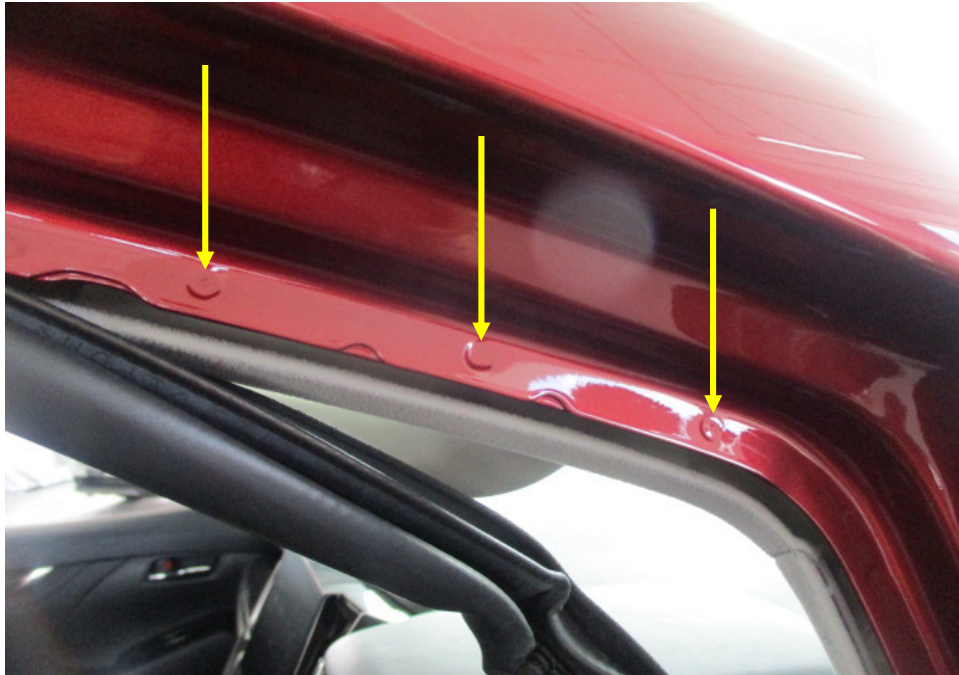
**Photo 32** shows the right side "A" pillar of the Motor Car. I did not find any weld marks other than original spot weld marks (arrowed) on the right side "A" pillar of the Motor Car, which indicates that there was no re-welding works carried out. In general, I had found all the non-detachable body panels of the Motor Car to be originally fitted at the time of my inspection.

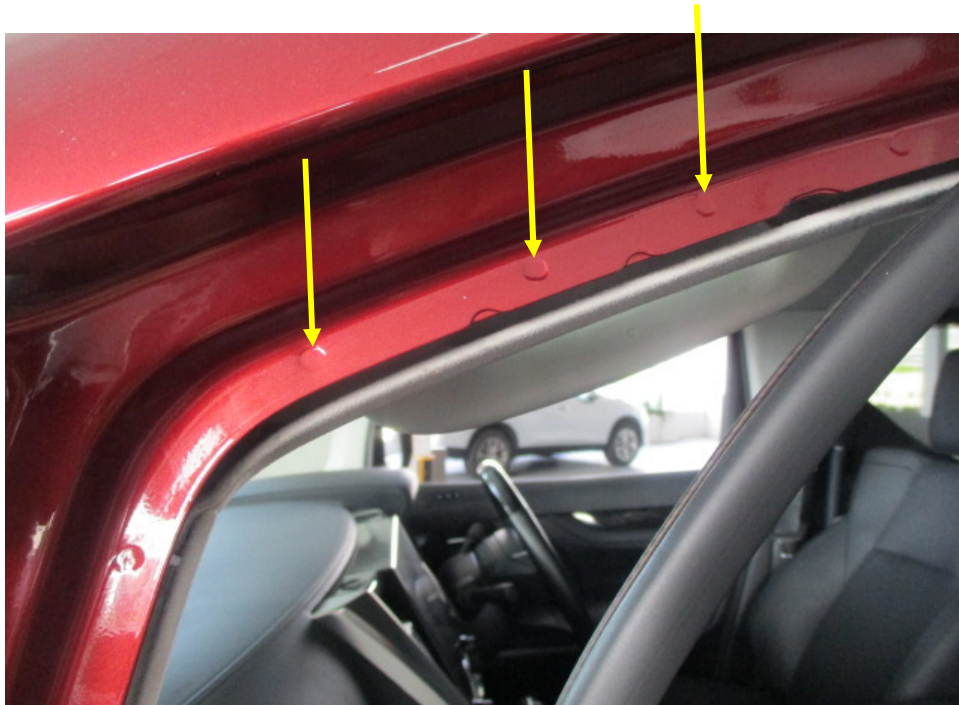
**Photo 33** shows the left side "A" pillar of the Motor Car. I did not find any weld marks other than original spot weld marks (arrowed) on the left side "A" pillar of the Motor Car, which indicates that there was no re-welding works carried out. In general, I had found all the non-detachable body panels of the Motor Car to be originally fitted at the time of my inspection.

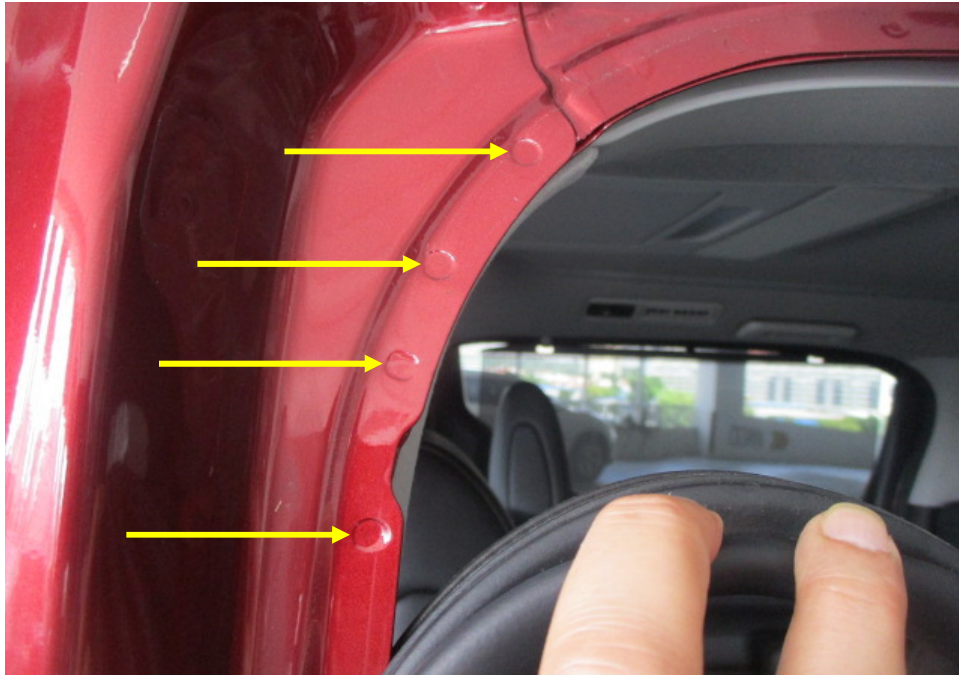
**Photo 34** shows the left side "B" pillar of the Motor Car. I did not find any weld marks other than original spot weld marks (arrowed) on the left side "B" pillar of the Motor Car, which indicates that there was no re-welding works carried out. In general, I had found all the non-detachable body panels of the Motor Car to be originally fitted at the time of my inspection.
