Your Ref: BMW M2 Coupe
(chassis number WBS2U720X07F26710)
Our Ref : CI/TP23005515/D

27 May 2023

INSPECTION REPORT OF AN UNREGISTERED BMW M2 COUPE MOTOR CAR WITH CHASSIS NUMBER WBS2U720X07F26710

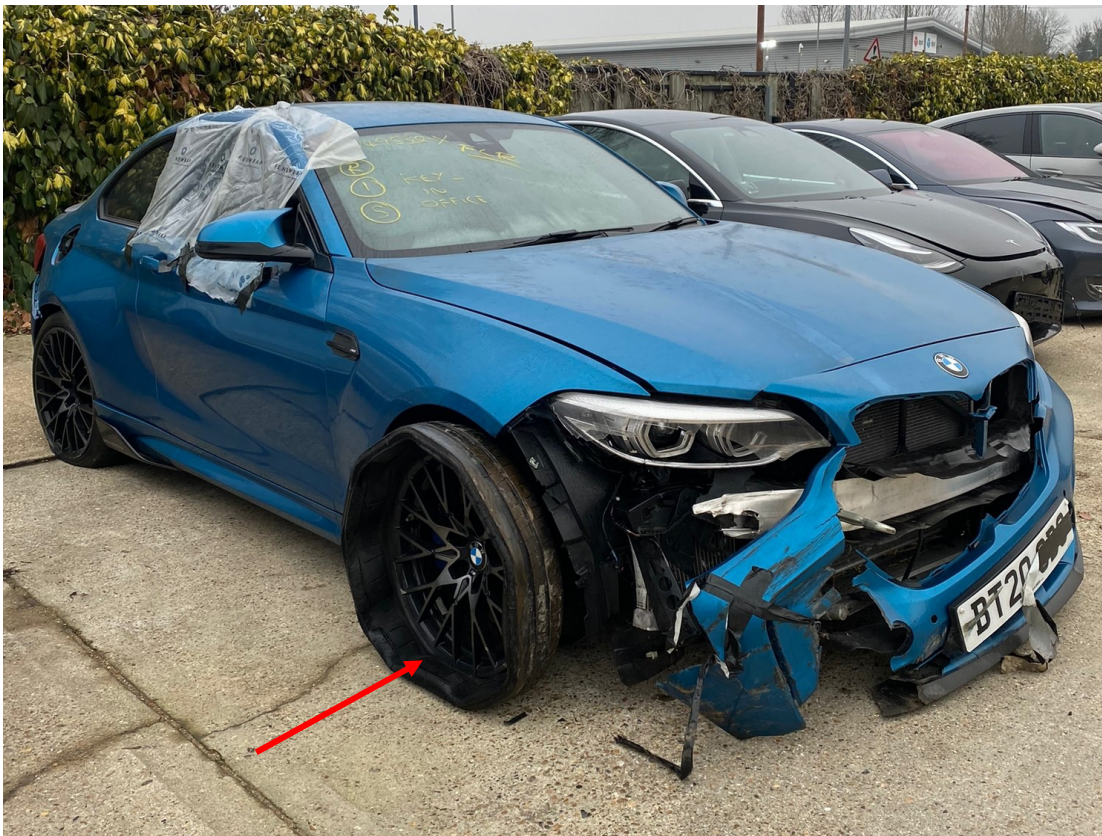
3. The photographs provided to me had showed damage to the front right portion and right rear portion of the Motor Car. Body parts damaged at the front right portion include the front bumper, front bumper lower lip, front bumper centre lower grille, front bumper right lower grille, front bumper sensors, front bumper tow cover, front bumper sponge, front bumper reinforcement, front bumper under cover, front grilles, front radiator air guide, front right headlamp, front right headlamp lower bracket, front right oil cooler, front right fender, front right fender inner shield and front right tyre amongst others.
4. As for the right rear portion of the Motor Car, I had observed damaged to the rear right fender and rear bumper amongst others. The fuel filler cover was also observed to be missing/dislodged/damaged.

5. The orientation of the Motor Car's front wheels (orientated in different directions) and rear right wheel (shifted forward) suggest damage to the undercarriage parts at the front right wheel and rear right wheel of the Motor Car. Undercarriage parts that may possibly be damaged include the front right lower arm, front right knuckle arm, front right steering tie rod end, front right shock absorber, rear right lower arm, rear right knuckle arm, rear right upper arm and rear right shock absorber amongst others.
6. There was no physical damage observed to other areas of the Motor Car. The airbag(s) of the Motor Car was not deployed as seen from the photographs that were provided to me. See photo 1 – 4 below.

Photo 1 shows the front right body of the Motor Car (photograph provided to me). The Motor Car was observed to have sustained damage at its front right portion. The front bumper, front bumper lower lip, front bumper centre lower grille, front bumper right lower grille, front bumper sensors, front bumper tow cover, front bumper sponge, front bumper reinforcement, front bumper under cover, front grilles, front radiator air guide, front right headlamp, front right headlamp lower bracket, front right oil cooler, front right fender, front right fender inner shield and front right tyre were amongst the body parts that were observed to have been damaged. The Motor Car's front right wheel (arrowed) and front left wheel (refer to photograph 4 below) were orientated in different directions. This would suggest damage to the undercarriage parts at the front right wheel of the Motor Car. Undercarriage parts that may possibly be damaged include the front right lower arm, front right knuckle arm, front right steering tie rod end and front right shock absorber amongst others.

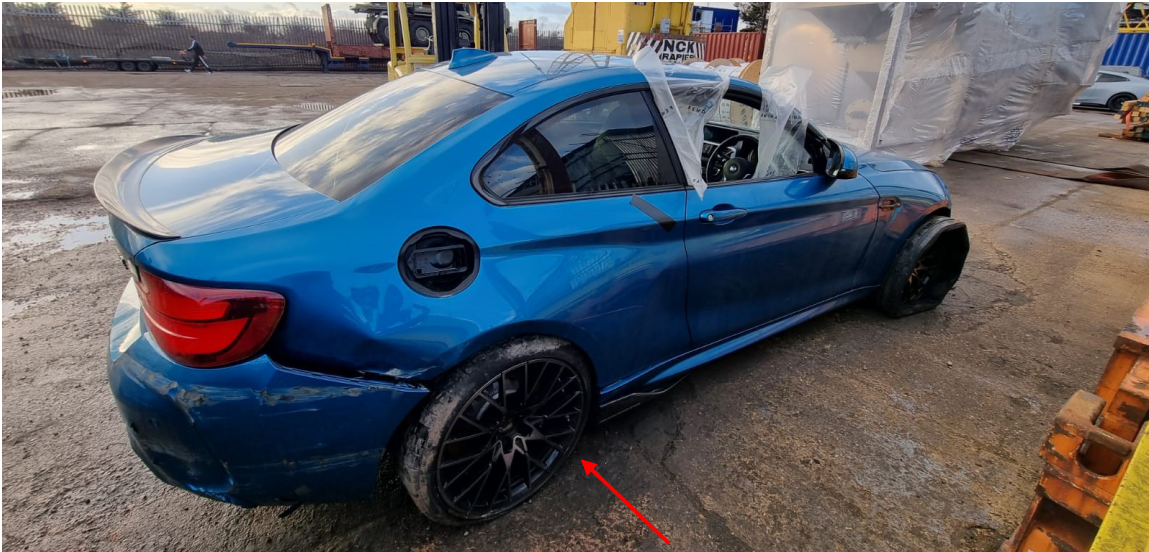
Photo 2 shows the rear right body of the Motor Car (photograph provided to me). The Motor Car's right rear portion was also observed to be damaged. The rear right fender and rear bumper were amongst the body parts that were damaged. The fuel filler cover was also observed to be missing/dislodged/damaged. The Motor Car's rear right wheel (arrowed) was also observed to be shifted inwards, suggesting damage to the undercarriage parts at the rear right wheel of the Motor Car. Undercarriage parts that may possibly be damaged include the rear right lower arm, rear right knuckle arm, rear right upper arm and rear right shock absorber amongst others.

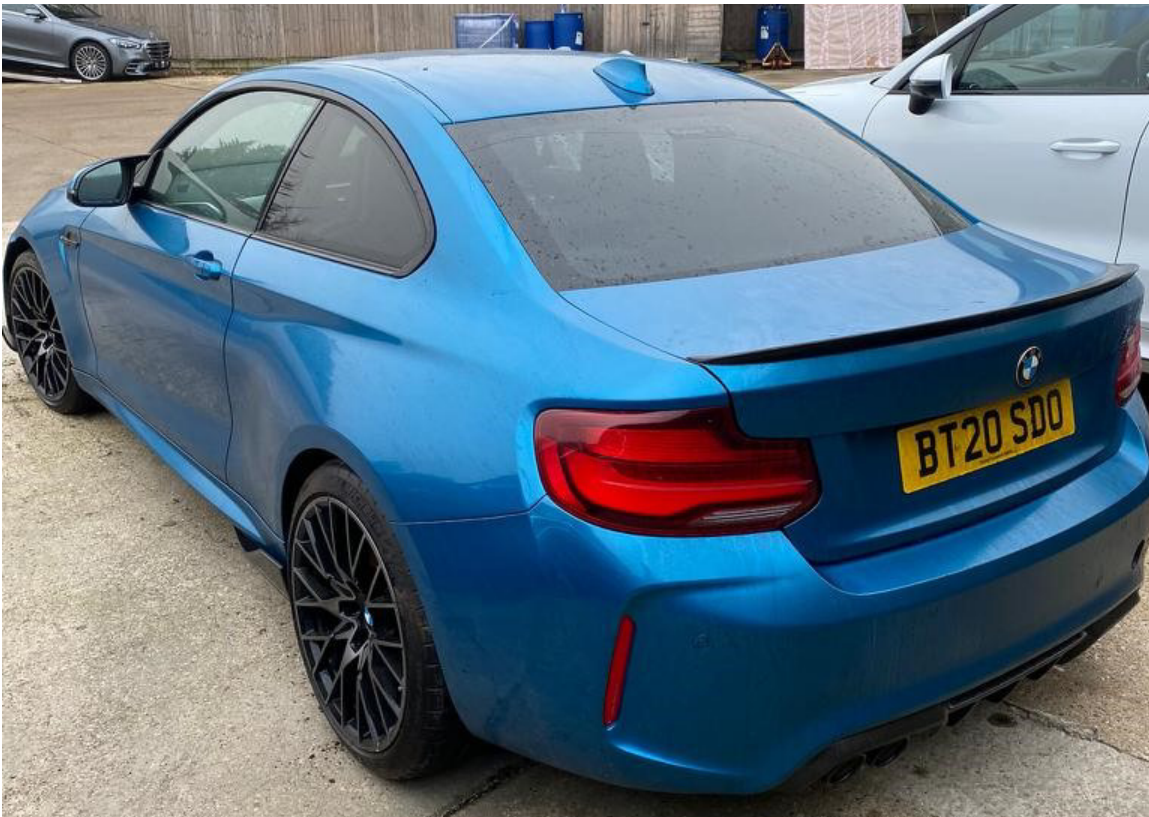
Photo 3 shows the rear left body of the Motor Car (photograph provided to me). Apart for the front right portion and right rear portion, there was no physical damage observed to other areas of the Motor Car. The Motor Car's airbag(s) was not deployed.

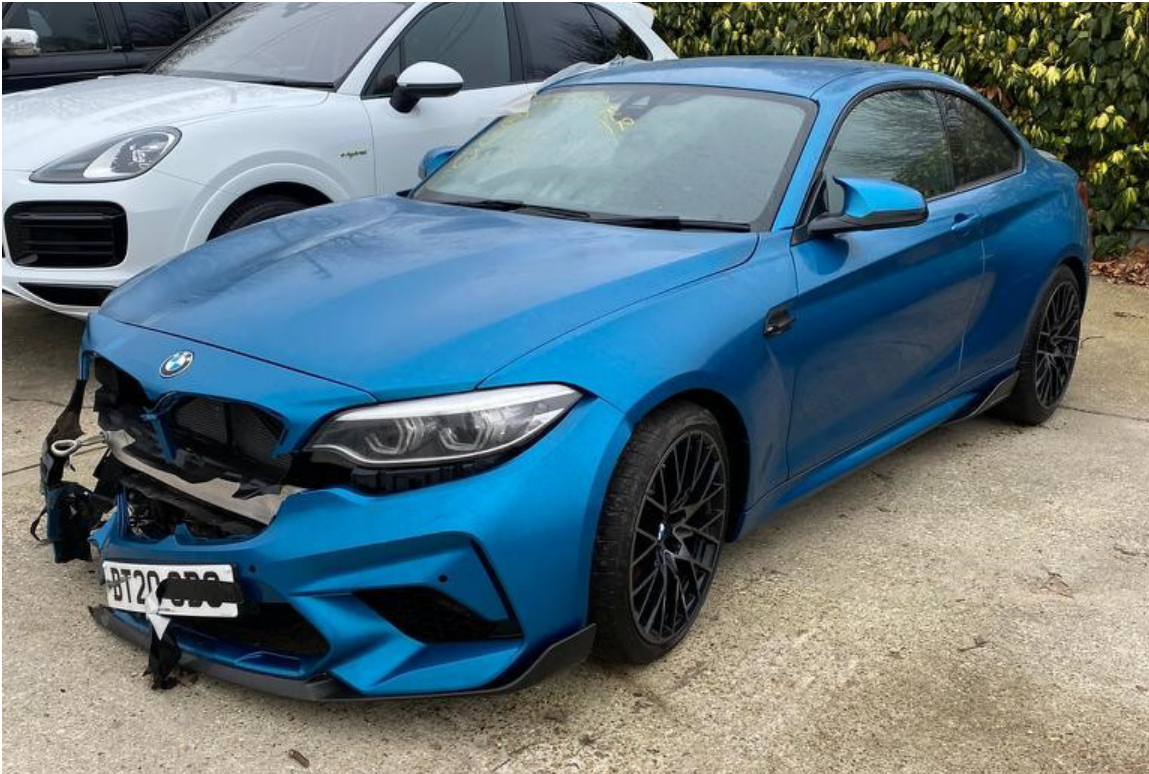
Photo 4 shows the front left body of the Motor Car (photograph provided to me). Apart for the front right portion and right rear portion, there was no physical damage observed to other areas of the Motor Car. The Motor Car's front left wheel (arrowed) and front right wheel (refer to photograph 1 above) were orientated in different directions. This would suggest damage to the undercarriage parts at the front right wheel of the Motor Car. The Motor Car's airbag(s) was not deployed.

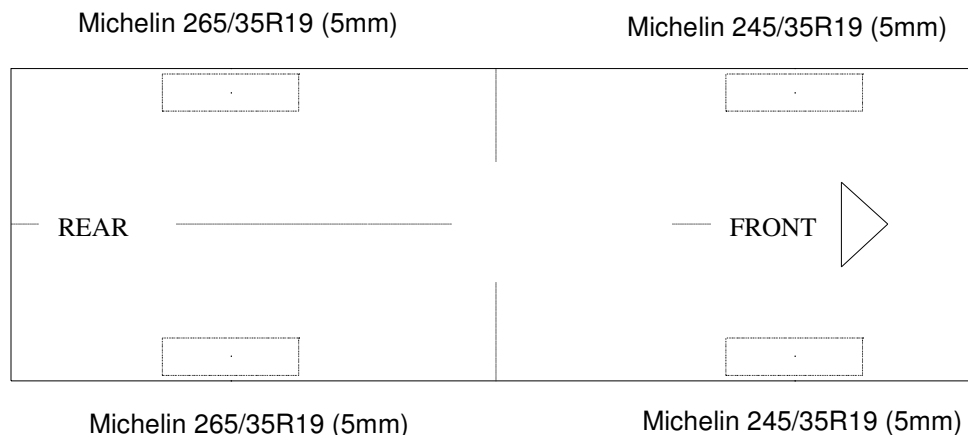
10. It was fitted with 19inch sport wheel rims that were wrapped with tyres that were observed to be of serviceable condition. The tyres were also sufficiently inflated for vehicular operation. The tyre brand, tyre size and approximate remaining tread depth of the 4 tyres of the Motor Car were recorded as follows: -

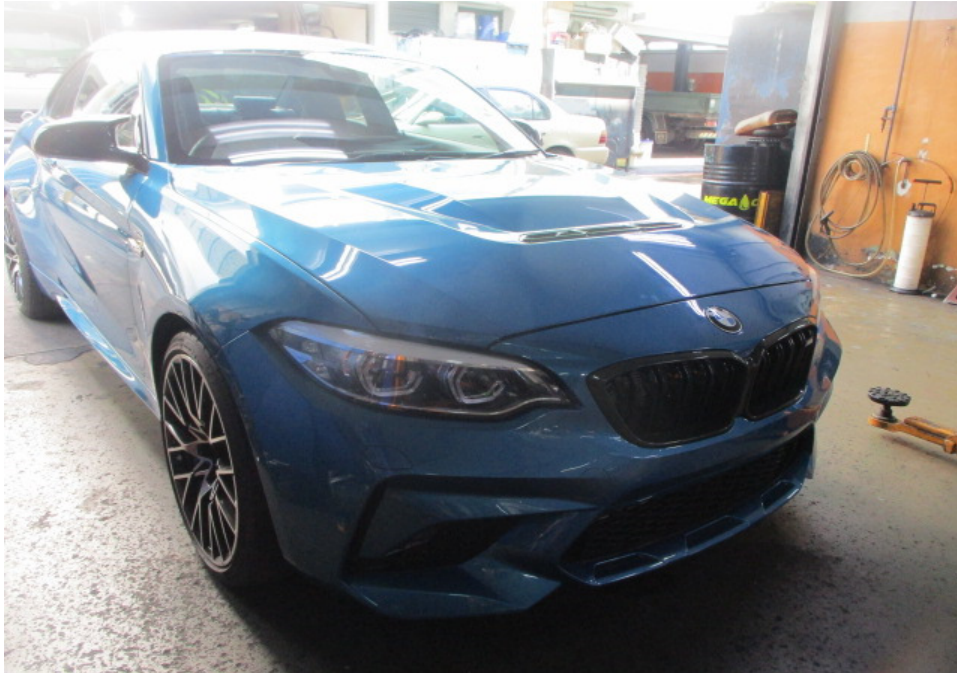
Photo 5 shows a general view of the front right body of the Motor Car at the time of my inspection. The Motor Car was observed to be in a relatively good general condition with no loose exterior fittings observed. The body parts at the front right portion of the Motor Car were visually examined and it was observed that the repair/restoration works carried out to the damaged area of the Motor Car (refer to photograph 1 above) were reasonably adequate and in order.

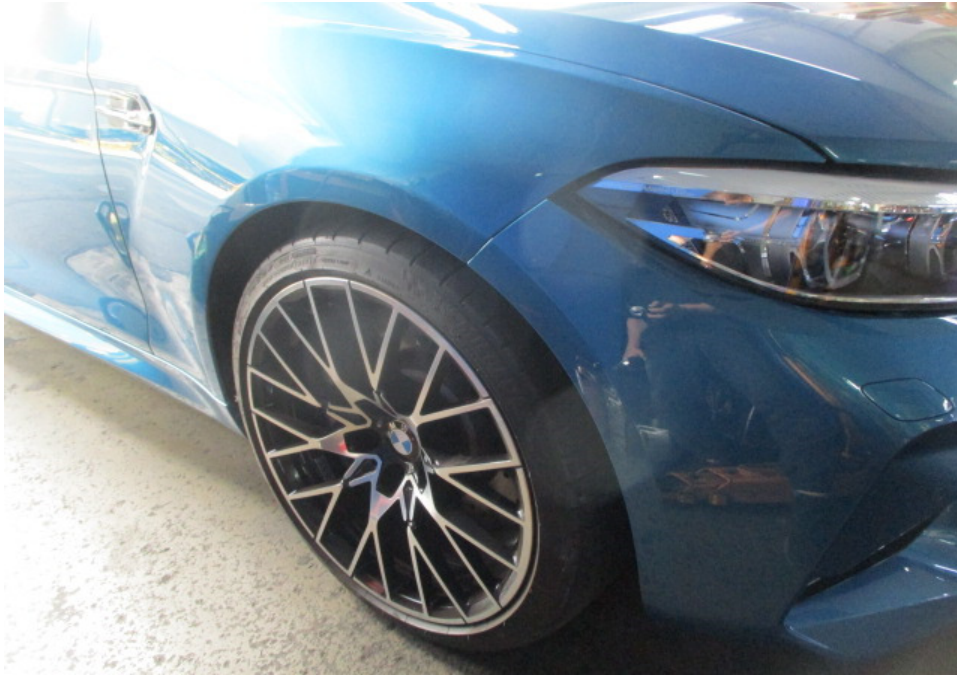
Photo 6 shows a closer view of the Motor Car's front bumper, front right headlamp, front right fender, front right wheel rim and front right tyre at the time of my inspection. The body parts at the front right portion of the Motor Car were visually examined and it was observed that the repair/restoration works carried out to the damaged area of the Motor Car (refer to photograph 1 above) were reasonably adequate and in order.

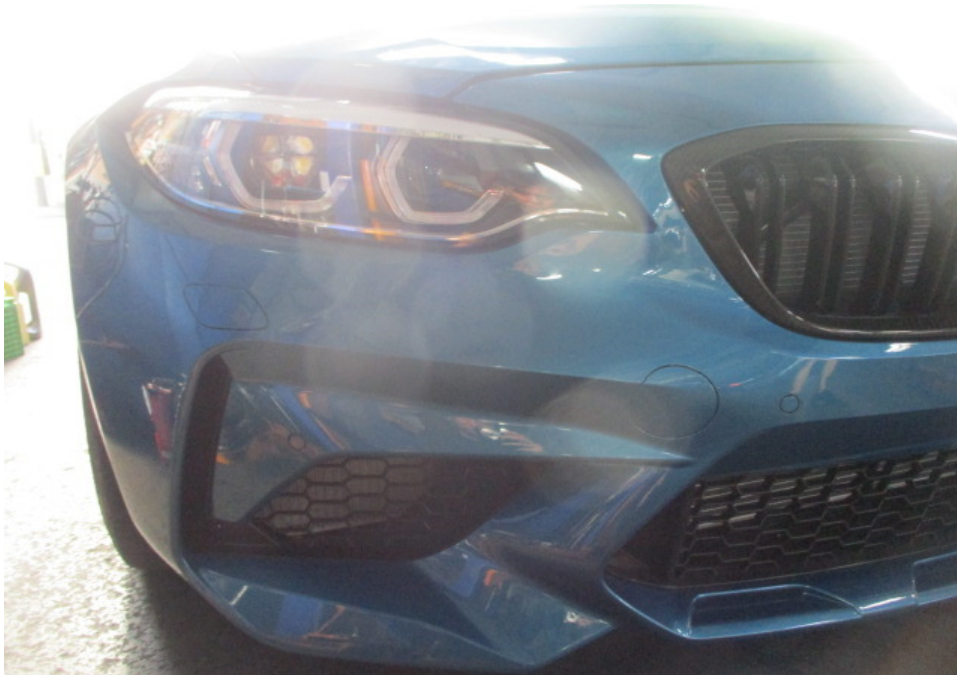
Photo 7 shows a closer view of the Motor Car's front bumper, front bumper right lower grille and front right headlamp. The body parts at the front right portion of the Motor Car were visually examined and it was observed that the repair/restoration works carried out to the damaged area of the Motor Car (refer to photograph 1 above) were reasonably adequate and in order.

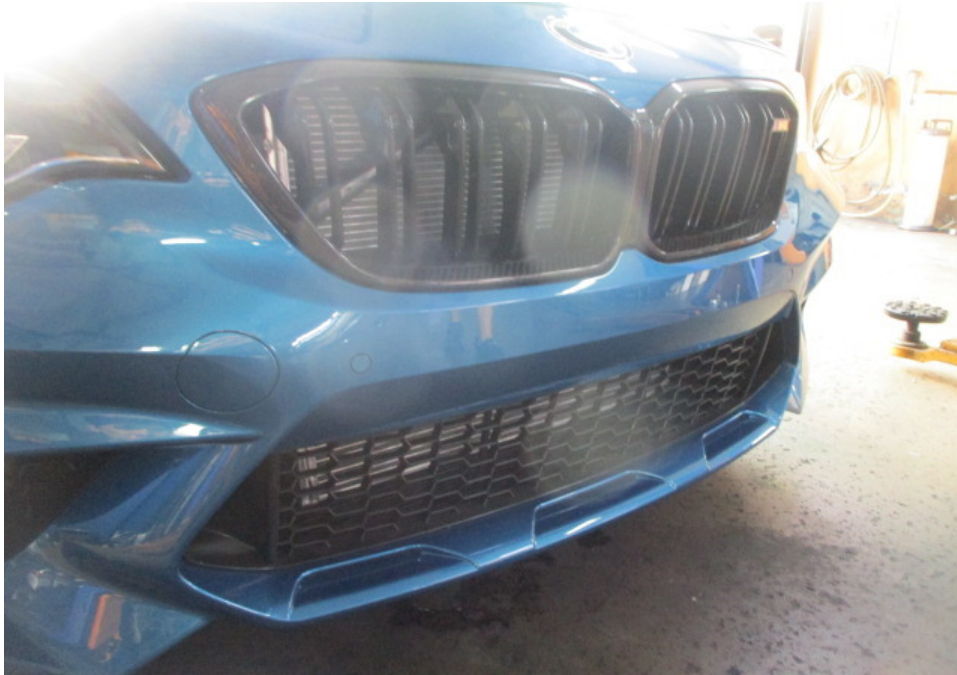
Photo 8 shows a closer view of the Motor Car's front bumper, front bumper centre lower grille and front grilles at the time of my inspection. The body parts at the front right portion of the Motor Car were visually examined and it was observed that the repair/restoration works carried out to the damaged area of the Motor Car (refer to photograph 1 above) were reasonably adequate and in order.

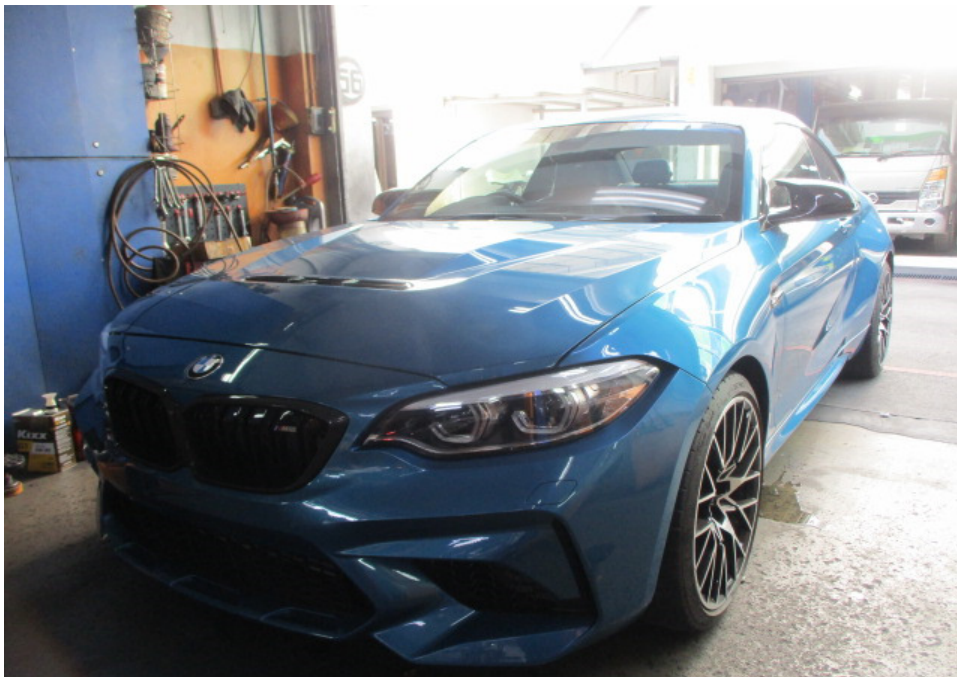
Photo 9 shows a general view of the front left body of the Motor Car at the time of my inspection. The Motor Car was observed to be in a relatively good general condition with no loose exterior fittings observed. The body parts at the front right portion of the Motor Car were visually examined and it was observed that the repair/restoration works carried out to the damaged area of the Motor Car (refer to photograph 1 above) were reasonably adequate and in order.

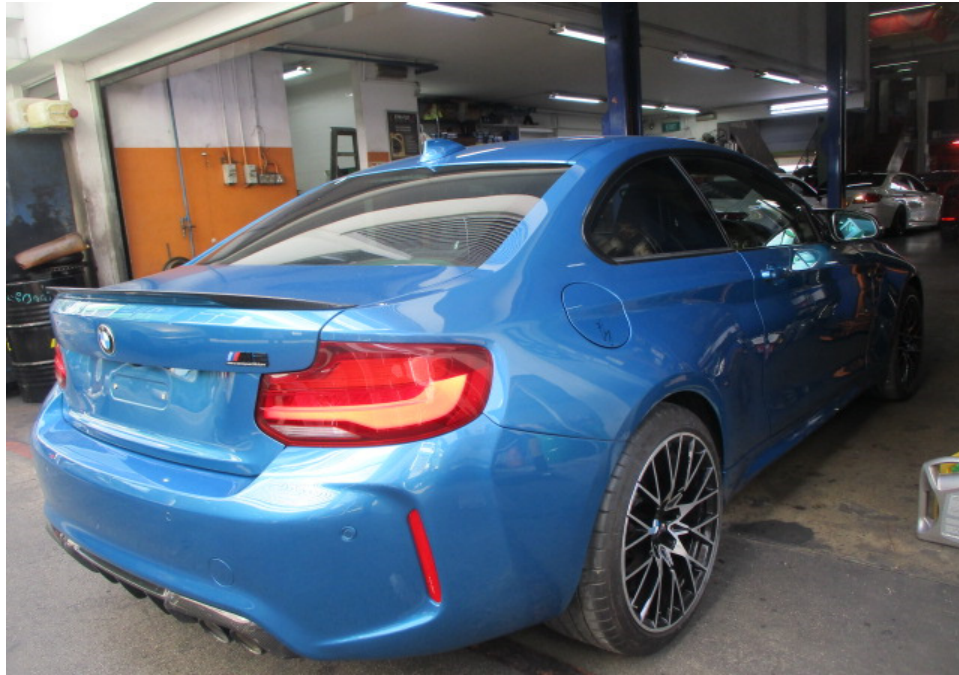
Photo 10 shows a general view of the rear right body of the Motor Car at the time of my inspection. The Motor Car was observed to be in a relatively good general condition with no loose exterior fittings observed. The body parts at the right rear portion of the Motor Car were visually examined and it was observed that the repair/restoration works carried out to the damaged area of the Motor Car (refer to photograph 2 above) were reasonably adequate and in order.

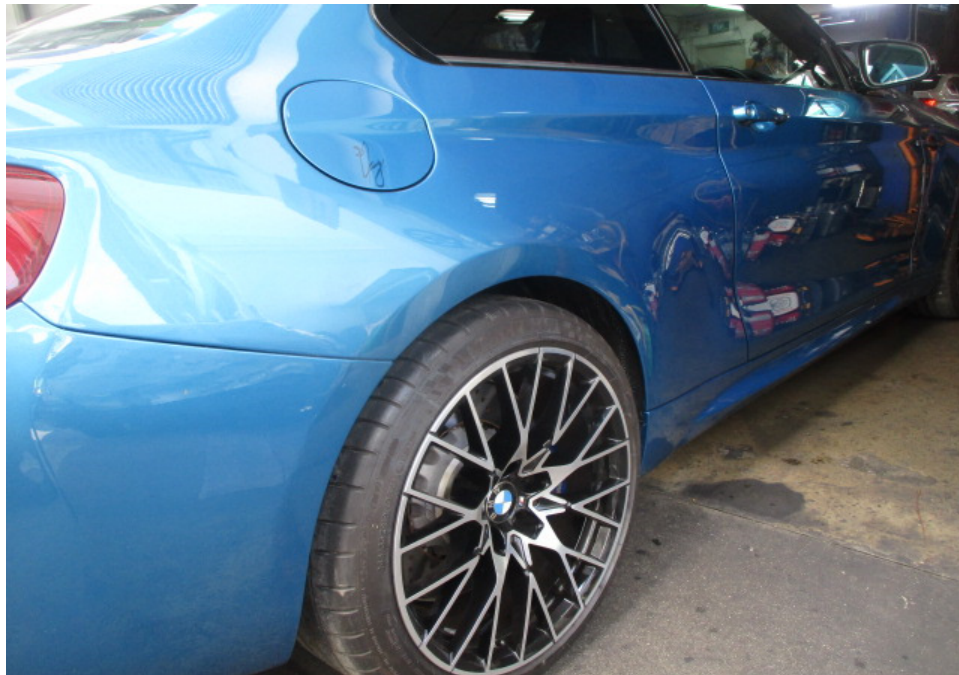
Photo 11 shows a closer view of the Motor Car's rear bumper, rear right fender, rear right wheel rim and fuel filler cover. The body parts at the right rear portion of the Motor Car were visually examined and it was observed that the repair/restoration works carried out to the damaged area of the Motor Car (refer to photograph 2 above) were reasonably adequate and in order.

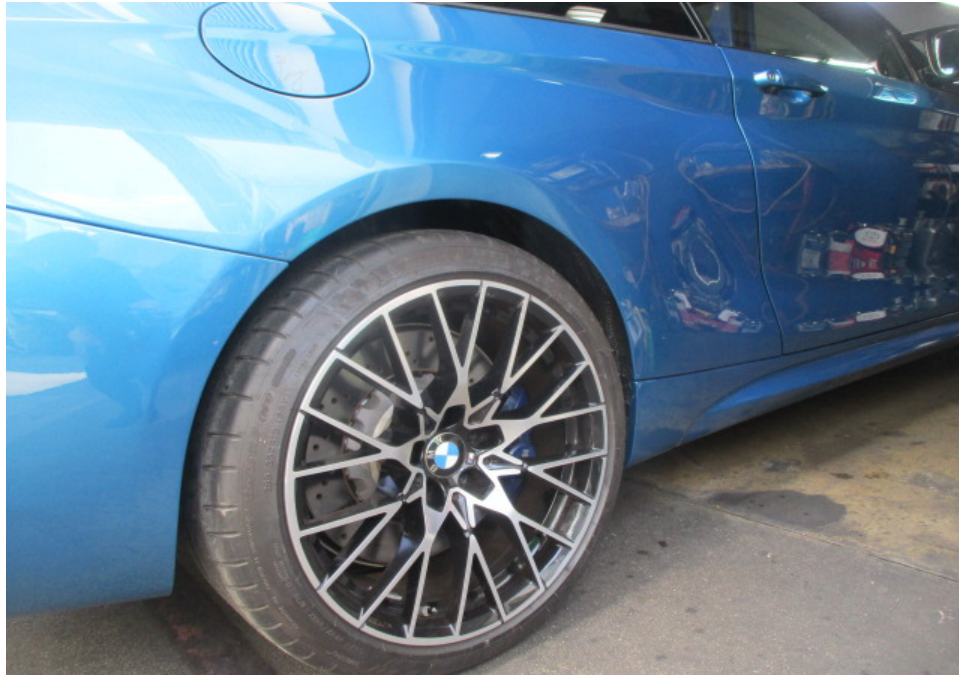
Photo 12 shows a closer view of the Motor Car's rear bumper, rear right fender, rear right wheel rim and right side rocker panel garnish. The body parts at the right rear portion of the Motor Car were visually examined and it was observed that the repair/restoration works carried out to the damaged area of the Motor Car (refer to photograph 2 above) were reasonably adequate and in order.

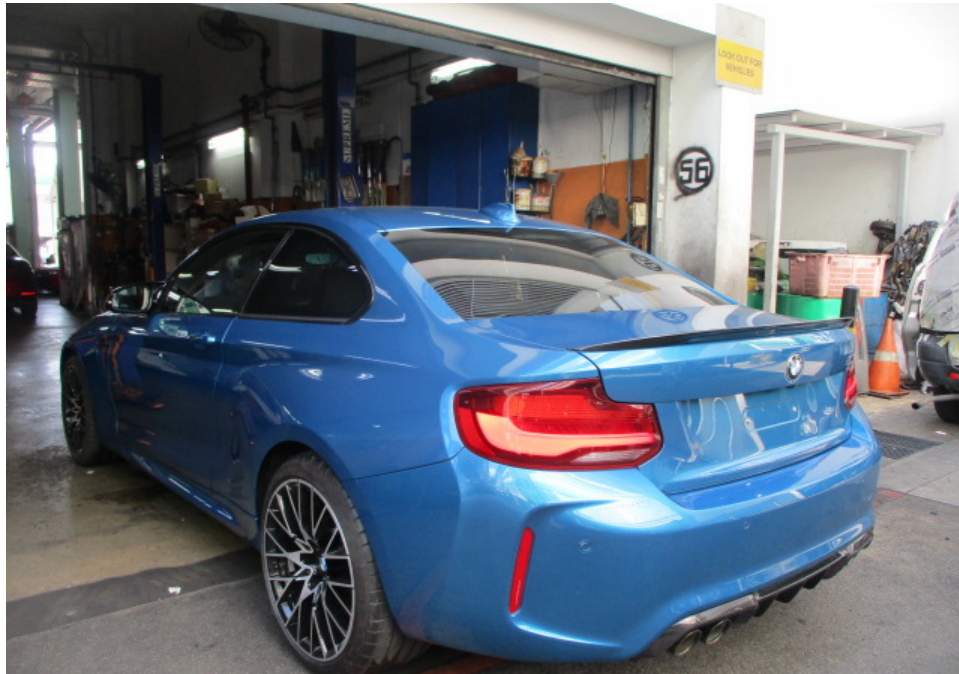
Photo 13 shows a general view of the rear left body of the Motor Car at the time of my inspection. The Motor Car was observed to be in a relatively good general condition with no loose exterior fittings observed. The mileage of the Motor Car recorded at the time of my inspection was 16,906km.

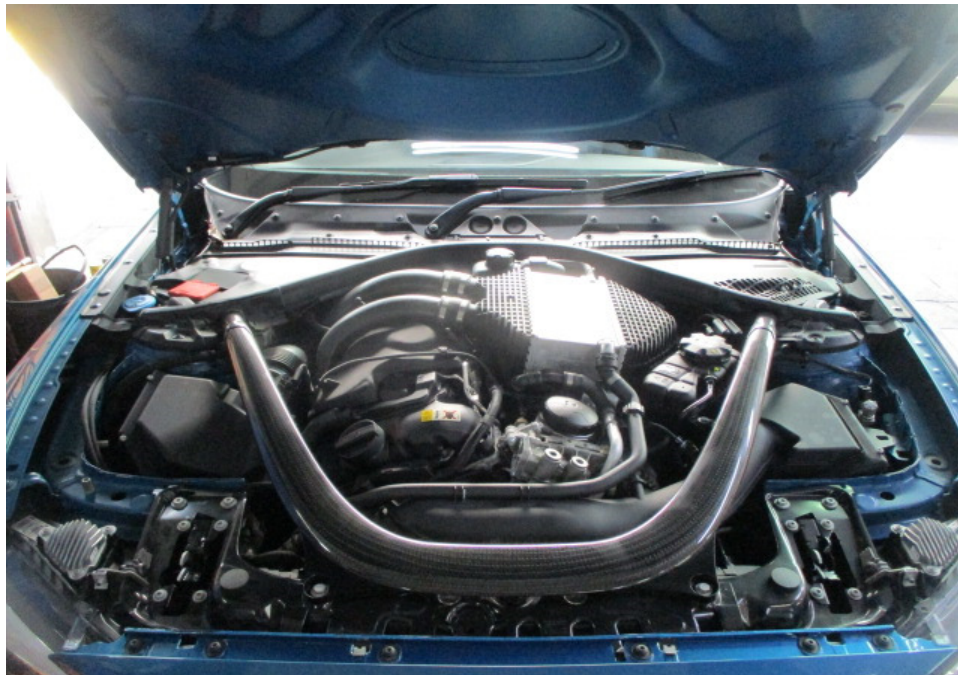
Photo 15 shows a general view of the engine compartment of the Motor Car at the time of my inspection. The various parts and components inside the engine compartment were all observed to be intact and properly fitted. There was also no sign(s) or indication(s) of fluid leak and/or fluid stain found inside the engine compartment.

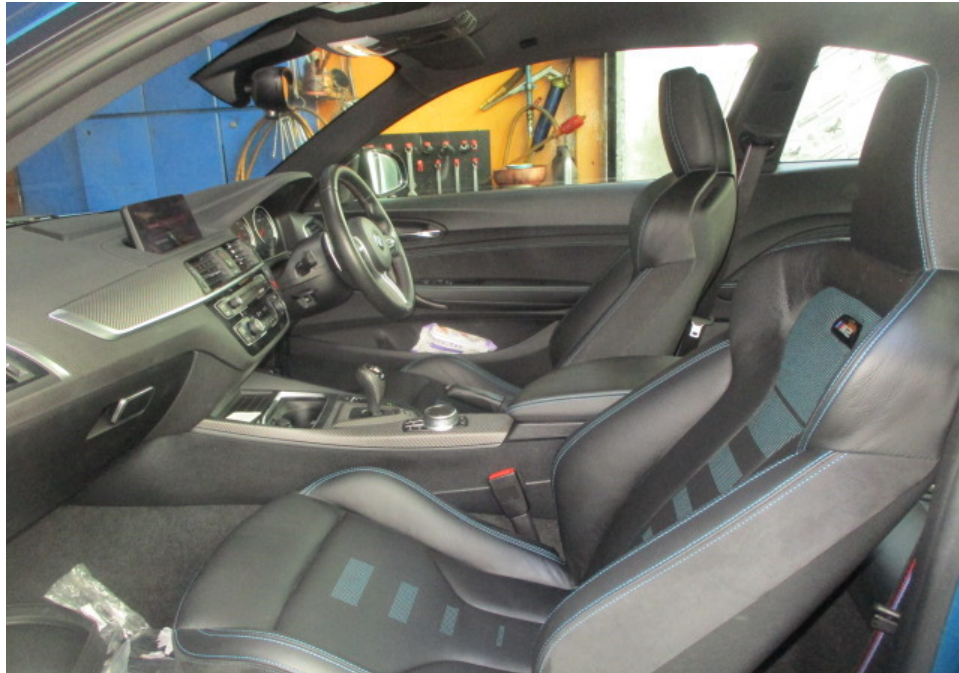
Photo 16 shows the interior compartment of the Motor Car at the time of my inspection. The various parts and components, trims, carpet, and upholstery inside the interior compartment were all observed to be intact and properly fitted.

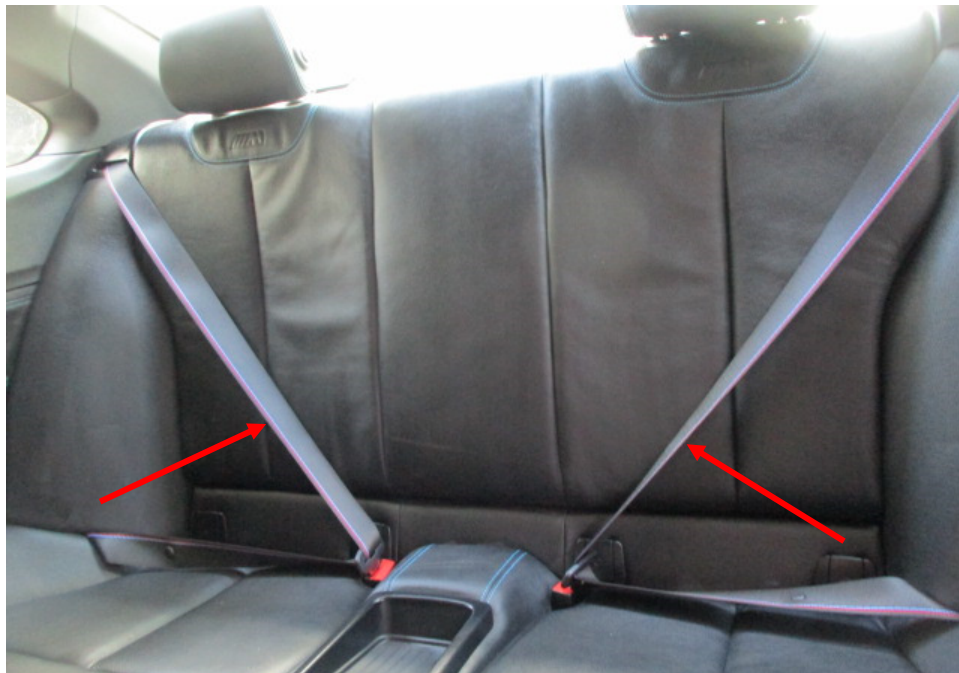
Photo 17 shows the rear seats of the Motor Car. All the seats of the Motor Car were secured via seat rails to the floorboard. They were also fitted with a retractable seat belt reel and a pre-tensioner. The seat belts (arrowed) were tested and were able to be fastened into the respective pre-tensions that were fitted on the side of each individual seat.

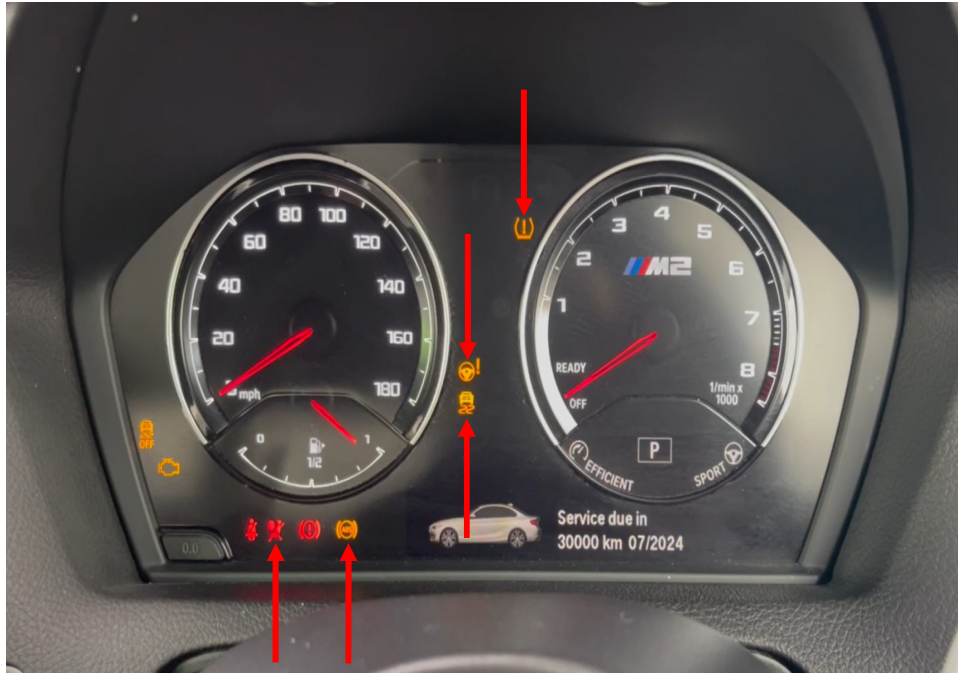
Photo 18 shows the warning lights for the various electronic safety features appearing on the instrument panel of the Motor Car during its self-test when the engine is cranked, in particular the ABS, SRS, IAS, TPM and DSC lights (arrowed).

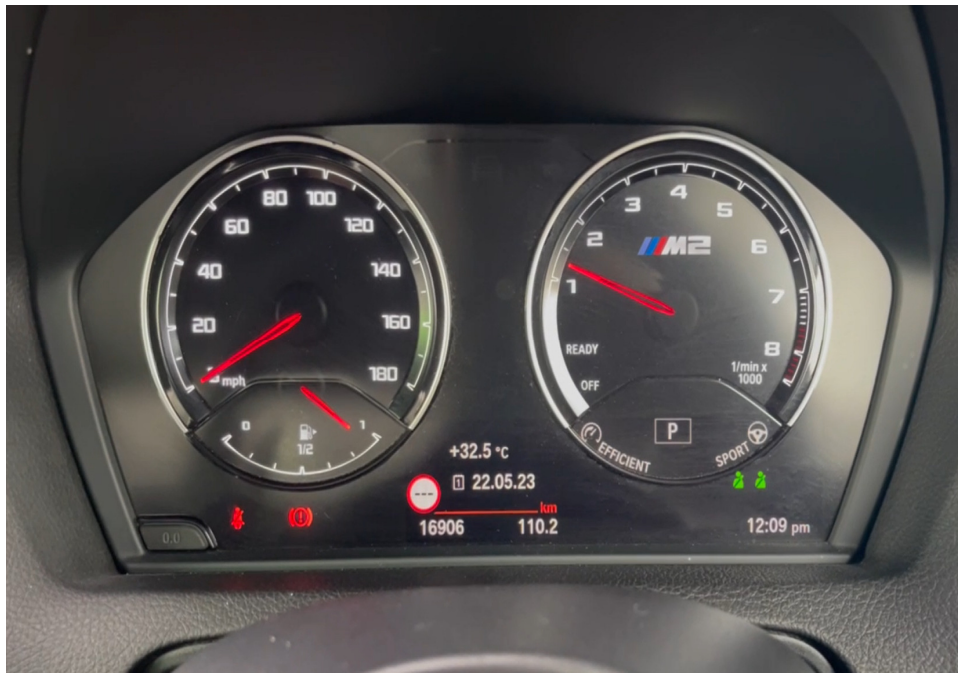
Photo 19 shows the respective warning lights no longer illuminated, indicating that there is no fault detected to the ABS, SRS, IAS, TPM and DSC systems of the Motor Car during the self-test. These electronic systems were hence in working condition at the time of my inspection.

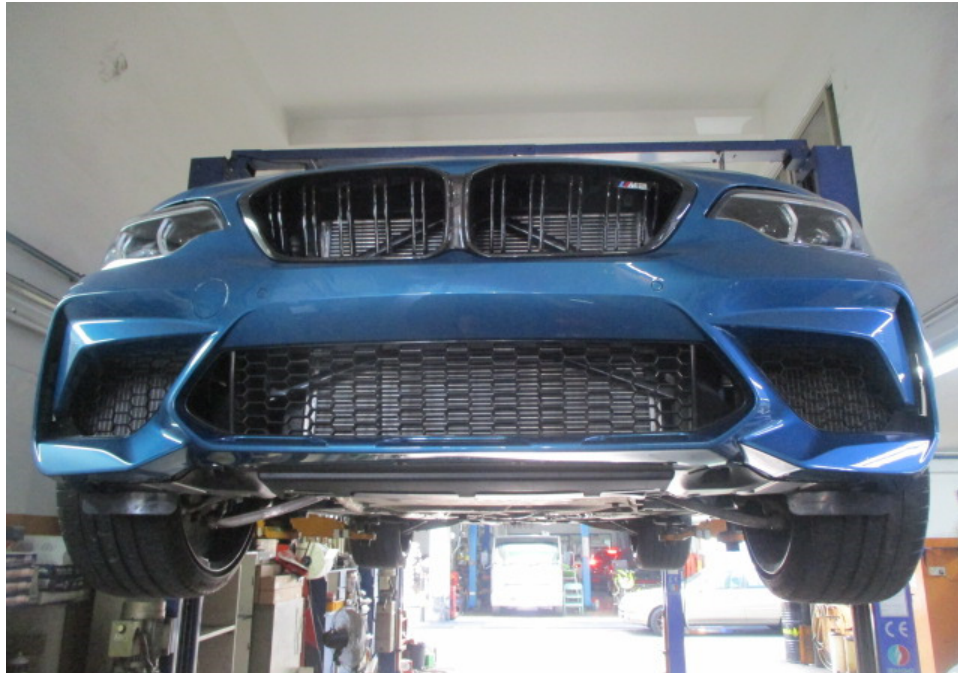
Photo 20 shows the Motor Car hoisted up for checks on its undercarriage. There was no sign(s) or indication(s) of fluid leakage and/or fluid stain(s) on the underside of the Motor Car. The undercarriage components of the Motor Car were also all observed to be intact and secured in an appropriate manner.

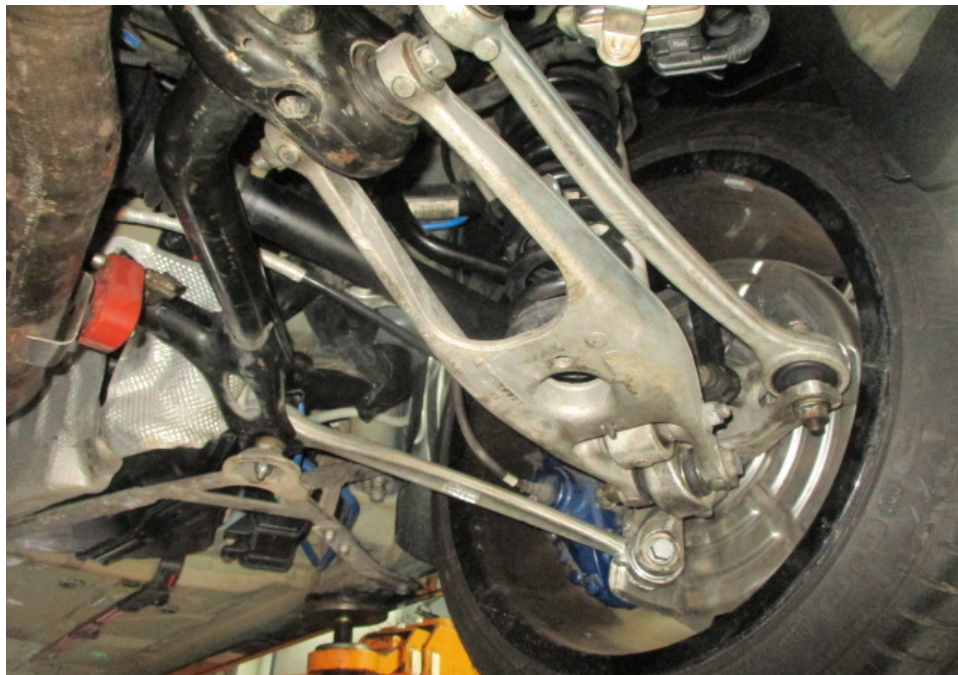
Photo 21 shows a general view of the control arms and linkages at the rear right wheel of the Motor Car. I did not observe any fluid leak and/or fluid stain on the underside of the Motor Car. All of the Motor Car's undercarriage components were observed to be intact and secured in an appropriate manner.

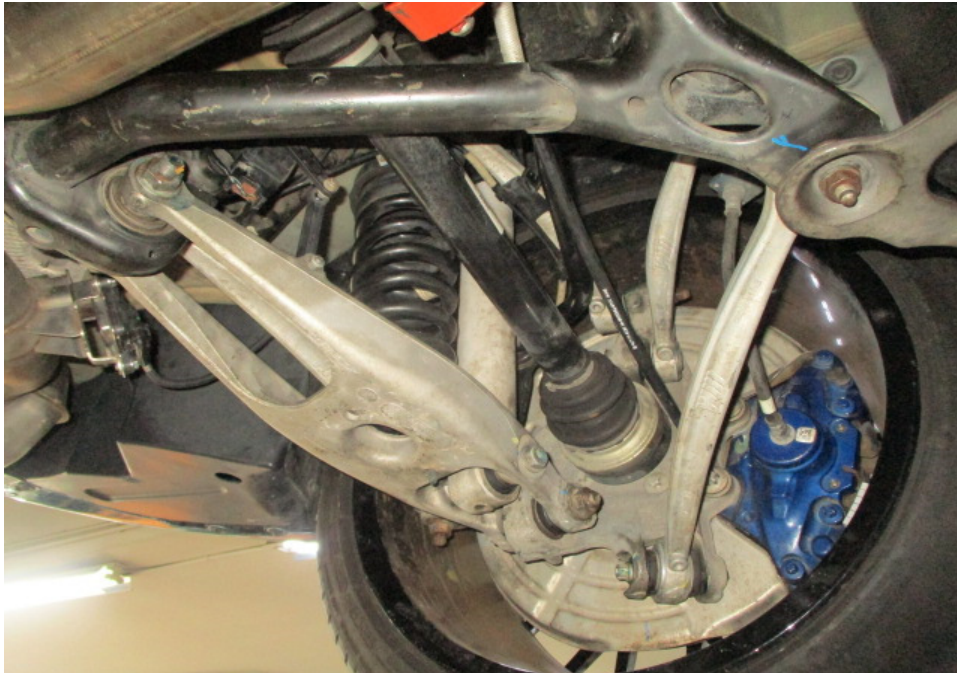
Photo 22 shows a general view of the control arms and linkages at the rear left wheel of the Motor Car. I did not observe any fluid leak and/or fluid stain on the underside of the Motor Car. All of the Motor Car's undercarriage components were observed to be intact and secured in an appropriate manner.

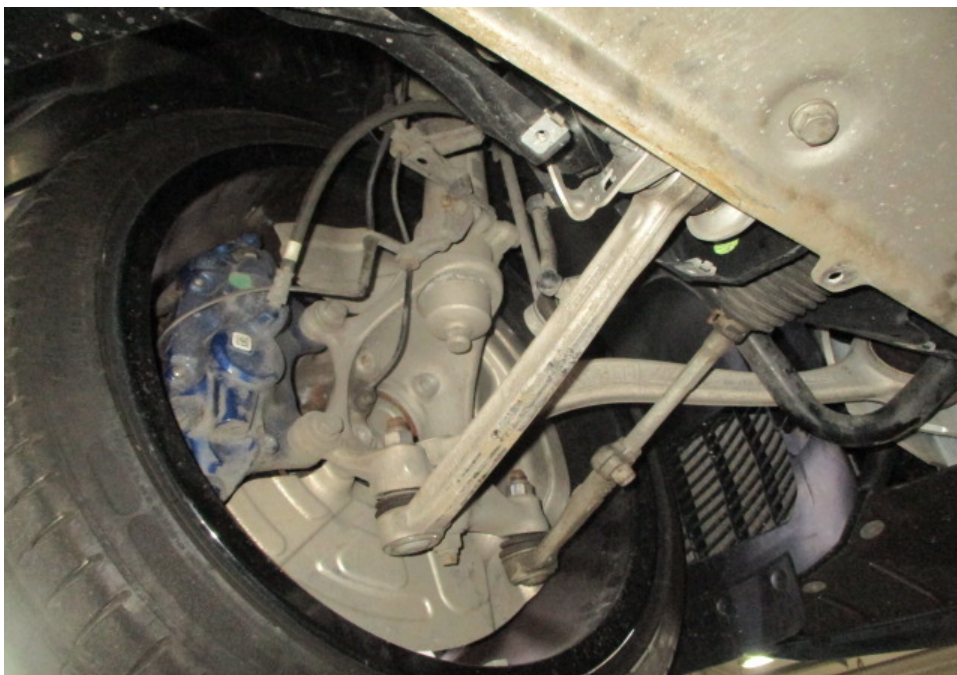
Photo 23 shows the various undercarriage components at the front left wheel of the Motor Car. The mechanical components, control arms and linkages were all found to be intact and secured in an appropriate manner.

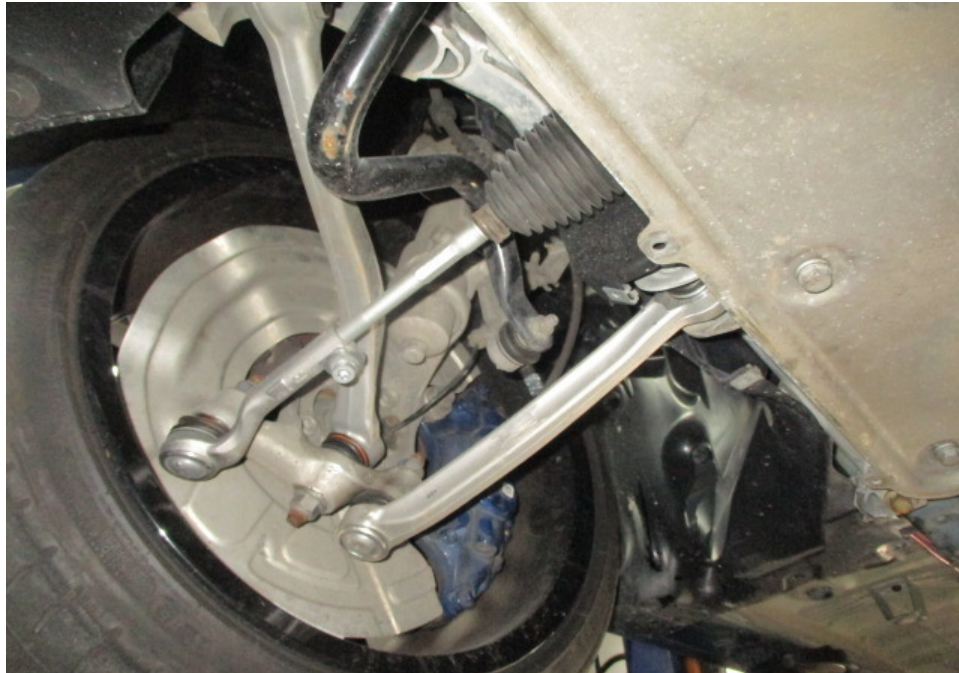
Photo 24 shows the various undercarriage components at the front right wheel of the Motor Car. The mechanical components, control arms and linkages were all found to be intact and secured in an appropriate manner. I also did not observe any fluid leak and/or fluid stain on the underside of the Motor Car.

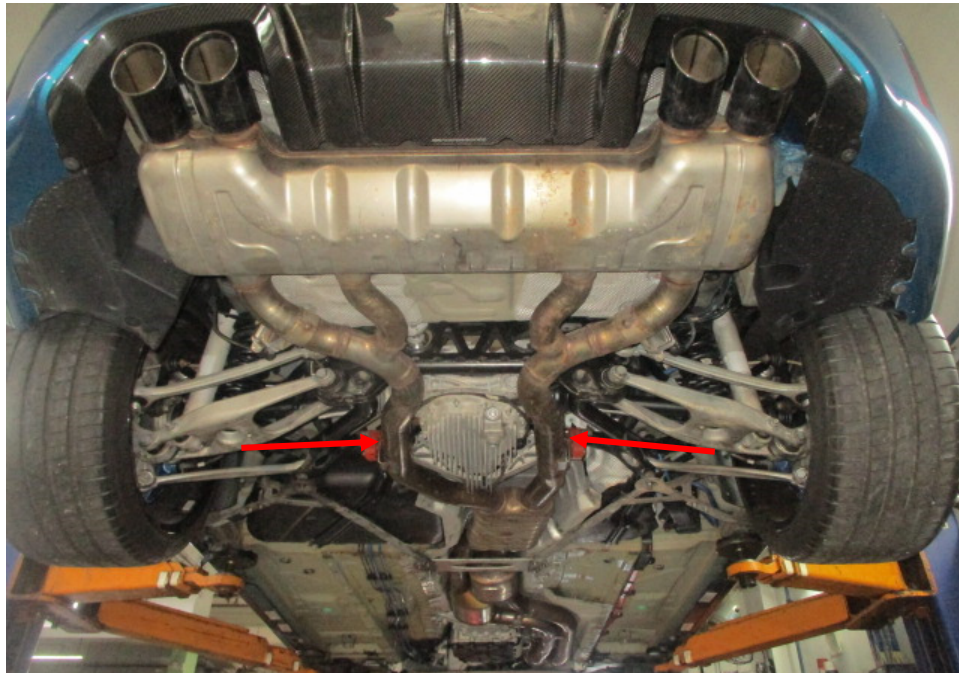
Photo 25 shows the rear section of the Motor Car's exhaust system. My examination of the Motor Car's exhaust system revealed no sign(s) or indication(s) of any cut or weld marks along its exhaust pipes (arrowed), on its rear muffler, on its centre resonator boxes and on its catalytic converters.

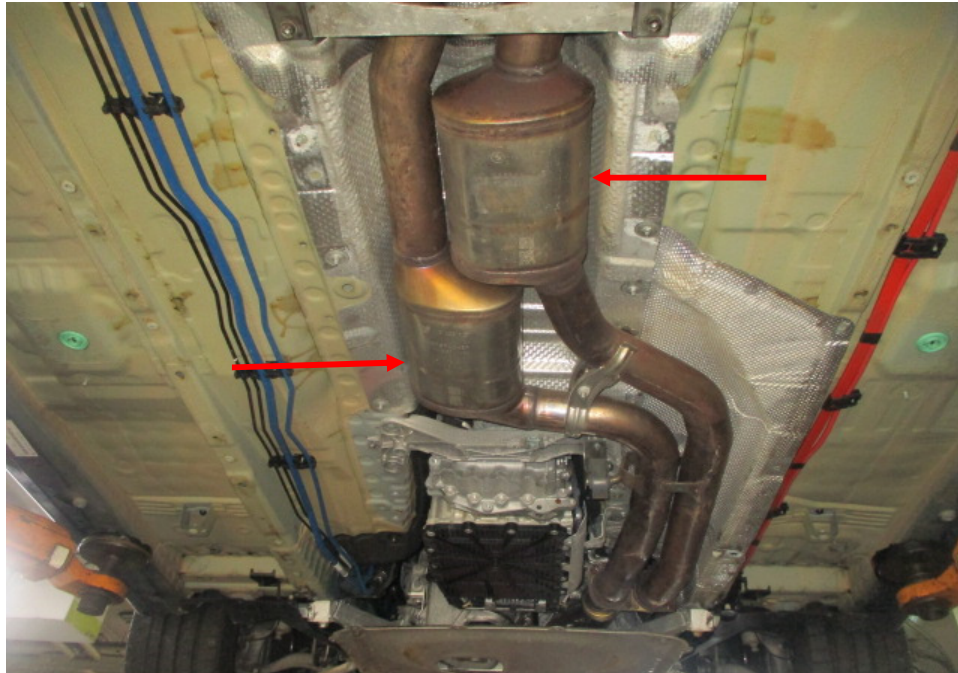
Photo 26 shows the front section of the Motor Car's exhaust system. My examination of the Motor Car's exhaust system revealed no sign(s) or indication(s) of any cut or weld marks along its exhaust pipes, on its rear muffler, on its centre resonator boxes (arrowed) and on its catalytic converters.

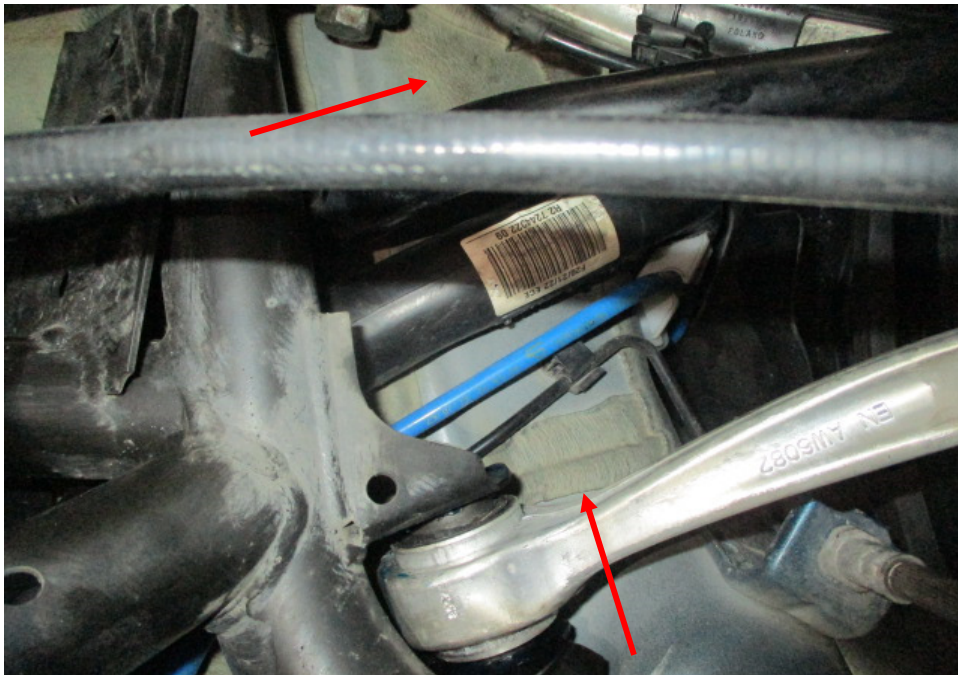
Photo 27 shows the chassis/structural body at the underside rear right of the Motor Car. I did not find any weld marks other than original spot weld marks on the chassis/structural body of the Motor Car. The original factory sealant (arrowed) at the joints along the chassis/structural body was untouched, indicating no work was done on the chassis/structural body of the Motor Car and that the chassis/structural body was originally fitted.

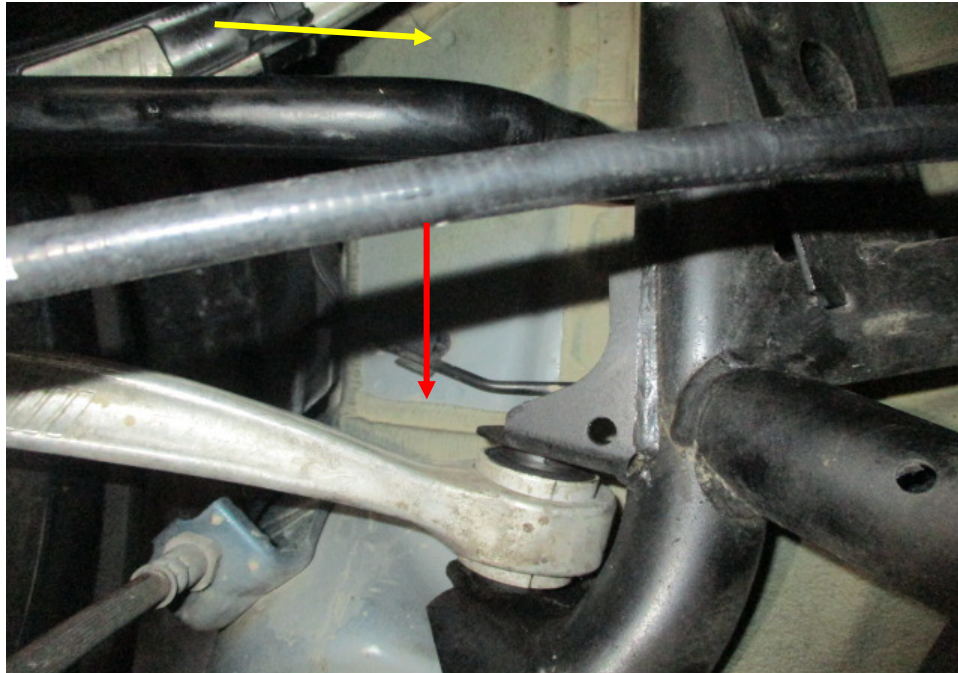
Photo 28 shows the chassis/structural body at the underside rear left of the Motor Car. I did not find any weld marks other than original spot weld marks (yellow arrow) on the chassis/structural body of the Motor Car. The original factory sealant (red arrow) at the joints along the chassis/structural body was untouched, indicating no work was done on the chassis/structural body of the Motor Car and that the chassis/structural body was originally fitted.

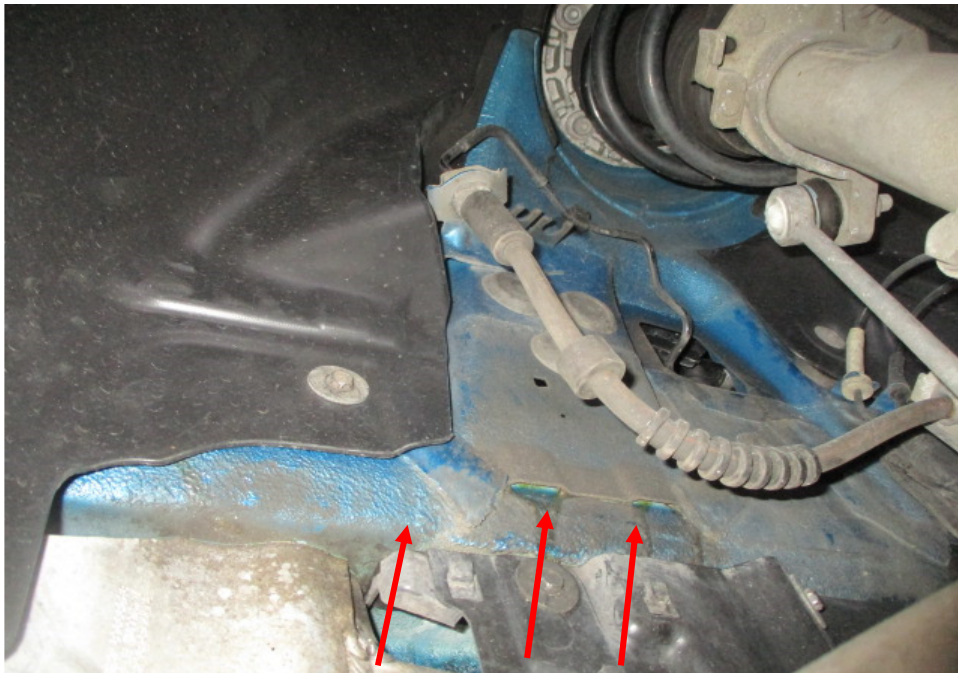
Photo 29 shows the chassis/structural body at the underside front left of the Motor Car. The original factory sealant (arrowed) at the joints along the chassis/structural body was observed to be untouched. In general, I had found no work was carried out on the chassis/structural body of the Motor Car. The chassis/structural body of the Motor Car was originally fitted.
