Your Ref: BMW M2 Coupe
(chassis number WBS2U720X07F26710)
Our Ref : CI/TP23005515/D

27 May 2023

INSPECTION REPORT OF AN UNREGISTERED BMW M2 COUPE MOTOR CAR WITH CHASSIS NUMBER WBS2U720X07F26710

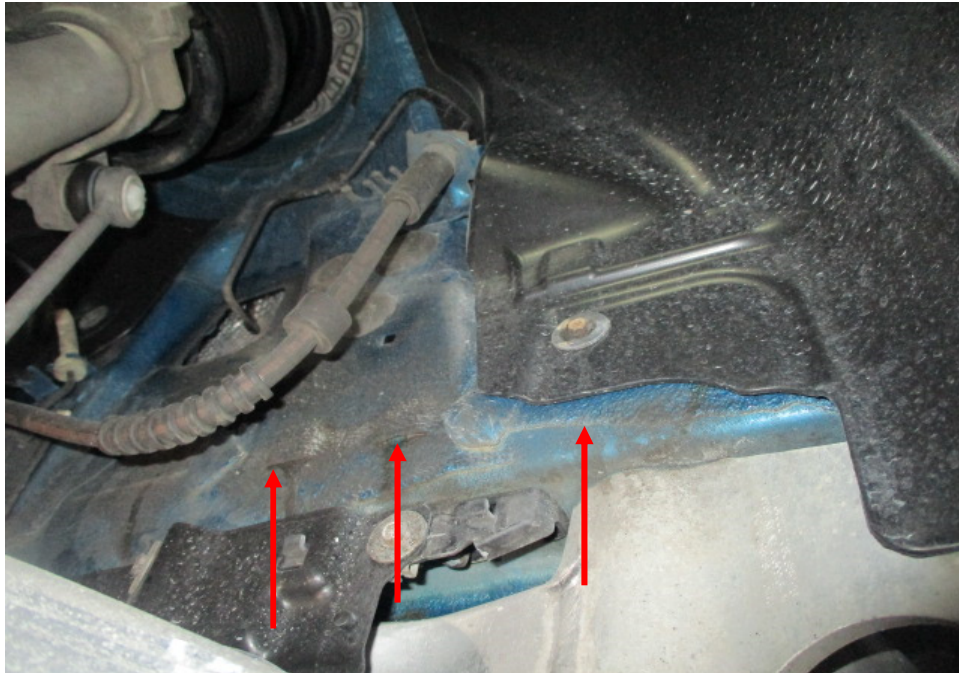
Photo 30 shows the chassis/structural body at the underside front right of the Motor Car. The original factory sealant (arrowed) at the joints along the chassis/structural body was observed to be untouched. In general, I had found no work was carried out on the chassis/structural body of the Motor Car. The chassis/structural body of the Motor Car was originally fitted.

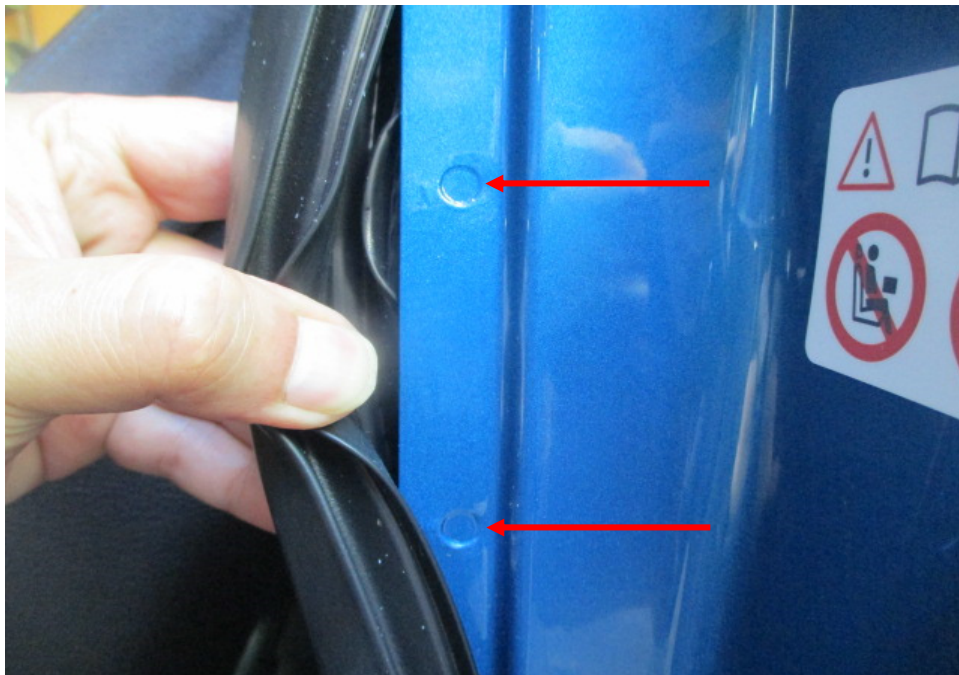
Photo 31 shows the left side rear body panel of the Motor Car. I did not find any weld marks other than original spot weld marks (arrowed) on the left side rear body panel of the Motor Car, which indicates that there was no re-welding works carried out. In general, I had found all the non-detachable body panels of the Motor Car to be originally fitted at the time of my inspection.

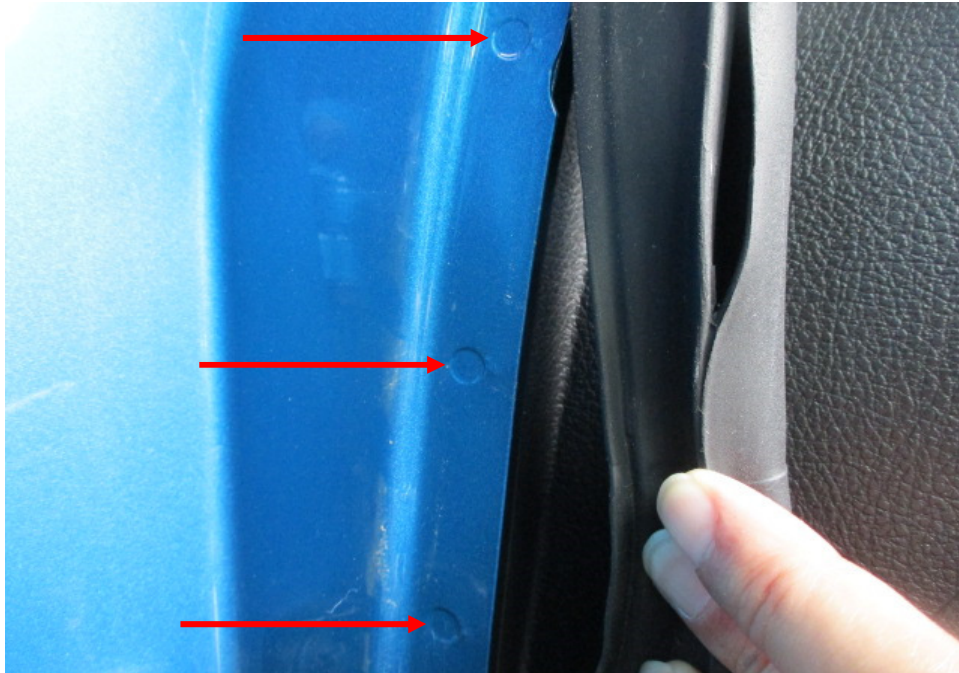
Photo 32 shows the left side “A” pillar of the Motor Car. I did not find any weld marks other than original spot weld marks (arrowed) on the left side “A” pillar of the Motor Car, which indicates that there was no re-welding works carried out. In general, I had found all the non-detachable body panels of the Motor Car to be originally fitted at the time of my inspection.

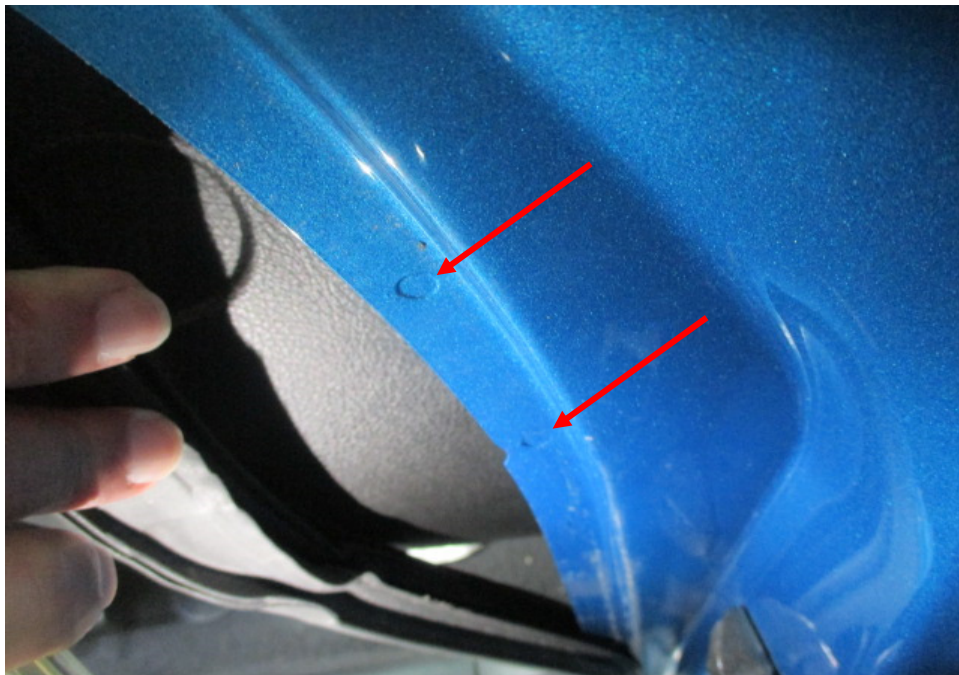
Photo 33 shows the right side “A” pillar of the Motor Car. I did not find any weld marks other than original spot weld marks (arrowed) on the right side “A” pillar of the Motor Car, which indicates that there was no re-welding works carried out. In general, I had found all the non-detachable body panels of the Motor Car to be originally fitted at the time of my inspection.

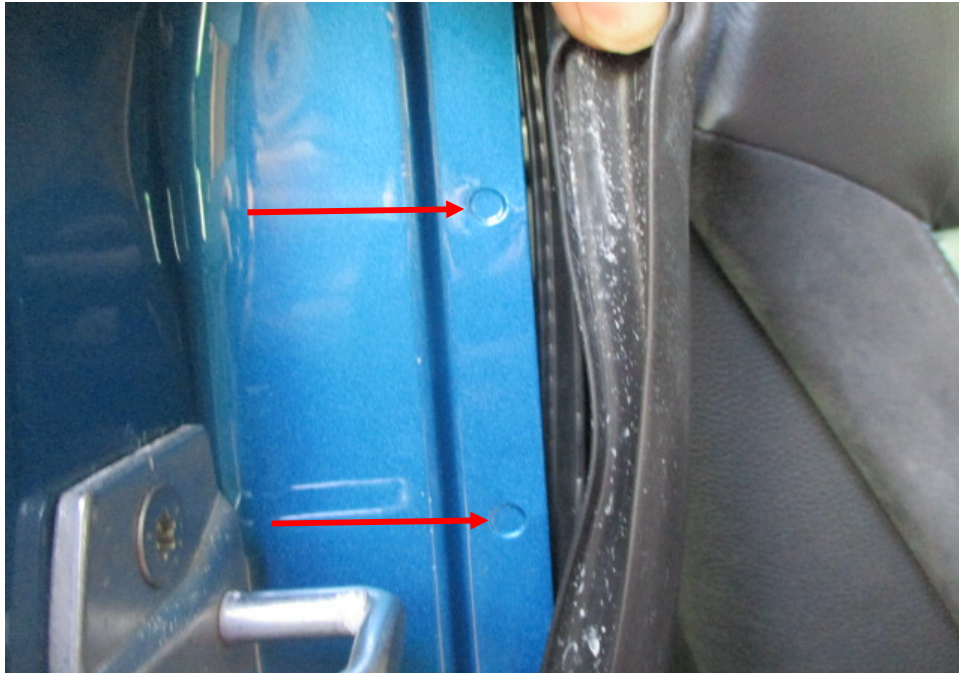
Photo 34 shows the right side rear body panel of the Motor Car. I did not find any weld marks other than original spot weld marks (arrowed) on the right side rear body panel of the Motor Car, which indicates that there was no re-welding works carried out. In general, I had found all the non-detachable body panels of the Motor Car to be originally fitted at the time of my inspection.
