# ALLIED AUTO APPRAISAL

**Our Ref: Allied/TP/22-09018**

**Veh No : SMJ 8722 R**

Make & Model	:	<b>Mercedes Benz C180</b>	Date of Registration	:	<b>17-May-13</b>
Engine No	:	<b>27491030039879</b>	Engine c.c.	:	<b>1595 cc</b>
Chassis No	:	<b>WDD2040312A833022</b>	COE Expiry Date	:	<b>16-May-23</b>

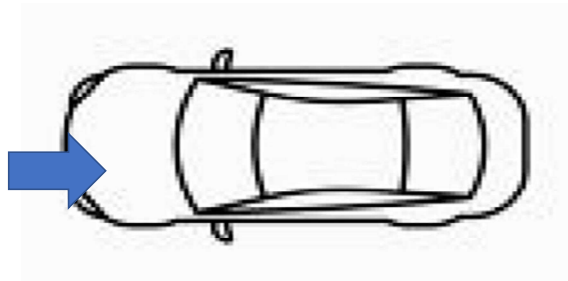
The inspected vehicle sustained damage at the **FRONT** portion.

During visual inspection, our surveyor noted that the front bumper, left headlamp, front support panel and among other parts were affected.
