Your Ref: IVS23/0962  
Our Ref : CI/LIP23005581/N

9 June 2023

### **TECHNICAL INVESTIGATION REPORT OF FIRE INCIDENT INVOLVING THE INSURED VEHICLE SND 4183S ON 24 MAY 2023**

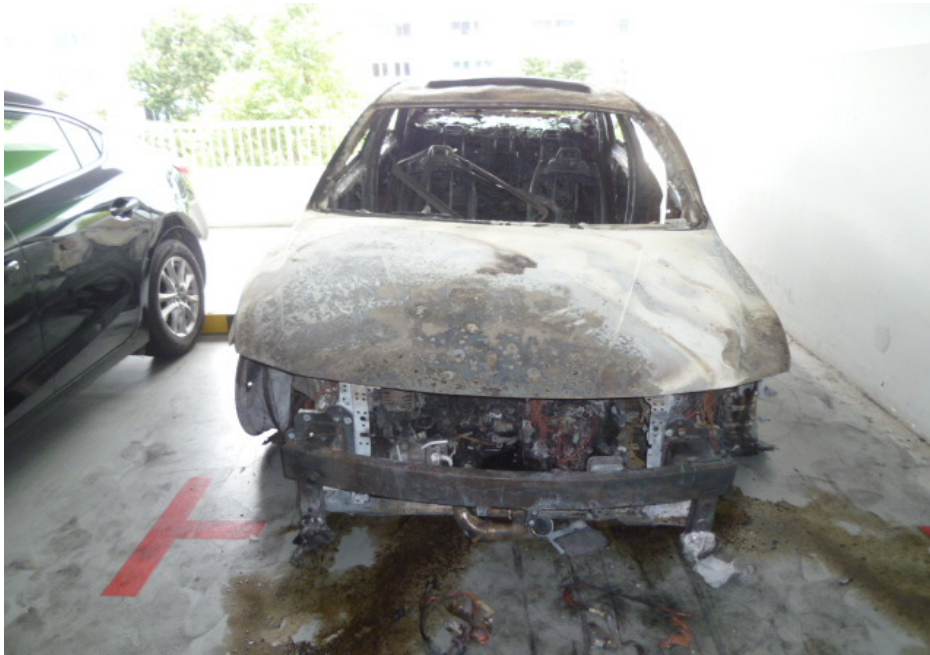
**Photo 1** shows the general view of the frontal portion of the Insured Vehicle at the time of our inspection. The Insured Vehicle was observed to have sustained extensive fire damage all around. Its engine compartment and interior compartment were completely burnt. Rust had accumulated all over the Insured Vehicle as a result of exposure to environmental condition for a period of time.

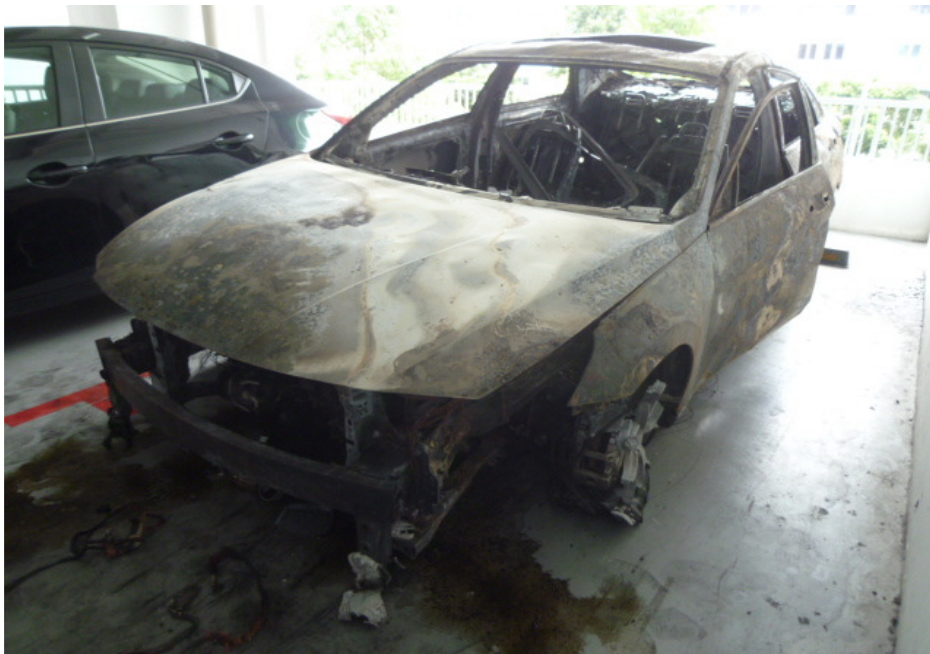
**Photo 2** shows the general view of the left body of the Insured Vehicle at the time of our inspection. The Insured Vehicle was observed to have sustained extensive fire damage all around. Rust had accumulated all over the Insured Vehicle as a result of exposure to environmental condition for a period of time.

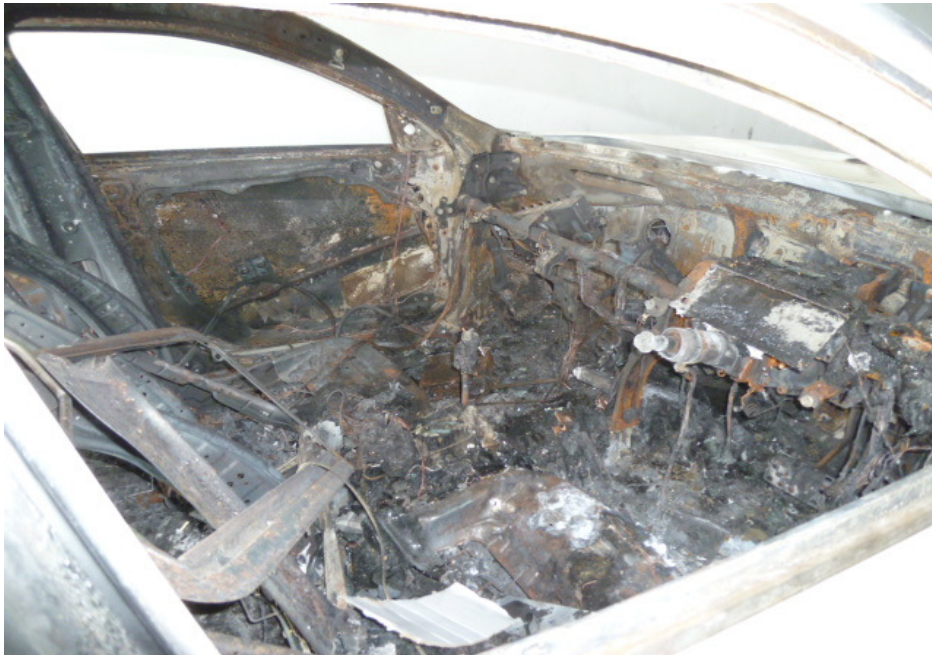
**Photo 3** shows the general view of the interior compartment of the Insured Vehicle at the time of our inspection. Its interior compartment was completely burnt.

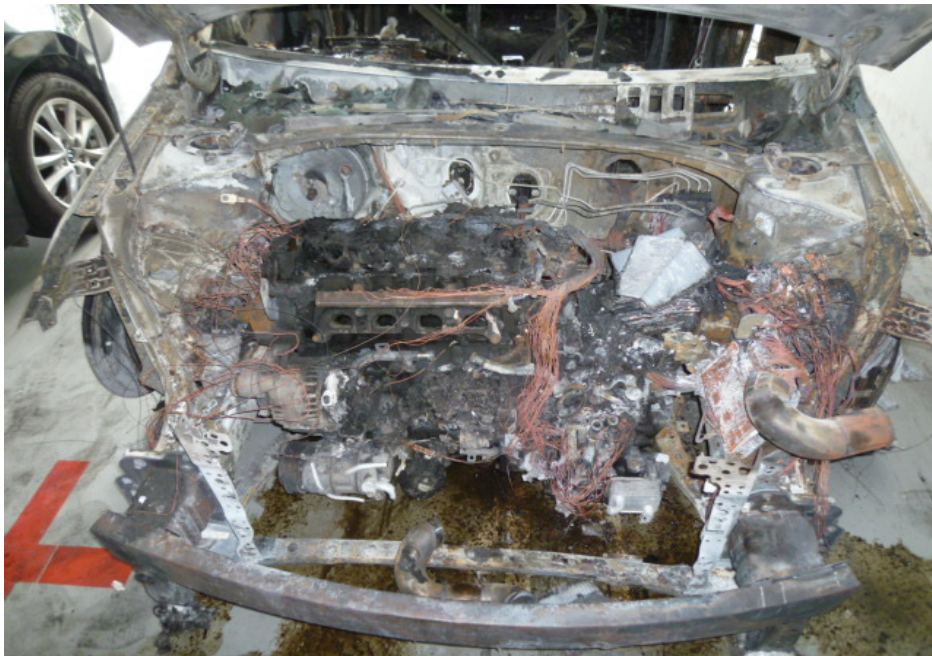
**Photo 4** shows the engine compartment of the Insured Vehicle at the time of our inspection. The entire engine compartment of the Insured Vehicle was observed to be severely burnt. Most of the parts inside the engine compartment were found to be burnt and/or melted as a result of the fire.

7. For this particular case, the fire appears to have originated within the engine compartment of the Insured Vehicle as this was the area where the damage of fire nature was most severe.

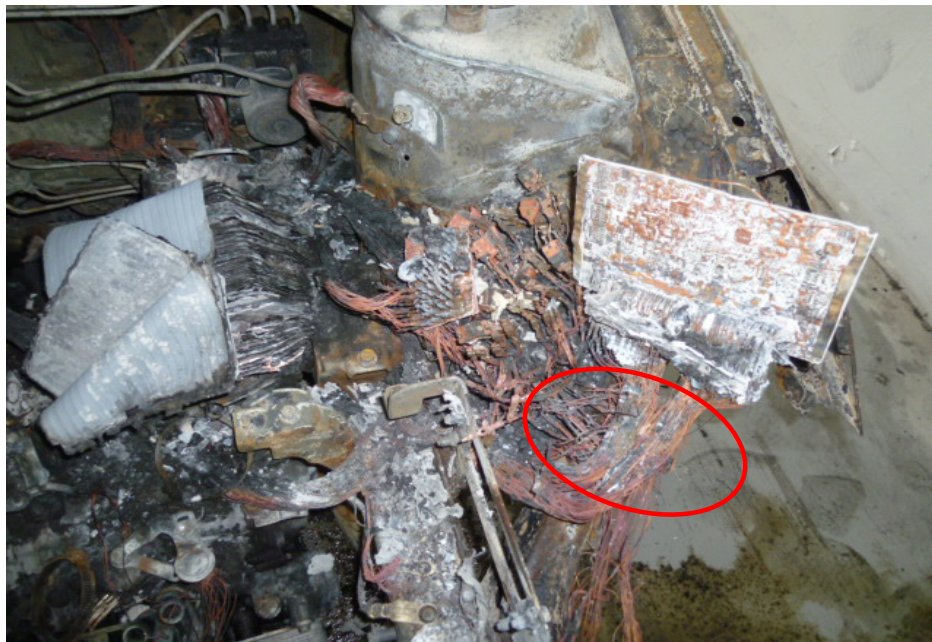
8. Upon closer examination of the left portion of the engine compartment, which was where the fire to the Insured Vehicle had likely started, we had found faint traces of greenish residue on several stretches of wirings. These wirings were original factory fitted wirings that were around the right portion of the engine compartment. The presence of greenish residue indicates internal heating of copper wires, a sign of an electrical short circuit occurring. The greenish residue is normally left behind from oxidation as a result of chemical reaction involving the copper wires. This physical evidence would appear to suggest that the cause of fire to the Insured Vehicle could have possibly been due to electrical in nature. See photos 5 - 7 below.

**Photo 5** shows the factory fitted wirings around the left portion of the engine compartment which is near to the vicinity where the fire to the Insured Vehicle had likely started. We observed faint traces of greenish residue on some of these wirings (circled).

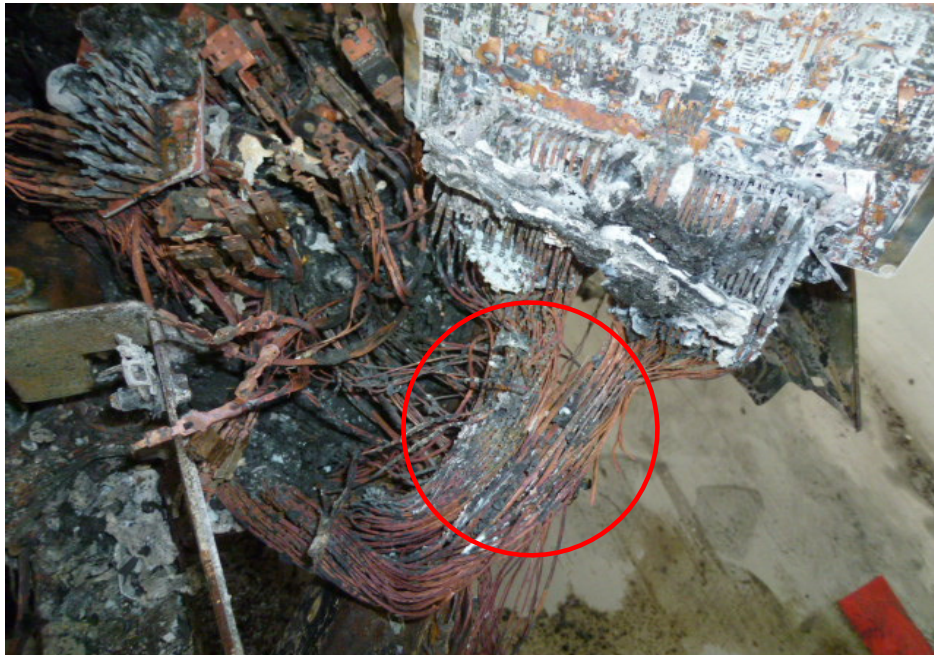
**Photo 6** shows a closer view of the wirings around the left portion of the engine compartment. We observed faint traces of greenish residue on some of these wirings (circled). This seems to suggest the occurrence of an electrical short circuit.

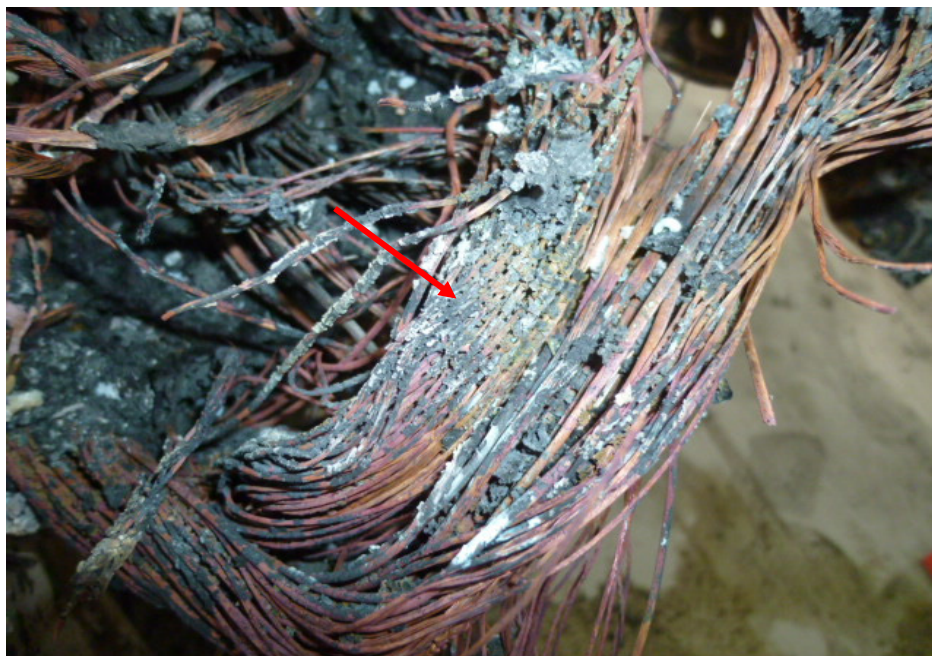
**Photo 7** shows a close up view of the faint greenish residue found on the wirings around the left portion of the engine compartment (arrowed). The presence of greenish residue indicates internal heating of copper wires, a sign of an electrical short circuit. The greenish residue is normally left behind from oxidation as a result of chemical reaction involving the copper wires.

20. The possibility of the fire being due to electrical in nature would then seem more likely given that engine overheating and external factors would both seem unlikely. The fire being due to electrical in nature is also supported by the condition of the wirings that were found in the engine compartment of the Insured Vehicle, which was earlier discussed in paragraph 8 above.

22. Having investigated and technically analysed the damages of burnt nature to the Insured Vehicle, we are of the view that the cause of fire to the Insured Vehicle was of electrical in nature. For this particular case, the fire had originated along the wirings inside the engine compartment, somewhere around the left portion of the engine compartment. The wirings were original factory fitted wirings of the Insured Vehicle.

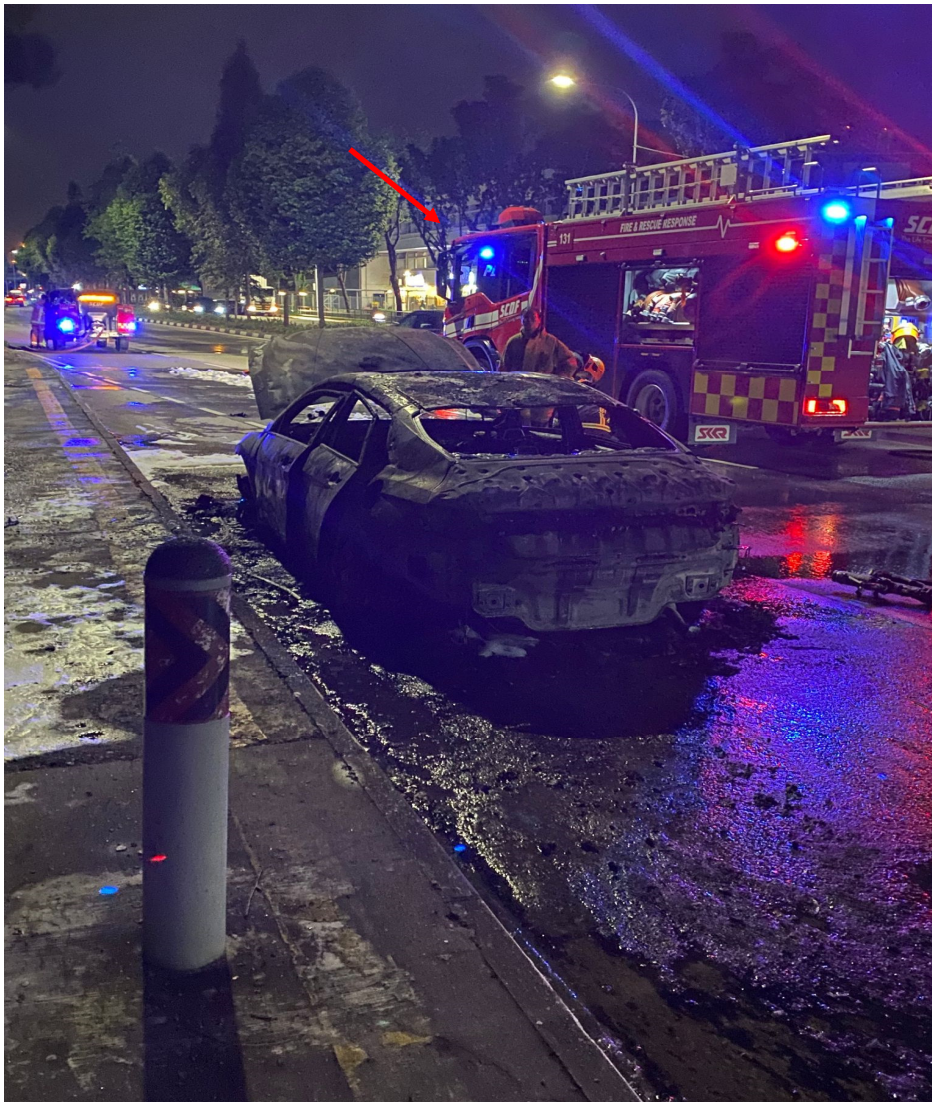
**Photo 8** shows the Insured Vehicle post- incident. In general, the information that could be gathered from this photograph had corresponded to the events that were related to us by Mr Tan, which is the SCDF were present at the incident location (arrowed).

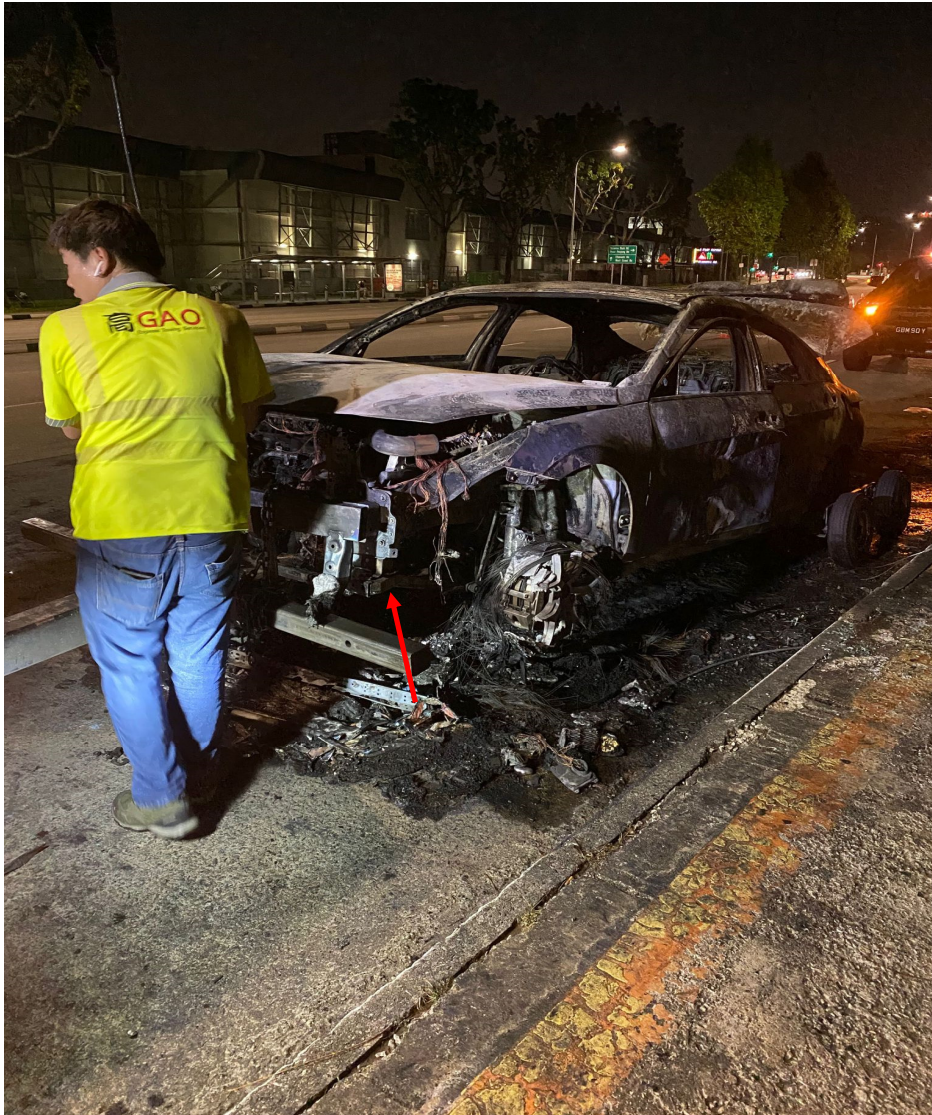
**Photo 9** shows the Insured Vehicle being prepped to be towed to Cartimes post-incident. The severity of damage of the frontal portion had corresponded to the events that were related to us by Mr Tan, which is the fire had started from the engine compartment of the Insured Vehicle (arrowed).
