Your Ref: BMW M5  
(chassis number WBS82CH080CH69715)  
Our Ref : CI/TP23005597/D

02 June 2023

**Rally Pitstop**

**INSPECTION REPORT OF AN UNREGISTERED BMW M5 MOTOR CAR WITH CHASSIS NUMBER WBS82CH080CH69715**

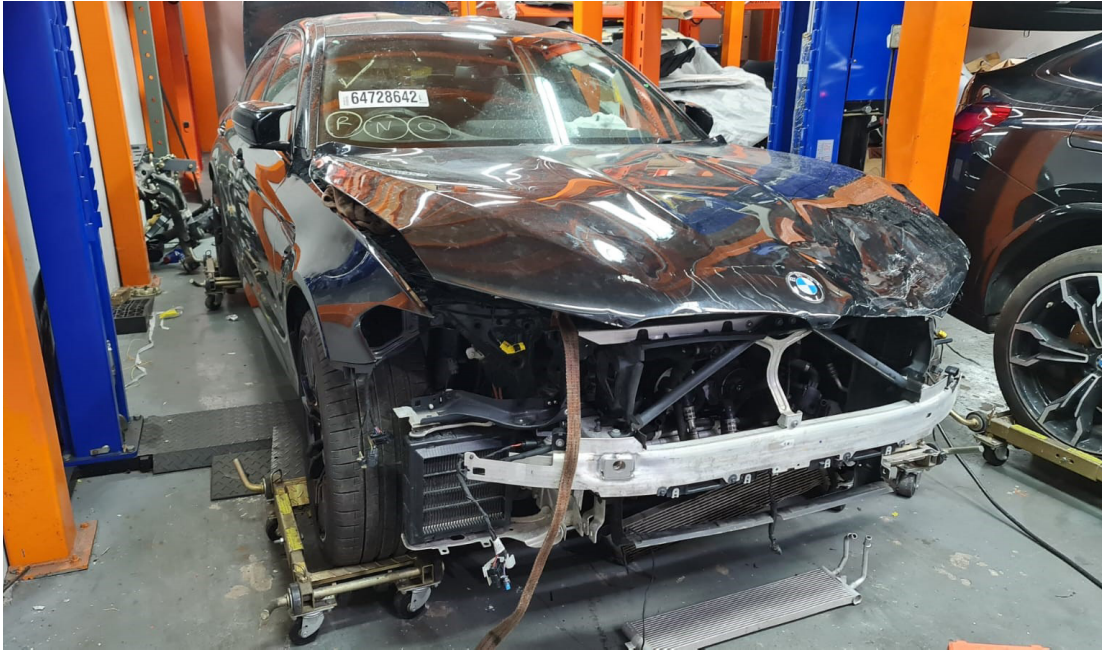
3. The photographs provided to me had showed damage to the frontal portion of the Motor Car. Body parts damaged include the front bumper reinforcement, front bonnet, front bonnet hinges, front bonnet locks, front left fender, front right fender, aircon condenser, radiator, cooling fan, oil cooler, front centre top panel, front centre top panel garnish, front air guide, front left headlamp lower bracket and front right headlamp lower bracket amongst others.

4. The Motor Car's front left headlamp, front left headlamp top panel, front right headlamp, front right headlamp top panel, front grilles, front left fender inner shield, front right fender inner shield, front bumper and all its related parts and attachments like the front bumper sponge, front bumper sensors, front bumper centre lower grille, front bumper left lower moulding, front bumper right lower moulding and front bumper tow cover amongst others, were also missing/dislodged/damaged.

**Photo 1** shows a general view of the front right body of the Motor Car (photograph provided to me). The Motor Car was observed to have sustained damage at its frontal portion. The front bumper reinforcement, front bonnet, front bonnet hinges, front bonnet locks, front right fender, aircon condenser, radiator, cooling fan, oil cooler, front centre top panel, front centre top panel garnish, front air guide and front right headlamp lower bracket were amongst the body parts that were observed to have been damaged. The Motor Car's front right headlamp, front right headlamp top panel, front grilles, front right fender inner shield, front bumper and all its related parts and attachments like the front bumper sponge, front bumper sensors, front bumper centre lower grille, front bumper right lower moulding and front bumper tow cover amongst others, were also missing/dislodged/damaged.

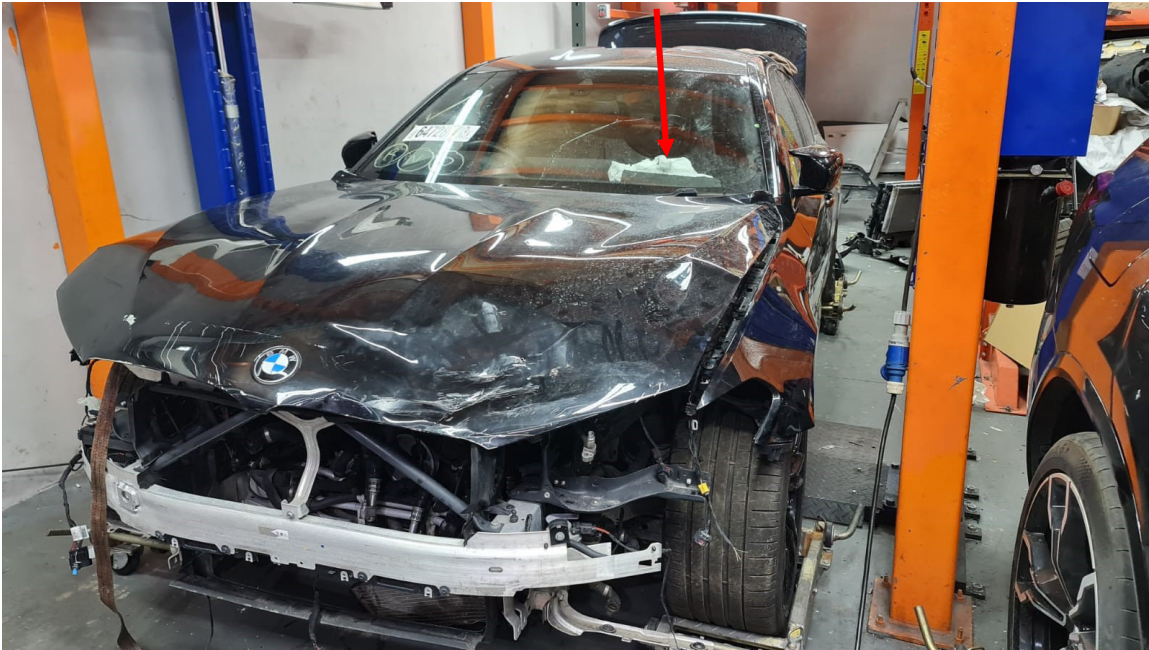
5. Apart for the frontal portion, there was no physical damage observed to other areas of the Motor Car. The front left passenger airbag of the Motor Car was deployed as seen from the photographs that were provided to me. See photo 1 – 4 below.

**Photo 2** shows a general view of the front left body of the Motor Car (photograph provided to me). The Motor Car was observed to have sustained damage at its frontal portion. The front bumper reinforcement, front bonnet, front bonnet hinges, front bonnet locks, front left fender and front left headlamp lower bracket were amongst the body parts that were observed to have been damaged. The Motor Car's front left headlamp, front left headlamp top panel, front grilles, front left fender inner shield, front bumper and all its related parts and attachments like the front bumper sponge, front bumper sensors, front bumper centre lower grille and front bumper left lower moulding amongst others, were also missing/dislodged/damaged. The front left passenger airbag (arrowed) of the Motor Car was deployed.

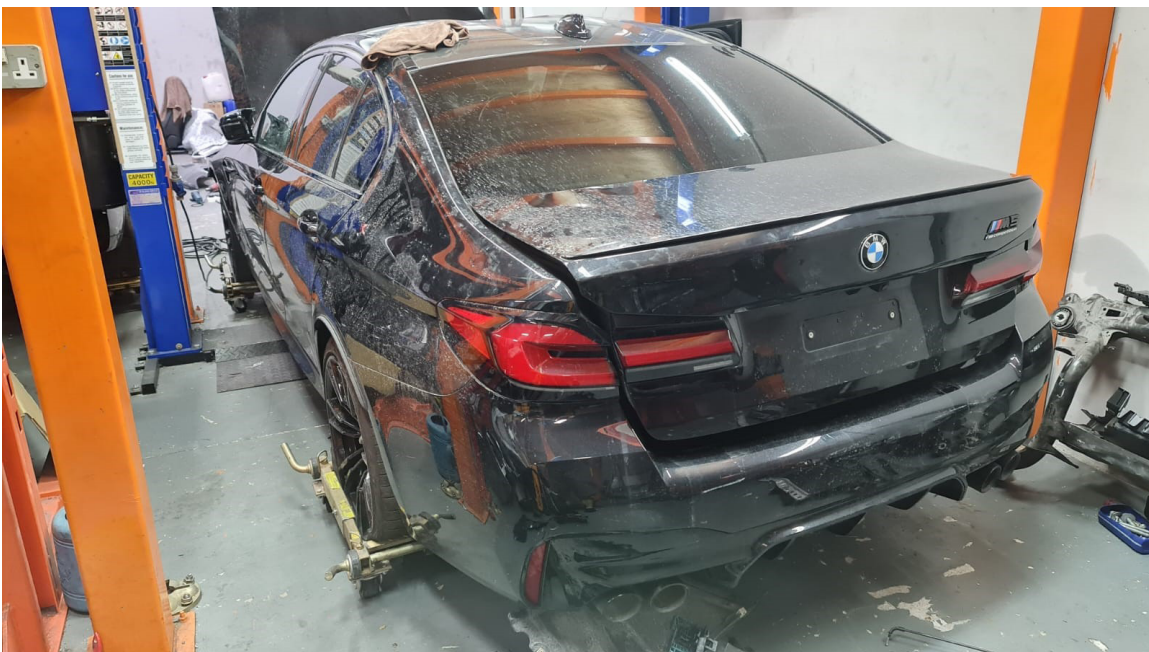
**Photo 3** shows a general view of the rear left body of the Motor Car (photograph provided to me). Apart for the frontal portion, there was no physical damage observed to other areas of the Motor Car.

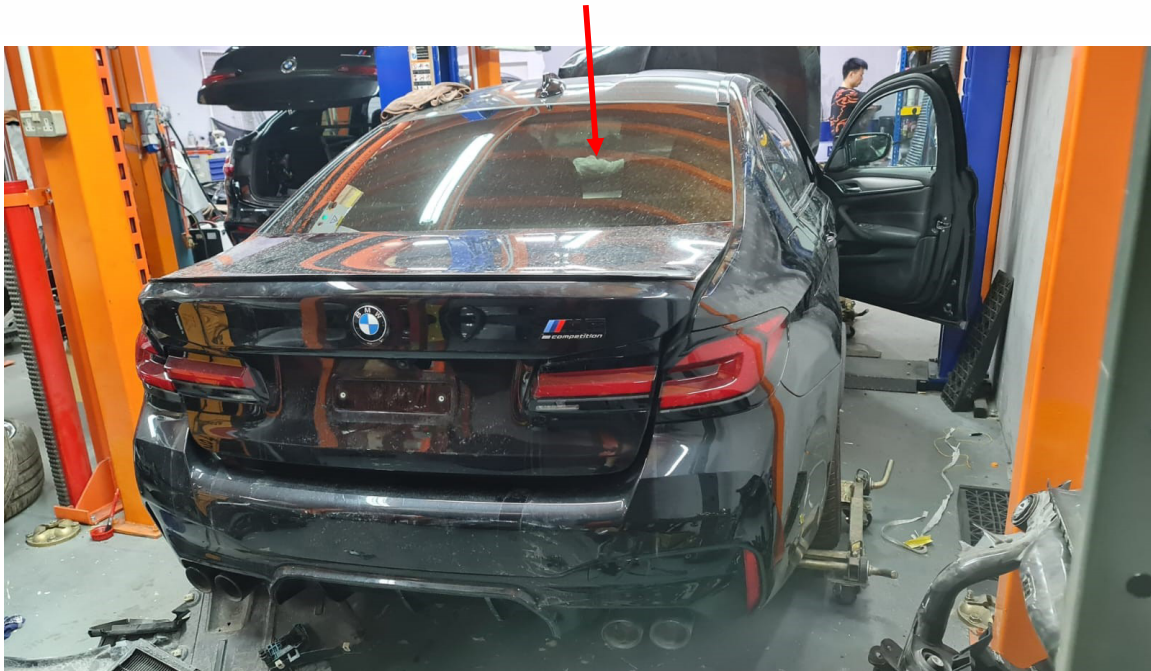
**Photo 4** shows a general view of the rear right body of the Motor Car (photograph provided to me). Apart for the frontal portion, there was no physical damage observed to other areas of the Motor Car. The front left passenger airbag (arrowed) of the Motor Car was deployed.

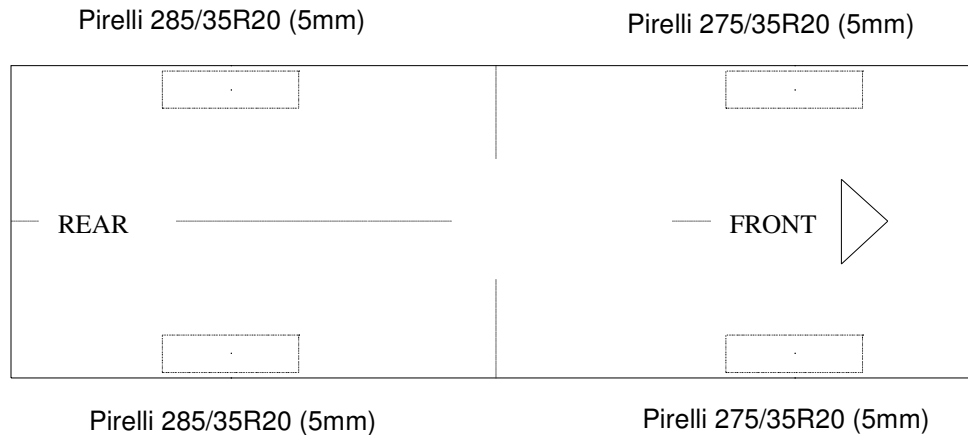
9. It was fitted with 20inch sport wheel rims that were wrapped with tyres that were observed to be of serviceable condition. The tyres were also sufficiently inflated for vehicular operation. The tyre brand, tyre size and approximate remaining tread depth of the 4 tyres of the Motor Car were recorded as follows: -

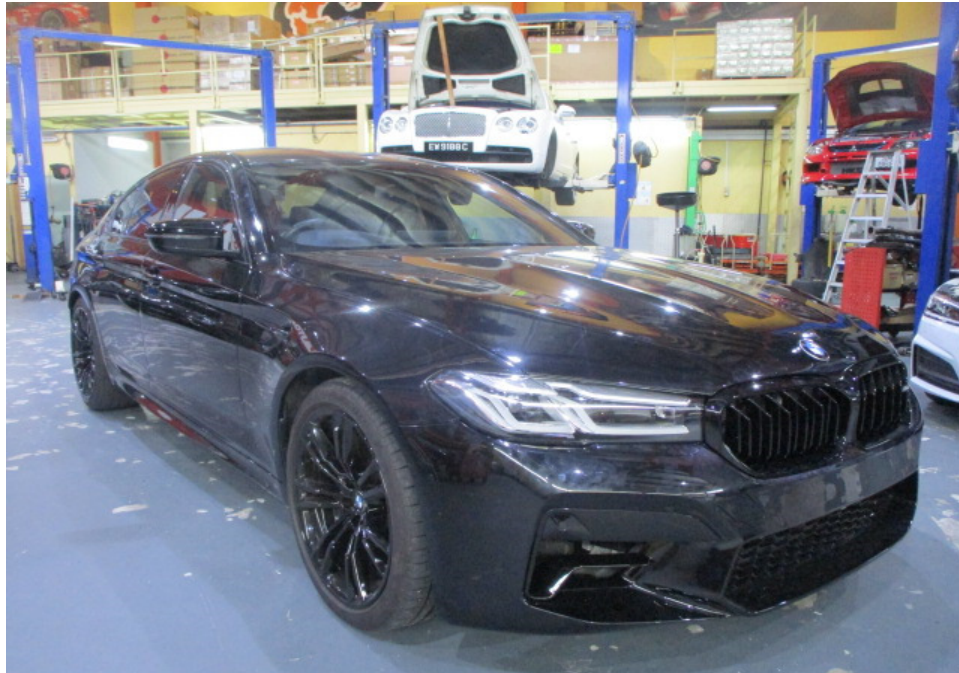
23. The body parts at the frontal portion of the Motor Car were visually examined and it was noted that the repair/restoration works carried out to the damaged area of the Motor Car (refer to photograph 1 & 2 above) were reasonably adequate and in order.

**Photo 5** shows a general view of the front right body of the Motor Car at the time of my inspection. The Motor Car was observed to be in a relatively good general condition with no loose exterior fittings observed. The body parts at the frontal portion of the Motor Car were visually examined and it was observed that the repair/restoration works carried out to the damaged area of the Motor Car (refer to photograph 1 & 2 above) were reasonably adequate and in order.

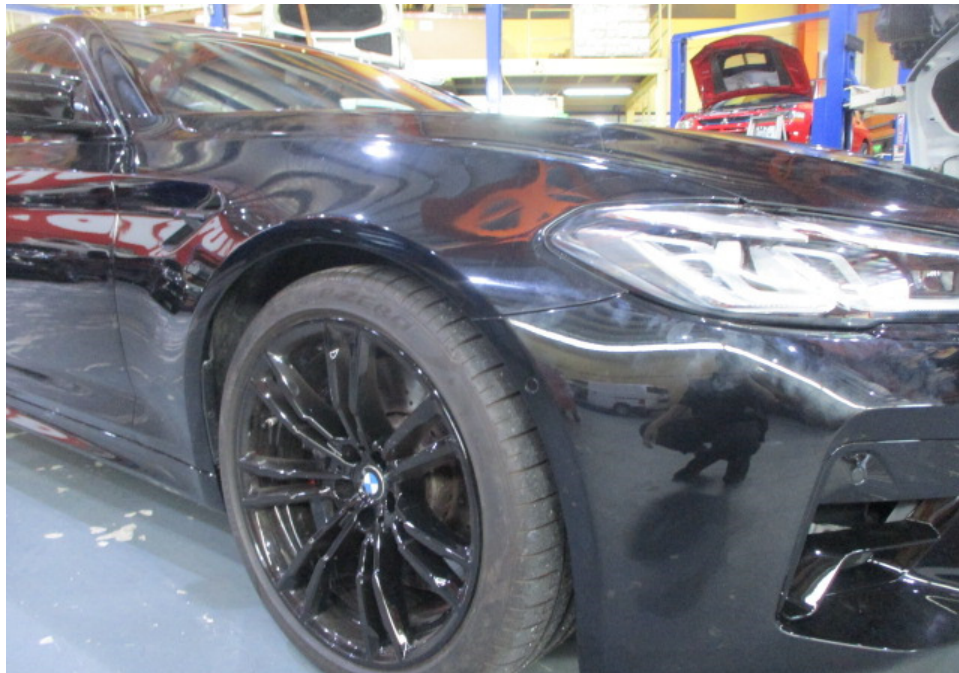
**Photo 6** shows a closer view of the Motor Car's front bumper, front right headlamp, front right fender and front right wheel rim. The body parts at the frontal portion of the Motor Car were visually examined and it was observed that the repair/restoration works carried out to the damaged area of the Motor Car (refer to photograph 1 & 2 above) were reasonably adequate and in order.

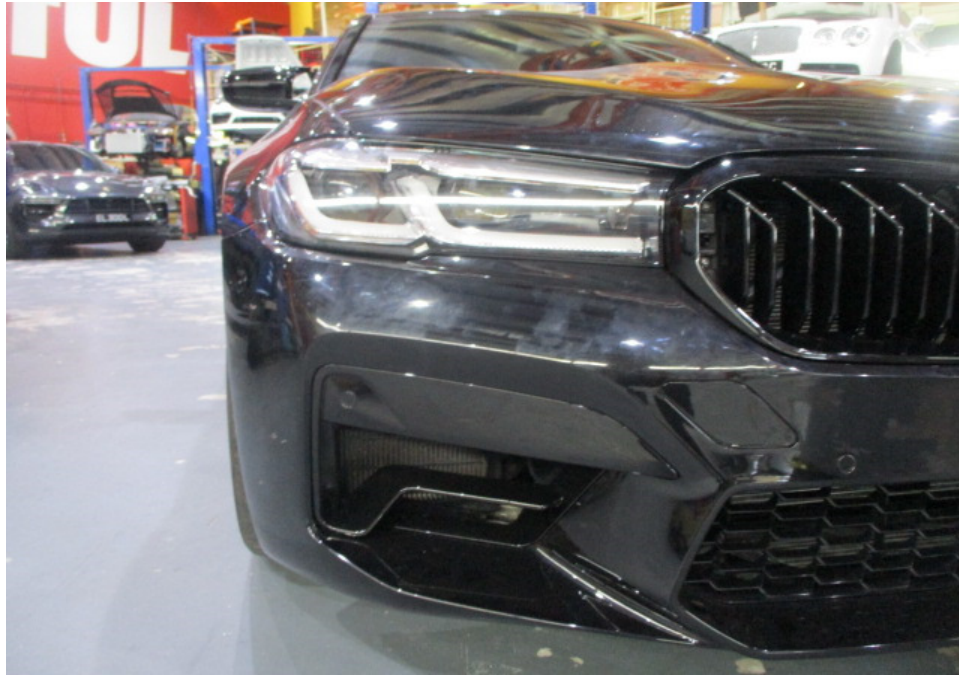
**Photo 7** shows a closer view of the Motor Car's front bumper, front bumper right lower moulding, front bumper right sensors, front bumper tow cover, front right headlamp and front bonnet. The body parts at the frontal portion of the Motor Car were visually examined and it was observed that the repair/restoration works carried out to the damaged area of the Motor Car (refer to photograph 1 & 2 above) were reasonably adequate and in order.

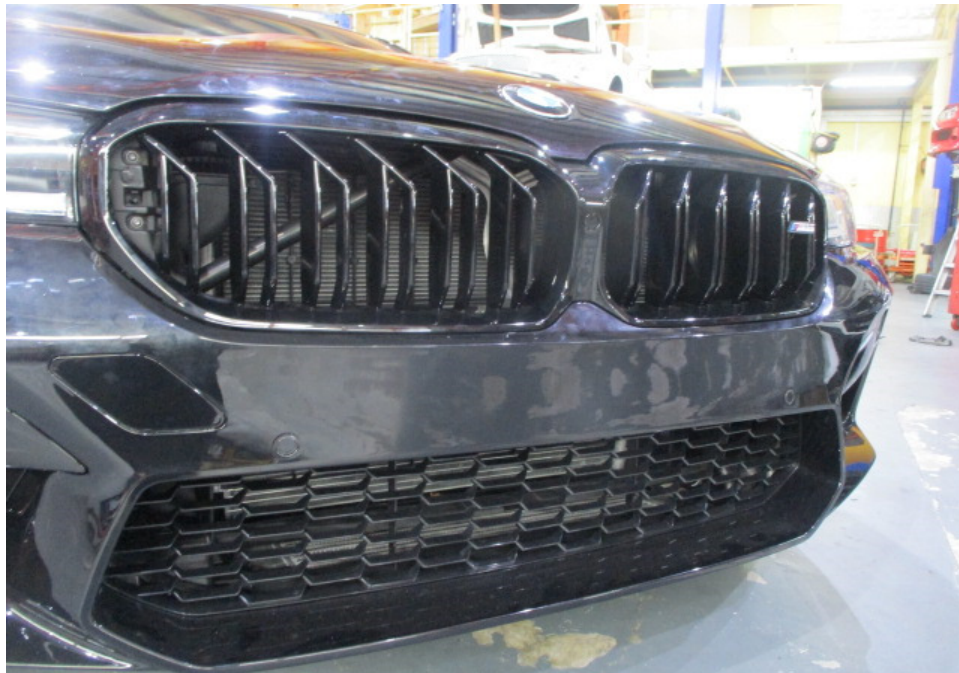
**Photo 8** shows a closer view of the Motor Car's front bumper centre lower grille, front grilles, oil cooler and aircon condenser. The body parts at the frontal portion of the Motor Car were visually examined and it was observed that the repair/restoration works carried out to the damaged area of the Motor Car (refer to photograph 1 & 2 above) were reasonably adequate and in order.

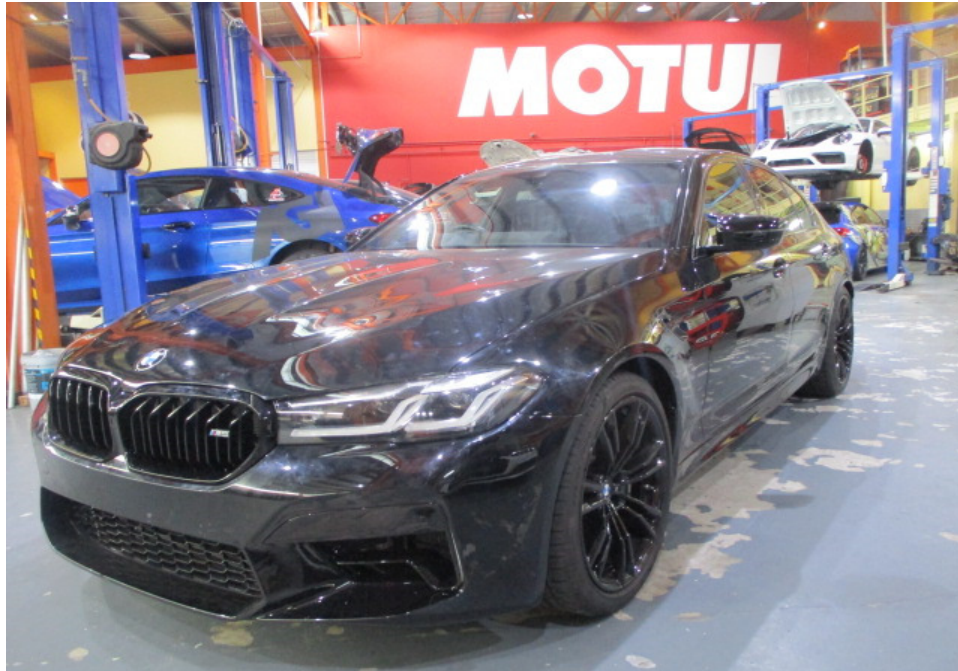
**Photo 9** shows a general view of the front left body of the Motor Car at the time of my inspection. The Motor Car was observed to be in a relatively good general condition with no loose exterior fittings observed. The body parts at the frontal portion of the Motor Car were visually examined and it was observed that the repair/restoration works carried out to the damaged area of the Motor Car (refer to photograph 1 & 2 above) were reasonably adequate and in order.

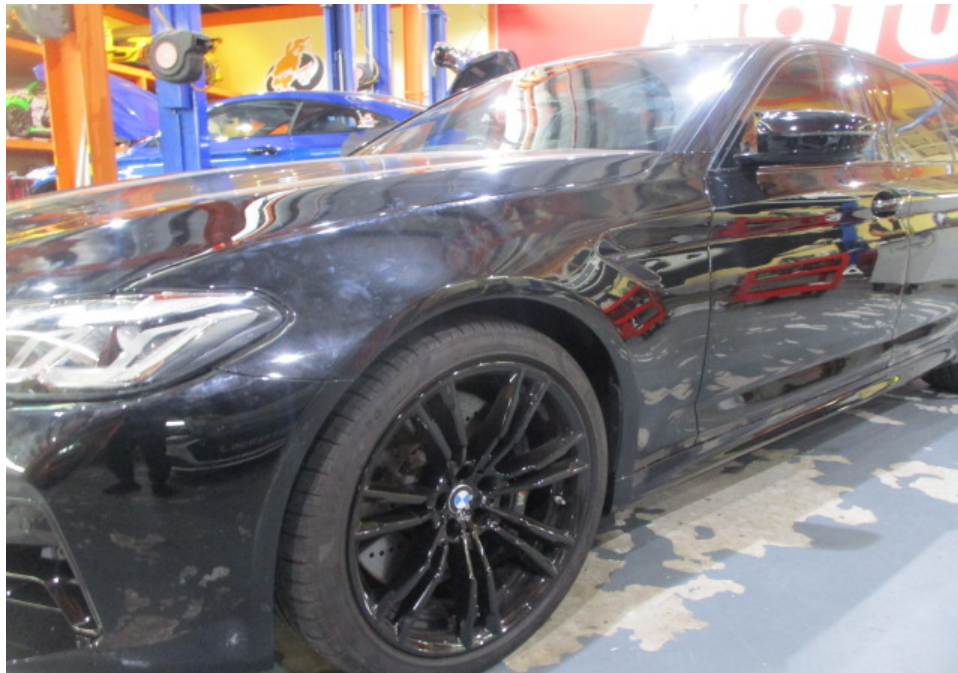
**Photo 10** shows a closer view of the Motor Car's front left headlamp, front left fender and front left wheel rim. The body parts at the frontal portion of the Motor Car were visually examined and it was observed that the repair/restoration works carried out to the damaged area of the Motor Car (refer to photograph 1 & 2 above) were reasonably adequate and in order.

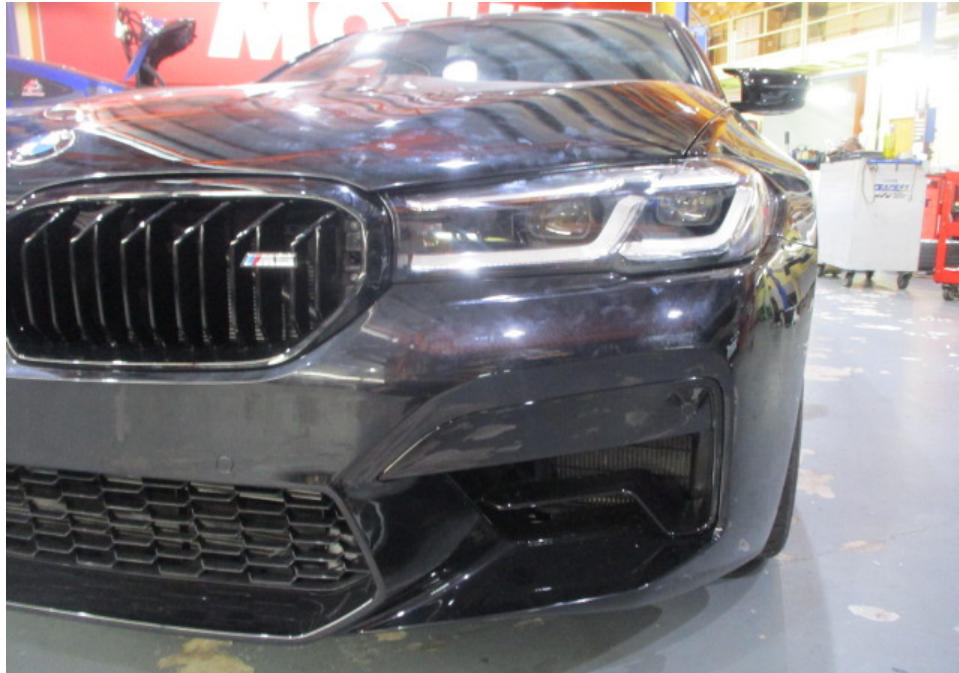
**Photo 11** shows a closer view of the Motor Car's front bumper, front bumper left lower moulding, front bumper centre lower grille, front bumper left sensors, front left headlamp and front bonnet. The body parts at the frontal portion of the Motor Car were visually examined and it was observed that the repair/restoration works carried out to the damaged area of the Motor Car (refer to photograph 1 & 2 above) were reasonably adequate and in order.

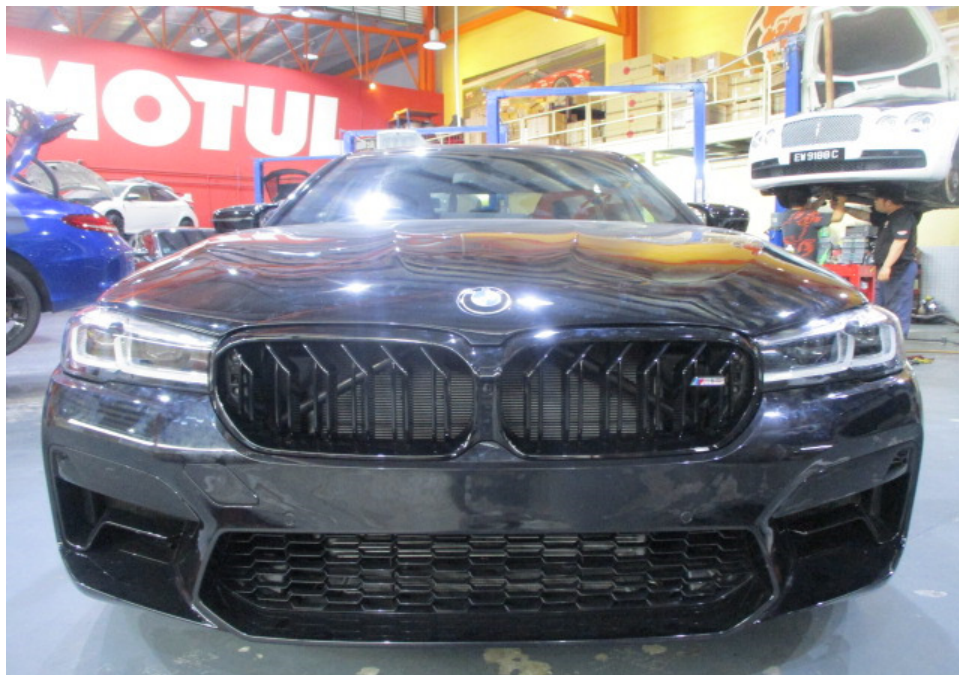
**Photo 12** shows a closer view of the Motor Car's frontal body. The body parts at the frontal portion of the Motor Car were visually examined and it was observed that the repair/restoration works carried out to the damaged area of the Motor Car (refer to photograph 1 & 2 above) were reasonably adequate and in order.

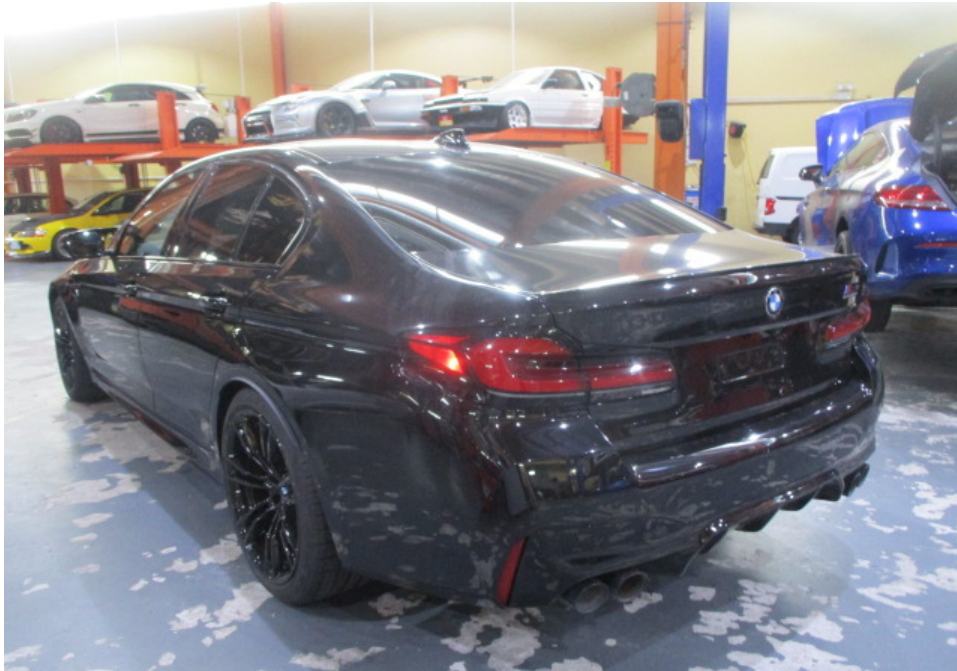
**Photo 13** shows a general view of the rear left body of the Motor Car at the time of my inspection. The Motor Car was observed to be in a relatively good general condition with no loose exterior fittings observed. The mileage of the Motor Car recorded at the time of my inspection was 18,147km.

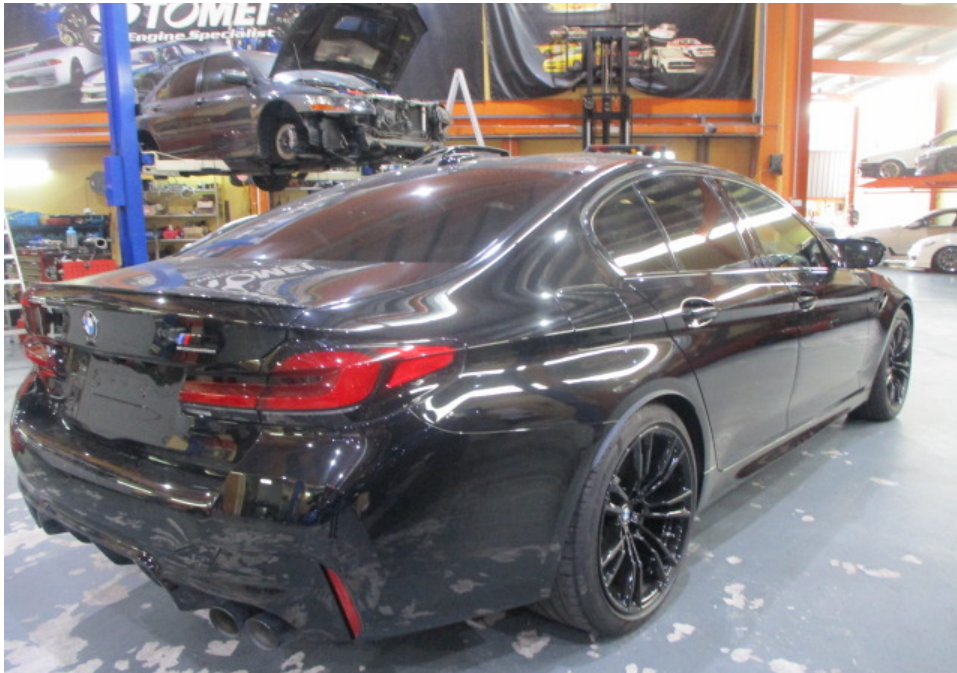
**Photo 14** shows a general view of the rear right body of the Motor Car at the time of my inspection. The Motor Car was observed to be in a relatively good general condition with no loose exterior fittings observed. The mileage of the Motor Car recorded at the time of my inspection was 18,147km.

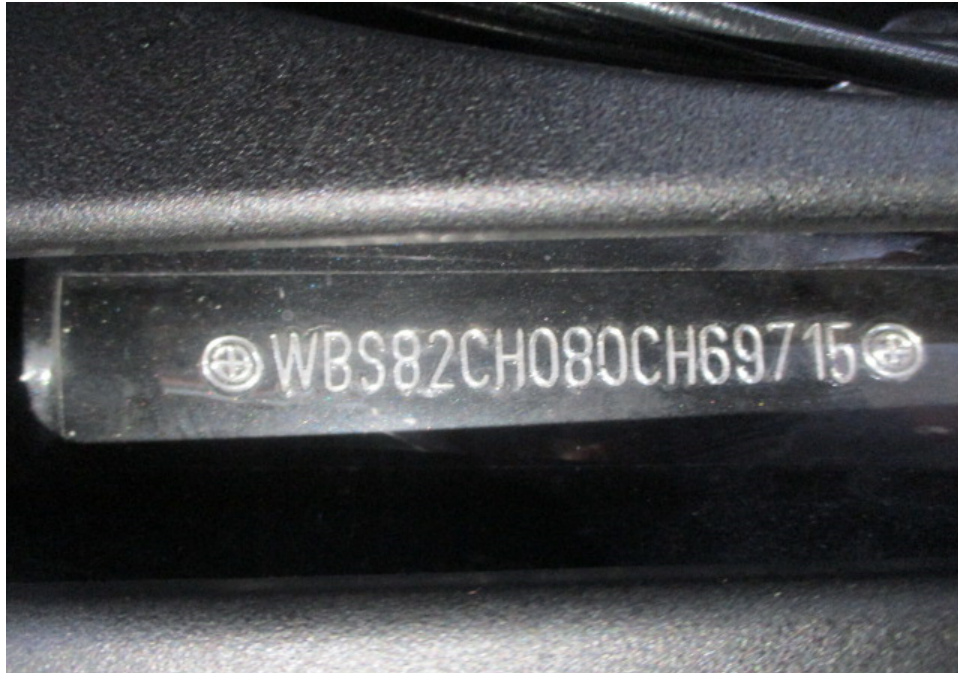
**Photo 15** shows the chassis number of the Motor Car. The chassis number recorded was WBS82CH080CH69715.

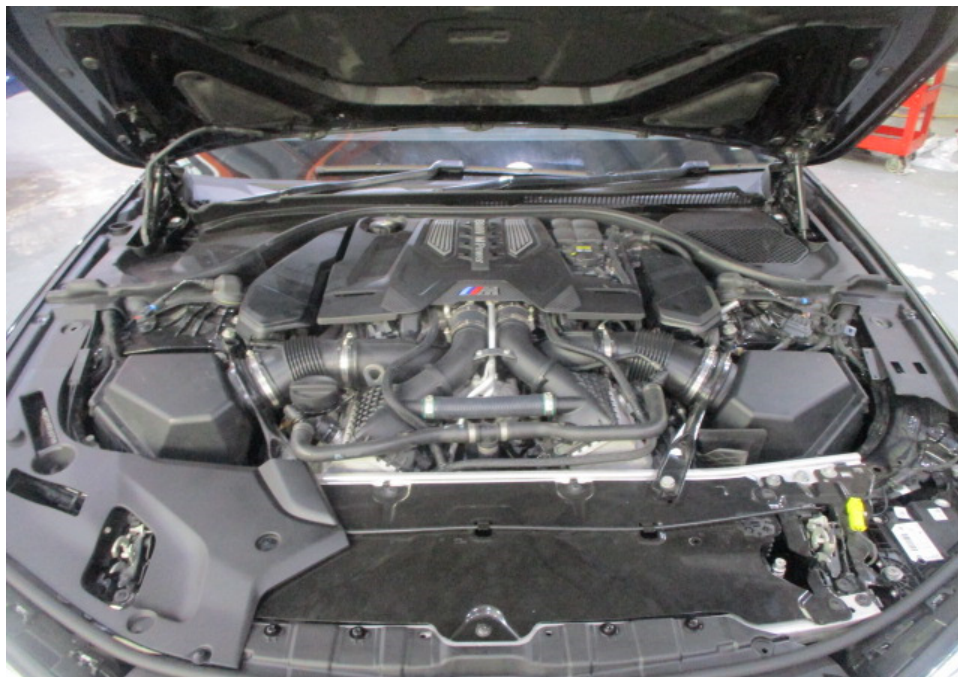
15. My examination of the engine compartment of the Motor Car revealed that the various parts and components inside the engine compartment were all intact and properly fitted. The engine oil, brake fluid and engine coolant were all found to be of sufficient level for operating purposes. Visually, there was also no contamination found to these fluids.

**Photo 16** shows a general view of the engine compartment of the Motor Car at the time of my inspection. The various parts and components inside the engine compartment were all observed to be intact and properly fitted. There was also no sign(s) or indication(s) of fluid leak and/or fluid stain found inside the engine compartment. The repair/restoration works carried out to the various parts within the engine compartment like the front headlamp top panels, front centre top panel, front centre top panel garnish, front air guide, aircon condenser, radiator and cooling fan amongst others, were reasonably adequate and in order.

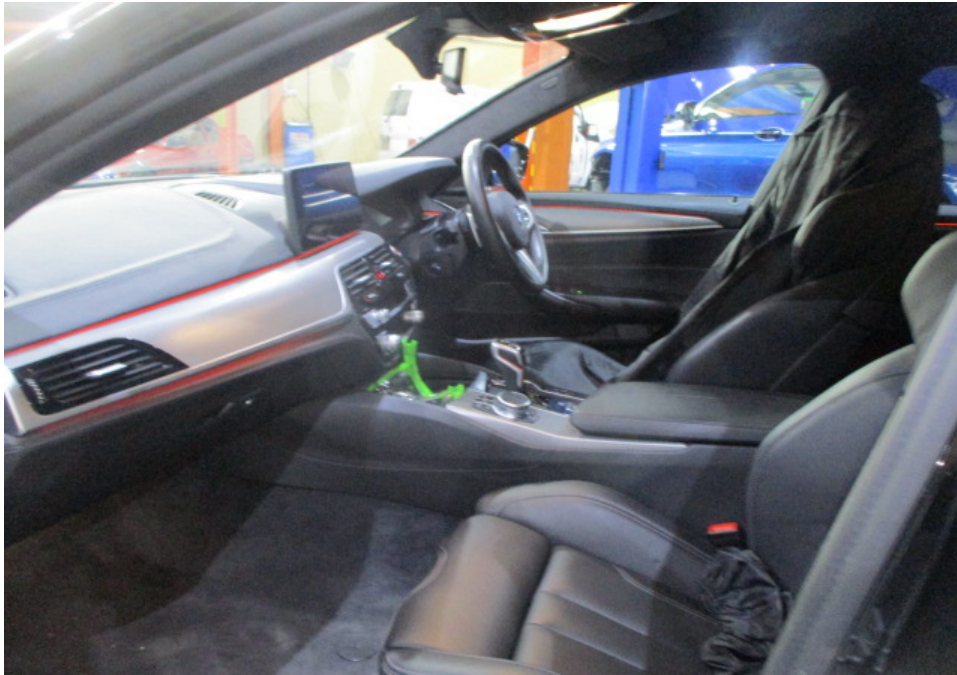
**Photo 17** shows the interior compartment of the Motor Car at the time of my inspection. The various parts and components, trims, carpet, and upholstery inside the interior compartment were all observed to be intact and properly fitted.

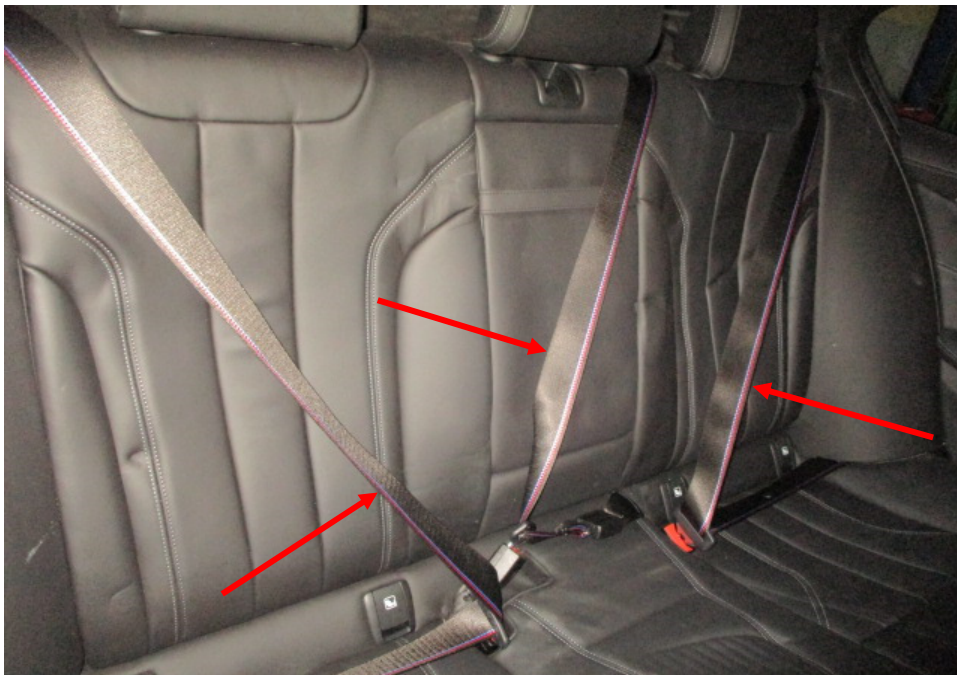
13. The seats of the Motor Car were found to be secured to the floorboard of the Motor Car via seat rails bolted onto the floorboard. Retractable seat belt reels and pre-tensioners were fitted on all seats of the Motor Car. The seat belts were tested and were able to be fastened securely into the respective pre-tensioners that were fixed to the side of all the seats.

**Photo 18** shows the rear seats of the Motor Car. All the seats of the Motor Car were secured via seat rails to the floorboard. They were also fitted with a retractable seat belt reel and a pre-tensioner. The seat belts (arrowed) were tested and were able to be fastened into the respective pre-tensions that were fitted on the side of each individual seat.

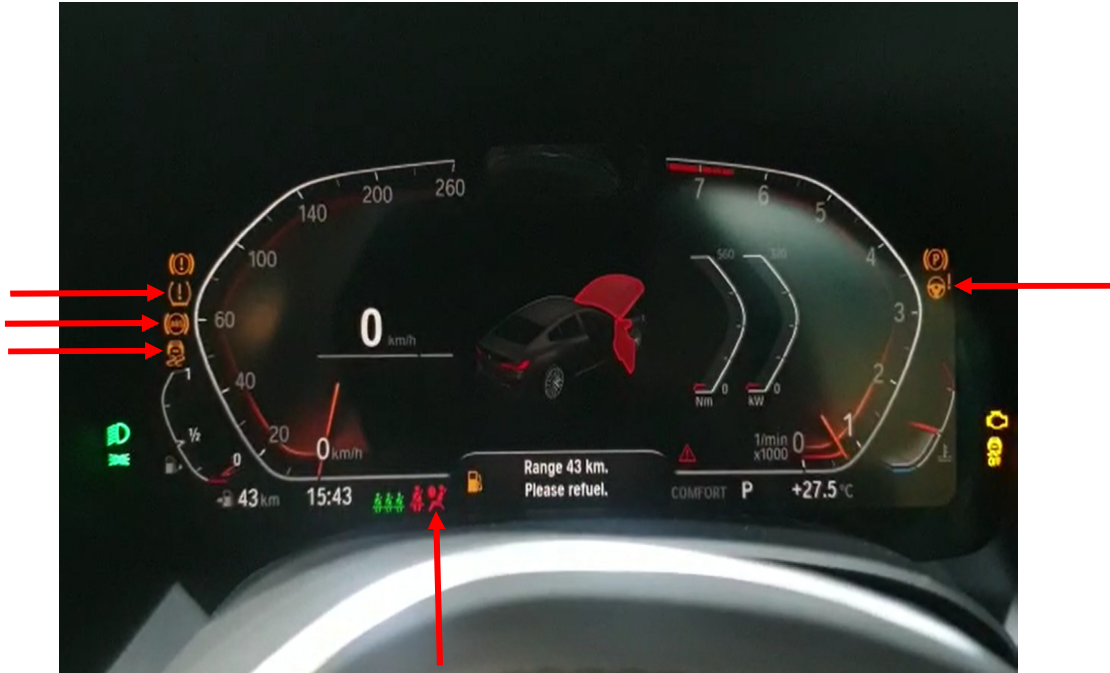
**Photo 19** shows the warning lights for the various electronic safety features appearing on the instrument panel of the Motor Car during its self-test when the engine is cranked, in particular the ABS, SRS, IAS, TPM and DSC lights (arrowed).

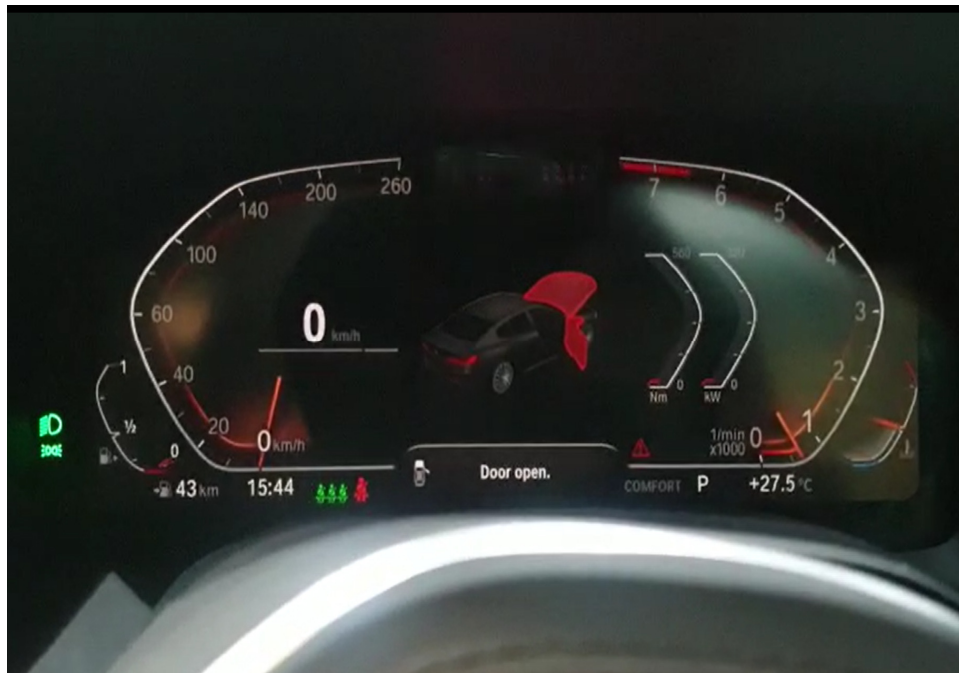
14. The Motor Car's automatic self-test of the functionality of its various electronic safety features like the Anti-Lock Brake System (ABS), Supplemental Restraint System (SRS), Integral Active Steering (IAS), Tyre Pressure Monitor (TPM) and Dynamic Stability Control (DSC) during cranking of the engine had indicated that these electronic systems were in working condition. This was determined from the respective warning lights disappearing from the instrument panel after the self-test.

**Photo 20** shows the respective warning lights no longer illuminated, indicating that there is no fault detected to the ABS, SRS, IAS, TPM and DSC systems of the Motor Car during the self-test. These electronic systems were hence in working condition at the time of my inspection.

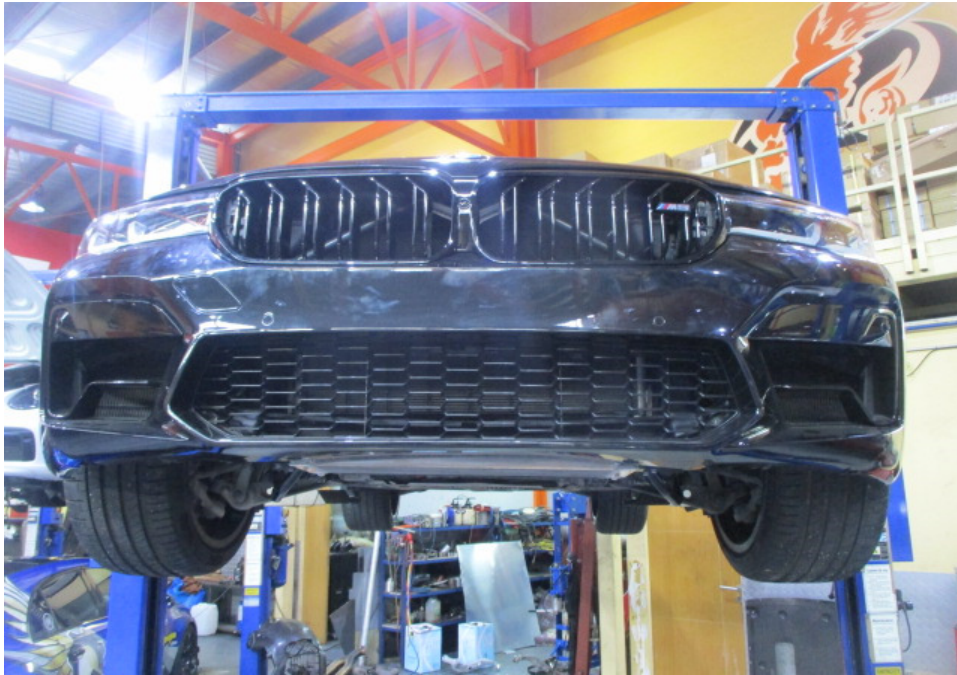
16. My checks on the underside of the Motor Car revealed no sign(s) or indication(s) of fluid leakage and/or fluid stain(s). The engine block and automatic transmission assembly were both secured properly. All undercarriage components of the Motor Car were also observed to be intact and secured in an appropriate manner.

**Photo 21** shows the Motor Car hoisted up for checks on its undercarriage. There was no sign(s) or indication(s) of fluid leakage and/or fluid stain(s) on the underside of the Motor Car. The undercarriage components of the Motor Car were also all observed to be intact and secured in an appropriate manner.

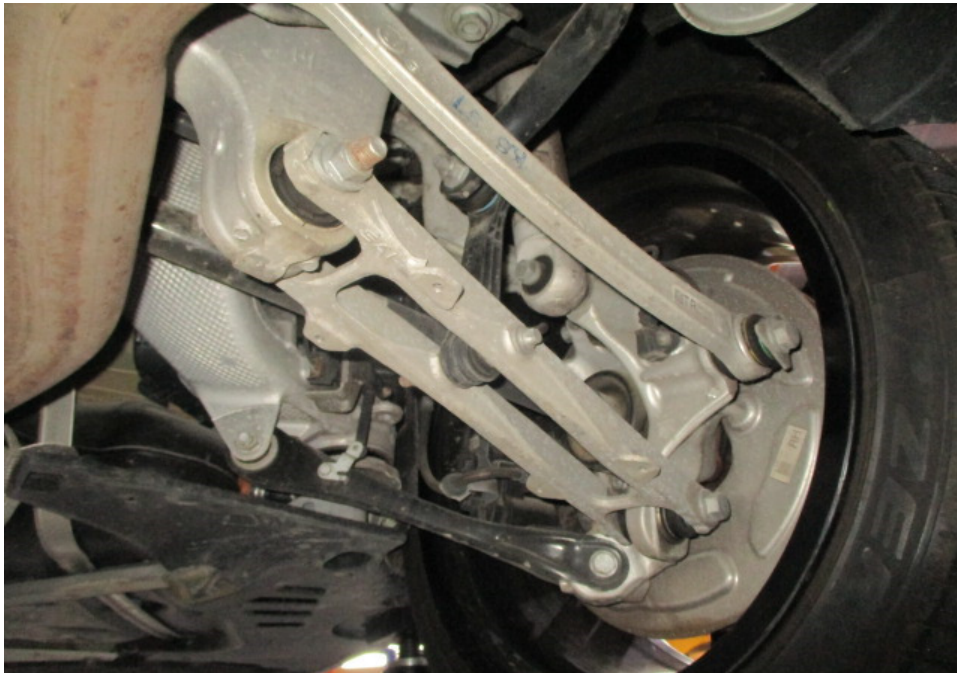
**Photo 22** shows a general view of the control arms and linkages at the rear right wheel of the Motor Car. I did not observe any fluid leak and/or fluid stain on the underside of the Motor Car. All of the Motor Car's undercarriage components were observed to be intact and secured in an appropriate manner.

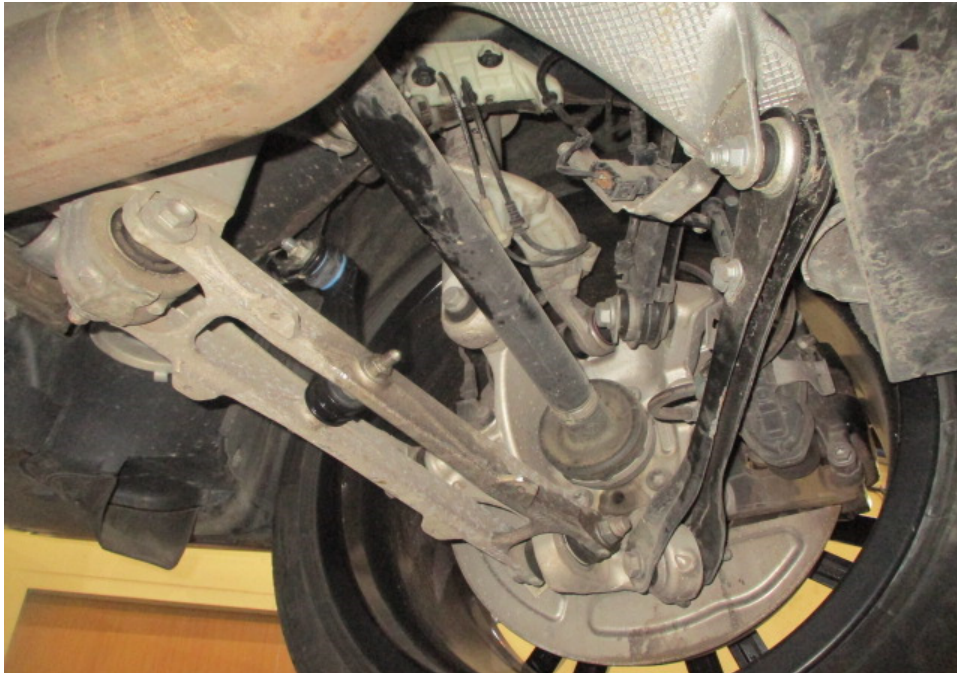
**Photo 23** shows a general view of the control arms and linkages at the rear left wheel of the Motor Car. I did not observe any fluid leak and/or fluid stain on the underside of the Motor Car. All of the Motor Car's undercarriage components were observed to be intact and secured in an appropriate manner.

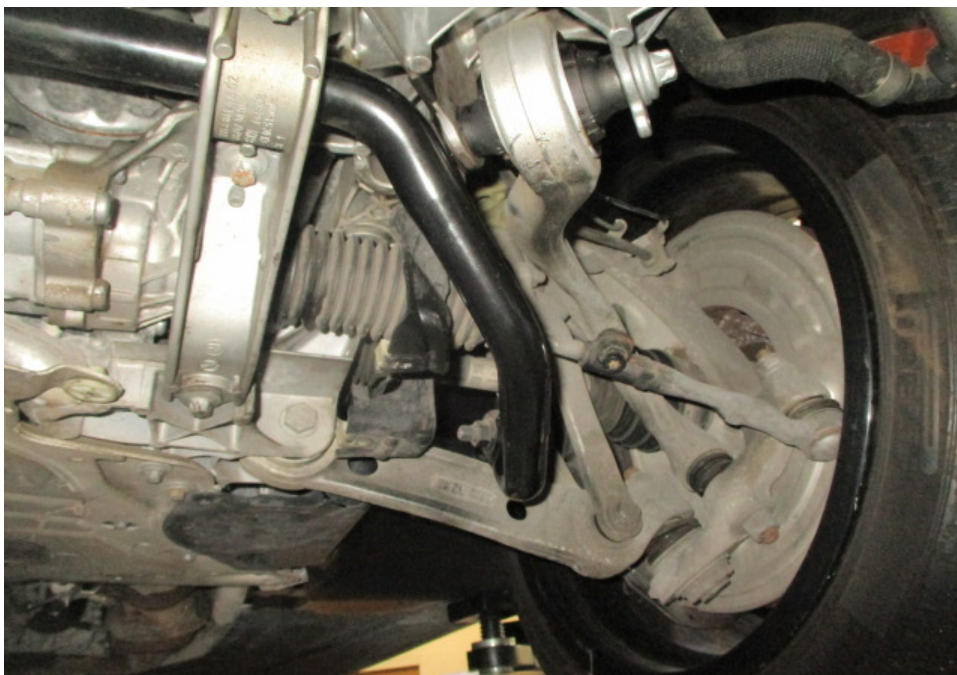
**Photo 24** shows the various undercarriage components at the front left wheel of the Motor Car. The mechanical components, control arms and linkages were all found to be intact and secured in an appropriate manner.

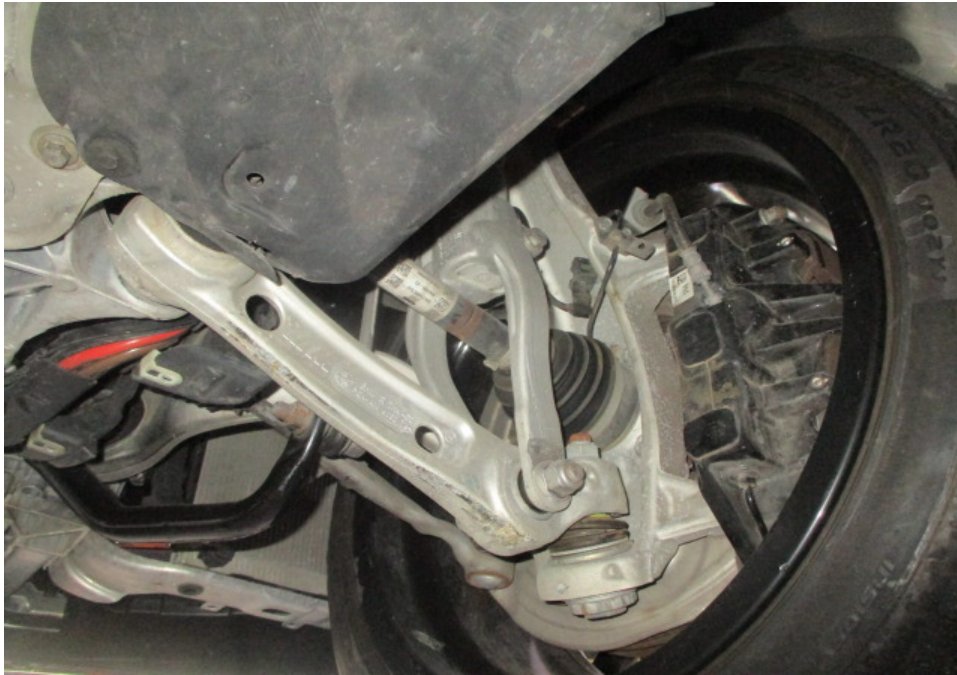
**Photo 25** shows the various undercarriage components at the front right wheel of the Motor Car. The mechanical components, control arms and linkages were all found to be intact and secured in an appropriate manner. I also did not observe any fluid leak and/or fluid stain on the underside of the Motor Car.

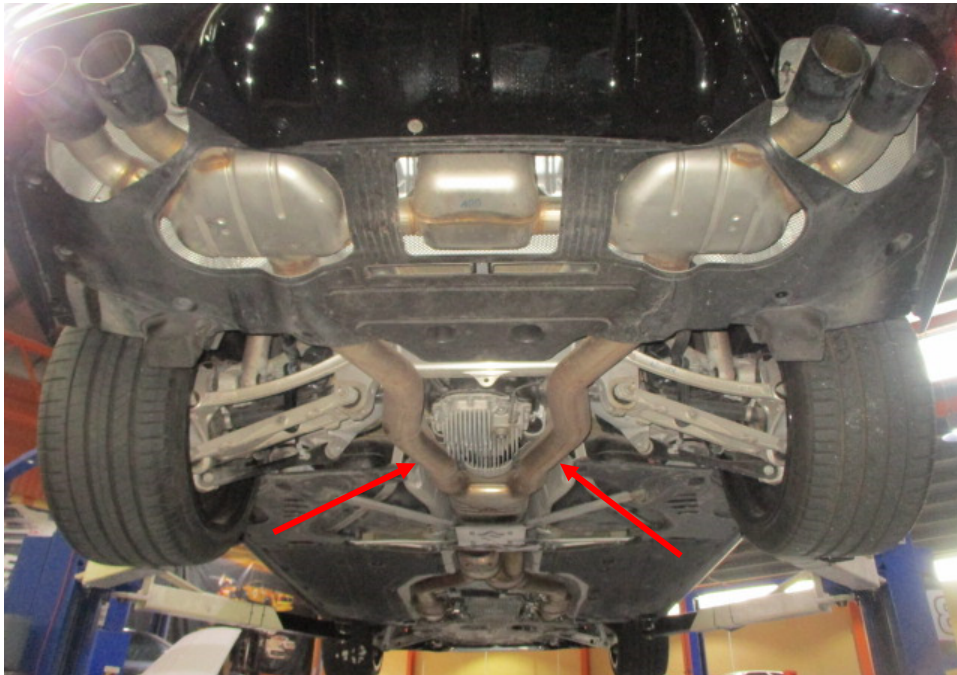
**Photo 26** shows the rear section of the Motor Car's exhaust system. My examination of the Motor Car's exhaust system revealed no sign(s) or indication(s) of any cut or weld marks along its exhaust pipes (arrowed), on its rear mufflers, on its centre resonator boxes and on its catalytic converters.

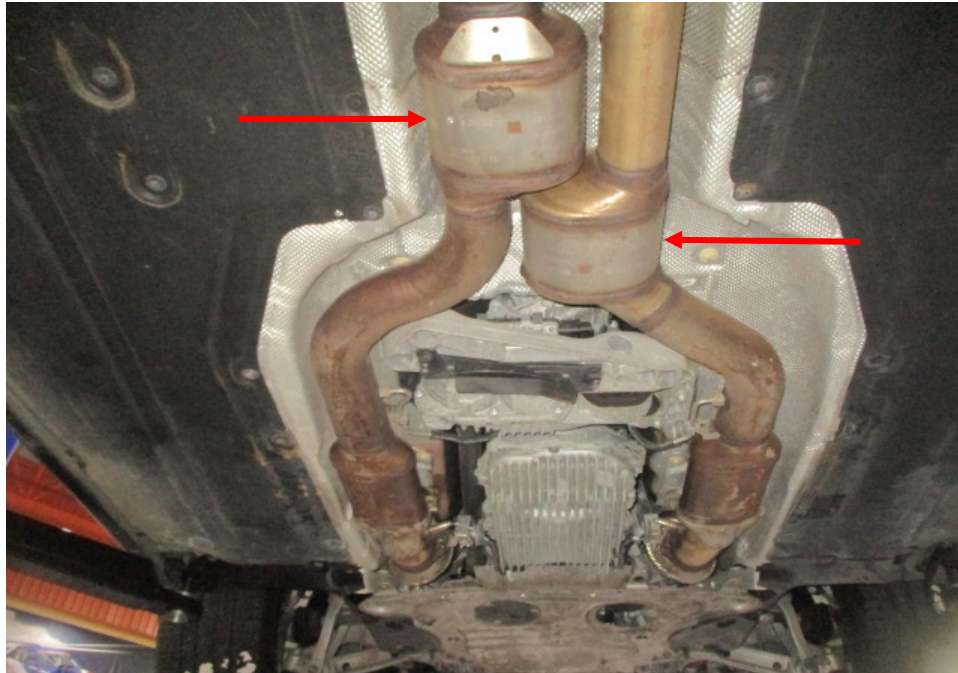
**Photo 27** shows the front section of the Motor Car's exhaust system. My examination of the Motor Car's exhaust system revealed no sign(s) or indication(s) of any cut or weld marks along its exhaust pipes, on its rear mufflers, on its centre resonator boxes (arrowed) and on its catalytic converters.

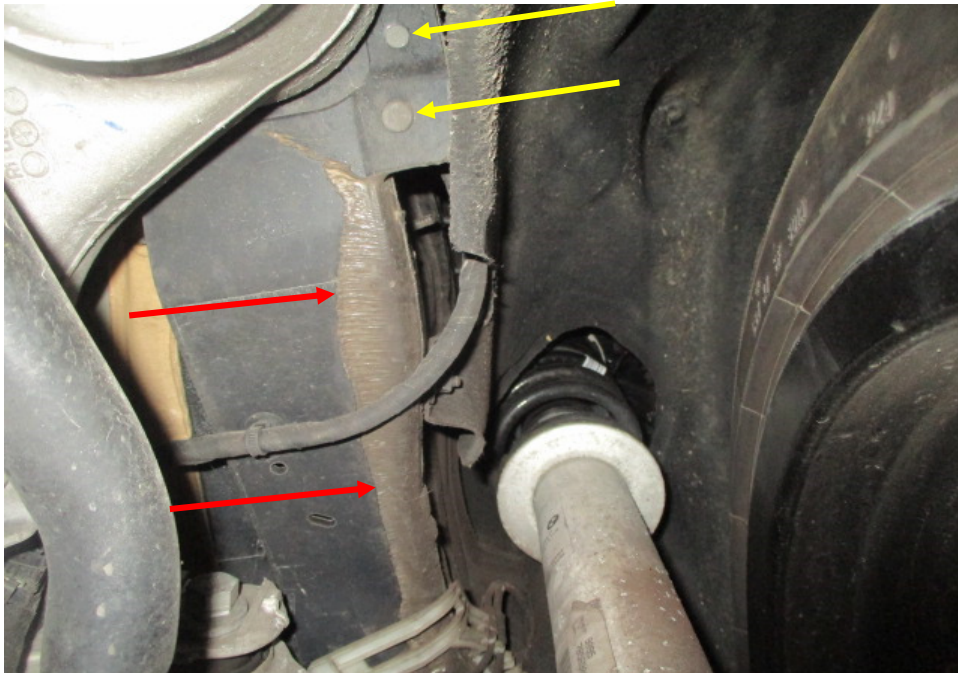
12. Visually, I did not find any weld marks, other than the original spot weld marks, on the chassis/structural body of the Motor Car. The original factory sealant at the joints along the chassis/structural body was also untouched, again indicating that no replacement of the chassis/structural body was carried out; and that the chassis/structural body was originally fitted.

**Photo 28** shows the chassis/structural body at the underside rear right of the Motor Car. I did not find any weld marks other than original spot weld marks (yellow arrow) on the chassis/structural body of the Motor Car. The original factory sealant (red arrow) at the joints along the chassis/structural body was untouched, indicating no work was done on the chassis/structural body of the Motor Car and that the chassis/structural body was originally fitted.
