Your Ref: BMW M5  
(chassis number WBS82CH080CH69715)  
Our Ref : CI/TP23005597/D

02 June 2023

**Rally Pitstop**

**INSPECTION REPORT OF AN UNREGISTERED BMW M5 MOTOR CAR WITH CHASSIS NUMBER WBS82CH080CH69715**

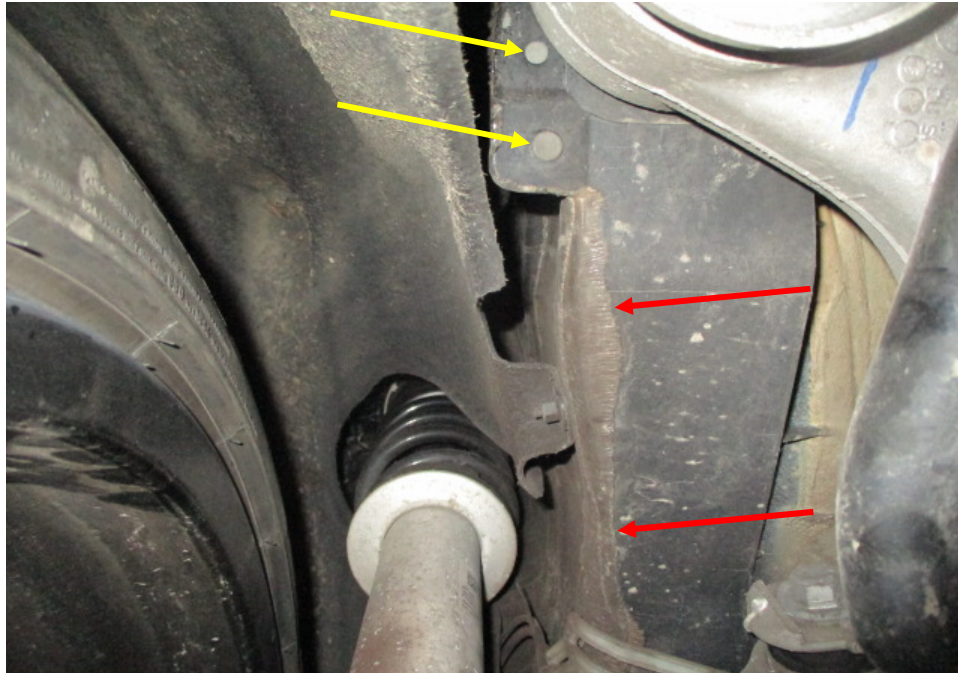
**Photo 29** shows the chassis/structural body at the underside rear left of the Motor Car. I did not find any weld marks other than original spot weld marks (yellow arrow) on the chassis/structural body of the Motor Car. The original factory sealant (red arrow) at the joints along the chassis/structural body was untouched, indicating no work was done on the chassis/structural body of the Motor Car and that the chassis/structural body was originally fitted.

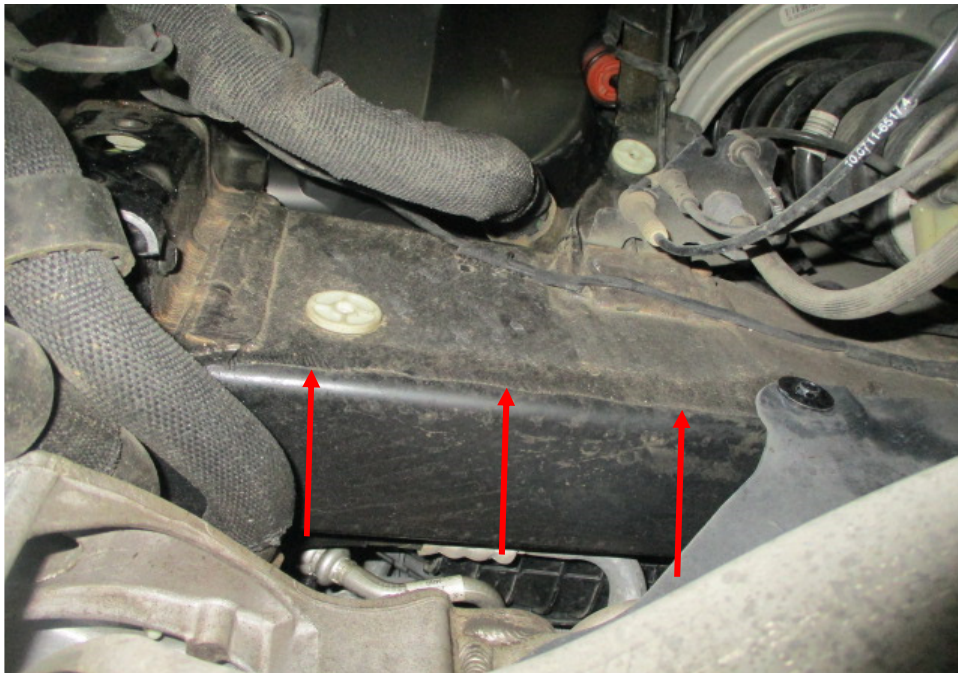
**Photo 30** shows the chassis/structural body at the underside front left of the Motor Car. The original factory sealant (arrowed) at the joints along the chassis/structural body was observed to be untouched. In general, I had found no work was carried out on the chassis/structural body of the Motor Car. The chassis/structural body of the Motor Car was originally fitted.

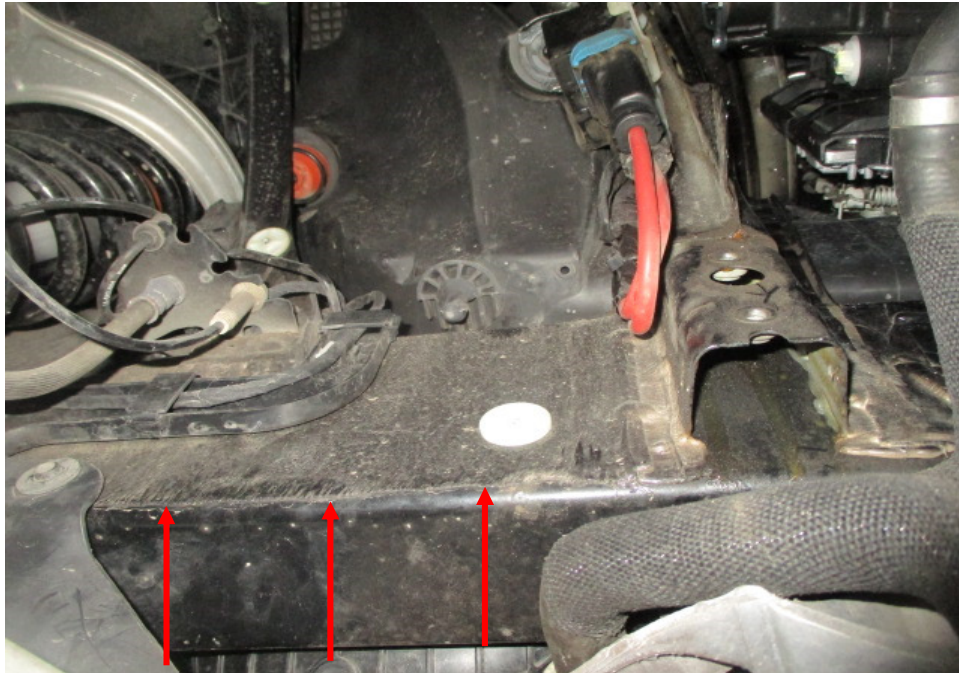
**Photo 31** shows the chassis/structural body at the underside front right of the Motor Car. The original factory sealant (arrowed) at the joints along the chassis/structural body was observed to be untouched. In general, I had found no work was carried out on the chassis/structural body of the Motor Car. The chassis/structural body of the Motor Car was originally fitted.

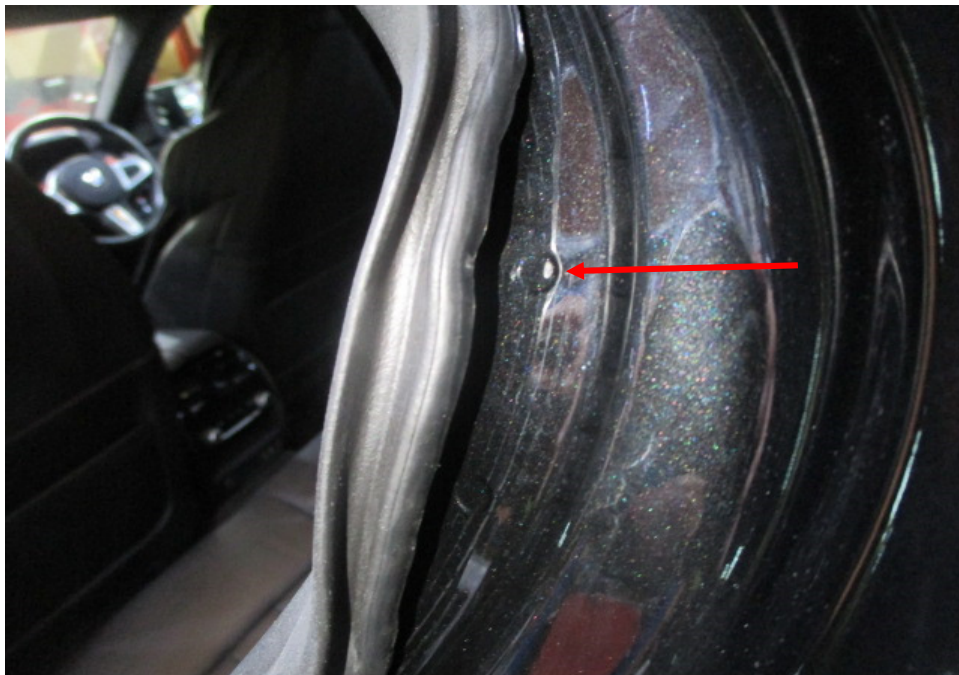
**Photo 32** shows the left side "C" pillar of the Motor Car. I did not find any weld marks other than original spot weld marks (arrowed) on the left side "C" pillar of the Motor Car, which indicates that there was no re-welding works carried out. In general, I had found all the non-detachable body panels of the Motor Car to be originally fitted at the time of my inspection.

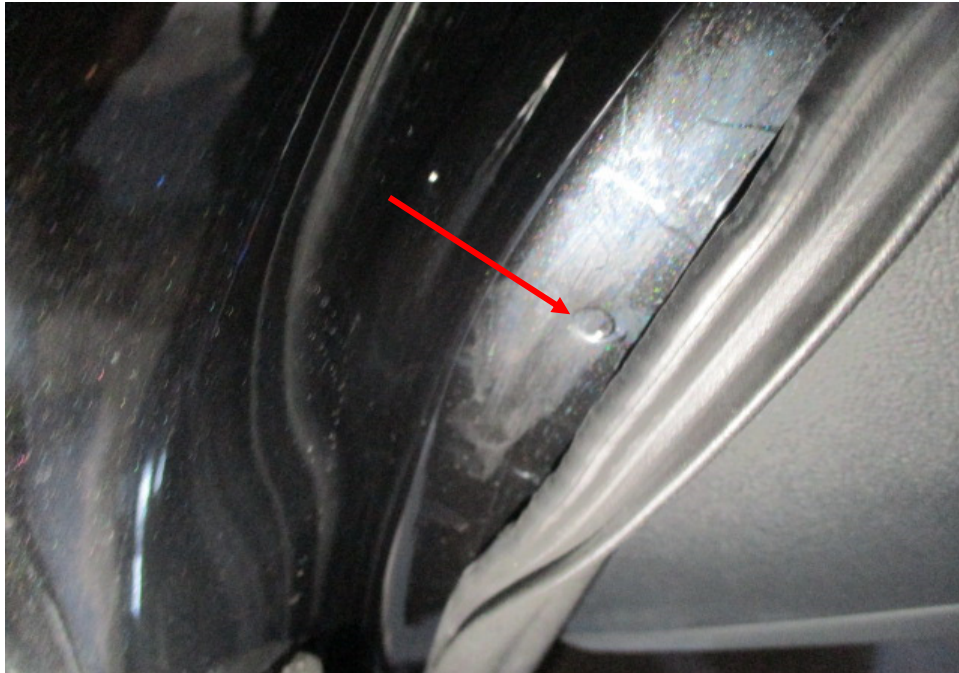
**Photo 33** shows the left side "A" pillar of the Motor Car. I did not find any weld marks other than original spot weld marks (arrowed) on the left side "A" pillar of the Motor Car, which indicates that there was no re-welding works carried out. In general, I had found all the non-detachable body panels of the Motor Car to be originally fitted at the time of my inspection.

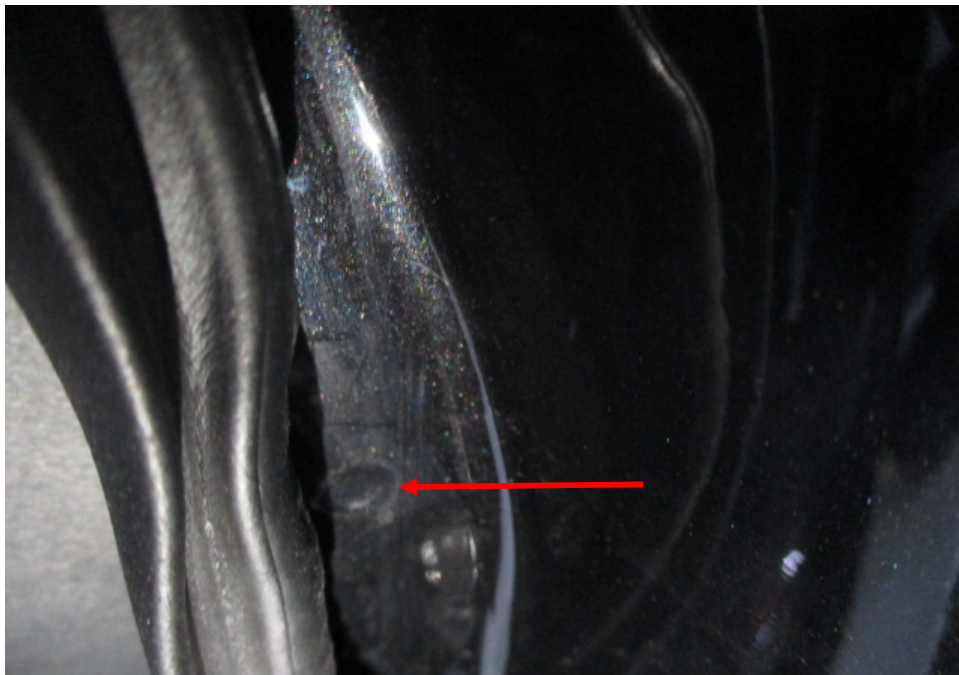
**Photo 34** shows the right side "A" pillar of the Motor Car. I did not find any weld marks other than original spot weld marks (arrowed) on the right side "A" pillar of the Motor Car, which indicates that there was no re-welding works carried out. In general, I had found all the non-detachable body panels of the Motor Car to be originally fitted at the time of my inspection.

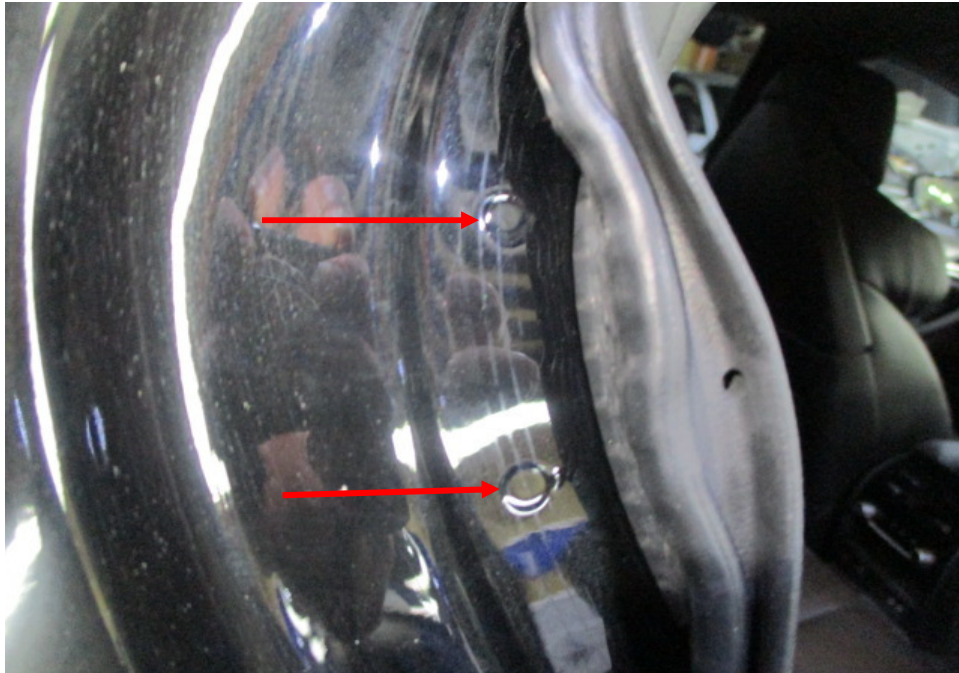
**Photo 35** shows the right side "C" pillar of the Motor Car. I did not find any weld marks other than original spot weld marks (arrowed) on the right side "C" pillar of the Motor Car, which indicates that there was no re-welding works carried out. In general, I had found all the non-detachable body panels of the Motor Car to be originally fitted at the time of my inspection.
