Your Ref: Porsche 911 Carrera 4 GTS Coupe  
(chassis number WP0ZZZ99ZNS210212)  
Our Ref: CI/TP23005598/D

02 June 2023

**INSPECTION REPORT OF AN UNREGISTERED PORSCHE 911 CARRERA 4  
GTS COUPE MOTOR CAR WITH CHASSIS NUMBER WP0ZZZ99ZNS210212**

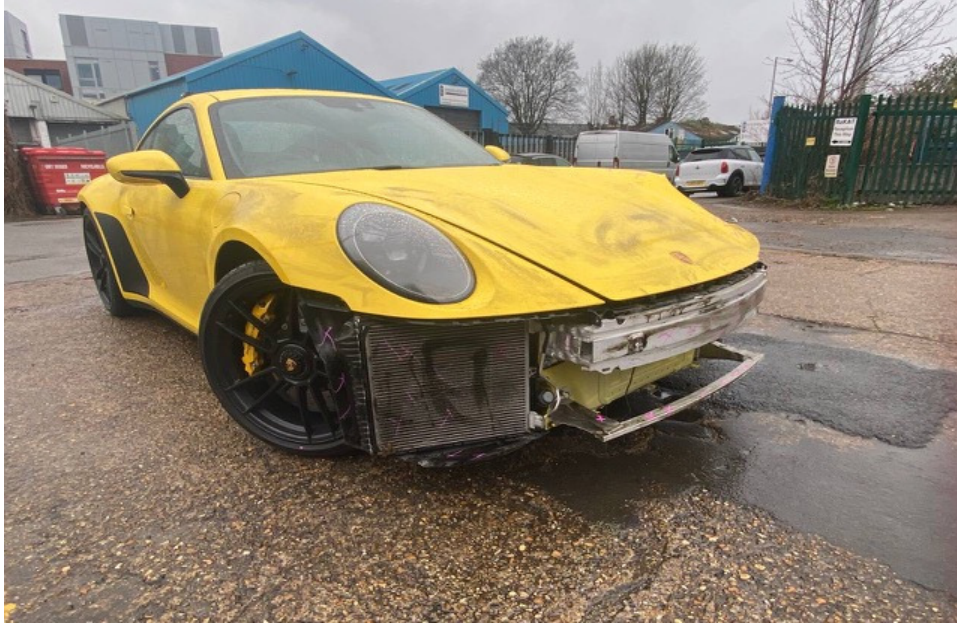
3. The photographs provided to me had showed the Motor Car's front left fender, front left fender inner shield and front left headlamp damaged.
4. The Motor Car's front bumper and all its related parts and attachments like the front bumper lower lip, front bumper left lower grille, front bumper right lower grille, front bumper centre air guide, front bumper sensors, front left day light, front right day light, front left signal lamp and front right signal lamp amongst others, were also missing/dislodged/damaged.

**Photo 1** shows a general view of the front right body of the Motor Car (photograph provided to me). The Motor Car's front bumper and all its related parts and attachments like the front bumper lower lip, front bumper left lower grille, front bumper right lower grille, front bumper centre air guide, front bumper sensors, front left day light, front right day light, front left signal lamp and front right signal lamp amongst others, were also missing/dislodged/damaged.

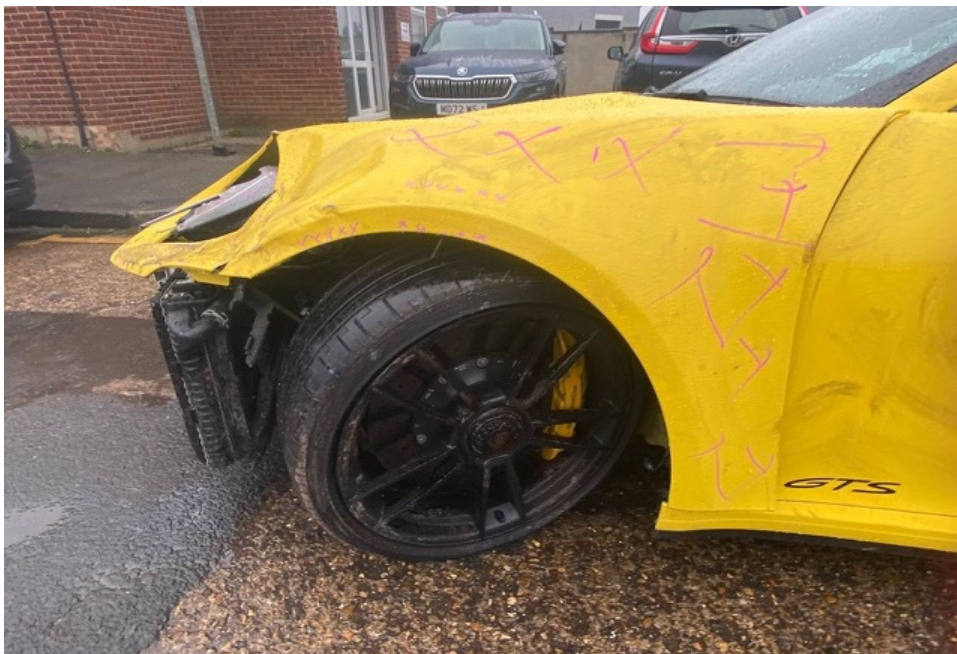
**Photo 2** shows a closer view of the left front body of the Motor Car (photograph provided to me). The Motor Car's front left fender, front left fender inner shield and front left headlamp were damaged.

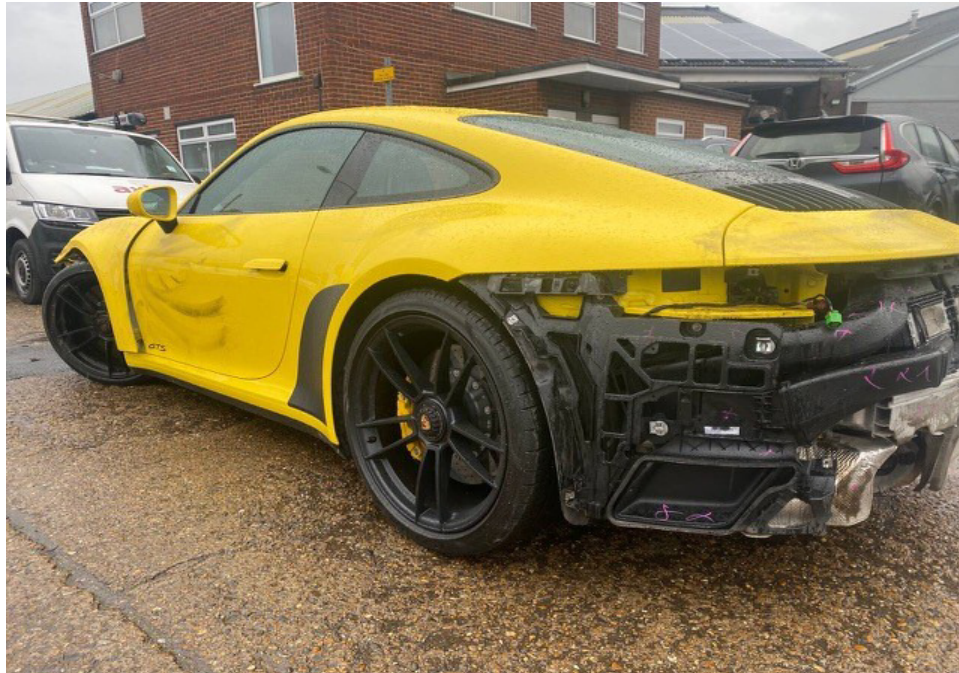
5. In addition, several body parts at the rear portion of the Motor Car were also observed to be missing/dislodged/damaged. This had included the Motor Car's rear left taillamp, rear right taillamp, rear centre lamp, rear bumper and all its related parts and attachments like the rear bumper lower cover, rear bumper left reflector, rear bumper right reflector, rear bumper sensors, rear bumper tow cover, rear left exhaust garnish and rear right exhaust garnish amongst others.

**Photo 3** shows a general view of the rear left body of the Motor Car (photograph provided to me). The Motor Car's rear left taillamp, rear centre lamp, rear bumper and all its related parts and attachments like the rear bumper lower cover, rear bumper left reflector, rear bumper sensors, rear bumper tow cover and rear left exhaust garnish amongst others, were missing/dislodged/damaged.

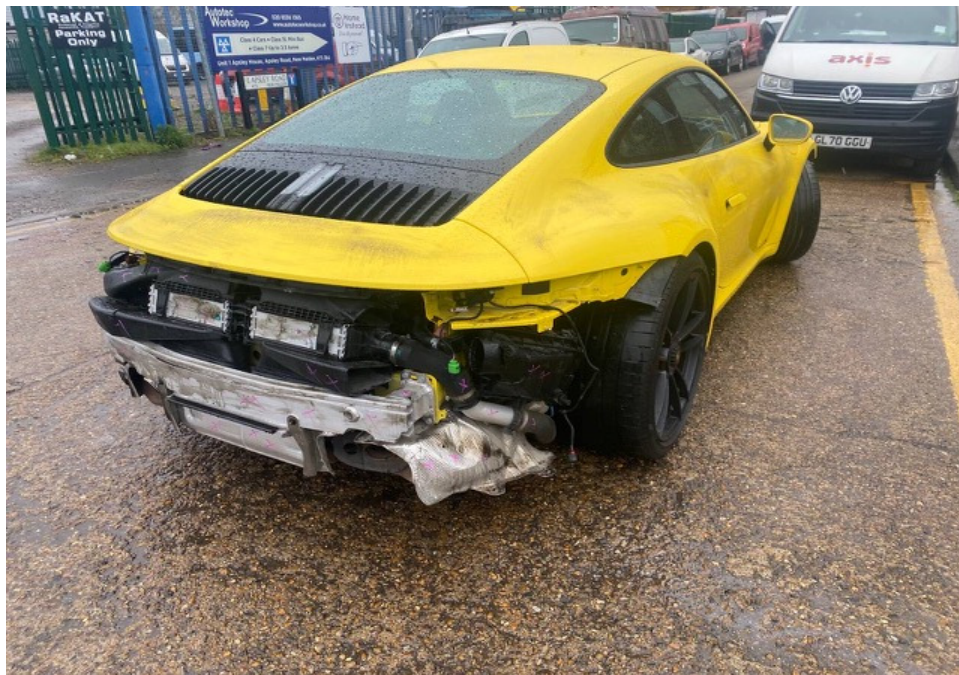
**Photo 4** shows the rear right body of the Motor Car (photograph provided to me). The Motor Car's rear right taillamp, rear centre lamp, rear bumper and all its related parts and attachments like the rear bumper lower cover, rear bumper right reflector, rear bumper sensors, rear bumper tow cover and rear right exhaust garnish amongst others, were missing/dislodged/damaged.

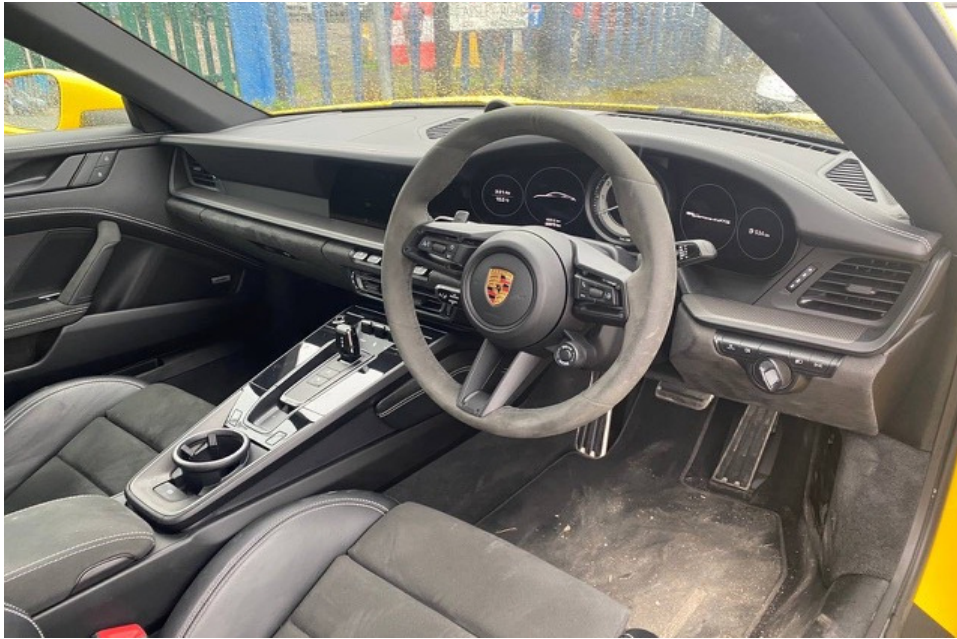
**Photo 5** shows the interior compartment of the Motor Car (photograph provided to me). The various parts and components within the interior compartment were all intact and unaffected. The Motor Car's airbag(s) was not deployed as seen from the photographs that were provided to me.

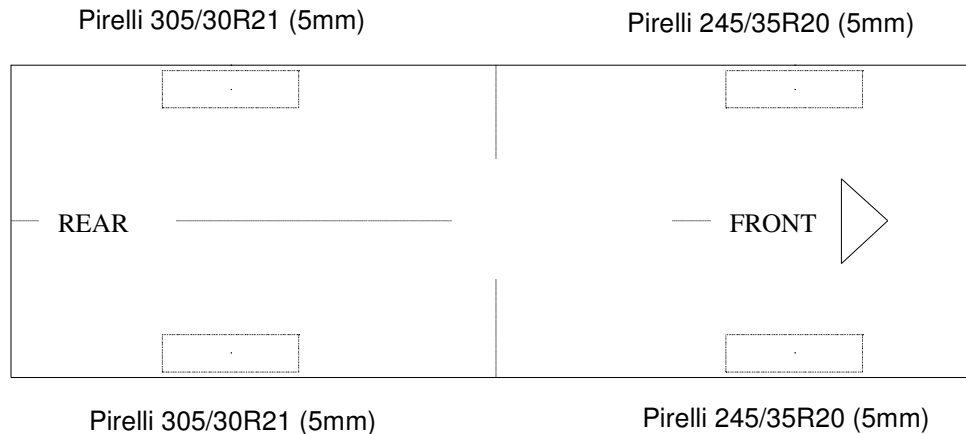
10. It was fitted with 20inch (front) and 21inch (rear) sport wheel rims that were wrapped with tyres that were observed to be of serviceable condition. The tyres were also sufficiently inflated for vehicular operation. The tyre brand, tyre size and approximate remaining tread depth of the 4 tyres of the Motor Car were recorded as follows: -

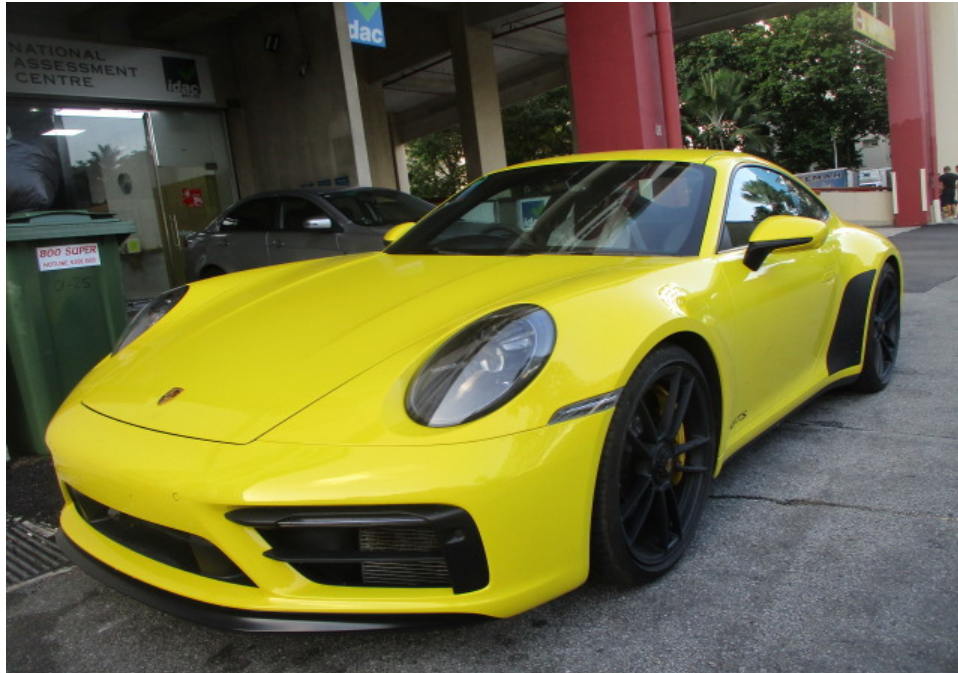
**Photo 6** shows a general view of the front left body of the Motor Car at the time of my inspection. The Motor Car was observed to be in a relatively good general condition with no loose exterior fittings observed. The body parts at the frontal portion of the Motor Car were visually examined and it was observed that the repair/restoration works carried out to the damaged area of the Motor Car (refer to photograph 1 & 2 above) were reasonably adequate and in order.

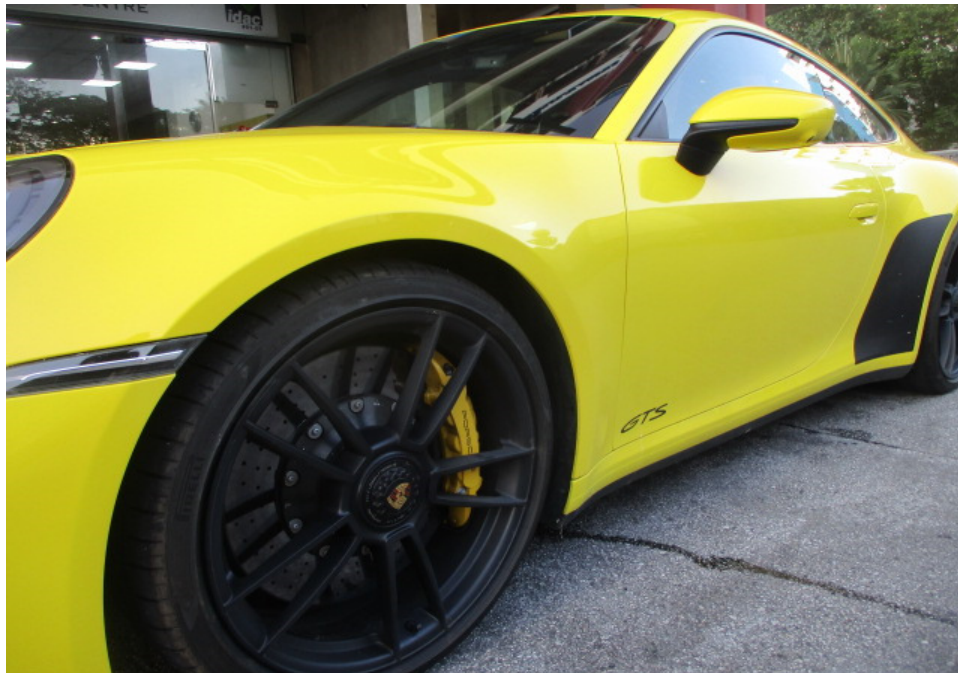
**Photo 7** shows a closer view of the Motor Car's front left signal lamp, front left fender and front left wheel rim. The body parts at the frontal portion of the Motor Car were visually examined and it was observed that the repair/restoration works carried out to the damaged area of the Motor Car (refer to photograph 1 & 2 above) were reasonably adequate and in order.

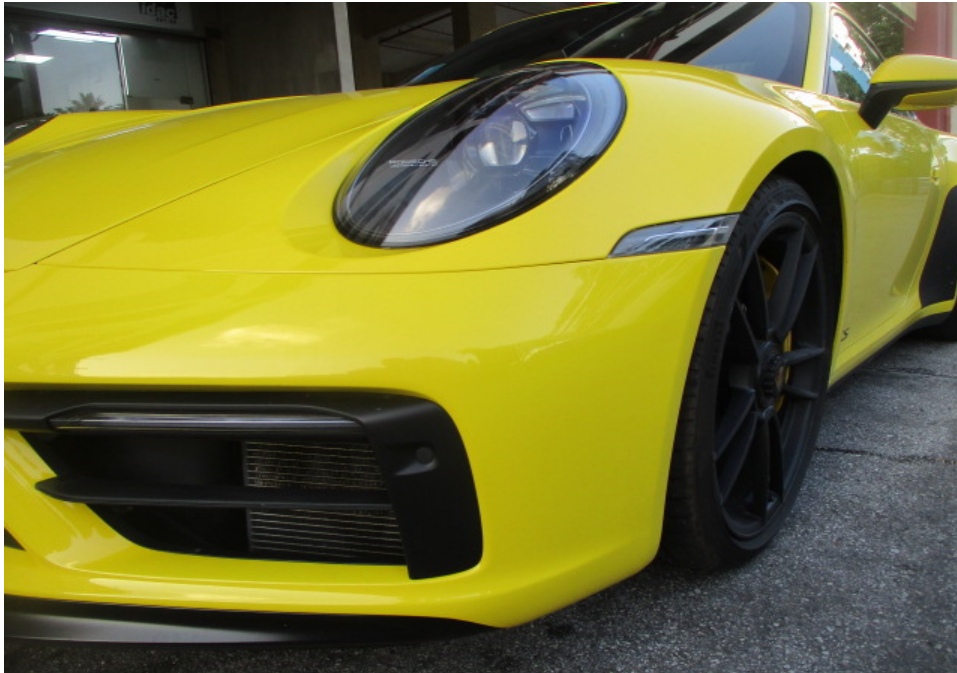
**Photo 8** shows a closer view of the Motor Car's front bumper, front bumper left lower grille, front left day light, front left signal lamp and front left headlamp. The body parts at the frontal portion of the Motor Car were visually examined and it was observed that the repair/restoration works carried out to the damaged area of the Motor Car (refer to photograph 1 & 2 above) were reasonably adequate and in order.

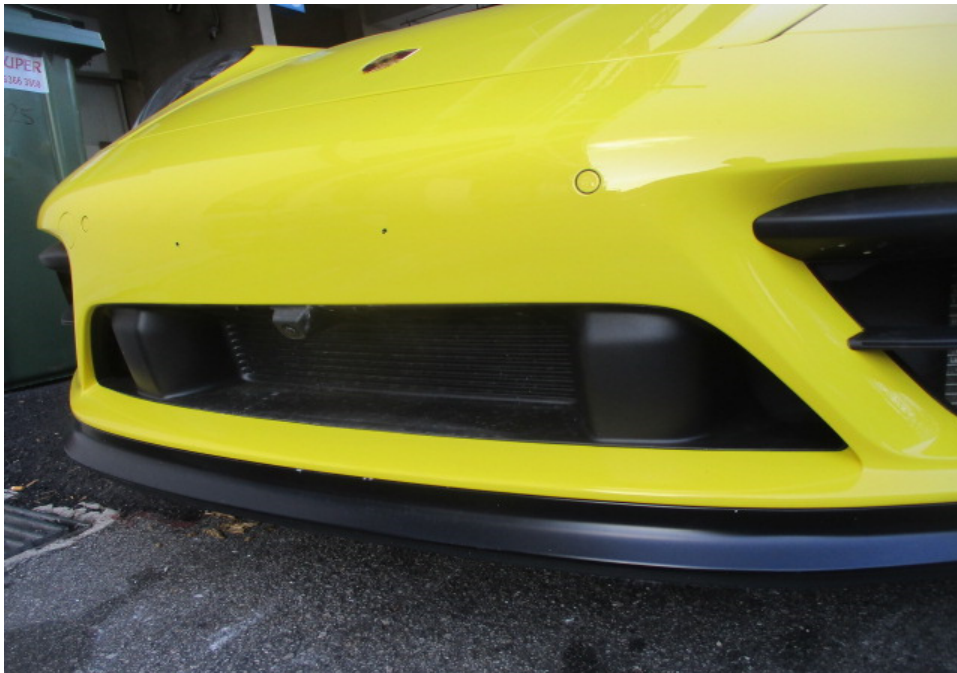
**Photo 9** shows a closer view of the Motor Car's front bumper, front bumper lower lip, front bumper centre air guide and front bumper sensors. The body parts at the frontal portion of the Motor Car were visually examined and it was observed that the repair/restoration works carried out to the damaged area of the Motor Car (refer to photograph 1 & 2 above) were reasonably adequate and in order.

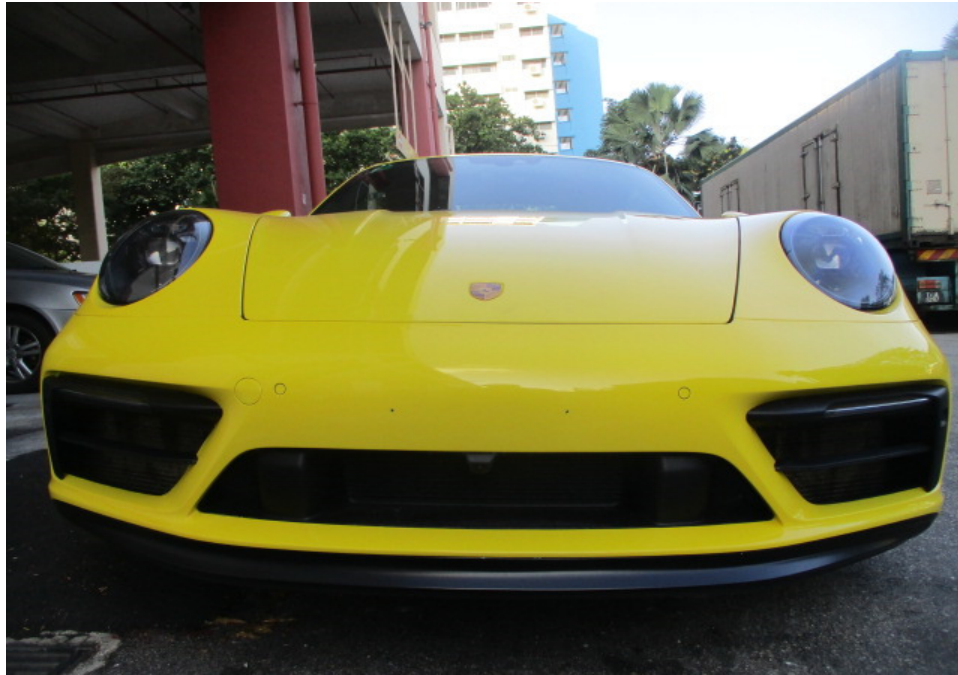
**Photo 10** shows a closer view of the Motor Car's frontal portion at the time of my inspection. The body parts at the frontal portion of the Motor Car were visually examined and it was observed that the repair/restoration works carried out to the damaged area of the Motor Car (refer to photograph 1 & 2 above) were reasonably adequate and in order.

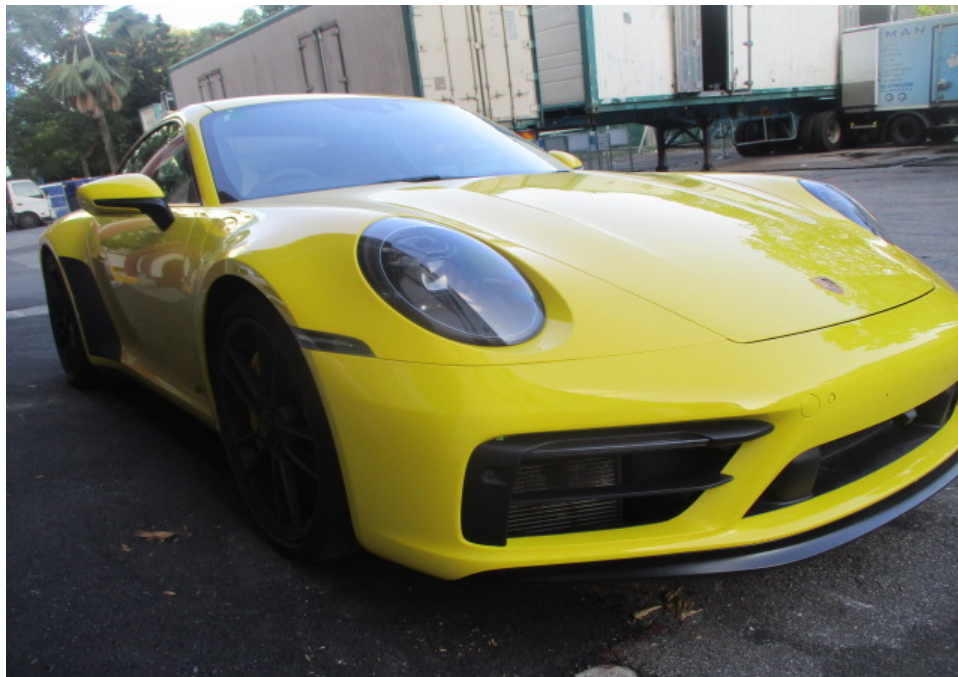
**Photo 11** shows a general view of the front right body of the Motor Car at the time of my inspection. The Motor Car was observed to be in a relatively good general condition with no loose exterior fittings observed. The body parts at the frontal portion of the Motor Car were visually examined and it was observed that the repair/restoration works carried out to the damaged area of the Motor Car (refer to photograph 1 & 2 above) were reasonably adequate and in order.

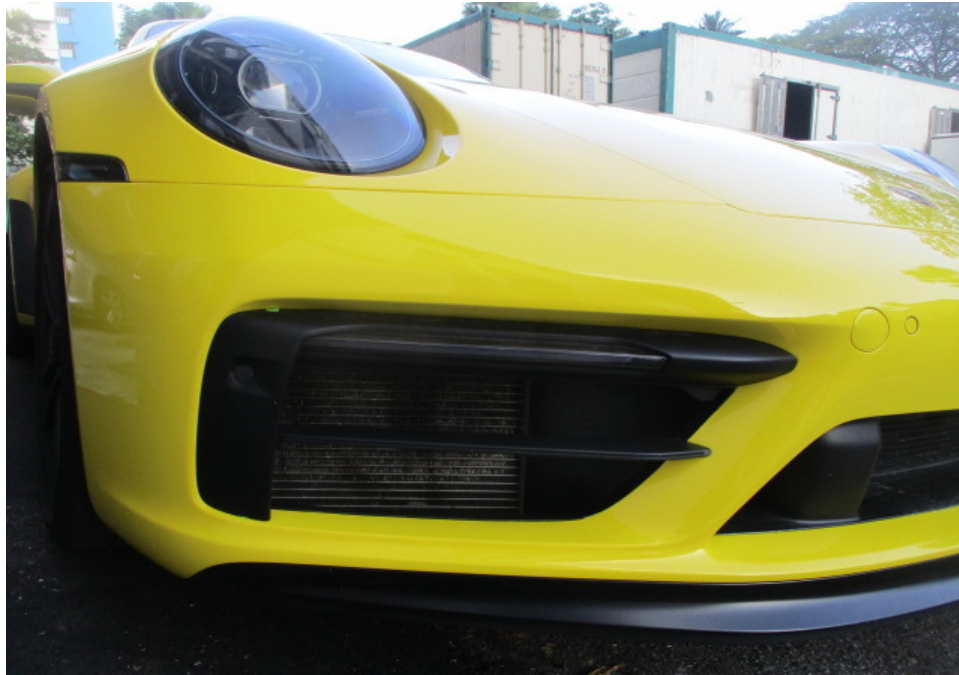
**Photo 12** shows a closer view of the Motor Car's front bumper, front bumper lower lip, front bumper right lower grille, front right day light, front right signal lamp and front right headlamp. The body parts at the frontal portion of the Motor Car were visually examined and it was observed that the repair/restoration works carried out to the damaged area of the Motor Car (refer to photograph 1 & 2 above) were reasonably adequate and in order.

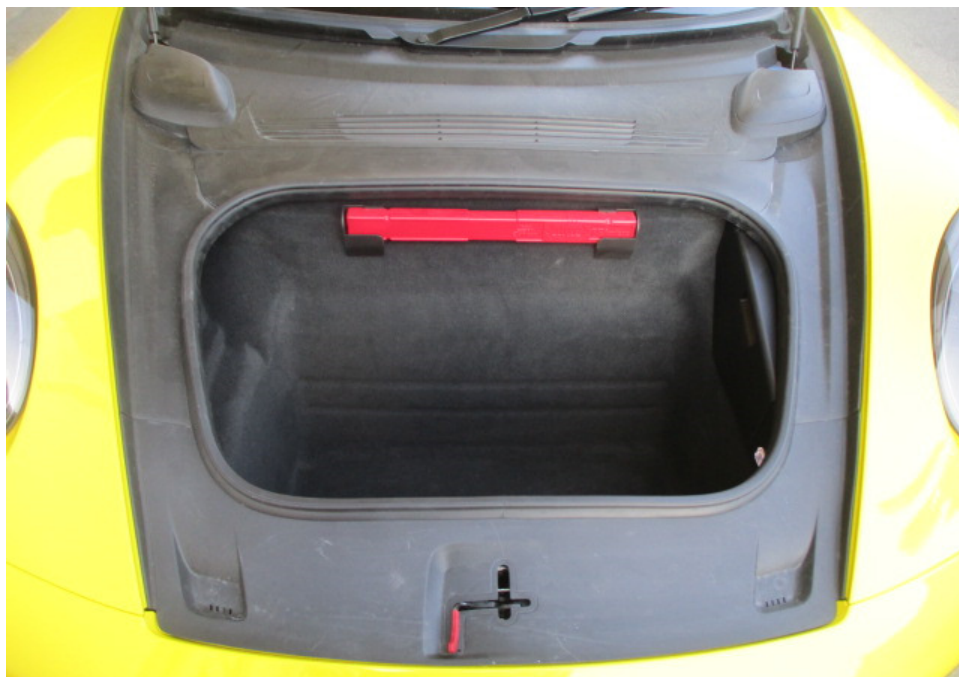
**Photo 13** shows a general view of the Motor Car's front bonnet compartment at the time of my inspection. All inner trims, garnishes and upholstery etc were observed to be properly fitted.

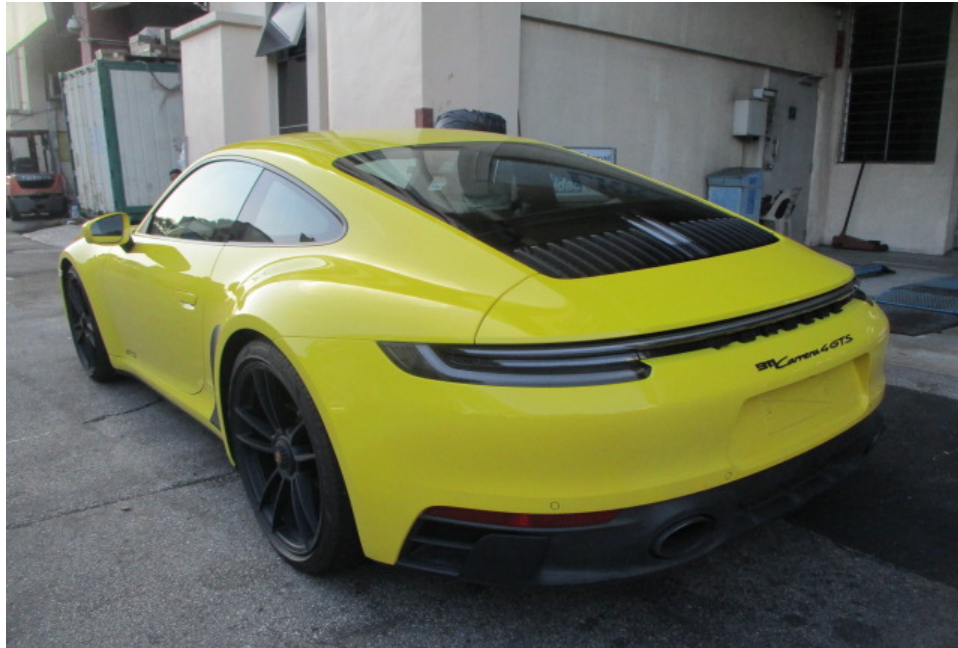
**Photo 14** shows a general view of the rear left body of the Motor Car at the time of my inspection. The Motor Car was observed to be in a relatively good general condition with no loose exterior fittings observed. The body parts at the rear portion of the Motor Car were visually examined and it was observed that the repair/restoration works carried out to the damaged area of the Motor Car (refer to photograph 3 & 4 above) were reasonably adequate and in order.

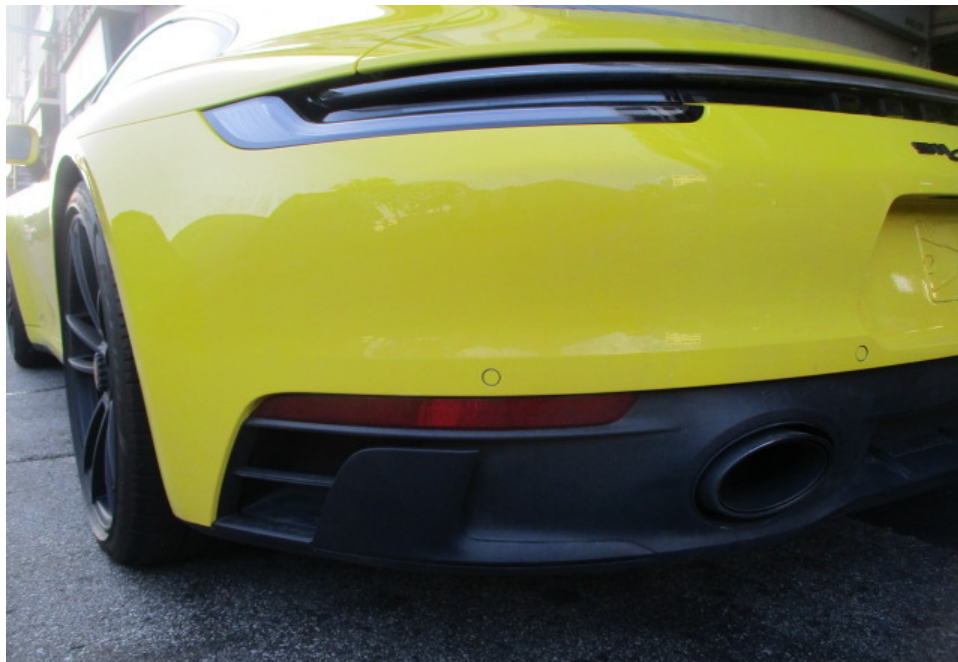
**Photo 15** shows a closer view of the Motor Car's rear bumper, rear bumper lower cover, rear bumper left reflector, rear bumper sensors, rear left exhaust garnish and rear left taillamp. The body parts at the rear portion of the Motor Car were visually examined and it was observed that the repair/restoration works carried out to the damaged area of the Motor Car (refer to photograph 3 & 4 above) were reasonably adequate and in order.

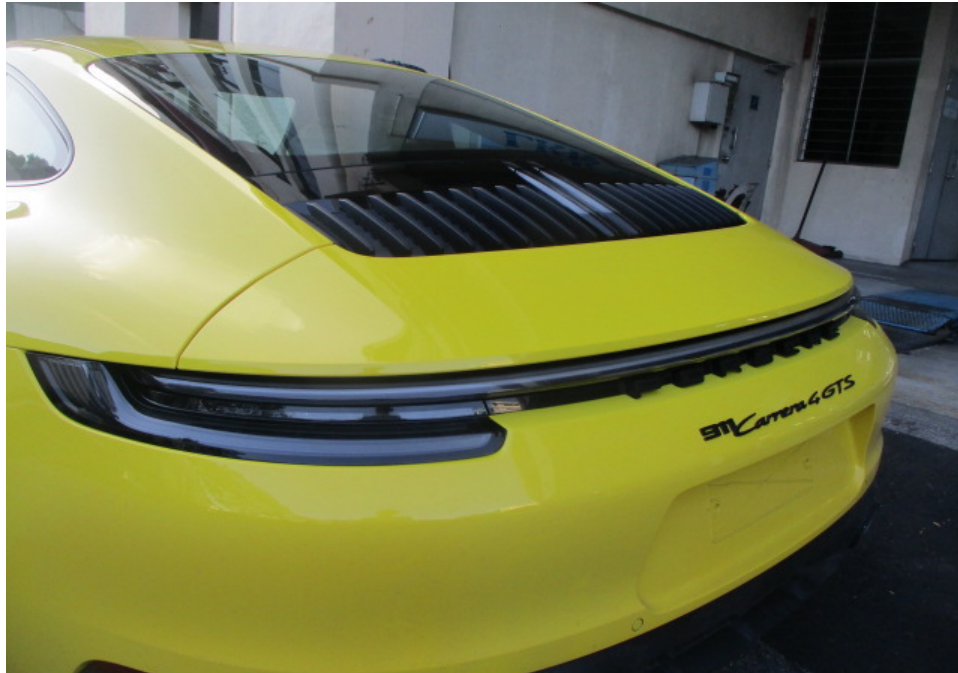
**Photo 16** shows a closer view of the Motor Car's rear bumper, rear left taillamp and rear centre lamp. The body parts at the rear portion of the Motor Car were visually examined and it was observed that the repair/restoration works carried out to the damaged area of the Motor Car (refer to photograph 3 & 4 above) were reasonably adequate and in order.

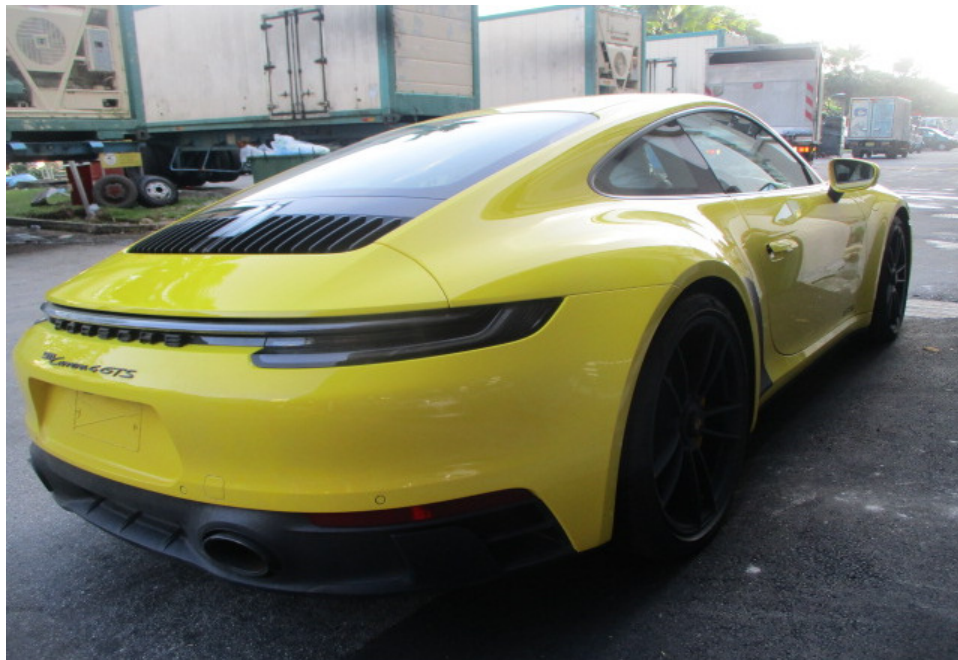
**Photo 17** shows a general view of the rear right body of the Motor Car at the time of my inspection. The Motor Car was observed to be in a relatively good general condition with no loose exterior fittings observed. The body parts at the rear portion of the Motor Car were visually examined and it was observed that the repair/restoration works carried out to the damaged area of the Motor Car (refer to photograph 3 & 4 above) were reasonably adequate and in order.

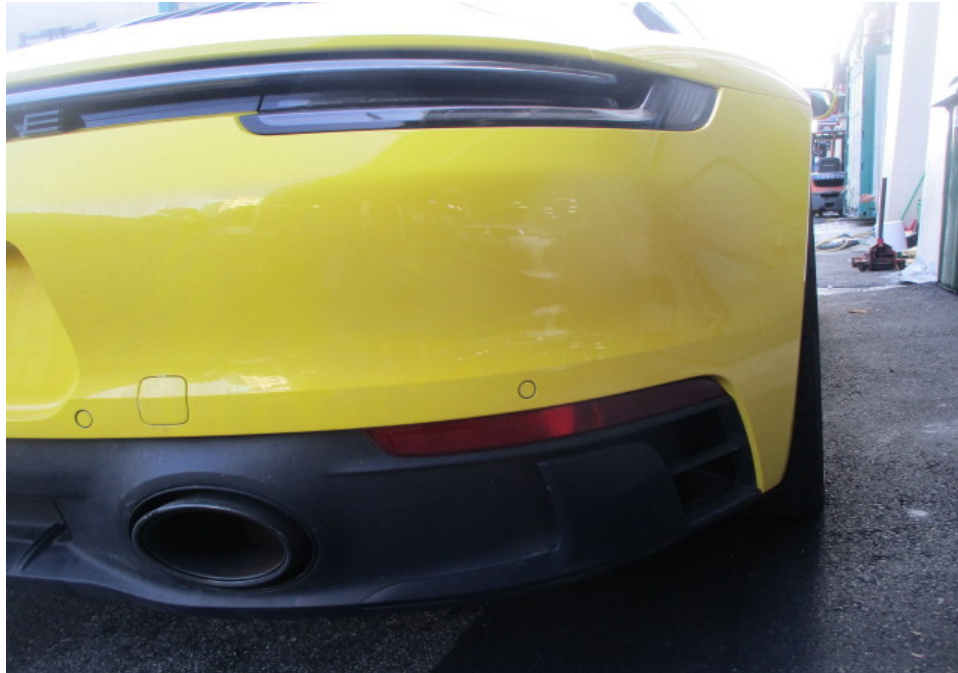
**Photo 18** shows a closer view of the Motor Car's rear bumper, rear bumper lower cover, rear bumper right reflector, rear bumper sensors, rear bumper tow cover, rear right taillamp and rear right exhaust garnish. The body parts at the rear portion of the Motor Car were visually examined and it was observed that the repair/restoration works carried out to the damaged area of the Motor Car (refer to photograph 3 & 4 above) were reasonably adequate and in order.

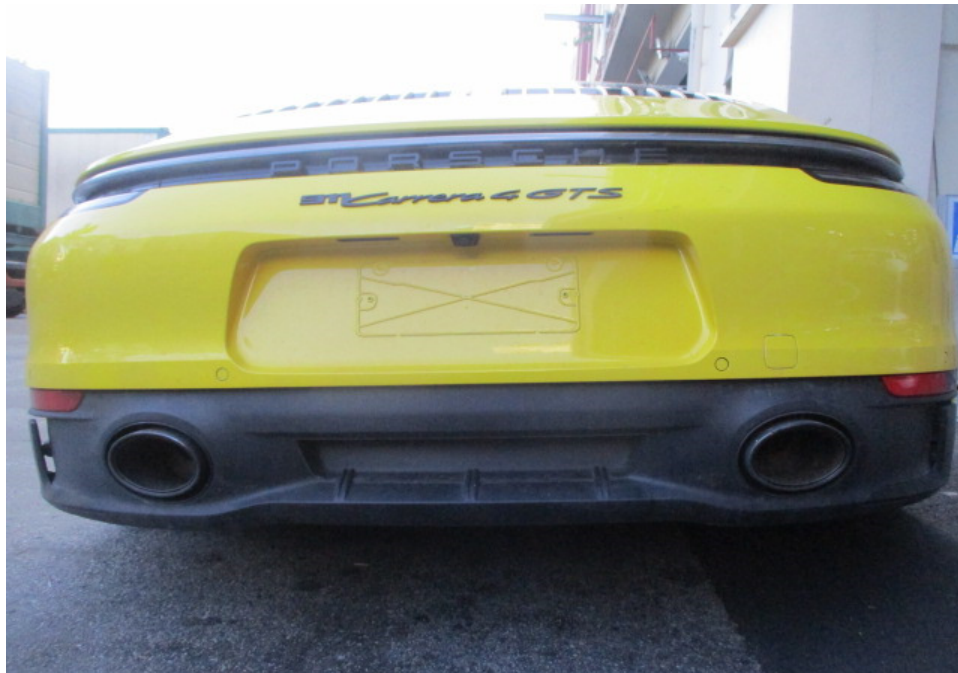
**Photo 19** shows a closer view of the Motor Car's rear portion at the time of my inspection. The body parts at the rear portion of the Motor Car were visually examined and it was observed that the repair/restoration works carried out to the damaged area of the Motor Car (refer to photograph 3 & 4 above) were reasonably adequate and in order.

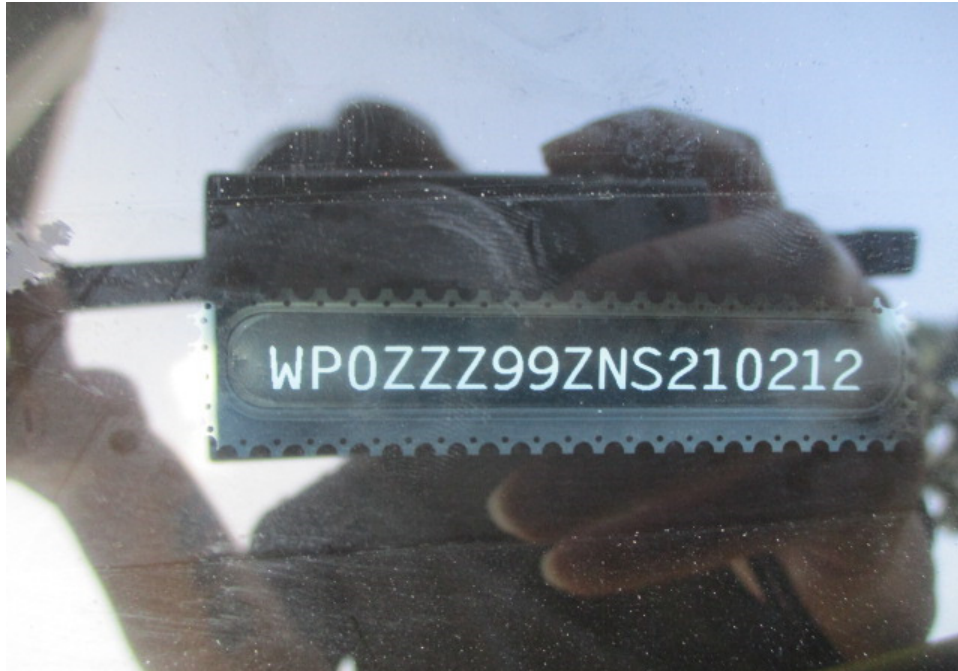
**Photo 20** shows the chassis number of the Motor Car. The chassis number recorded was WP0ZZZ99ZNS210212.

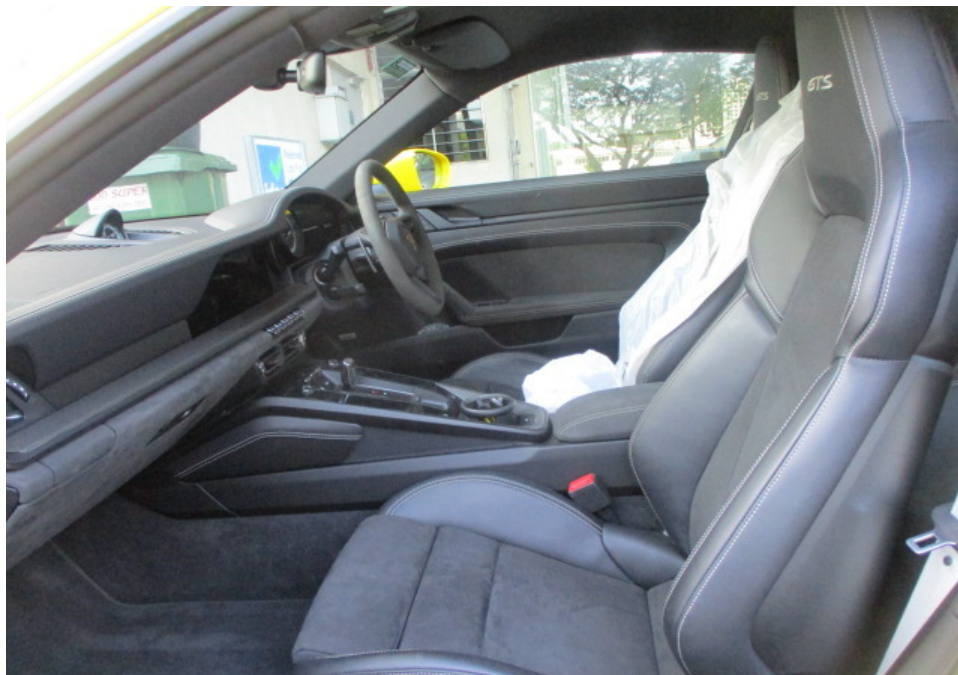
**Photo 21** shows the interior compartment of the Motor Car at the time of my inspection. The various parts and components, trims, carpet, and upholstery inside the interior compartment were all observed to be intact and properly fitted.

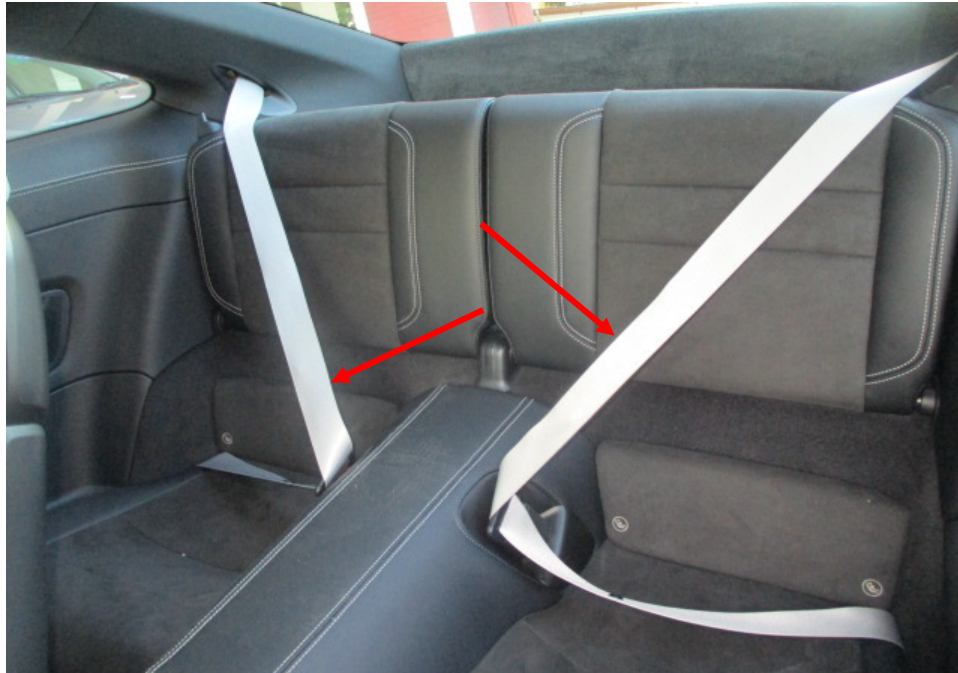
**Photo 22** shows the rear seats of the Motor Car. All the seats of the Motor Car were secured via seat rails to the floorboard. They were also fitted with a retractable seat belt reel and a pre-tensioner. The seat belts (arrowed) were tested and were able to be fastened into the respective pre-tensions that were fitted on the side of each individual seat.

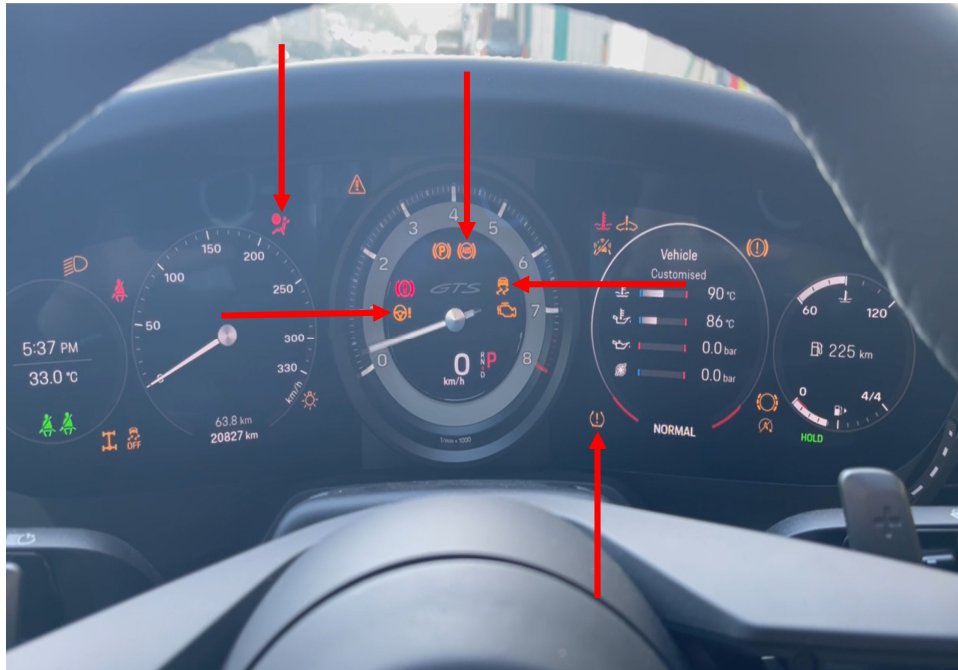
**Photo 23** shows the warning lights for the various electronic safety features appearing on the instrument panel of the Motor Car during its self-test when the engine is cranked, in particular the ABS, SRS, EPS, TPM and TCS lights (arrowed).

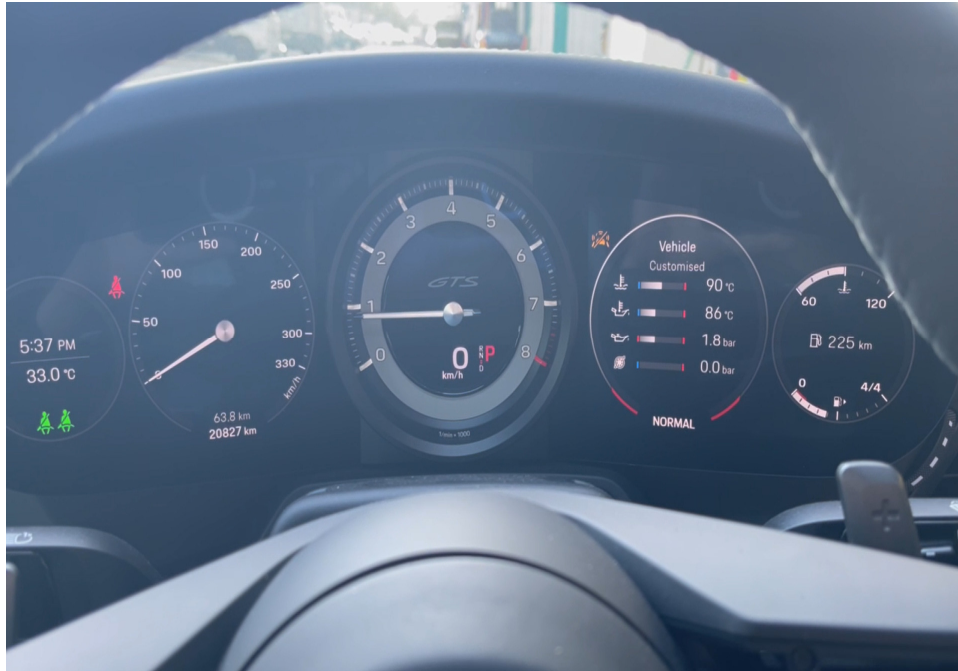
**Photo 24** shows the respective warning lights no longer illuminated, indicating that there is no fault detected to the ABS, SRS, EPS, TPM and TCS systems of the Motor Car during the self-test. These electronic systems were hence in working condition at the time of my inspection.

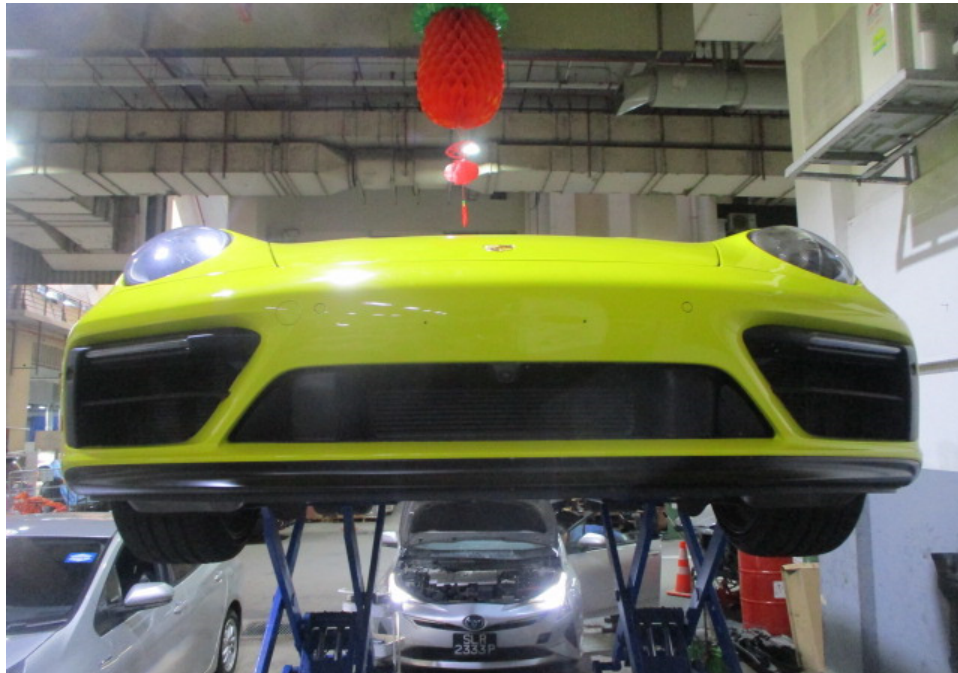
**Photo 25** shows the Motor Car hoisted up for checks on its undercarriage. There was no sign(s) or indication(s) of fluid leakage and/or fluid stain(s) on the underside of the Motor Car. The undercarriage components of the Motor Car were also all observed to be intact and secured in an appropriate manner.

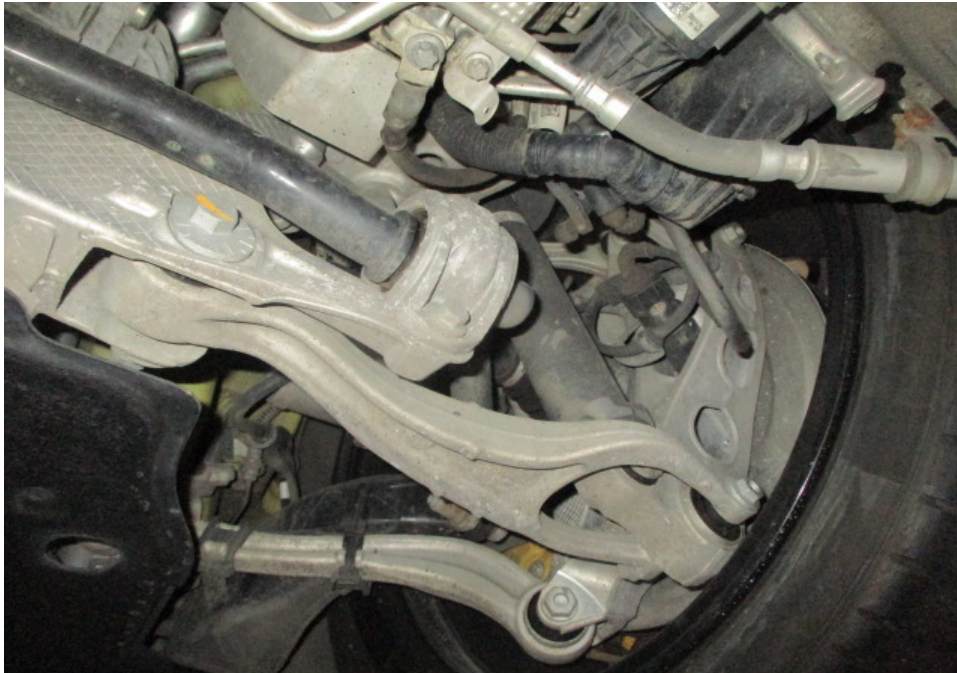
**Photo 26** shows a general view of the control arms and linkages at the rear right wheel of the Motor Car. I did not observe any fluid leak and/or fluid stain on the underside of the Motor Car. All of the Motor Car's undercarriage components were observed to be intact and secured in an appropriate manner.

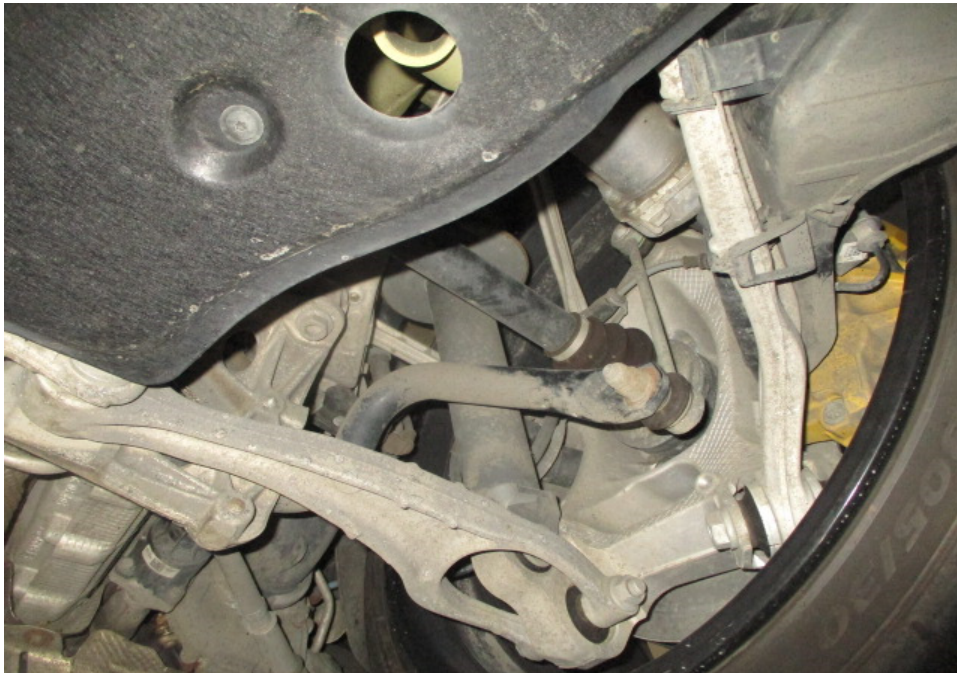
**Photo 27** shows a general view of the control arms and linkages at the rear left wheel of the Motor Car. I did not observe any fluid leak and/or fluid stain on the underside of the Motor Car. All of the Motor Car's undercarriage components were observed to be intact and secured in an appropriate manner.

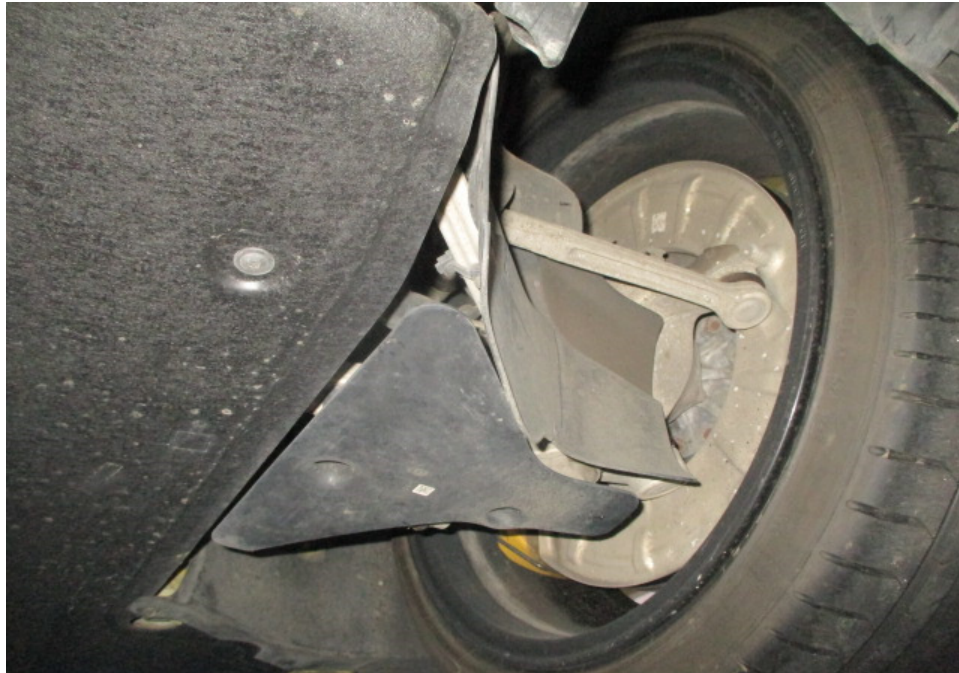
**Photo 28** shows the various undercarriage components at the front left wheel of the Motor Car. The mechanical components, control arms and linkages were all found to be intact and secured in an appropriate manner.

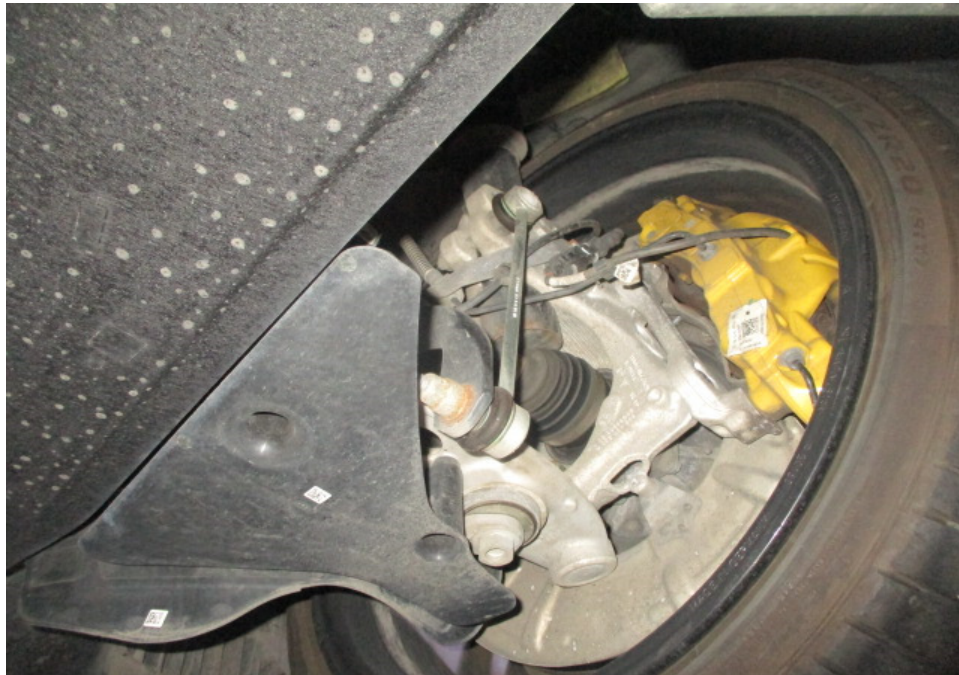
**Photo 29** shows the various undercarriage components at the front right wheel of the Motor Car. The mechanical components, control arms and linkages were all found to be intact and secured in an appropriate manner. I also did not observe any fluid leak and/or fluid stain on the underside of the Motor Car.

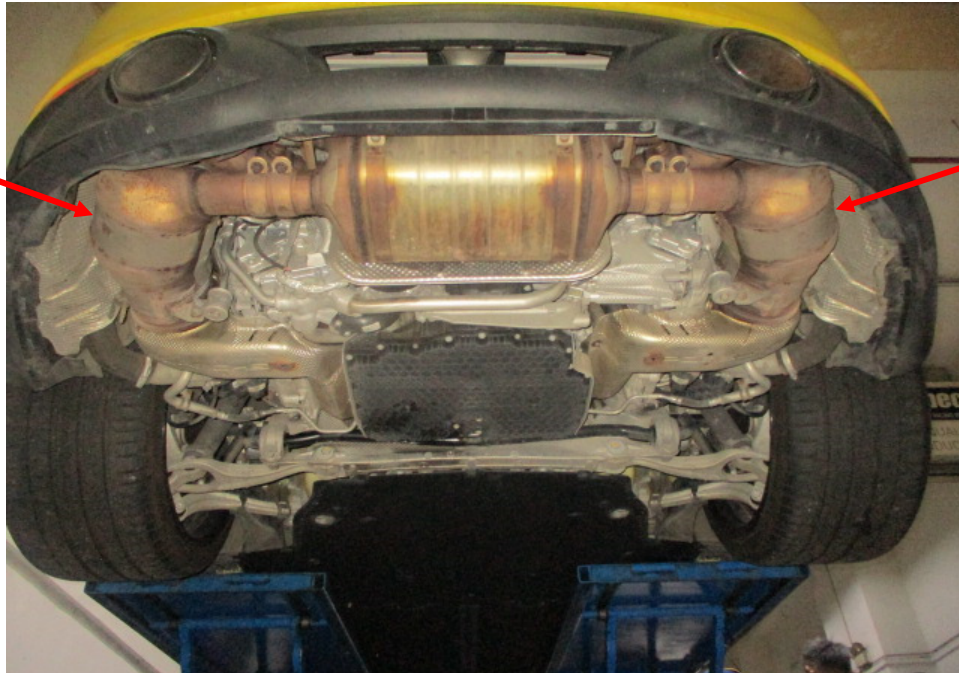
**Photo 30** shows the Motor Car's exhaust system. My examination of the Motor Car's exhaust system revealed no sign(s) or indication(s) of any cut or weld marks along its exhaust pipes, on its catalytic converters (arrowed) and on its rear muffler.
