Your Ref: Porsche 911 Carrera 4 GTS Coupe  
(chassis number WP0ZZZ99ZNS210212)  
Our Ref: CI/TP23005598/D

02 June 2023

**INSPECTION REPORT OF AN UNREGISTERED PORSCHE 911 CARRERA 4  
GTS COUPE MOTOR CAR WITH CHASSIS NUMBER WP0ZZZ99ZNS210212**

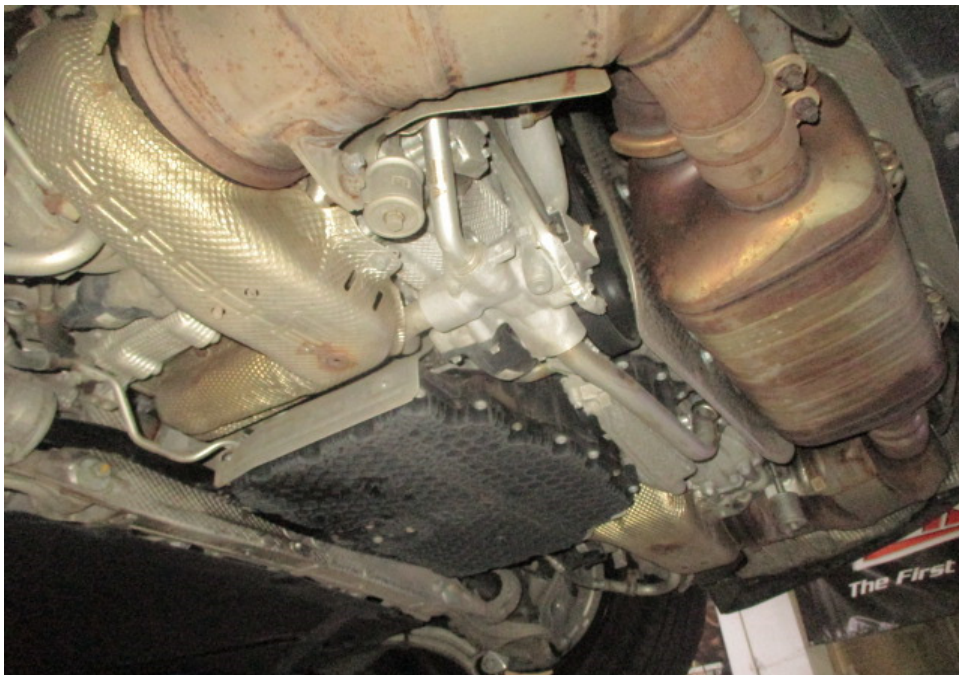
**Photo 31** shows a general view of the Motor Car's engine compartment. The engine compartment was at the rear underside of the Motor Car. The various parts and components within the engine compartment were all observed to be intact and properly fitted. There was also no sign(s) or indication(s) of fluid leak and/or fluid stain found inside the engine compartment.

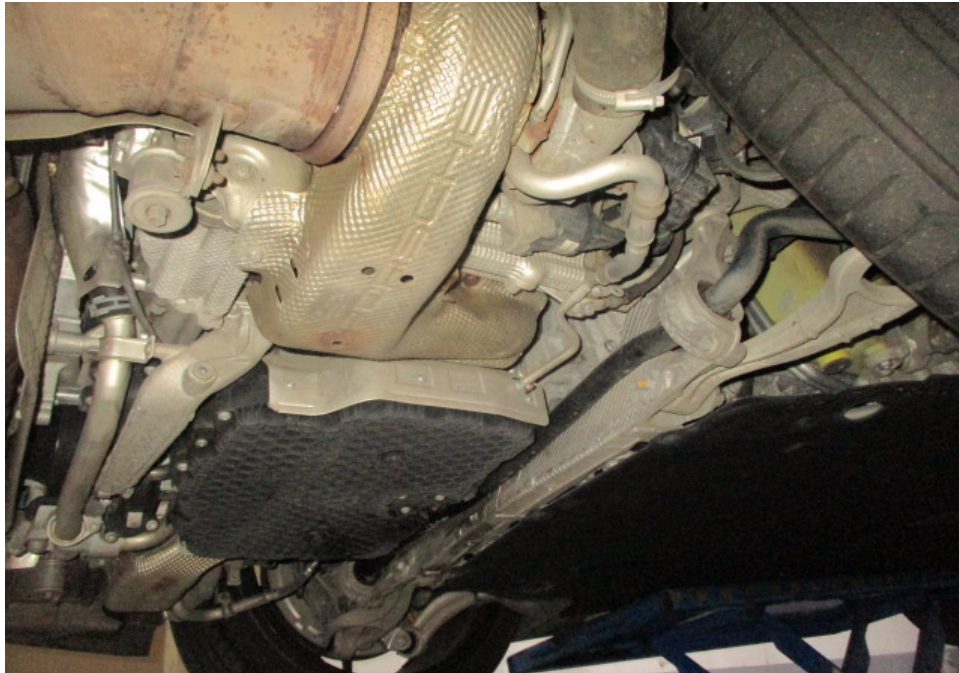
**Photo 32** shows another view of the Motor Car's engine compartment. The engine compartment was at the rear underside of the Motor Car. The various parts and components within the engine compartment were all observed to be intact and properly fitted. There was also no sign(s) or indication(s) of fluid leak and/or fluid stain found inside the engine compartment.

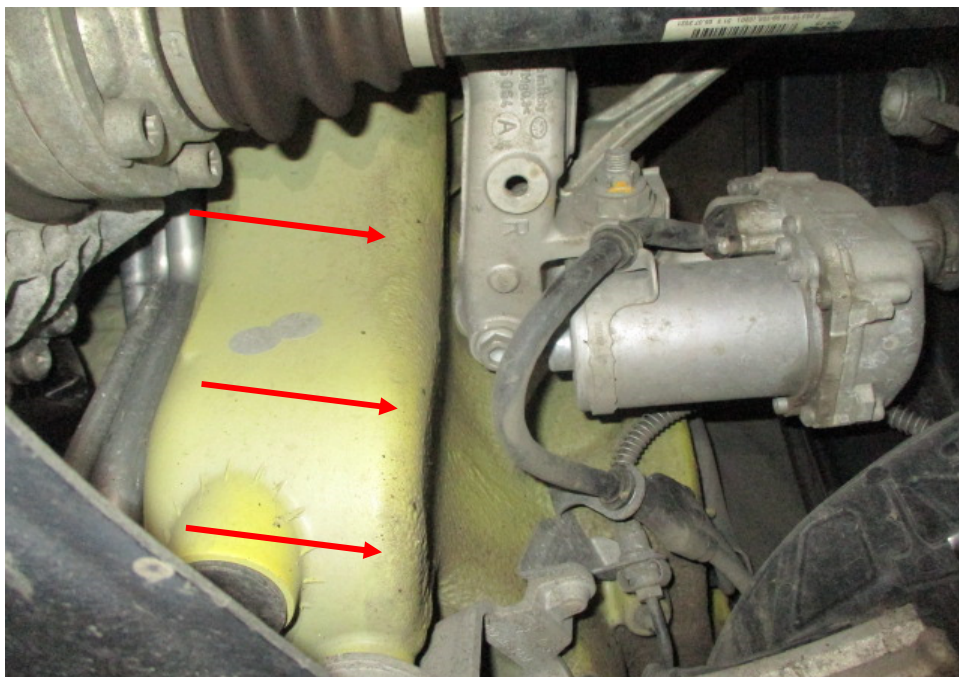
**Photo 33** shows the chassis/structural body at the underside rear right of the Motor Car. I did not find any weld marks other than original spot weld marks on the chassis/structural body of the Motor Car. The original factory sealant (arrowed) at the joints along the chassis/structural body was untouched, indicating no work was done on the chassis/structural body of the Motor Car and that the chassis/structural body was originally fitted.

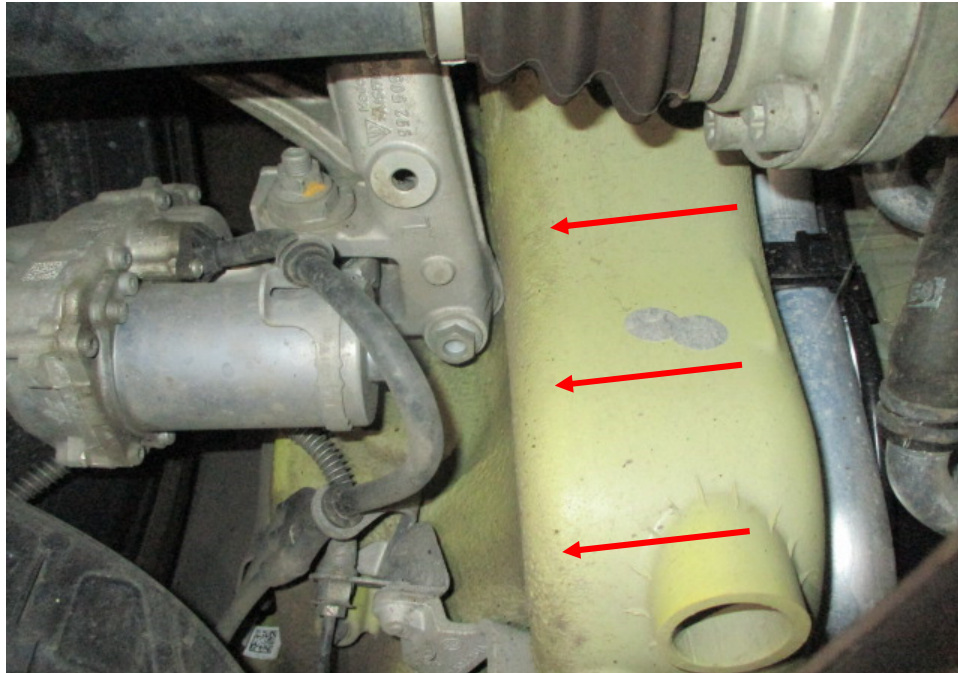
**Photo 34** shows the chassis/structural body at the underside rear left of the Motor Car. The original factory sealant (arrowed) at the joints along the chassis/structural body was observed to be untouched. In general, I had found no work was carried out on the chassis/structural body of the Motor Car. The chassis/structural body of the Motor Car was originally fitted.

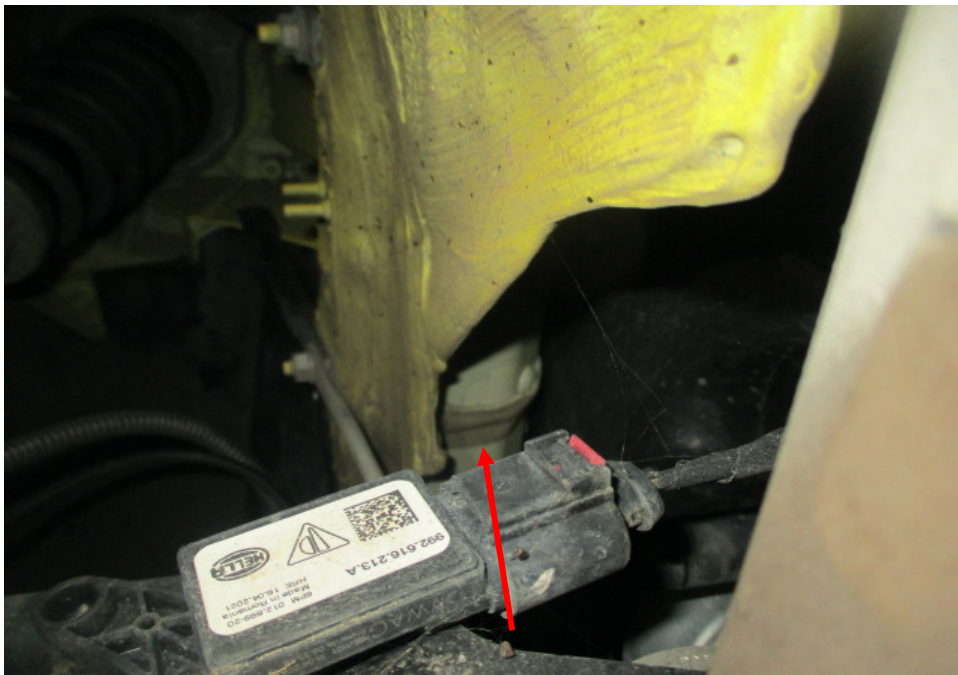
**Photo 35** shows the chassis/structural body at the underside front left of the Motor Car. I did not find any weld marks other than original spot weld marks on the chassis/structural body of the Motor Car. The original factory sealant (arrowed) at the joints along the chassis/structural body was untouched, indicating no work was done on the chassis/structural body of the Motor Car and that the chassis/structural body was originally fitted.

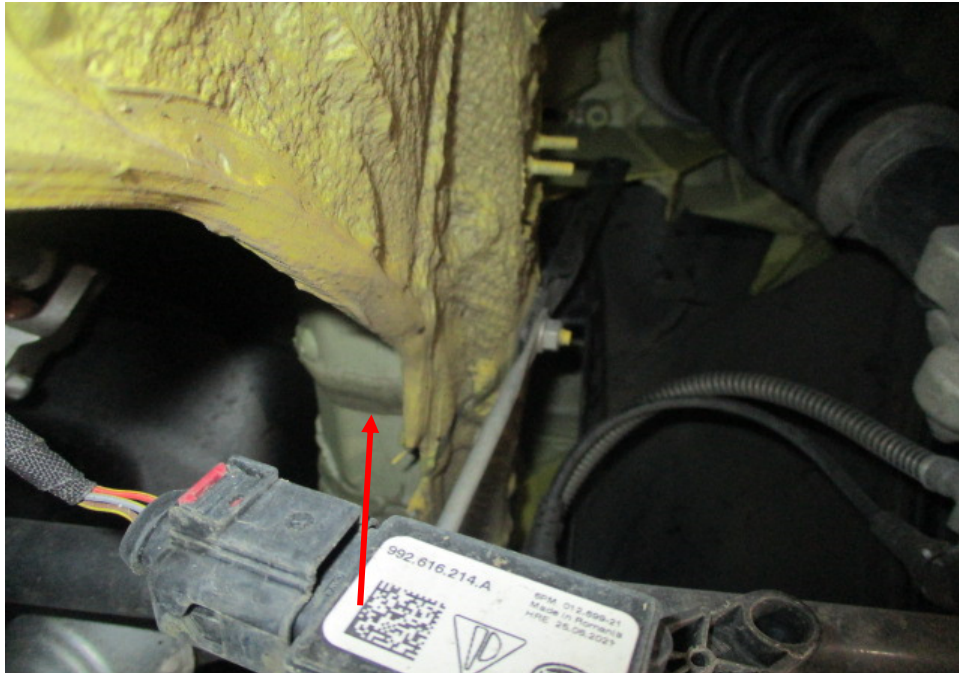
**Photo 36** shows the chassis/structural body at the underside front right of the Motor Car. The original factory sealant (arrowed) at the joints along the chassis/structural body was observed to be untouched. In general, I had found no work was carried out on the chassis/structural body of the Motor Car. The chassis/structural body of the Motor Car was originally fitted.
