Your Ref: Rolls Royce Cullinan  
(chassis number SCATV6201PU215430)  
Our Ref : CI/TP23005599/D

03 June 2023

**INSPECTION REPORT OF AN UNREGISTERED ROLLS ROYCE CULLINAN  
MOTOR CAR WITH CHASSIS NUMBER SCATV6201PU215430**

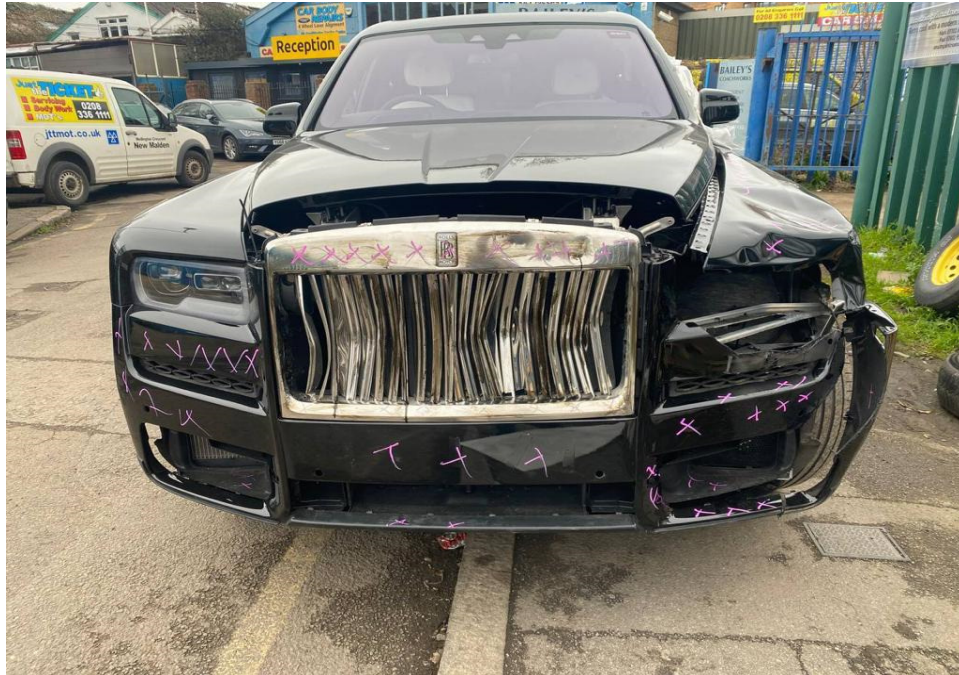
**Photo 1** shows the frontal body of the Motor Car (photograph provided to me). The photographs provided to me had showed damage to the frontal portion of the Motor Car. The front bumper, front bumper centre lower garnish, front bumper centre lower grille, front bumper sensors, front bumper top cover, front radar unit, front grille and front emblem were amongst the body parts that were observed to have been damaged. The Motor Car's airbag(s) was not deployed.

23. The body parts at the frontal portion of the Motor Car were visually examined and it was noted that the repair/restoration works carried out to the damaged area of the Motor Car (refer to photograph 1, 2, 3 & 6 above) were reasonably adequate and in order.

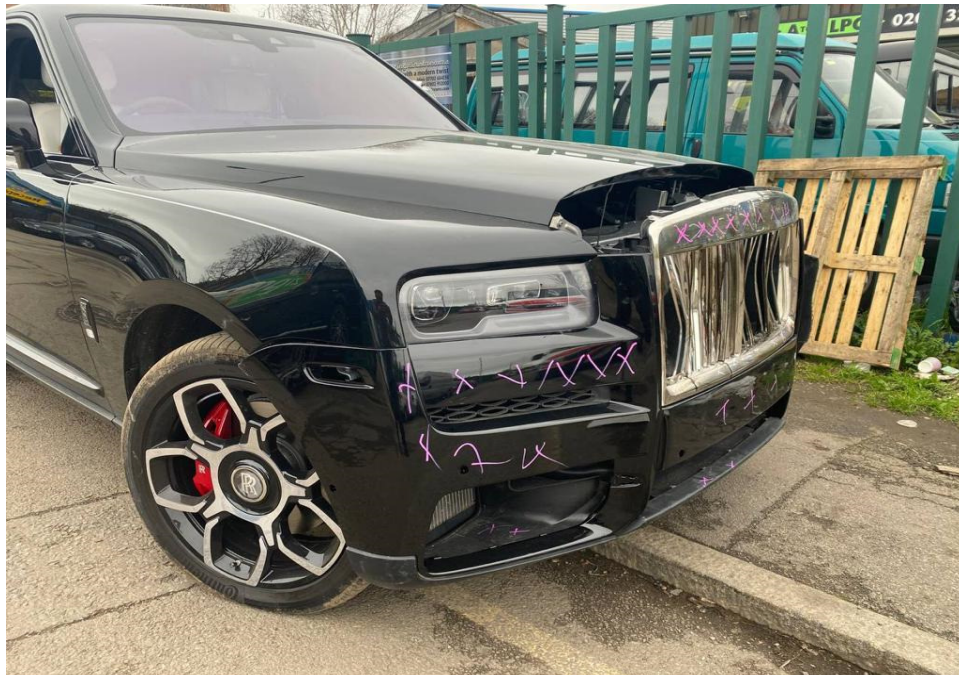
**Photo 2** shows the front right portion of the Motor Car (photograph provided to me). The front bumper, front bumper right lower grille, front bumper right signal lamp, front bumper sensors, front bumper top cover, front grille and front emblem were amongst the body parts that were observed to have been damaged.

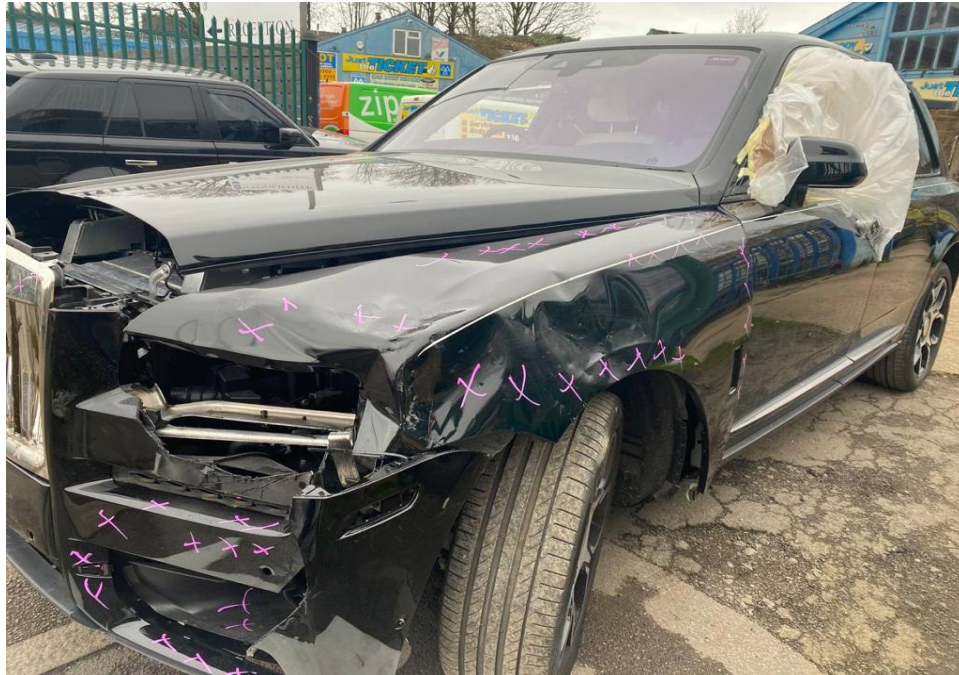
**Photo 3** shows the front left body of the Motor Car (photograph provided to me). The photographs provided to me had showed damage to the frontal portion of the Motor Car. The front bumper, front bumper left lower grille, front bumper left lower grille garnish, front bumper left signal lamp, front bumper sensors, front left headlamp and front left fender were amongst the body parts that were observed to have been damaged. The Motor Car's airbag(s) was not deployed.

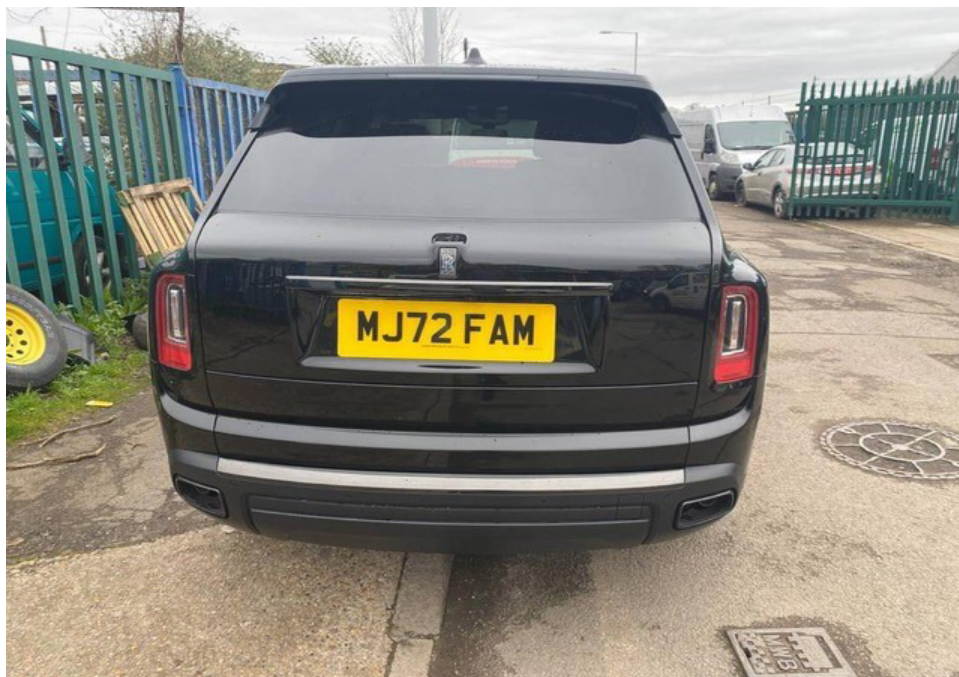
**Photo 4** shows the rear body of the Motor Car (photograph provided to me). Apart for the damage at the frontal portion, there was no physical damage observed to other areas of the Motor Car.

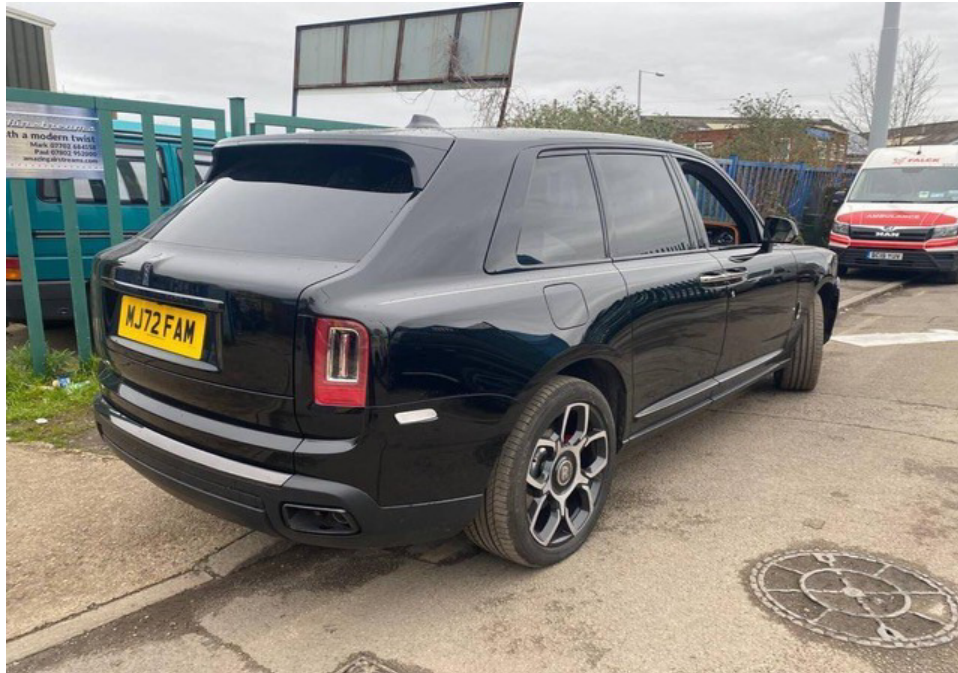
**Photo 5** shows the rear right body of the Motor Car (photograph provided to me). Apart for the damage at the frontal portion, there was no physical damage observed to other areas of the Motor Car.

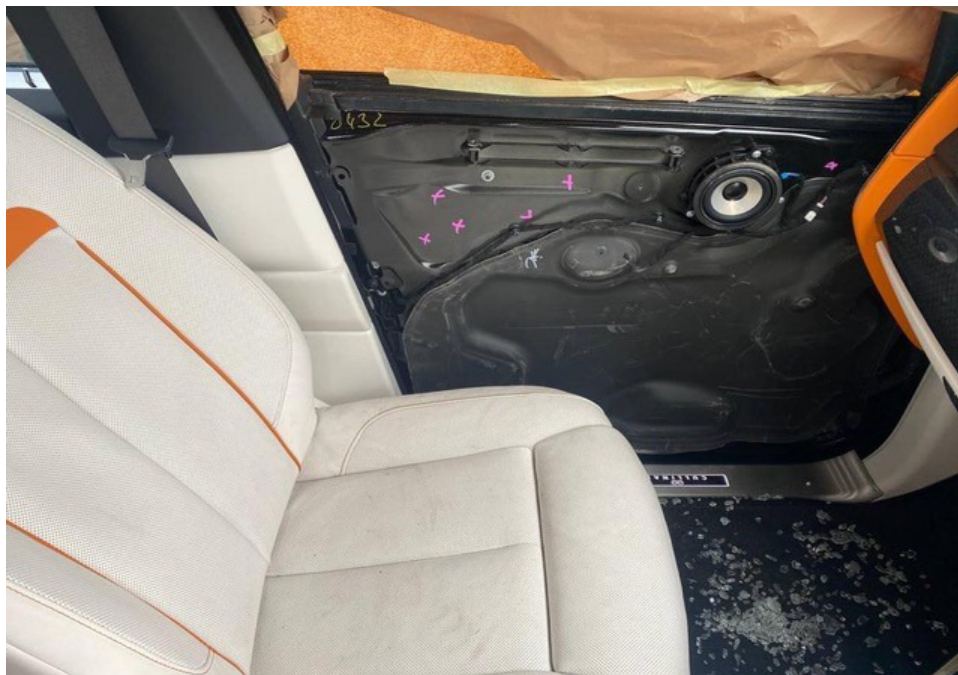
**Photo 6** shows the Motor Car's front left door window shattered and its front left door inner trimboard missing/dislodged/damaged (photograph provided to me).

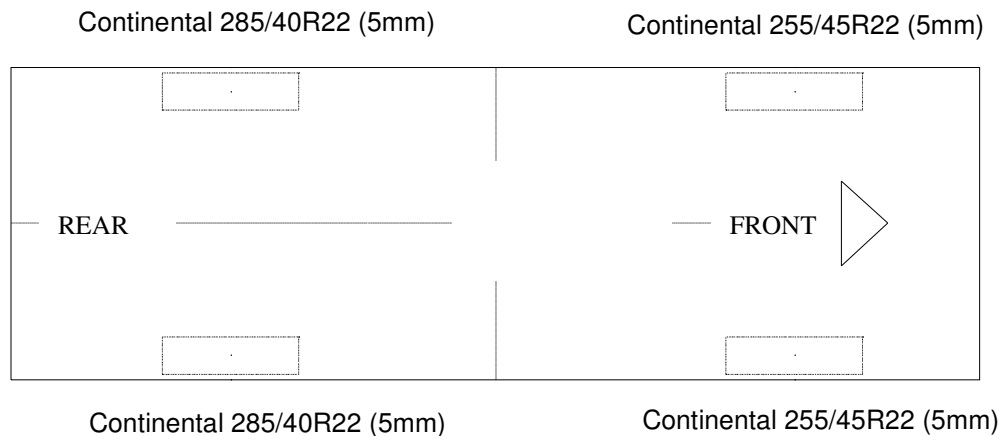
9. The Motor Car was fitted with 22inch sport wheel rims that were wrapped with tyres that were observed to be of serviceable condition. The tyres were also sufficiently inflated for vehicular operation. The tyre brand, tyre size and approximate remaining tread depth of the 4 tyres of the Motor Car were recorded as follows: -

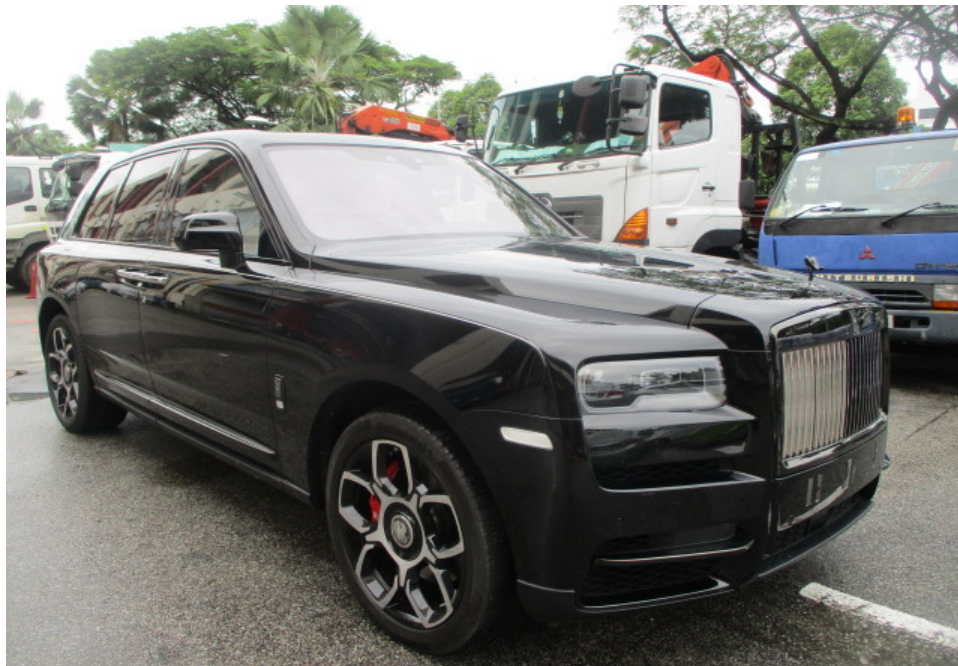
**Photo 7** shows a general view of the front right body of the Motor Car at the time of my inspection. The Motor Car was observed to be in a relatively good general condition with no loose exterior fittings observed. The body parts at the frontal portion of the Motor Car were visually examined and it was observed that the repair/restoration works carried out to the damaged area of the Motor Car (refer to photograph 1 - 3 above) were reasonably adequate and in order.

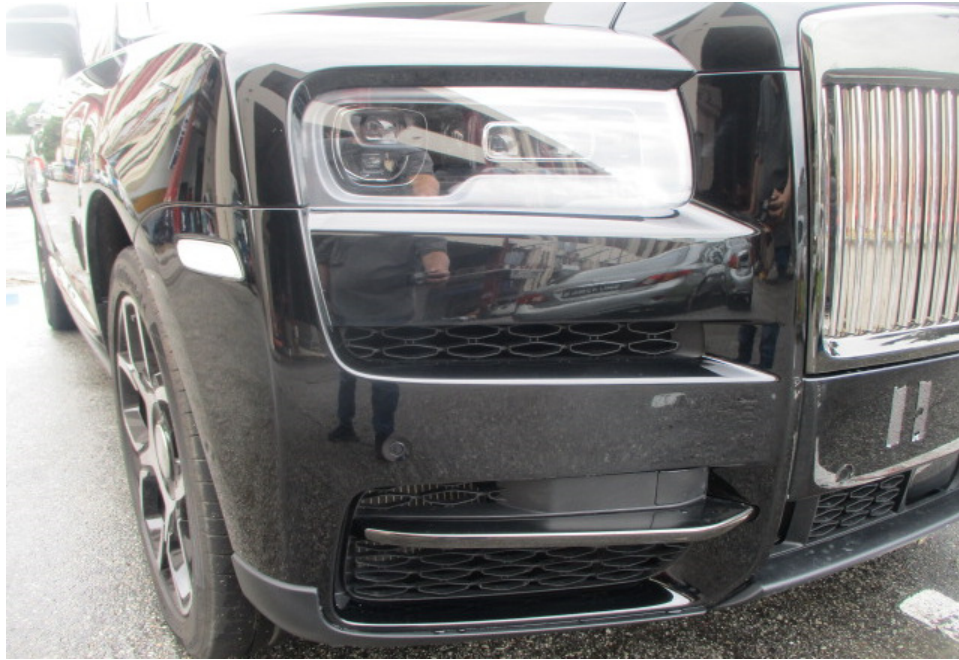
**Photo 8** shows a closer view of the Motor Car's front bumper, front bumper right lower grille, front bumper right lower grille garnish, front bumper right sensors, front right signal lamp and front right headlamp. The body parts at the frontal portion of the Motor Car were visually examined and it was observed that the repair/restoration works carried out to the damaged area of the Motor Car (refer to photograph 1 - 3 above) were reasonably adequate and in order.

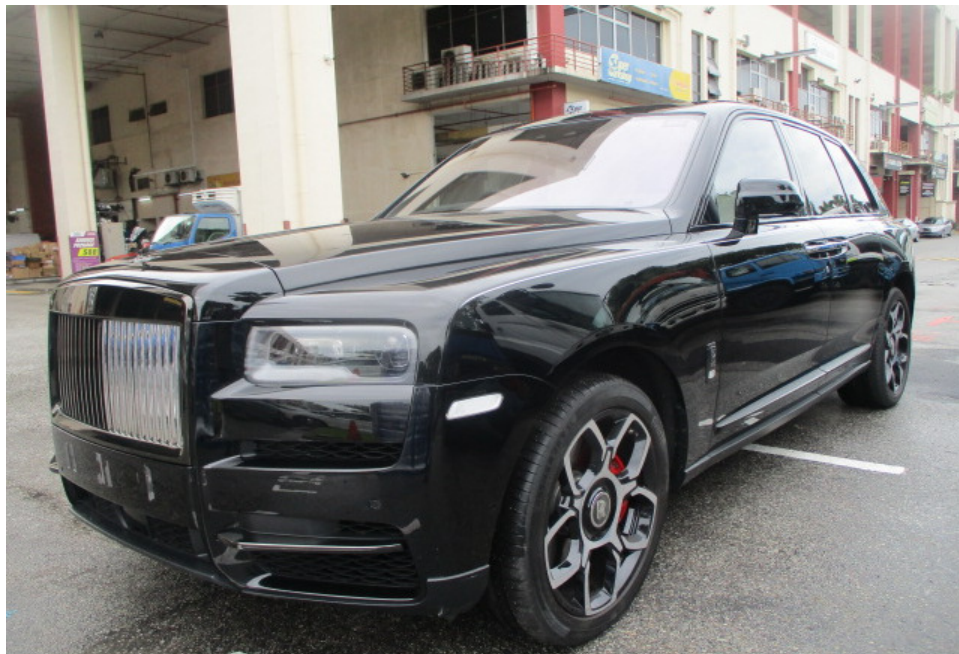
**Photo 9** shows a general view of the front left body of the Motor Car at the time of my inspection. The Motor Car was observed to be in a relatively good general condition with no loose exterior fittings observed. The body parts at the frontal portion of the Motor Car were visually examined and it was observed that the repair/restoration works carried out to the damaged area of the Motor Car (refer to photograph 1 - 3 above) were reasonably adequate and in order.

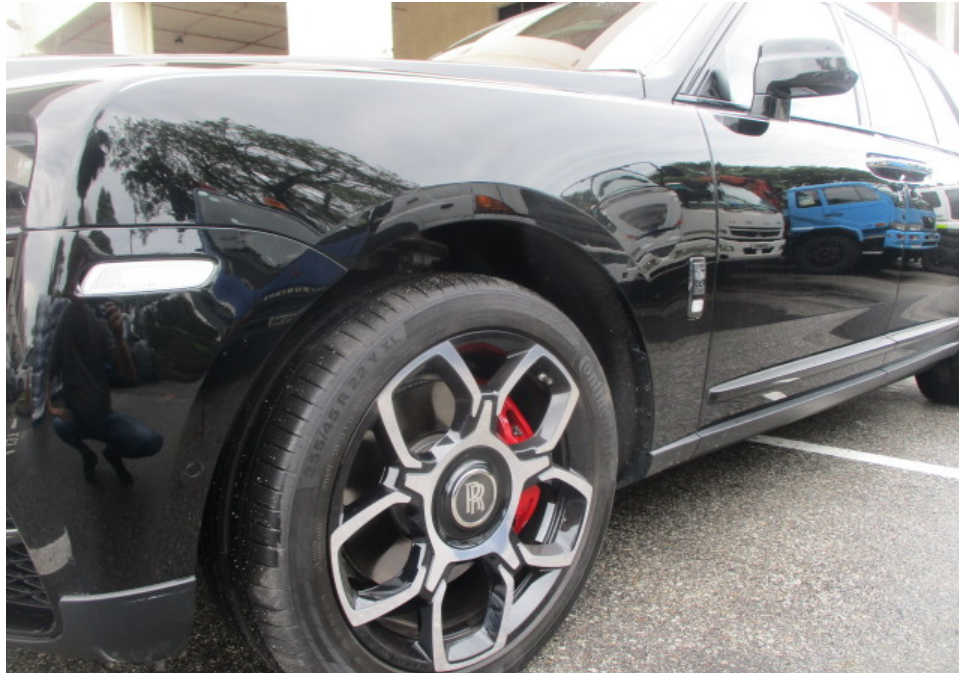
**Photo 10** shows a closer view of the Motor Car's front left signal lamp, front left wheel rim and front left fender. The body parts at the frontal portion of the Motor Car were visually examined and it was observed that the repair/restoration works carried out to the damaged area of the Motor Car (refer to photograph 1 - 3 above) were reasonably adequate and in order.

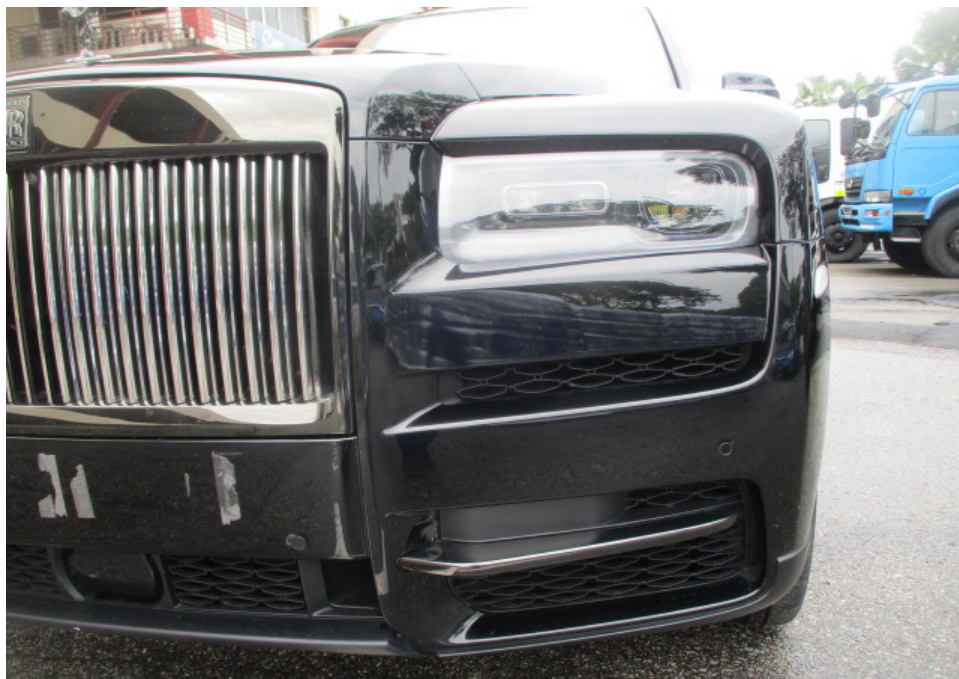
**Photo 11** shows a closer view of the Motor Car's front bumper, front bumper right lower grille, front bumper right lower grille garnish and front right headlamp. The body parts at the frontal portion of the Motor Car were visually examined and it was observed that the repair/restoration works carried out to the damaged area of the Motor Car (refer to photograph 1 - 3 above) were reasonably adequate and in order.

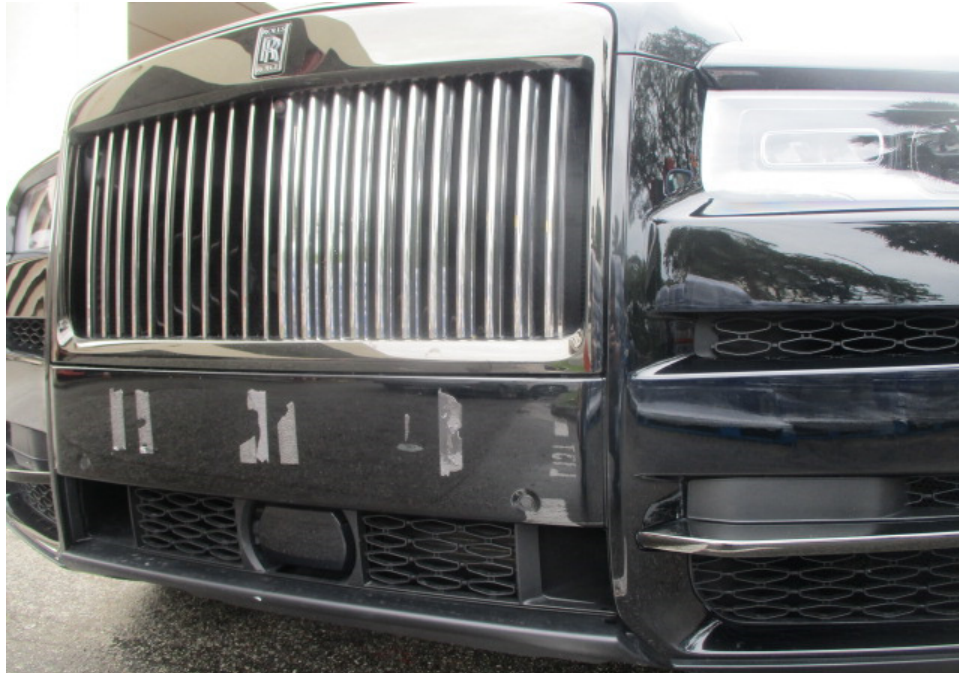
**Photo 12** shows a closer view of the Motor Car's front bumper, front bumper centre lower grille, front bumper centre lower garnish, front radar unit and front grille. The body parts at the frontal portion of the Motor Car were visually examined and it was observed that the repair/restoration works carried out to the damaged area of the Motor Car (refer to photograph 1 - 3 above) were reasonably adequate and in order.

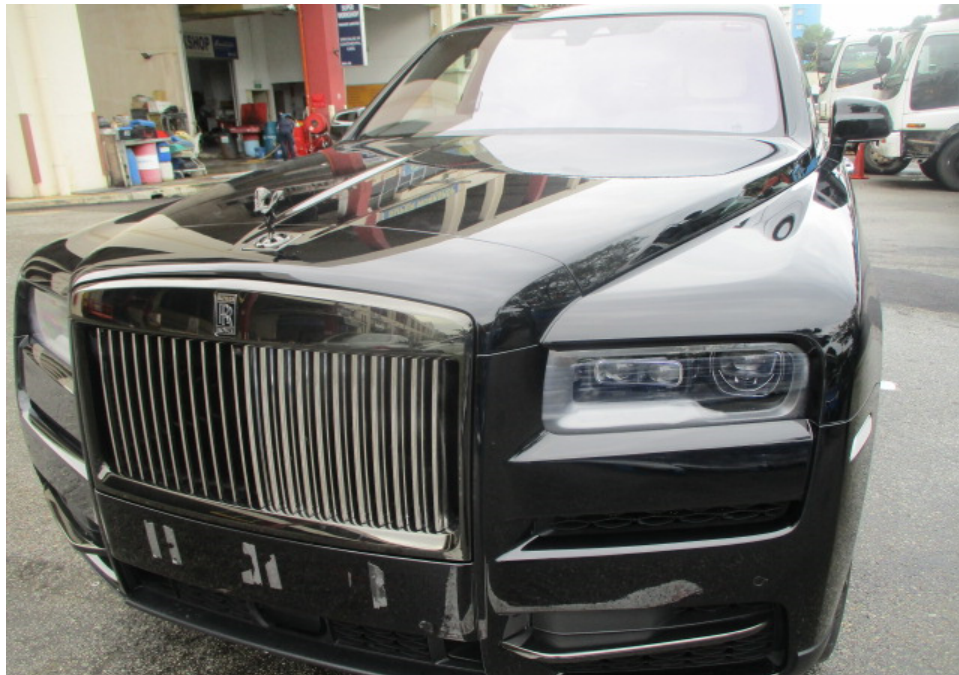
**Photo 13** shows a closer view of the Motor Car's front bumper top cover, front grille, front emblem and front left headlamp. The body parts at the frontal portion of the Motor Car were visually examined and it was observed that the repair/restoration works carried out to the damaged area of the Motor Car (refer to photograph 1 - 3 above) were reasonably adequate and in order.

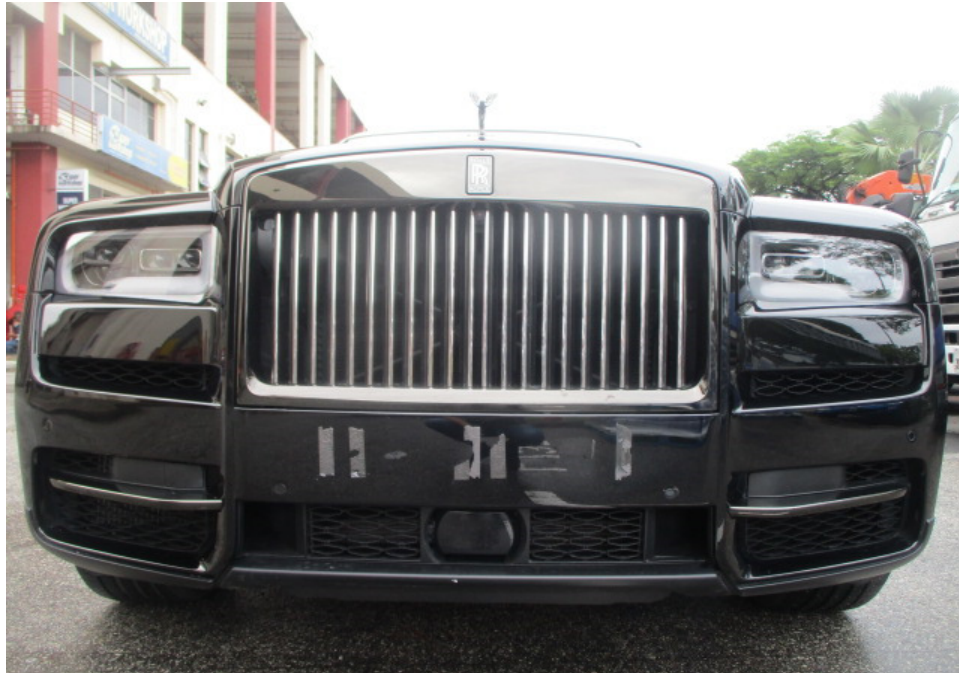
**Photo 14** shows a closer view of the Motor Car's frontal body. The body parts at the frontal portion of the Motor Car were visually examined and it was observed that the repair/restoration works carried out to the damaged area of the Motor Car (refer to photograph 1 - 3 above) were reasonably adequate and in order.

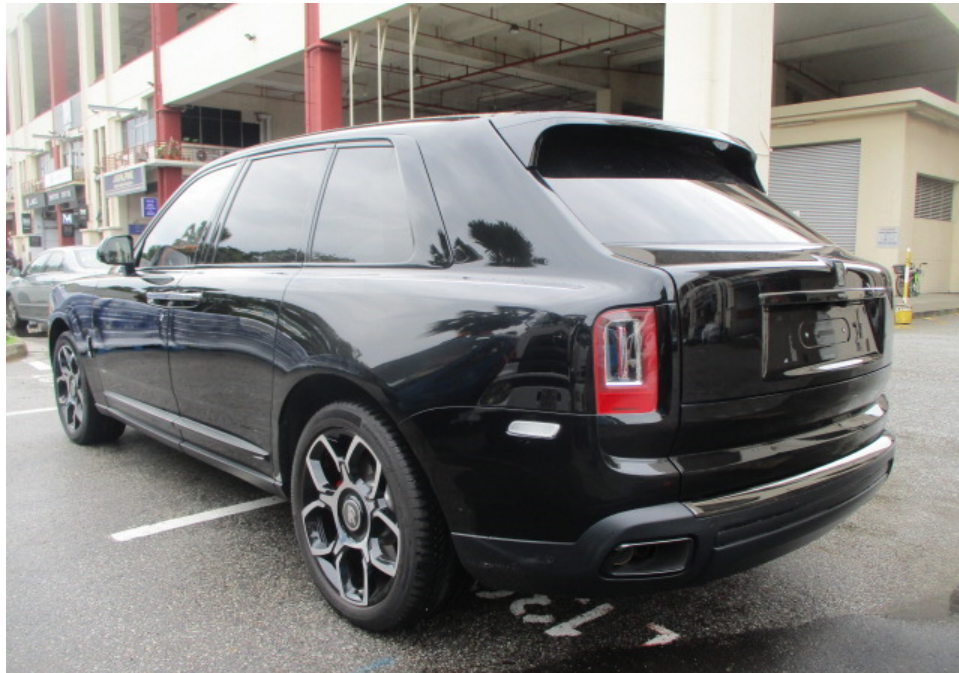
**Photo 15** shows a general view of the rear left body of the Motor Car at the time of my inspection. The Motor Car was observed to be in a relatively good general condition with no loose exterior fittings observed. The mileage of the Motor Car recorded at the time of my inspection was 3,793km.

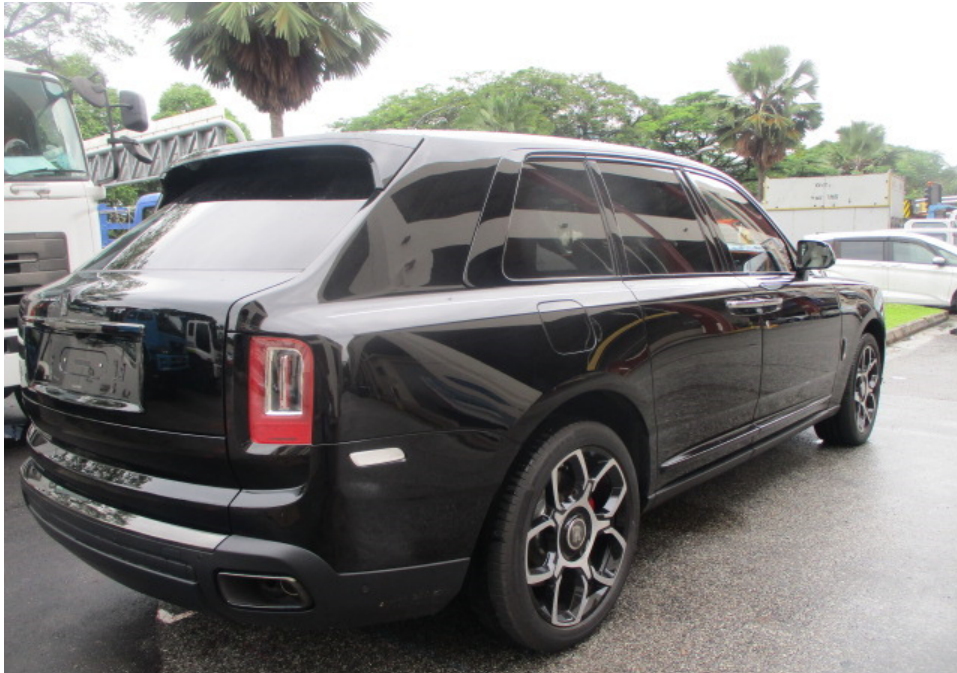
**Photo 16** shows a general view of the rear right body of the Motor Car at the time of my inspection. The Motor Car was observed to be in a relatively good general condition with no loose exterior fittings observed. The mileage of the Motor Car recorded at the time of my inspection was 3,793km.

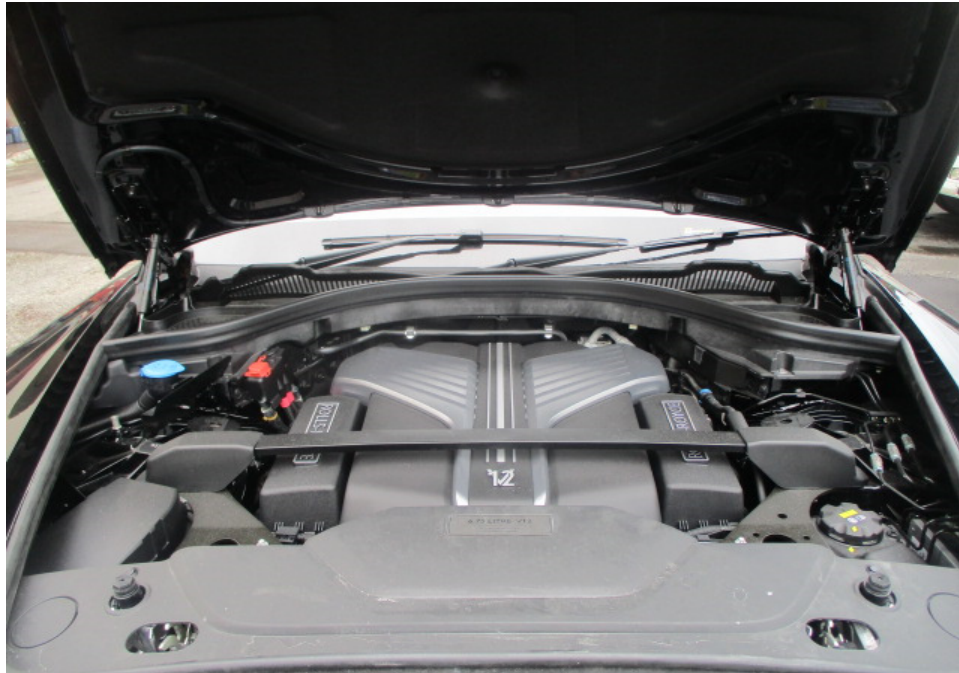
**Photo 18** shows a general view of the Motor Car's engine compartment at the time of my inspection. The various parts and components inside the engine compartment were all observed to be intact and properly fitted. There was also no sign(s) or indication(s) of fluid leak and/or fluid stain found inside the engine compartment.

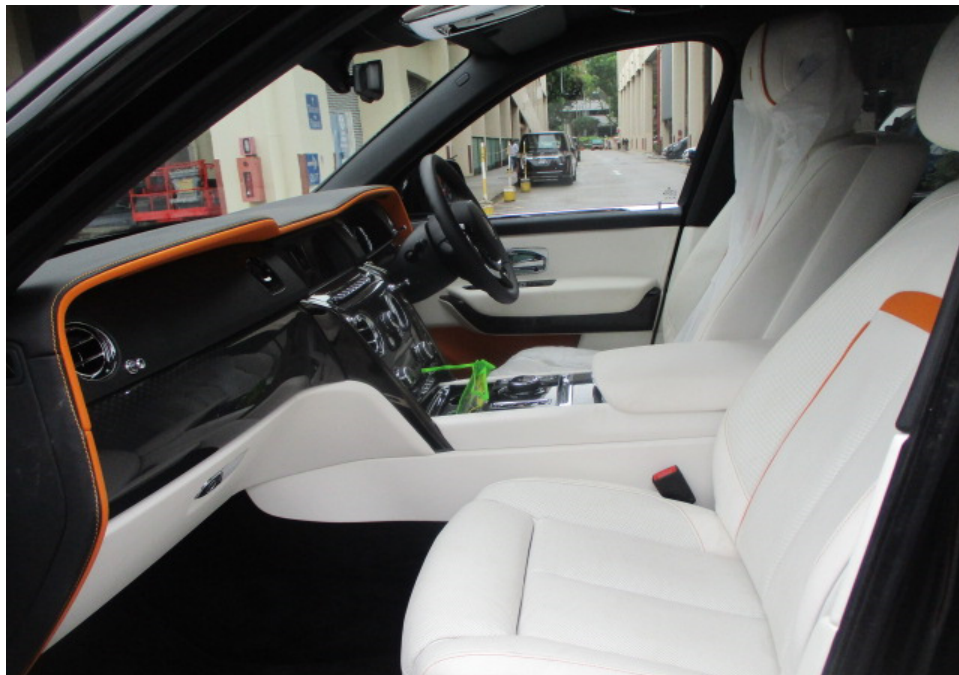
**Photo 19** shows the interior compartment of the Motor Car at the time of my inspection. The various parts and components, trims, carpet, and upholstery inside the interior compartment were all observed to be intact and properly fitted.

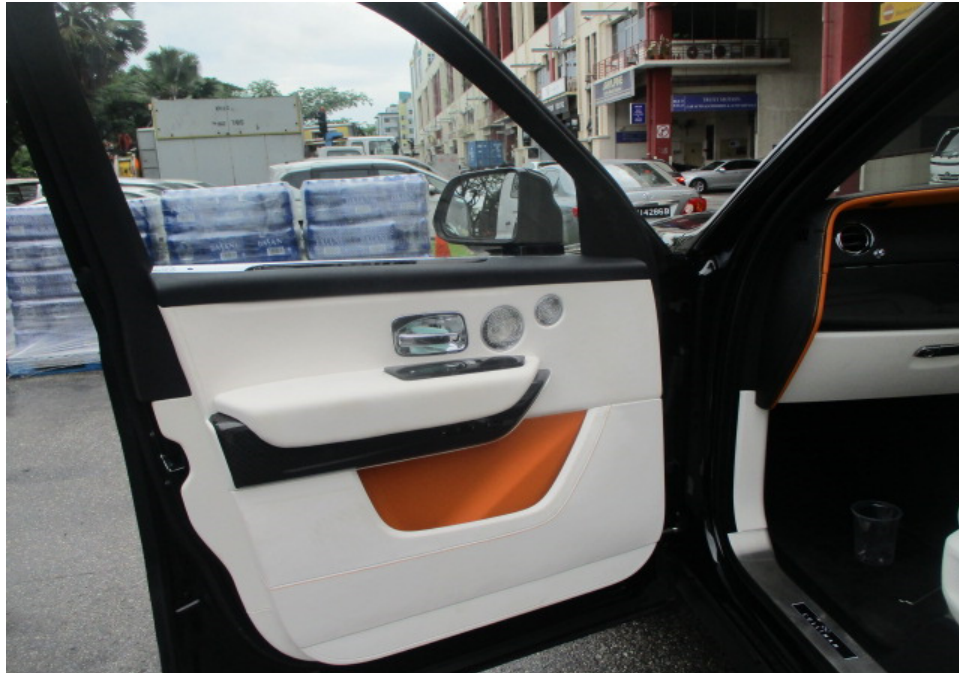
**Photo 20** shows a closer view of the Motor Car's front left door inner trimboard and front left door window. The repair/restoration works carried out to the damaged area of the Motor Car (refer to photograph 6 above) were reasonably adequate and in order.

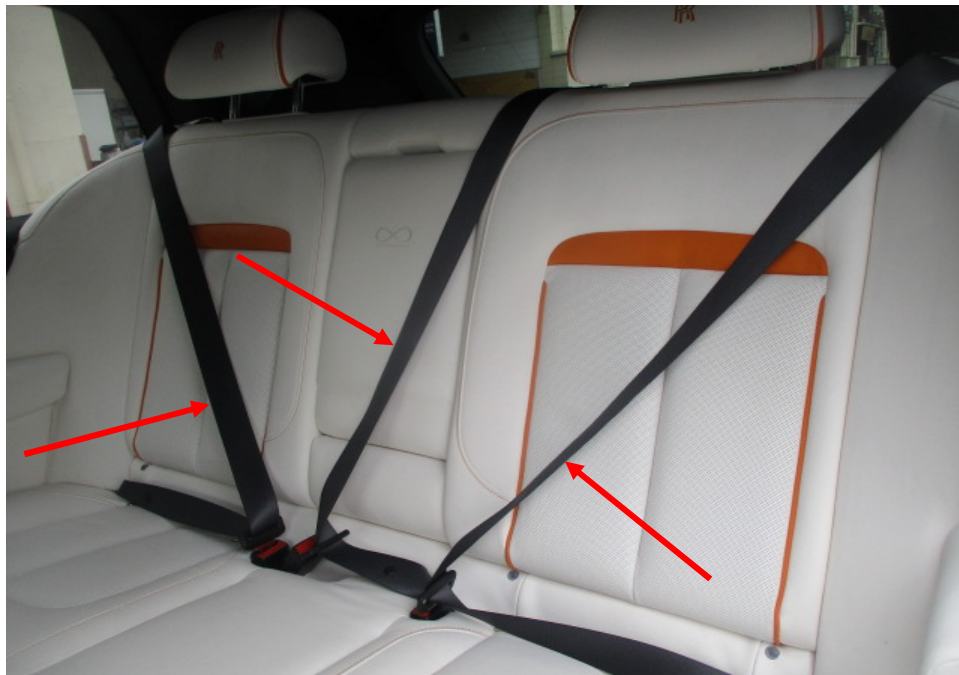
**Photo 21** shows the rear seats of the Motor Car. All the seats of the Motor Car were secured via seat rails to the floorboard. They were also fitted with a retractable seat belt reel and a pre-tensioner. The seat belts (arrowed) were tested and were able to be fastened into the respective pre-tensions that were fitted on the side of each individual seat.

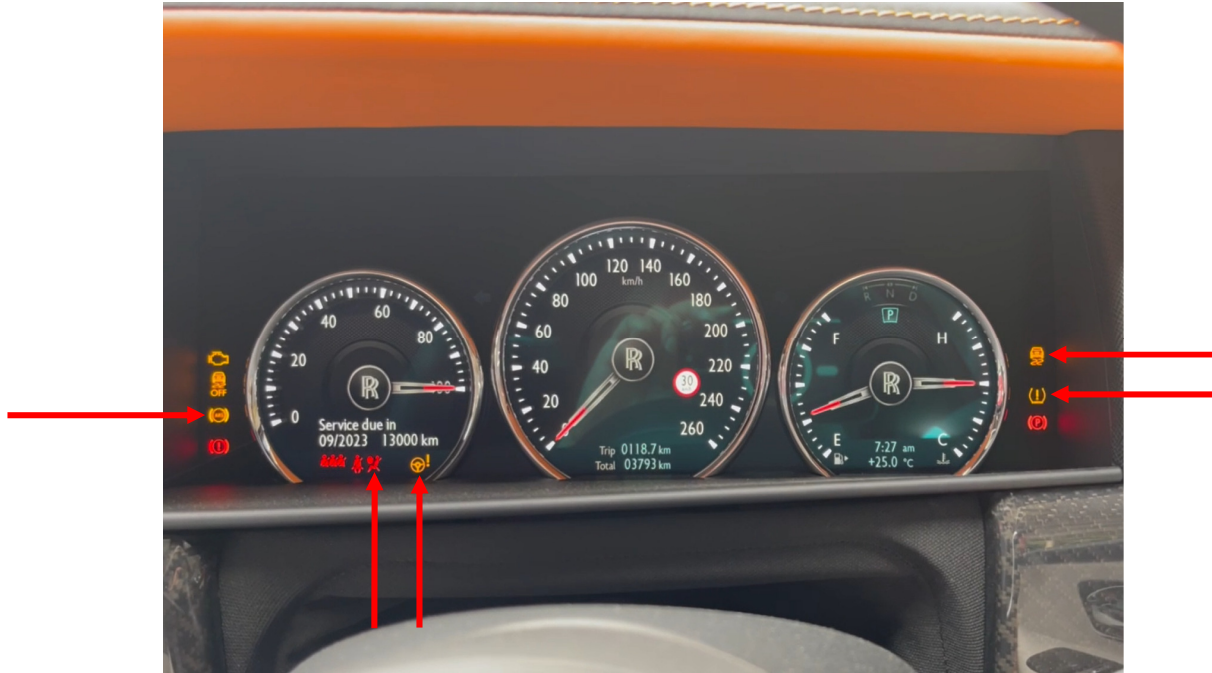
**Photo 22** shows the warning lights for the various electronic safety features appearing on the instrument panel of the Motor Car during its self-test when the engine is cranked, in particular the ABS, SRS, EPS, TPM and TCS lights (arrowed).

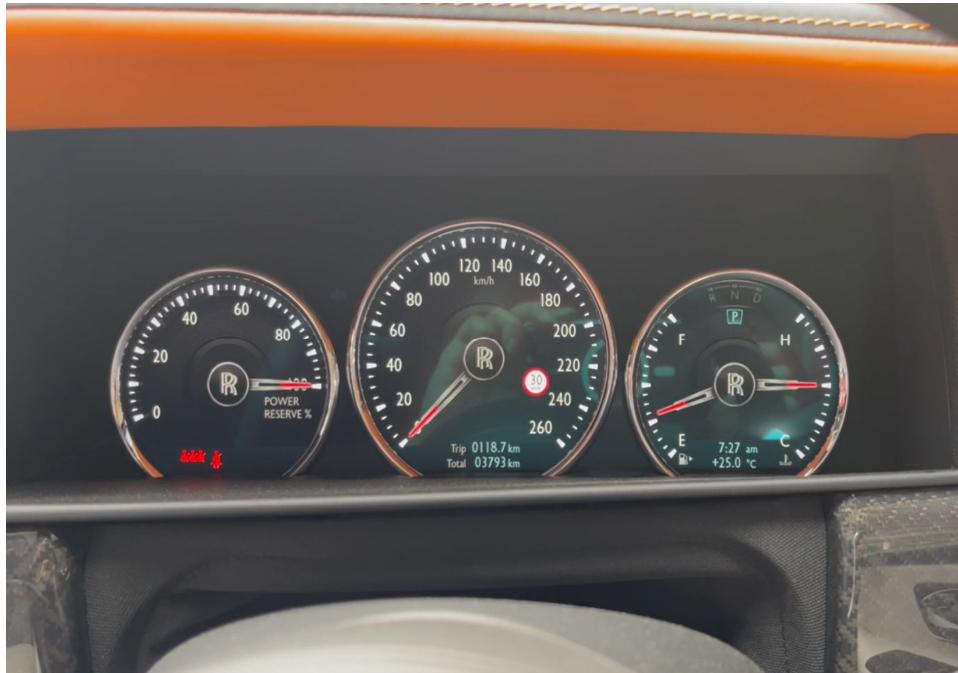
**Photo 23** shows the respective warning lights no longer illuminated, indicating that there is no fault detected to the ABS, SRS, EPS, TPM and TCS systems of the Motor Car during the self-test. These electronic systems were hence in working condition at the time of my inspection.

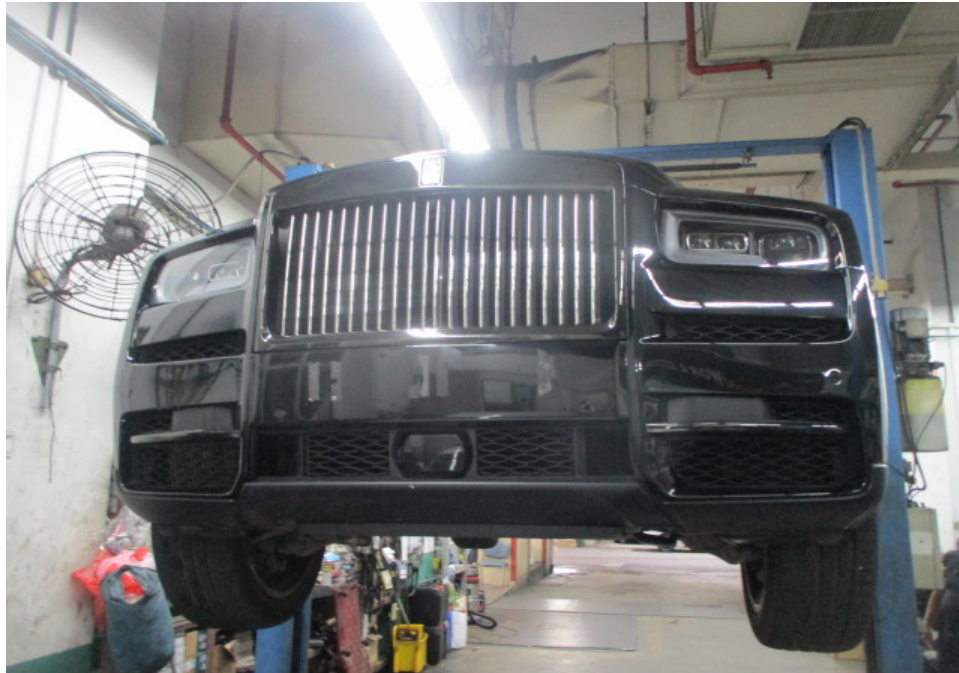
**Photo 24** shows the Motor Car hoisted up for checks on its undercarriage. There was no sign(s) or indication(s) of fluid leakage and/or fluid stain(s) on the underside of the Motor Car. The undercarriage components of the Motor Car were also all observed to be intact and secured in an appropriate manner.

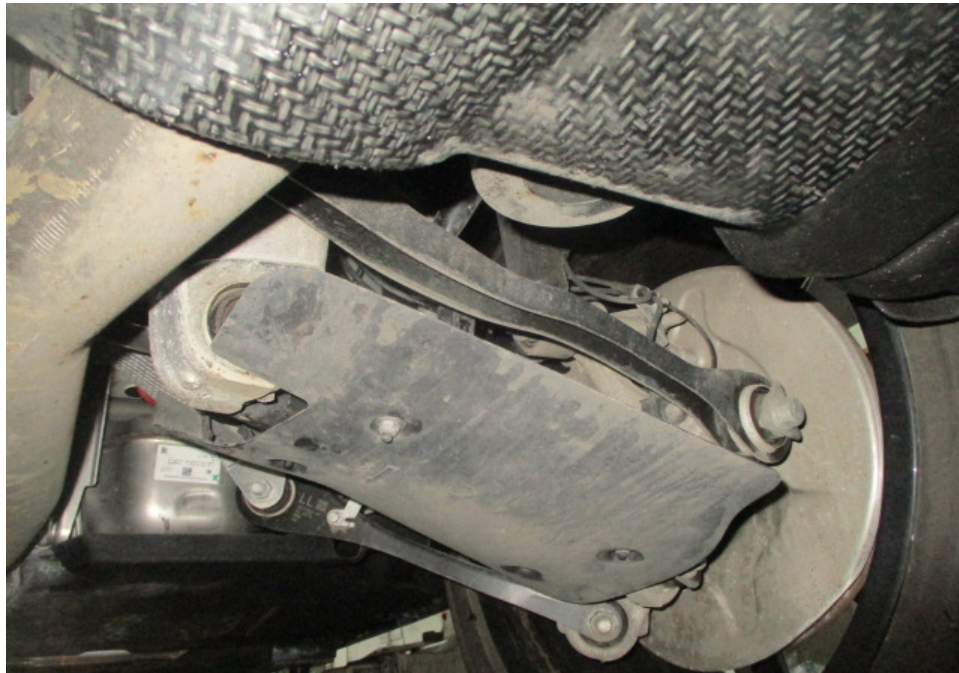
**Photo 25** shows a general view of the control arms and linkages at the rear right wheel of the Motor Car. I did not observe any fluid leak and/or fluid stain on the underside of the Motor Car. All of the Motor Car's undercarriage components were observed to be intact and secured in an appropriate manner.

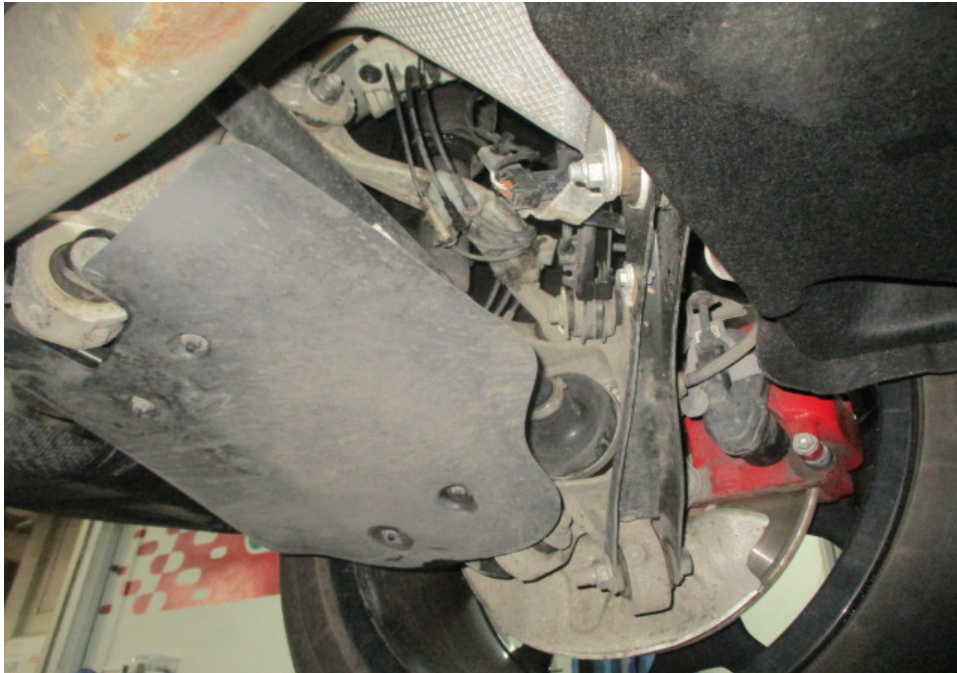
**Photo 26** shows a general view of the control arms and linkages at the rear left wheel of the Motor Car. I did not observe any fluid leak and/or fluid stain on the underside of the Motor Car. All of the Motor Car's undercarriage components were observed to be intact and secured in an appropriate manner.

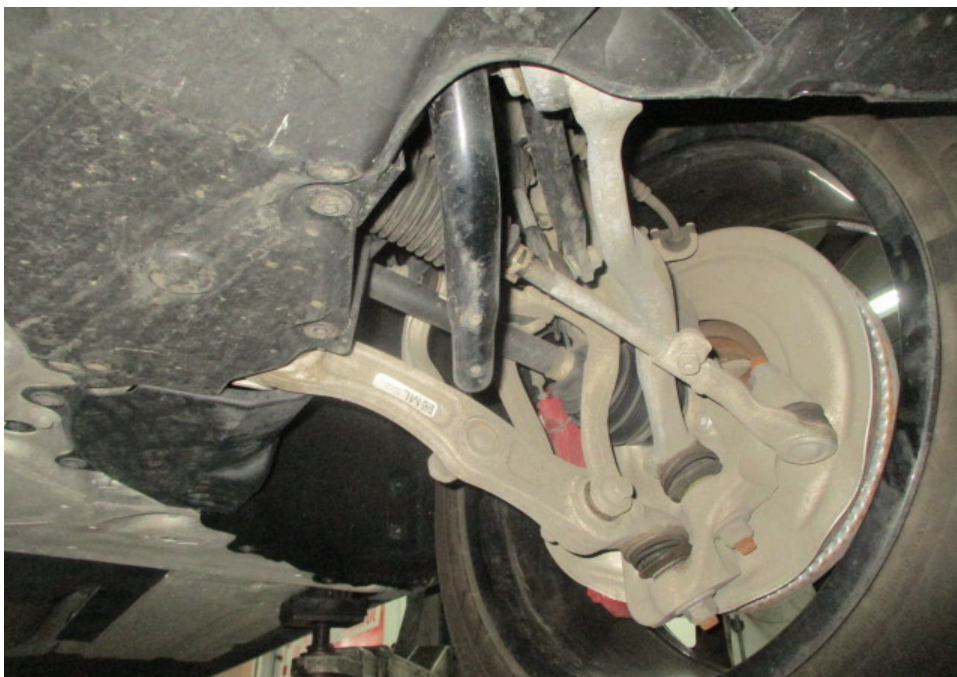
**Photo 27** shows the various undercarriage components at the front left wheel of the Motor Car. The mechanical components, control arms and linkages were all found to be intact and secured in an appropriate manner.

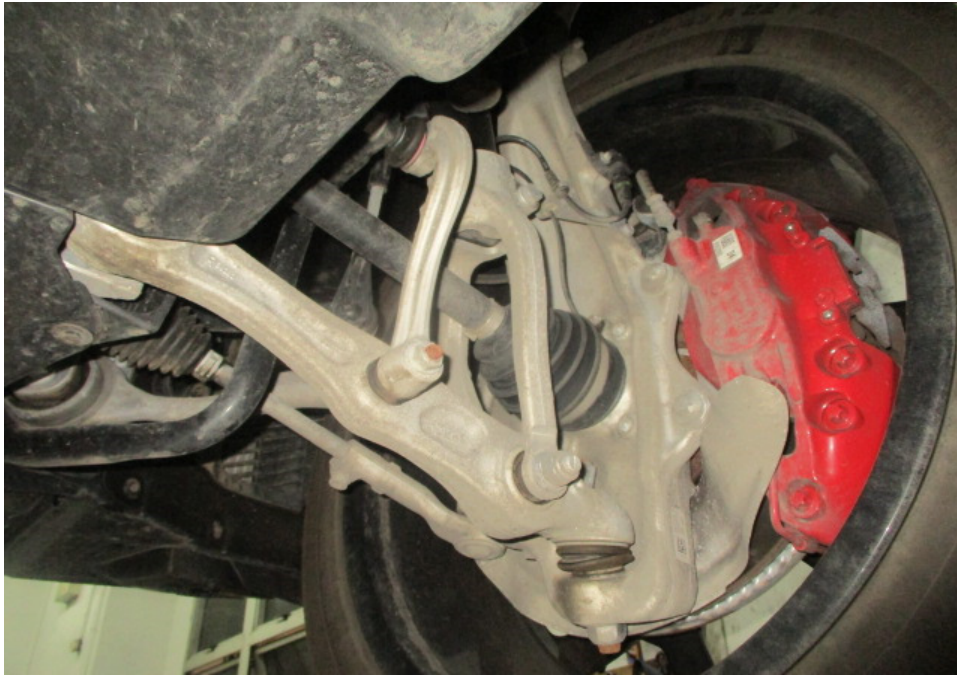
**Photo 28** shows the various undercarriage components at the front right wheel of the Motor Car. The mechanical components, control arms and linkages were all found to be intact and secured in an appropriate manner. I also did not observe any fluid leak and/or fluid stain on the underside of the Motor Car.

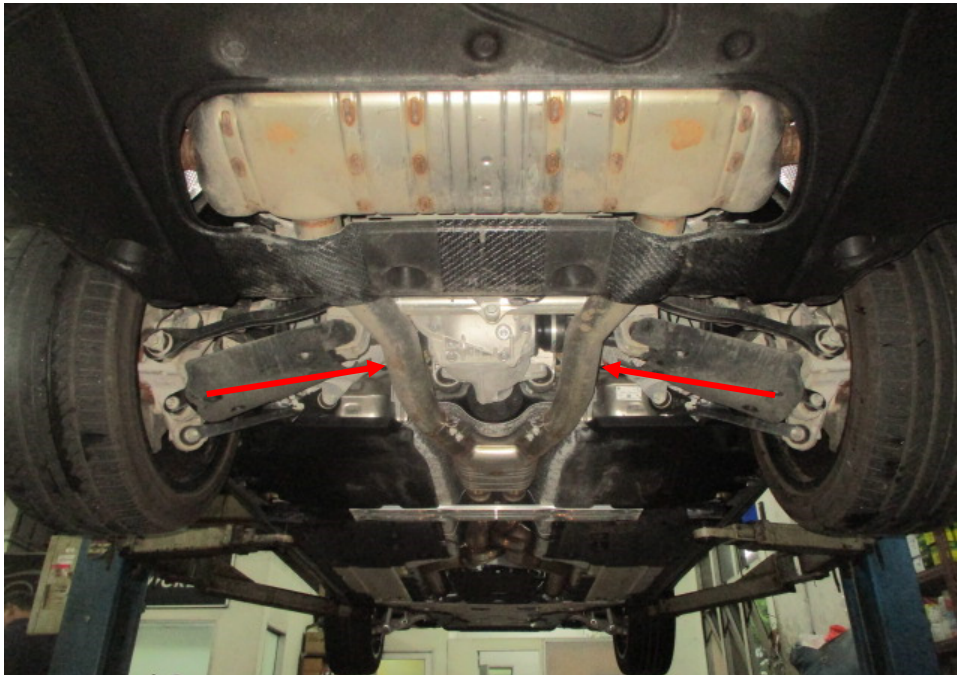
**Photo 29** shows the rear section of the Motor Car's exhaust system. My examination of the Motor Car's exhaust system revealed no sign(s) or indication(s) of any cut or weld marks along its exhaust pipes (arrowed), on its rear muffler, on its centre resonator boxes and on its catalytic converters.

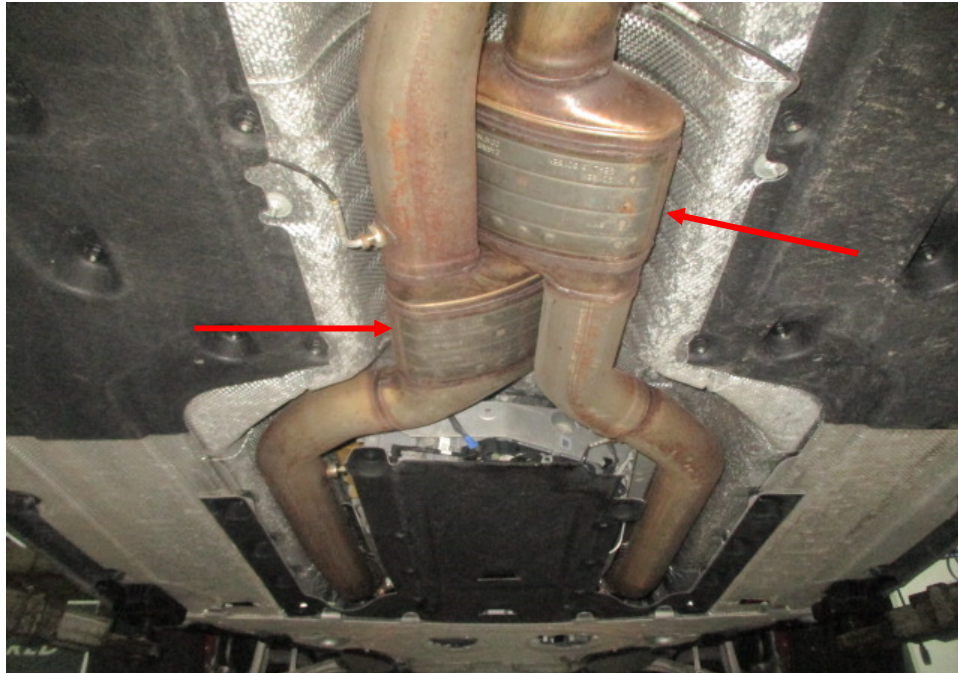
**Photo 30** shows the front section of the Motor Car's exhaust system. My examination of the Motor Car's exhaust system revealed no sign(s) or indication(s) of any cut or weld marks along its exhaust pipes, on its rear muffler, on its centre resonator boxes (arrowed) and on its catalytic converters.

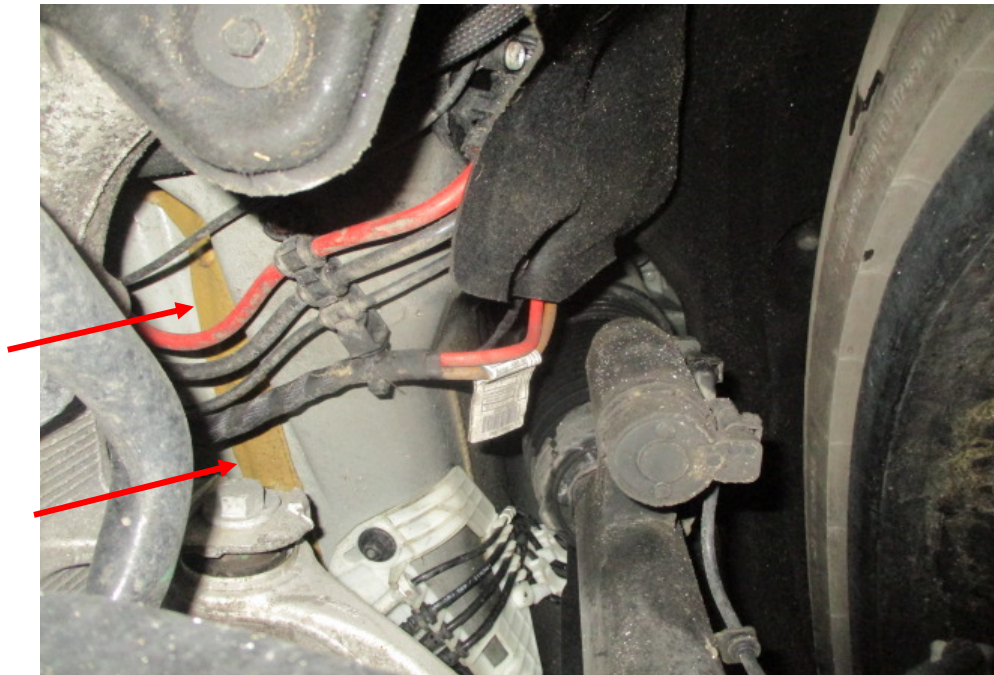
**Photo 31** shows the chassis/structural body at the underside rear right of the Motor Car. I did not find any weld marks other than original spot weld marks on the chassis/structural body of the Motor Car. The original factory sealant (arrowed) at the joints along the chassis/structural body was untouched, indicating no work was done on the chassis/structural body of the Motor Car and that the chassis/structural body was originally fitted.
