Your Ref: Rolls Royce Cullinan  
(chassis number SCATV6201PU215430)  
Our Ref : CI/TP23005599/D

03 June 2023

**INSPECTION REPORT OF AN UNREGISTERED ROLLS ROYCE CULLINAN  
MOTOR CAR WITH CHASSIS NUMBER SCATV6201PU215430**

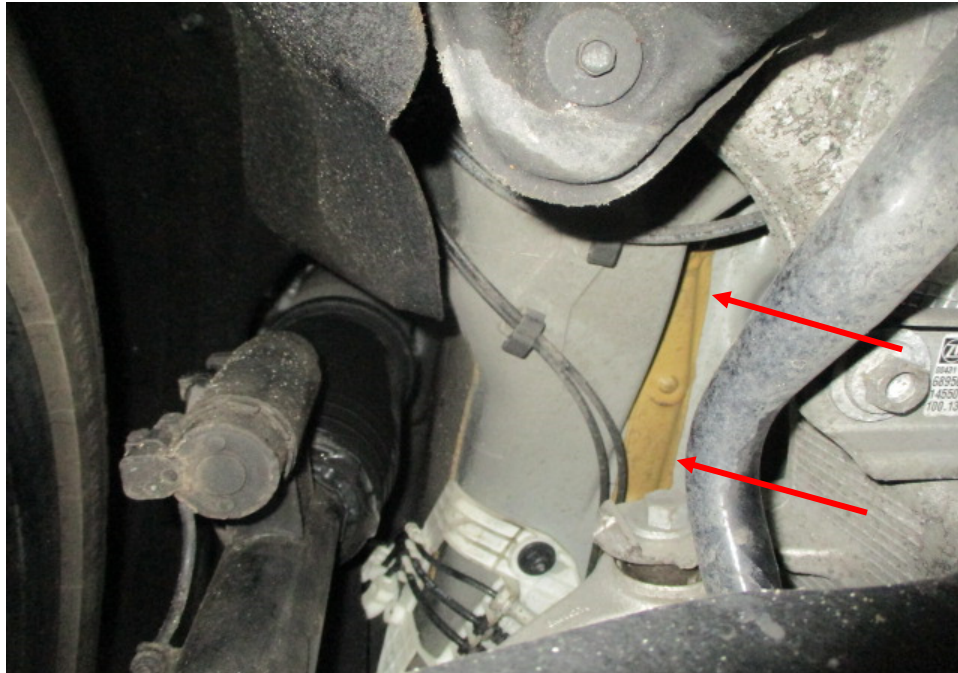
**Photo 32** shows the chassis/structural body at the underside rear left of the Motor Car. I did not find any weld marks other than original spot weld marks on the chassis/structural body of the Motor Car. The original factory sealant (arrowed) at the joints along the chassis/structural body was untouched, indicating no work was done on the chassis/structural body of the Motor Car and that the chassis/structural body was originally fitted.

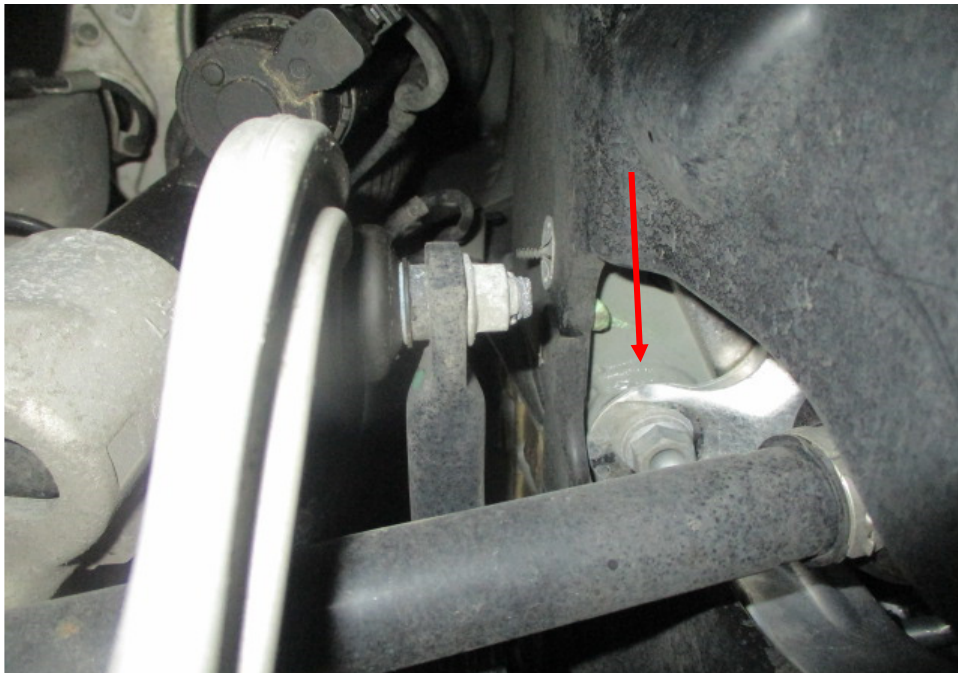
**Photo 33** shows the chassis/structural body at the underside front left of the Motor Car. The original factory sealant (arrowed) at the joints along the chassis/structural body was observed to be untouched. In general, I had found no work was carried out on the chassis/structural body of the Motor Car. The chassis/structural body of the Motor Car was originally fitted.

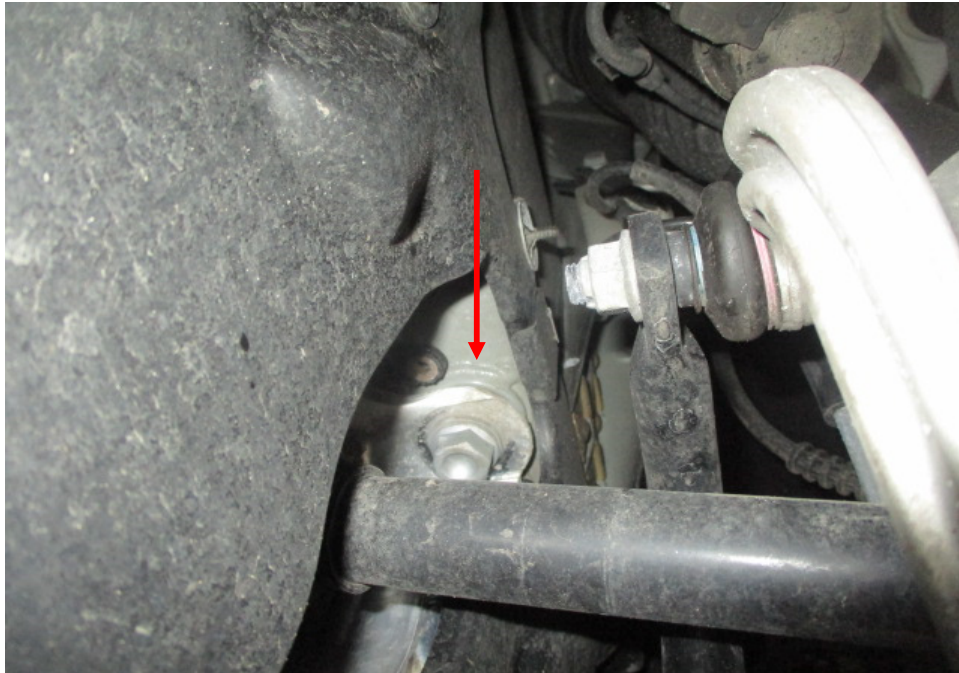
**Photo 34** shows the chassis/structural body at the underside front right of the Motor Car. I did not find any weld marks other than original spot weld marks on the chassis/structural body of the Motor Car. The original factory sealant (arrowed) at the joints along the chassis/structural body was untouched, indicating no work was done on the chassis/structural body of the Motor Car and that the chassis/structural body was originally fitted.

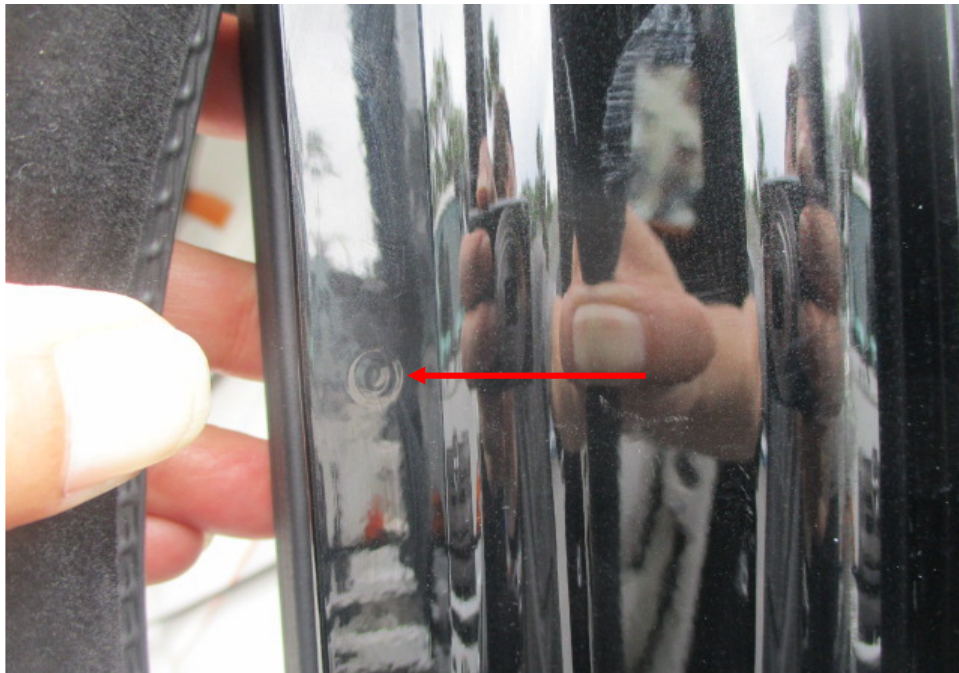
**Photo 35** shows the left side "C" pillar of the Motor Car. I did not find any weld marks other than original spot weld marks (arrowed) on the left side "C" pillar of the Motor Car, which indicates that there was no re-welding works carried out. In general, I had found all the non-detachable body panels of the Motor Car to be originally fitted at the time of my inspection.

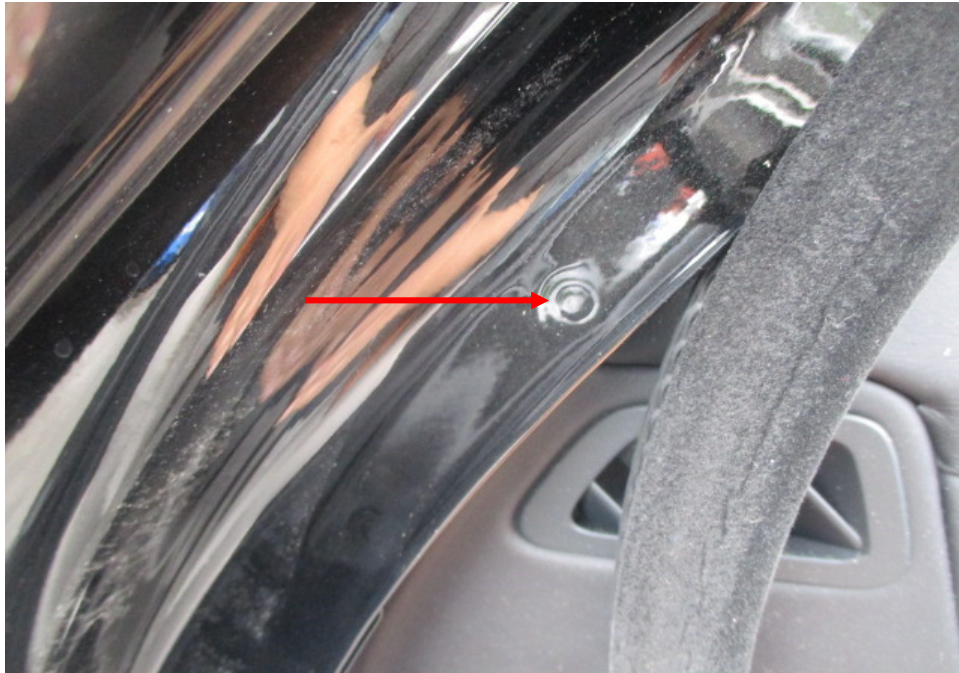
**Photo 36** shows the left side "A" pillar of the Motor Car. I did not find any weld marks other than original spot weld marks (arrowed) on the left side "A" pillar of the Motor Car, which indicates that there was no re-welding works carried out. In general, I had found all the non-detachable body panels of the Motor Car to be originally fitted at the time of my inspection.

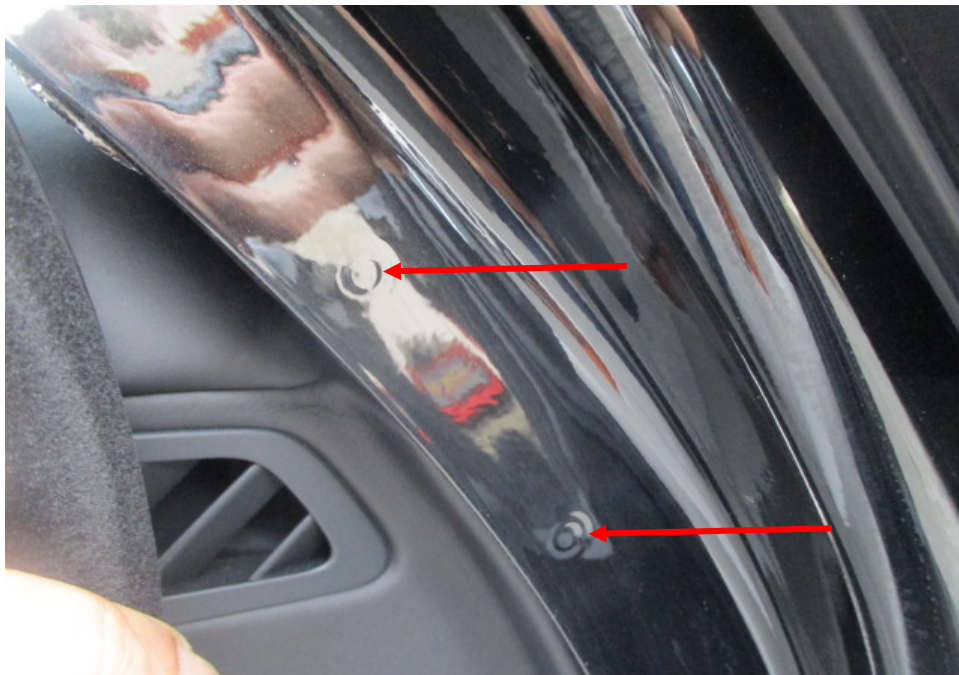
**Photo 37** shows the right side "A" pillar of the Motor Car. I did not find any weld marks other than original spot weld marks (arrowed) on the right side "A" pillar of the Motor Car, which indicates that there was no re-welding works carried out. In general, I had found all the non-detachable body panels of the Motor Car to be originally fitted at the time of my inspection.

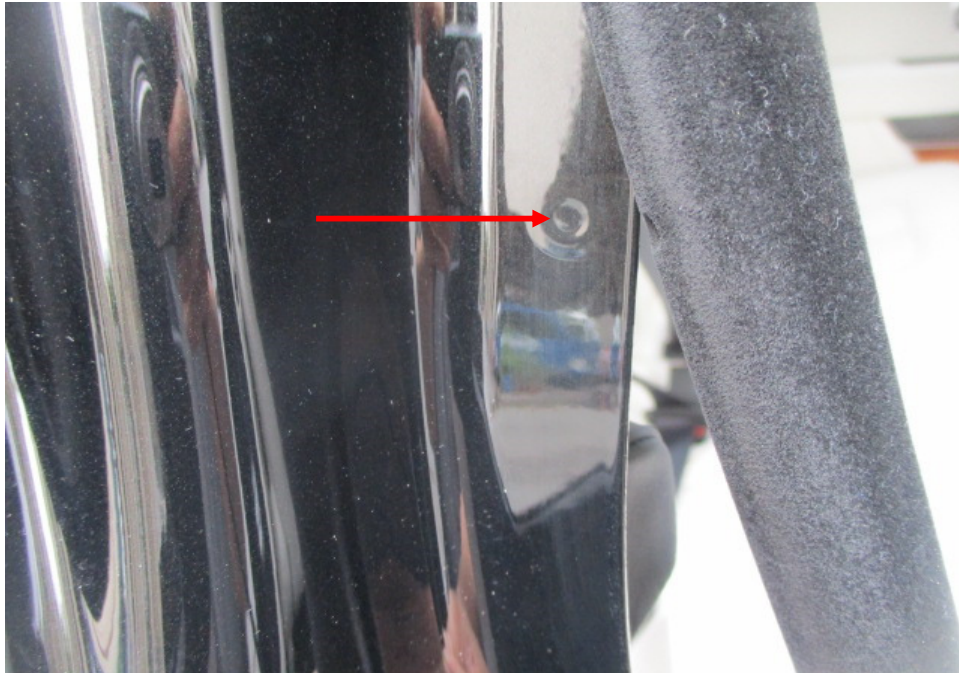
**Photo 38** shows the right side "C" pillar of the Motor Car. I did not find any weld marks other than original spot weld marks (arrowed) on the right side "C" pillar of the Motor Car, which indicates that there was no re-welding works carried out. In general, I had found all the non-detachable body panels of the Motor Car to be originally fitted at the time of my inspection.
