Your Ref: 316297
Our Ref : CS4/MSG23005607/P

**TECHNICAL INVESTIGATION REPORT OF FIRE INCIDENT INVOLVING THE
INSURED VEHICLE SML 682PON 5th JUNE 2023**

Vehicle Registration No.	: SML 682P
Make / Model	: LEXUS ES250 4DR SEDAN (AUTO) EXECUTIVE
Chassis No	: JTHB11B1702003045
Year of Registration	: 02 MAY 2019
Mileage	: 49,795KM

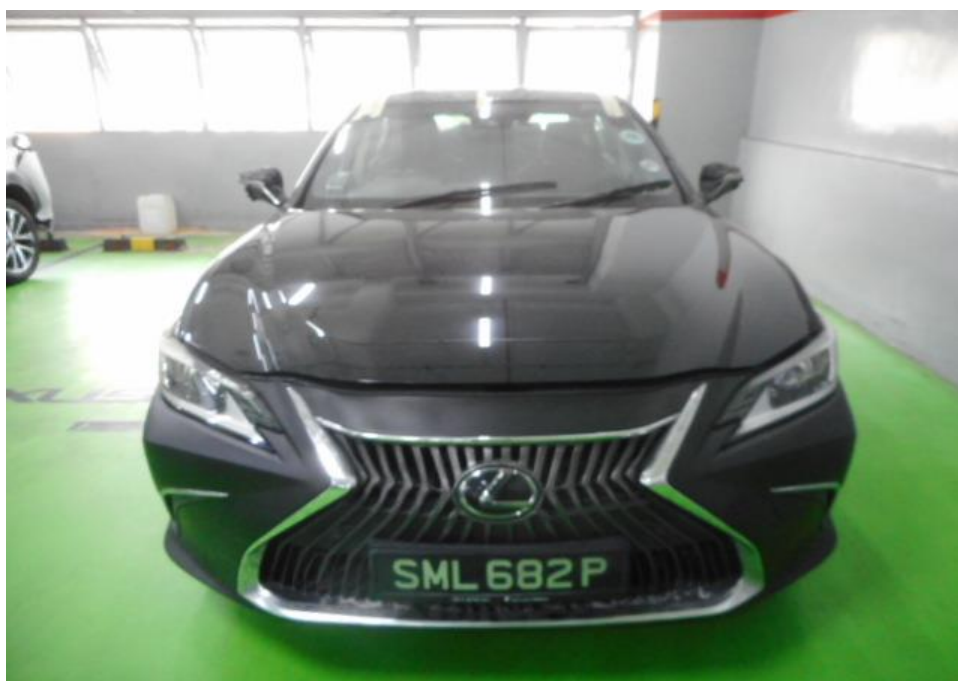
Photo 1 shows the front view of the Insured Vehicle at the time of our inspection. The exterior body of the Insured Vehicle was affected by the heat. Its front both plastic headlamps, plastic front grille, rubber weather seals and front plastic water drain channel had sustained heat damage as a result of the fire.

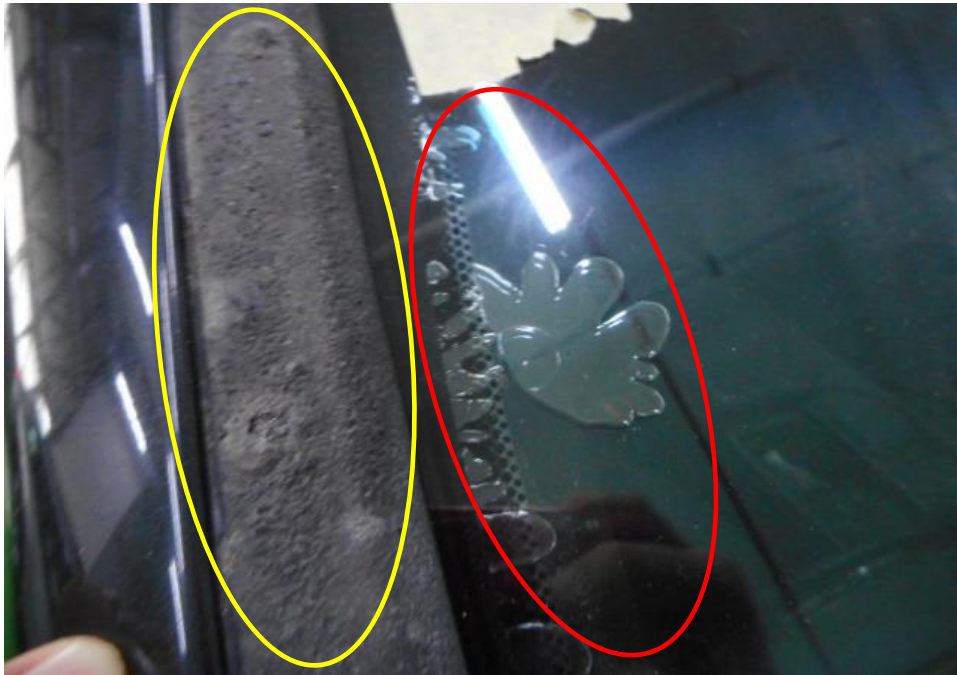
Photo 2 shows the close up view of the front of the Insured Vehicle at the time of our inspection. The rubber weather seals (yellow circle)) and front windscreen plastic protection films (red circle) had sustained heat damage and melted as a result of the fire.

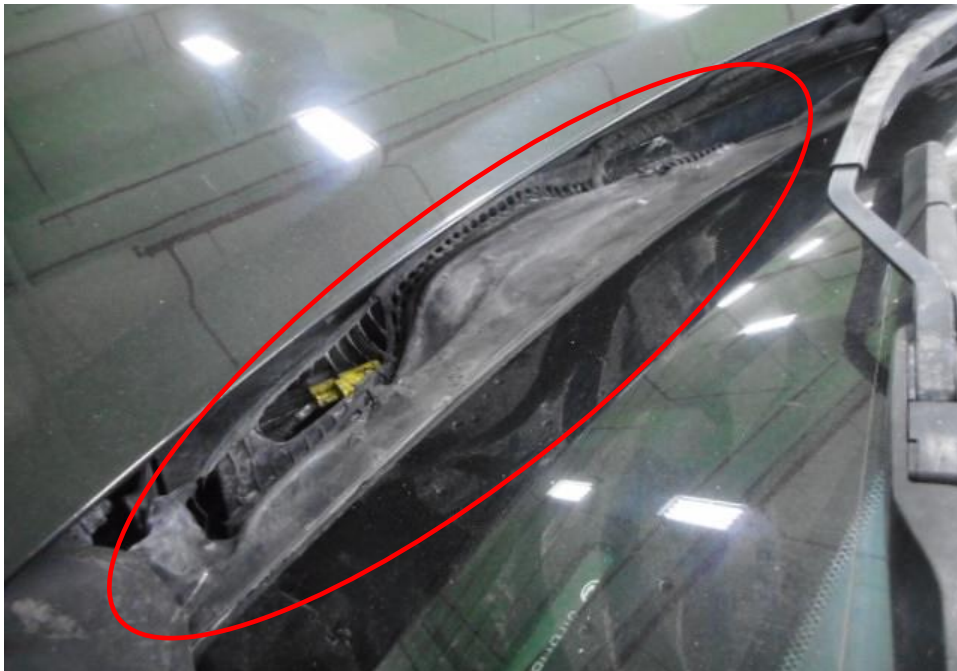
Photo 3 shows the close up view of the front of the Insured Vehicle at the time of our inspection. The front plastic water drain channel (circled) had sustained heat damage and melted as a result of the fire.

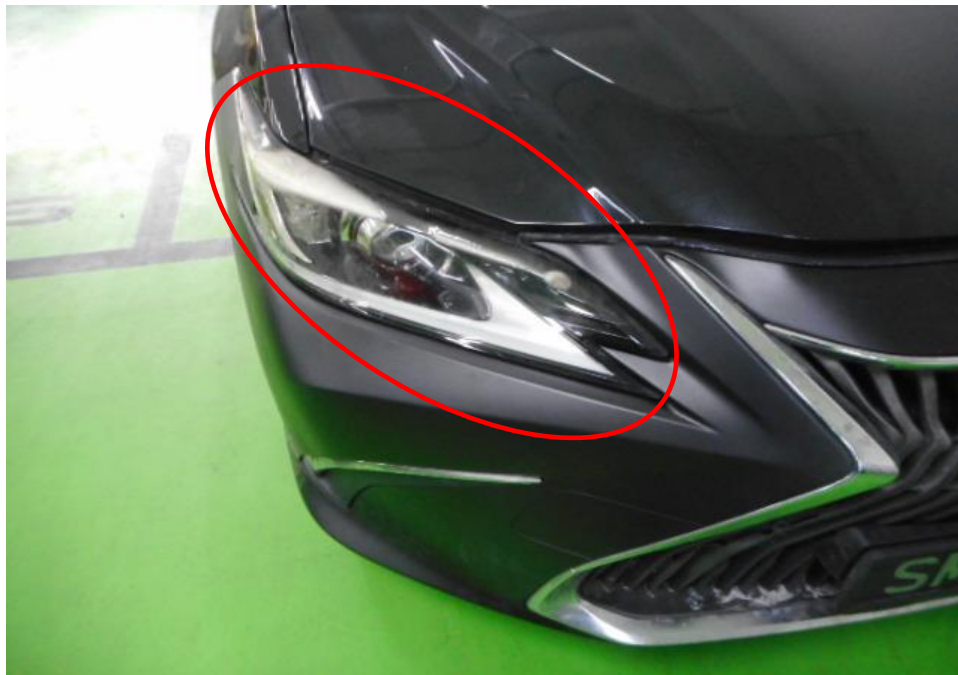
Photo 4 shows the general view of the front of the Insured Vehicle at the time of our inspection. The front right plastic headlamp (circled) had sustained heat damage and melted as a result of the fire.

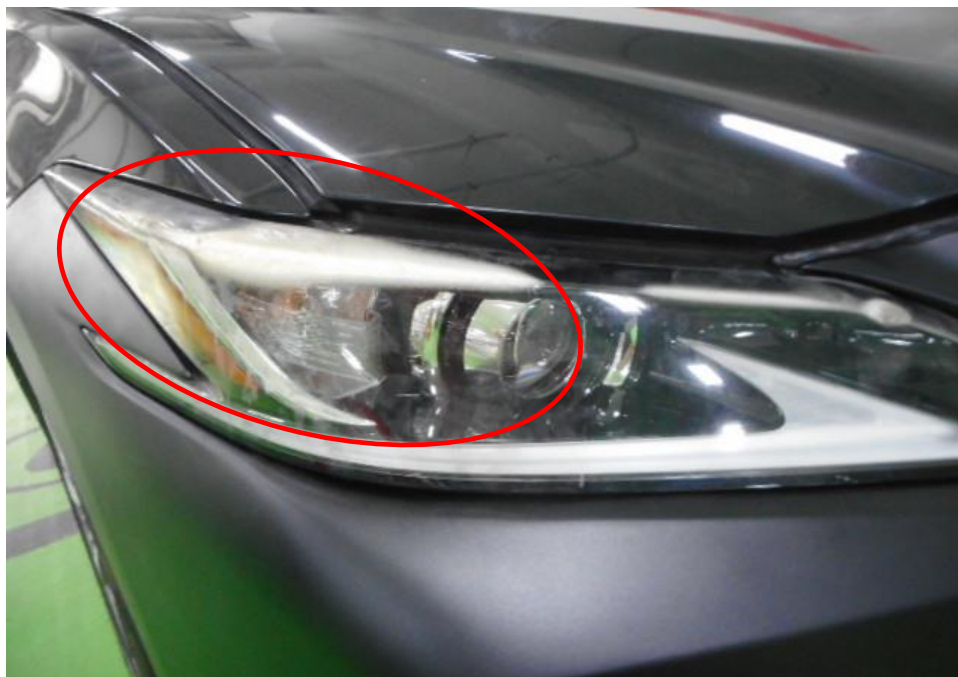
Photo 5 shows the close up view of the front of the Insured Vehicle at the time of our inspection. The front right plastic headlamp (circled) had sustained heat damage and melted as a result of the fire.

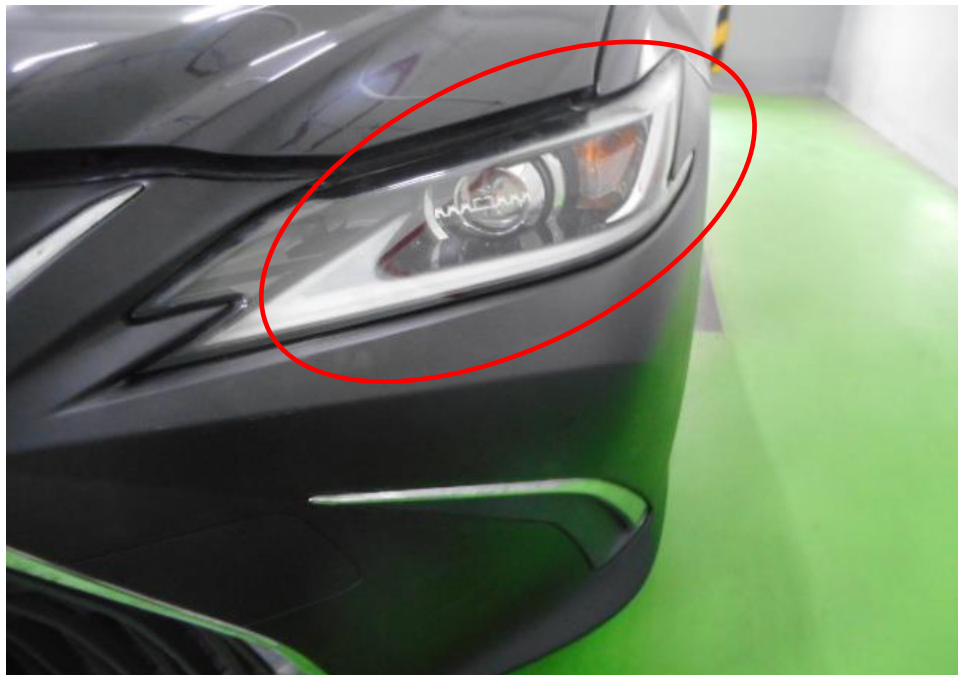
Photo 6 shows the general view of the front of the Insured Vehicle at the time of our inspection. The front left plastic headlamp (circled) had sustained heat damage and melted as a result of the fire.

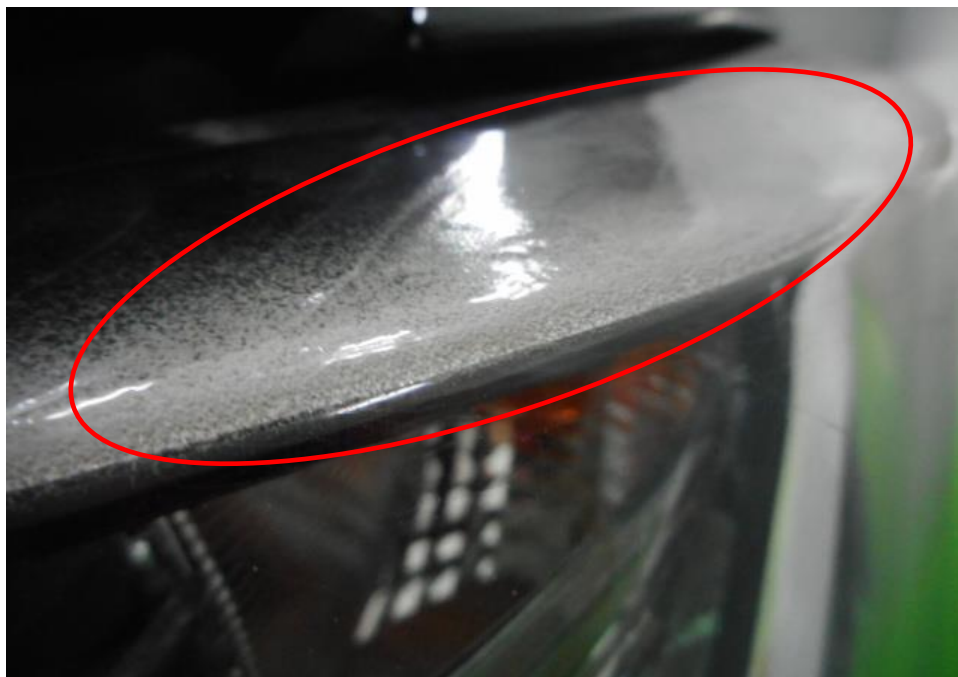
Photo 7 shows the close up view of the front of the Insured Vehicle at the time of our inspection. The front left plastic headlamp (circled) had sustained heat damage and melted as a result of the fire.

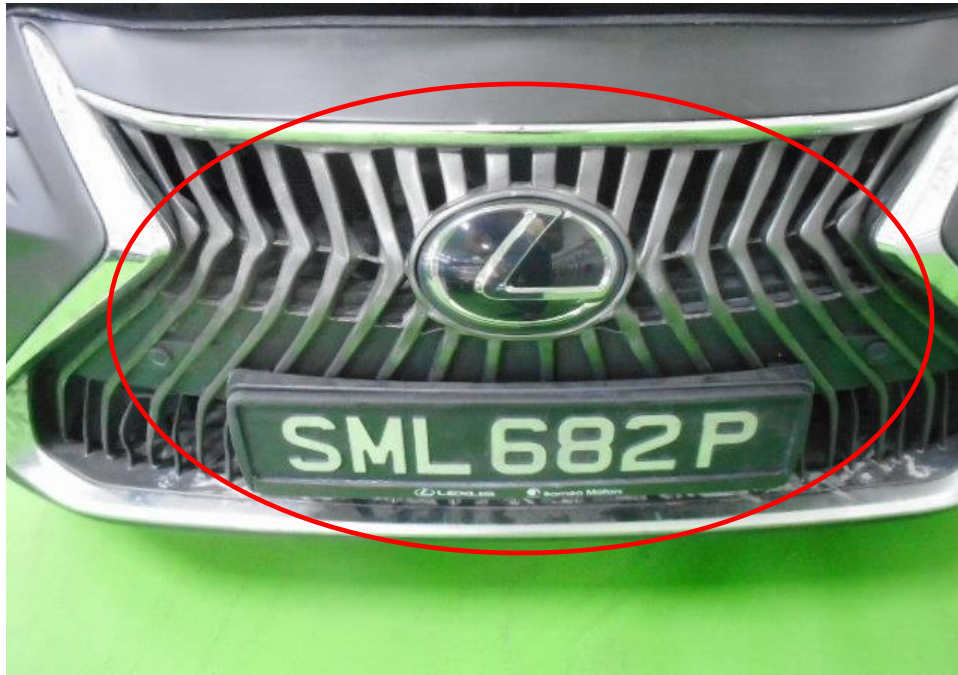
Photo 8 shows the general view of the front of the Insured Vehicle at the time of our inspection. The plastic front grille (circled) had sustained heat damage and melted as a result of the fire.

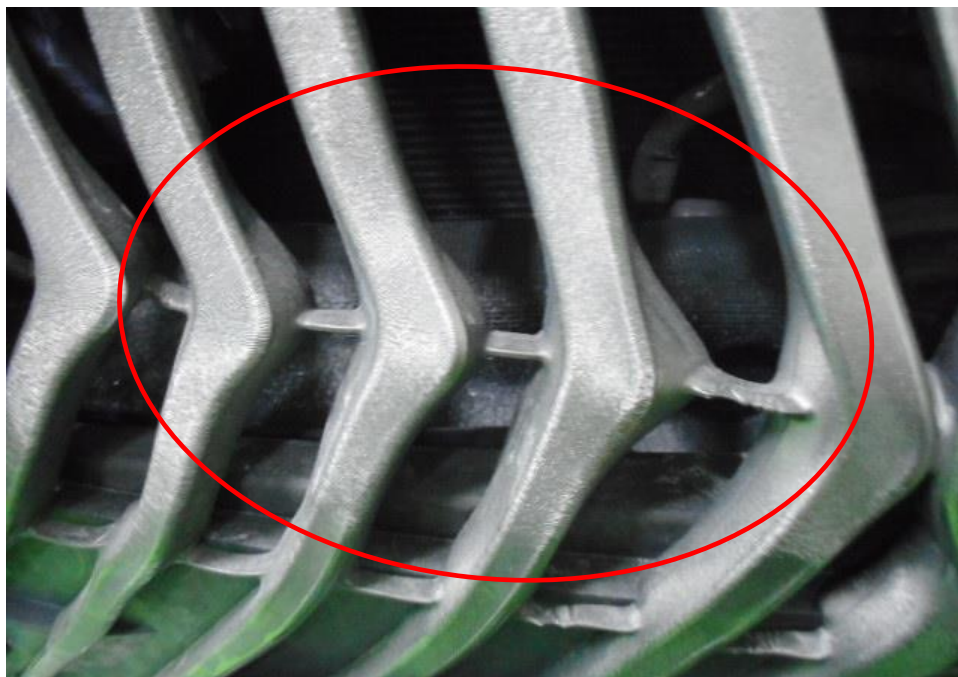
Photo 9 shows the close up view of the front of the Insured Vehicle at the time of our inspection. The plastic front grille (circled) had sustained heat damage and melted as a result of the fire.

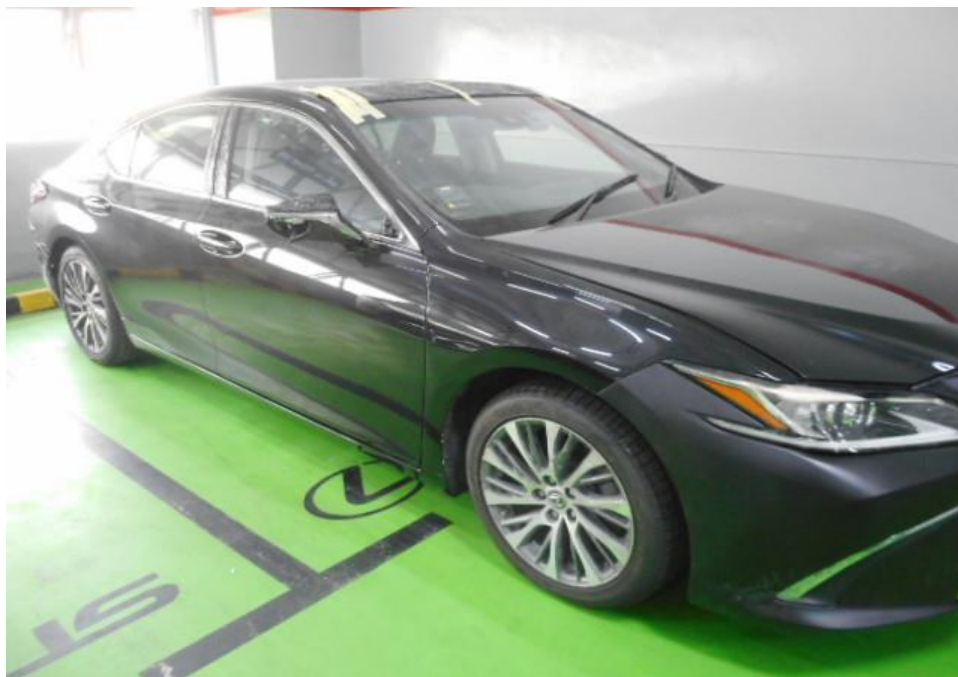
Photo 10 shows the right view of the Insured Vehicle at the time of our inspection. The exterior body of the Insured Vehicle was affected by the heat. Damages to its right side would be its rear-view mirror, all its plastic door handles and plastic door panels.

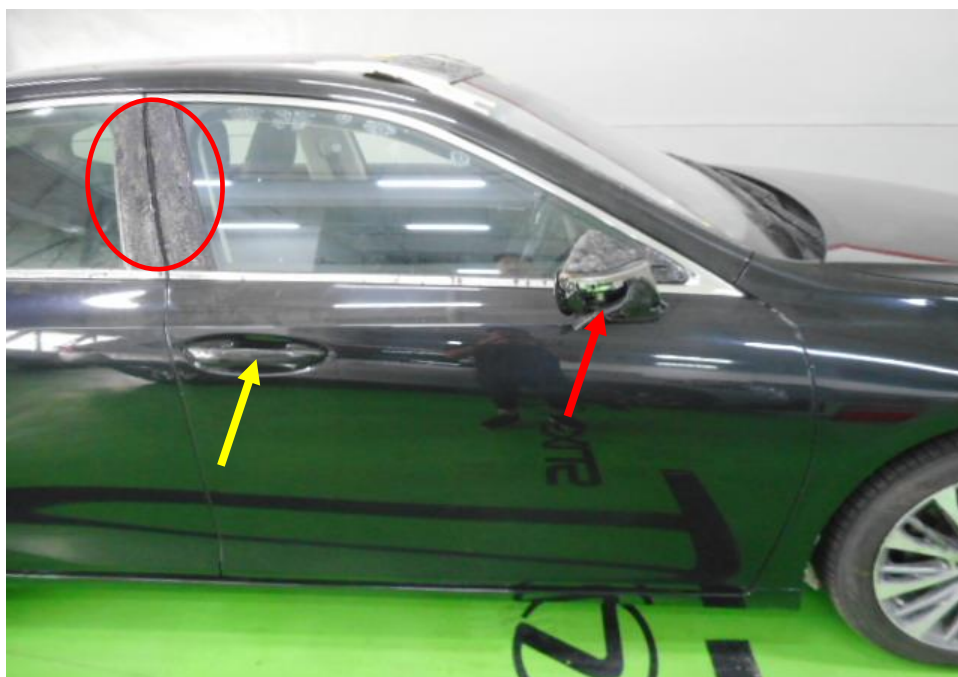
Photo 11 shows the right view of the Insured Vehicle at the time of our inspection. The exterior body of the Insured Vehicle was affected by the heat. Damages to its right side would be its rear-view mirror (red arrow), all its plastic door handles (yellow arrow) and plastic door panels (circled).

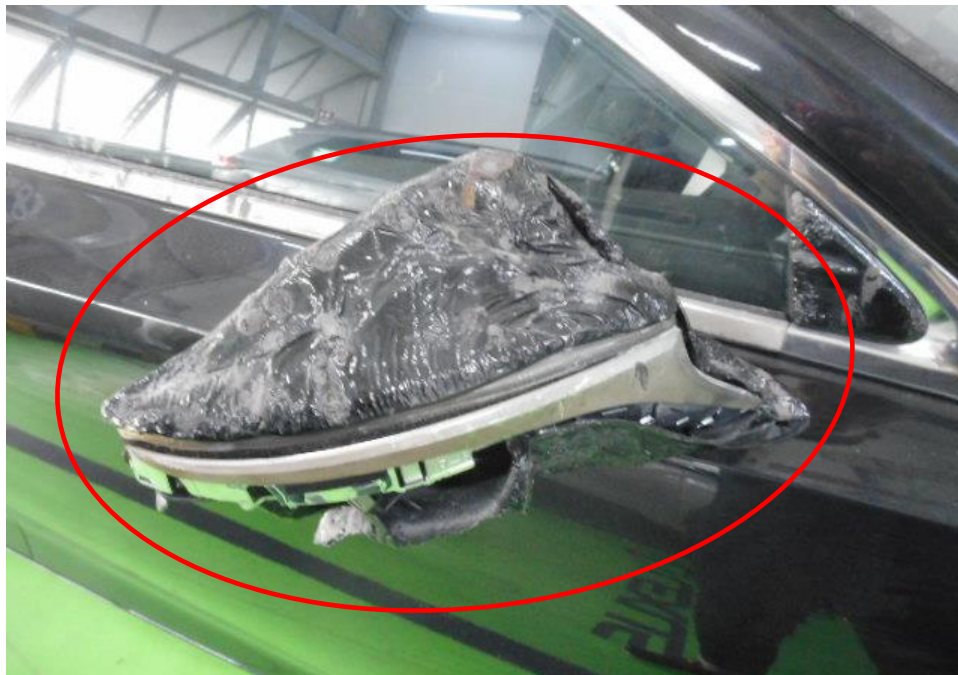
Photo 12 shows the right view of the Insured Vehicle at the time of our inspection. The exterior body of the Insured Vehicle was affected by the heat. Damages to its right side would be its rear view mirror (circled).

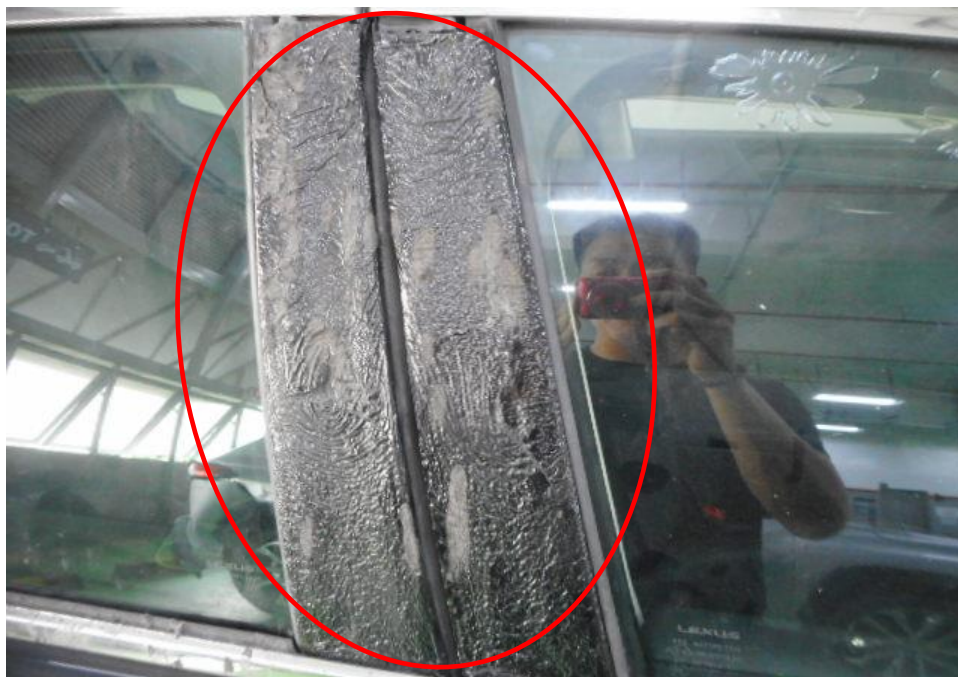
Photo 13 shows the right view of the Insured Vehicle at the time of our inspection. The exterior body of the Insured Vehicle was affected by the heat. Damages to its right side would be its plastic door panels (circled).

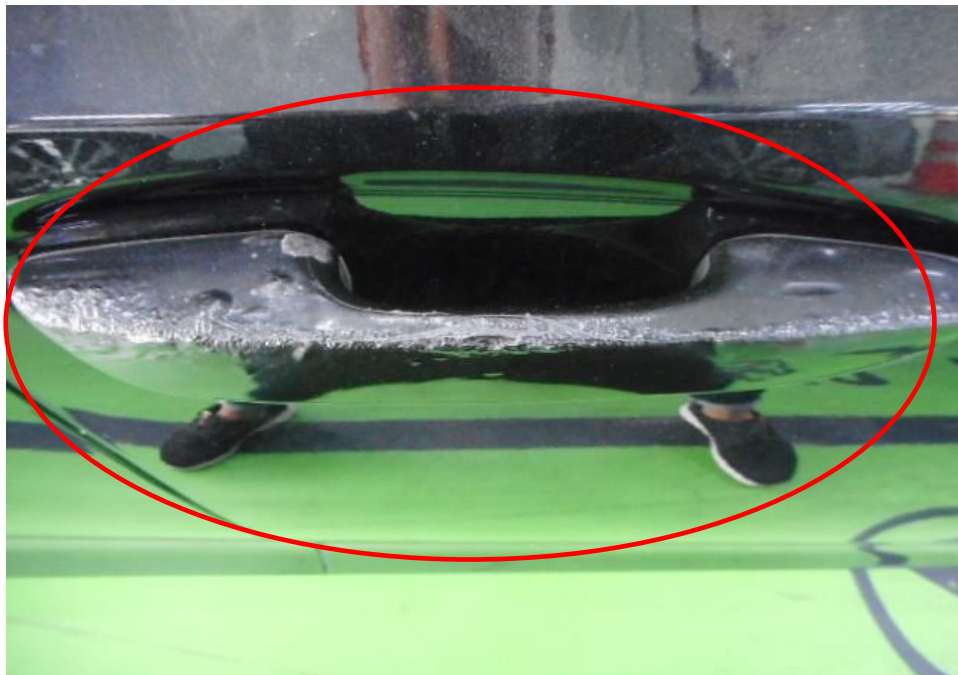
Photo 14 shows the right view of the Insured Vehicle at the time of our inspection. The exterior body of the Insured Vehicle was affected by the heat. Damages to its right side would be its plastic door handles (circled).

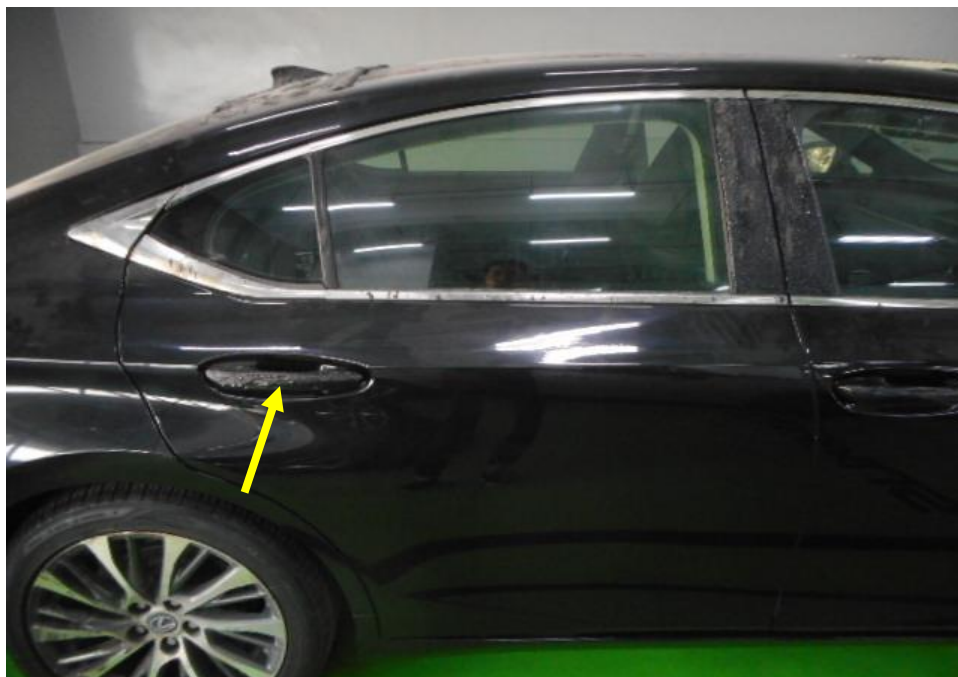
Photo 15 shows the right view of the Insured Vehicle at the time of our inspection. The exterior body of the Insured Vehicle was affected by the heat. Damages to its right side would be its plastic door handles (arrowed).

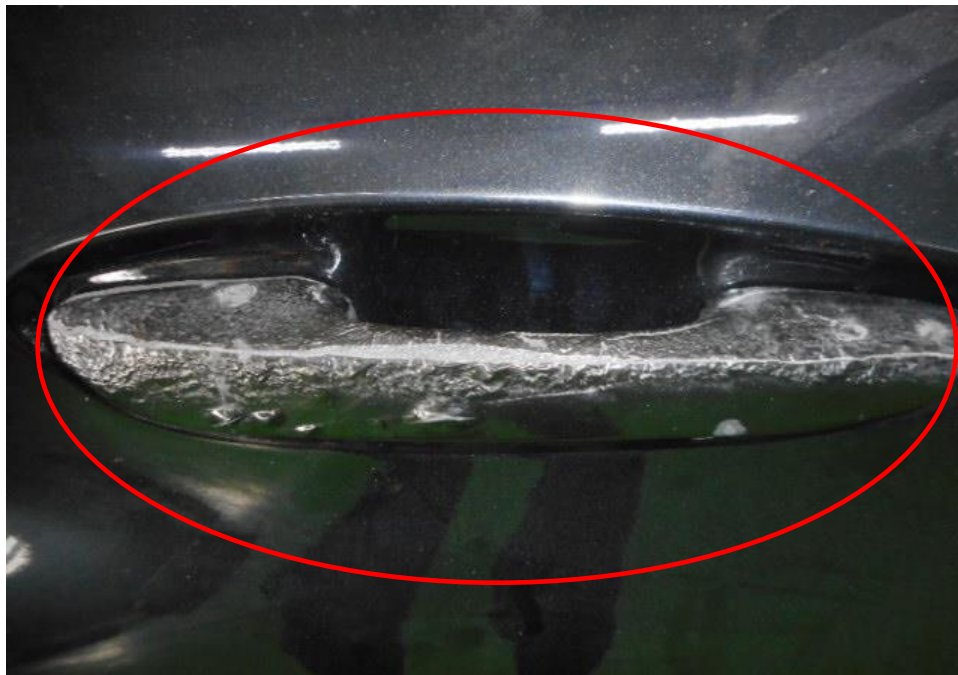
Photo 16 shows the right view of the Insured Vehicle at the time of our inspection. The exterior body of the Insured Vehicle was affected by the heat. Damages to its right side would be its plastic door handles (circled).

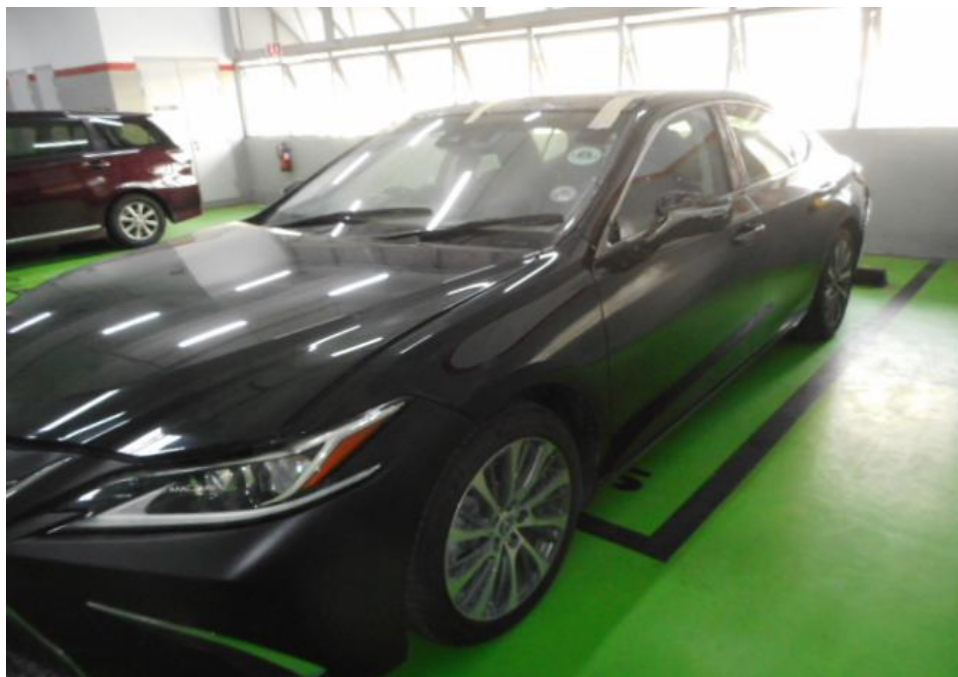
Photo 17 shows the left view of the Insured Vehicle at the time of our inspection. The exterior body of the Insured Vehicle was affected by the heat. Damages to its left side would be its rear-view mirror, all its door plastic handles and door panels.

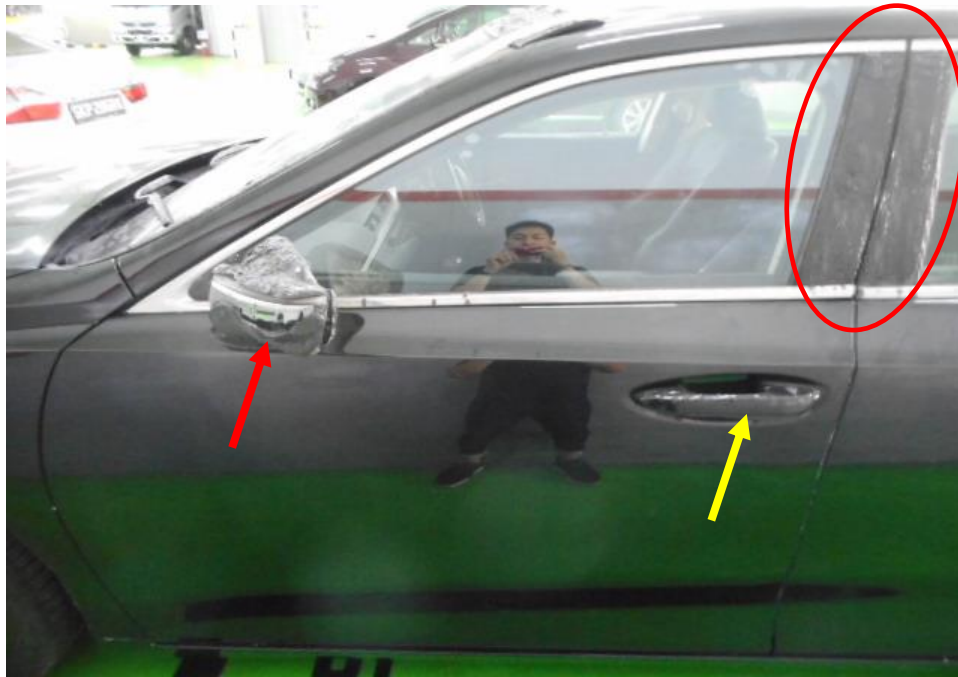
Photo 18 shows the left view of the Insured Vehicle at the time of our inspection. The exterior body of the Insured Vehicle was affected by the heat. Damages to its left side would be its rear-view mirror (red arrow), all its plastic door handles (yellow arrow) and plastic door panels (circled).

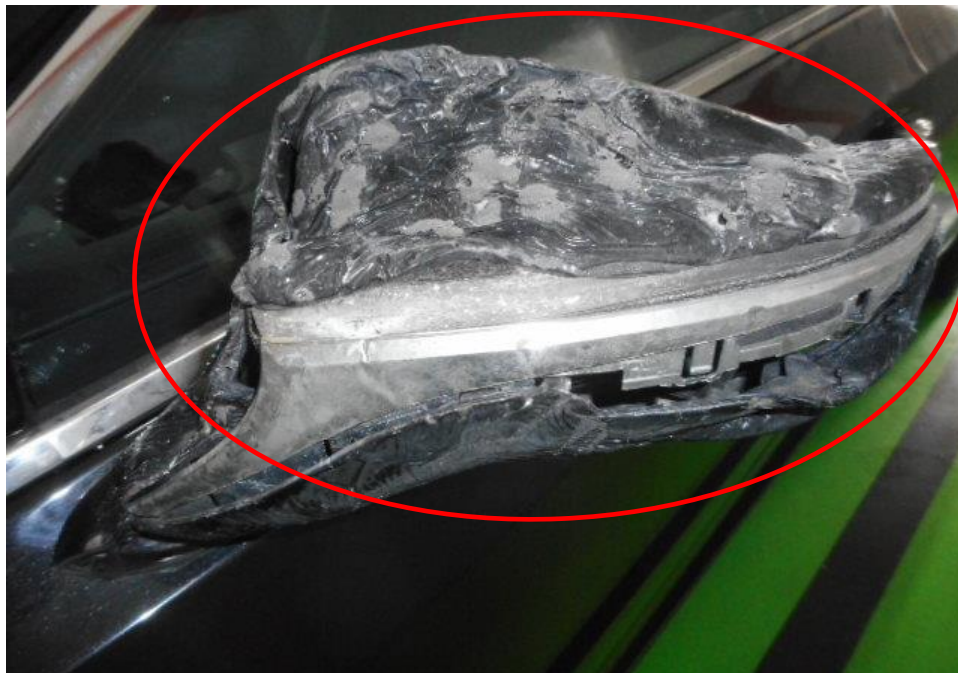
Photo 19 shows the left view of the Insured Vehicle at the time of our inspection. The exterior body of the Insured Vehicle was affected by the heat. Damages to its left side would be its rear view mirror (circled).

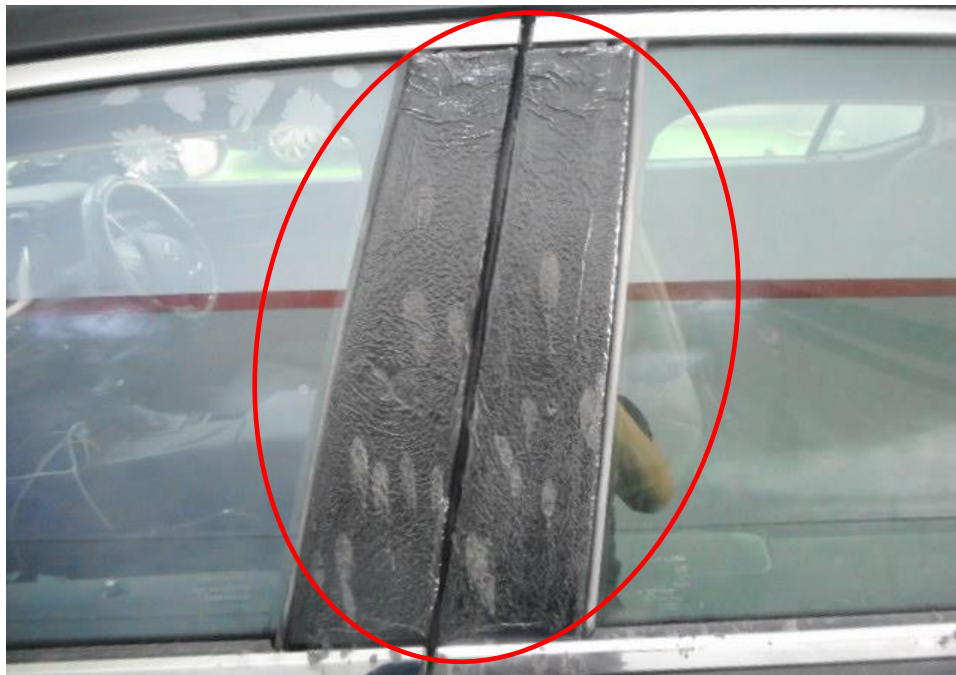
Photo 20 shows the left view of the Insured Vehicle at the time of our inspection. The exterior body of the Insured Vehicle was affected by the heat. Damages to its left side would be its plastic door panels (circled).

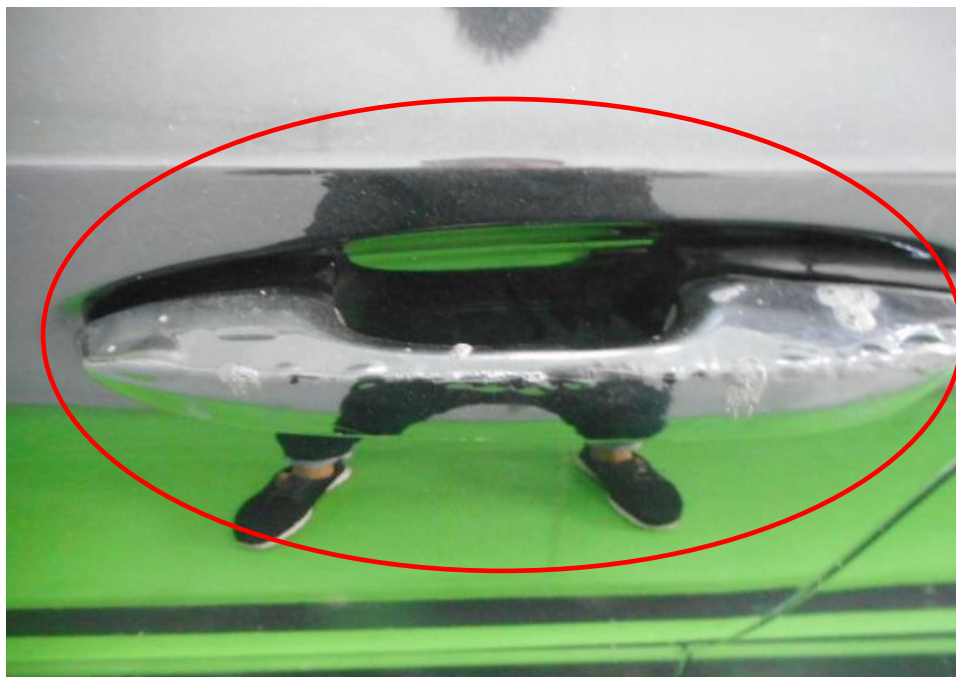
Photo 21 shows the left view of the Insured Vehicle at the time of our inspection. The exterior body of the Insured Vehicle was affected by the heat. Damages to its left side would be its plastic door handles (circled).

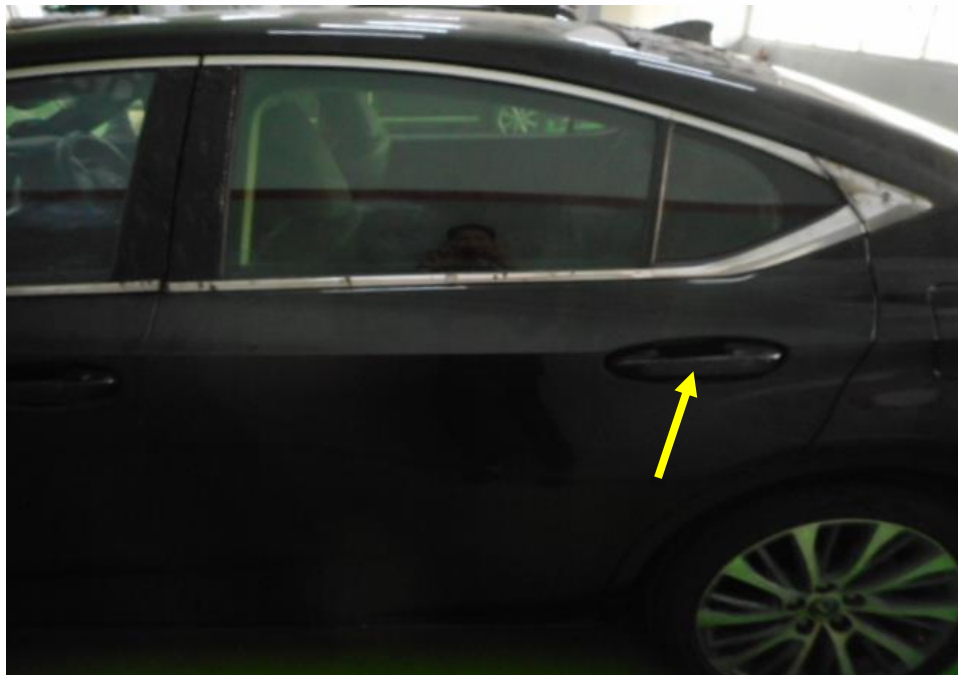
Photo 22 shows the left view of the Insured Vehicle at the time of our inspection. The exterior body of the Insured Vehicle was affected by the heat. Damages to its left side would be its door plastic handles (arrowed).

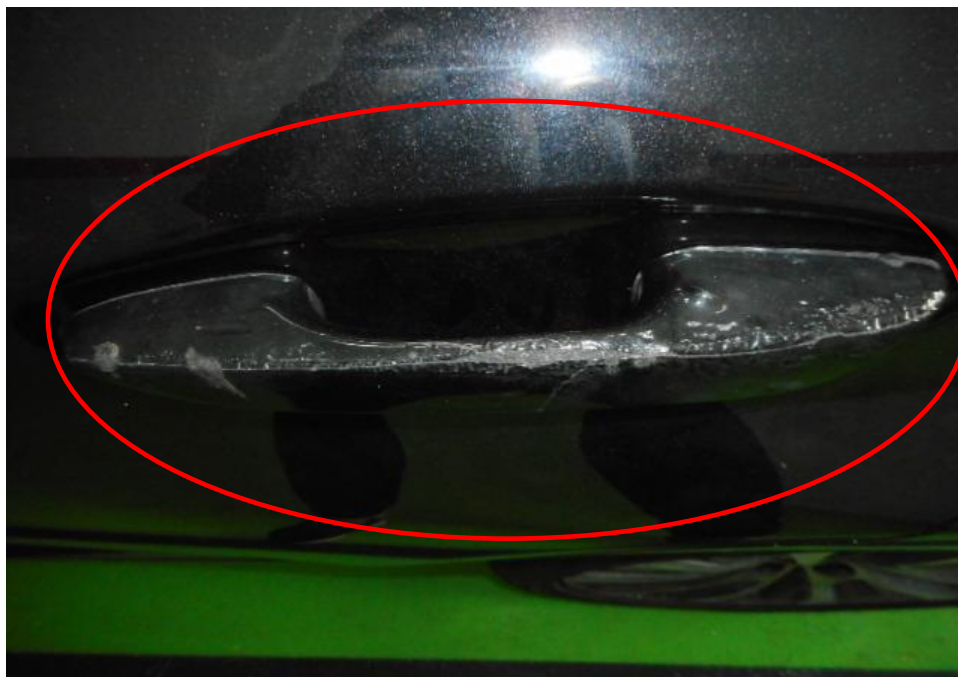
Photo 23 shows the left view of the Insured Vehicle at the time of our inspection. The exterior body of the Insured Vehicle was affected by the heat. Damages to its left side would be its plastic door handles (circled).

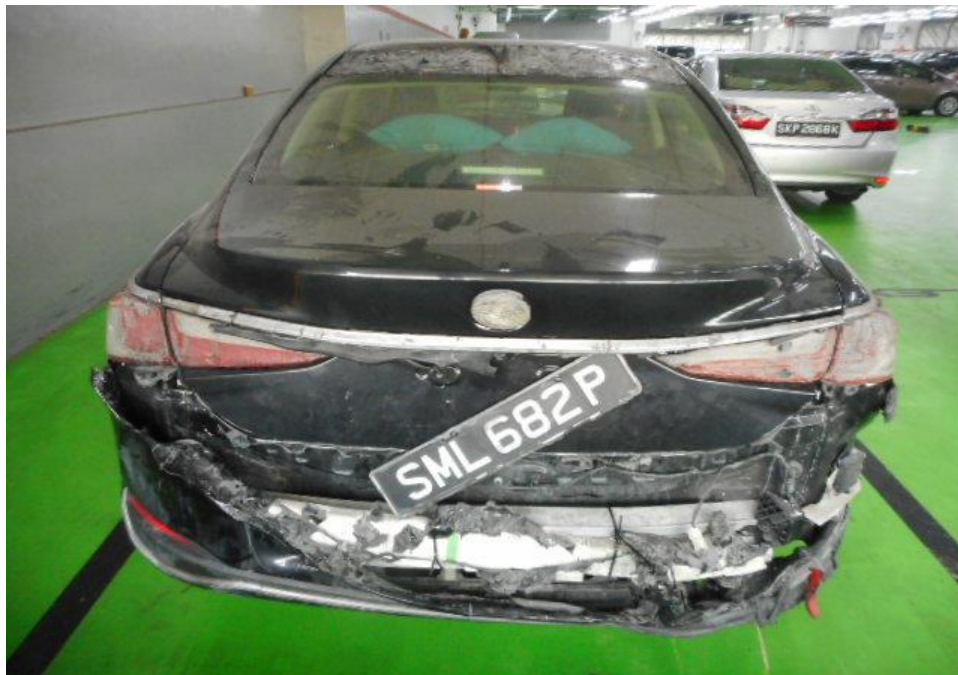
Photo 24 shows the rear view of the Insured Vehicle at the time of our inspection. The exterior body of the Insured Vehicle was affected by the heat. Damages to the rear portion would be both rear plastic brake lamps, rear plastic vehicle emblem and the rear plastic bumper.

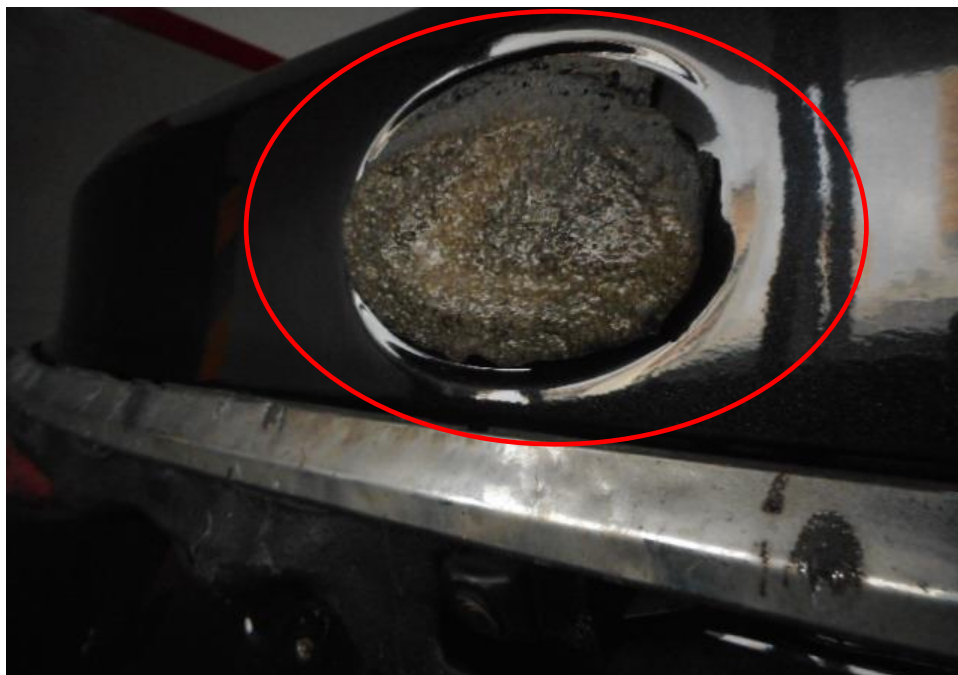
Photo 25 shows the rear view of the Insured Vehicle at the time of our inspection. The exterior body of the Insured Vehicle was affected by the heat. Damages to its rear portion would be its plastic vehicle emblem (circled).

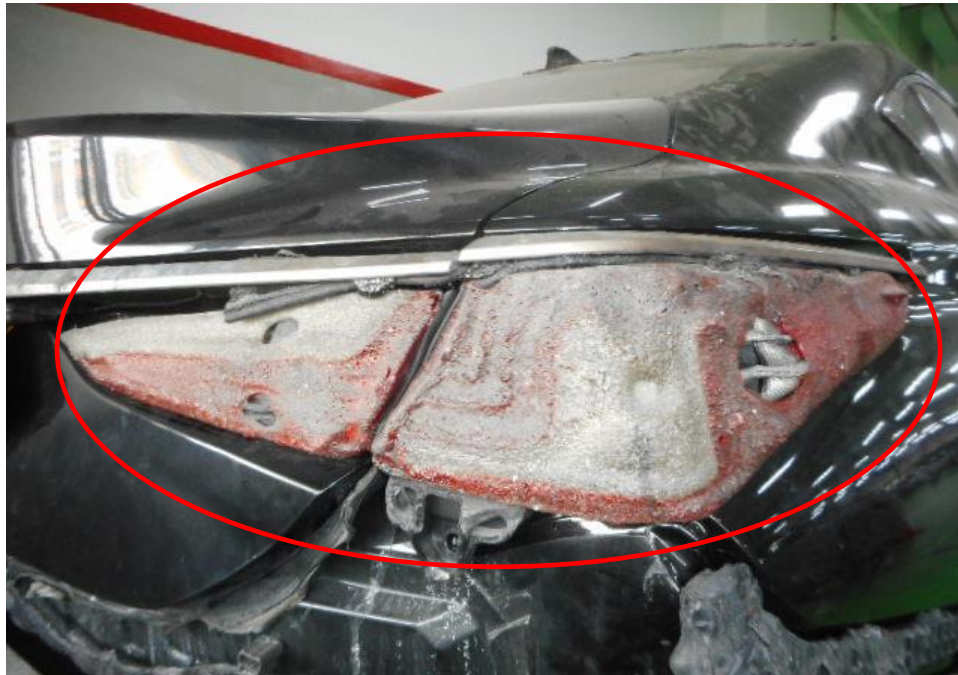
Photo 26 shows the rear view of the Insured Vehicle at the time of our inspection. The exterior body of the Insured Vehicle was affected by the heat. Damages to its rear portion would be its rear right brake lamp (circled).

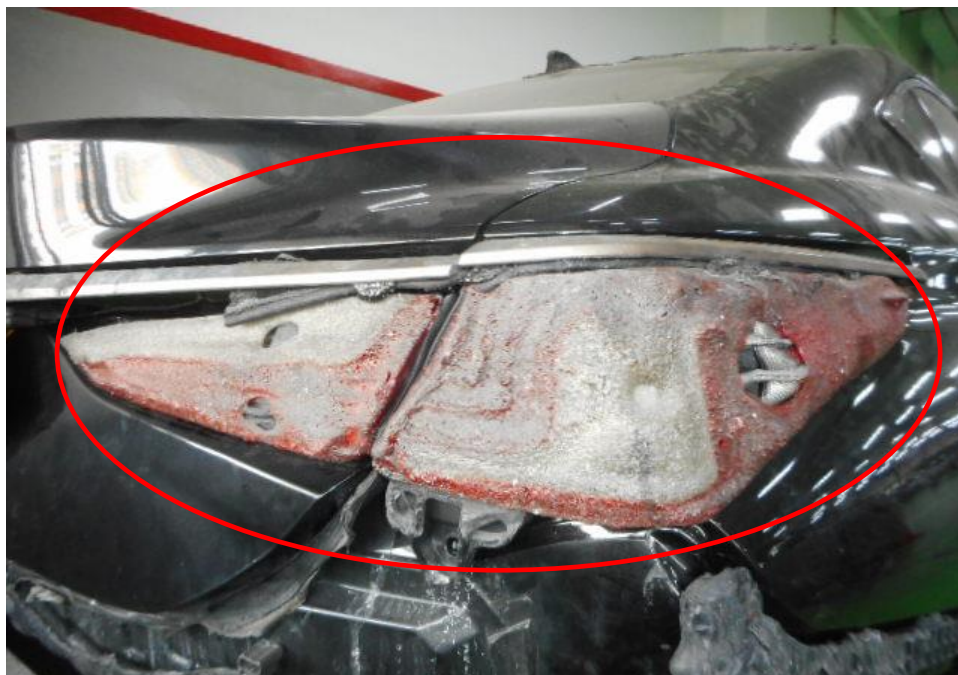
Photo 27 shows the rear view of the Insured Vehicle at the time of our inspection. The exterior body of the Insured Vehicle was affected by the heat. Damages to its rear portion would be its rear right brake lamp (circled).

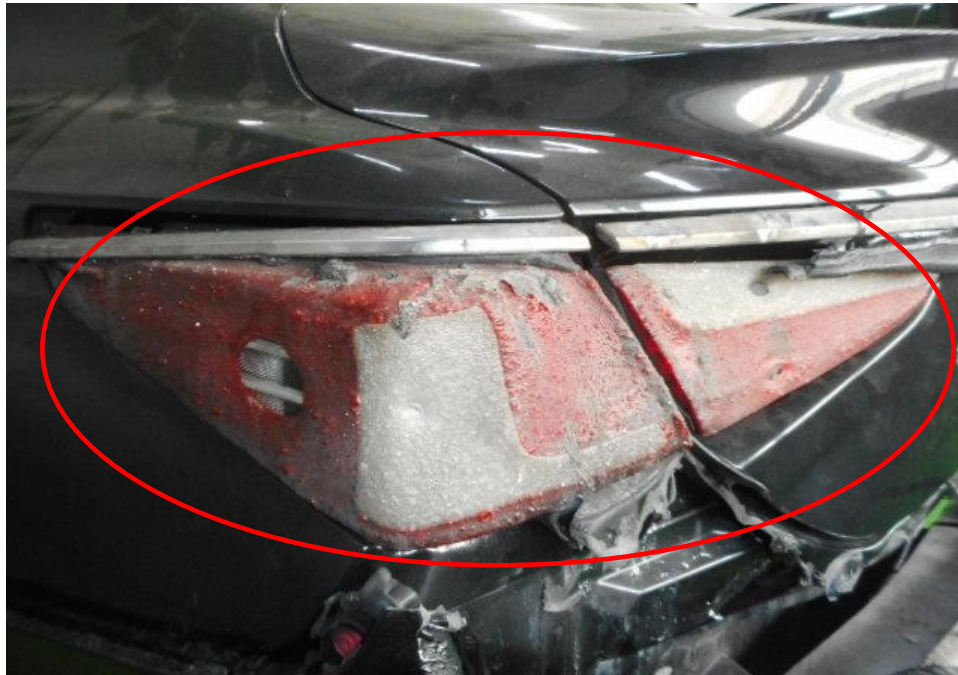
Photo 28 shows the rear view of the Insured Vehicle at the time of our inspection. The exterior body of the Insured Vehicle was affected by the heat. Damages to its rear portion would be its rear left brake lamp (circled).

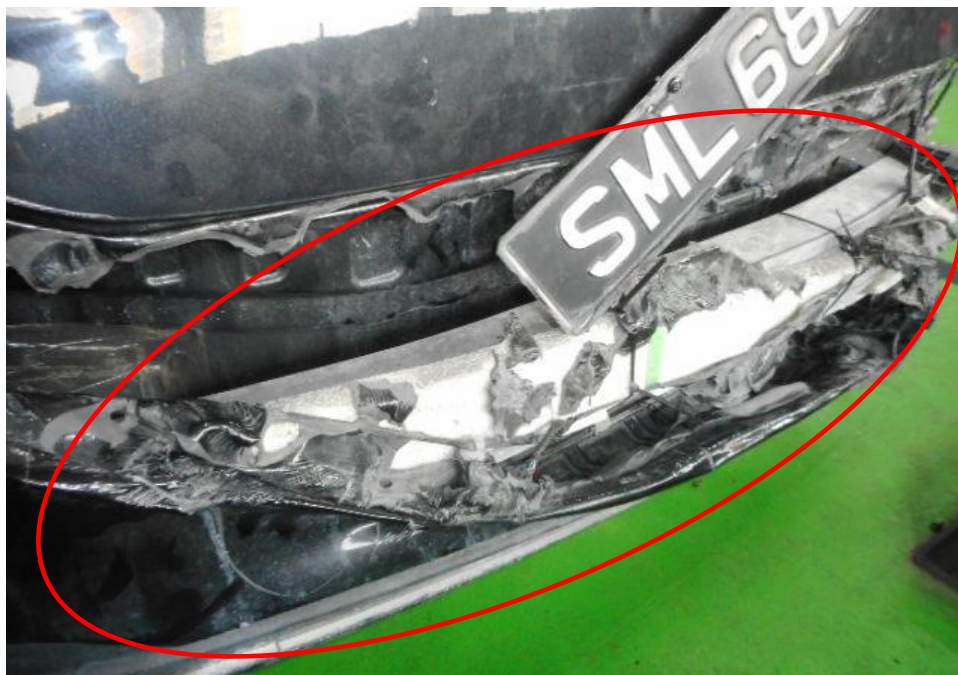
Photo 29 shows the rear view of the Insured Vehicle at the time of our inspection. The exterior body of the Insured Vehicle was affected by the heat. Damages to its rear portion would be its rear plastic bumper (circled).

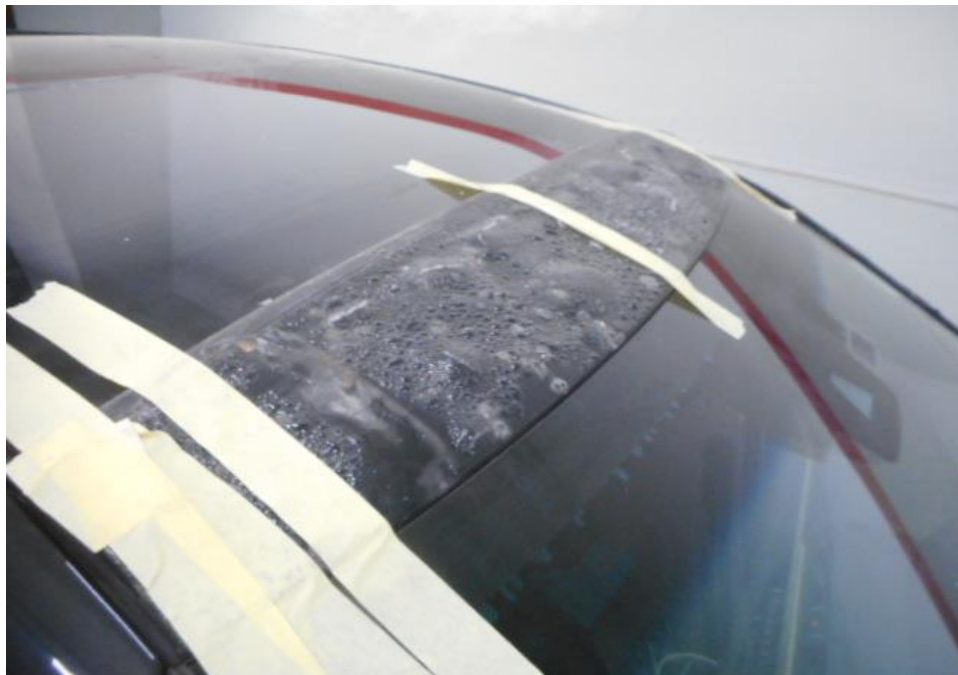
Photo 30 shows the roof view of the Insured Vehicle at the time of our inspection. The exterior body of the Insured Vehicle was affected by the heat. Damages to the roof portion would be the plastic roof panels.

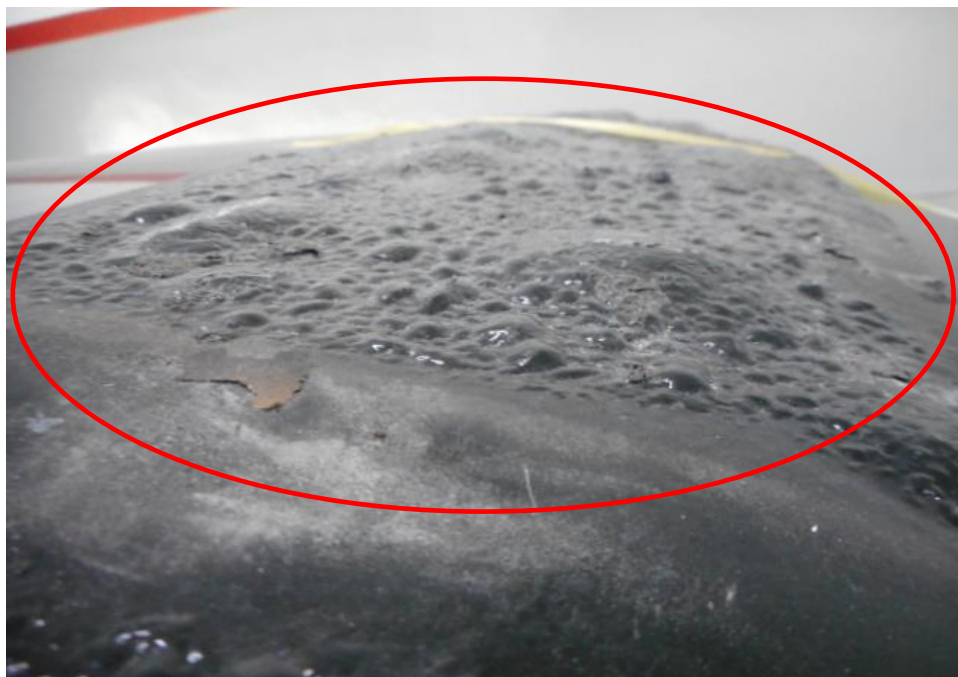
Photo 31 shows the roof view of the Insured Vehicle at the time of our inspection. The exterior body of the Insured Vehicle was affected by the heat. Damages to its roof portion would be its plastic roof panels (circled).

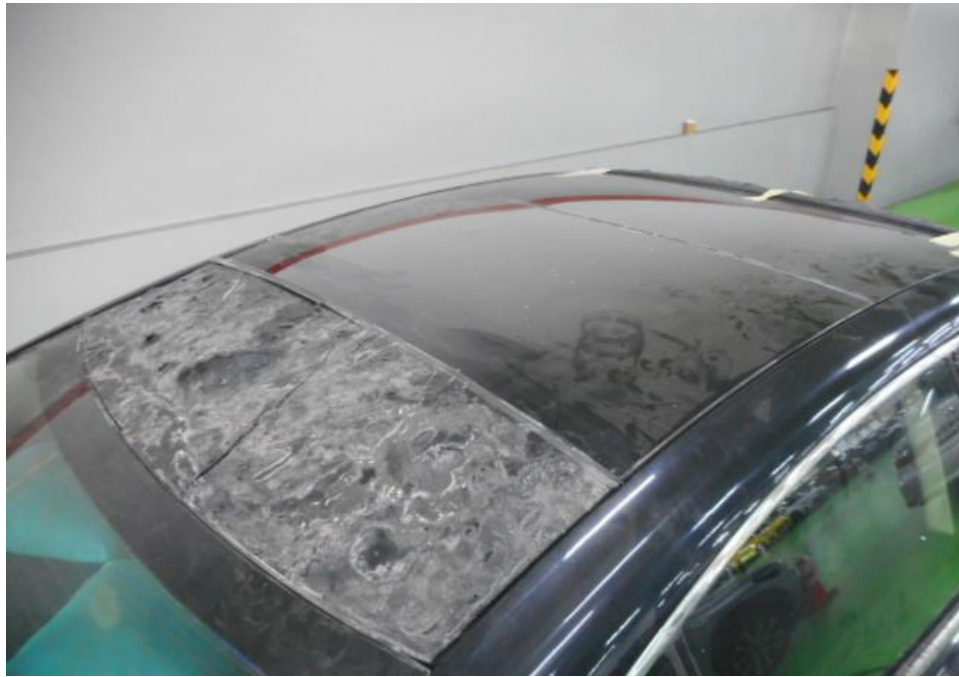
Photo 32 shows the roof view of the Insured Vehicle at the time of our inspection. The exterior body of the Insured Vehicle was affected by the heat. Damages to the roof portion would be the plastic roof panels.
