Your Ref: 316297
Our Ref : CS4/MSG23005607/P

**TECHNICAL INVESTIGATION REPORT OF FIRE INCIDENT INVOLVING THE
INSURED VEHICLE SML 682PON 5th JUNE 2023**

Vehicle Registration No.	: SML 682P
Make / Model	: LEXUS ES250 4DR SEDAN (AUTO) EXECUTIVE
Chassis No	: JTHB11B1702003045
Year of Registration	: 02 MAY 2019
Mileage	: 49,795KM

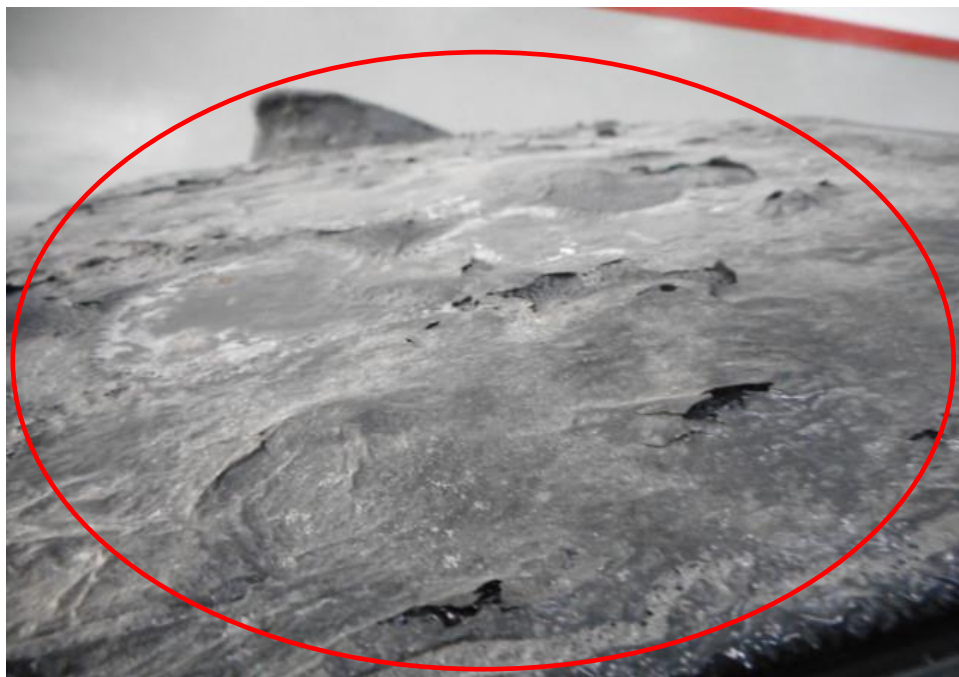
Photo 33 shows the roof view of the Insured Vehicle at the time of our inspection. The exterior body of the Insured Vehicle was affected by the heat. Damages to its roof portion would be its plastic roof panels (circled).
