Your Ref: Porsche 911 Carrera S Convertible
(chassis number WP0ZZZ99ZNS239105)
Our Ref : CI/TP23005685/D

06 June 2023

**INSPECTION REPORT OF AN UNREGISTERED PORSCHE 911 CARRERA S
CONVERTIBLE MOTOR CAR WITH CHASSIS NUMBER
WP0ZZZ99ZNS239105**

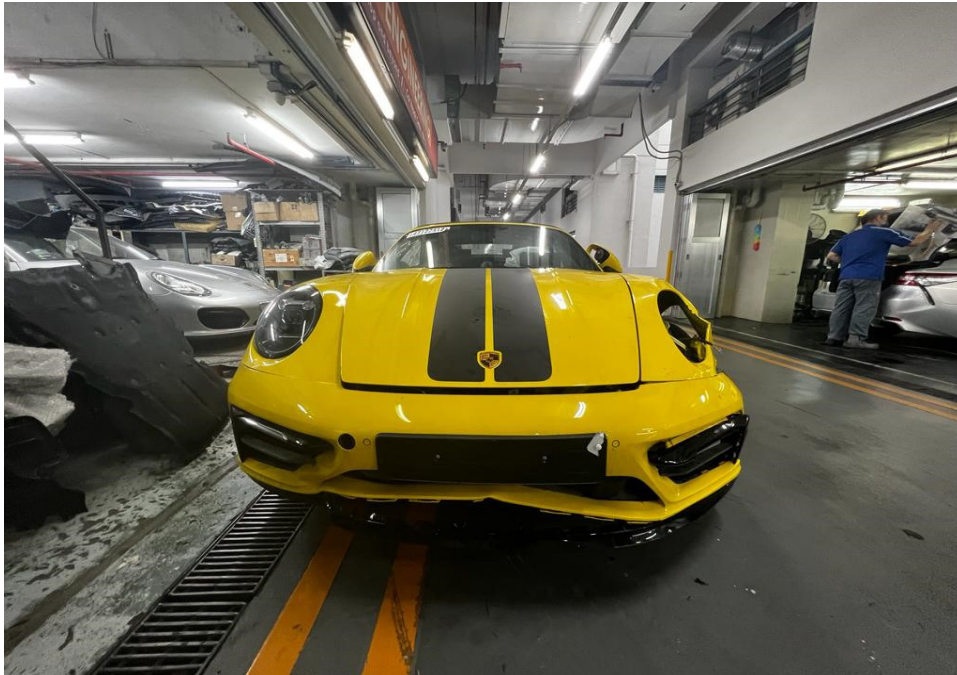
3. The photographs provided to me had showed damage to the front left portion of the Motor Car. Body parts damaged include the front bumper, front bumper lower lip, front bumper right lower grille, front bumper left lower grille, front bumper centre air guide, front bumper left bracket, front left day light, front left signal lamp, front left headlamp, front left fender and front left fender inner shield amongst others.
4. No physical damage was observed to other areas of the Motor Car. The airbag(s) of the Motor Car was not deployed as seen from the photographs that were provided to me. See photo 1 – 5 below.

Photo 1 shows a general view of the frontal body of the Motor Car (photograph provided to me). The Motor Car was observed to have sustained damage at its front left portion. The front bumper, front bumper lower lip, front bumper right lower grille, front bumper left lower grille, front bumper centre air guide, front left day light and front left headlamp were amongst the body parts that were observed to be damaged.

23. The body parts at the front left portion of the Motor Car were visually examined and it was noted that the repair/restoration works carried out to the damaged area of the Motor Car (refer to photograph 1 – 3 above) were reasonably adequate and in order.

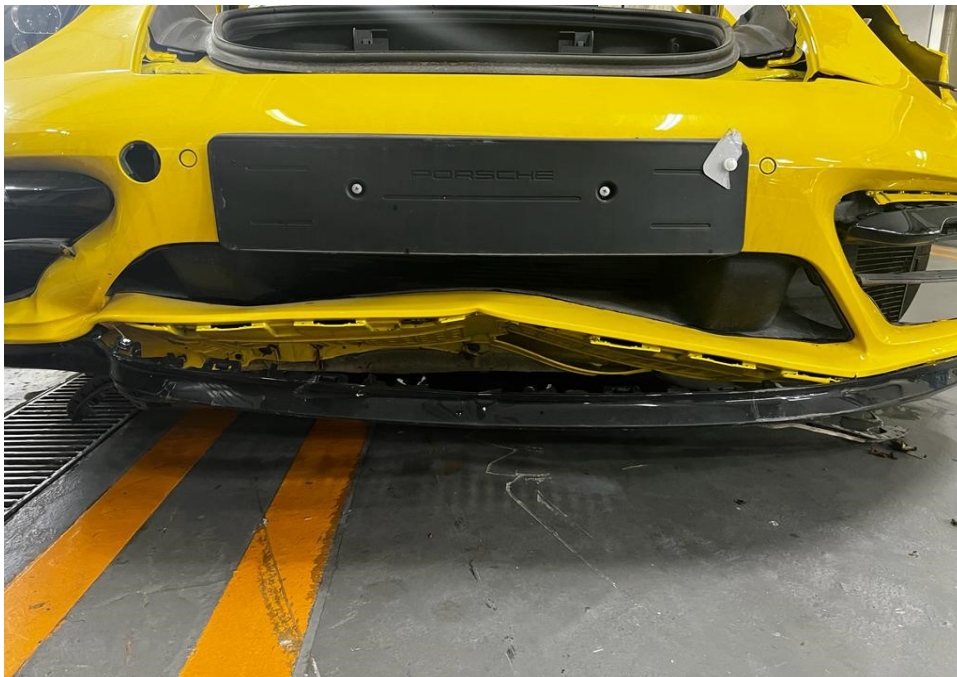
Photo 2 shows a closer view of the Motor Car's damaged front bumper, front bumper lower lip, front bumper right lower grille, front bumper left lower grille, front bumper centre air guide and front left day light (photograph provided to me).

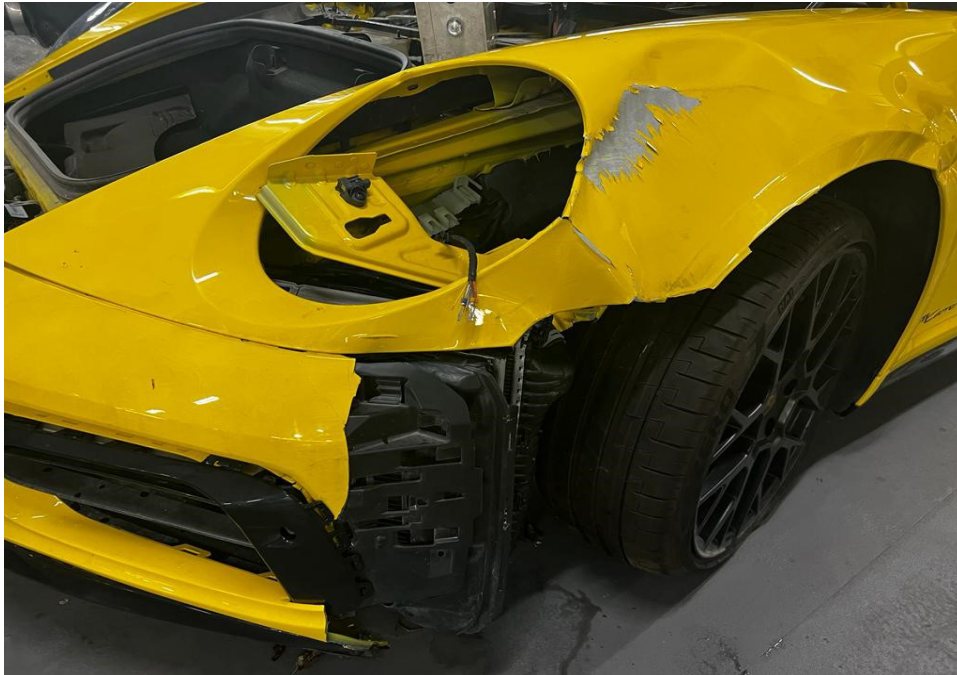
Photo 3 shows a closer view of the Motor Car's damaged front bumper, front bumper left lower grille, front bumper left bracket, front left day light, front left headlamp, front left fender and front left fender inner shield (photograph provided to me).

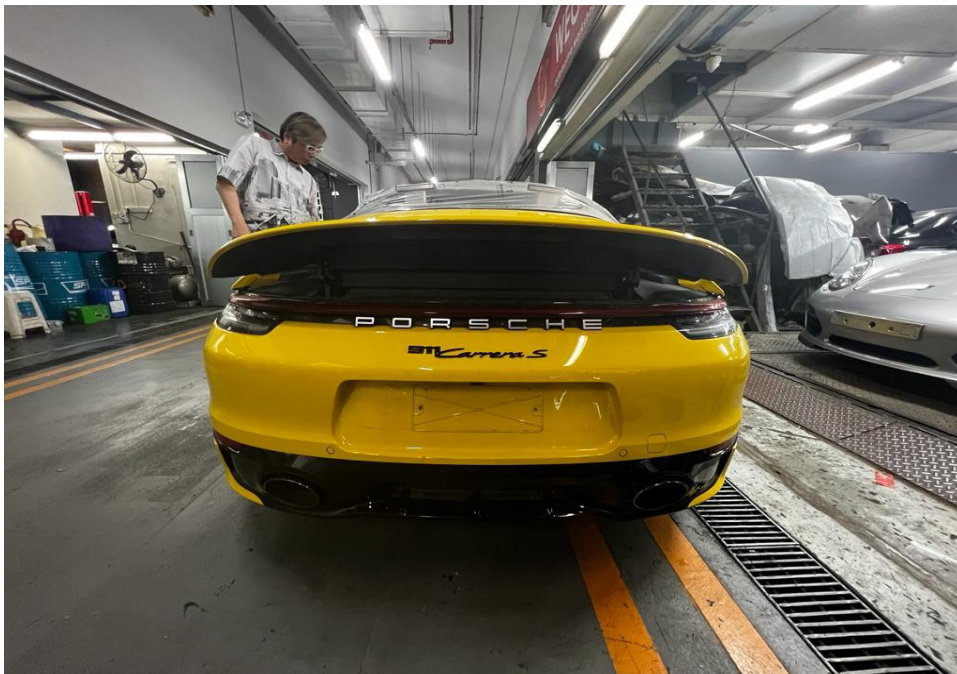
Photo 4 shows the rear body of the Motor Car (photograph provided to me). Apart for the front left portion, the photographs provided to me did not show physical damage to other areas of the Motor Car.

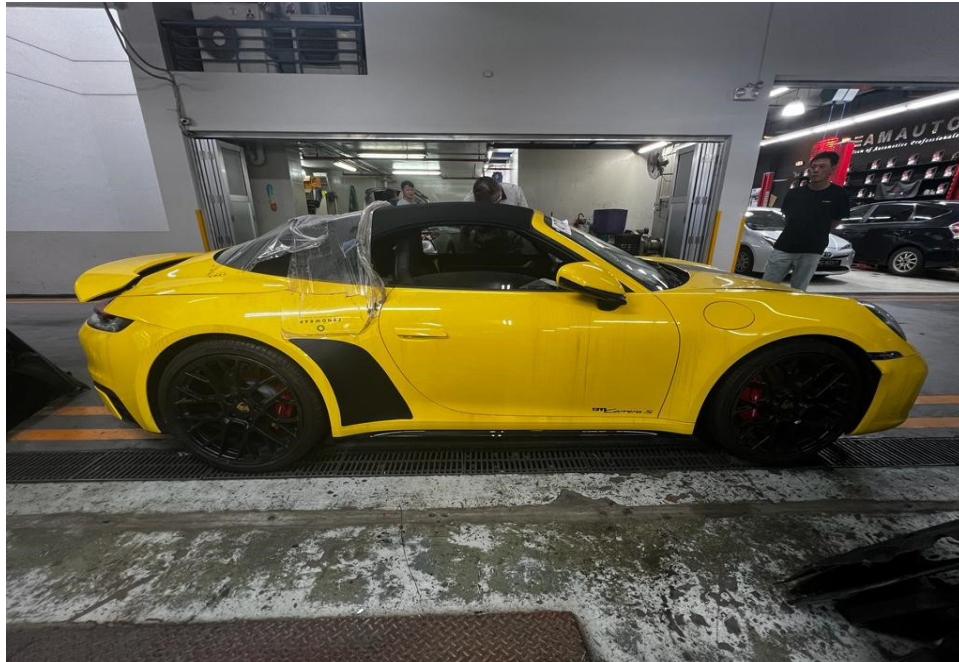
Photo 5 shows the right side body of the Motor Car (photograph provided to me). Apart for the front left portion, the photographs provided to me did not show physical damage to other areas of the Motor Car. The airbag(s) of the Motor Car was not deployed.

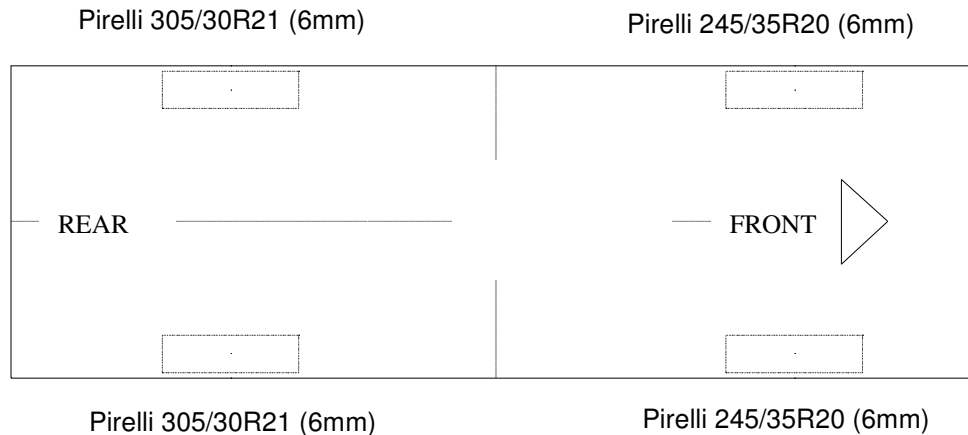
9. The Motor Car was fitted with 20inch (front) and 21inch (rear) sport wheel rims that were wrapped with tyres that were observed to be of serviceable condition. The tyres were also sufficiently inflated for vehicular operation. The tyre brand, tyre size and approximate remaining tread depth of the 4 tyres of the Motor Car were recorded as follows: -

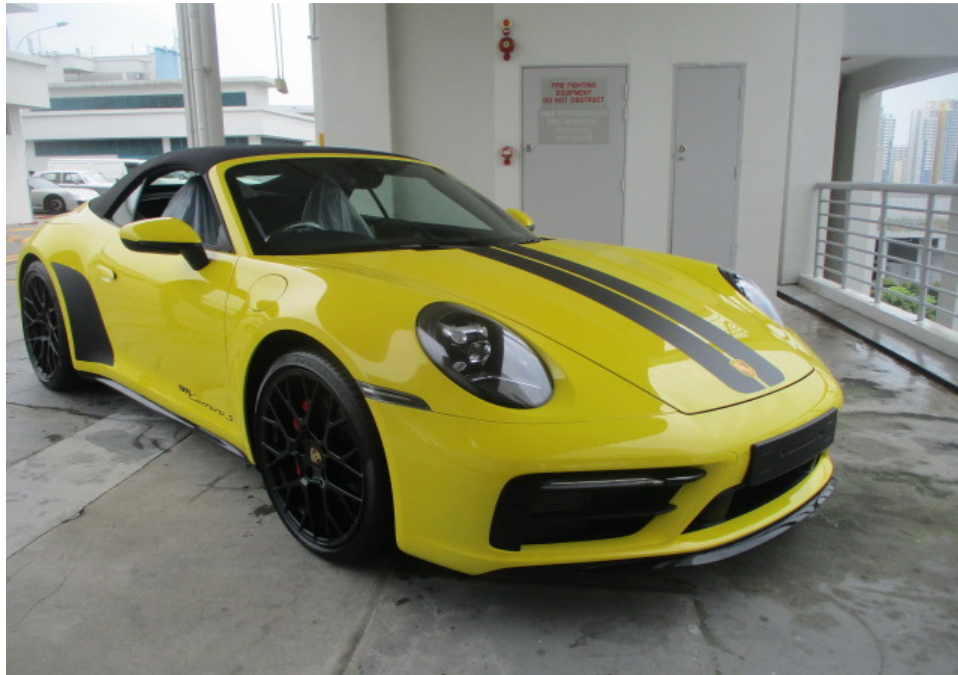
Photo 6 shows a general view of the front right body of the Motor Car at the time of my inspection. The Motor Car was observed to be in a relatively good general condition with no loose exterior fittings observed. The body parts at the front left portion of the Motor Car were visually examined and it was observed that the repair/restoration works carried out to the damaged area of the Motor Car (refer to photograph 1 – 3 above) were reasonably adequate and in order.

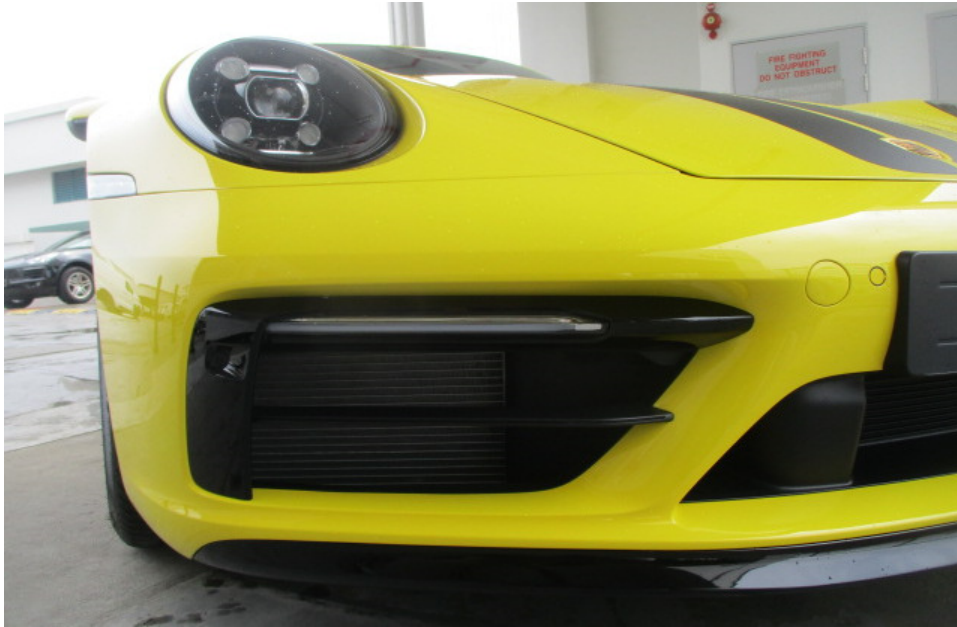
Photo 7 shows a closer view of the Motor Car's front bumper, front bumper right lower grille, front bumper right sensor, front right daylight, front right signal lamp and front right headlamp. The body parts at the front left portion of the Motor Car were visually examined and it was observed that the repair/restoration works carried out to the damaged area of the Motor Car (refer to photograph 1 – 3 above) were reasonably adequate and in order.

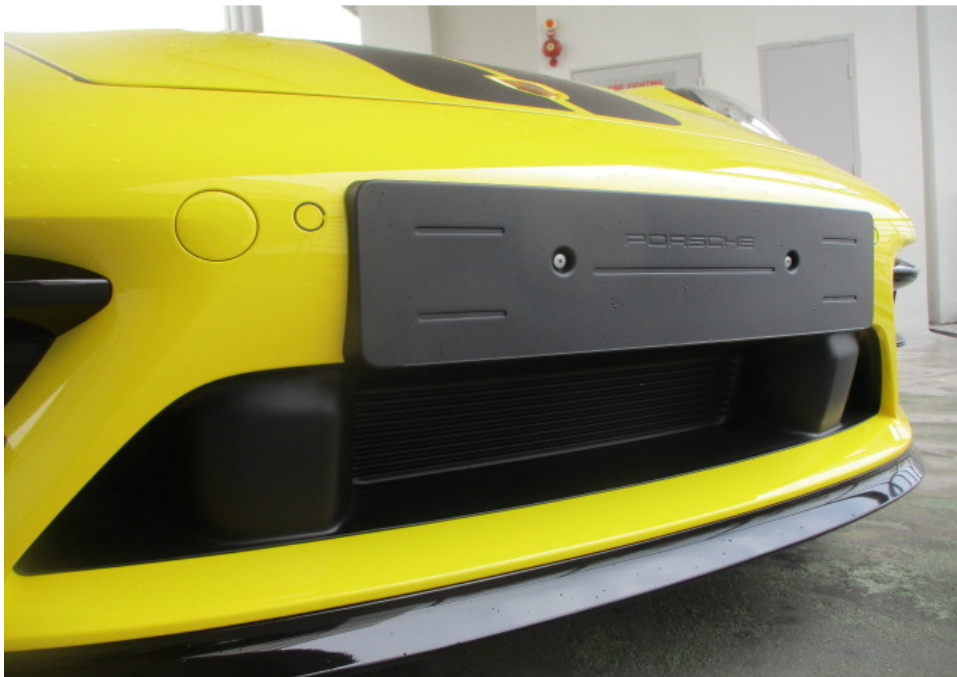
Photo 8 shows a closer view of the Motor Car's front bumper, front bumper lower lip, front bumper tow hook cover, front bumper right sensor and front bumper centre air guide. The body parts at the front left portion of the Motor Car were visually examined and it was observed that the repair/restoration works carried out to the damaged area of the Motor Car (refer to photograph 1 – 3 above) were reasonably adequate and in order.

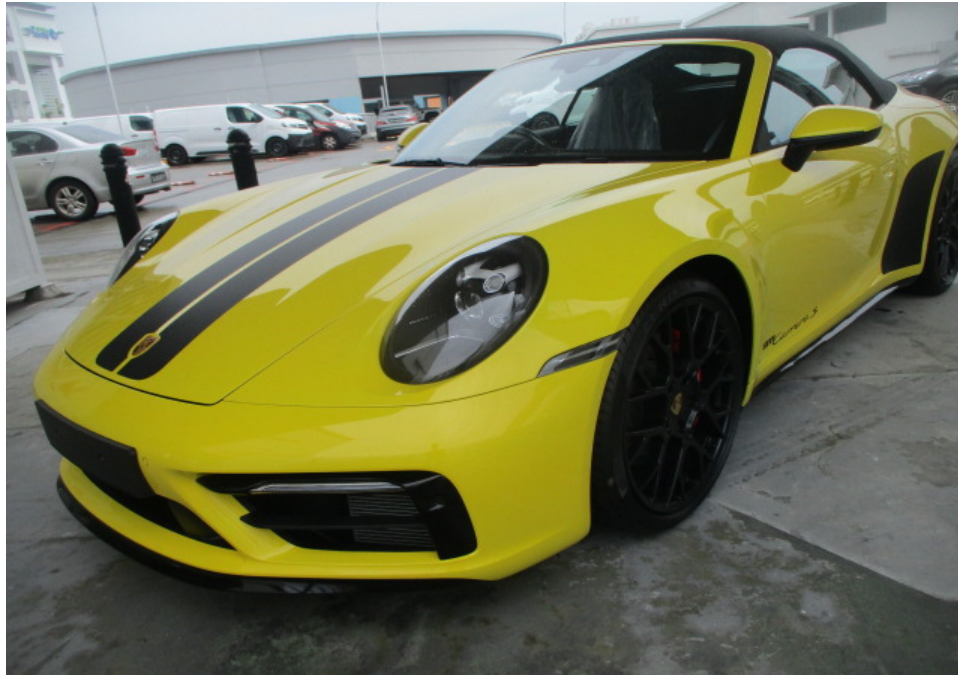
Photo 9 shows a general view of the front left body of the Motor Car at the time of my inspection. The Motor Car was observed to be in a relatively good general condition with no loose exterior fittings observed. The body parts at the front left portion of the Motor Car were visually examined and it was observed that the repair/restoration works carried out to the damaged area of the Motor Car (refer to photograph 1 – 3 above) were reasonably adequate and in order.

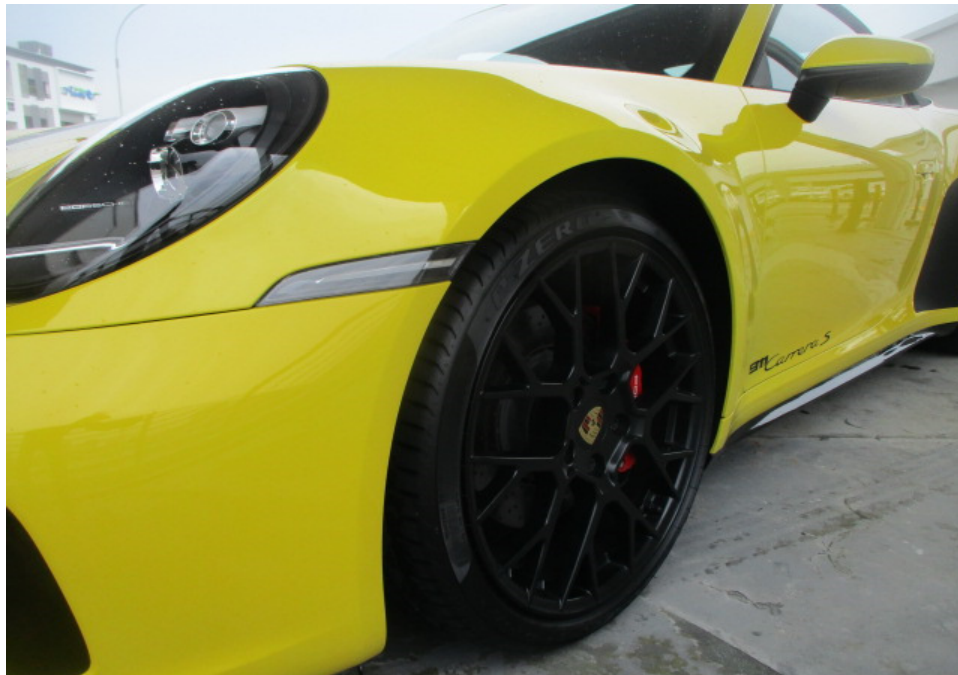
Photo 10 shows a closer view of the Motor Car's front left signal lamp, front left headlamp, front left fender and front left wheel rim. The body parts at the front left portion of the Motor Car were visually examined and it was observed that the repair/restoration works carried out to the damaged area of the Motor Car (refer to photograph 1 – 3 above) were reasonably adequate and in order.

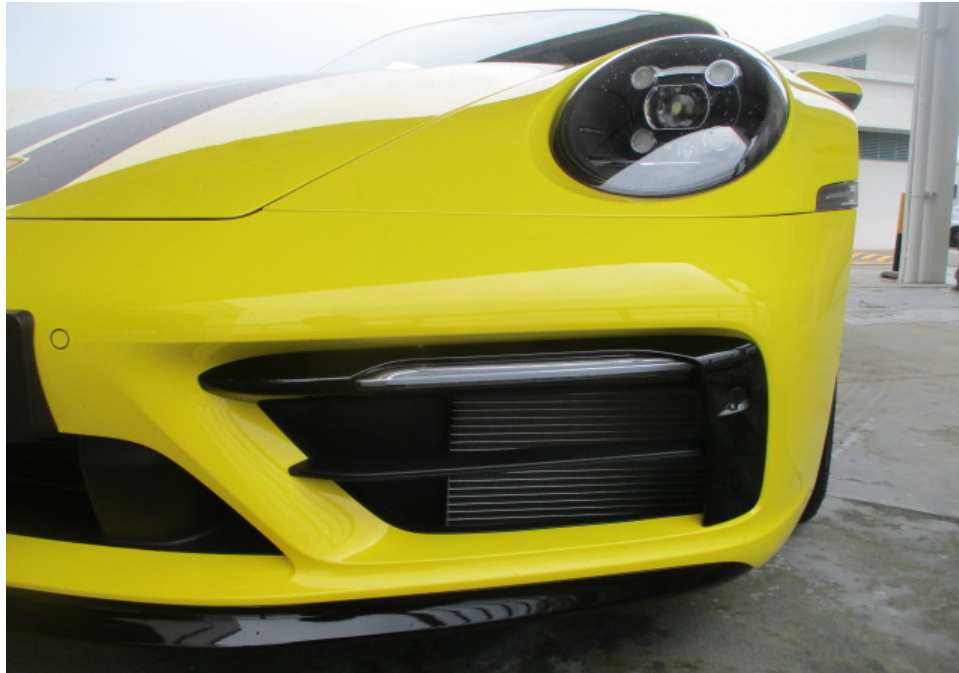
Photo 11 shows a closer view of the Motor Car's front bumper, front bumper left lower grille, front left daylight, front left signal lamp and front left headlamp. The body parts at the front left portion of the Motor Car were visually examined and it was observed that the repair/restoration works carried out to the damaged area of the Motor Car (refer to photograph 1 – 3 above) were reasonably adequate and in order.

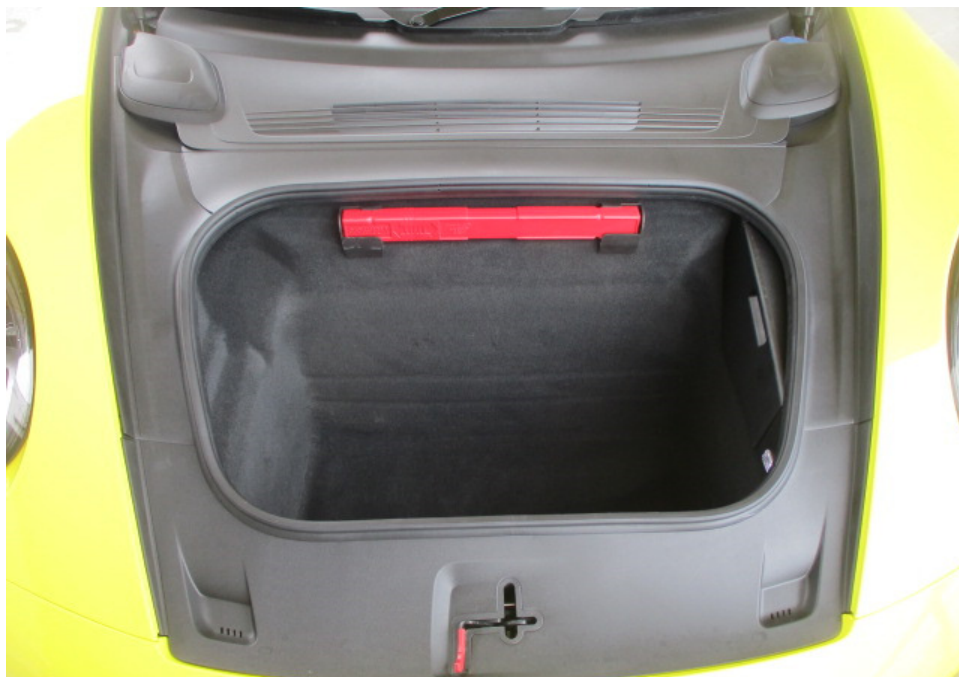
Photo 12 shows a general view of the Motor Car's front bonnet compartment at the time of my inspection. All inner trims, garnishes and upholstery etc were observed to be properly fitted.

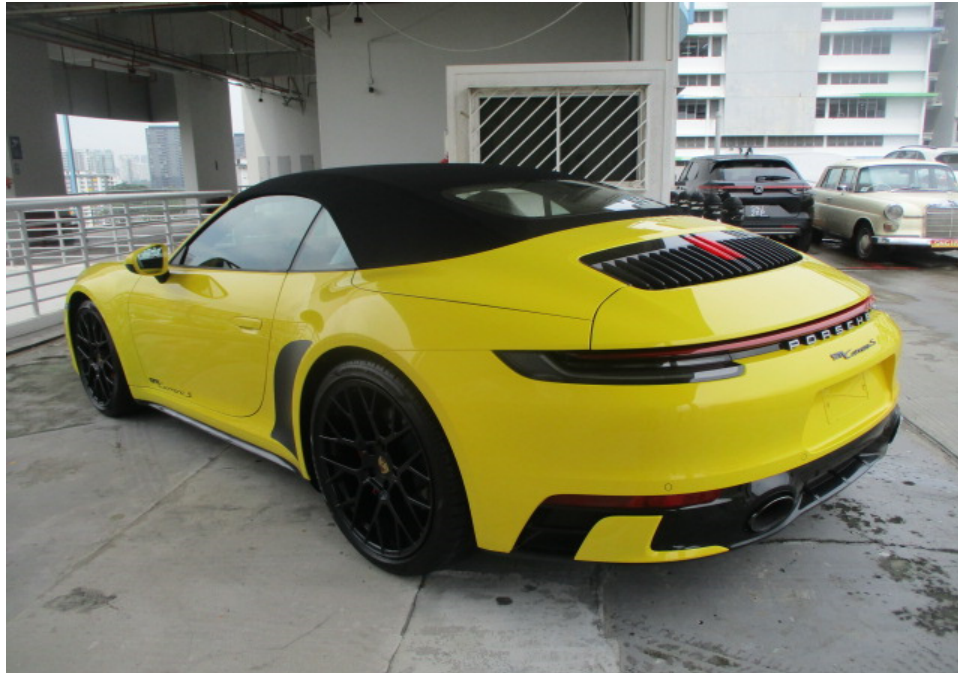
Photo 13 shows a general view of the rear left body of the Motor Car at the time of my inspection. The Motor Car was observed to be in a relatively good general condition with no loose exterior fittings observed. The mileage of the Motor Car recorded at the time of my inspection was 2,004km.

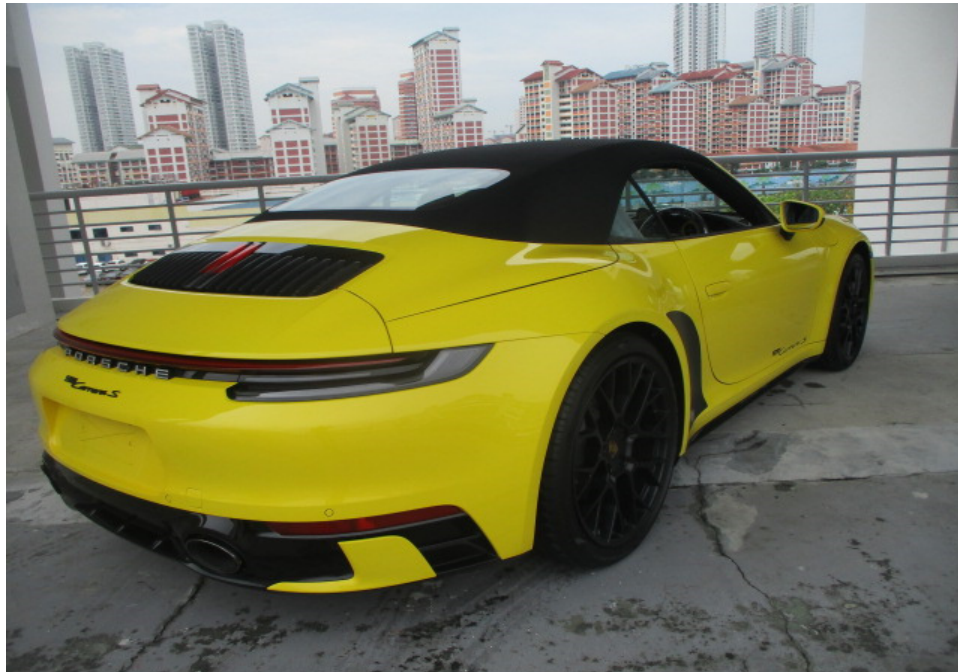
Photo 14 shows a general view of the rear right body of the Motor Car at the time of my inspection. The Motor Car was observed to be in a relatively good general condition with no loose exterior fittings observed. The mileage of the Motor Car recorded at the time of my inspection was 2,004km.

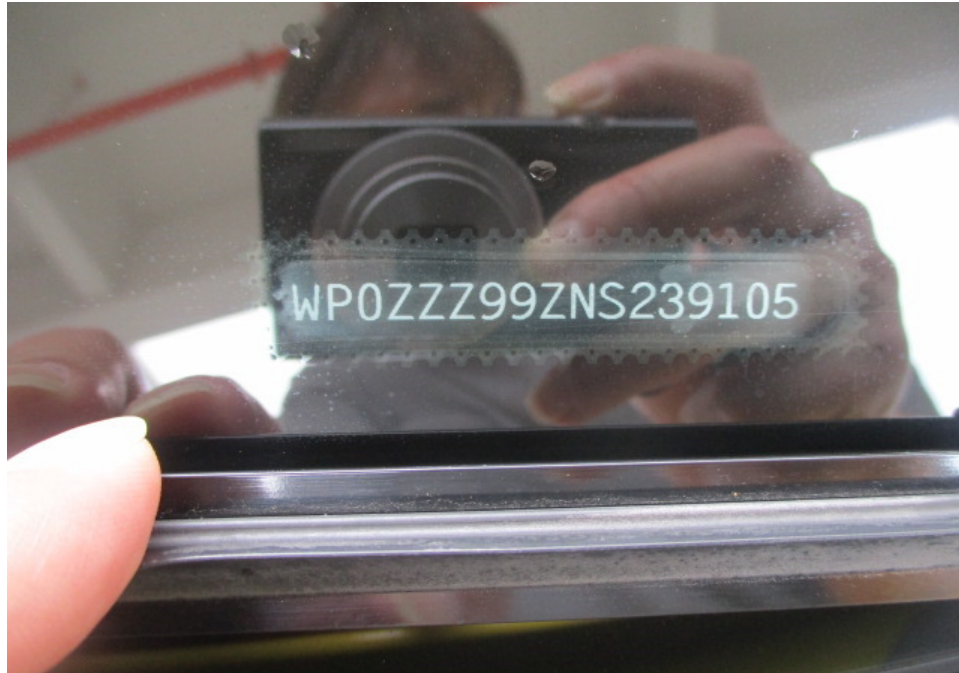
Photo 15 shows the chassis number of the Motor Car. The chassis number recorded was WP0ZZZ99ZNS239105.

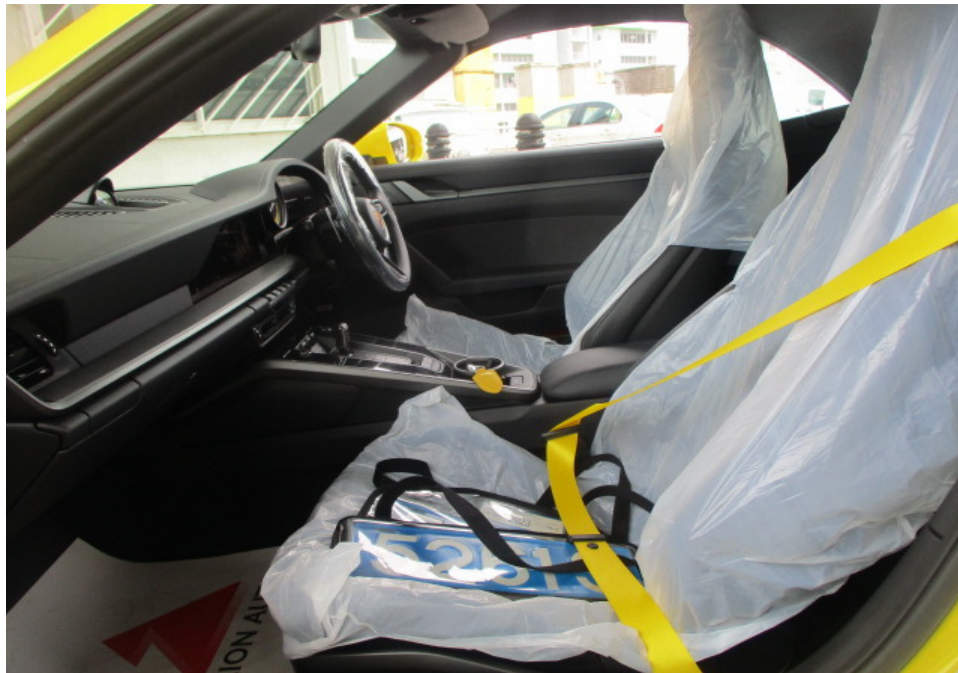
Photo 16 shows the interior compartment of the Motor Car at the time of my inspection. The various parts and components, trims, carpet, and upholstery inside the interior compartment were all observed to be intact and properly fitted.

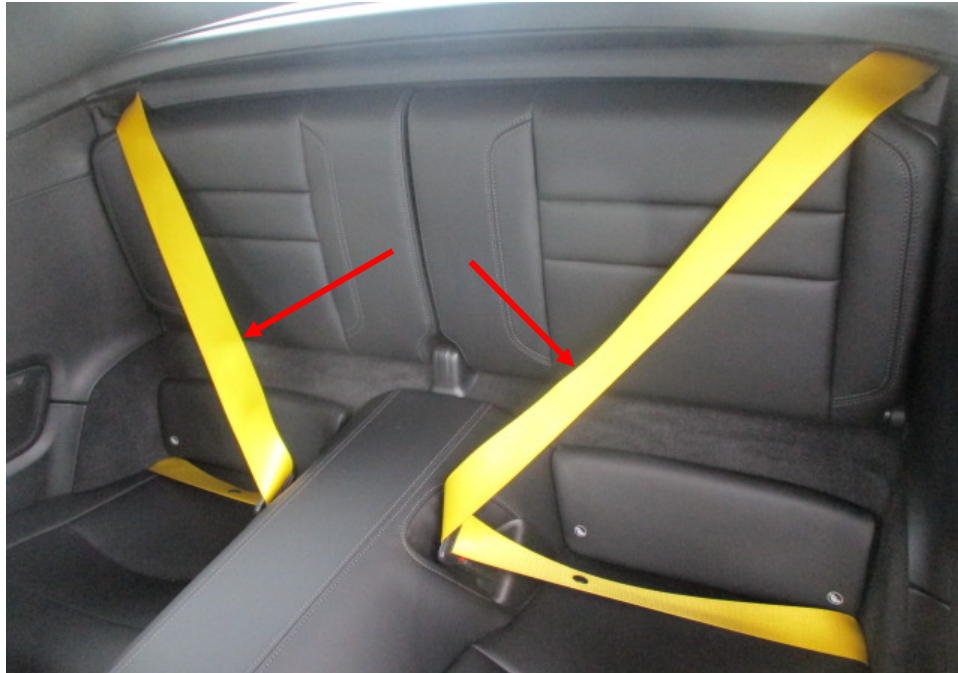
Photo 17 shows the rear seats of the Motor Car. All the seats of the Motor Car were secured via seat rails to the floorboard. They were also fitted with a retractable seat belt reel and a pre-tensioner. The seat belts (arrowed) were tested and were able to be fastened into the respective pre-tensions that were fitted on the side of each individual seat.

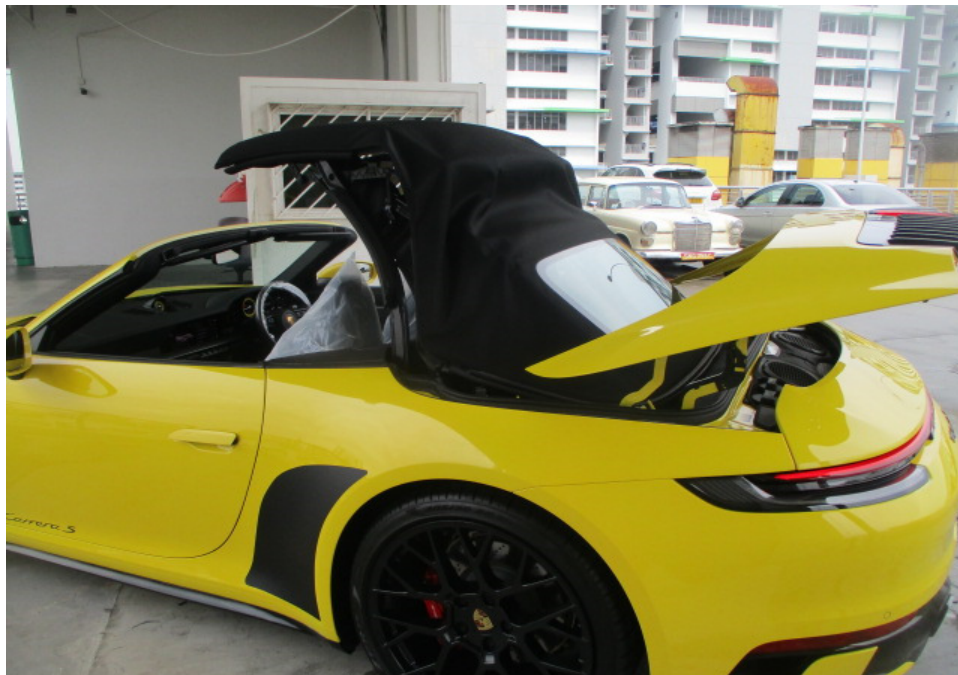
Photo 18 shows the Motor Car's soft top roof being tested. It was observed that as a safety feature, the soft top roof could only open and close when the Motor Car was in a stationary position or at low travelling speed. When opened, the soft top roof is completely folded into the rear compartment with no parts protruding out of the Motor Car's body. The soft top roof was also found adequately secured to the "A" pillar after closing.

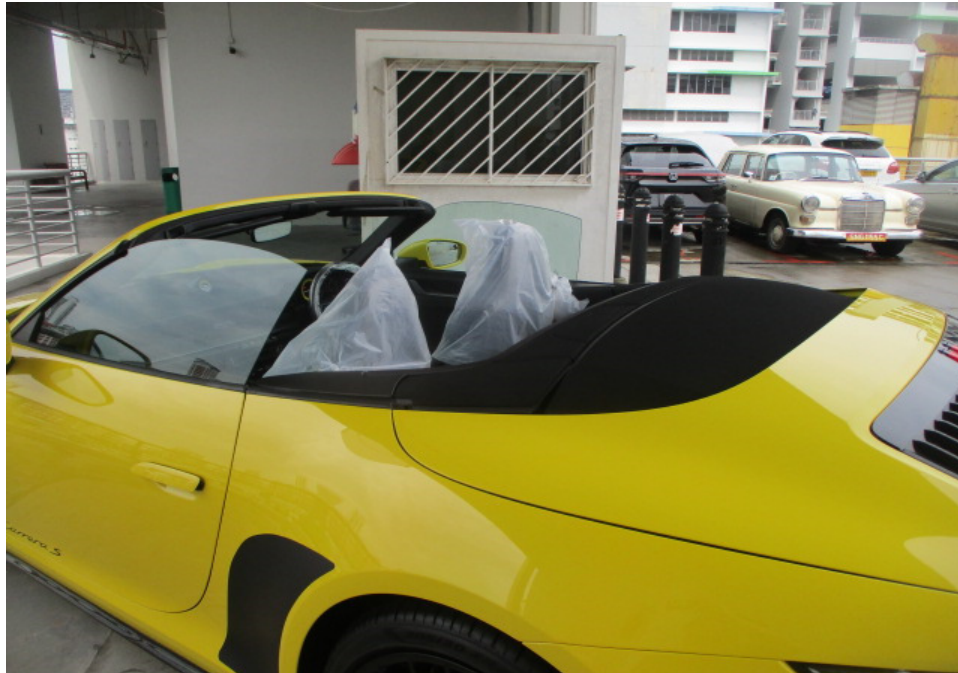
Photo 19 shows the Motor Car with its soft top roof completely folded. It was observed that as a safety feature, the soft top roof could only open and close when the Motor Car was in a stationary position or at low travelling speed. When opened, the soft top roof is completely folded into the rear compartment with no parts protruding out of the Motor Car's body. The soft top roof was also found adequately secured to the "A" pillar after closing.

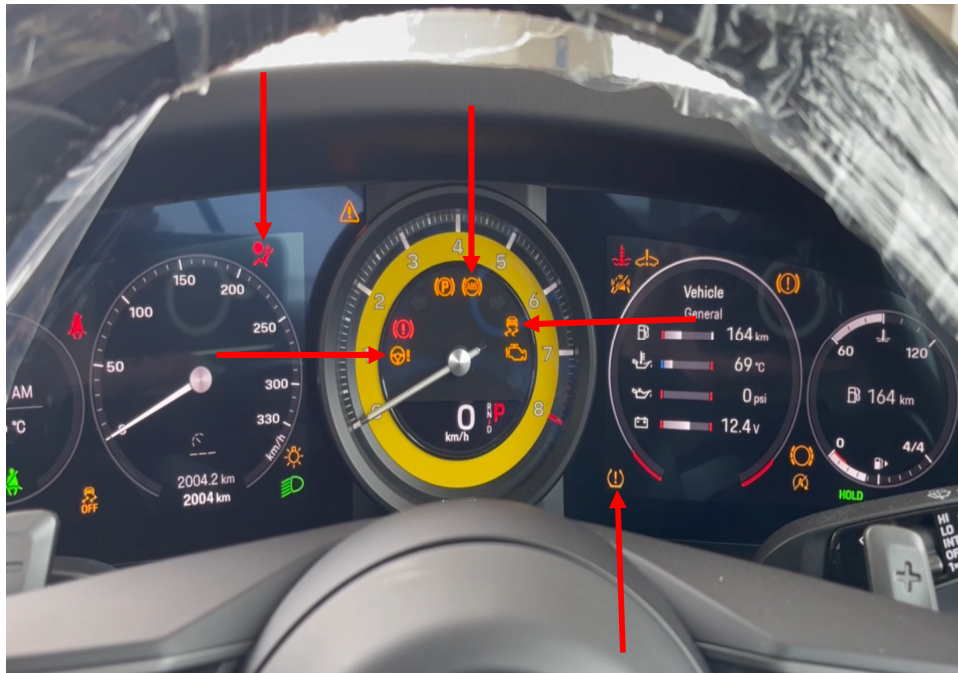
Photo 20 shows the warning lights for the various electronic safety features appearing on the instrument panel of the Motor Car during its self-test when the engine is cranked, in particular the ABS, SRS, EPS, TPM and TCS lights (arrowed).

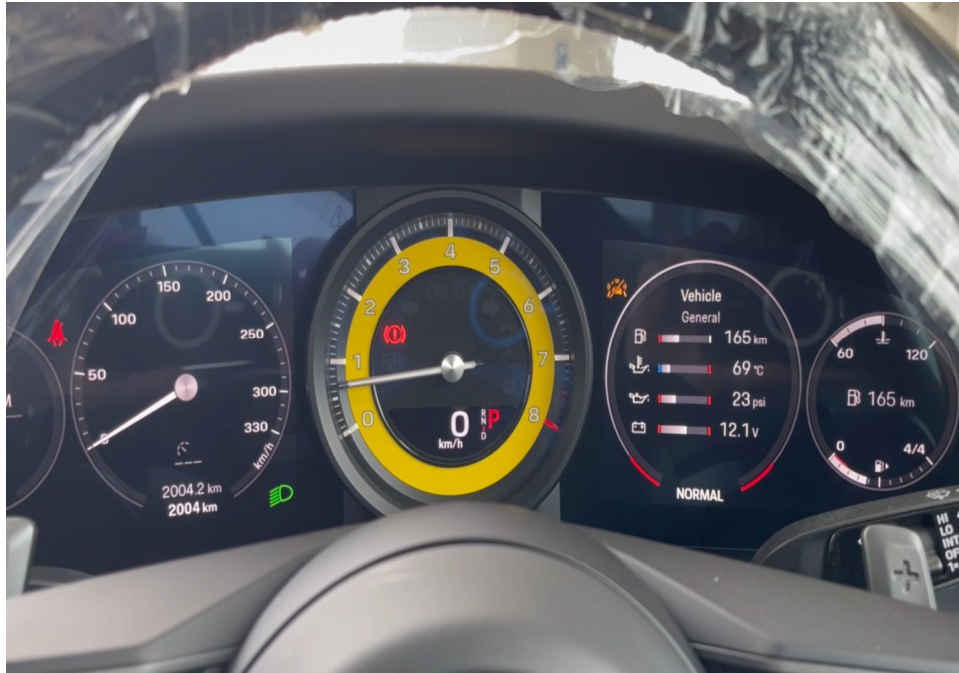
Photo 21 shows the respective warning lights no longer illuminated, indicating that there is no fault detected to the ABS, SRS, EPS, TPM and TCS systems of the Motor Car during the self-test. These electronic systems were hence in working condition at the time of my inspection.

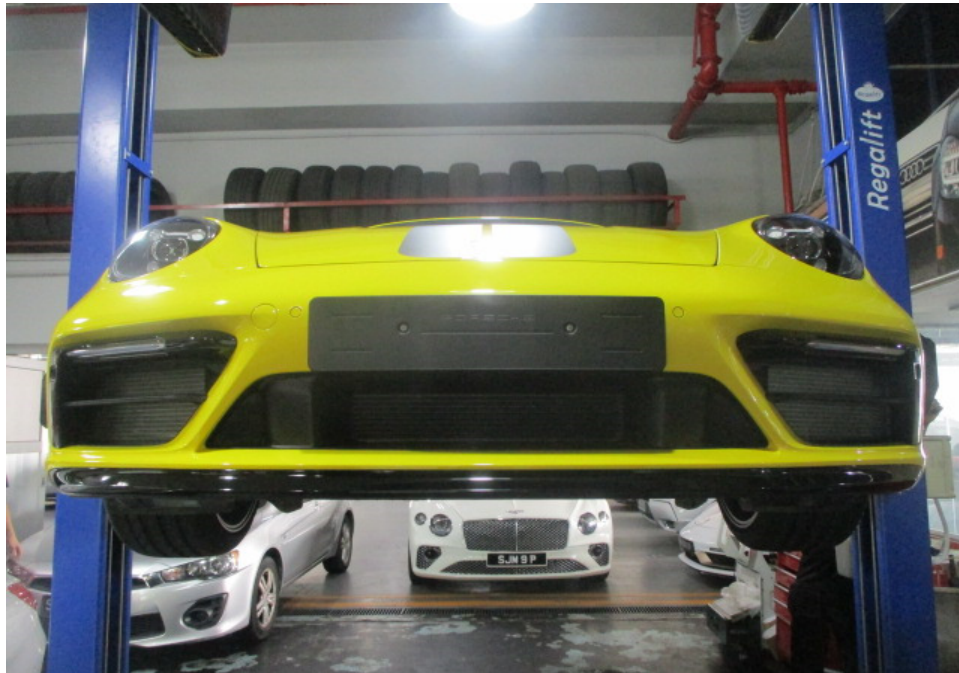
Photo 22 shows the Motor Car hoisted up for checks on its undercarriage. There was no sign(s) or indication(s) of fluid leakage and/or fluid stain(s) on the underside of the Motor Car. The undercarriage components of the Motor Car were also all observed to be intact and secured in an appropriate manner.

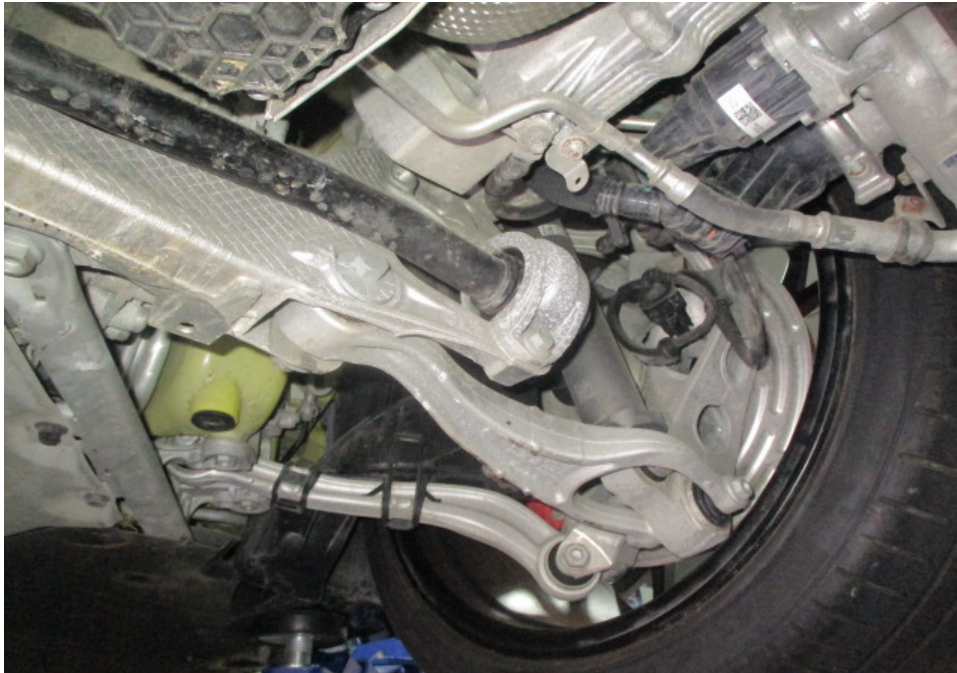
Photo 23 shows a general view of the control arms and linkages at the rear right wheel of the Motor Car. I did not observe any fluid leak and/or fluid stain on the underside of the Motor Car. All of the Motor Car's undercarriage components were observed to be intact and secured in an appropriate manner.

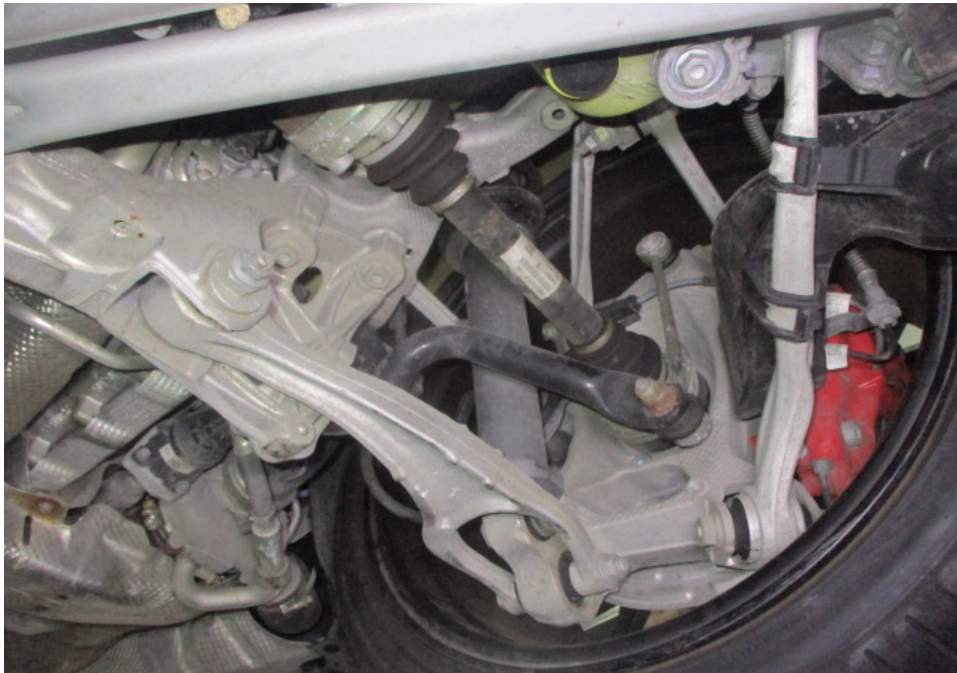
Photo 24 shows a general view of the control arms and linkages at the rear left wheel of the Motor Car. I did not observe any fluid leak and/or fluid stain on the underside of the Motor Car. All of the Motor Car's undercarriage components were observed to be intact and secured in an appropriate manner.

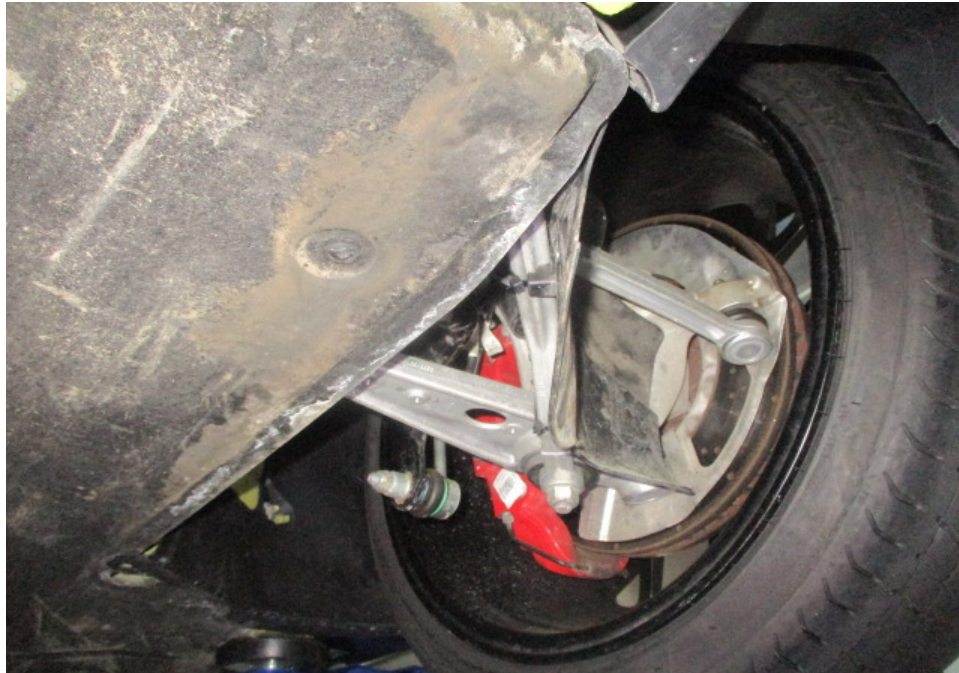
Photo 25 shows the various undercarriage components at the front left wheel of the Motor Car. The mechanical components, control arms and linkages were all found to be intact and secured in an appropriate manner.

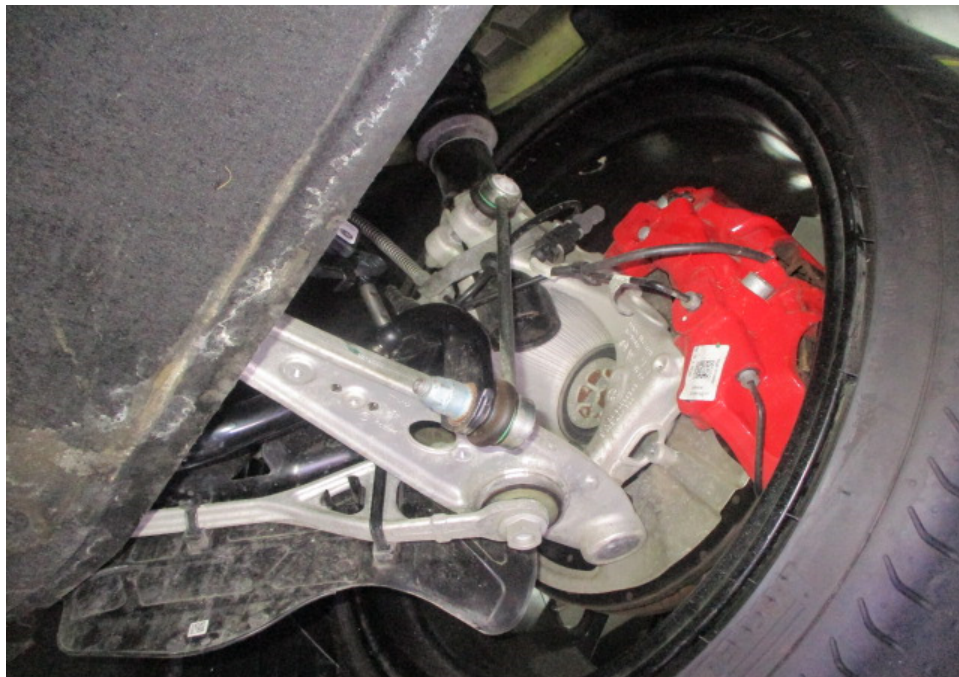
Photo 26 shows the various undercarriage components at the front right wheel of the Motor Car. The mechanical components, control arms and linkages were all found to be intact and secured in an appropriate manner. I also did not observe any fluid leak and/or fluid stain on the underside of the Motor Car.

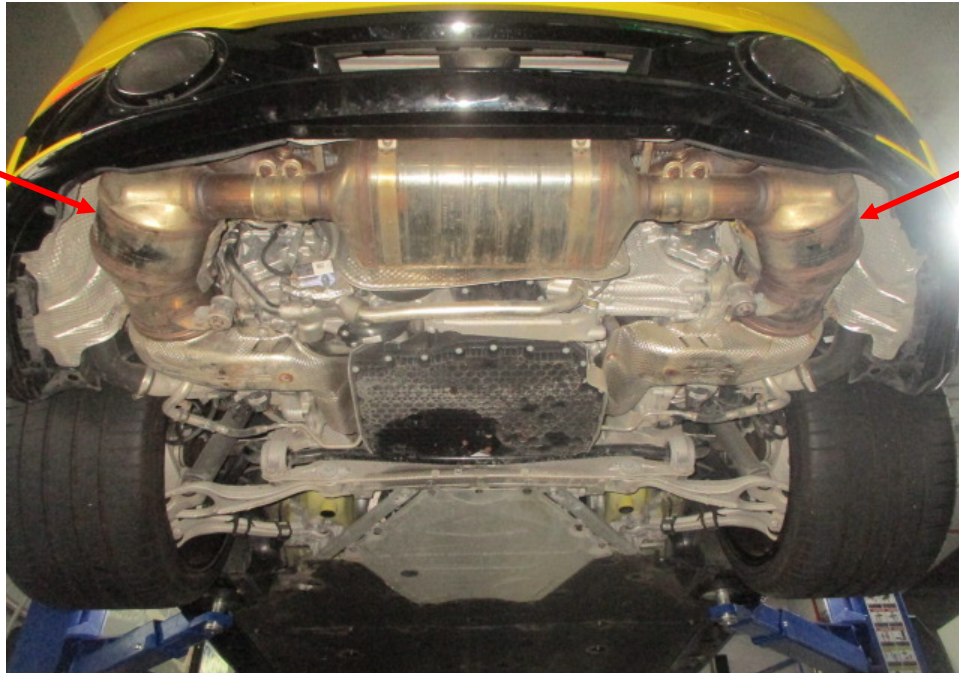
Photo 27 shows the Motor Car's exhaust system. My examination of the Motor Car's exhaust system revealed no sign(s) or indication(s) of any cut or weld marks along its exhaust pipes, on its catalytic converters (arrowed) and on its rear muffler.

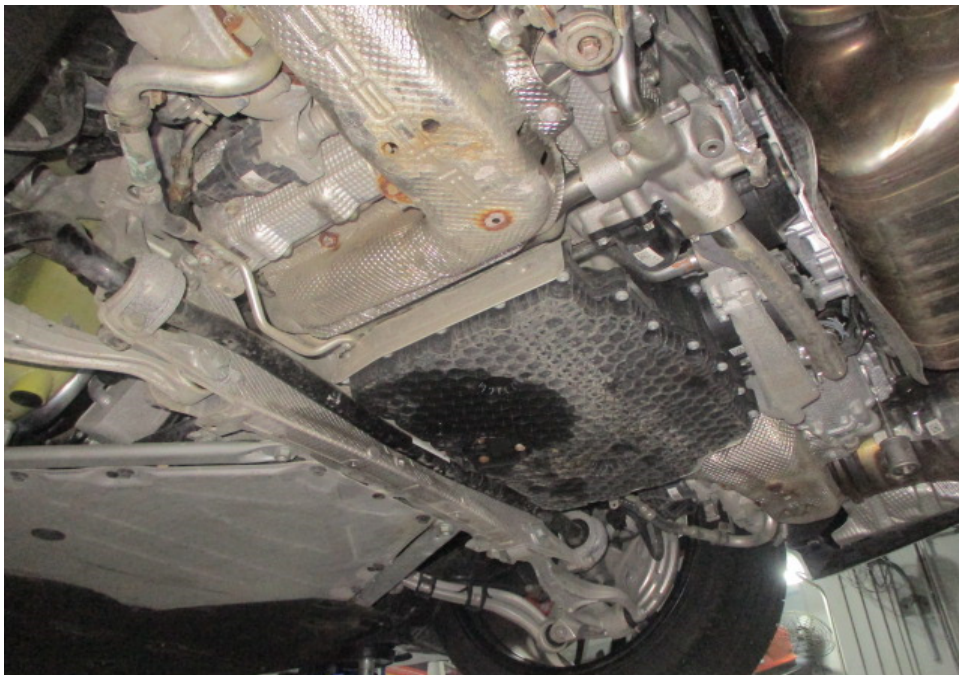
Photo 28 shows a general view of the Motor Car's engine compartment. The engine compartment was at the rear underside of the Motor Car. The various parts and components within the engine compartment were all observed to be intact and properly fitted. There was also no sign(s) or indication(s) of fluid leak and/or fluid stain found inside the engine compartment.

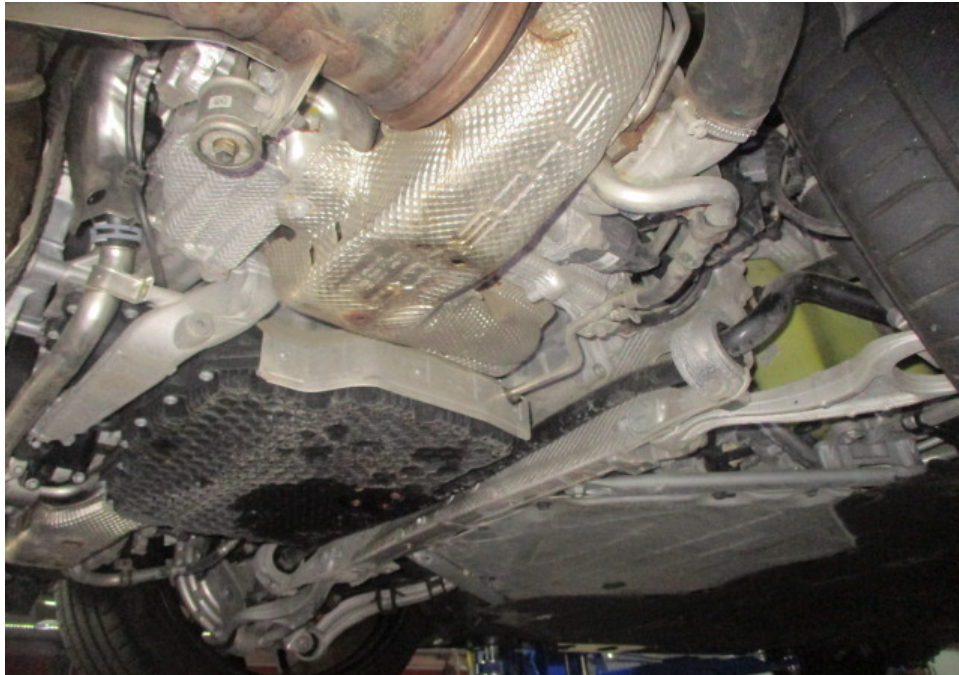
Photo 29 shows another view of the Motor Car's engine compartment. The engine compartment was at the rear underside of the Motor Car. The various parts and components within the engine compartment were all observed to be intact and properly fitted. There was also no sign(s) or indication(s) of fluid leak and/or fluid stain found inside the engine compartment.

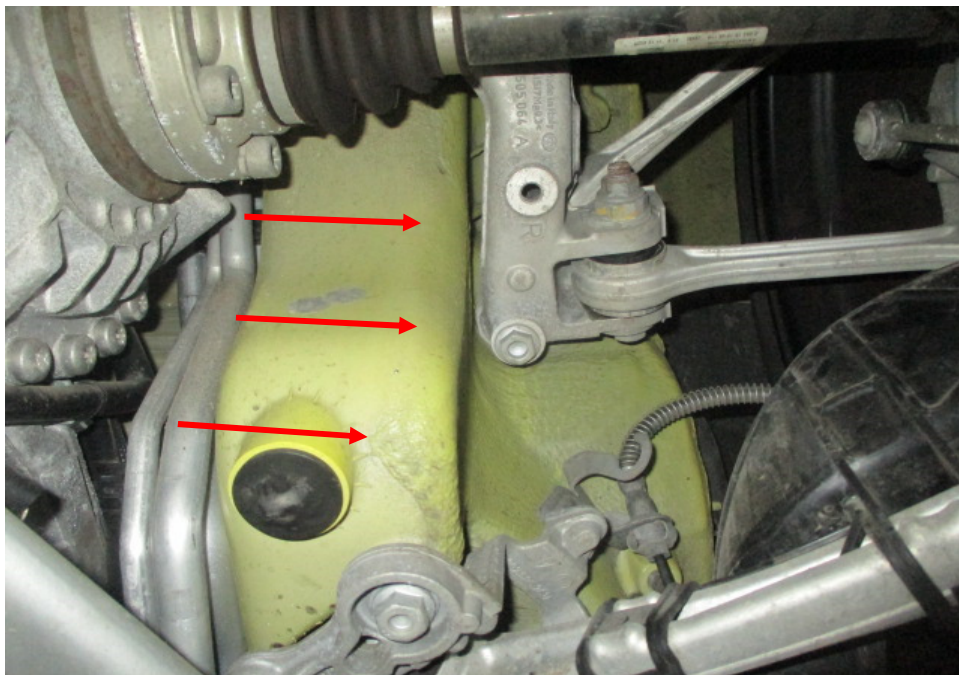
Photo 30 shows the chassis/structural body at the underside rear right of the Motor Car. I did not find any weld marks other than original spot weld marks on the chassis/structural body of the Motor Car. The original factory sealant (arrowed) at the joints along the chassis/structural body was untouched, indicating no work was done on the chassis/structural body of the Motor Car and that the chassis/structural body was originally fitted.
